Clean Water Act Section 404: Site Visit/Case Development

Site Name: Newburg Egg Processing Plant

CWA 404 Inspection
Newburg Egg Processing Plant
Woodridge, Sullivan County, NY

June 22, 2021

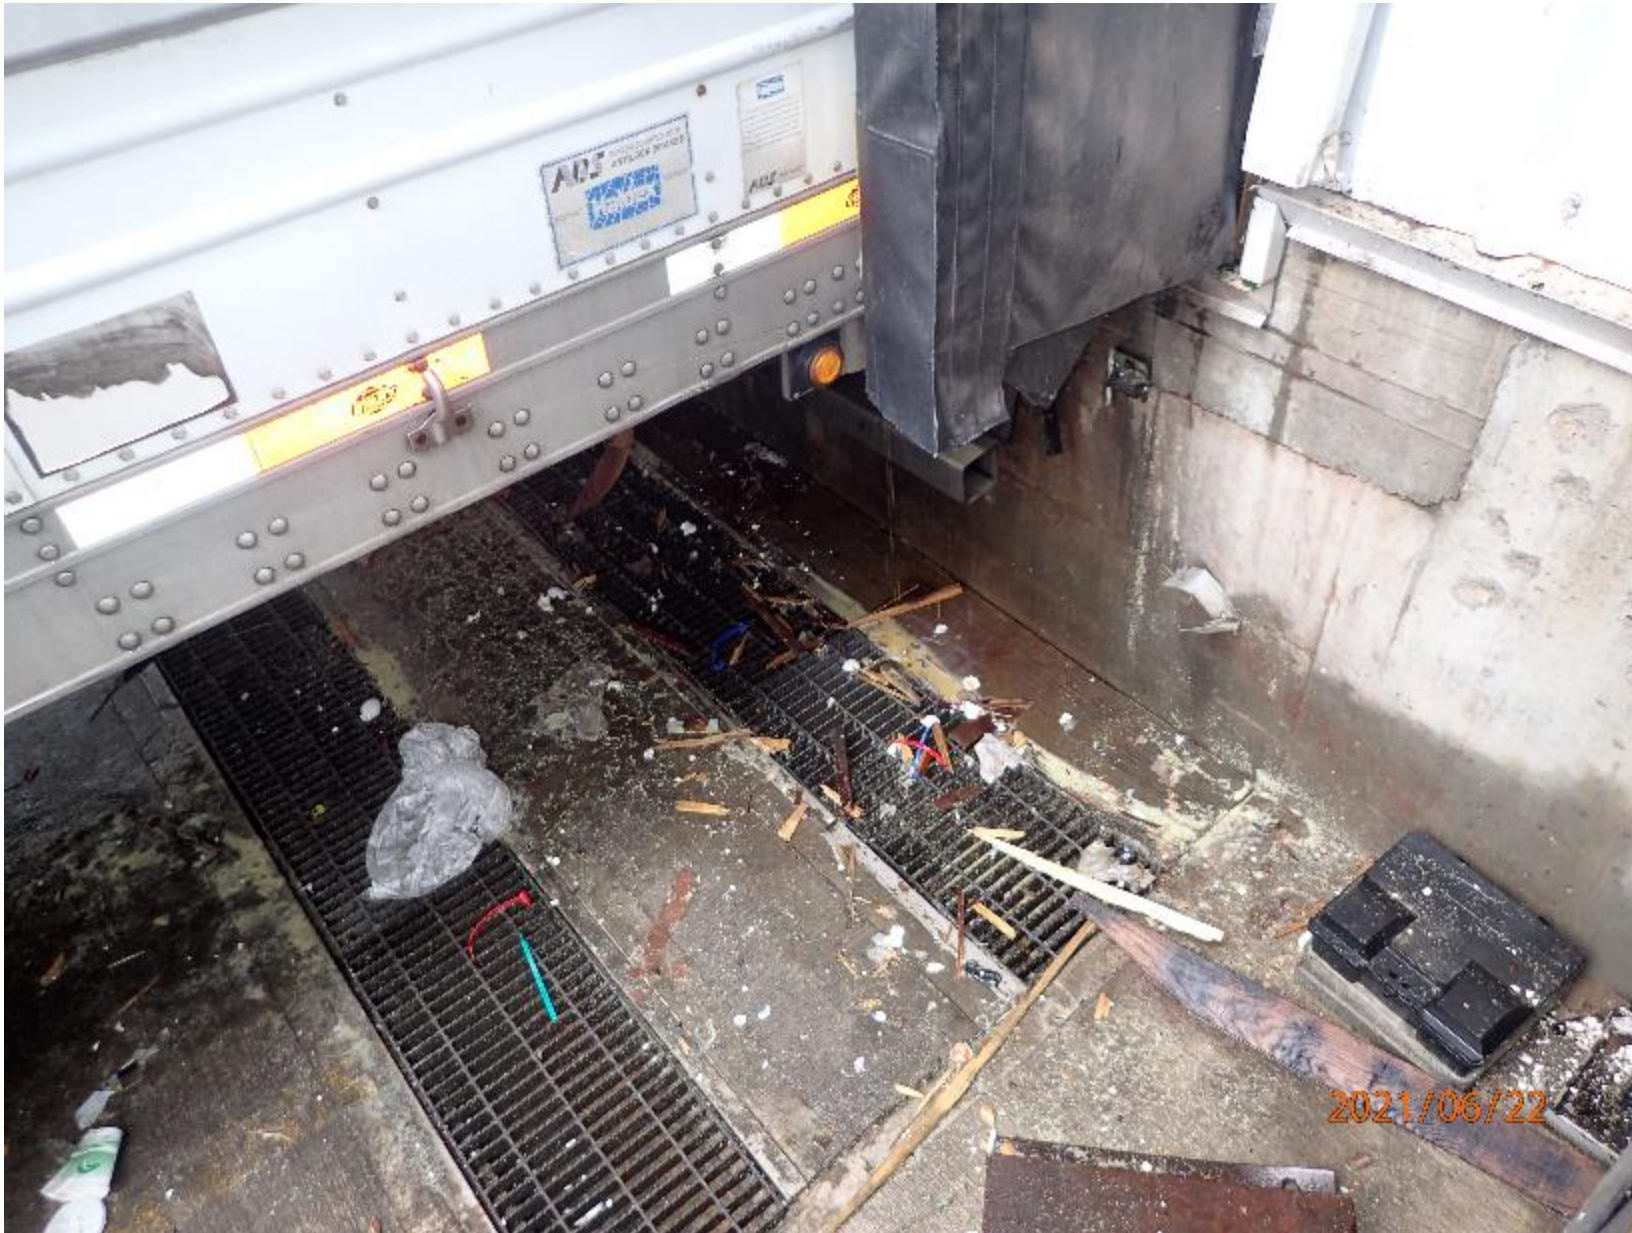
Date: 6/22/2021
Time: 12:22 PM
Photographer: SSA
Photo ID: 1 – P6220132

Broken egg runoff at plant
loading dock

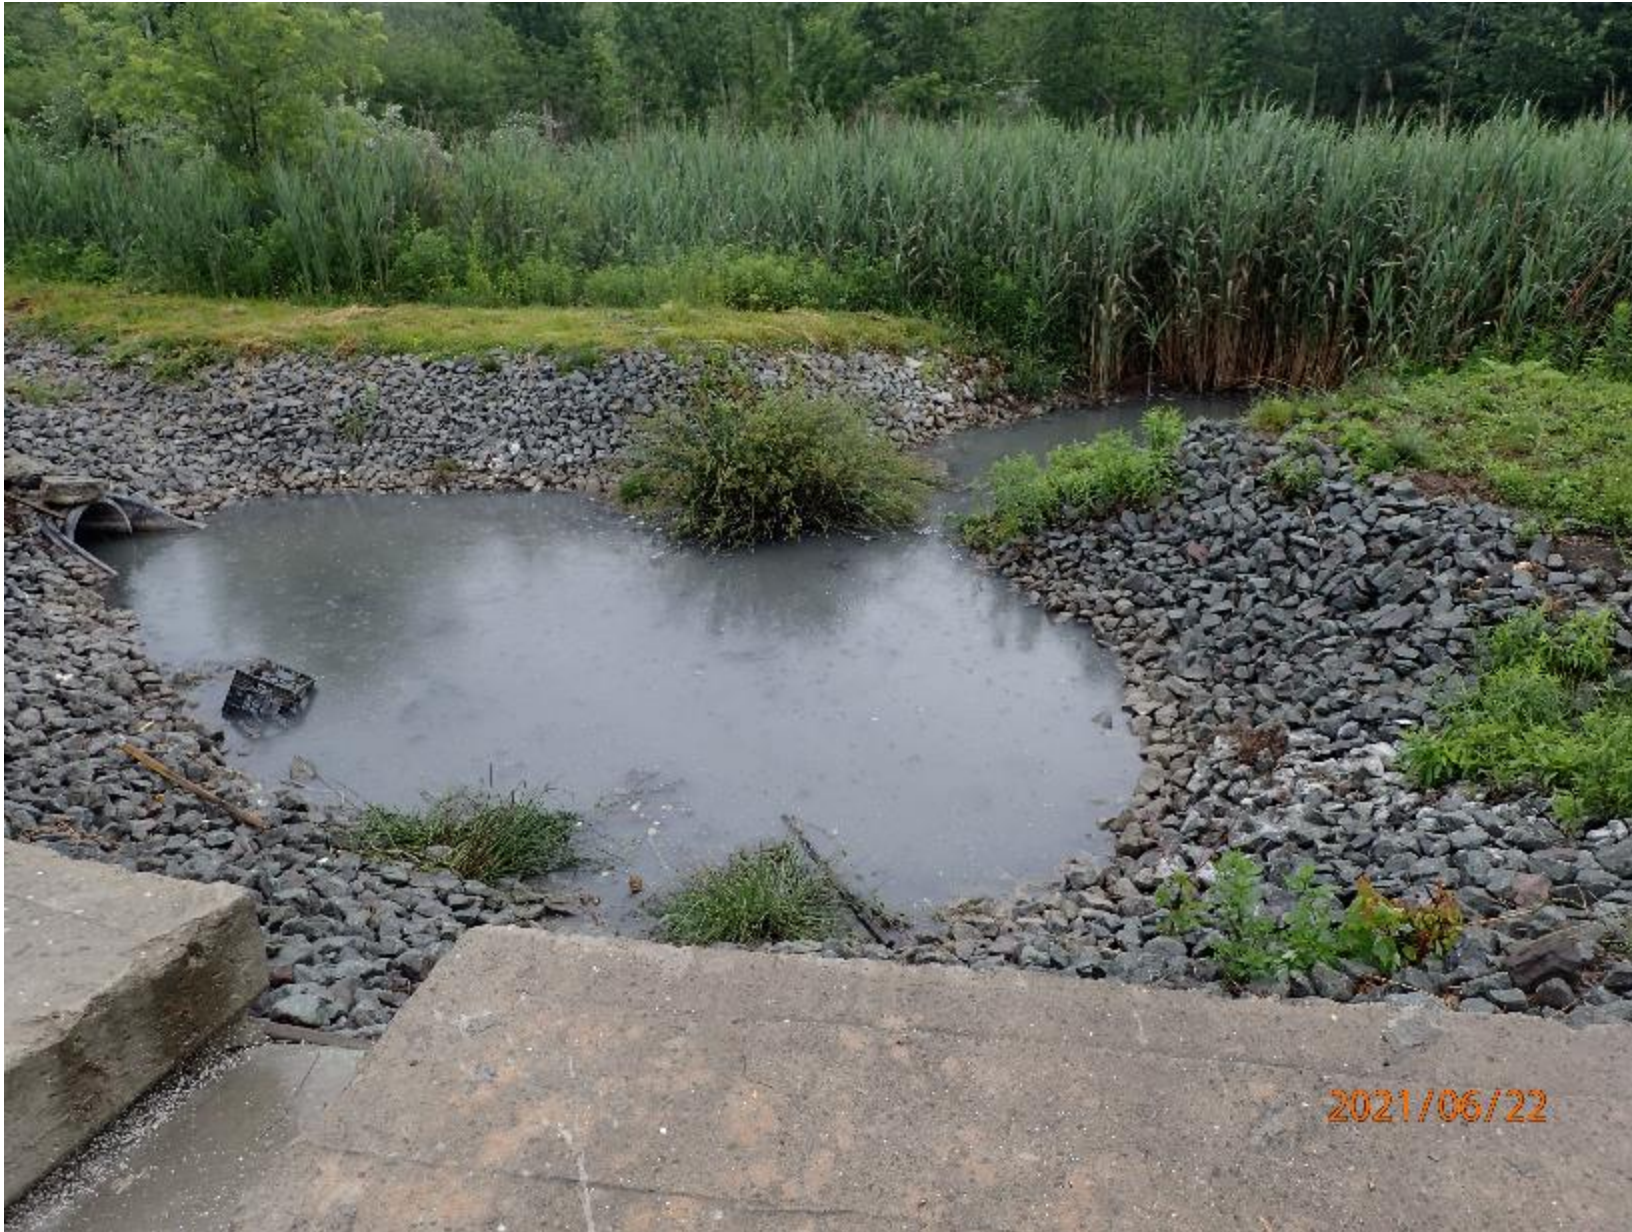
Date: 6/22/2021
Time: 12:38 PM
Photographer: SSA
Photo ID: 2 – P6220133

Stormwater basin lined with rip-rap draining to emergent NWI/DEC wetland.

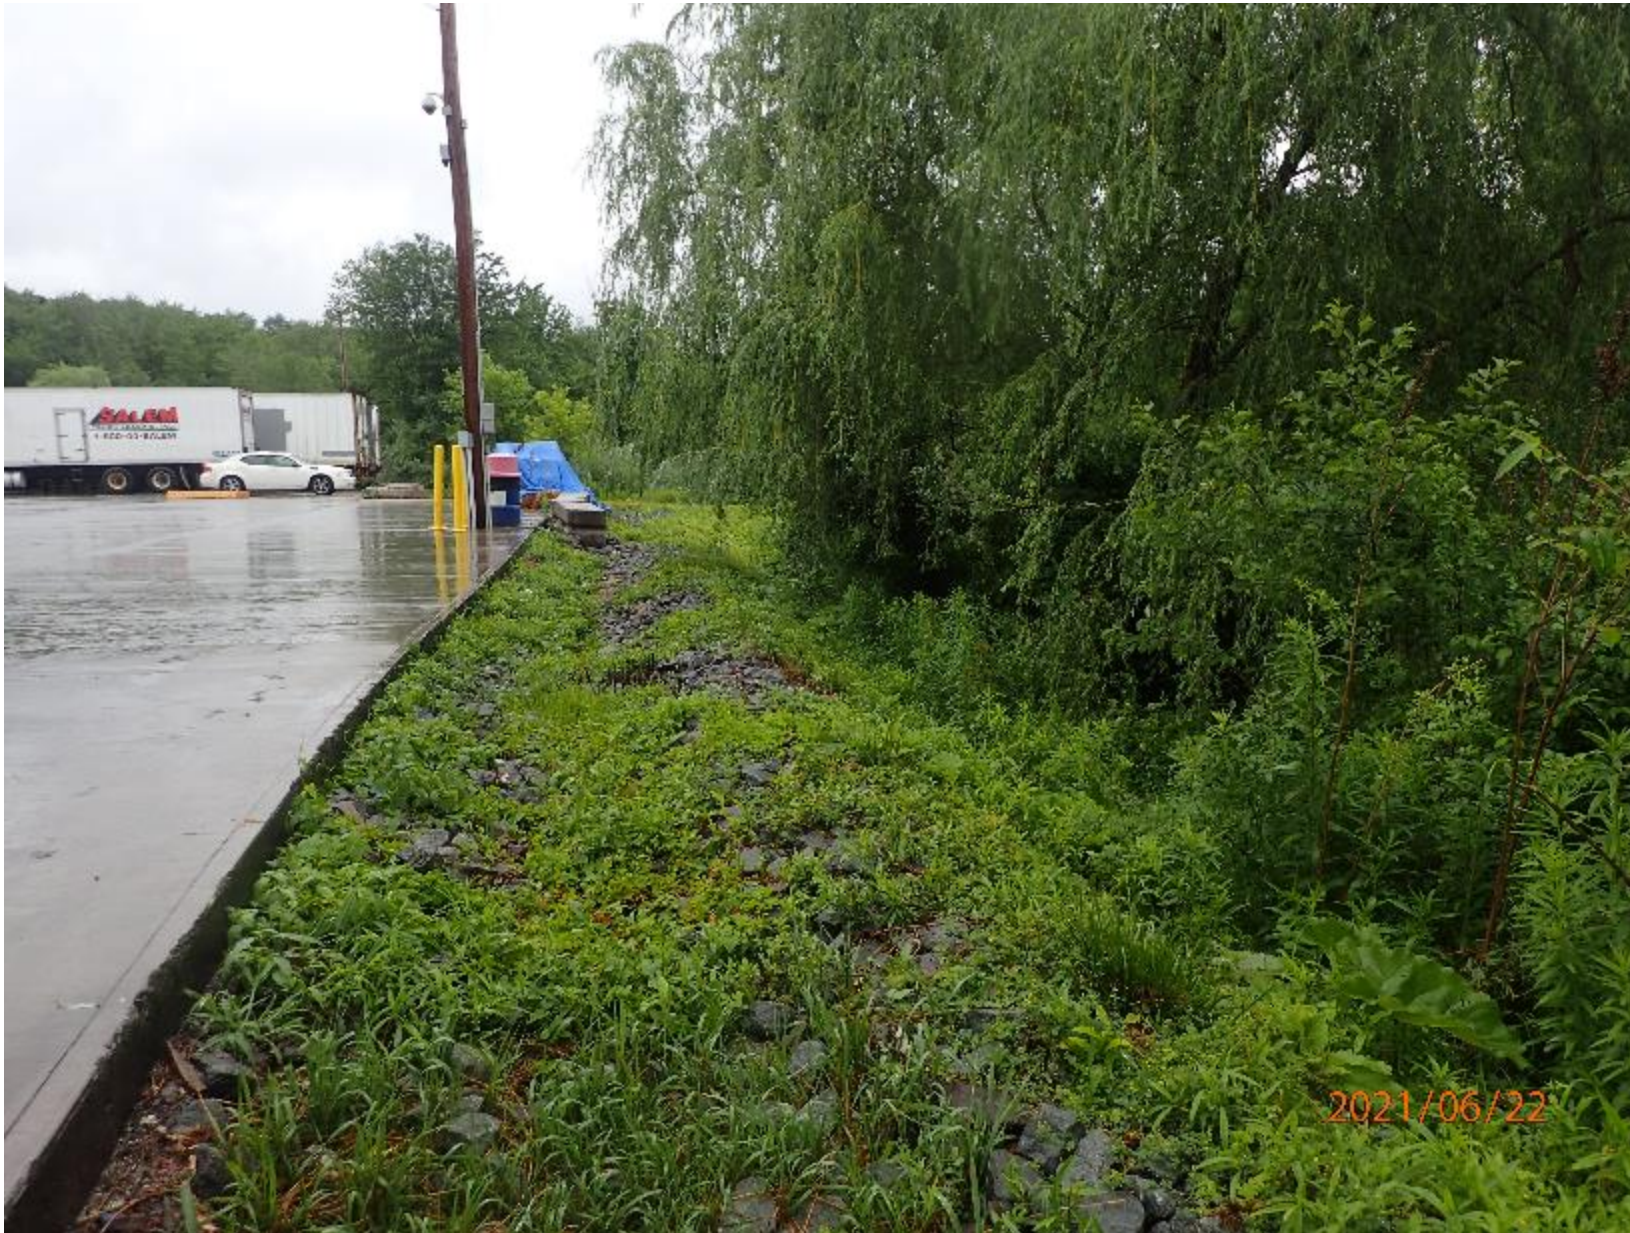
Date: 6/22/2021
Time: 12:42 PM
Photographer: SSA
Photo ID: 3 – P6220134

Rip-rap lined stormwater channel that drains towards stormwater basin

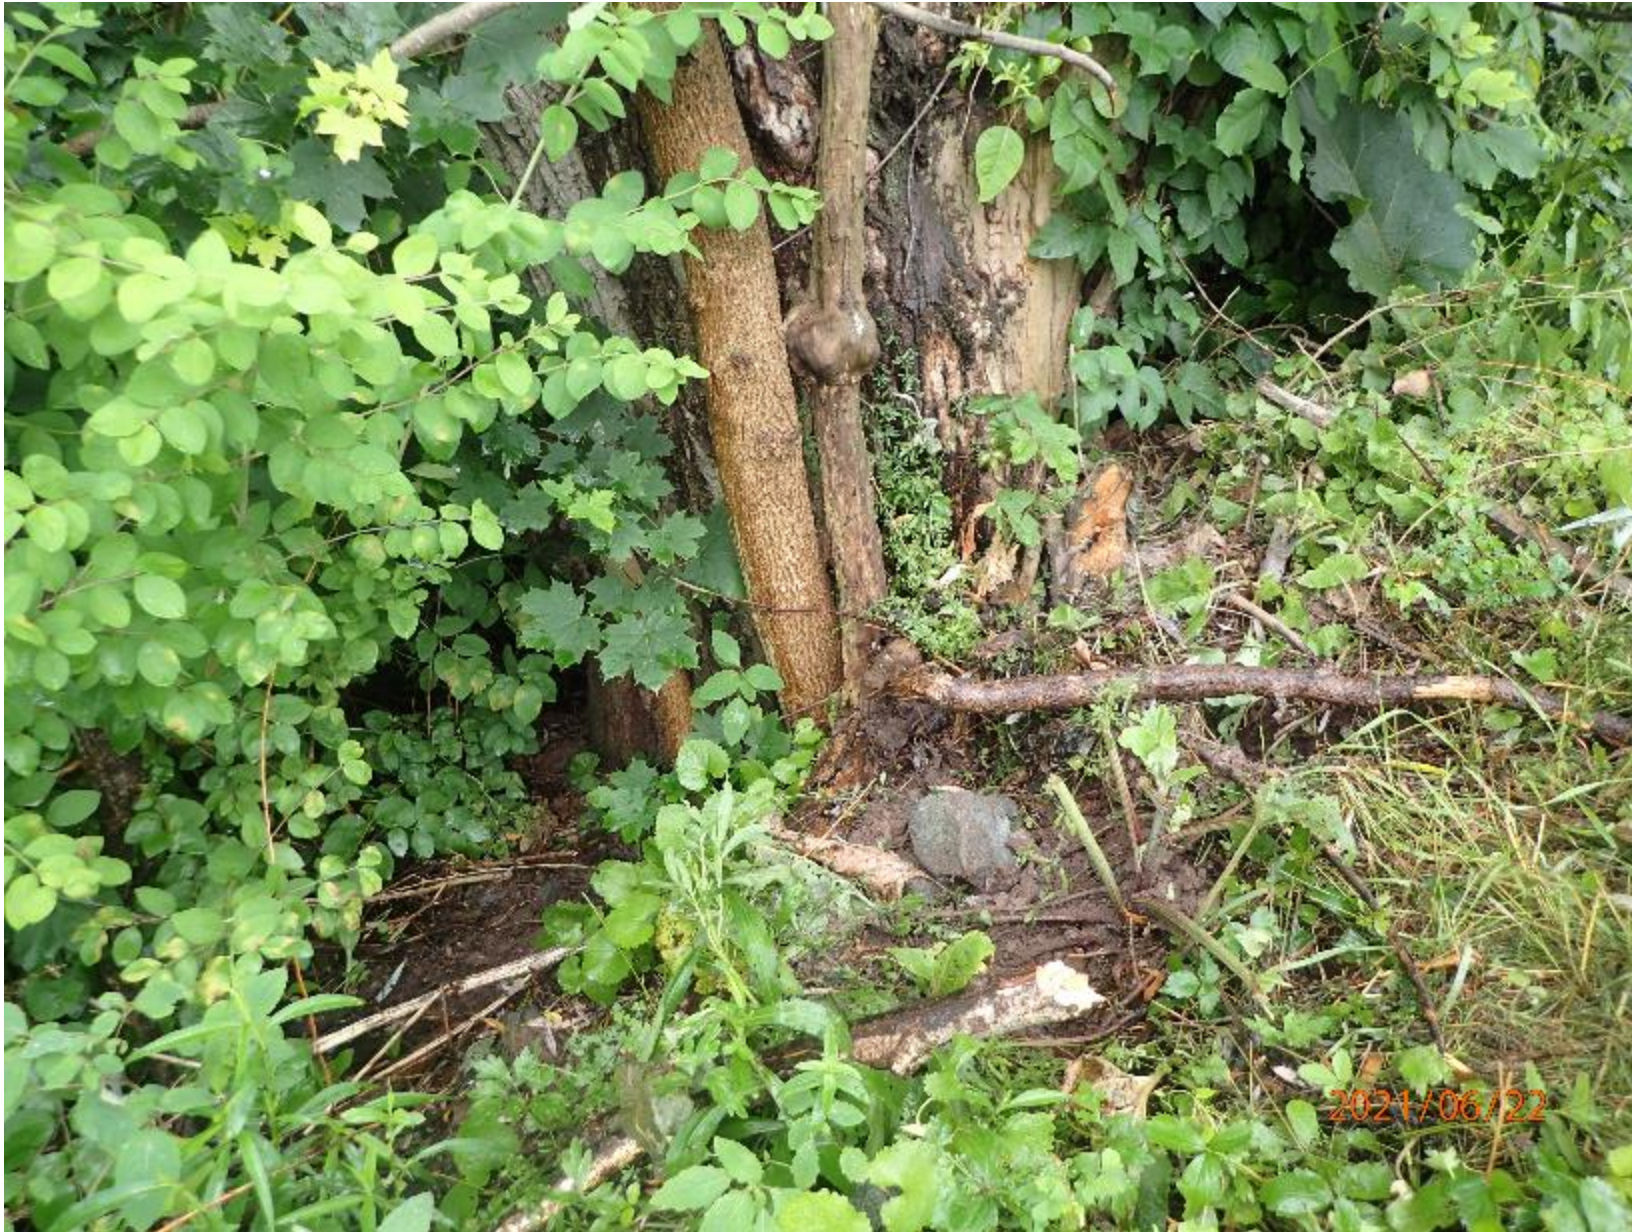
Date: 6/22/2021
Time: 12:49 PM
Photographer: SSA
Photo ID: 4 – P6220135

Fill surrounding large tree near
stormwater channel south of
stormwater basin

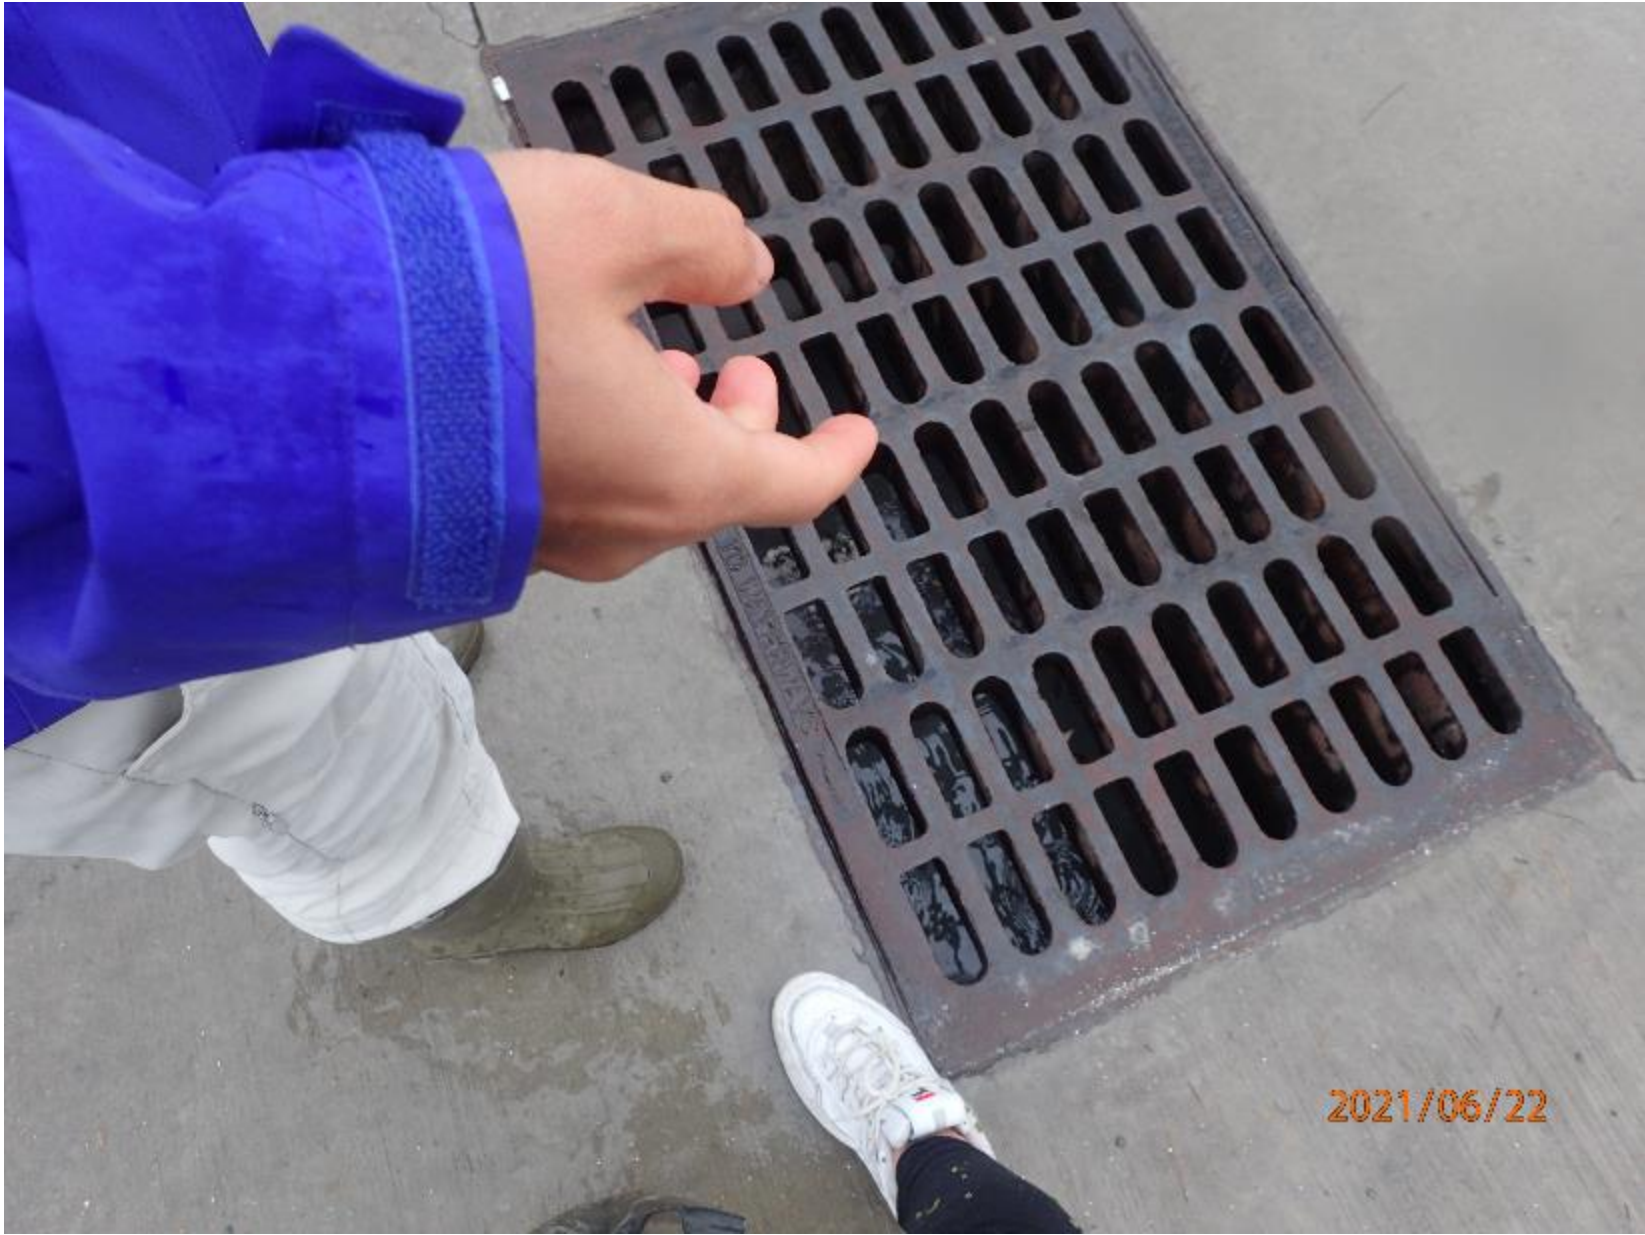
Date: 6/22/2021
Time: 12:53 PM
Photographer: SSA
Photo ID: 5 – P6220136

Description:
Accidental photo of stormwater
grate

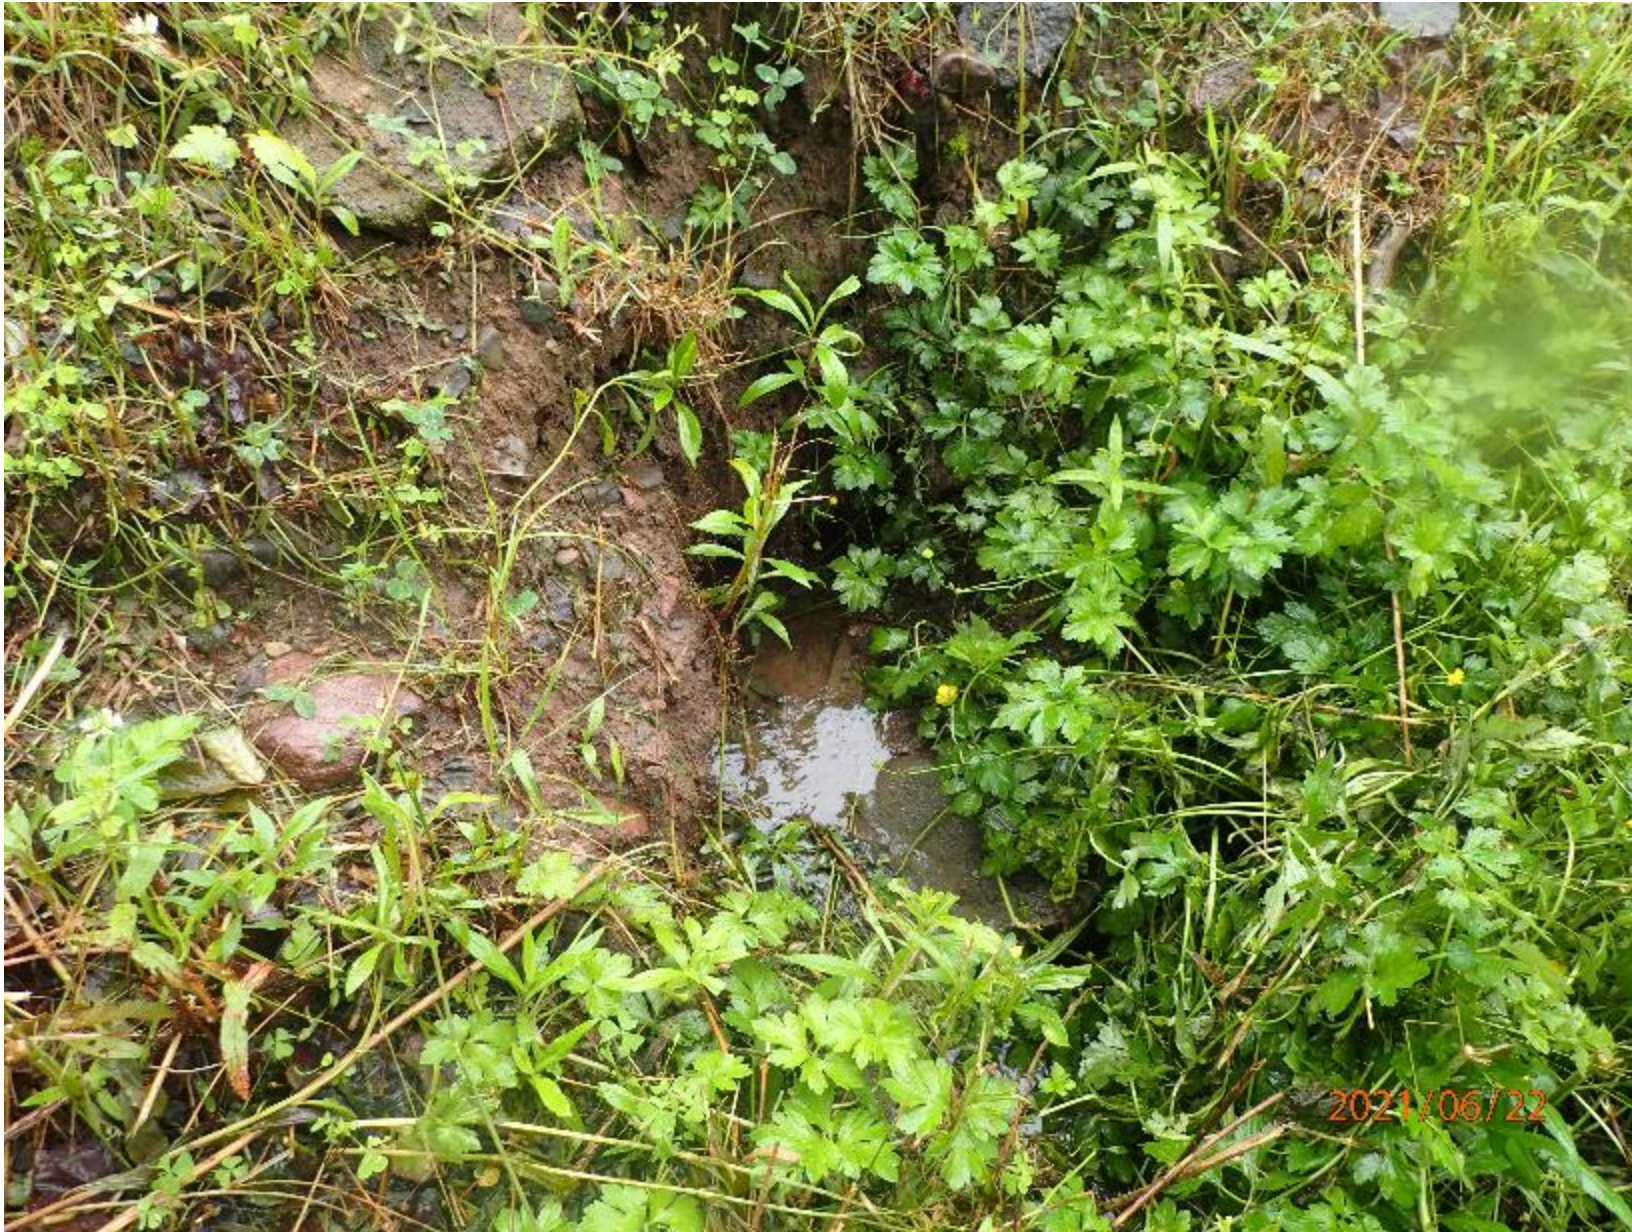
Date: 6/22/2021
Time: 1:03 PM
Photographer: SSA
Photo ID: 7 – P6220138

(1/4) Water flowing from underneath fill material to large NWI/DEC wetland

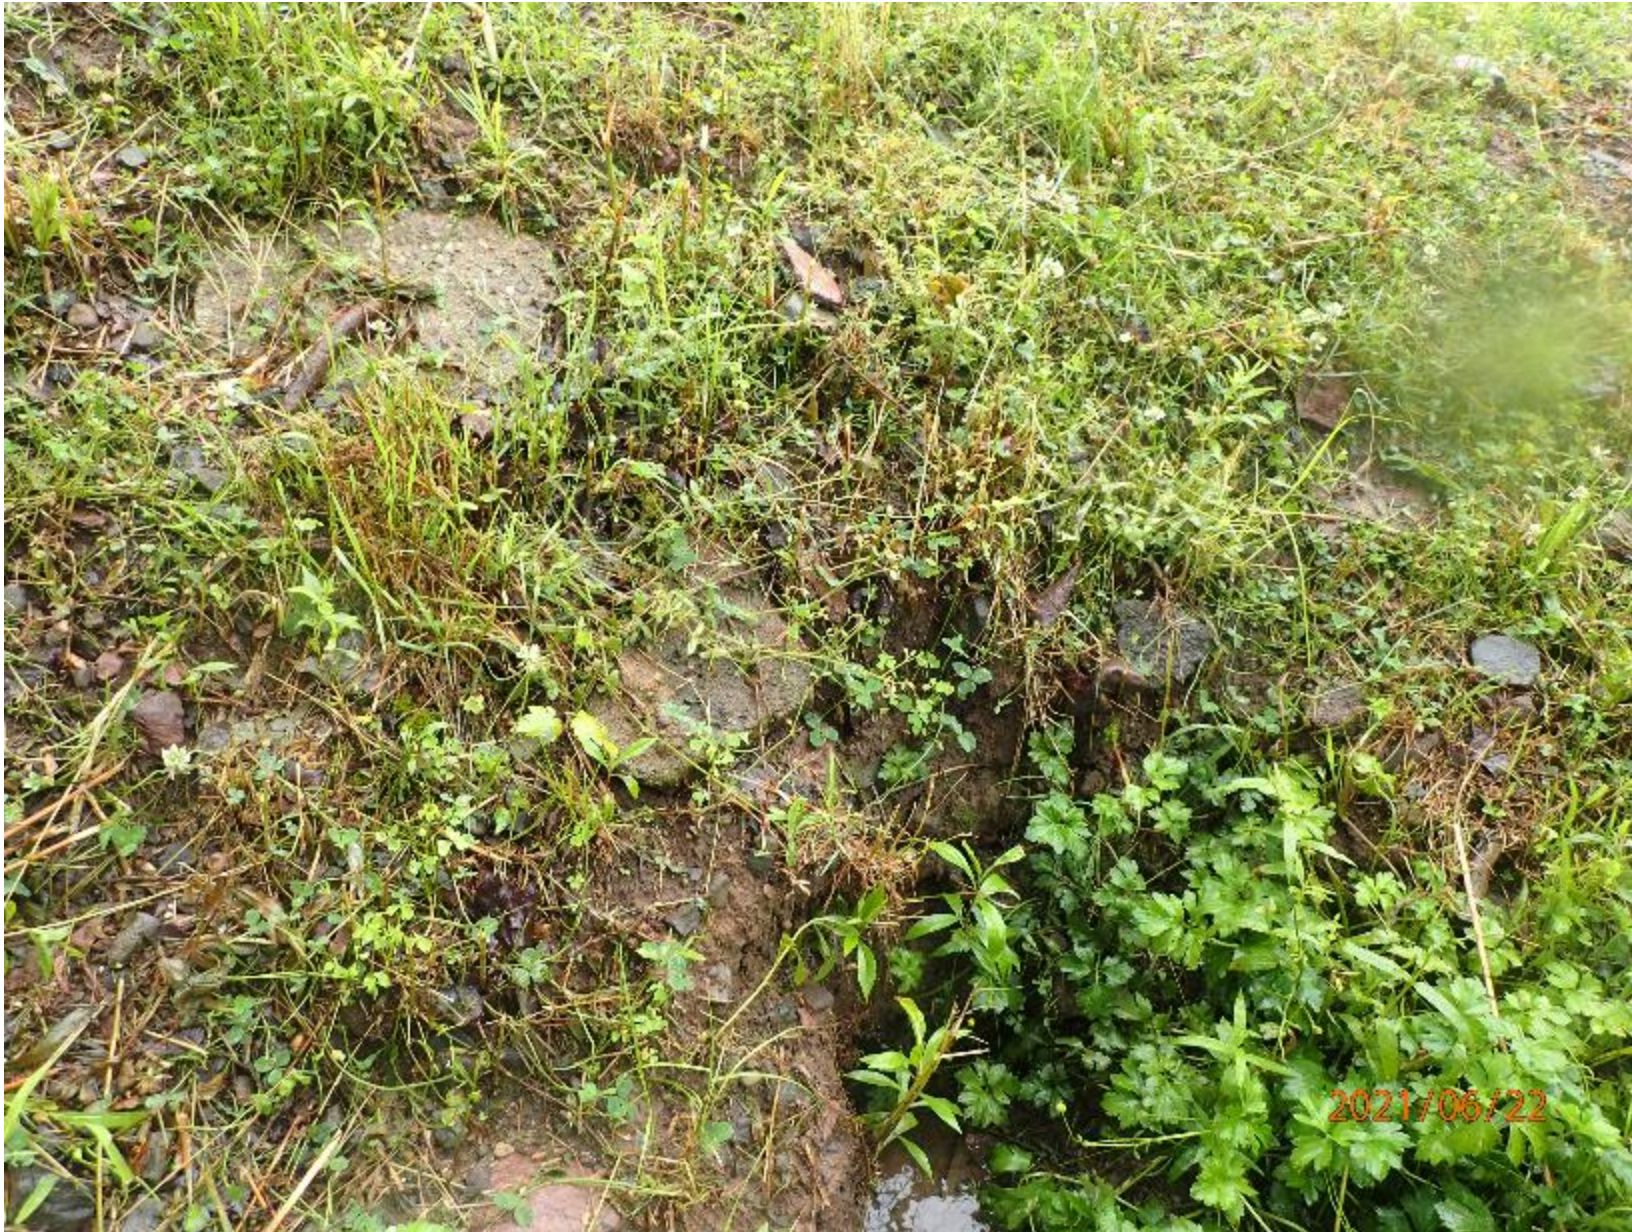
Date: 6/22/2021
Time: 1:03 PM
Photographer: SSA
Photo ID: 8 – P6220139

(2/4) Water flowing from underneath fill material to large NWI/DEC wetland

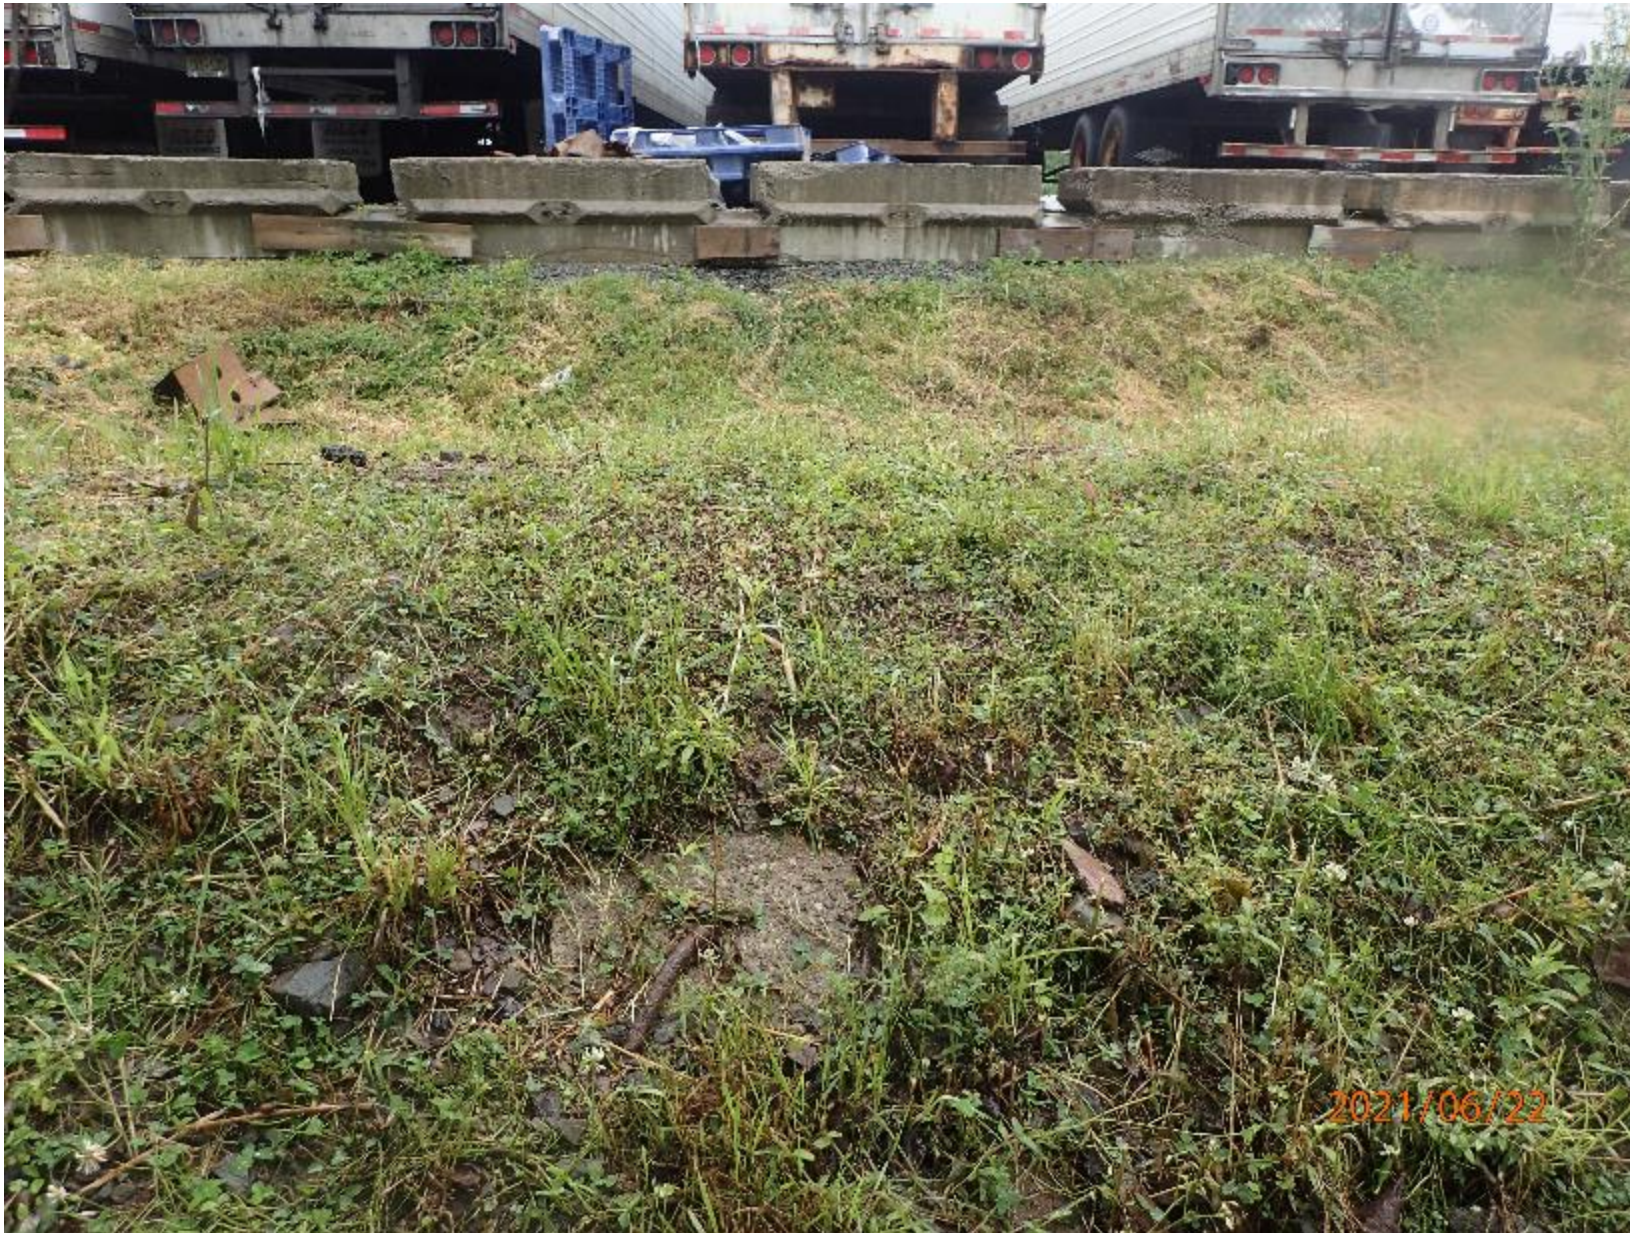
Date: 6/22/2021
Time: 1:03 PM
Photographer: SSA
Photo ID: 9 – P6220140

(3/4) Water flowing from underneath fill material to large NWI/DEC wetland

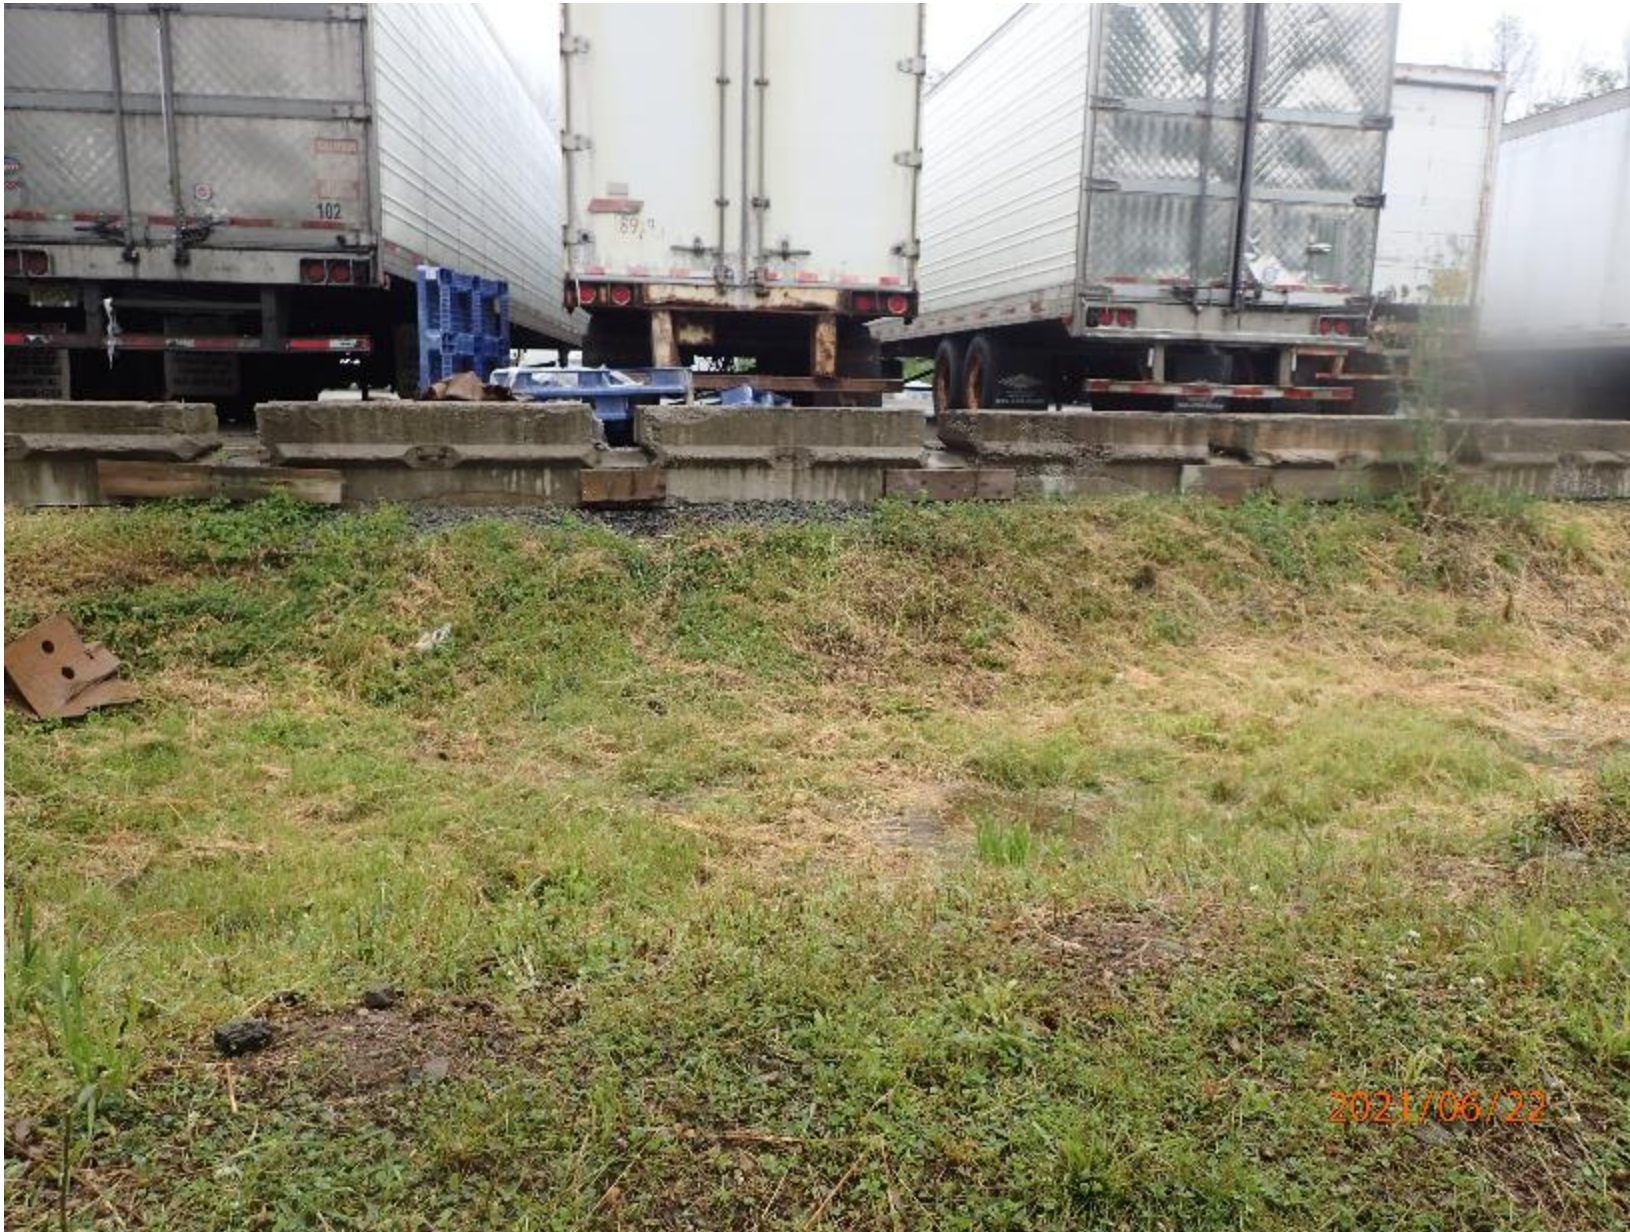
Date: 6/22/2021
Time: 1:03 PM
Photographer: SSA
Photo ID: 10 – P6220141

(4/4) Water flowing from underneath fill material to large NWI/DEC wetland

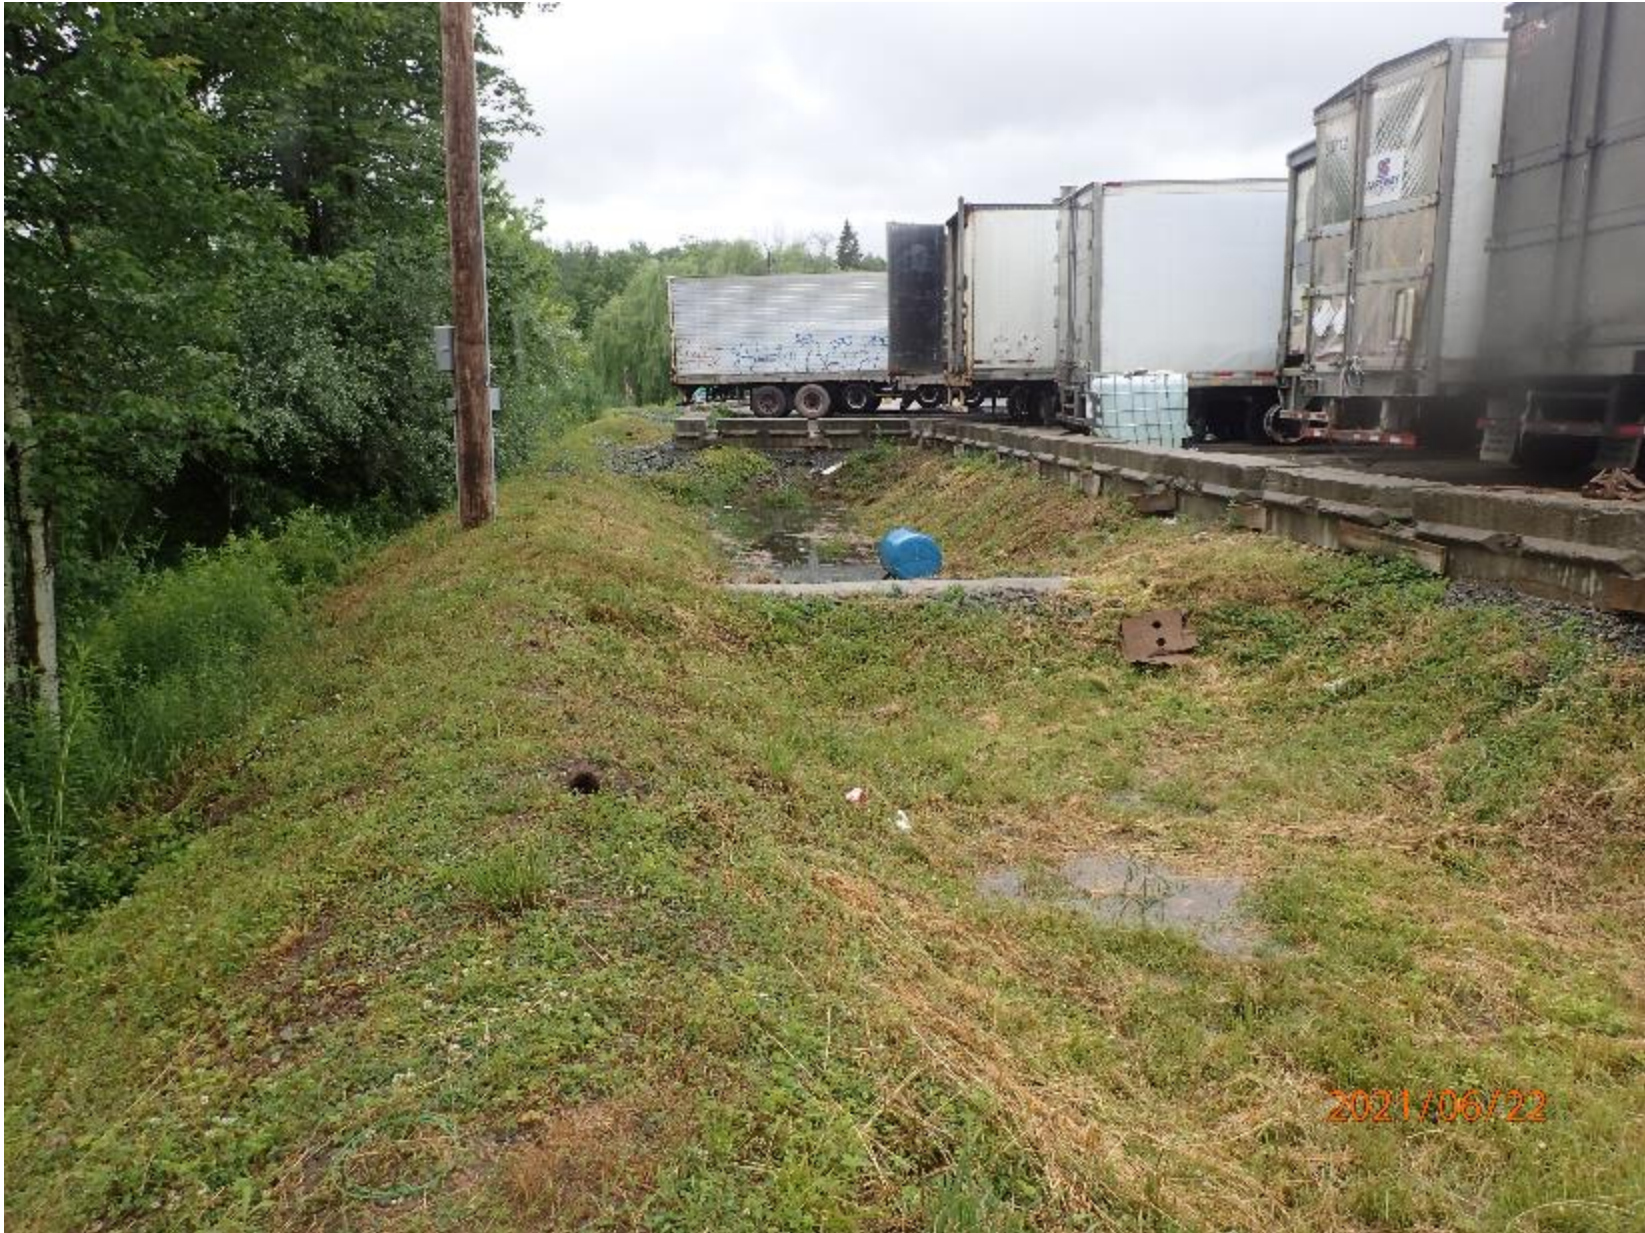
Date: 6/22/2021
Time: 1:07 PM
Photographer: SSA
Photo ID: 11 – P6220142

Description:
(1/5) Water flowing from series of stormwater cells

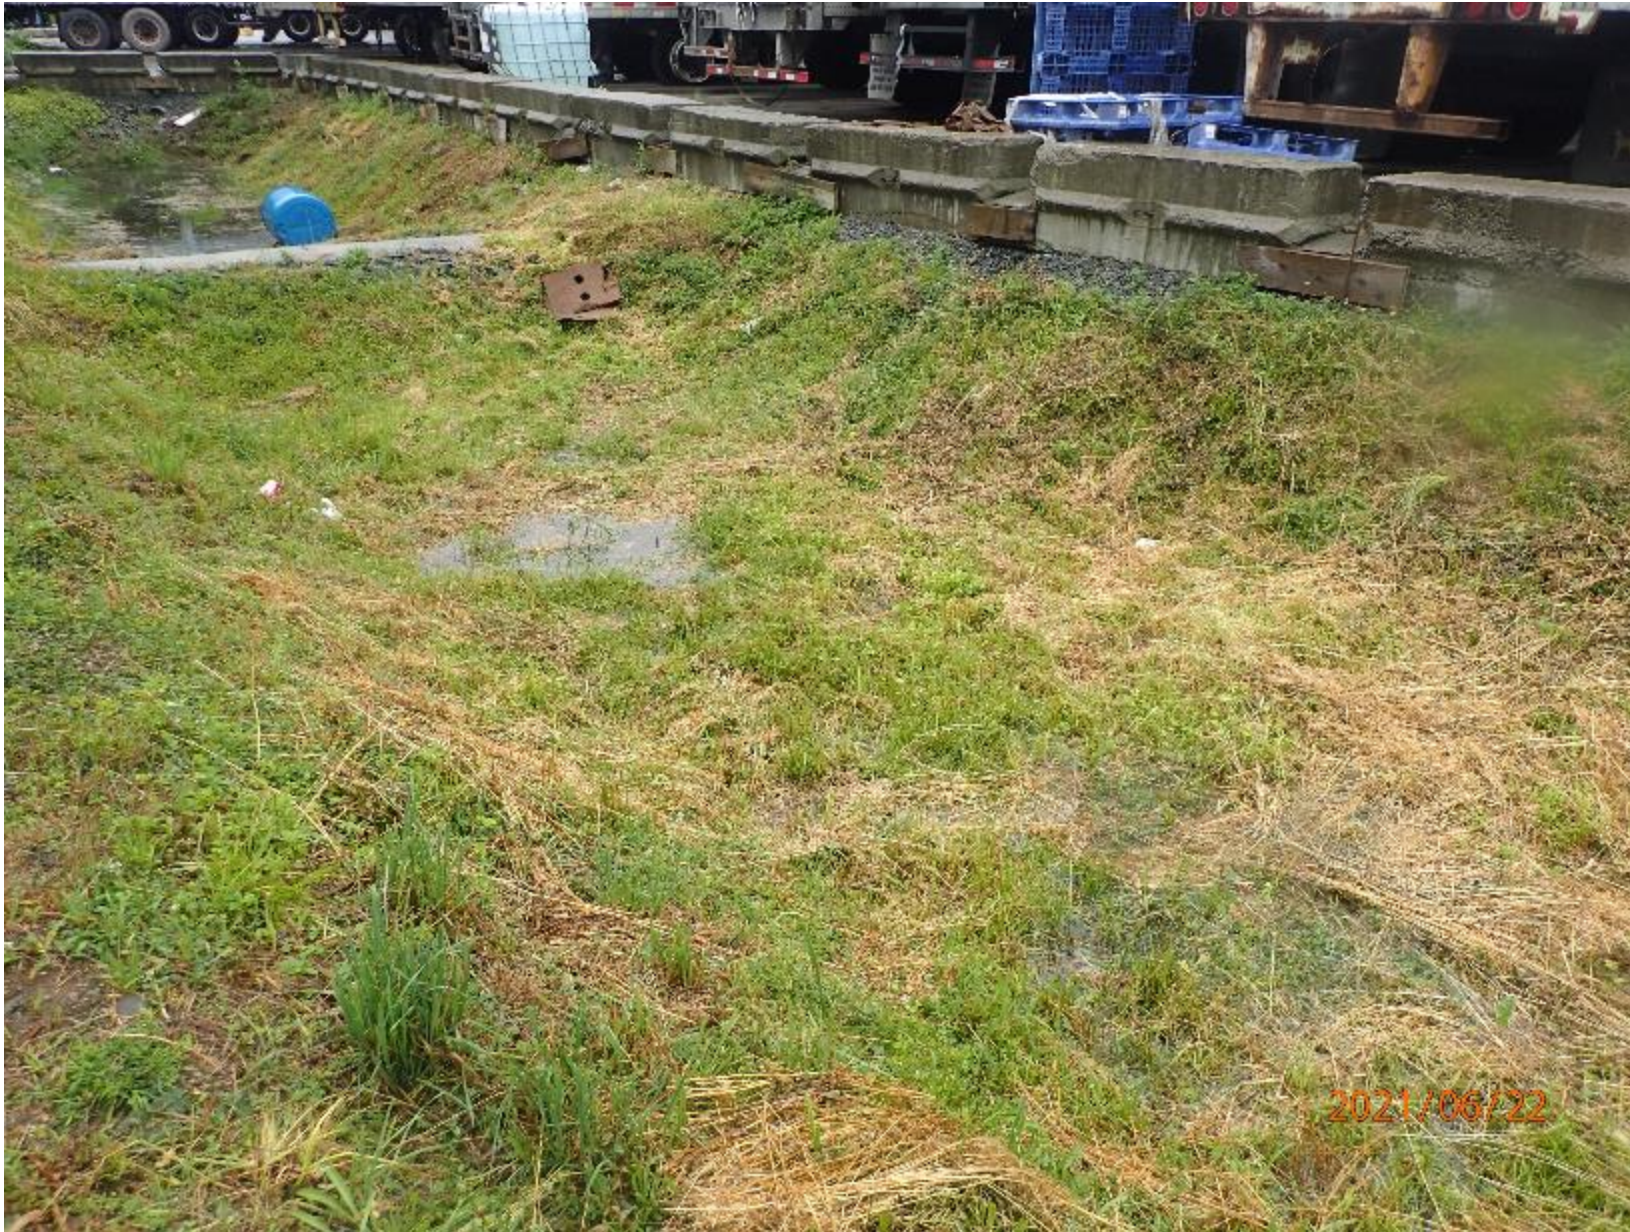
Date: 6/22/2021
Time: 1:07 PM
Photographer: SSA
Photo ID: 12 – P6220143

(2/5) Water flowing from series of stormwater cells
