Clean Water Act Section 404: Site Visit/Case Development

Site Name: Newburg Egg Processing Plant

CWA 404 Inspection
Newburg Egg Processing Plant
Woodridge, Sullivan County, NY

June 22, 2021

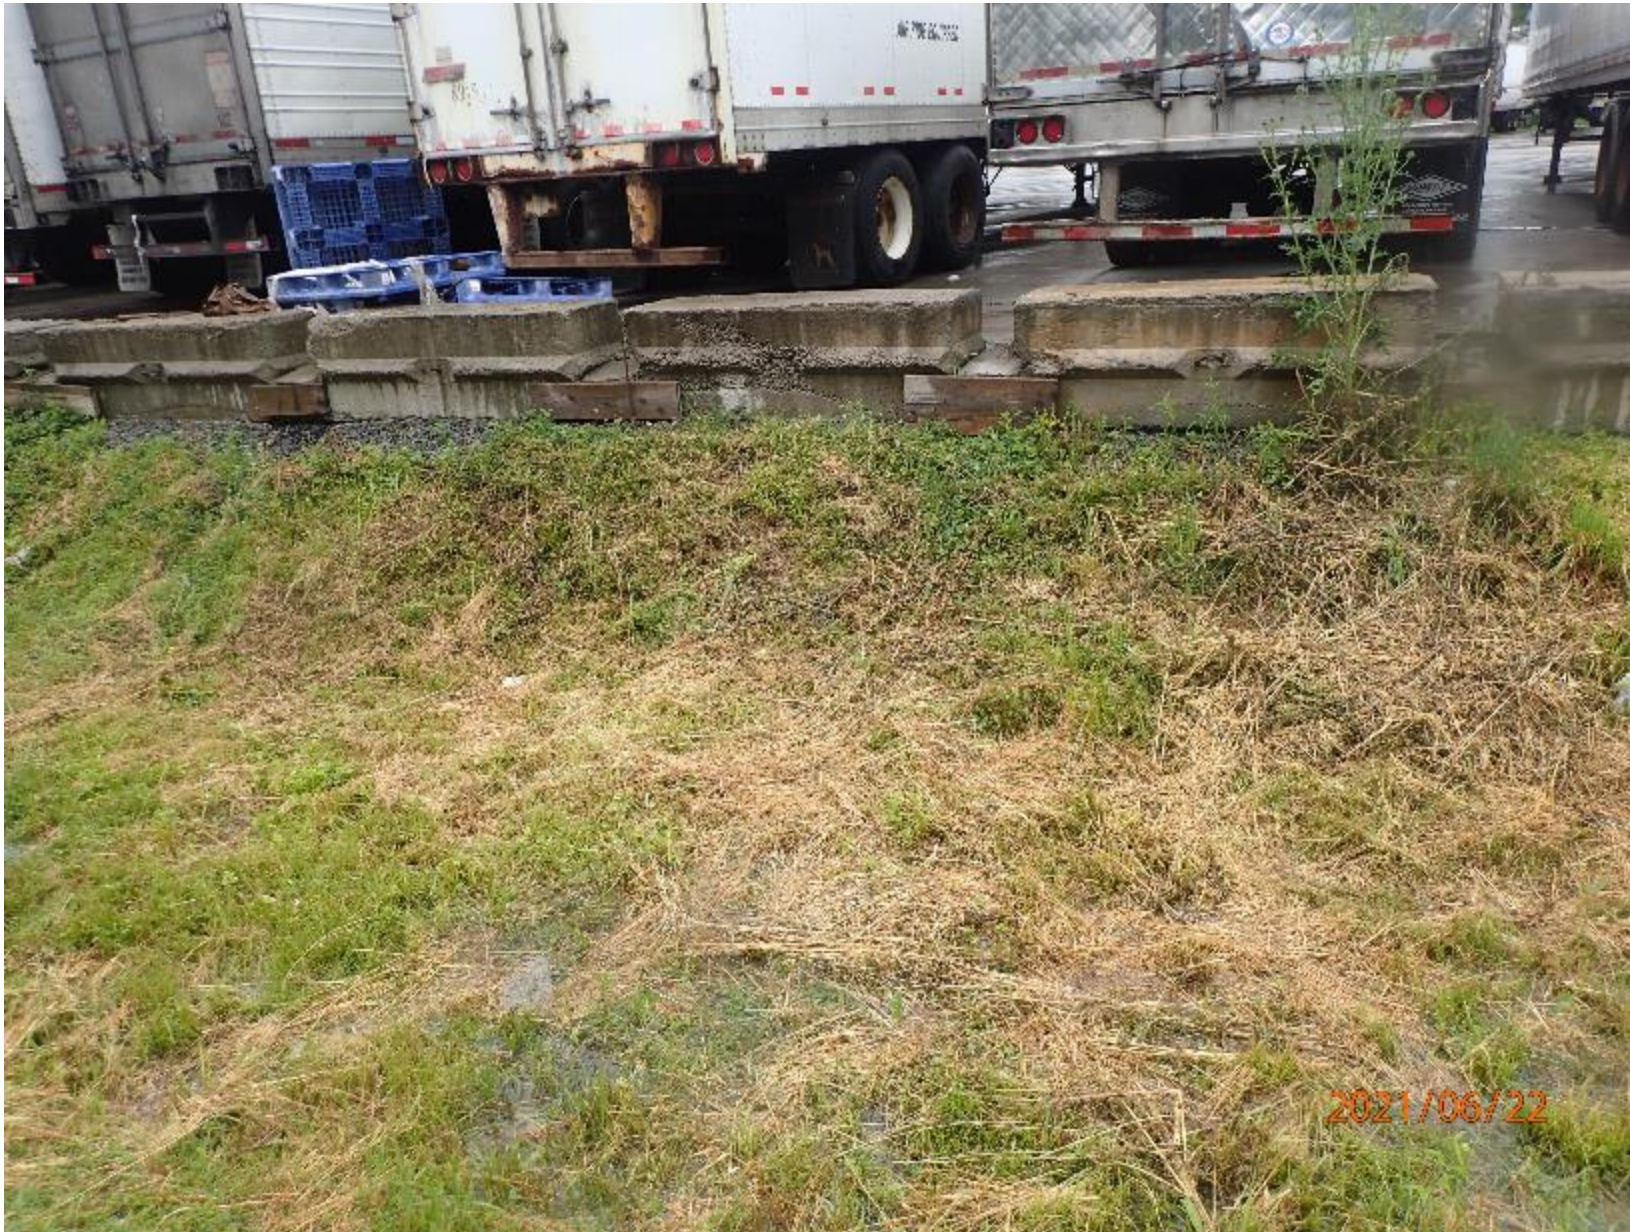
Date: 6/22/2021
Time: 1:08 PM
Photographer: SSA
Photo ID: 13 – P6220144

(3/5) Water flowing from series of stormwater cells

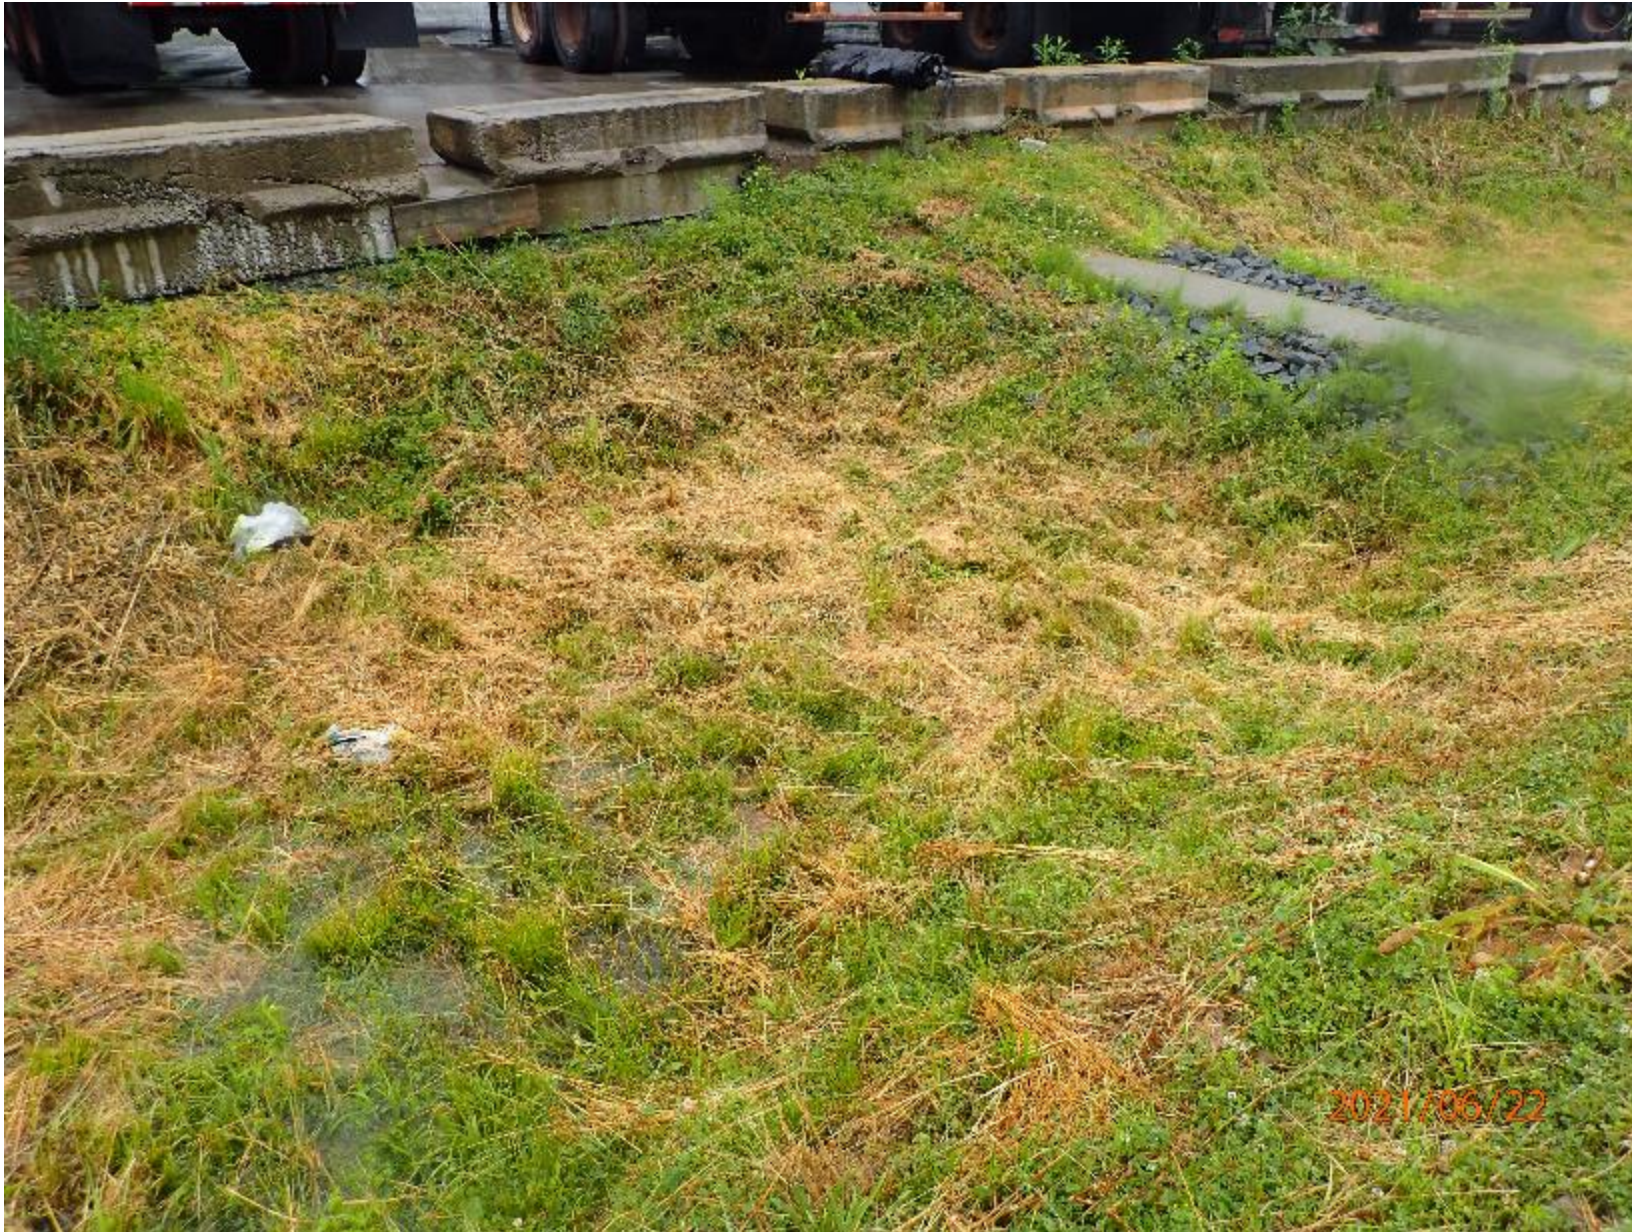
Date: 6/22/2021
Time: 1:08 PM
Photographer: SSA
Photo ID: 14 – P6220145

(4/5) Water flowing from series of stormwater cells

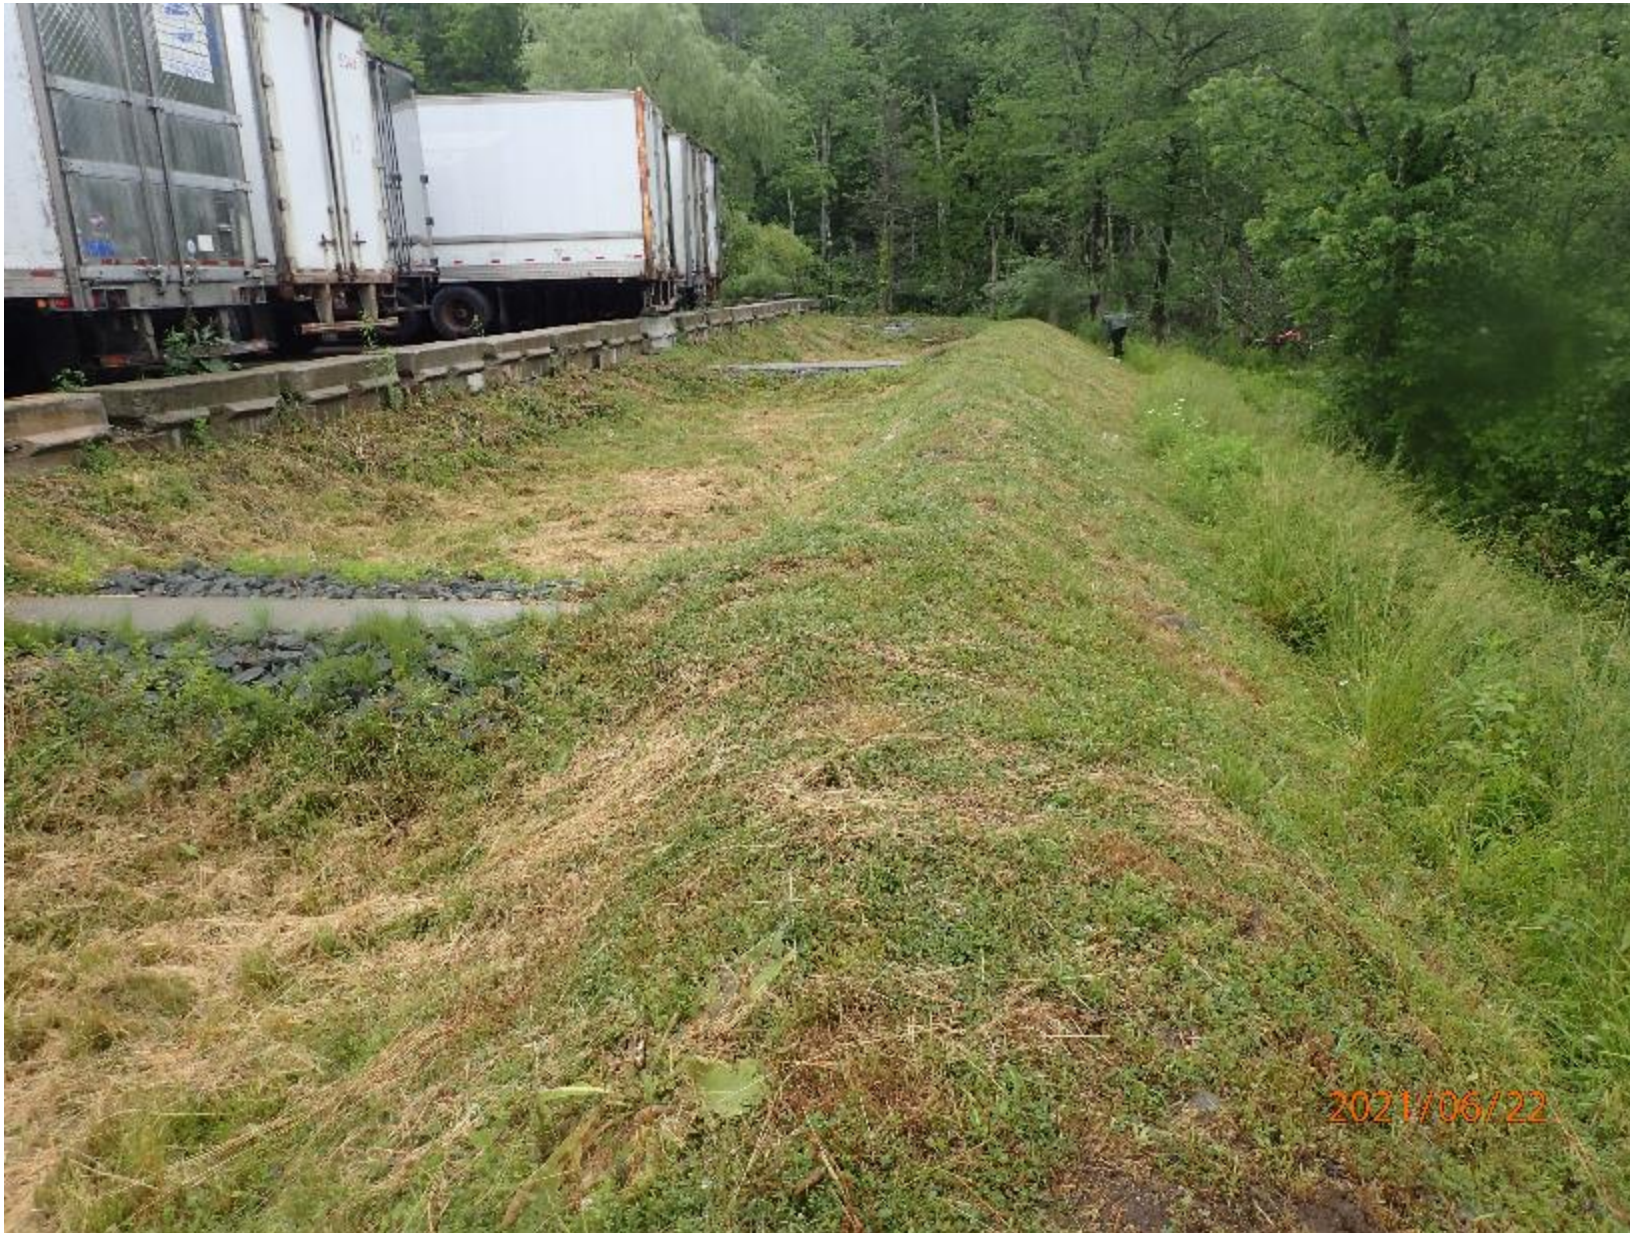
Date: 6/22/2021
Time: 1:08 PM
Photographer: SSA
Photo ID: 15 – P6220146

(5/5) Water flowing from series of stormwater cells

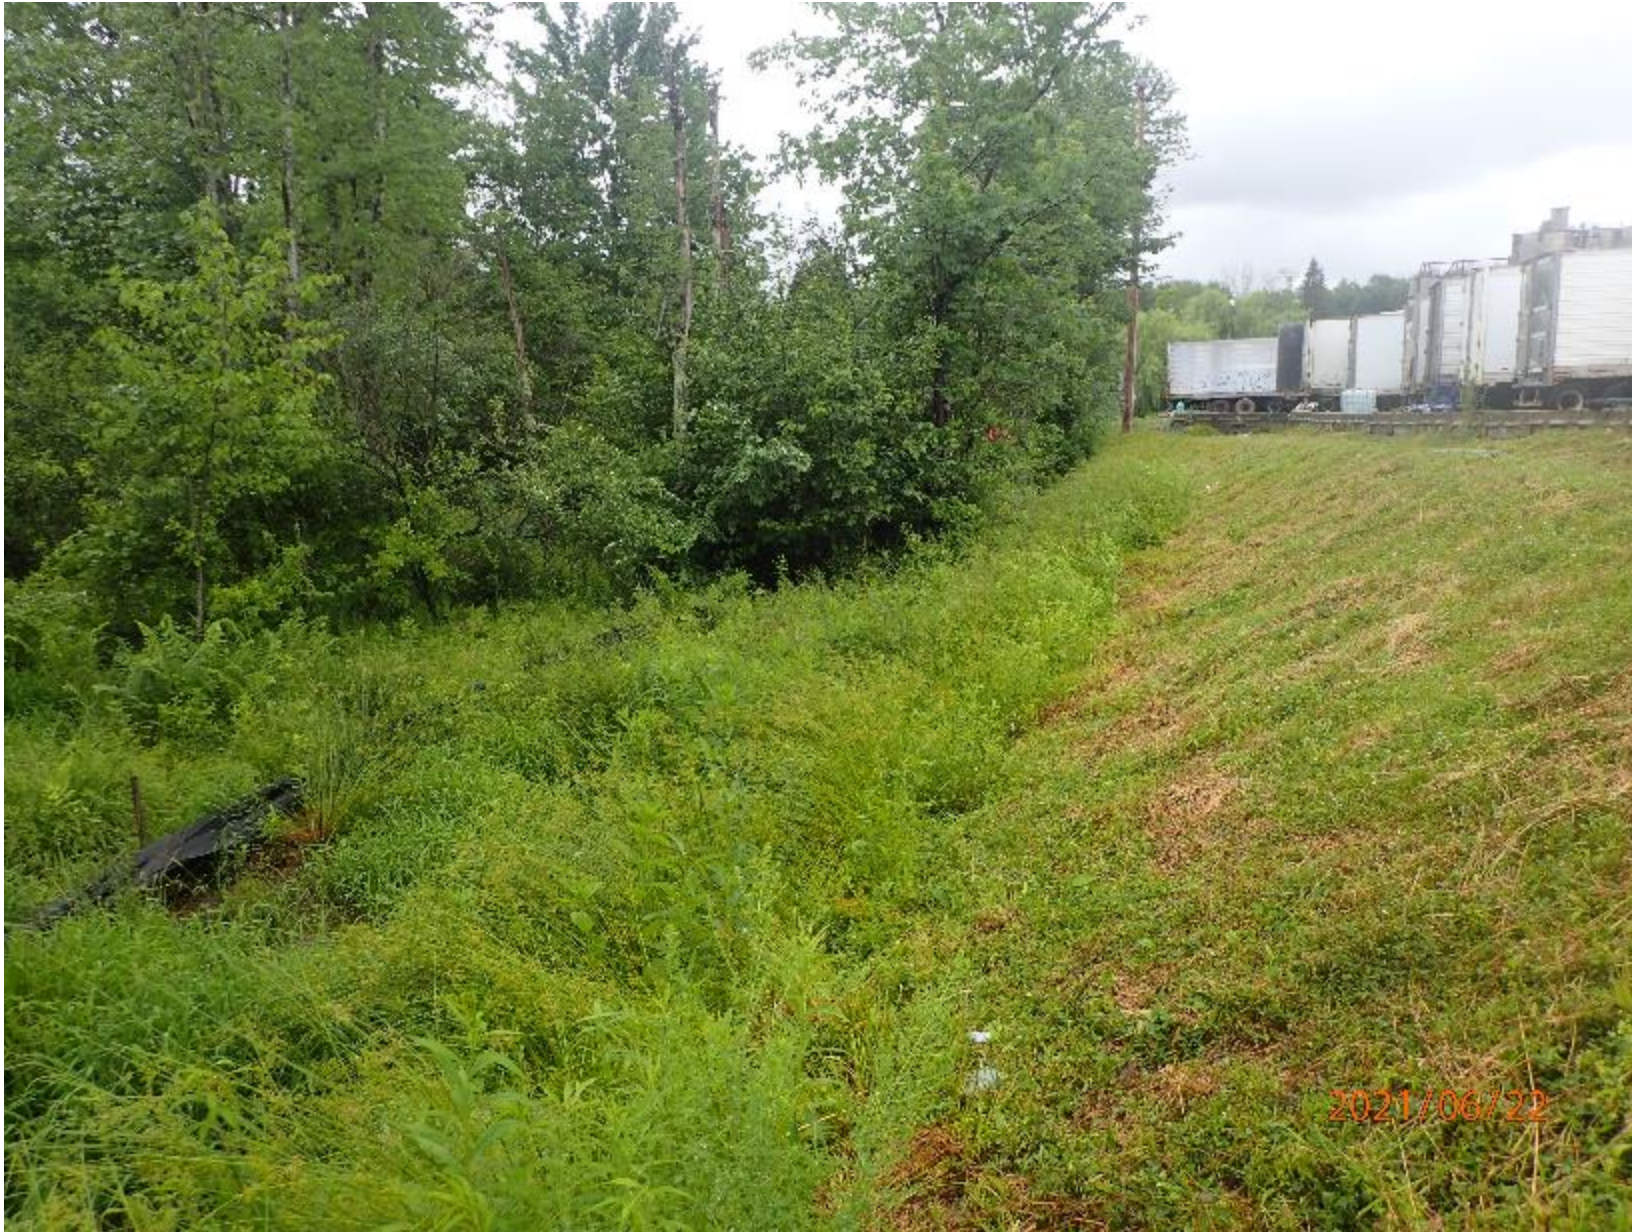
Date: 6/22/2021
Time: 1:10 PM
Photographer: SSA
Photo ID: 16 – P6220147

Limits of Disturbance (LOD), toe of fill slope

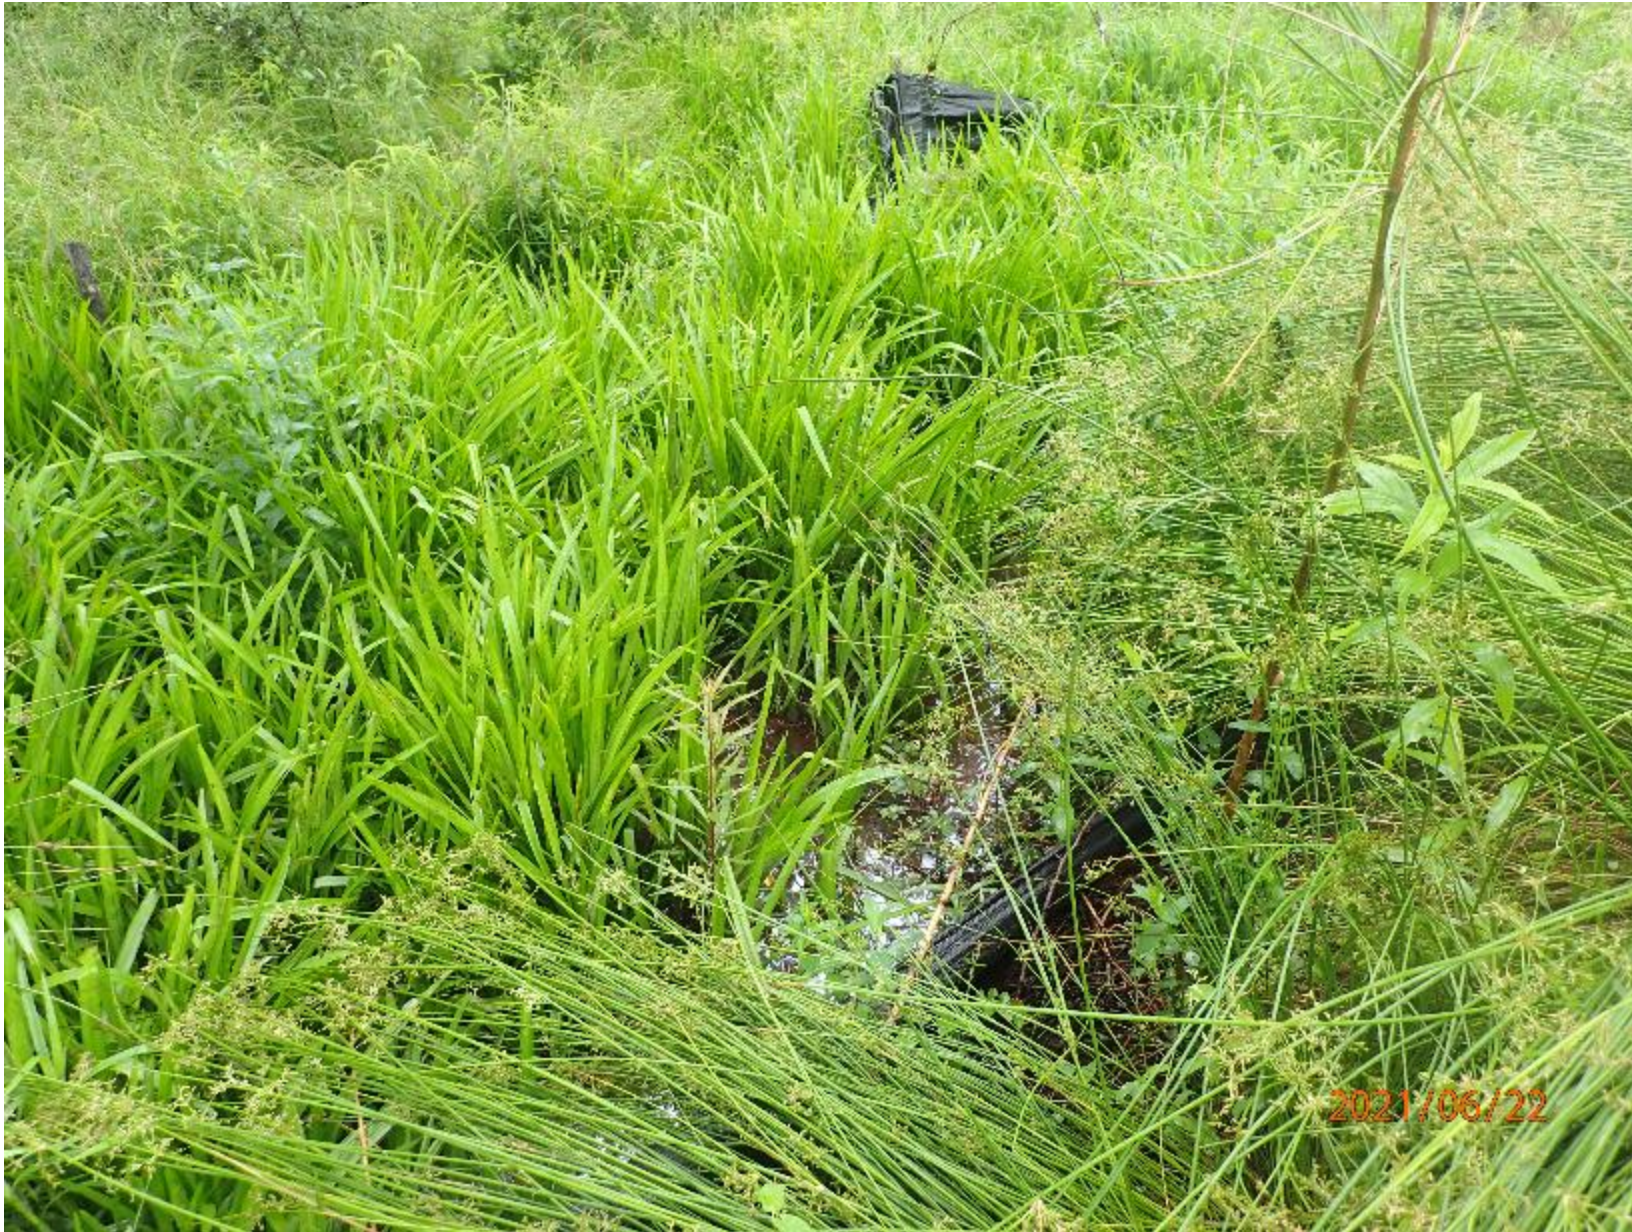
Date: 6/22/2021
Time: 1:10 PM
Photographer: SSA
Photo ID: 17 – P6220148

Surface water ponding in
presumed wetland

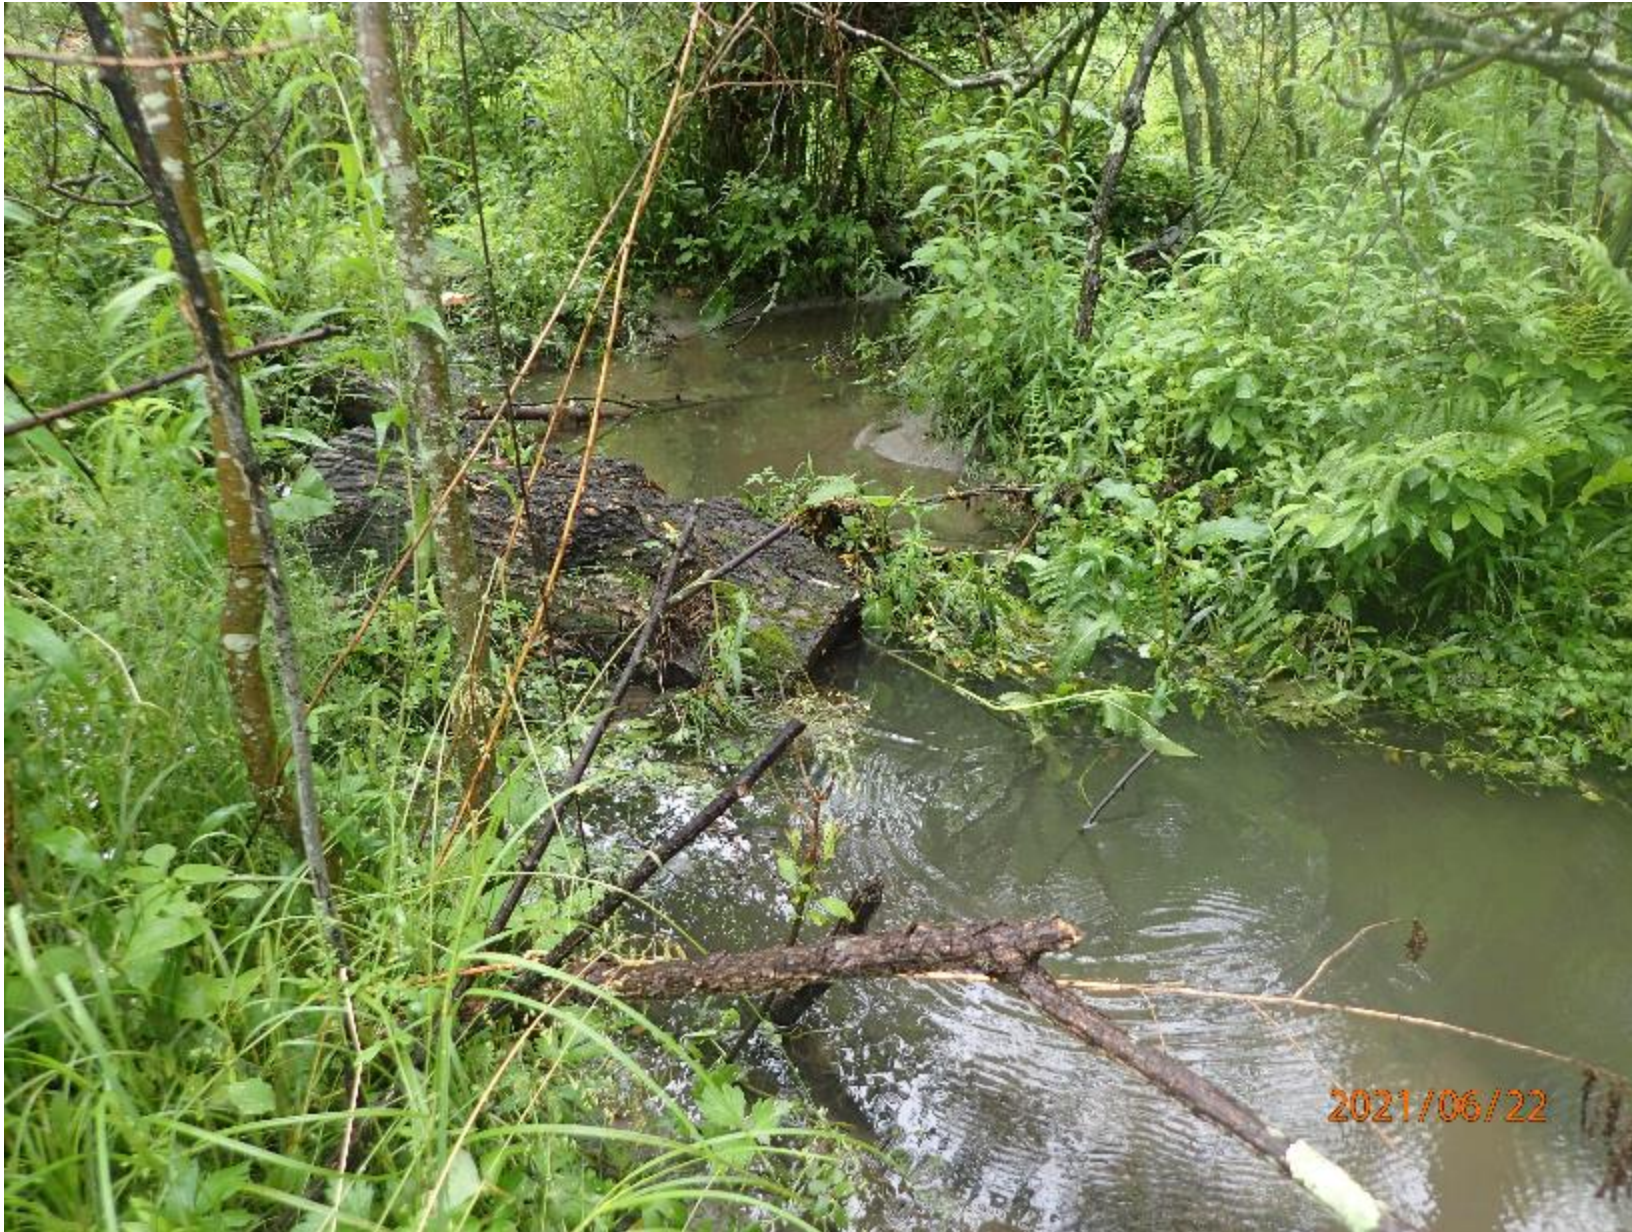
Date: 6/22/2021
Time: 1:15 PM
Photographer: SSA
Photo ID: 18 – P6220149

(1/5) Panorama of stream that flows south into large NWI/DEC wetland

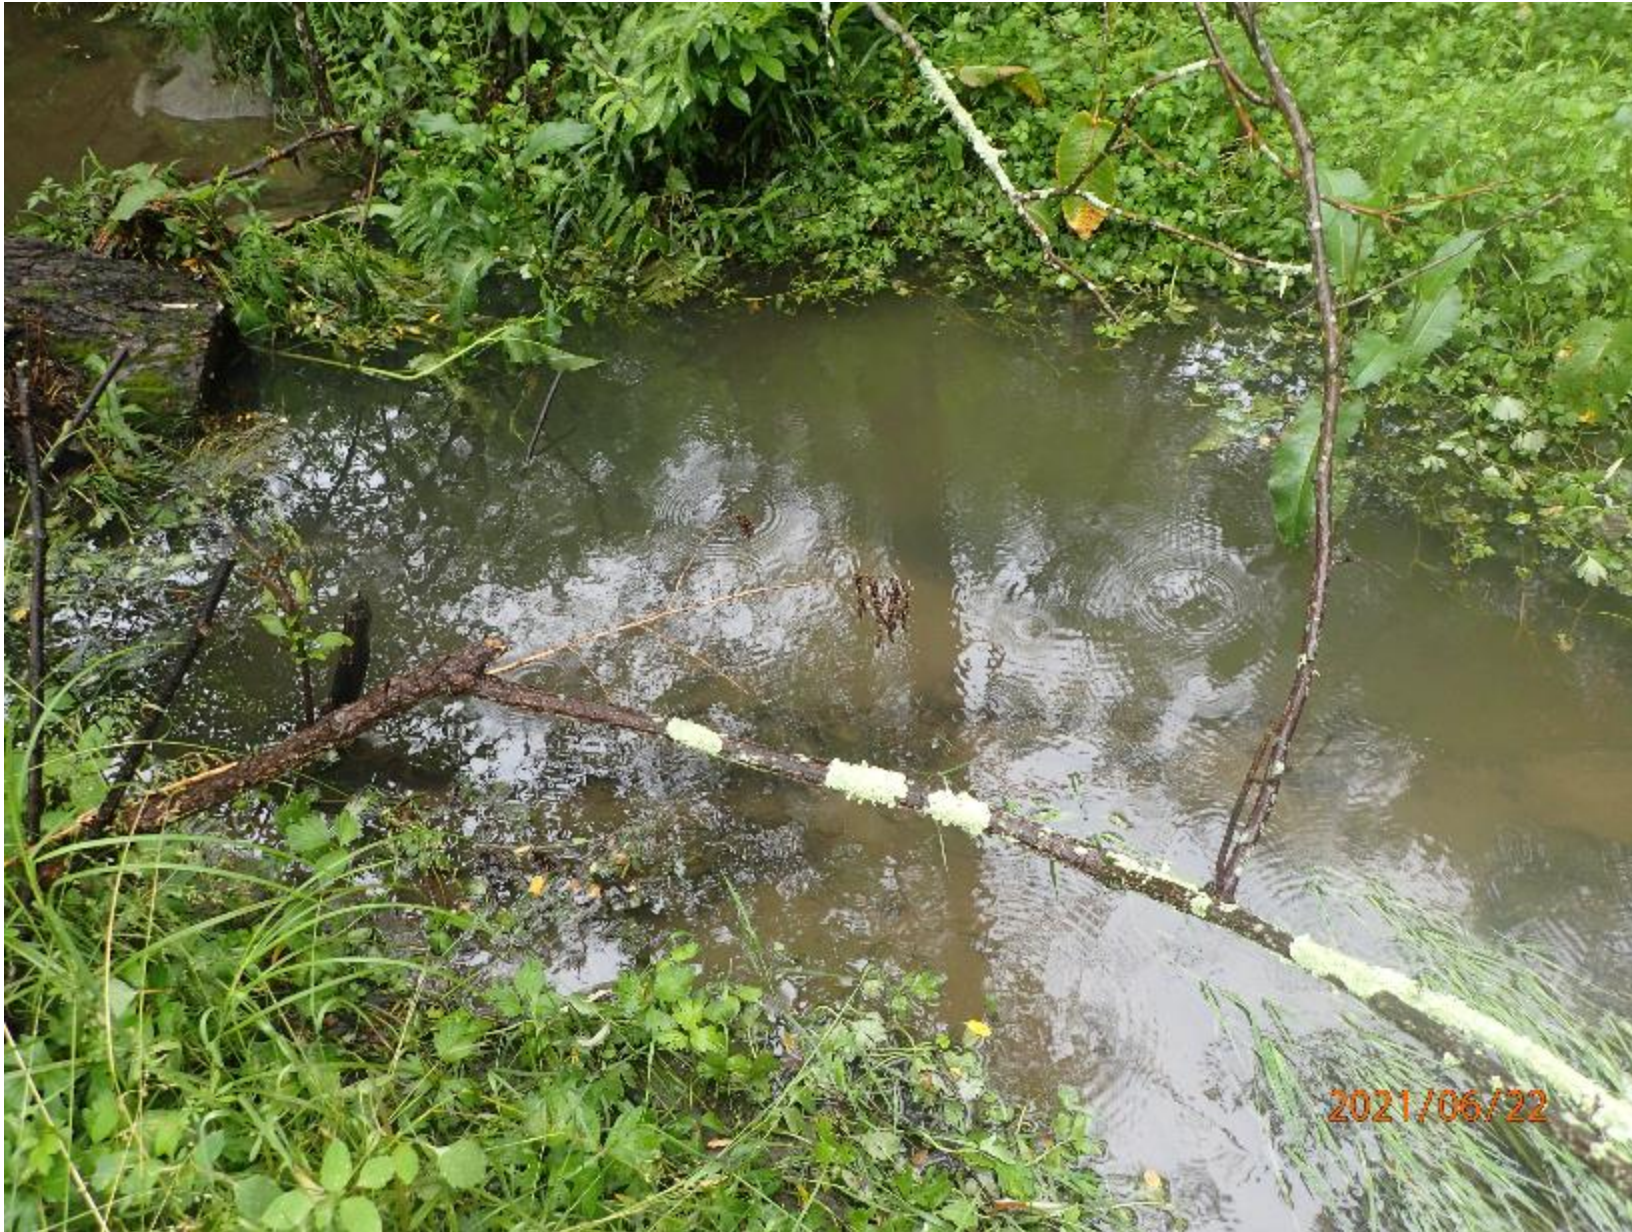
Date: 6/22/2021
Time: 1:15 PM
Photographer: SSA
Photo ID: 19 – P6220150

(2/5) Panorama of stream that flows south into large NWI/DEC wetland

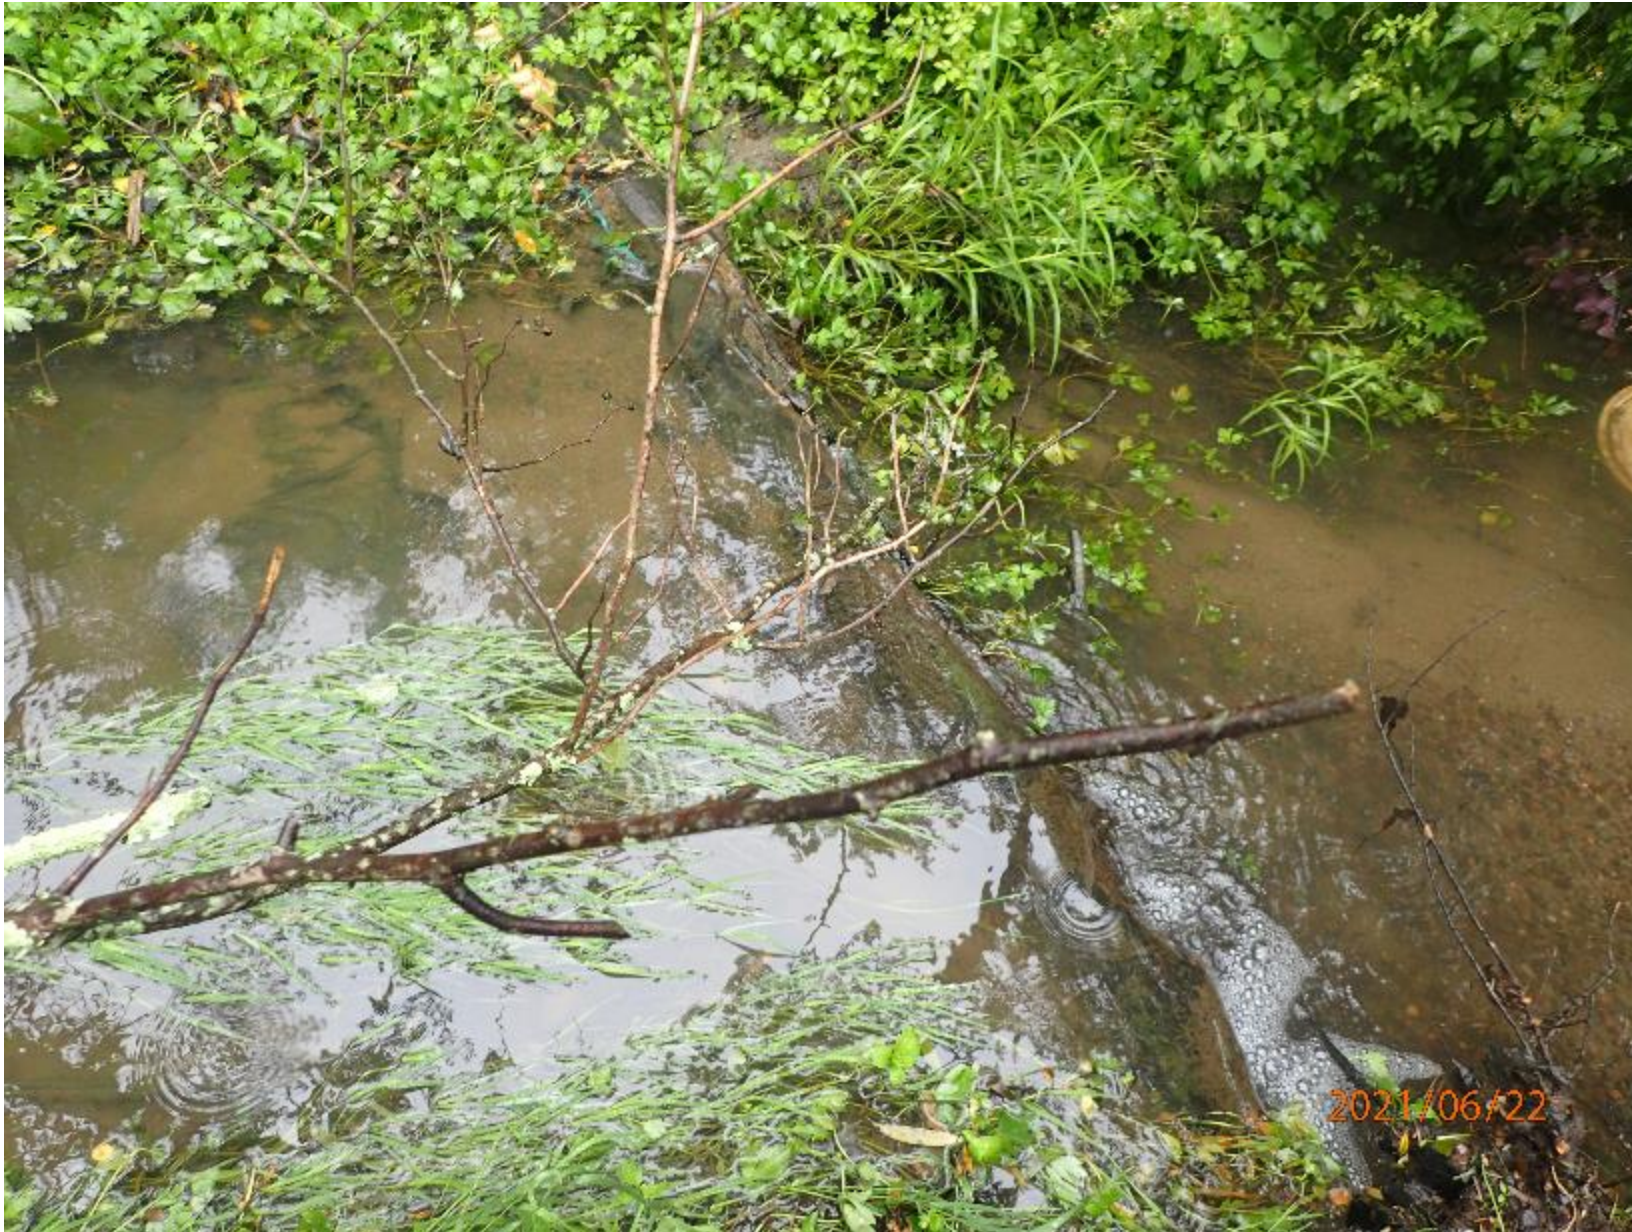
Date: 6/22/2021
Time: 1:15 PM
Photographer: SSA
Photo ID: 20 – P6220151

(3/5) Panorama of stream that flows south into large NWI/DEC wetland

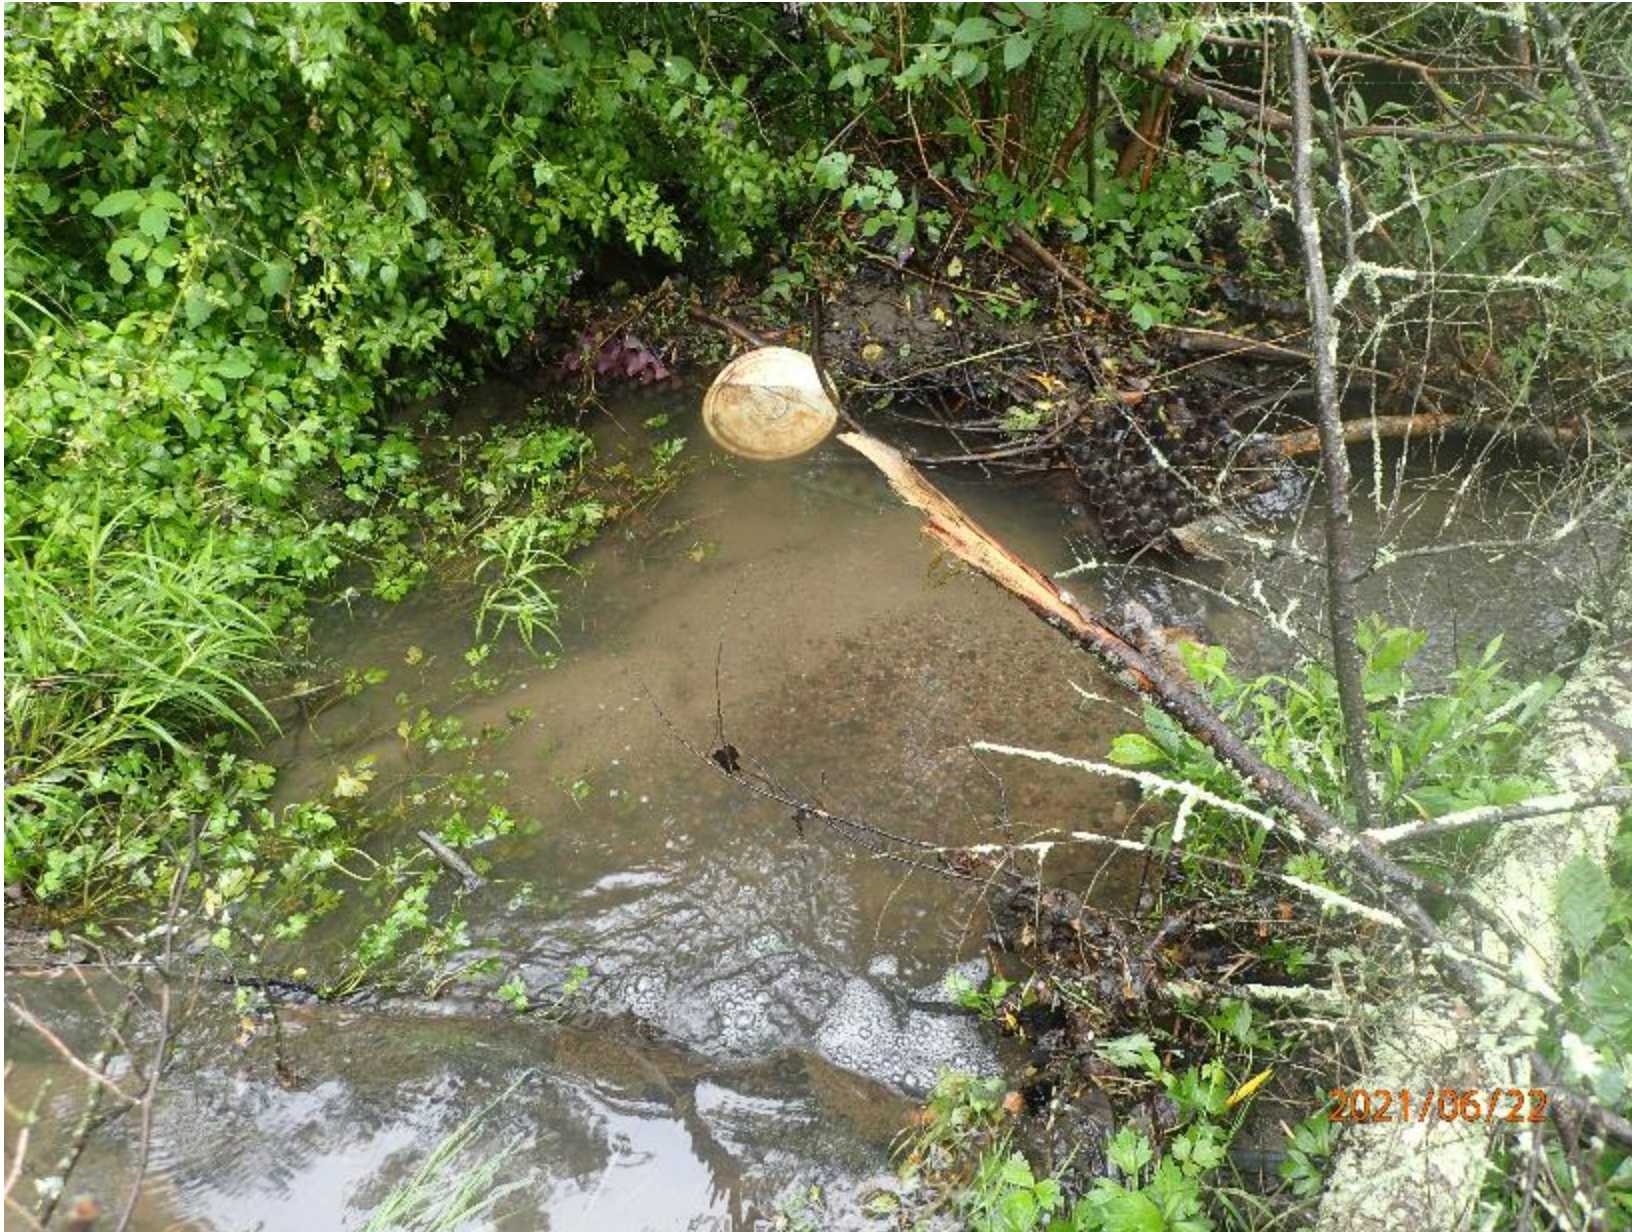
Date: 6/22/2021
Time: 1:15 PM
Photographer: SSA
Photo ID: 21 – P6220152

(4/5) Panorama of stream that flows south into large NWI/DEC wetland

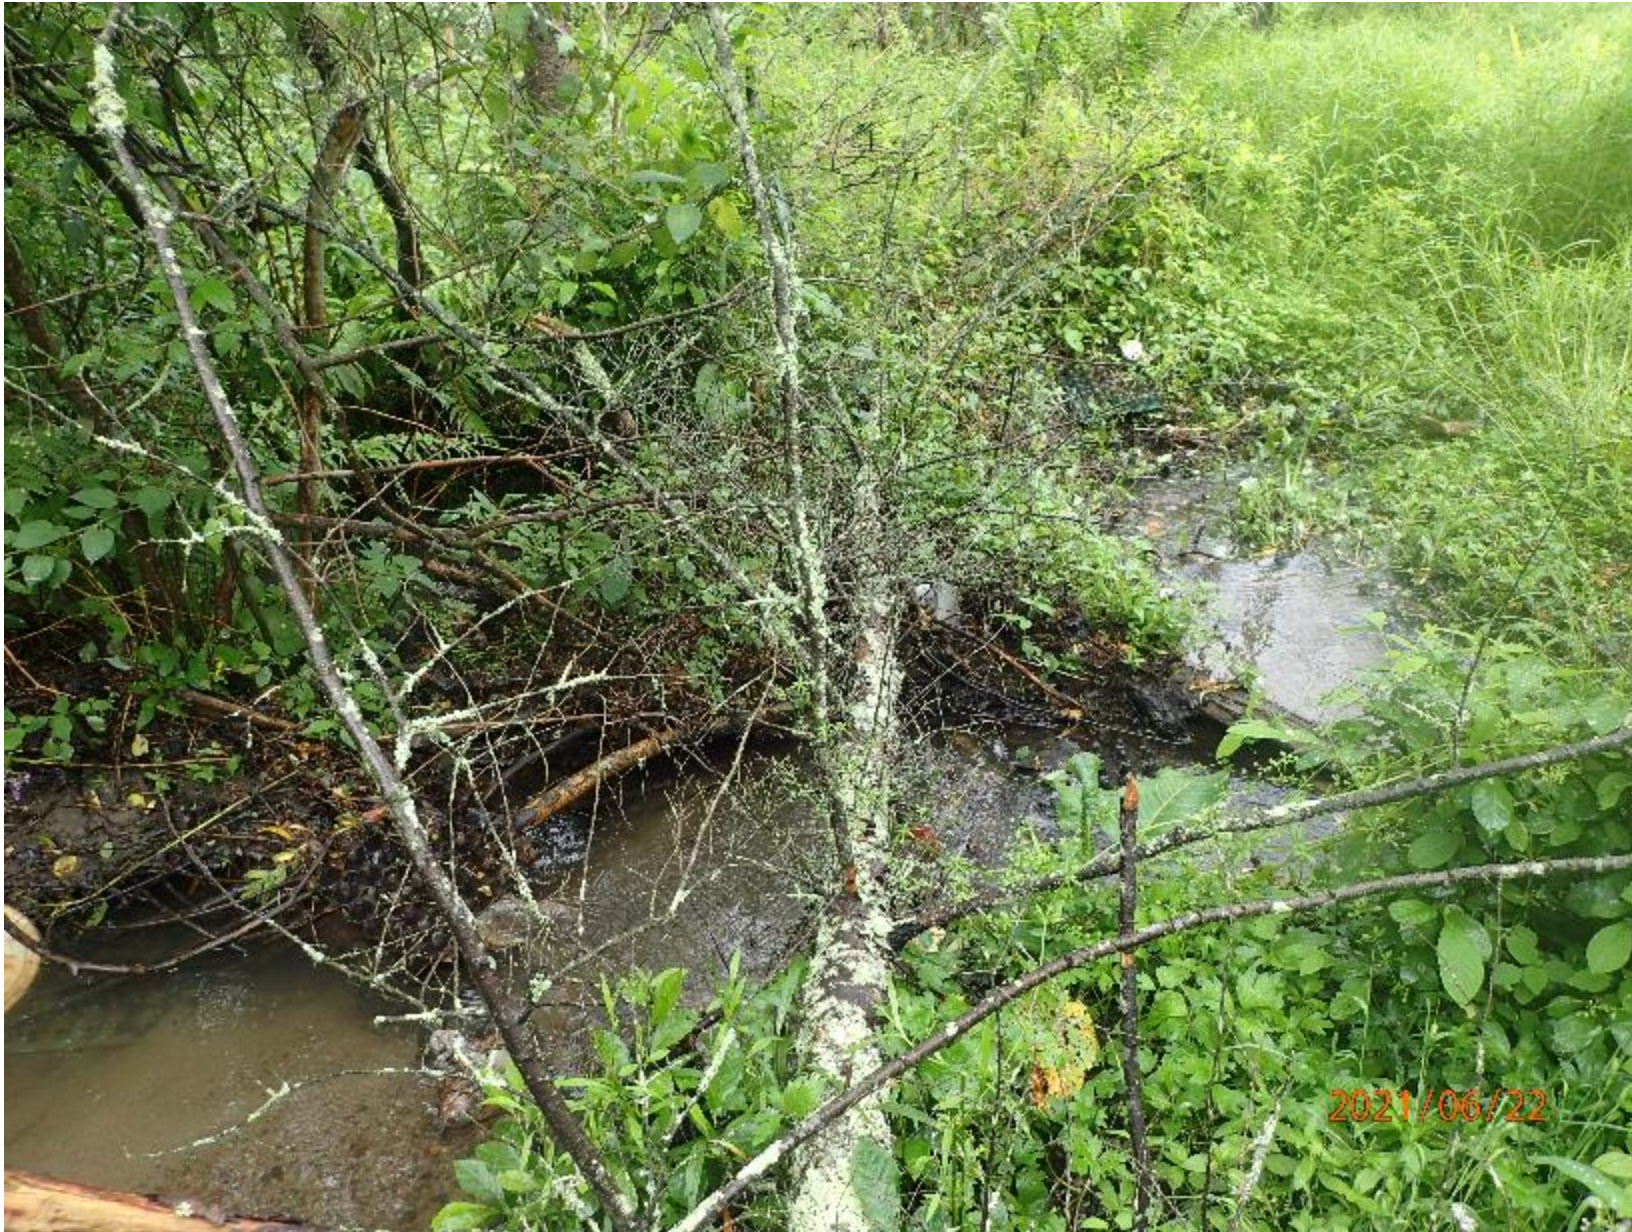
Date: 6/22/2021
Time: 1:15 PM
Photographer: SSA
Photo ID: 22 – P6220153

(5/5) Panorama of stream that flows south into large NWI/DEC wetland

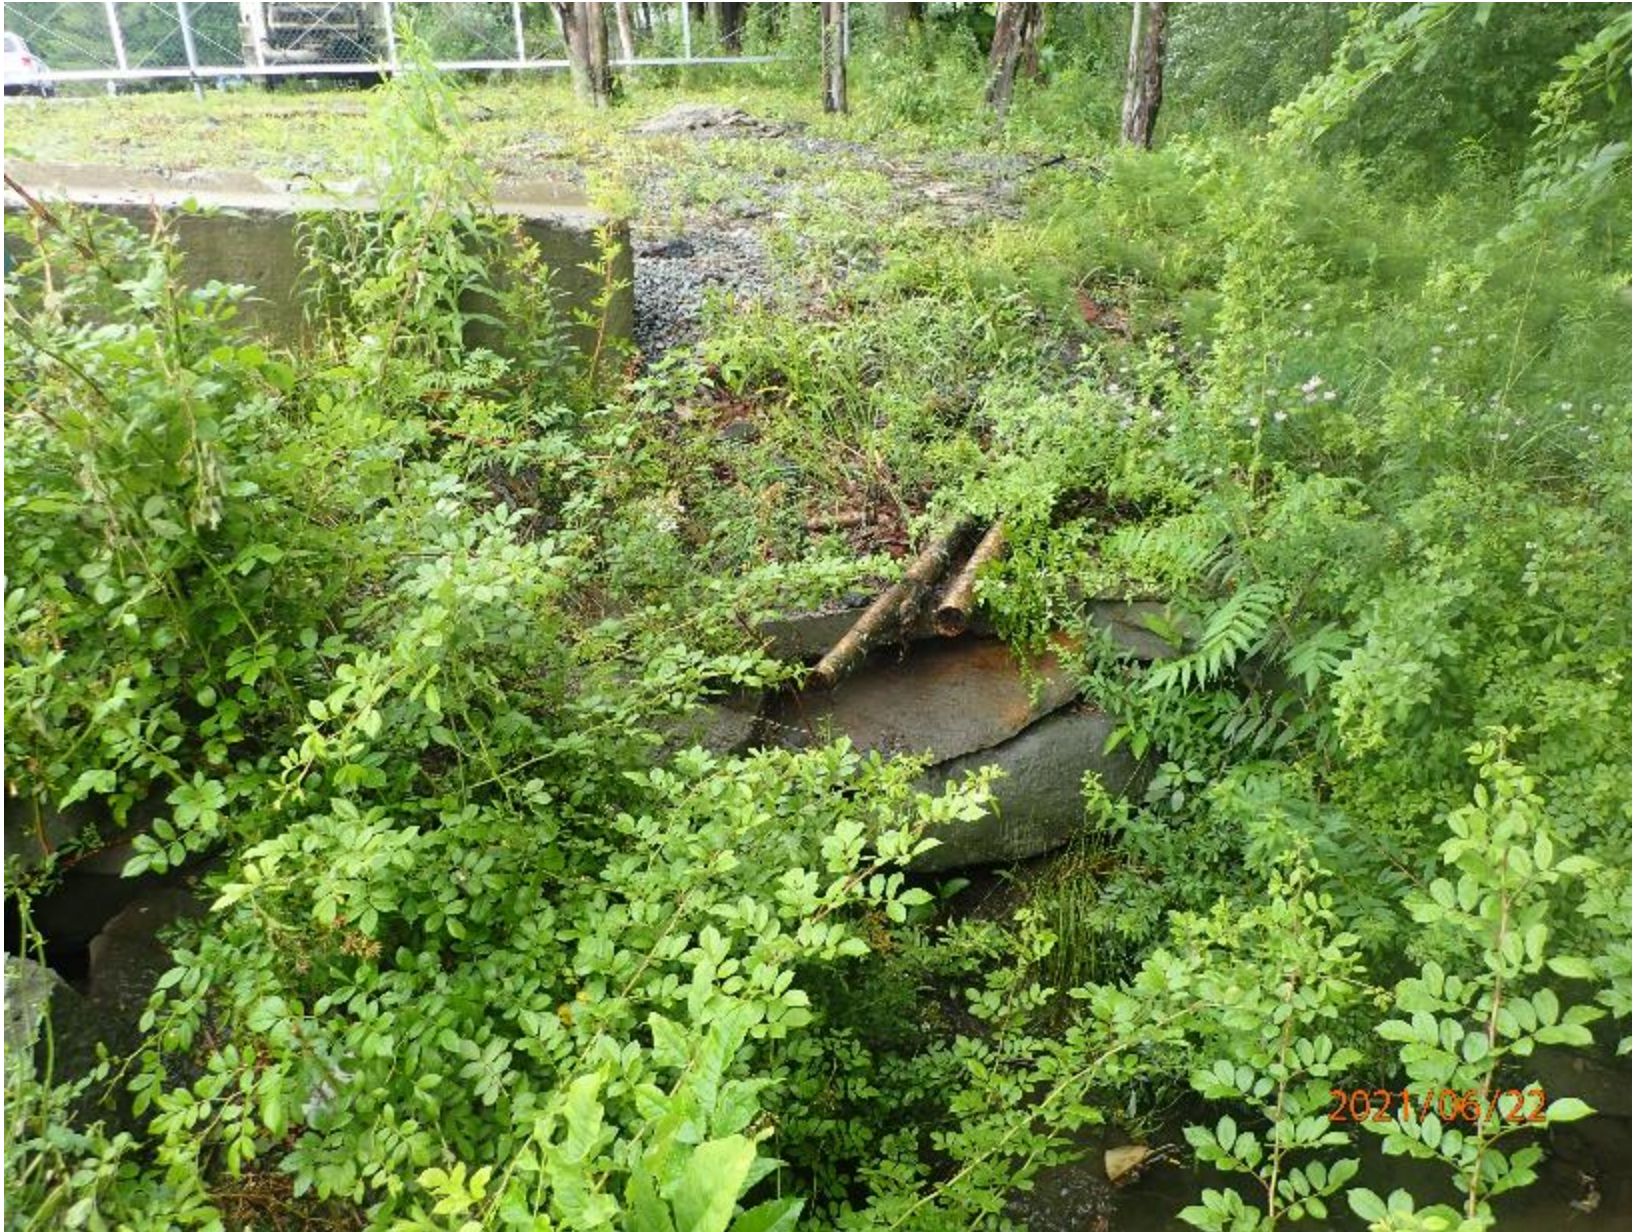
Date: 6/22/2021
Time: 1:29 PM
Photographer: SSA
Photo ID: 23 – P6220154

Downstream end of culvert
under access road/driveway
