Clean Water Act Section 404: Site Visit/Case Development

Site Name: Newburg Egg Processing Plant

CWA 404 Inspection
Newburg Egg Processing Plant
Woodridge, Sullivan County, NY

June 22, 2021

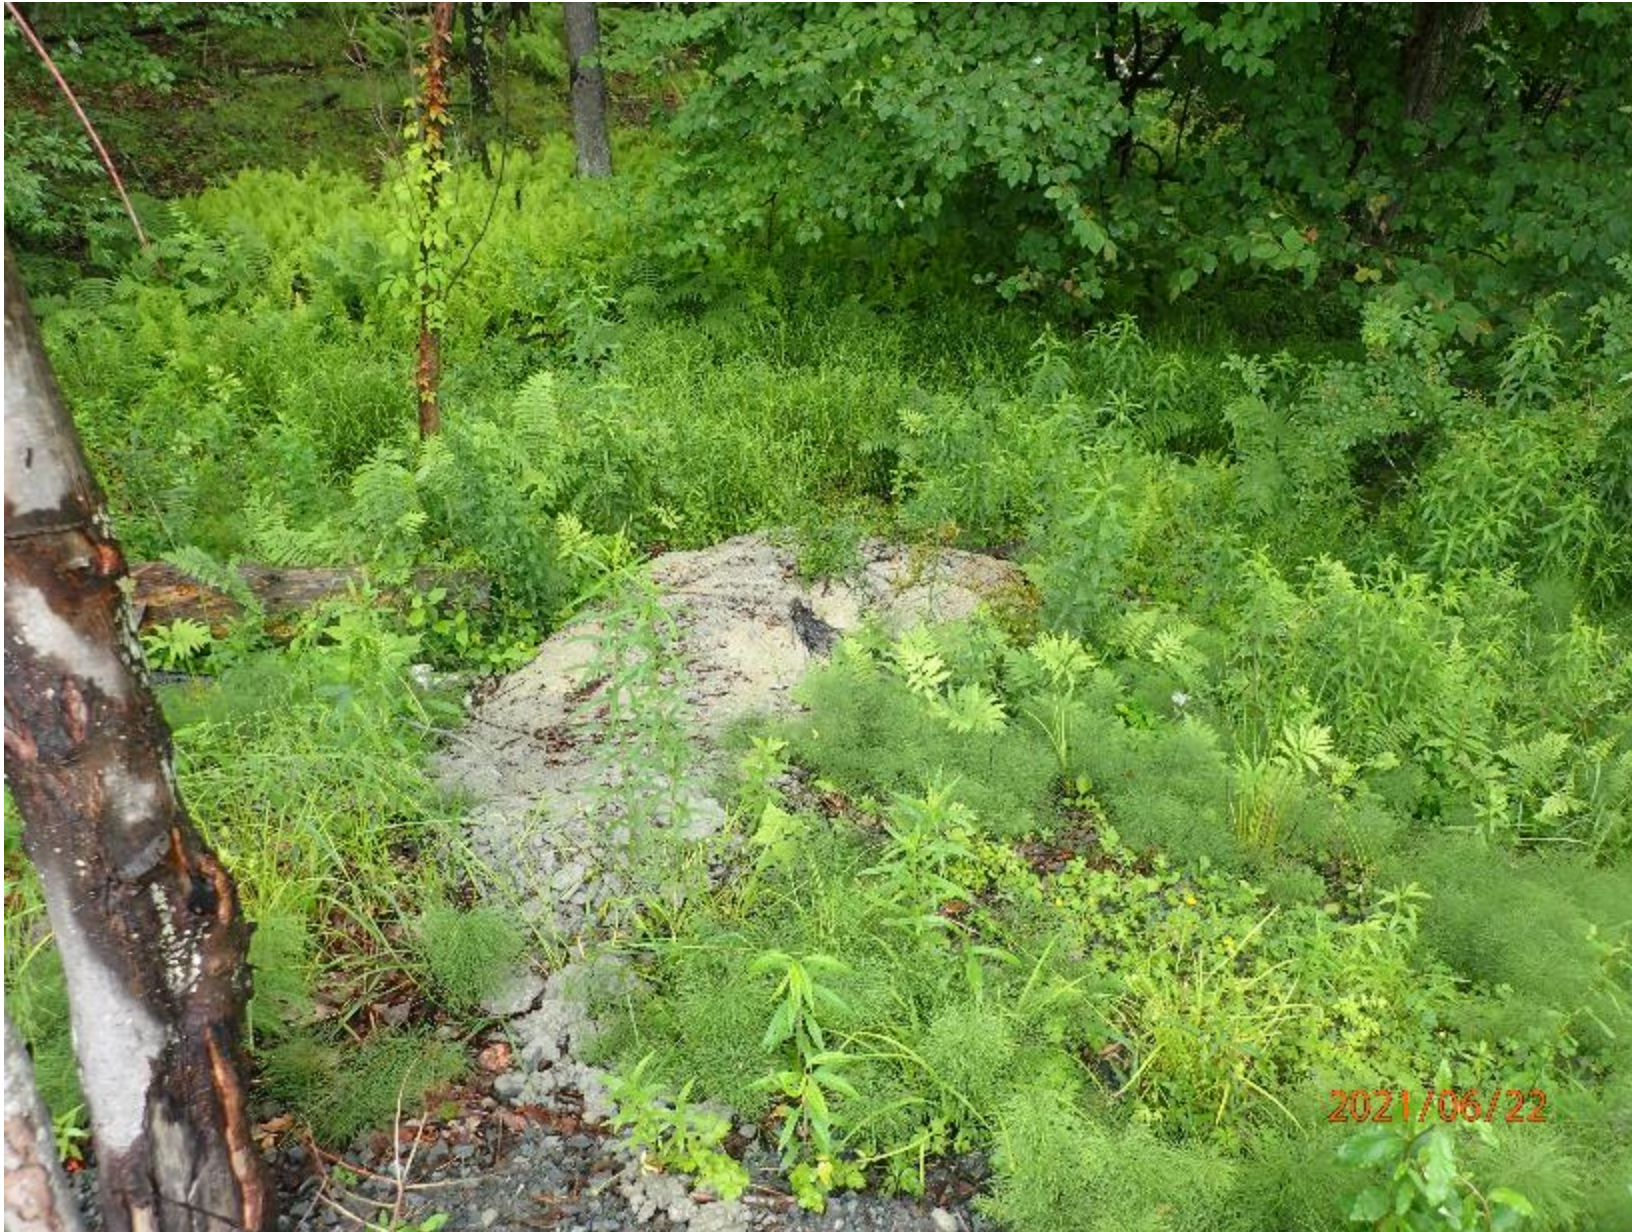
Date: 6/22/2021
Time: 1:39 PM
Photographer: SSA
Photo ID: 24 – P6220155

Concrete disposal area near
access road/driveway

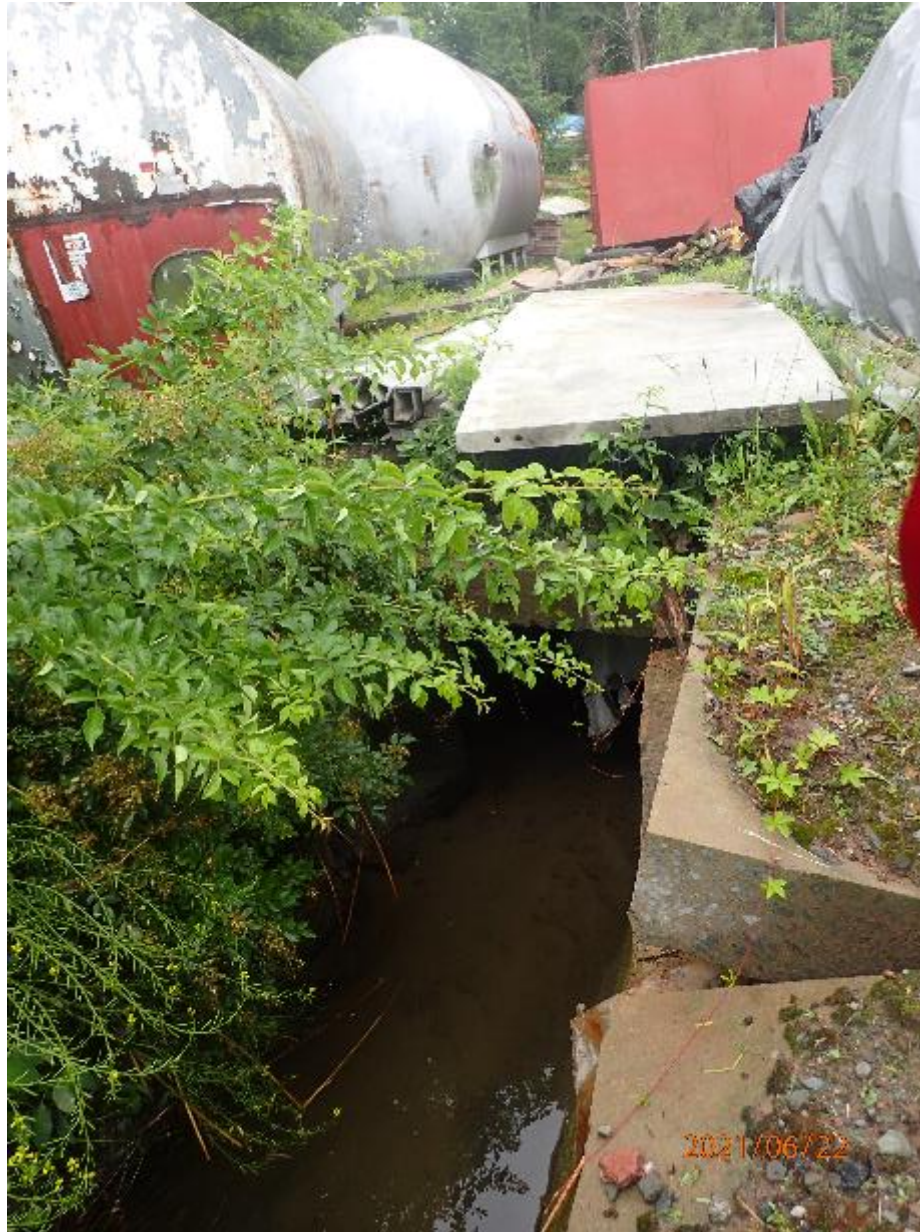
Date: 6/22/2021
Time: 1:43 PM
Photographer: SSA
Photo ID: 25 – P6220156

Description:
Upstream end of culvert

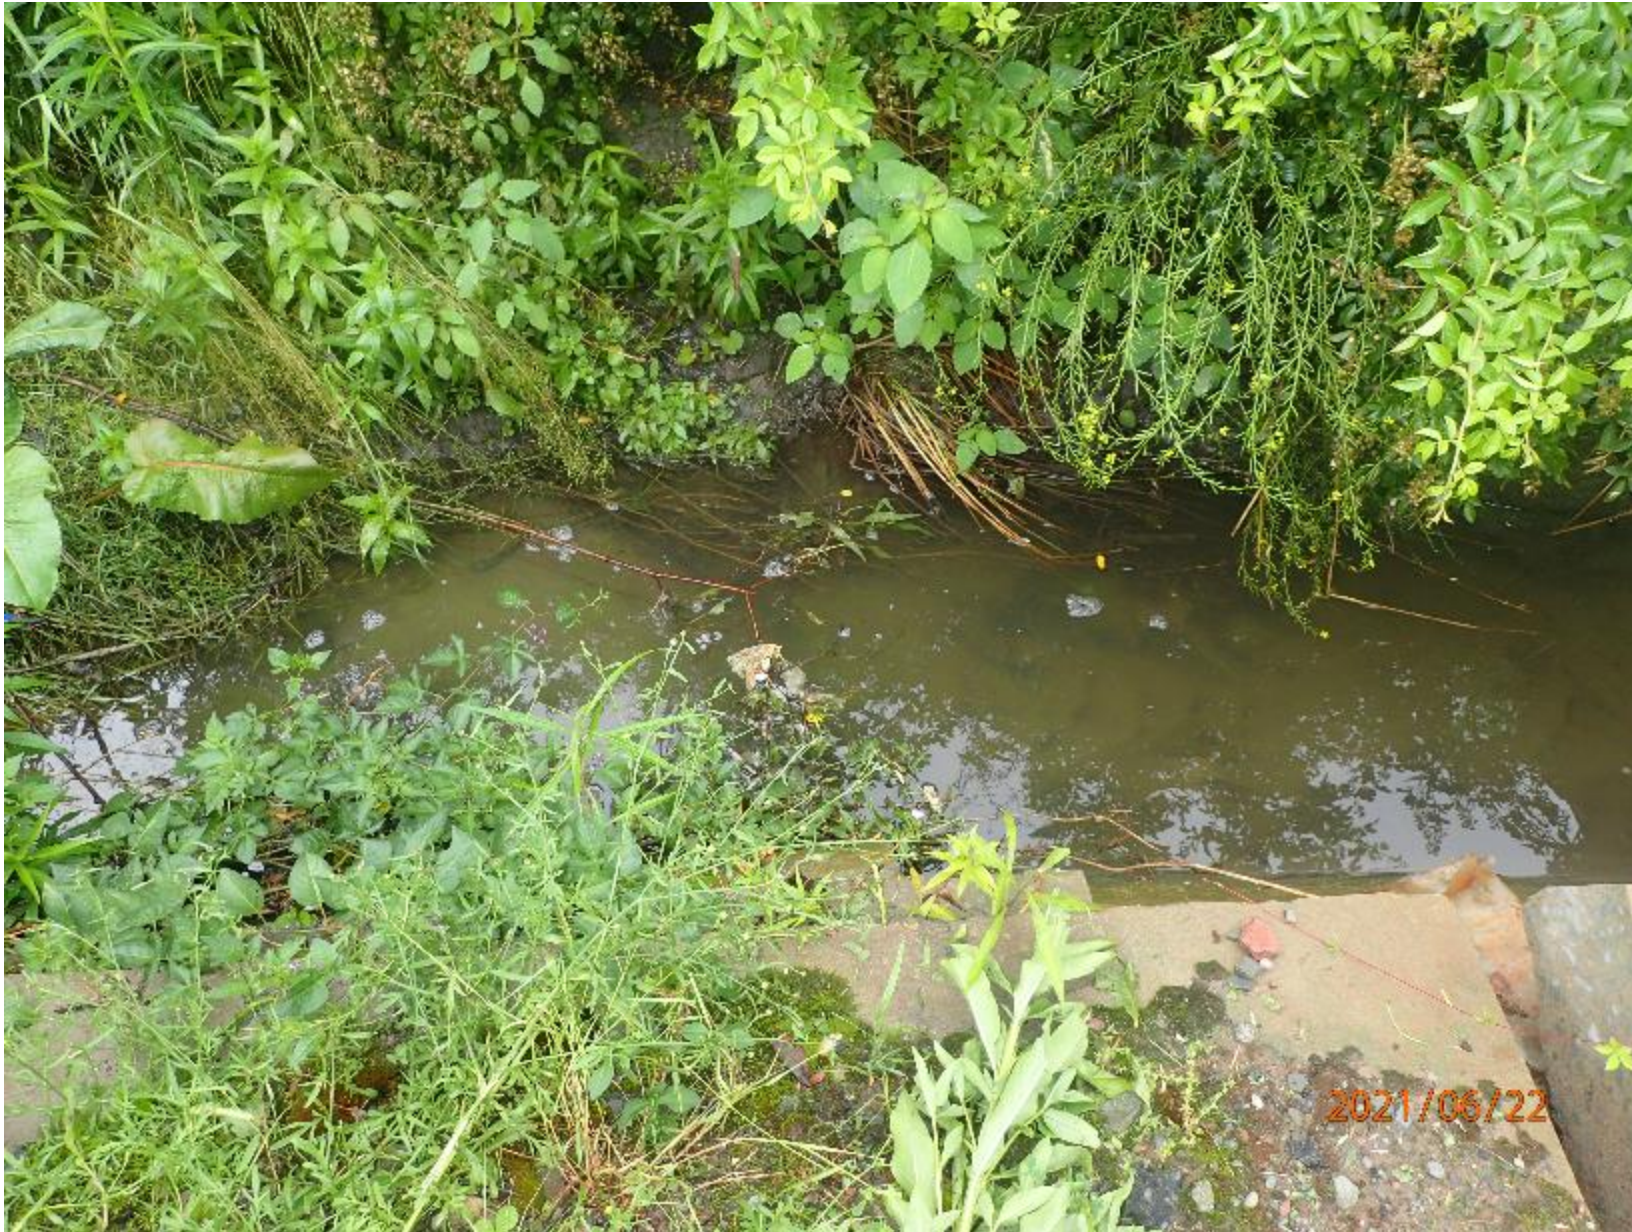
Date: 6/22/2021
Time: 1:43 PM
Photographer: SSA
Photo ID: 26 – P6220157

Stream with defined bed and banks flowing into culvert

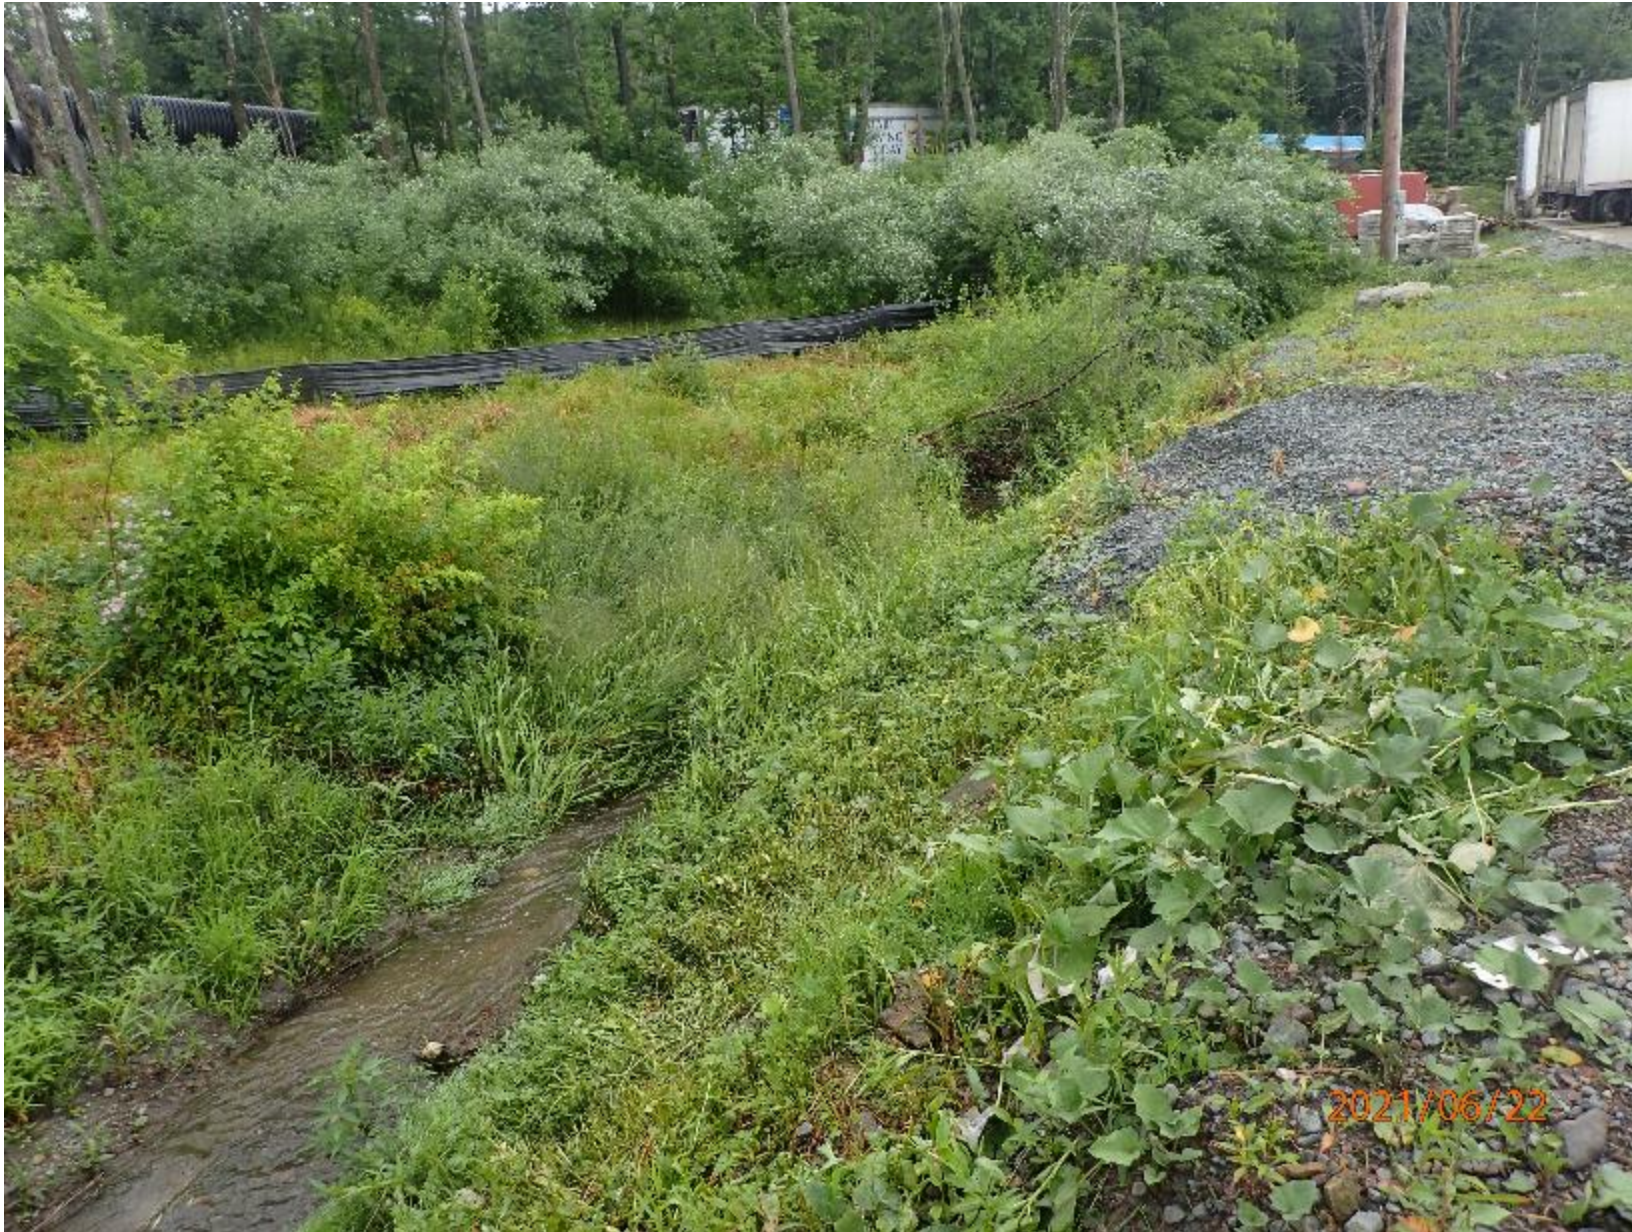
Date: 6/22/2021
Time: 1:53 PM
Photographer: SSA
Photo ID: 27 – P6220158

(1/3) Stream adjacent to western perimeter of parking pad

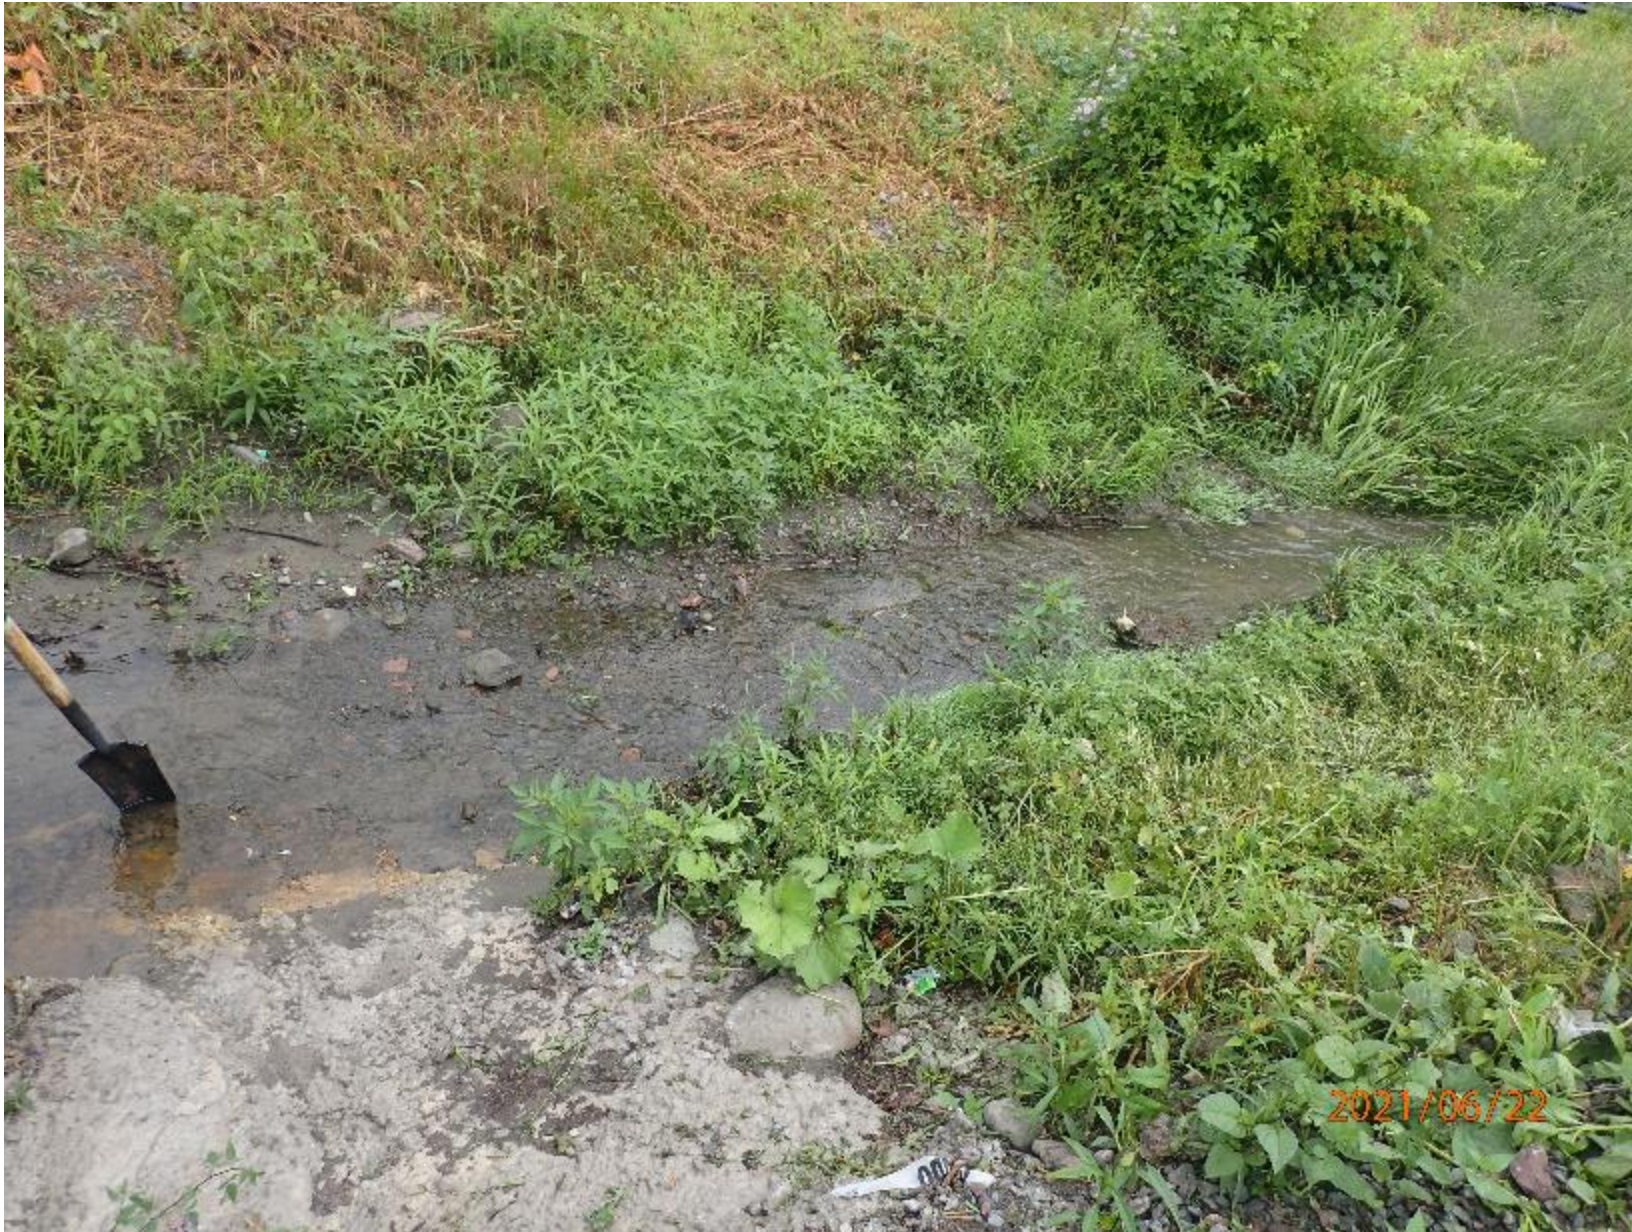
Date: 6/22/2021
Time: 1:53 PM
Photographer: SSA
Photo ID: 28 – P6220159

(2/3) Stream adjacent to western perimeter of parking pad

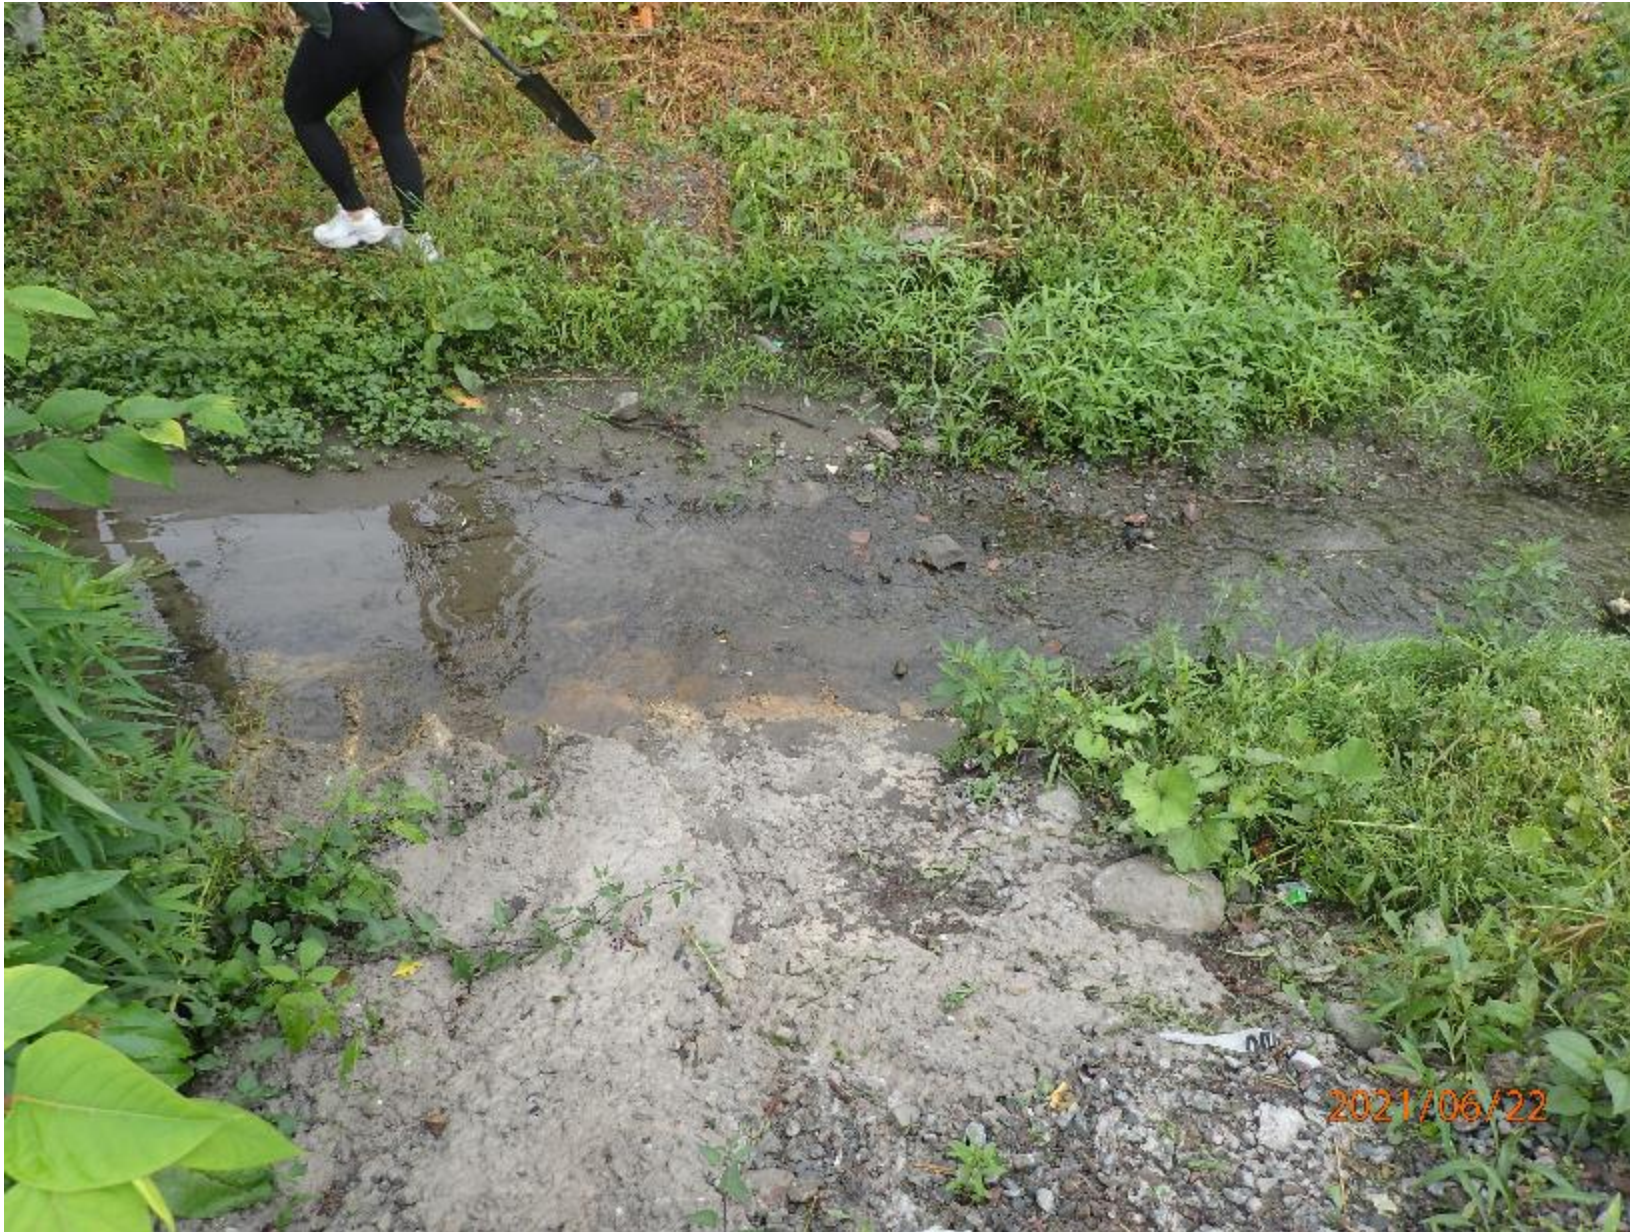
Date: 6/22/2021
Time: 1:53 PM
Photographer: SSA
Photo ID: 29 – P6220160

(3/3) Stream adjacent to western perimeter of parking pad; concrete encroachment on right descending bank of stream

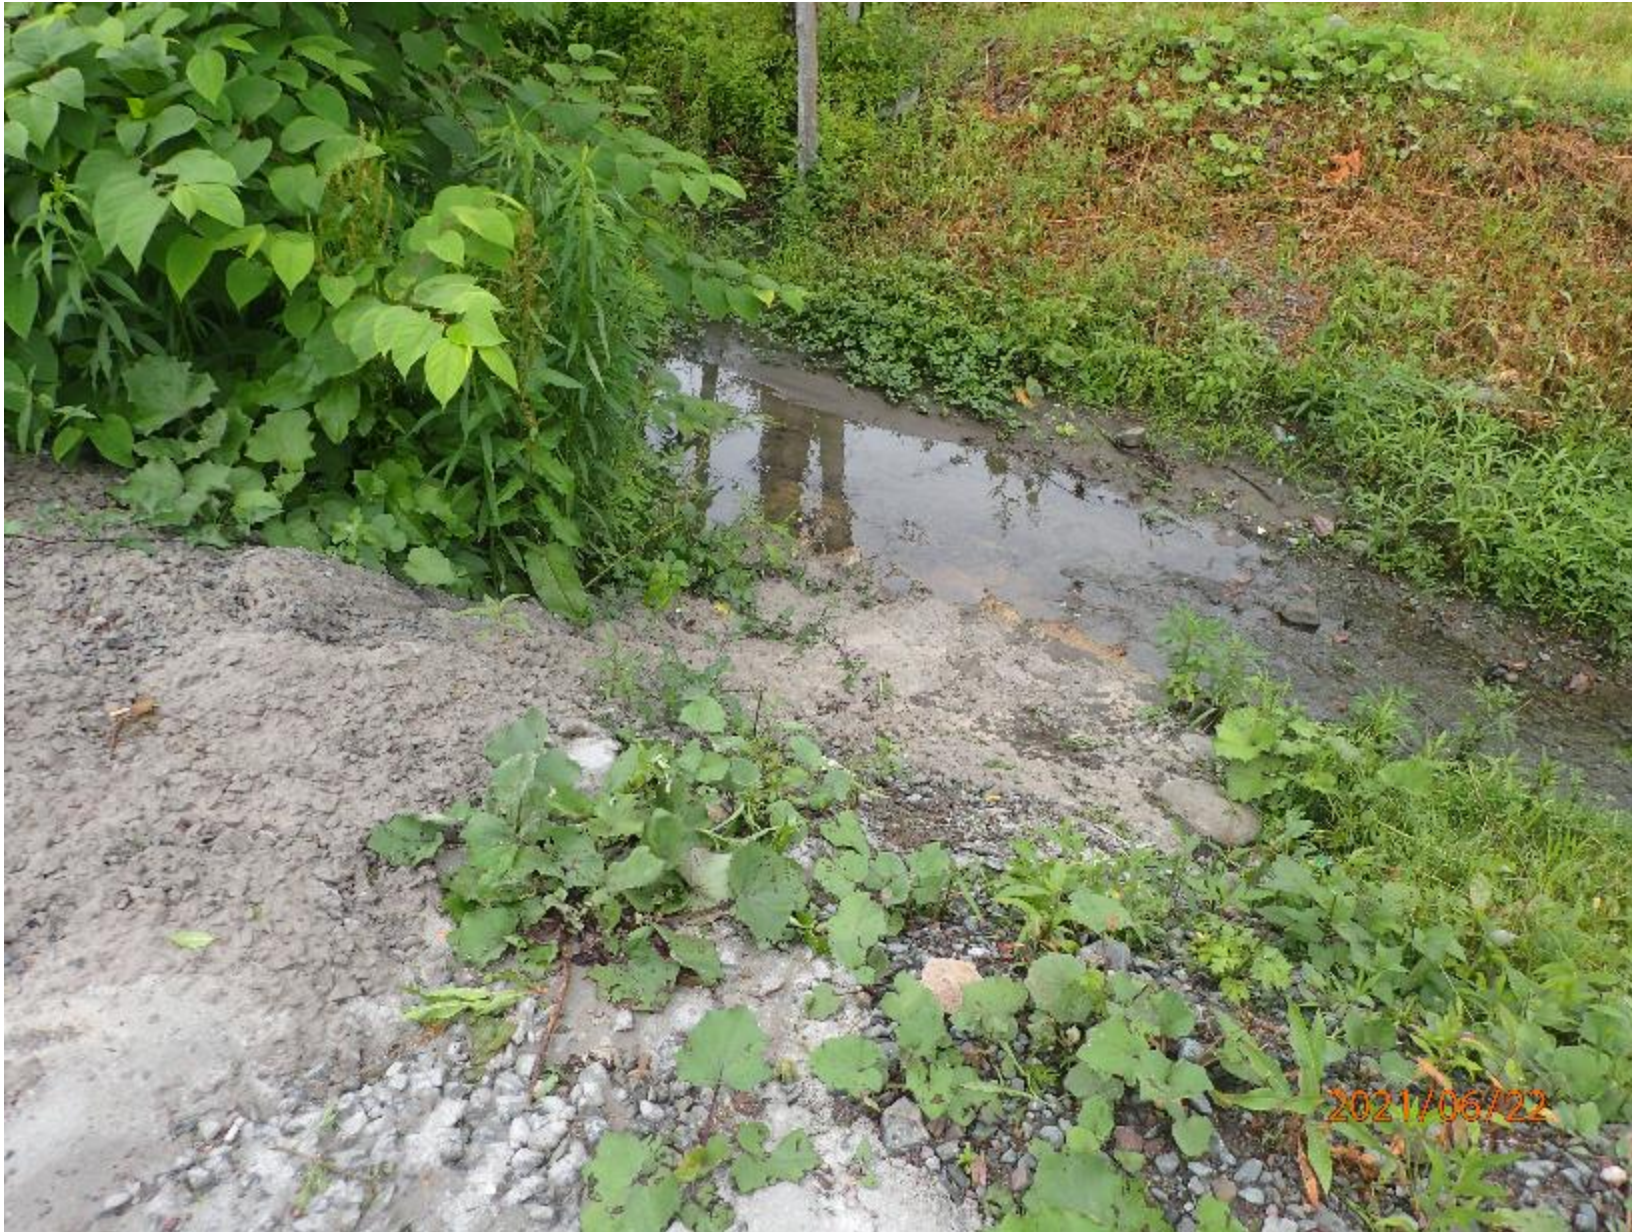
Date: 6/22/2021
Time: 1:54 PM
Photographer: SSA
Photo ID: 30 – P6220161

Concrete encroachment on right descending bank of stream

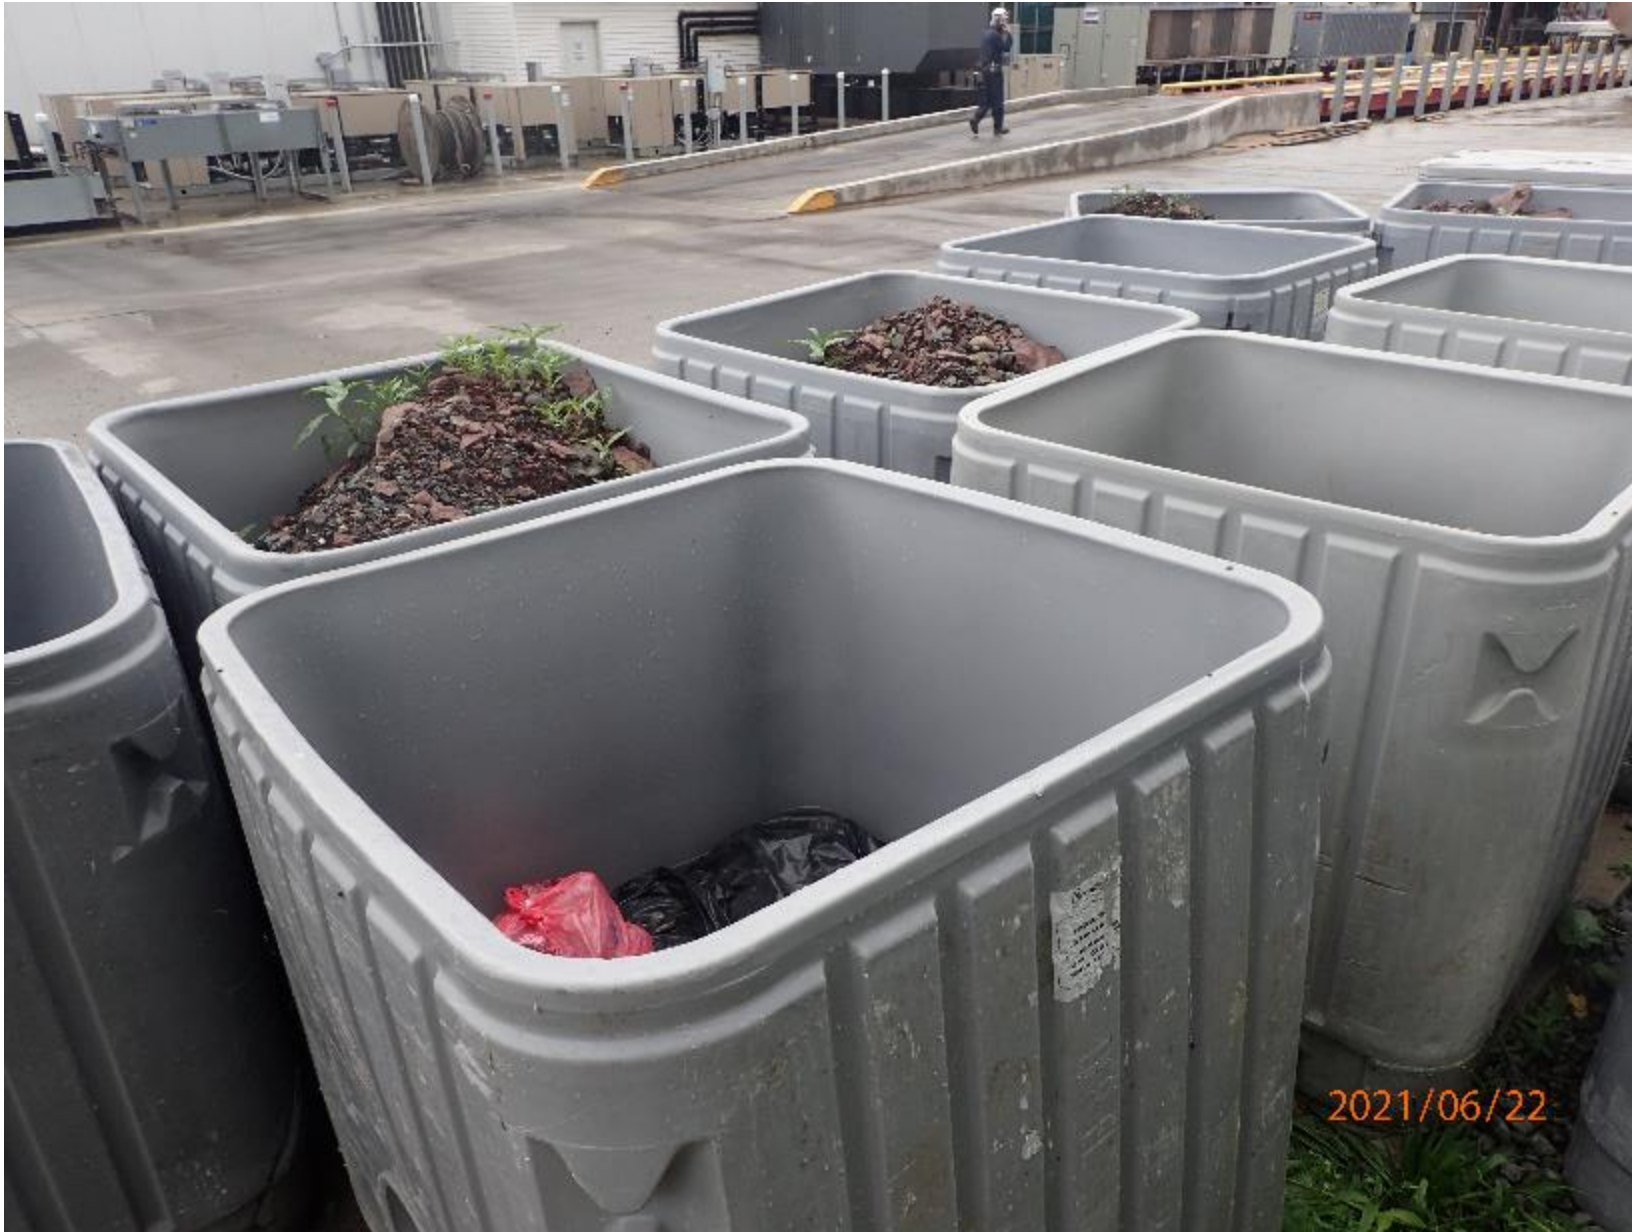
Date: 6/22/2021
Time: 1:55 PM
Photographer: SSA
Photo ID: 31 – P6220162

Plastic bins with excavated material

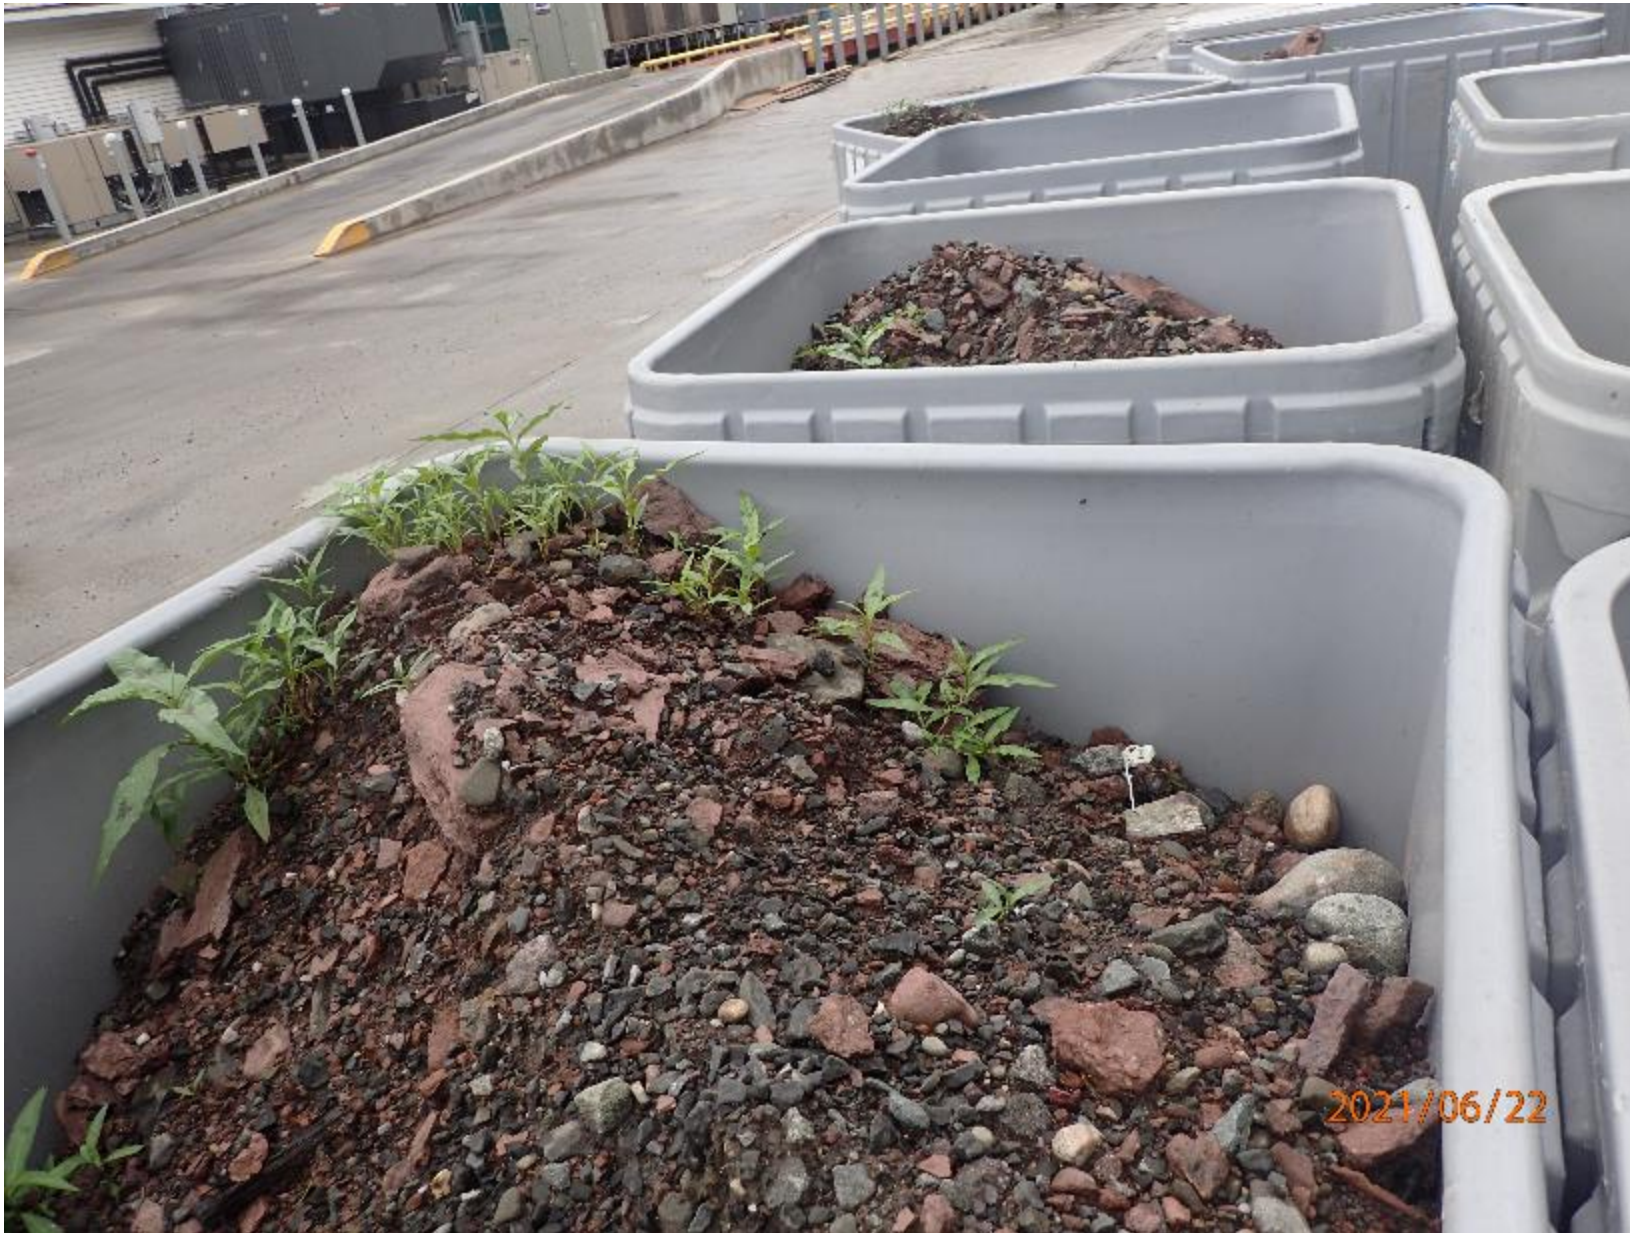
Date: 6/22/2021
Time: 1:58 PM
Photographer: SSA
Photo ID: 32 – P6220163

Plastic bins with excavated material

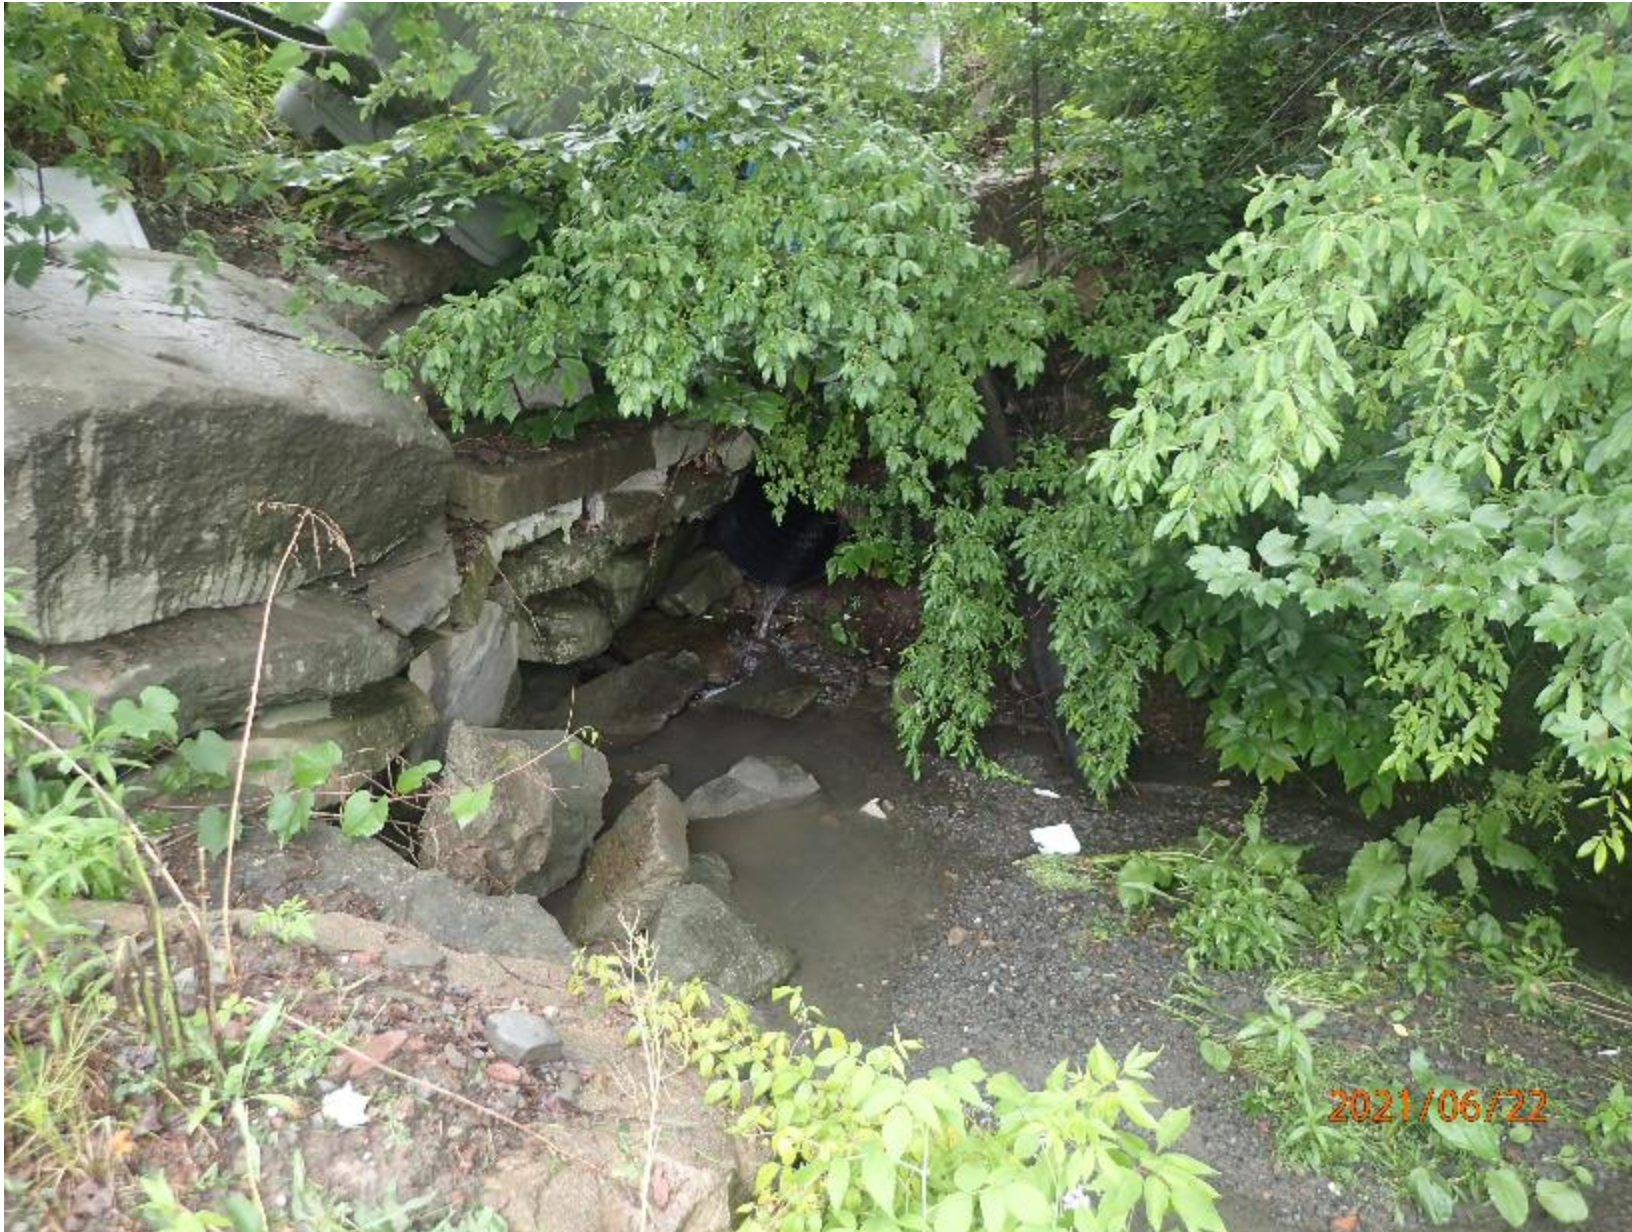
Date: 6/22/2021
Time: 2:01 PM
Photographer: SSA
Photo ID: 35 – P6220166

Downstream end of culvert flowing into stream; Culvert runs under newly constructed storage area

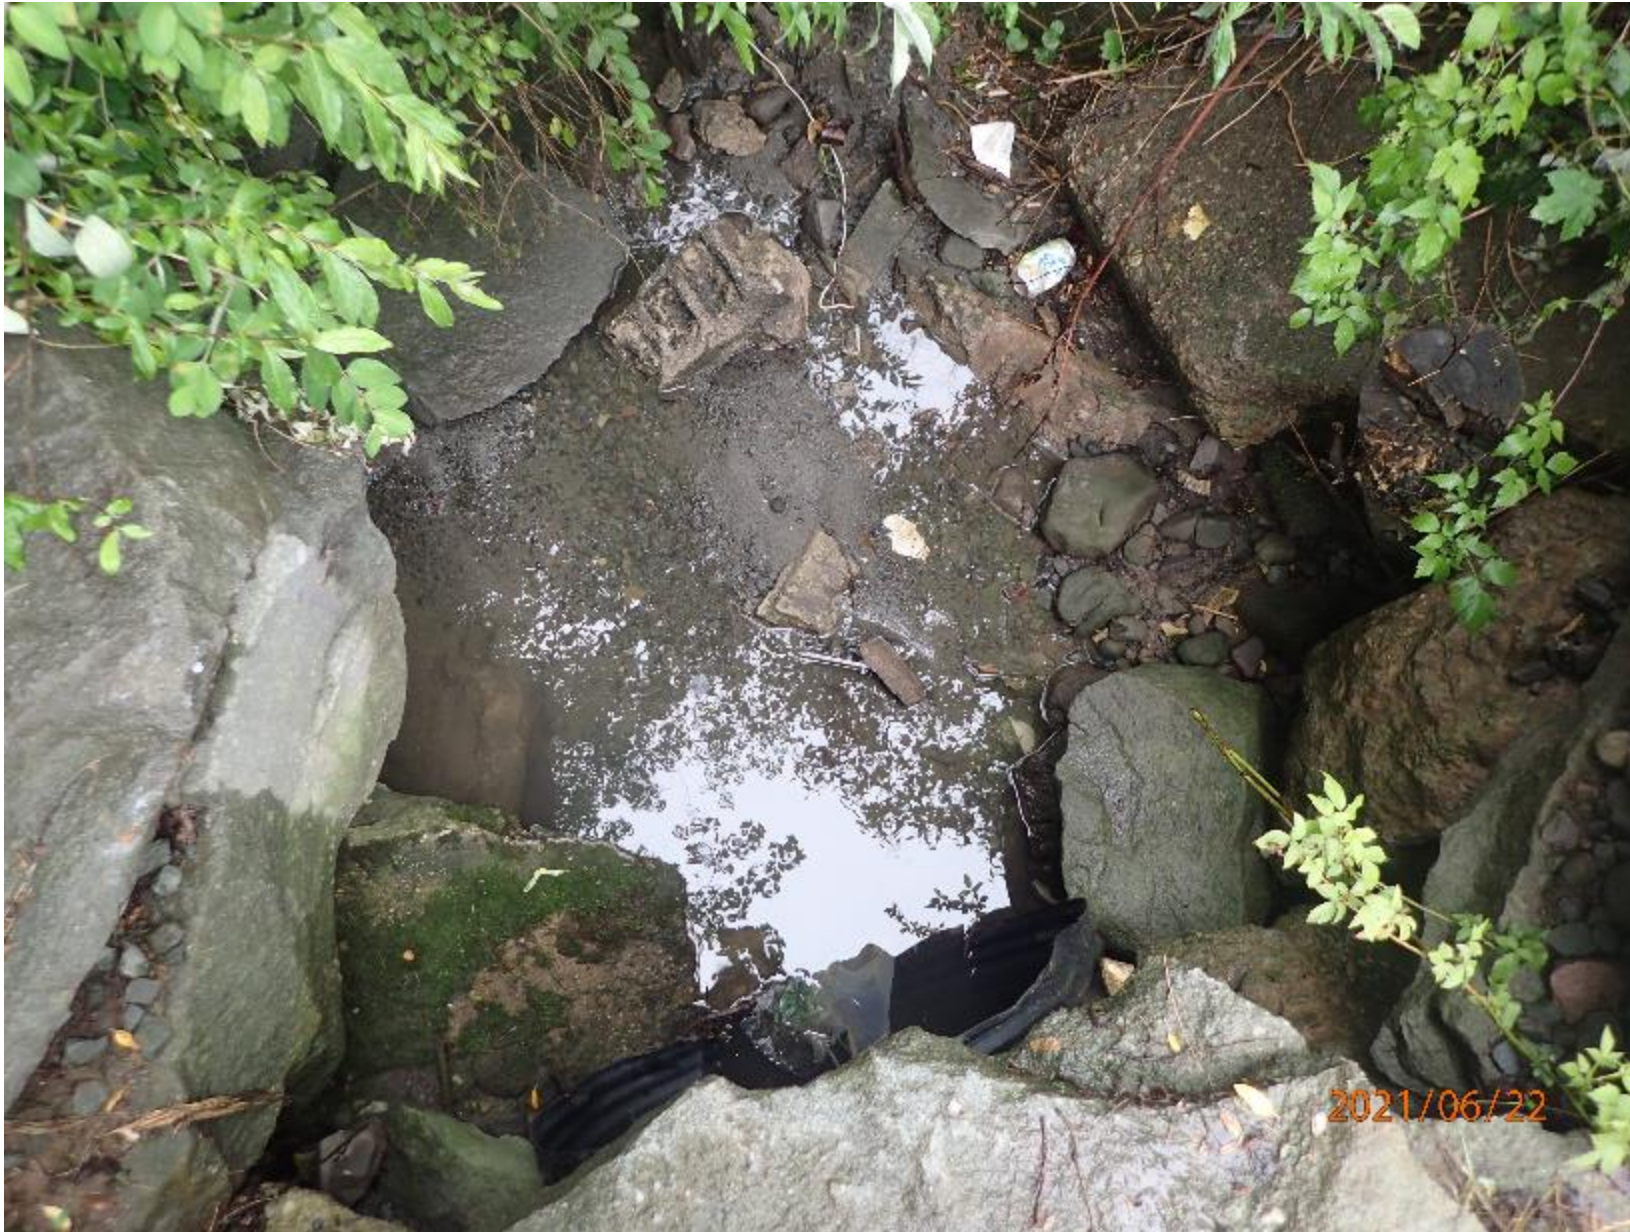
Date: 6/22/2021
Time: 2:12 PM
Photographer: SSA
Photo ID: 36 – P6220167

Upstream end of culvert under newly constructed storage area
