Clean Water Act Section 404: Site Visit/Case Development

Site Name: Newburg Egg Processing Plant

CWA 404 Inspection
Newburg Egg Processing Plant
Woodridge, Sullivan County, NY

June 22, 2021

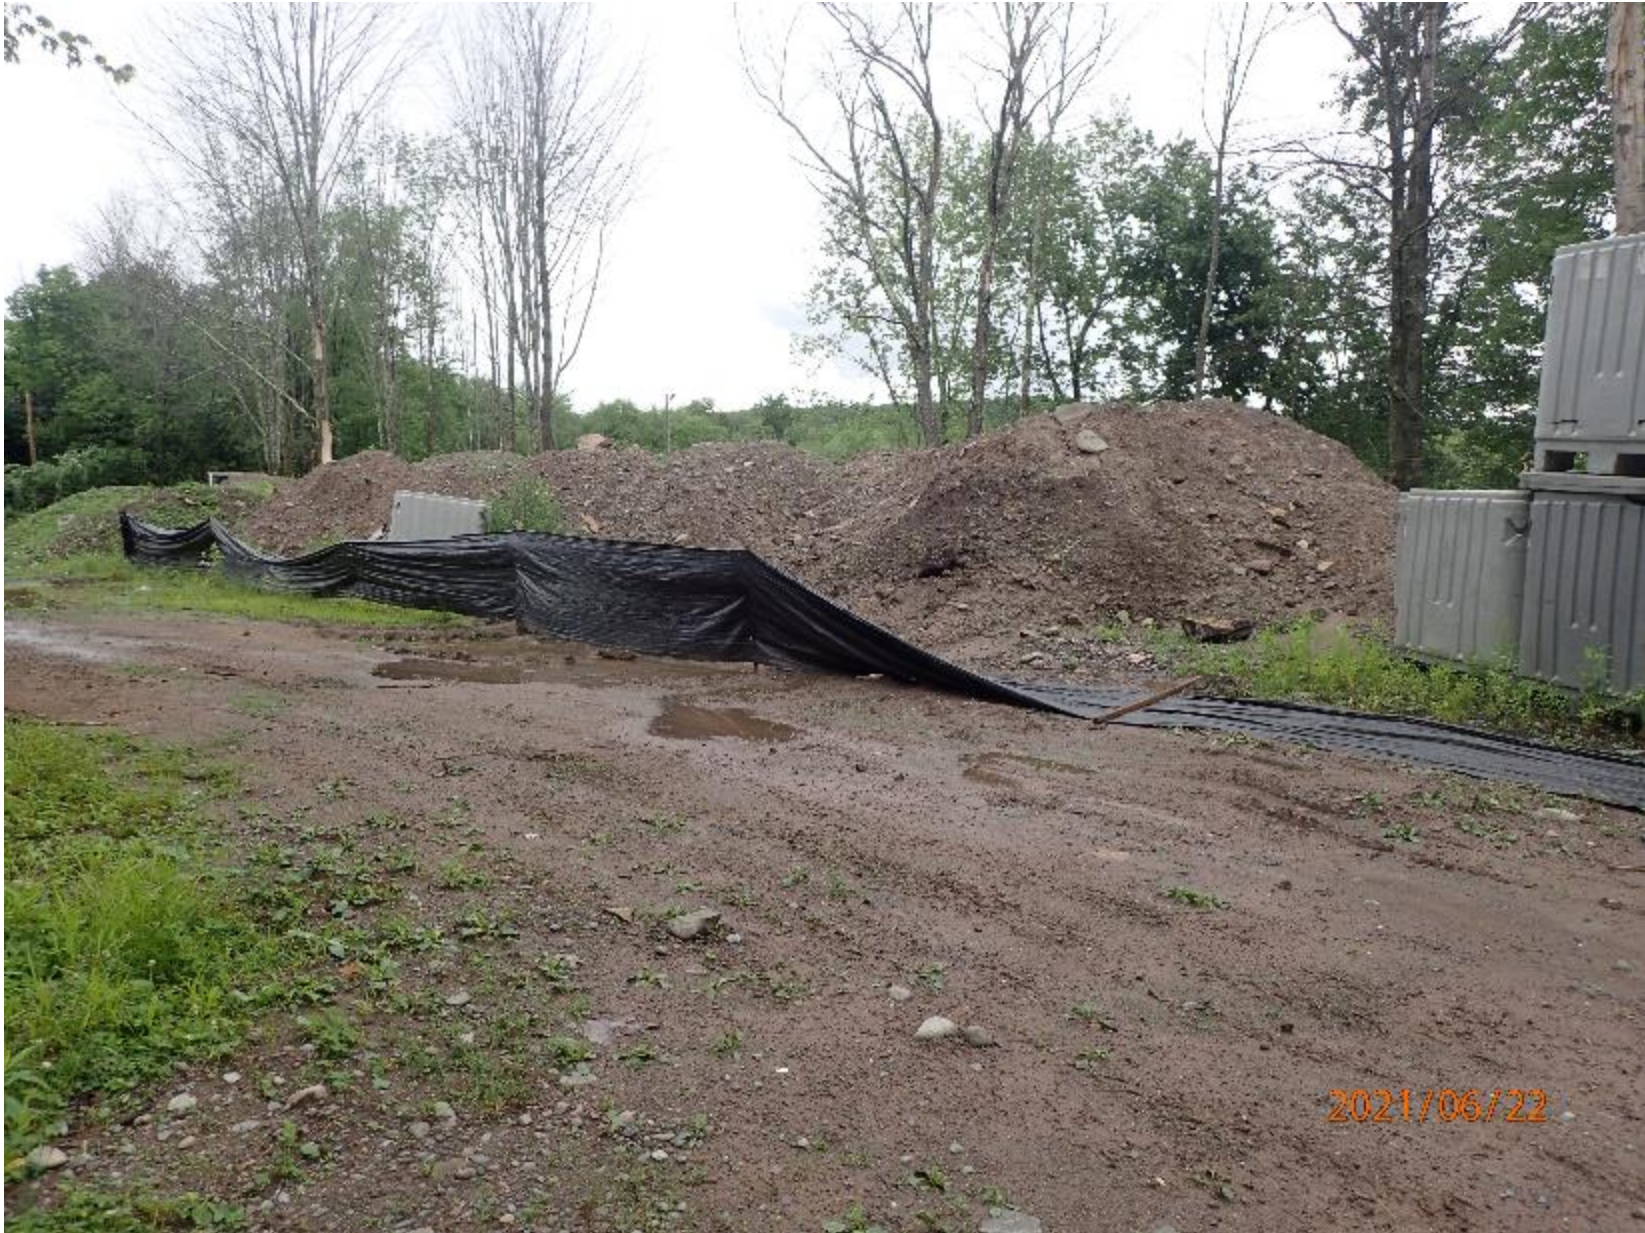
Date: 6/22/2021
Time: 2:14 PM
Photographer: SSA
Photo ID: 37 – P6220168

Description:
Fill piles on newly constructed storage area

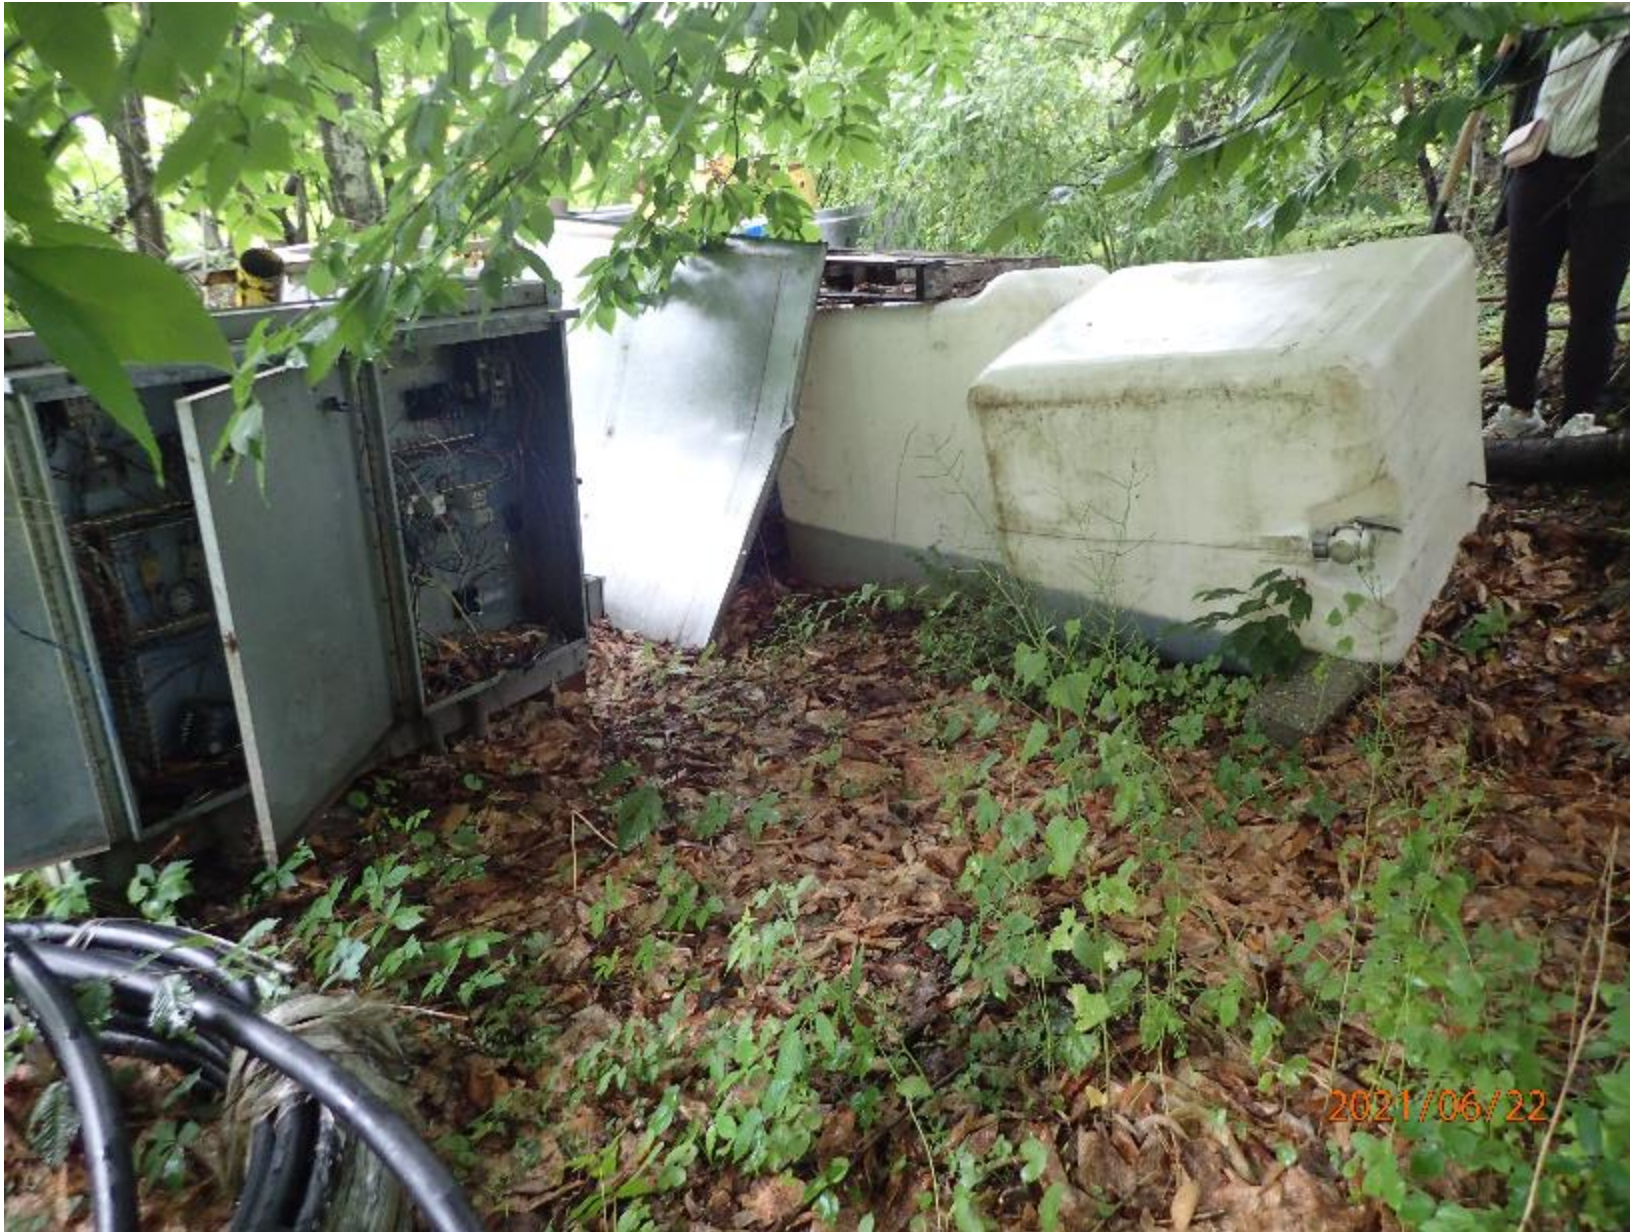
Date: 6/22/2021
Time: 2:19 PM
Photographer: SSA
Photo ID: 38 – P6220169

Containers being stored near
corner of western parcel
