## REGION 1

**Subj:** Inspection Report  
Clean Water Act - National Pollutant Discharge Elimination System  
("NPDES")  
Stiles and Hart Brick Company

- A. *Date(s) of inspection:* September 3, 2024
- B. *Weather Conditions:* Sunny, 70 degrees Fahrenheit
- C. *US EPA Representative(s):*  
Alex Rosenberg, Clean Water Act Inspector, U.S. EPA Region 1  
Eleanor Horvath, Clean Water Act Inspector, U.S. EPA Region 1

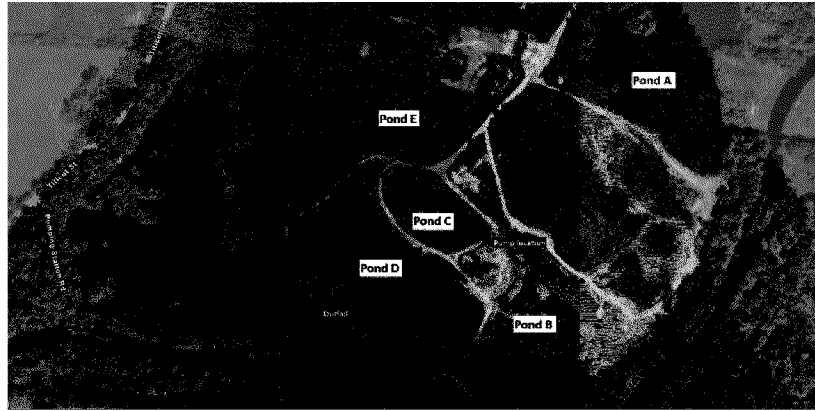
*Figure 1. Aerial image of mining areas with ponds labeled.*

EPA observed a pump being used to move water from the southeasternmost pond ("Pond B"), and a diesel tank with an approximate capacity of 100 gallons associated with the pump (see photos 4-7, 9-11). Mr. Maltais explained that water is pumped from Pond B into an adjacent pond to the northeast ("Pond C"), from which water flows by gravity drainage through a culvert into the pond to the North ("Pond E"). Another area northeast of Pond B, south of Pond A, was entirely dry (see photo 8 and figure 1). This dry area is where facility representatives stated mining activities are currently being conducted. Facility representatives further explained that when mining activities are to be conducted in Pond B, water must be removed via the pump to enable the removal of clay by dragging a claw along the ground and loading the aggregated material into a dump truck.

The group walked counterclockwise around Pond D from the pump location, and observed the location where Pond E discharges on occasion into the Taunton River. Inspector Tedder observed the discharge location through very dense vegetation (see photos 1-2). Facility representatives stated that discharge into the river from Pond E usually occurs a few times per year, dependent on seasonal rainfall amounts.
