## NPDES Compliance Inspection Report

### LKQ Heavy Truck

NPDES Tracking # ORU000502

Inspection Date: January 28, 2021

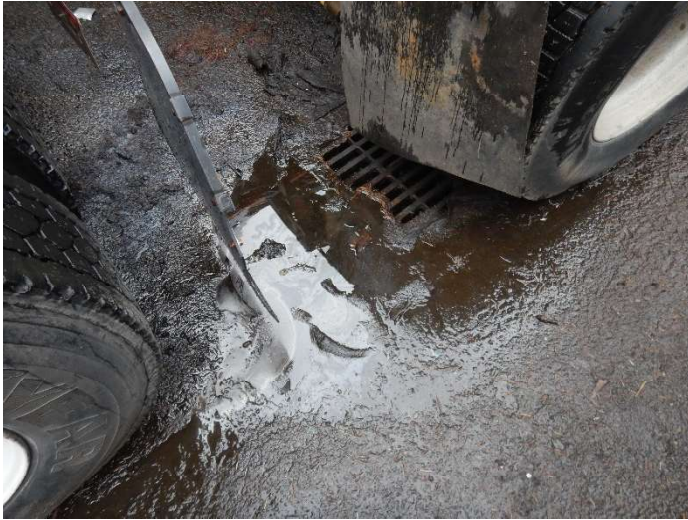
Photo #:01 (DSCN0577)

During my review of the facility at the time of the inspection, I noted several storm drains that appeared to be routing stormwater with visible oil sheen (**See Attachment B, Photos 1 & 6**). I mentioned this to Mr. McIntyre during the closing conference and we discussed the UIC permit for the facility's dry wells. I indicated that oil & grease management should be improved, particularly for the catch basins contributing to groundwater via the dry well in Lot 2. Mr. McIntyre stated that he would work on making immediate improvement to oil & grease management following the inspection.

Description: Photo of a catch basin in Lot 2, which routes stormwater to a dry well. Note the presence of visible sheen (O&G).

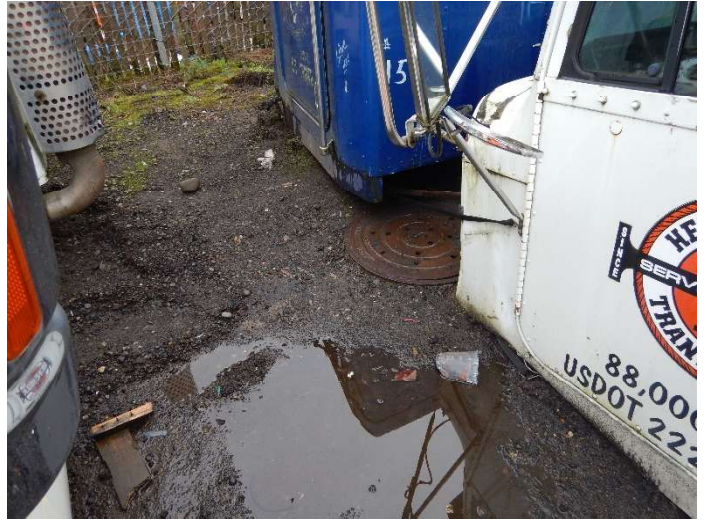
Photo #:02 (DSCN0578)

Description: Facing east, photo of a manhole cover for the dry well in Lot 2.

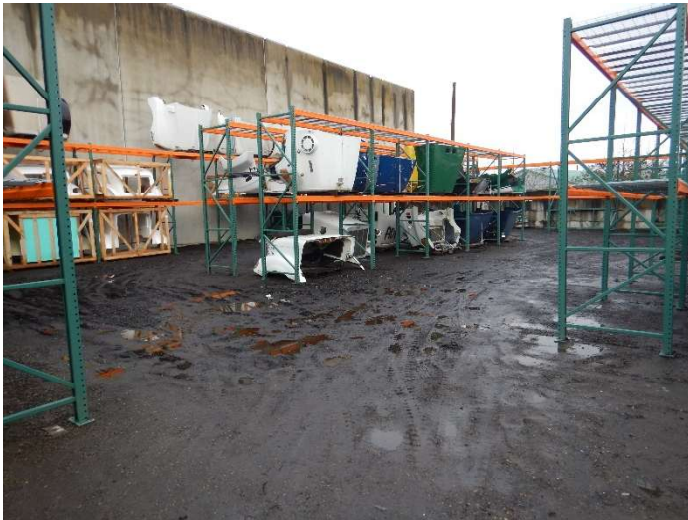
Photo #:03 (DSCN0579)

Description: Facing northwest, photo of parts storage in Lot 2.

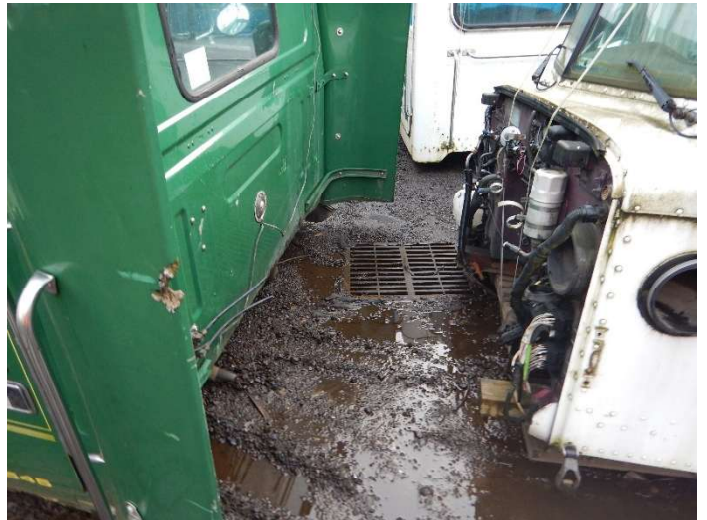
Photo #:04 (DSCN0580)

Description: Photo of a catch basin in Lot 2, which routes stormwater to a dry well.

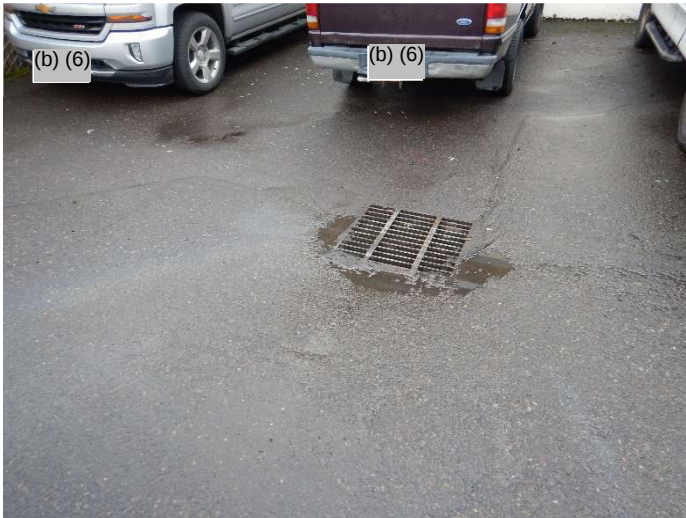
Photo #:05 (DSCN0581)

Description: Photo of a catch basin in Lot 1, which routes stormwater to the City of Portland sanitary sewer system.

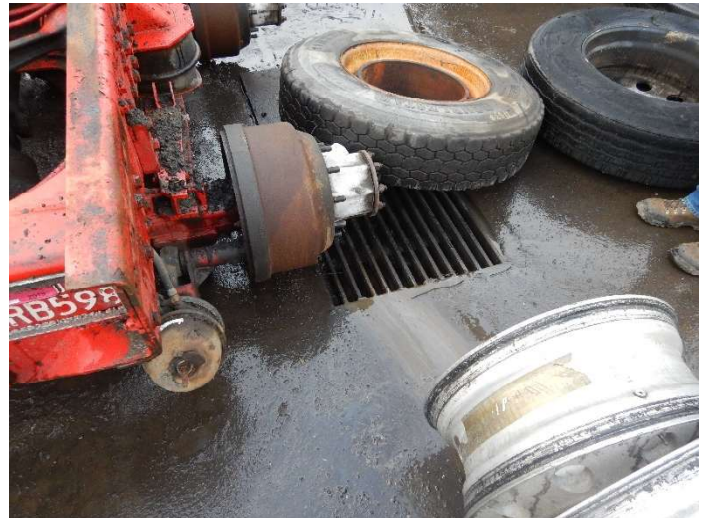
Photo #:06 (DSCN0582)

Description: Photo of a catch basin in Lot 1. This catch basin collects all of the "yard" stormwater (main activity area). Note the presence of visible sheen (O&G).

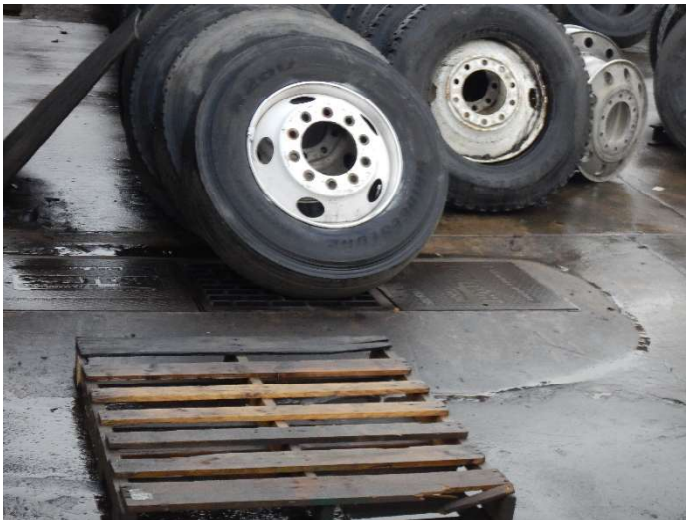
Photo #:07 (DSCN0583)

Description: Photo of a catch basin in Lot 1, which routes stormwater to the City of Portland sanitary sewer system. This storm drain also contains a filtration system, which treats stormwater prior to entry into the sanitary system.

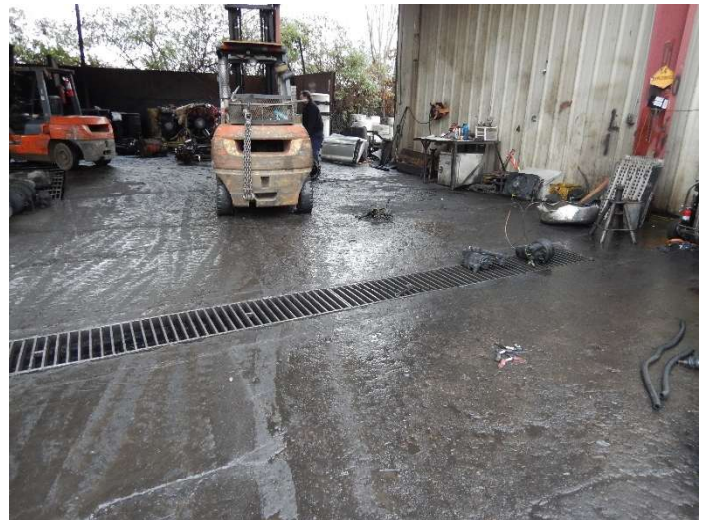
Photo #:08 (DSCN0584)

Description: Facing north, photo of a collection vent that collects stormwater in a sub-surface collection vault. This water is held in the vault indefinitely, never discharged.

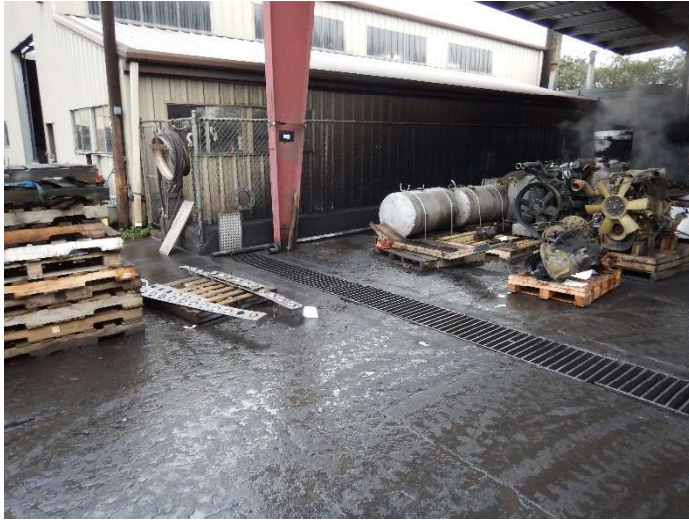
Photo #:09 (DSCN0585)

Description: Facing northwest, photo of a collection vent that collects stormwater in a sub-surface collection vault. This water is held in the vault indefinitely, never discharged.

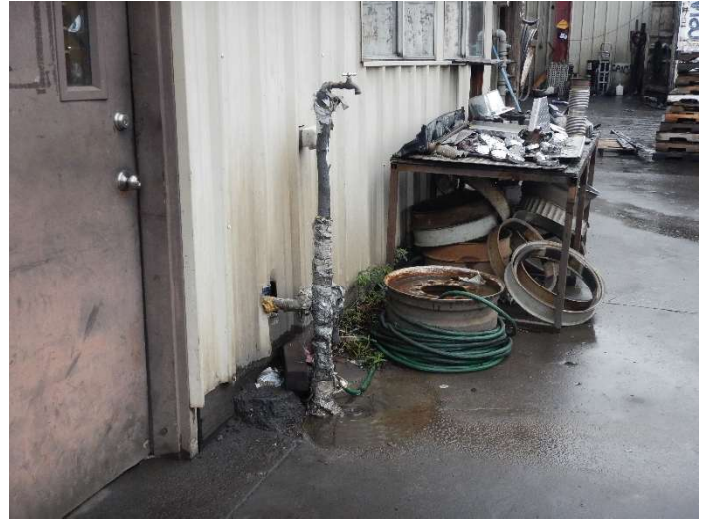
Photo #:10 (DSCN0586)

Description: Facing northeast, photo of water pump that draws City of Portland water.

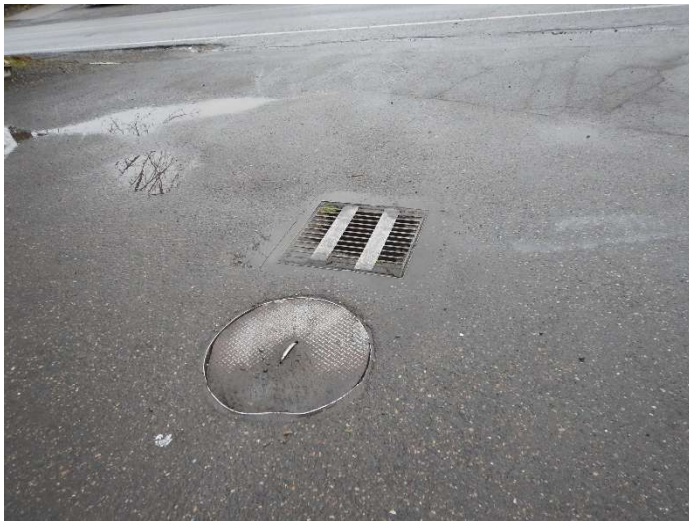
Photo #:11 (DSCN0587)

Description: Facing east, photo of a storm drain located in the sales office parking lot. This drain routes stormwater to a small settling vault.

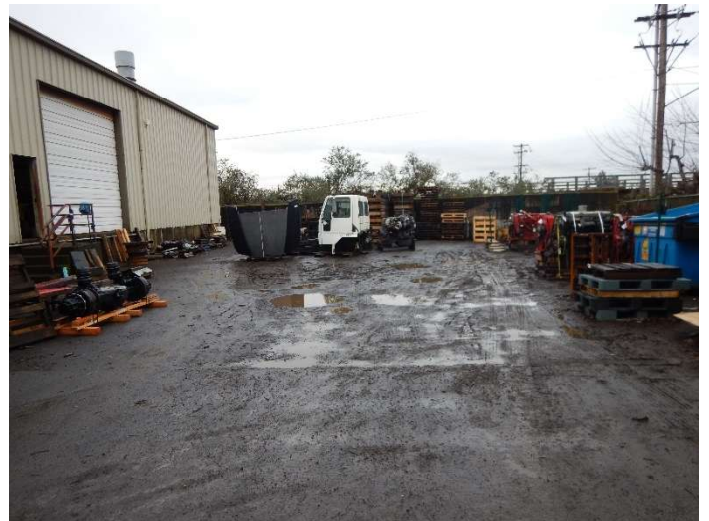
Photo #:12 (DSCN0588)

Description: Facing north, photo of the side yard in Lot 1.

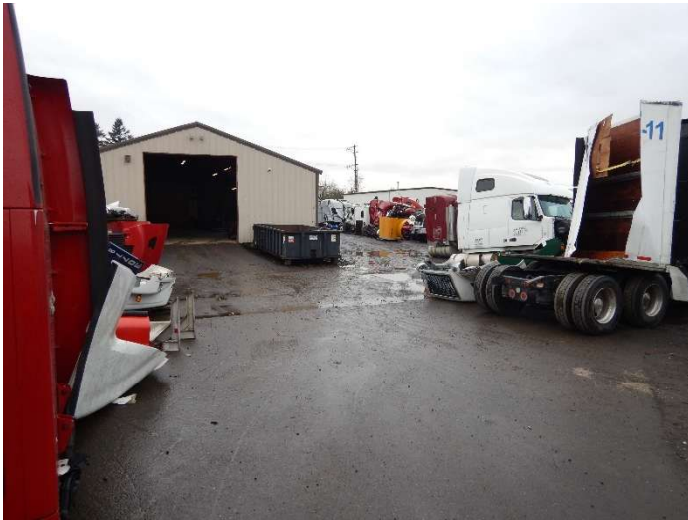
Photo #:13 (DSCN0589)

Description: Facing west, photo of the “old half” of Lot 3. This was the initially purchased portion of the lot.

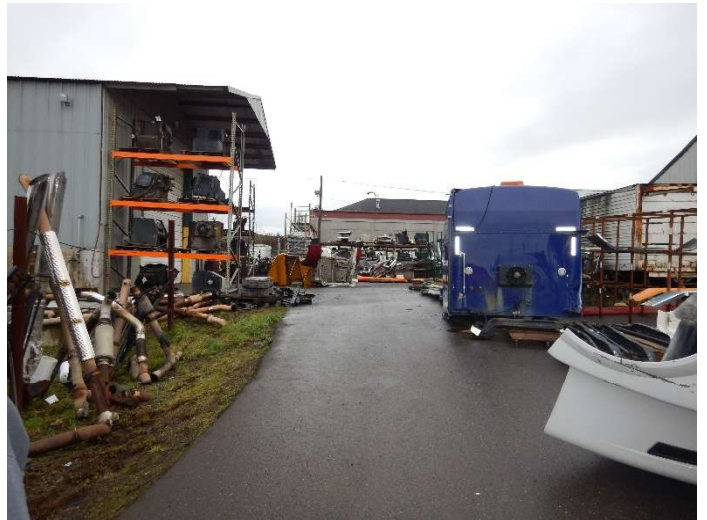
Photo #:14 (DSCN0590)

Description: Facing east, photo of the “new half” of Lot 3. This portion of the lot was purchased later.

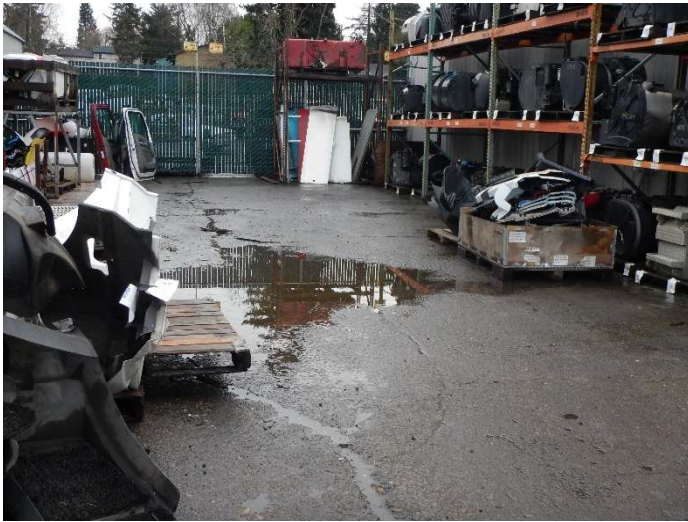
Photo #:15 (DSCN0591)

Description: Facing south, photo of stormwater pooling on a paved portion of the “new half” of Lot 3.

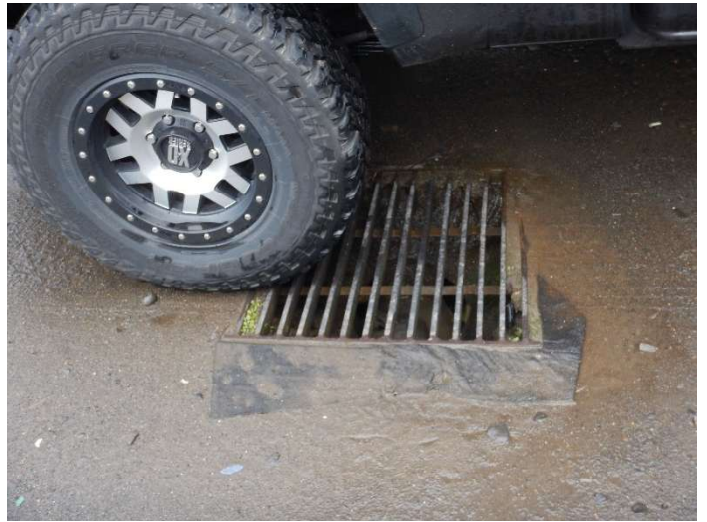
Photo #:16 (DSCN0592)

Description: Photo of the catch basin in Lot 3 that contributes to a dry well.
