| To-Name & Department | | File Code | Date | CIMS Number |
|---|--|---|---|---|
| S. C. Enders | | Stamping and Assembly | October 21, 1977<br>Trenton Chemical | 453-00-00 |

Subject: ASBESTOS SURVEY

TRENTON FRICTION PRODUCTS

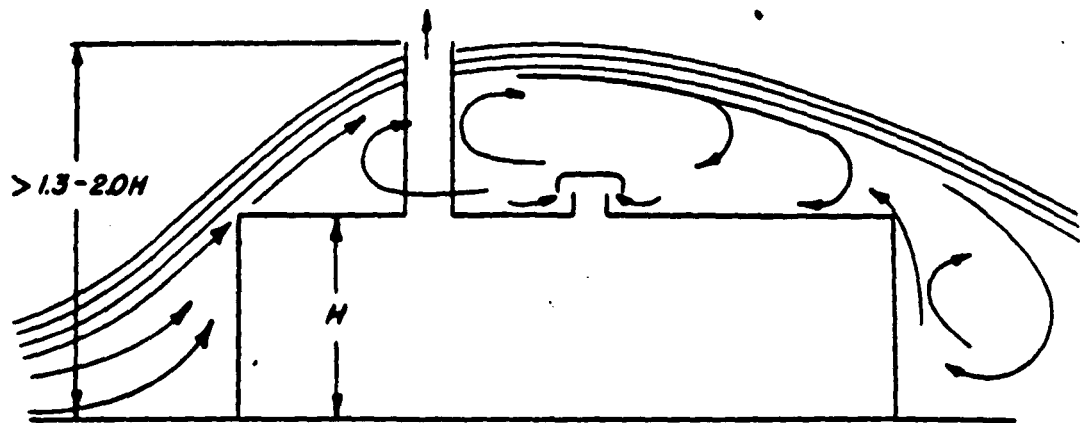
**GOOD**

*High discharge stack relative to building height,  
air inlet on roof.*

During the course of this survey, two large make-up air units were installed on the east end of the Friction Products Building. The intake of the north make-up air unit is in close proximity to the exhaust of the #2 Baghouse. Air sample No. 22 indicates that asbestos emissions are being recirculated back into the Friction Products Building through the north make-up air unit. Industrial Hygiene recommends that the #2 Baghouse exhaust be relocated so as to direct any fugitive baghouse emissions away from the north make-up air unit. It is good Industrial Hygiene practice to design building air inlets and outlets in accordance with the attached A. C. G. I. H. sketch.

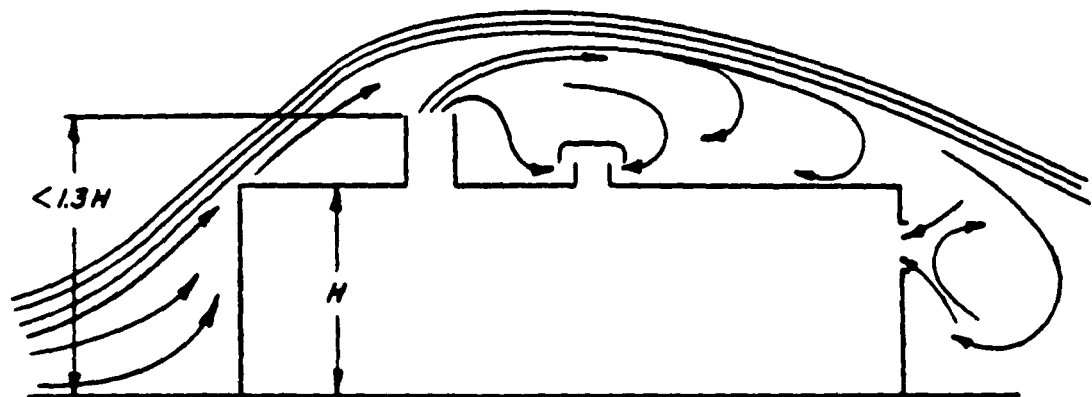
**POOR**

*Low discharge stack relative to building height,  
air inlet on roof and wall.*
