## Clean Water Act Section 404: Site Visit/Case Development

| Site Name | Rincon Blue Water, LLC (hereinafter as "RBW") | | | | |

# CWA 404 Inspection

Rincon BlueWater, LLC  
PR-413, km 1, parcel number 95-000-010-88-00  
in Rincon, Puerto Rico

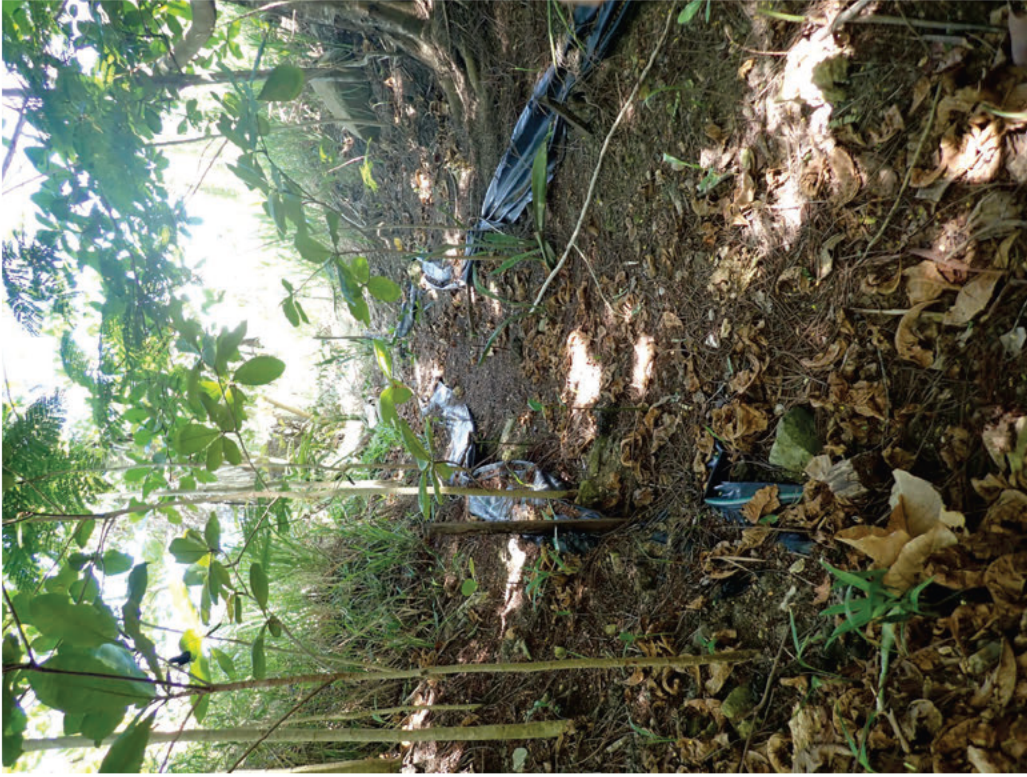
Photo ID: P4040001

Description: Predominantly upland path lined with collapsed erosion fencing.

Location of the path is north of Ensenada Creek and south of the unauthorized wetland fill pile.

| EPA noted that the current state of all erosion fencing on the property are not up to proper best management practice standards and would need to be corrected before the start of any activities within the wetland areas. | | | |

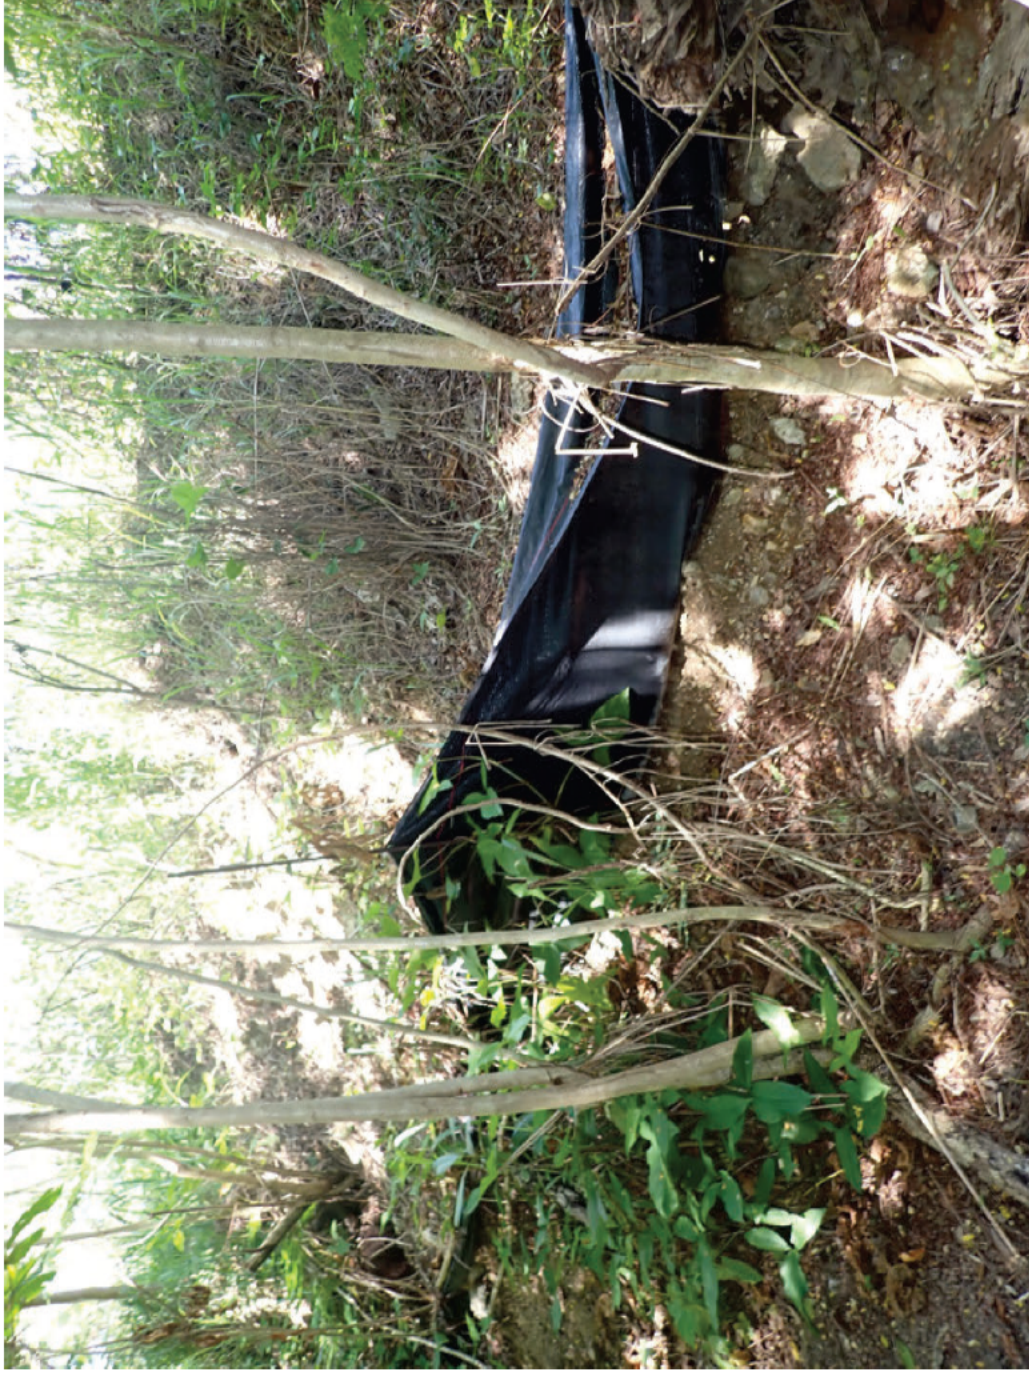
Photo ID: P4040020

Description: All erosion fencing on site have structurally failed.

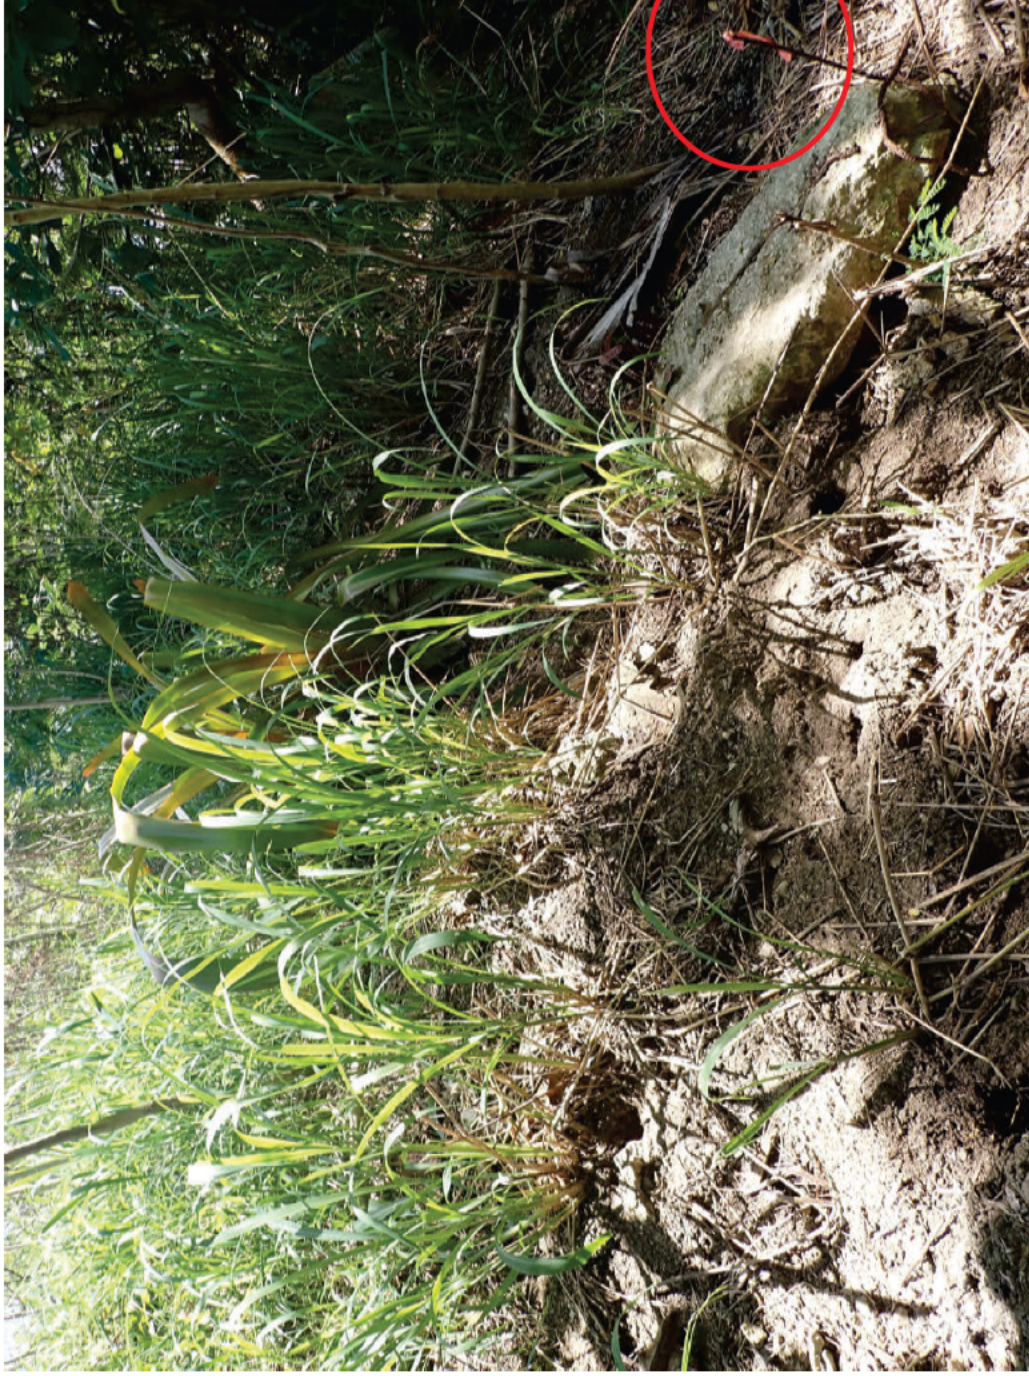
Photo ID: P4040007

Description: Northern portion of the Path. Pink wetland delineation flag can be seen placed by a RBW consultant.

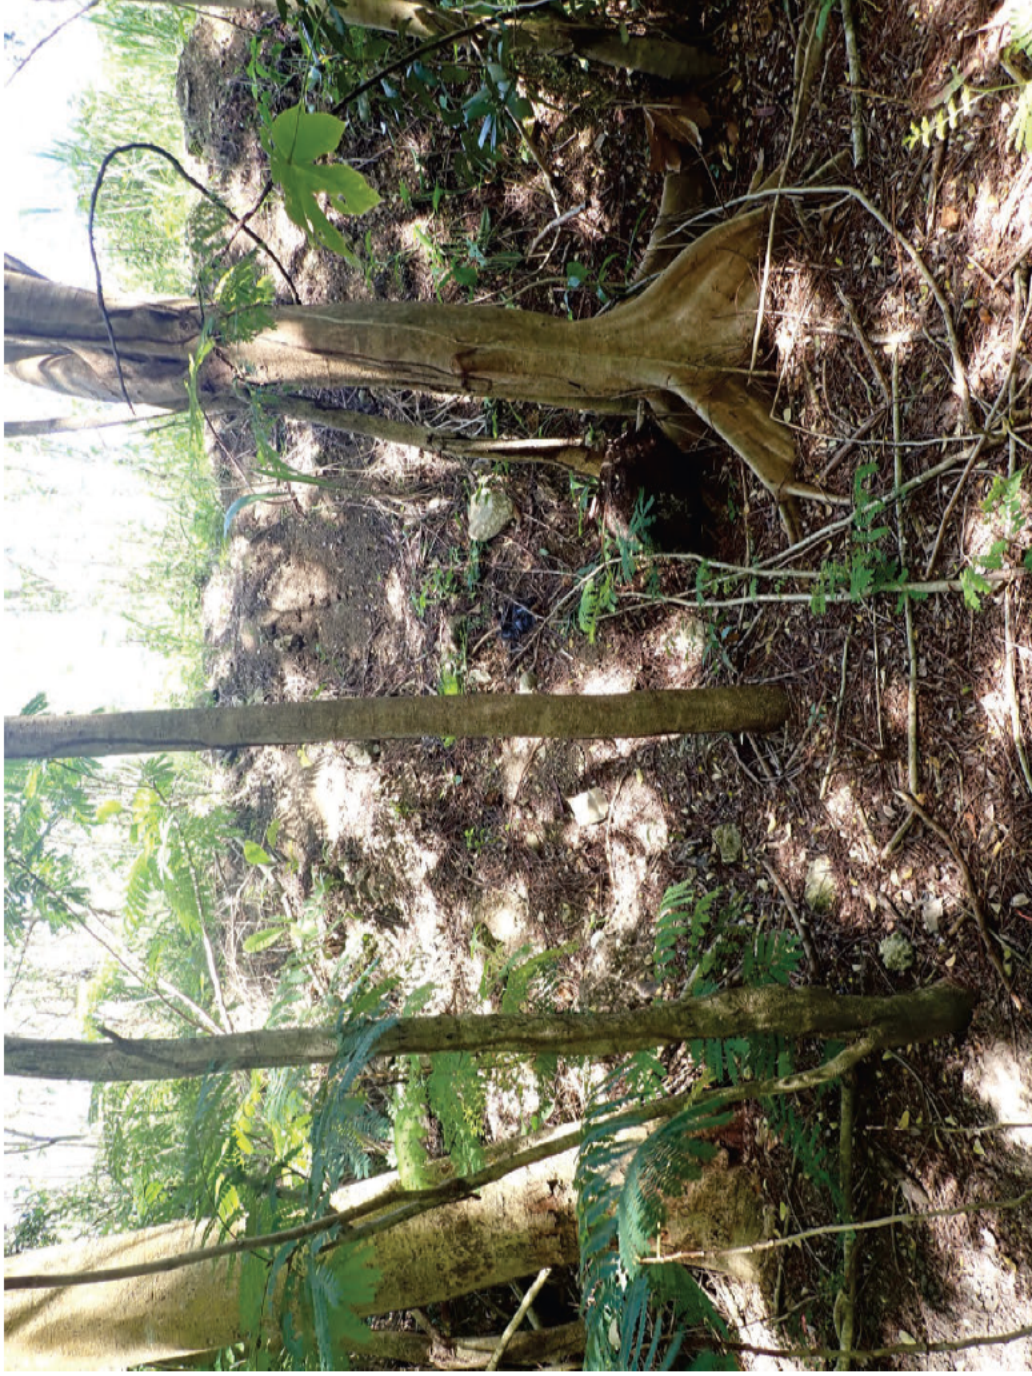
Photo ID: P4040016

Description: Buttress roots were observed on trees located adjacent to the unauthorized fill pile within wetlands (seen behind the trees).

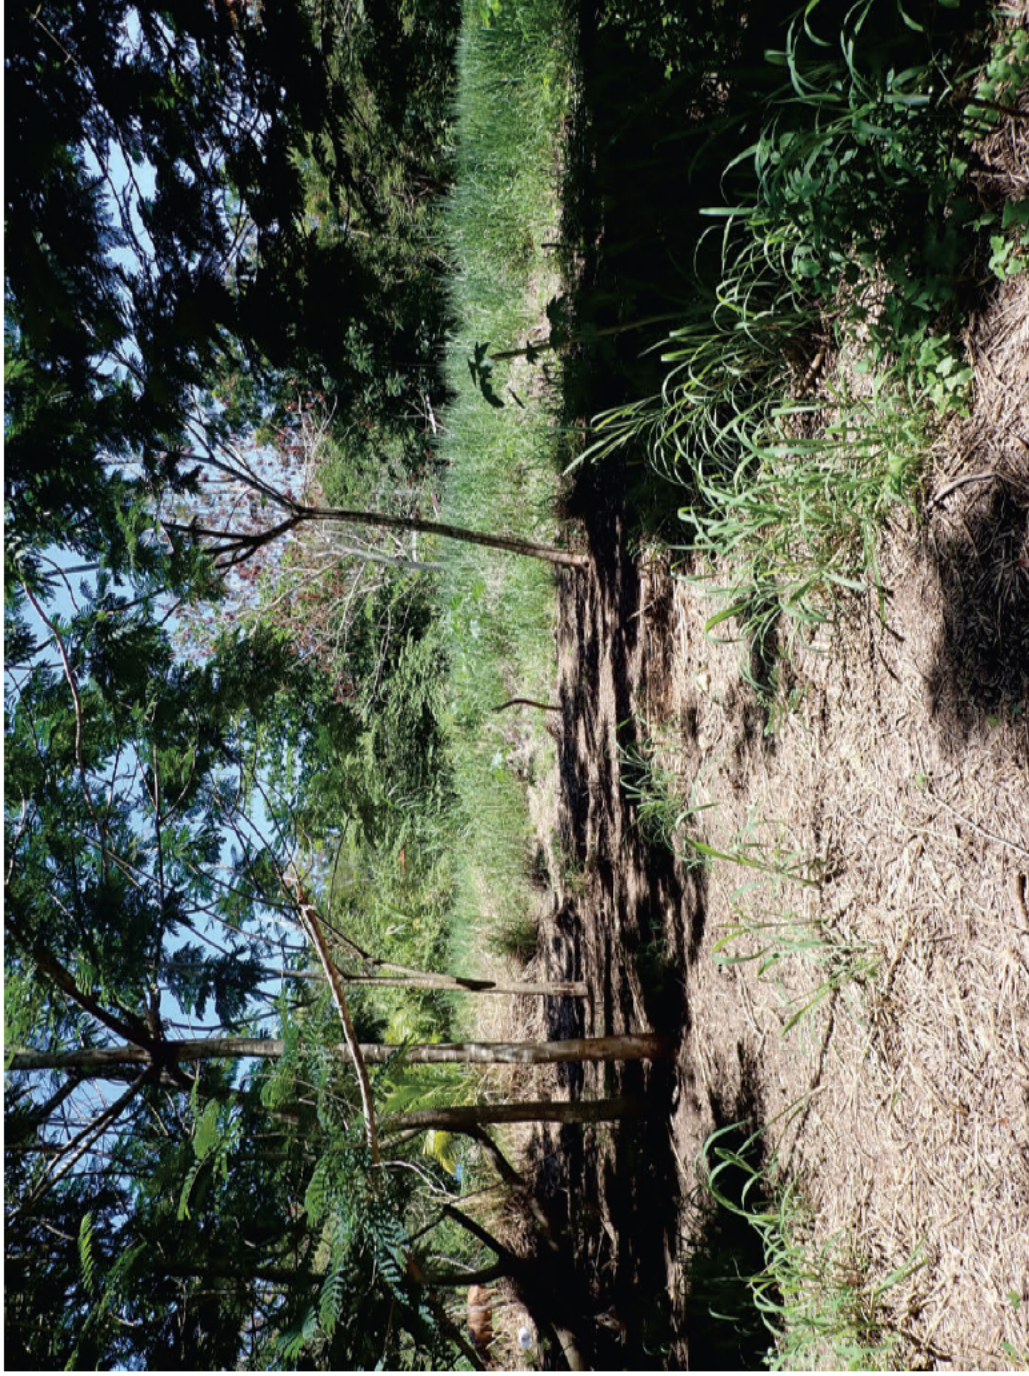
Photo ID: P4040034

Description: Located north of the property, additional federal wetland were delineated by RBW consultants.

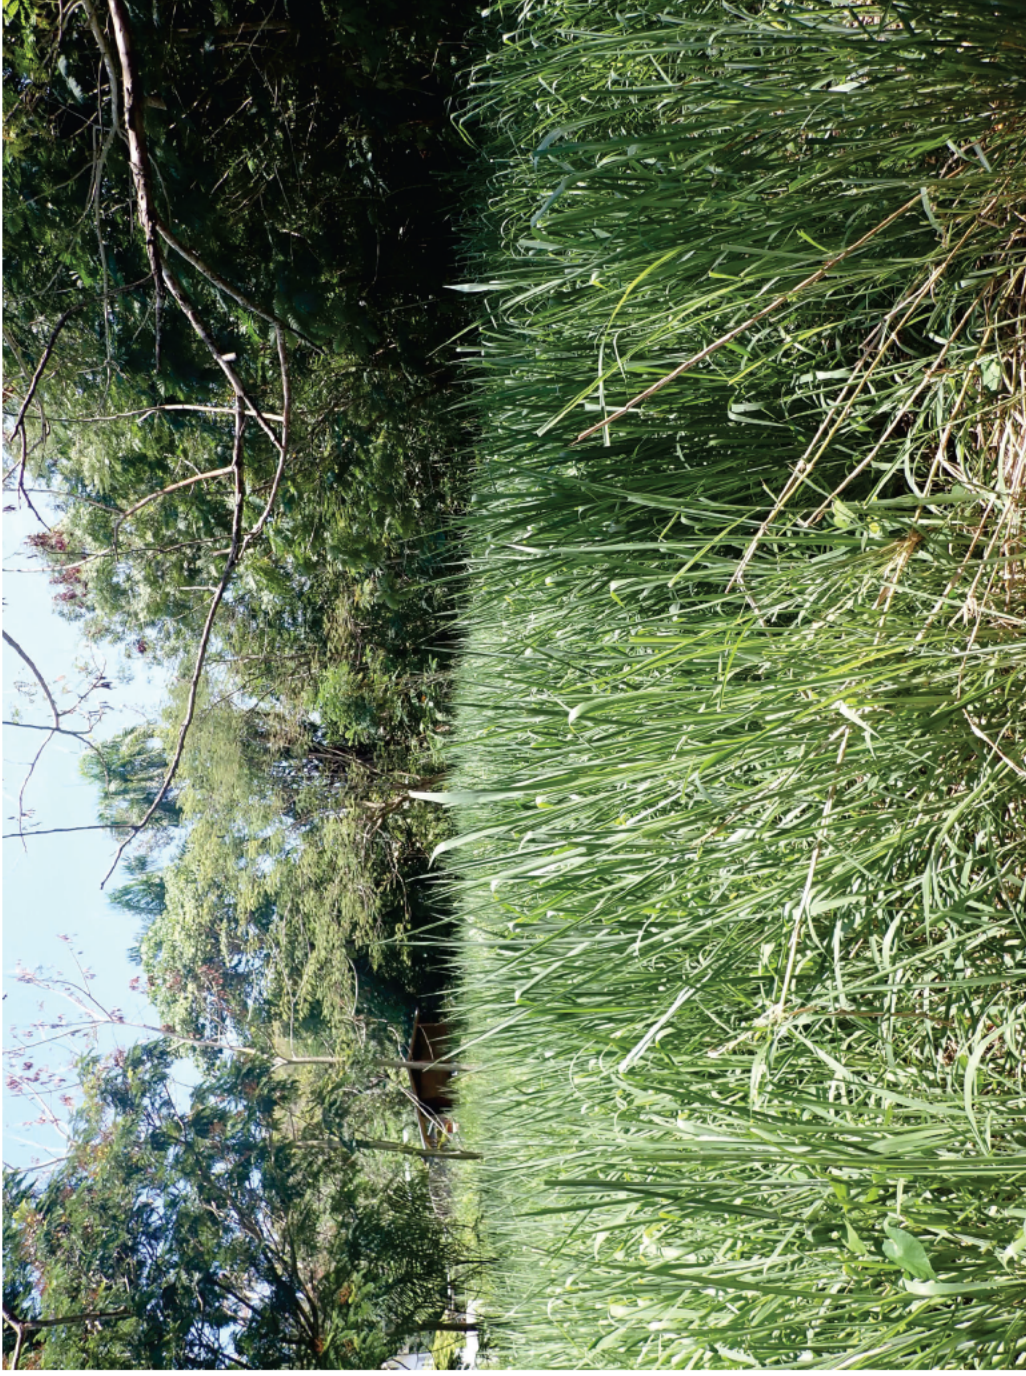
Photo ID: P4040024

Description: Located north of the property, additional federal wetland were delineated by RBW consultants.

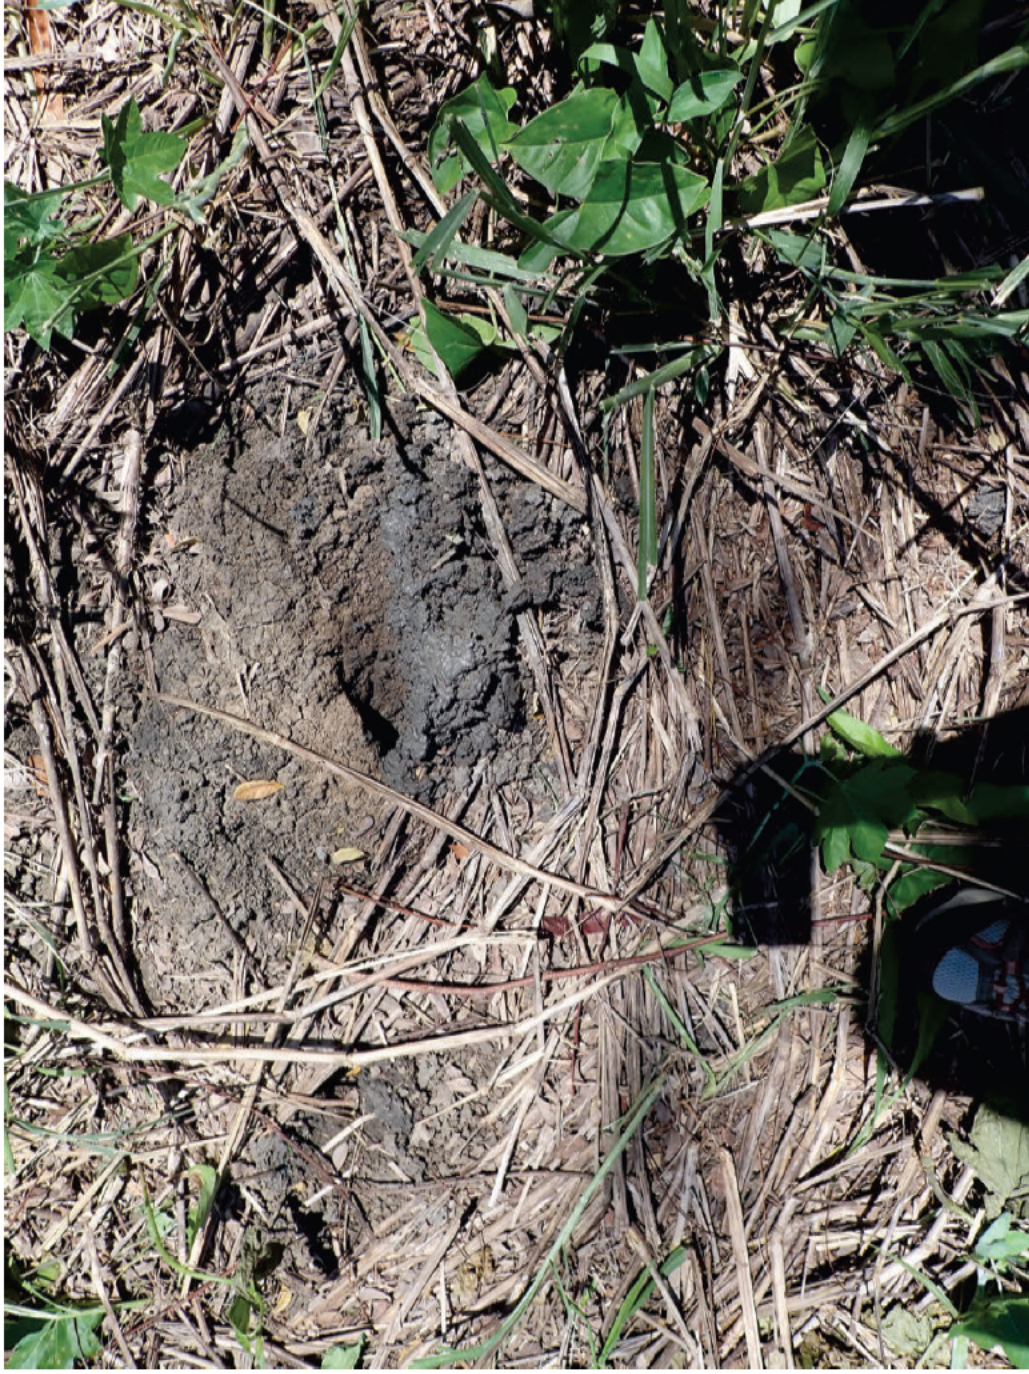
Photo ID: P4040025

Description: Located north of the property, additional federal wetland were delineated by RBW consultants.

Evidence of dark, hydric soils with saturation were present within the area to observe.

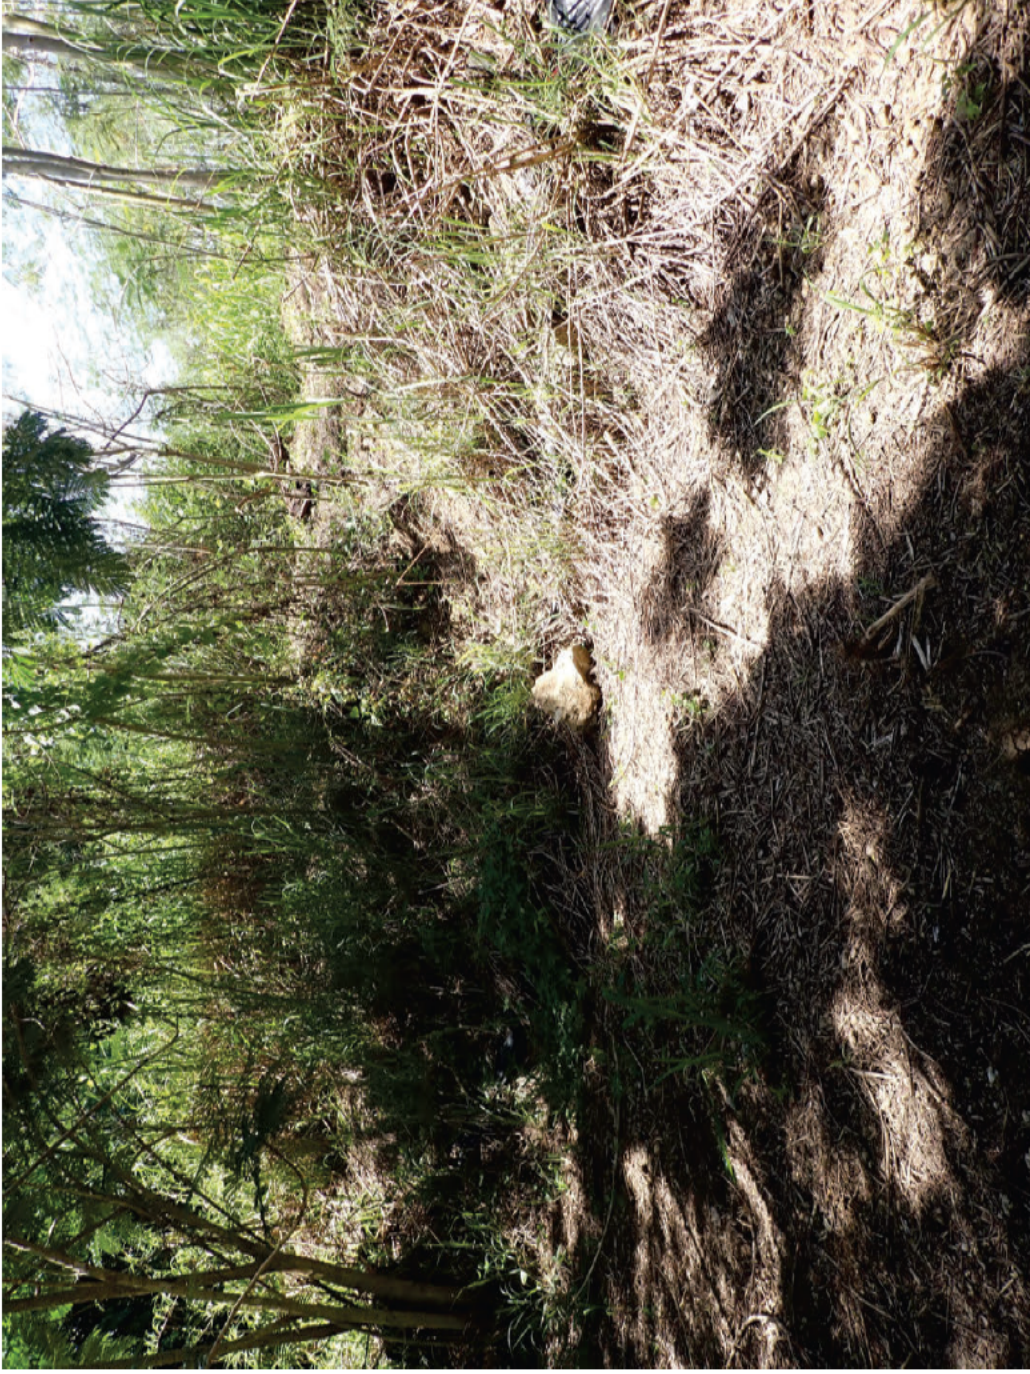
Date: April 4, 2022  
Time: 11:53 AM  
Photographer: Sofia Olivero Lora, PhD  
Photo ID: P4040030

Description: Approximately 6-foot tall fill pile located within wetlands with new upland vegetation growth.

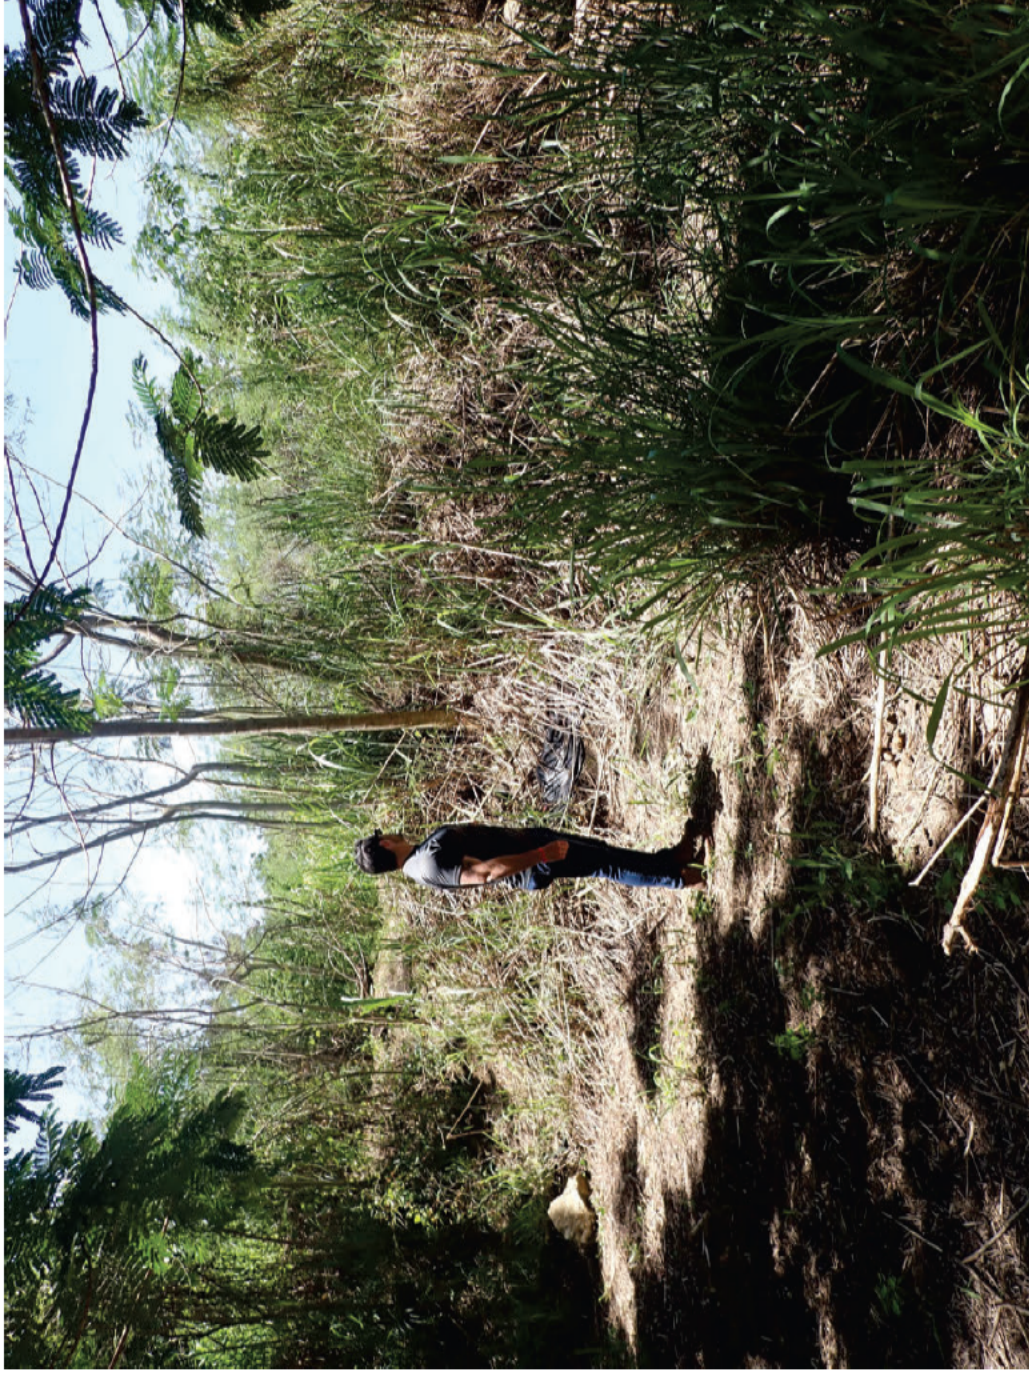
Photo ID: P4040052

Description: Approximately 6-foot tall fill pile located within wetlands with new upland vegetation growth.

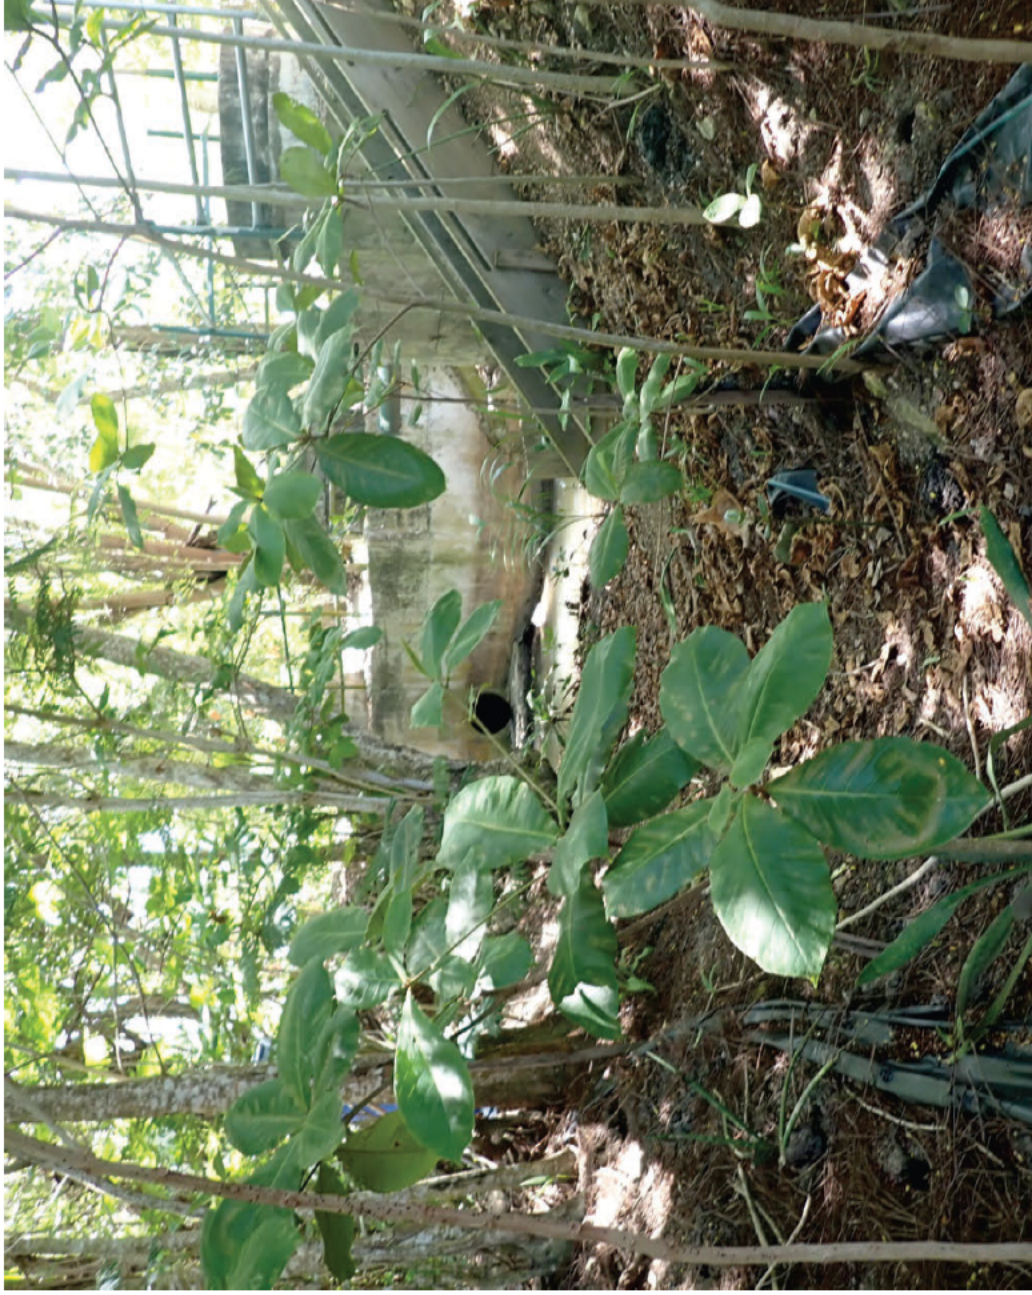
Photo ID: P4040014

Description: Culverted structures in which  
Ensenada Creek actively flows south under.

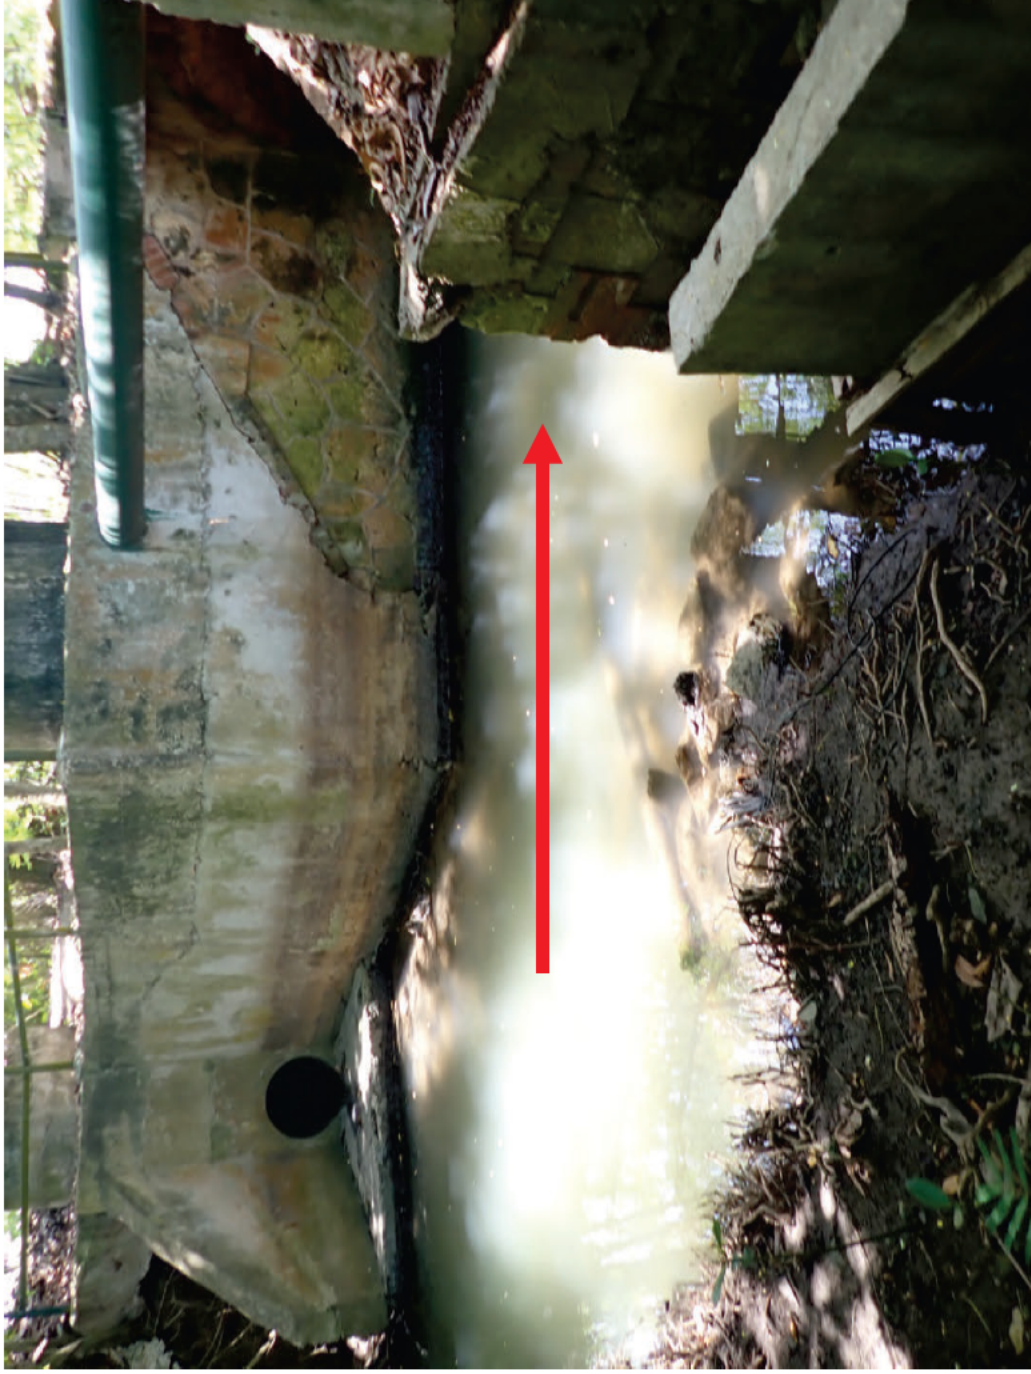
Photo ID: P4040036

Description: Ensenada Creek actively flowing south, under a culvert.

The red arrow marks the direction of the flow.

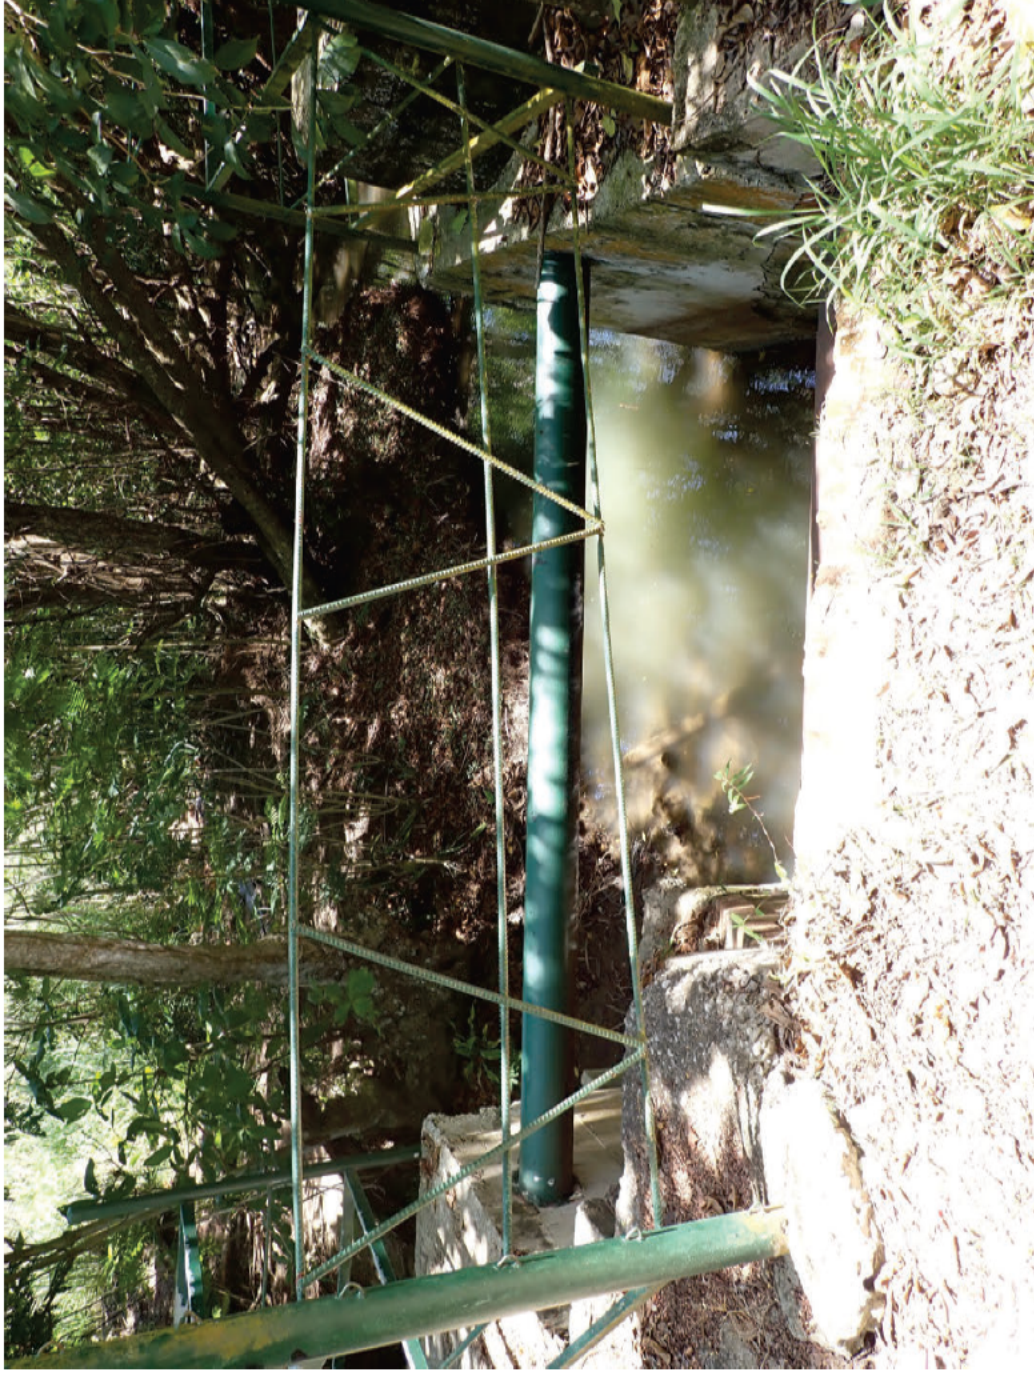
Photo ID: P4040040

Description: Ensenada Creek actively flowing south, under a culvert.

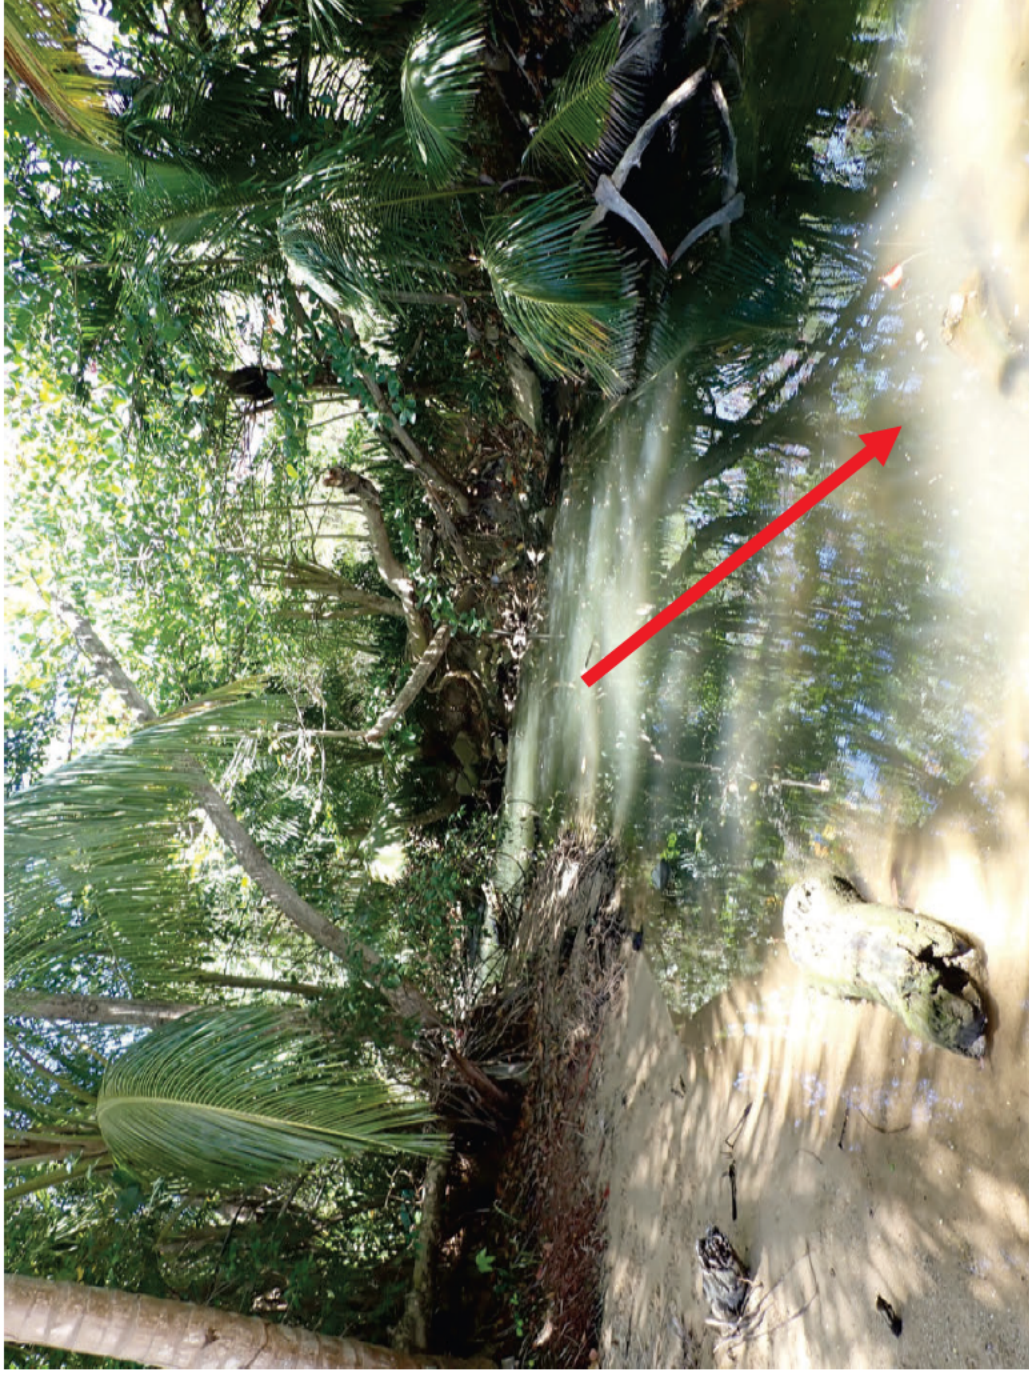
Photo ID: P4040046

Description: Ensenada Creek actively flowing and draining into the Atlantic Ocean.

The red arrow marks the direction of the flow.

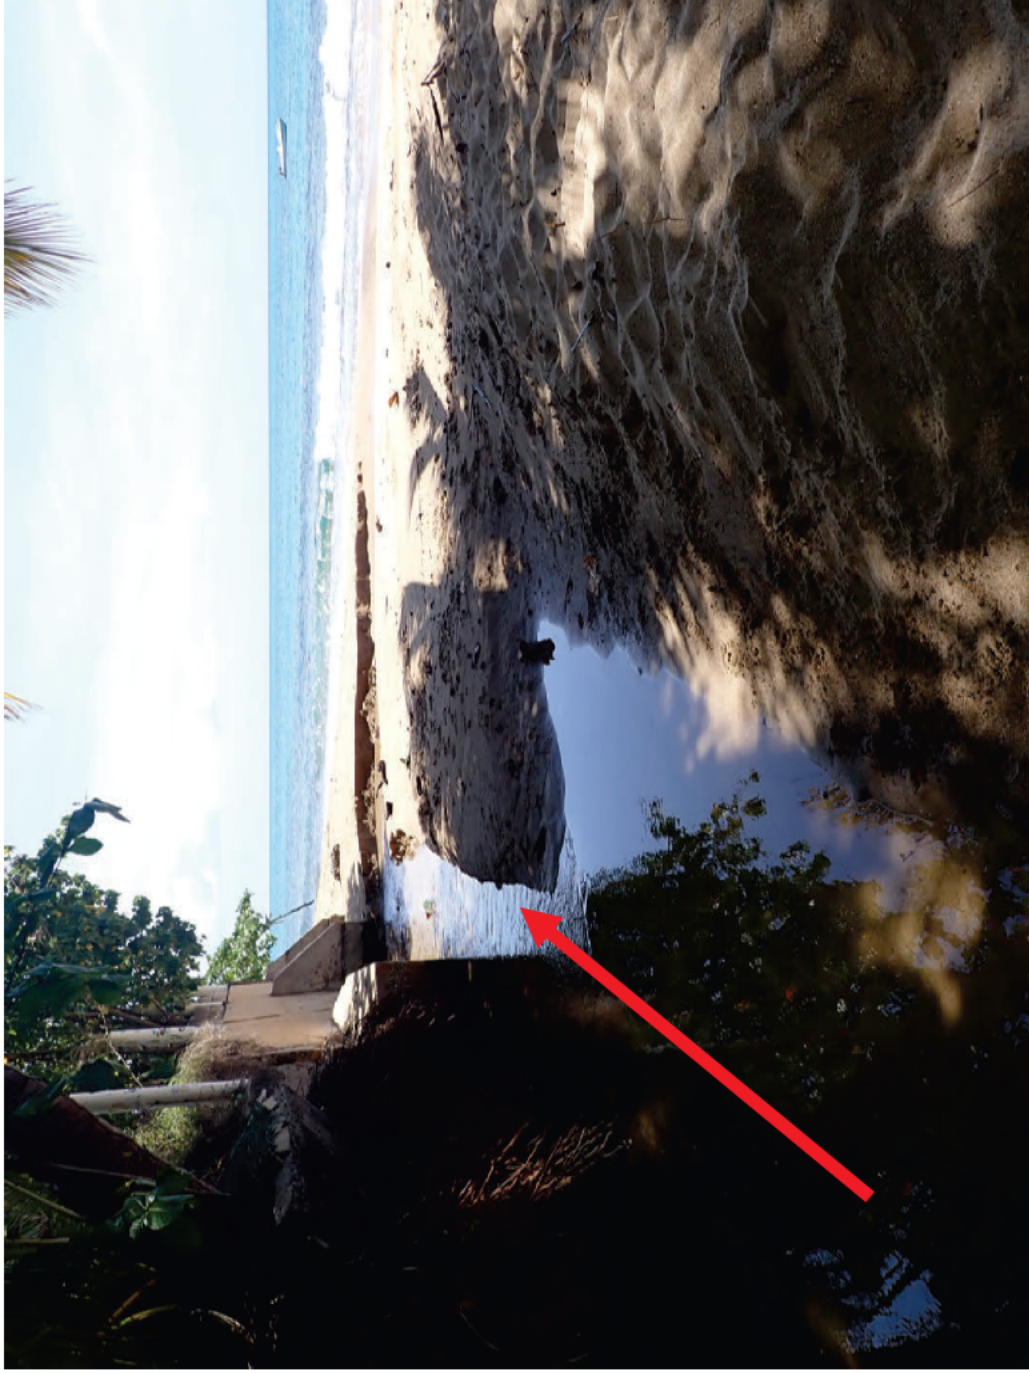
Photo ID: P4040047

Description: Ensenada Creek actively flowing and draining into the Atlantic Ocean

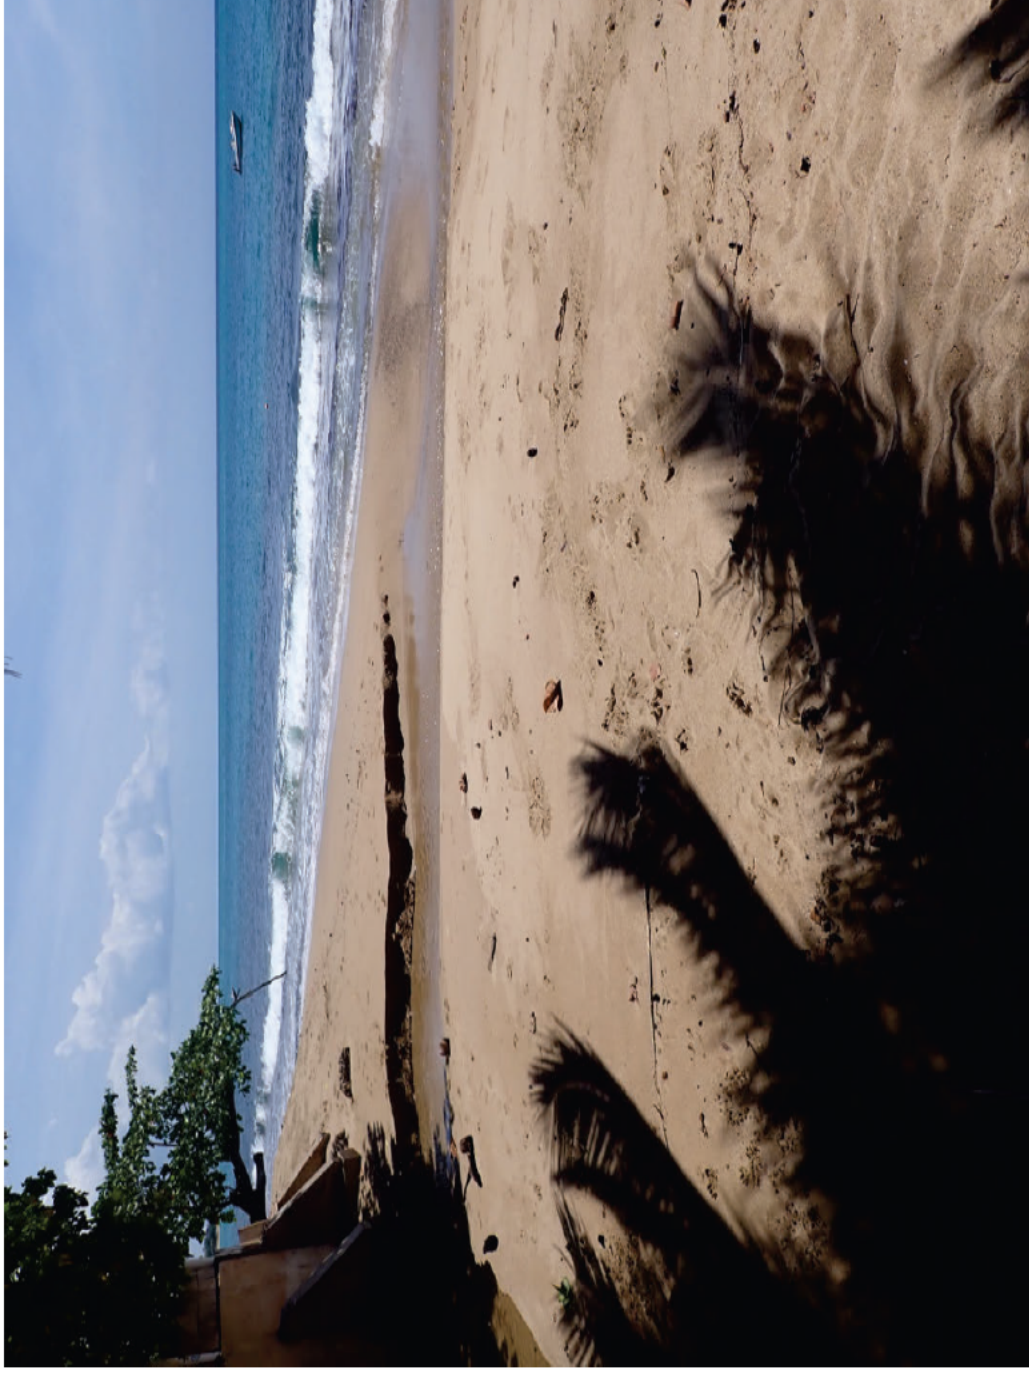
Photo ID: P4040049

Description: Ensenada Creek actively flowing and draining into the Atlantic Ocean.

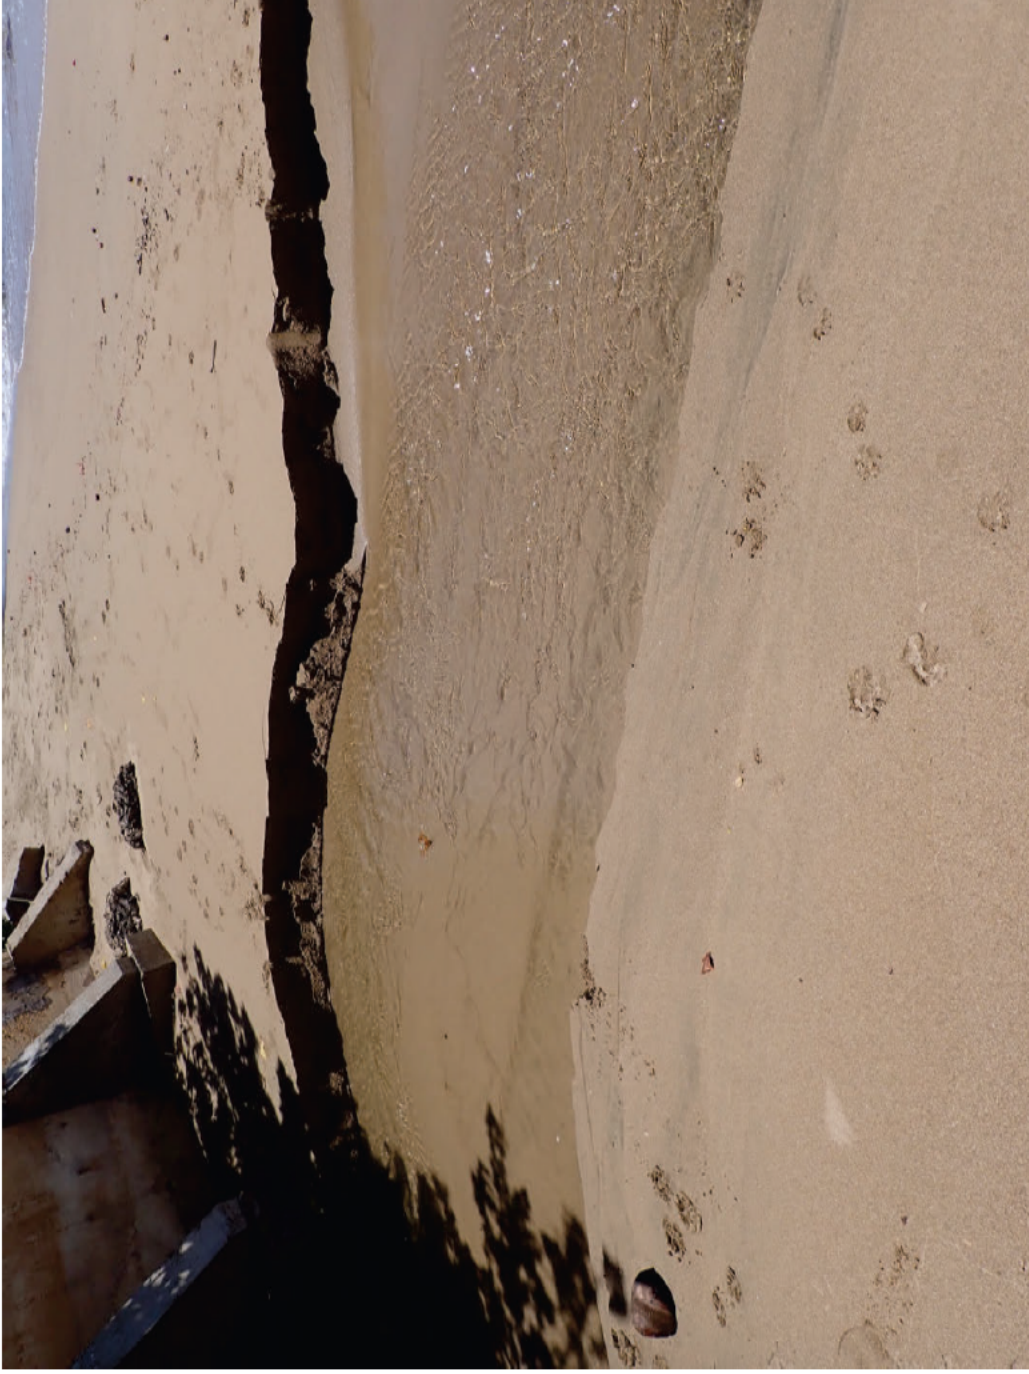
Photo ID: P4040053

Description: Ensenada Creek actively flowing and draining into the Atlantic Ocean

Beach erosion present at the mouth of the tributary.
