**INSPECTION REPORT**

| <b>Inspection Date:</b> | 05/26/2021 | |
| <b>Regulatory Program:</b> | CWA NPDES/Industrial Stormwater | |
| <b>Permittee Name(s):</b> | Woodgrain Millwork | |

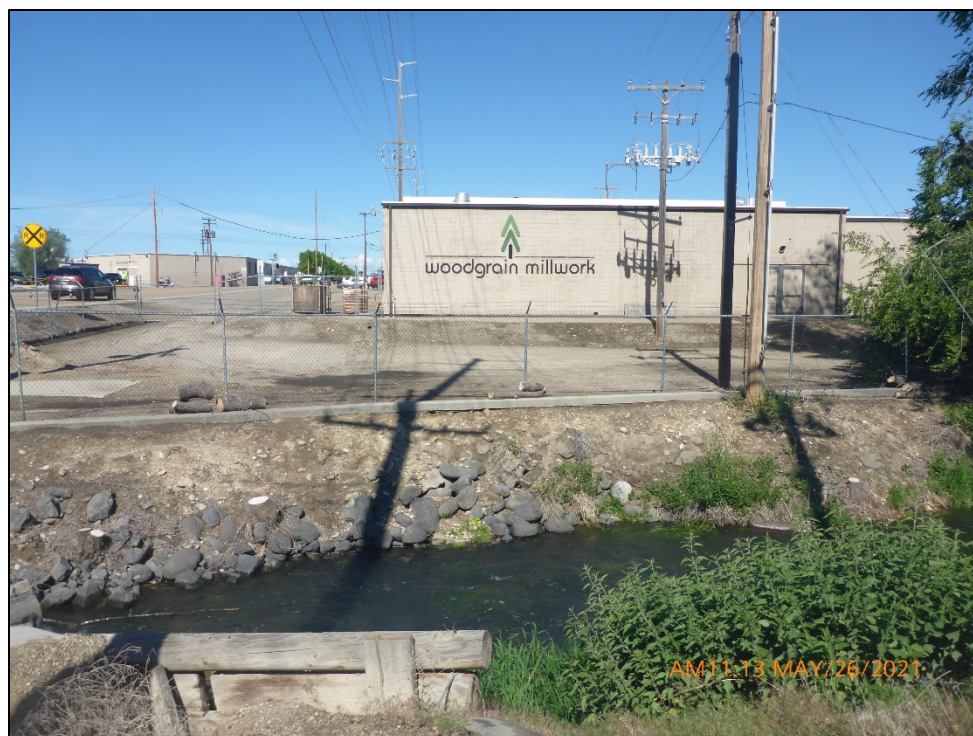
**Photograph 1.** View of Indian Creek along the southeast perimeter of the northern parcel.

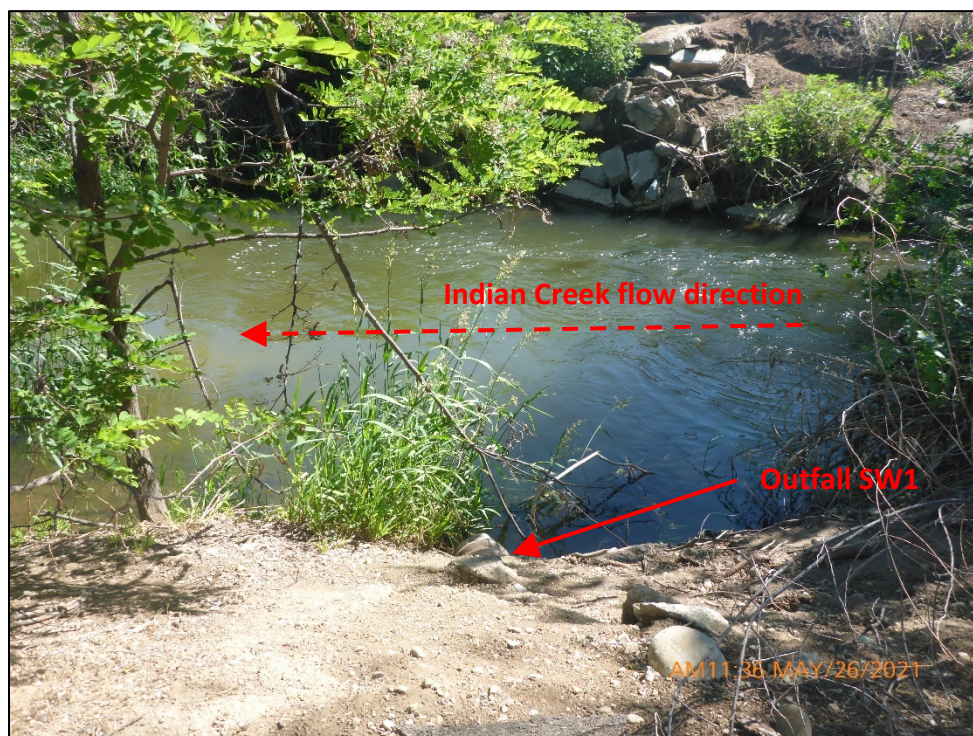
**Photograph 2.** View of Outfall SW1 into Indian Creek along the Facility's eastern perimeter.

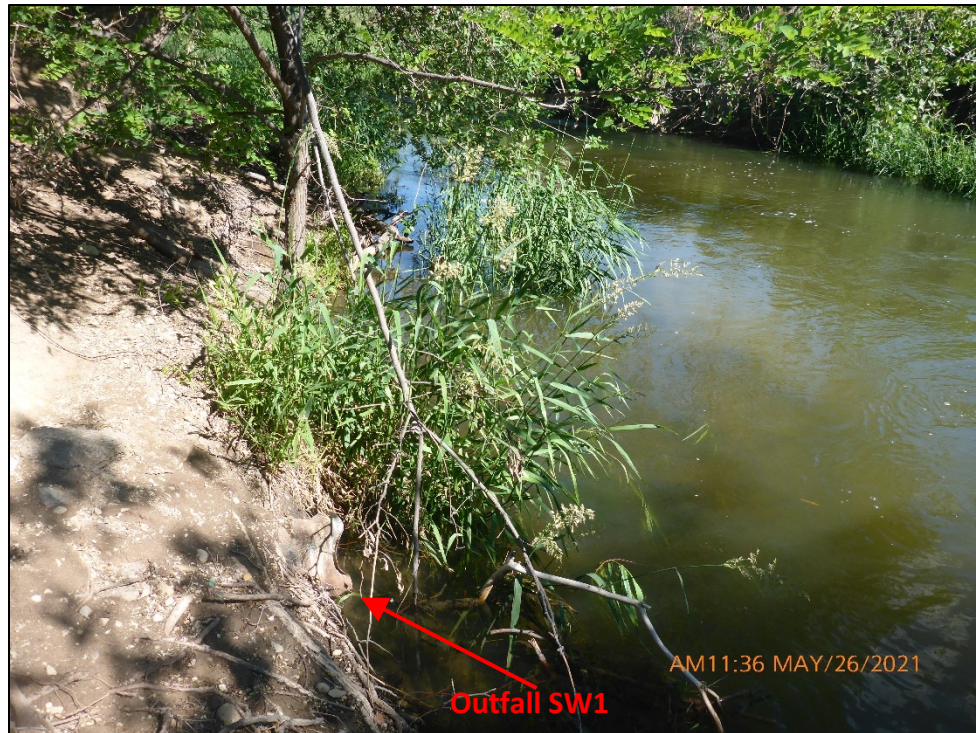
The Facility's sample collection location was located at the end of pipe at Outfall SW1 which, at the time of the inspection, was directly at the water line of Indian Creek with creek water partially in the outfall pipe (refer to Photographs 2 and 3). Since the end of pipe was located at the water line of Indian Creek, the Inspection Team observed a potential for creek water to comeingle with stormwater discharges at the point of collection, especially during wet weather events where the creek level may be higher than normal.

**Photograph 3.** Additional view of Outfall SW1. The end of pipe was located at the water level of Indian Creek which may impact sampling conducted in this location.

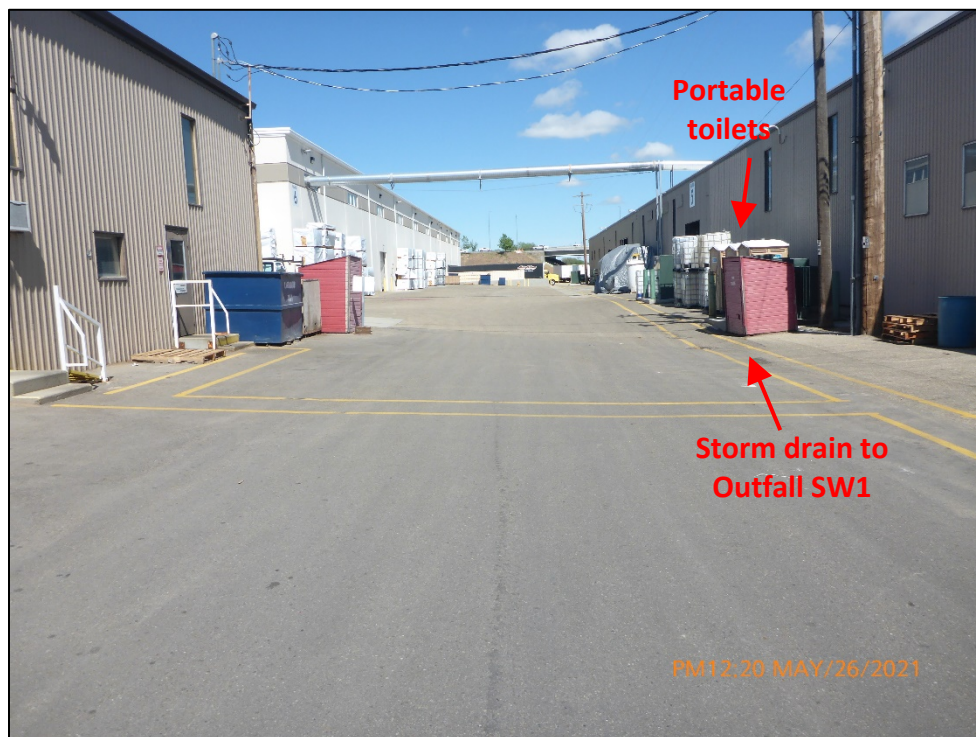
**Photograph 4.** View of a storm drain located in the central portion of the northern parcel. This storm drain flows through a sand/oil separator and to Outfall SW1 shown in Photographs 2 and 3. Note the portable toilets adjacent to the storm drain which were not on the site map.

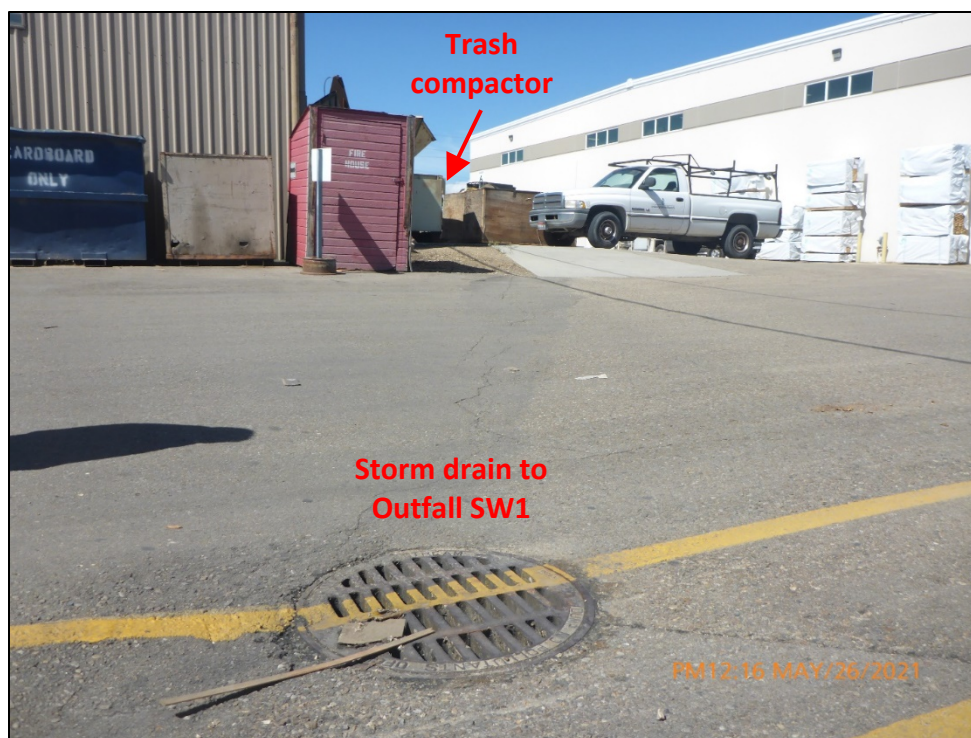
**Photograph 5.** Additional view of the storm drain located in the central portion of the northern parcel, as shown in Photograph 4. Note the trash compactor located upgradient of this storm drain was not identified on the site map.

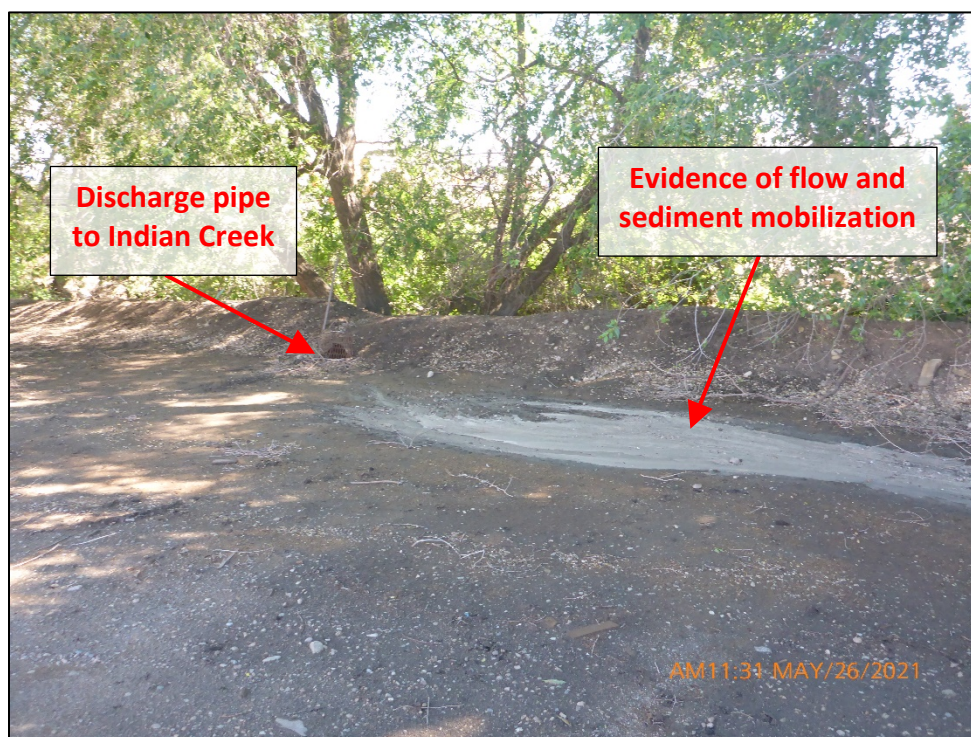
The Inspection Team observed evidence of recent sediment mobilization and stormwater discharge from the Facility to Indian Creek at various locations, via piped conveyances and discrete overland conveyances (refer to Photographs 6 through 13). In general, the Inspection Team observed an overall lack of best management practices (BMPs) deployed along the Facility's eastern perimeter, directly adjacent to Indian Creek. Multiple industrial activities were present along this perimeter including fuel storage, waste collection, baghouse operations, truck loading/unloading, and outdoor equipment/material storage.

The Facility's stormwater sample collection location, Outfall SW1, is not representative of all industrial activities conducted at the Facility. The Inspection Team observed multiple and differing industrial areas at the Facility which would not contribute stormwater runoff to Outfall SW1. Specifically, baghouse operations, equipment storage, and waste dumpster staging was observed along the eastern perimeter of the northern parcel, south of Outfall SW1. Stormwater runoff from this area of the Facility is discharged through an unnamed open pipe stormwater outfall to Indian Creek, south of Outfall SW1 (refer to Exhibit 1, and Photographs 6, 7, 17, and 18).

**Photograph 6.** View of the unnamed open pipe stormwater discharge point south of Outfall SW1. With the exception of a metal screen, no other BMPs were deployed at this discharge point. Note the evidence of flow and sediment mobilization to the outfall.

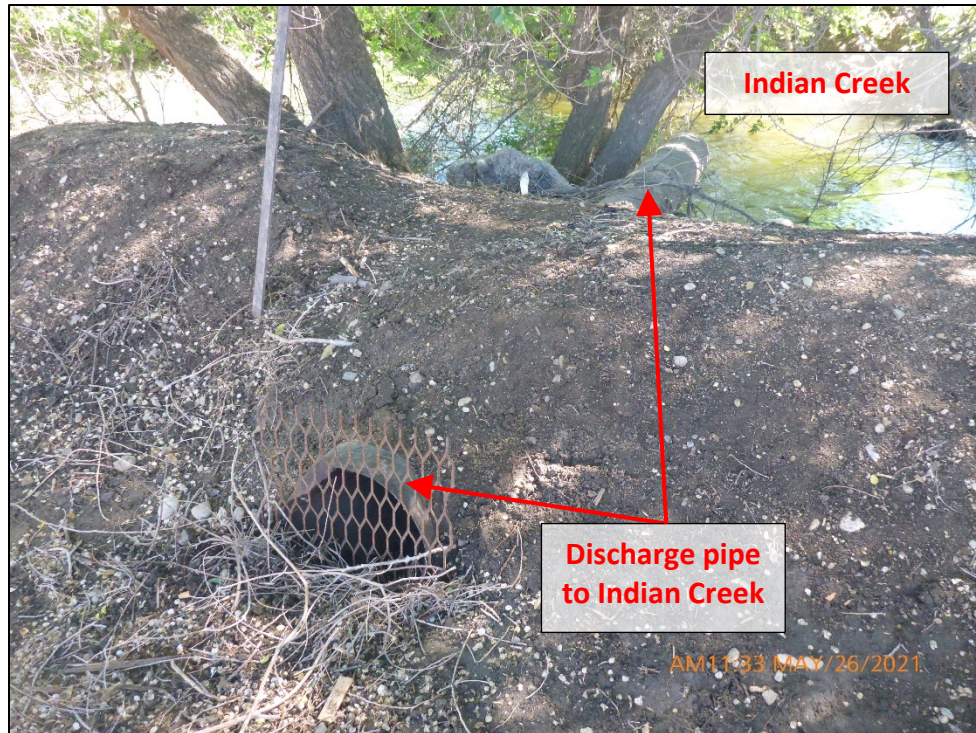
**Photograph 7.** Close-up view of the unnamed open pipe stormwater discharge point south of Outfall SW1, shown in Photograph 6.

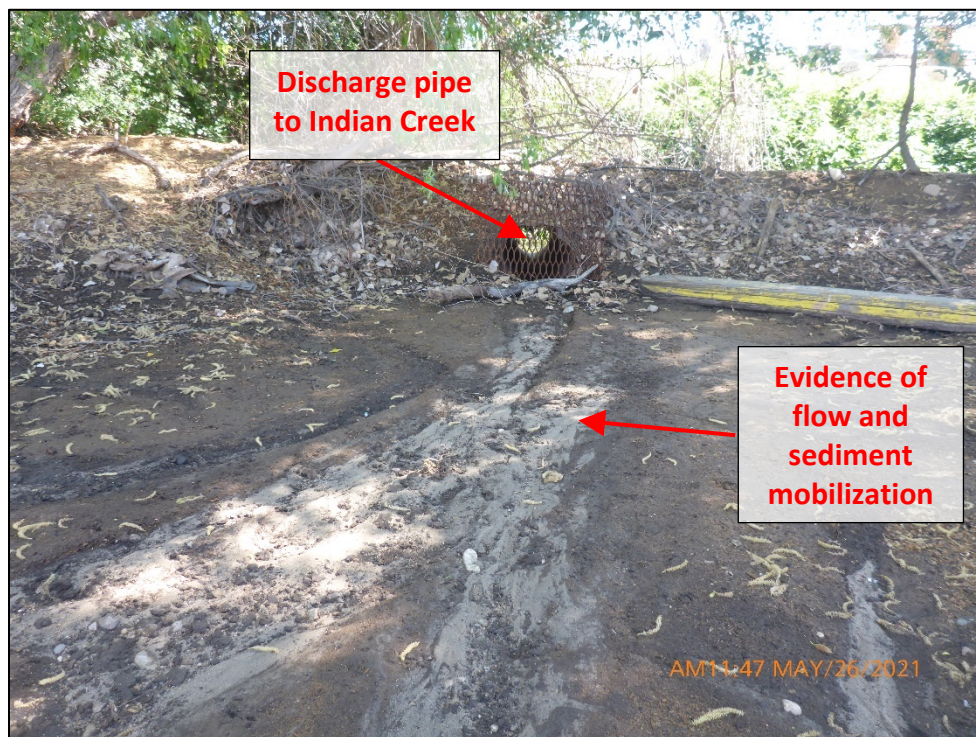
Additionally, sawdust loading operations and truck loading/unloading activities were observed occurring on the northeastern side of the northern parcel. Stormwater runoff from this area of the Facility is discharged through an unnamed open pipe stormwater outfall to Indian Creek, north of Outfall SW1 (refer to Exhibit 1, and Photographs 8 and 19).

**Photograph 8.** View of the unnamed open pipe stormwater discharge point north of Outfall SW1. With the exception of a metal screen, no other BMPs were deployed at this discharge point. Note the evidence of flow and sediment mobilization to the outfall.

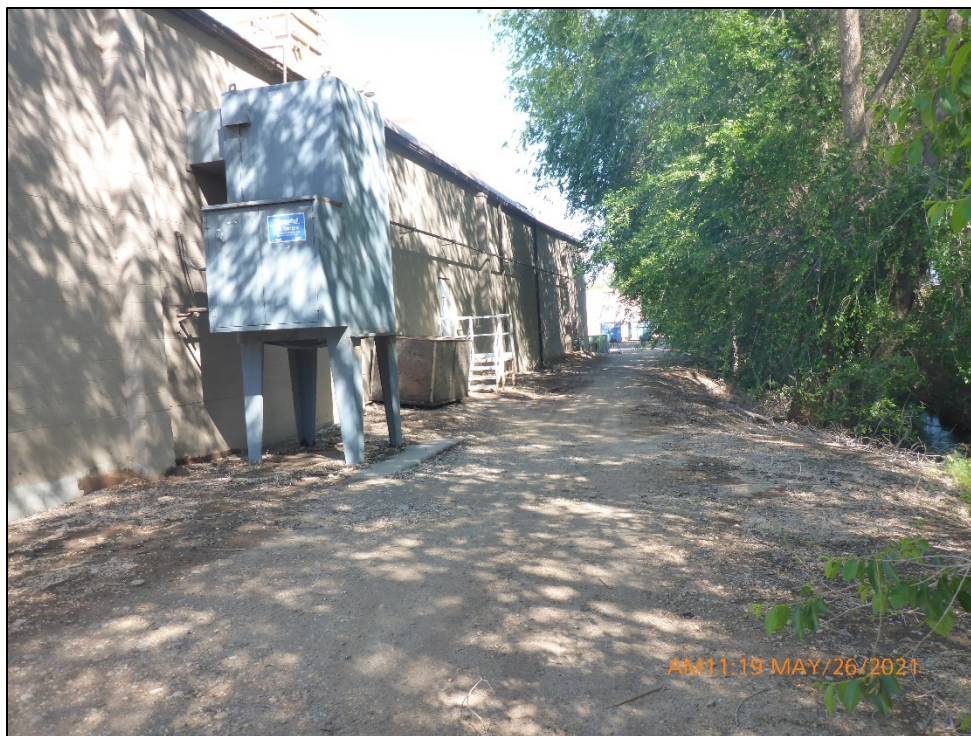
**Photograph 9.** View, facing northwest, along the Facility's southeast perimeter with Indian Creek. Multiple roof downspouts from the warehouse building are piped underground to Indian Creek. Other discrete overland conveyance discharge points were also observed in this area.

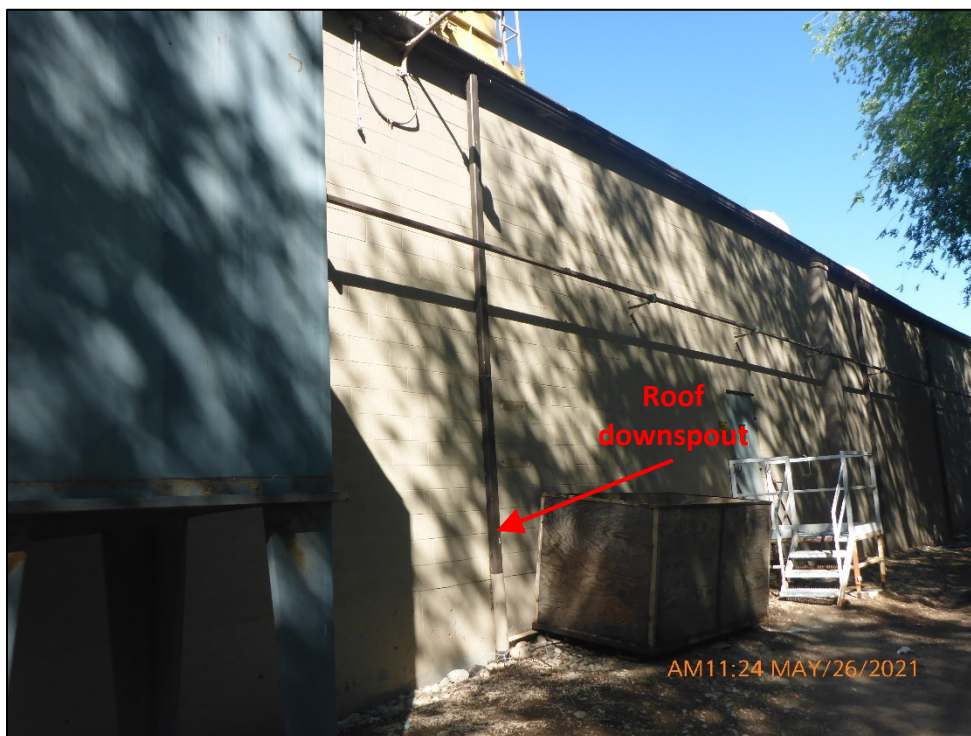
**Photograph 10.** View of a roof downspout on the warehouse building shown in Photograph 9. This downspout is piped underground to Indian Creek (as depicted in Photograph 11).

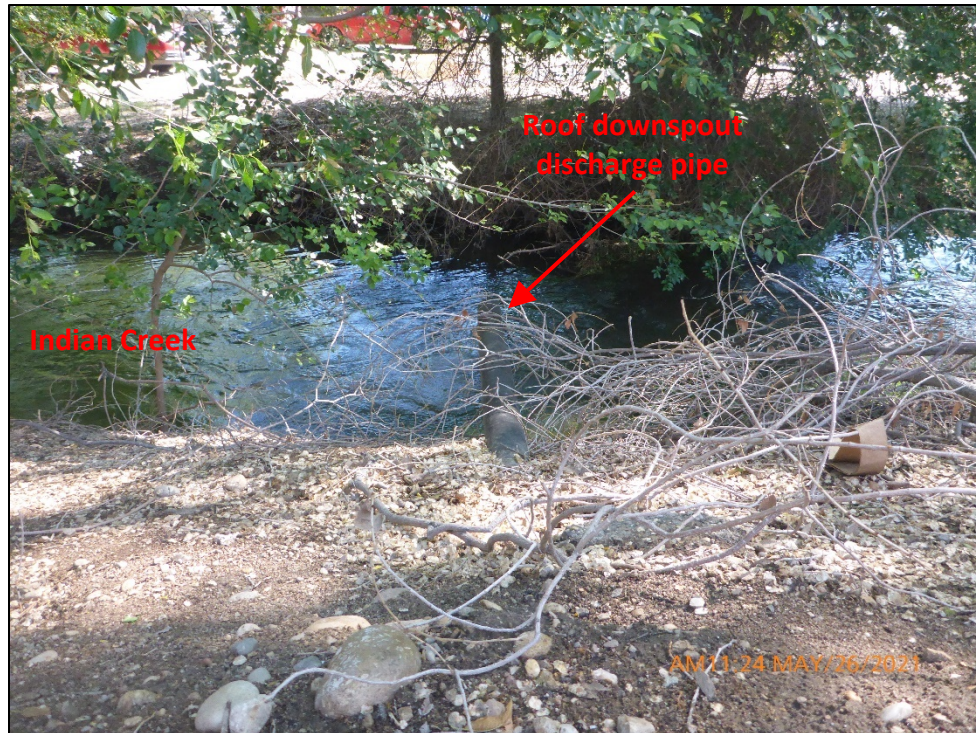
**Photograph 11.** View of the discharge pipe to Indian Creek from the roof downspout shown in Photograph 10.

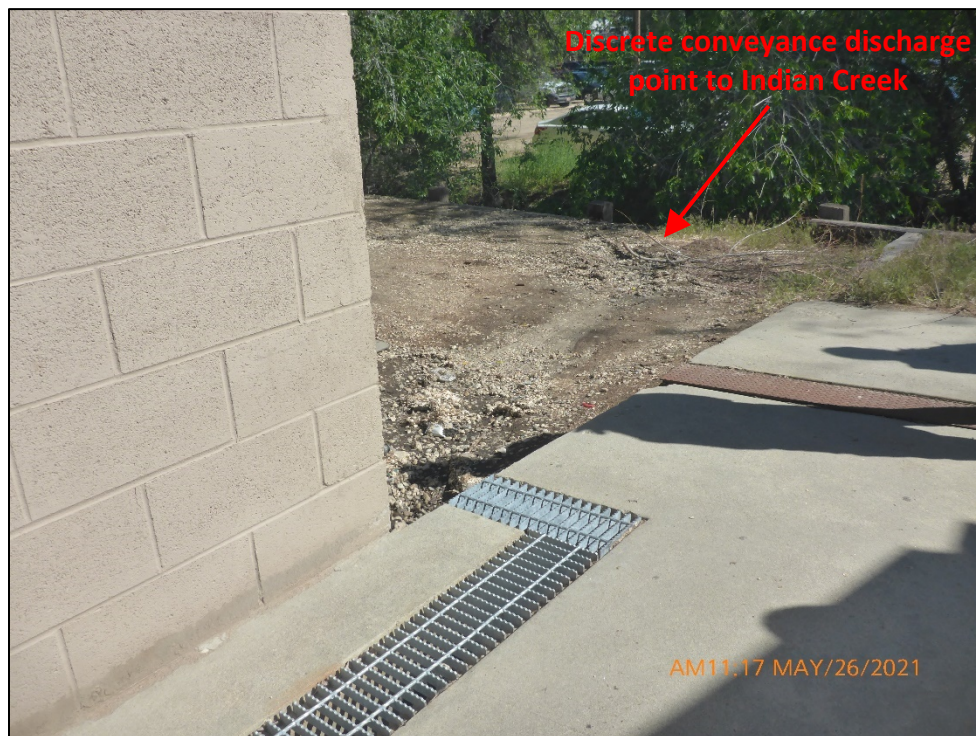
**Photograph 12.** View of a discrete overland conveyance discharge point to Indian Creek from the southeastern portion of the northern parcel.

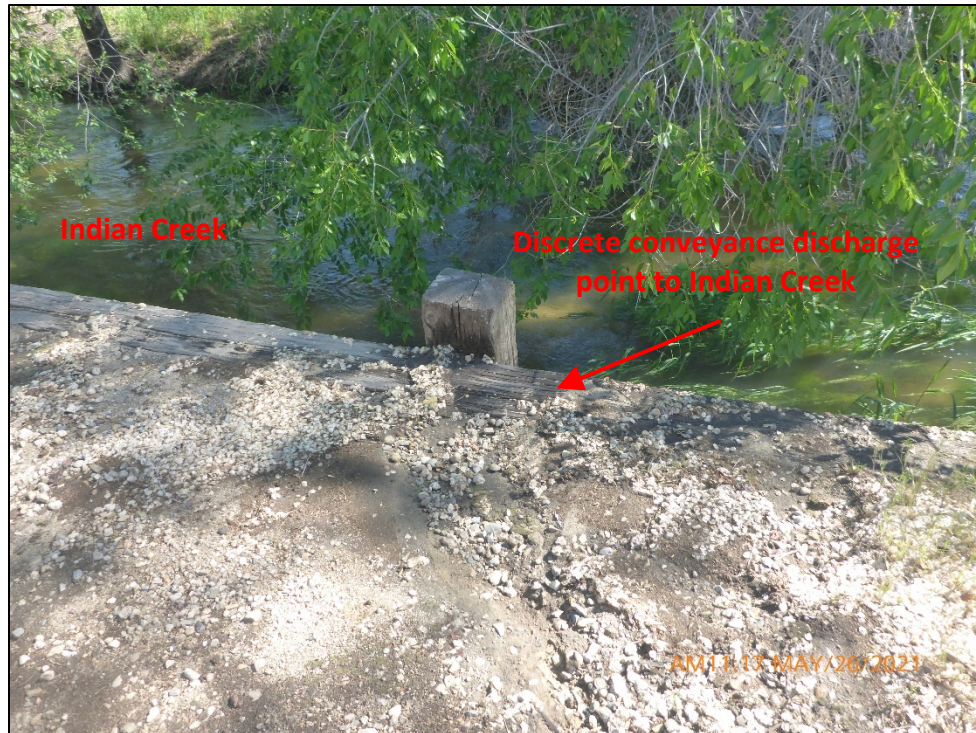
**Photograph 13.** Close-up view of the discrete overland conveyance discharge point shown in Photograph 12.

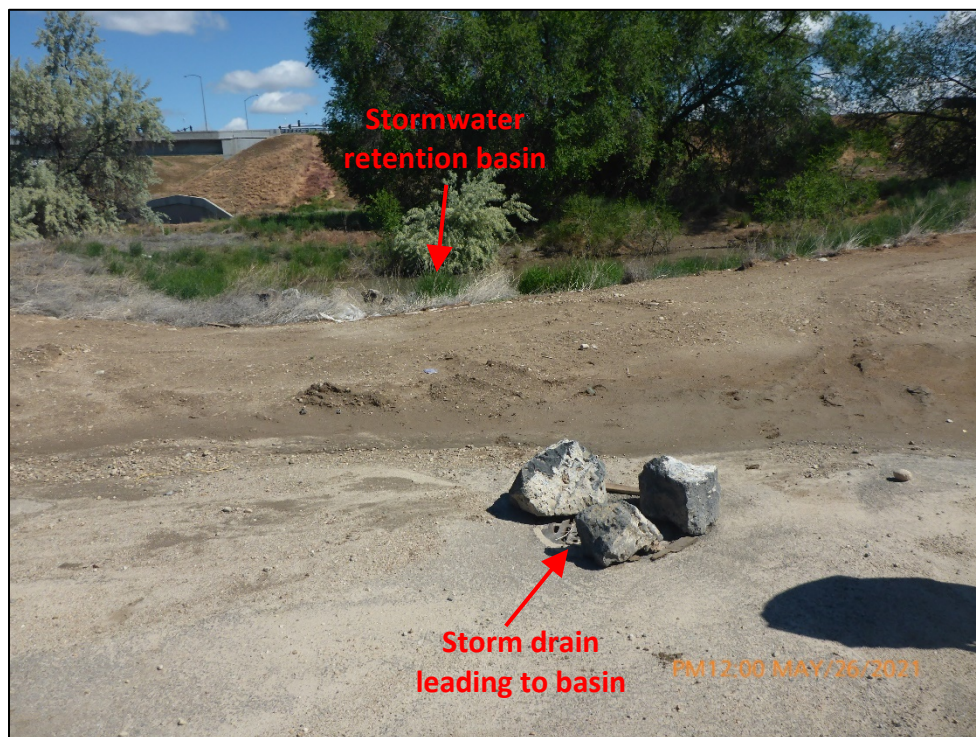
**Photograph 14.** View of the stormwater retention basin and associated storm drain in the northeastern portion of the northern parcel.

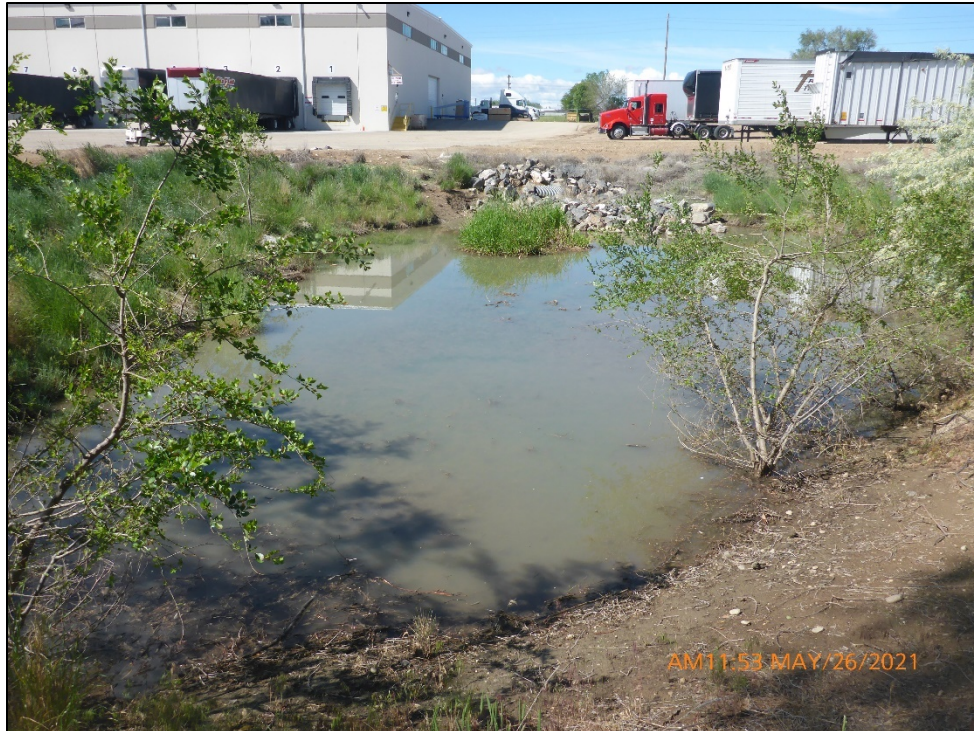
**Photograph 15.** Additional view, facing southwest, of the stormwater retention basin shown in Photograph 14. Note the basin has standing water from a storm even that occurred the night before.

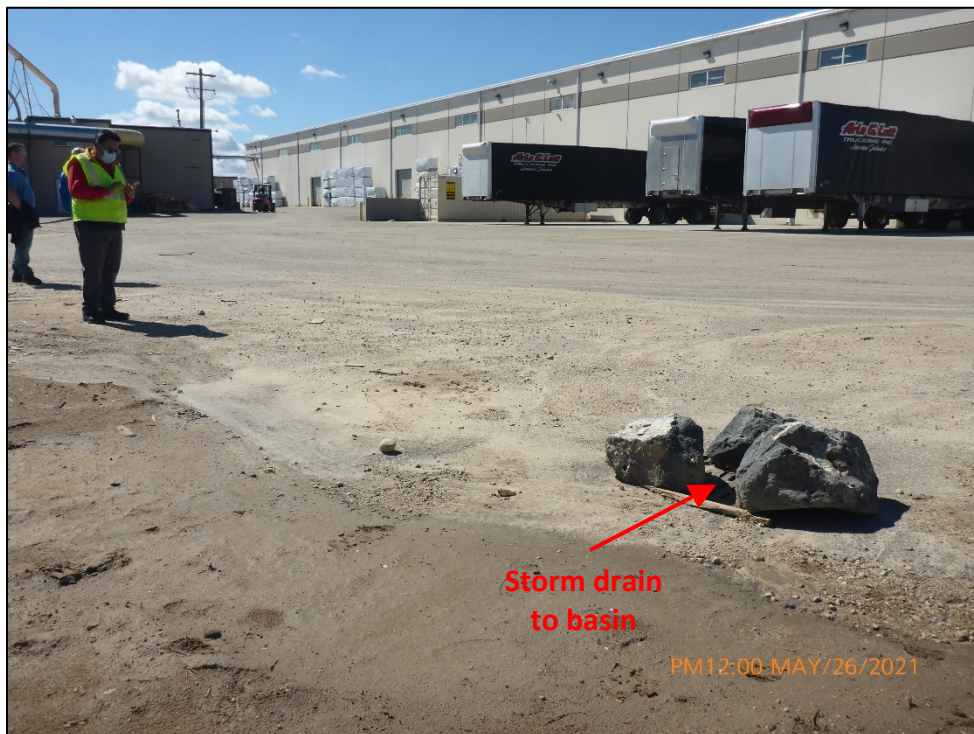
**Photograph 16.** View of drainage area upgradient of the storm drain that flows to the stormwater retention basin, shown in Photographs 14 and 15.

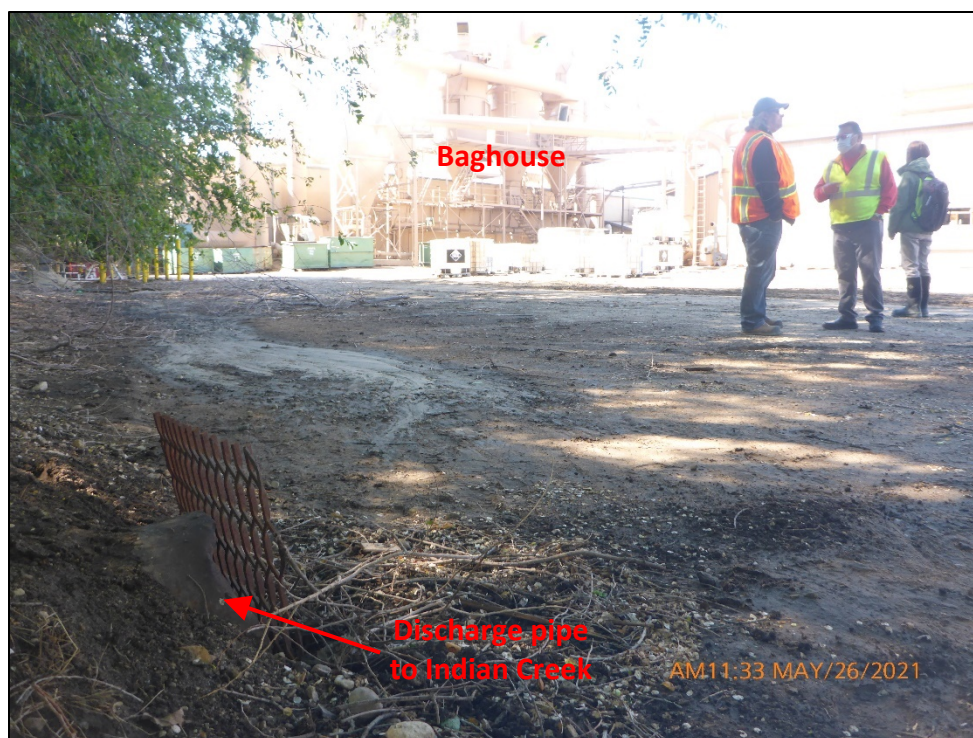
**Photograph 17.** View of the baghouse located upgradient of the unnamed open pipe stormwater discharge point (shown in Photographs 6 and 7) south of Outfall SW1.

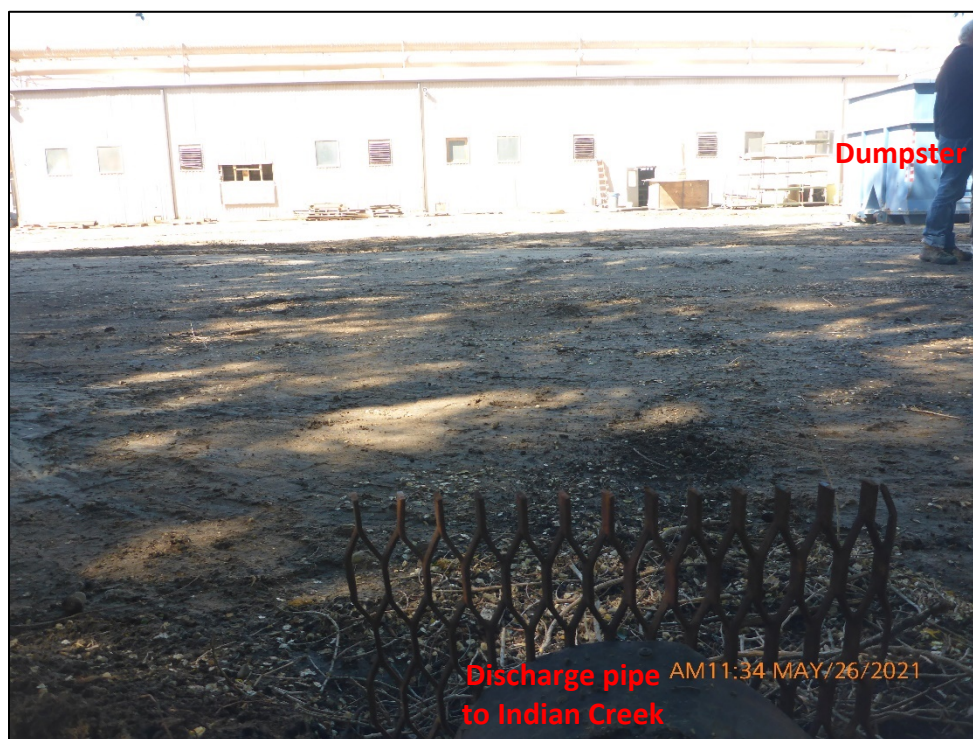
- The dumpster staging area to the south of Outfall SW1 by the unnamed open pipe stormwater discharge point (refer to Photograph 18). Pallet and empty tote storage was also observed in this area during the inspection but were not included on the site map.
- Outdoor equipment/material storage areas along Indian Creek near Outfall SW1 (refer to Photograph 29).
- Trash compactor and adjacent outdoor material storage in the center of the northern parcel (refer to Photographs 5 and 26).
- Portable restrooms located in the central portion of the northern parcel (refer to Photograph 4).
- Equipment storage/boneyard area on the northwest side of the Facility (identified on May 2021 STORM WATER RUNOFF map' solely as trailer parking; refer to Exhibit 2).

**Photograph 18.** View of the waste dumpster located upgradient of the unnamed open pipe stormwater discharge point (shown in Photographs 6 and 7) south of Outfall SW1.

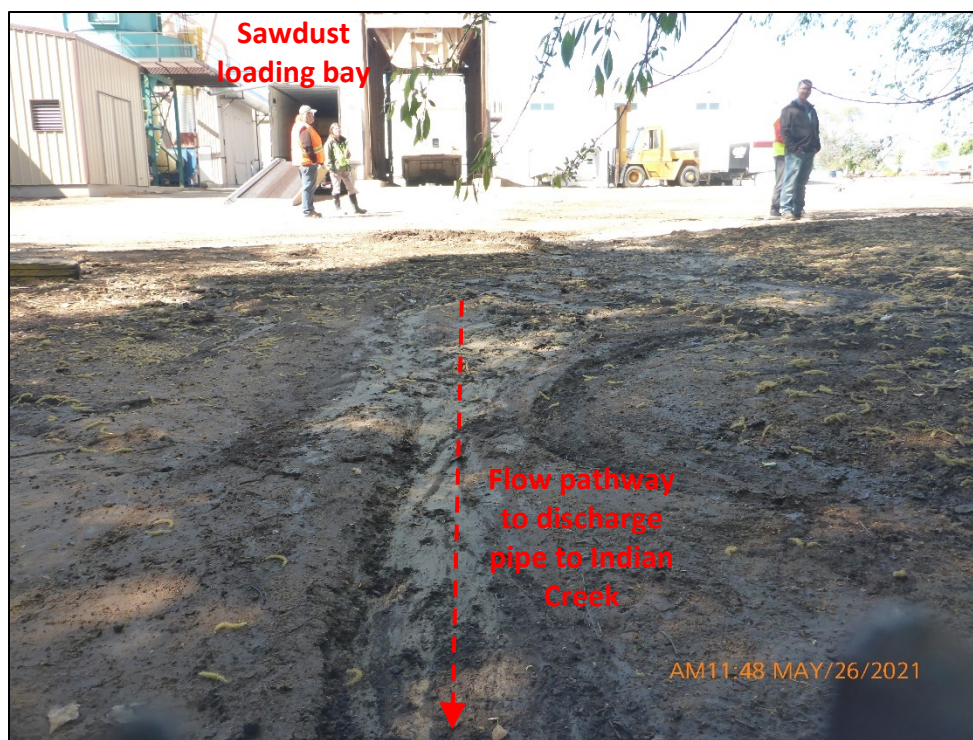
**Photograph 19.** View of the sawdust loading bay located upgradient of the unnamed open pipe stormwater discharge point (shown in Photograph 8) north of Outfall SW1.

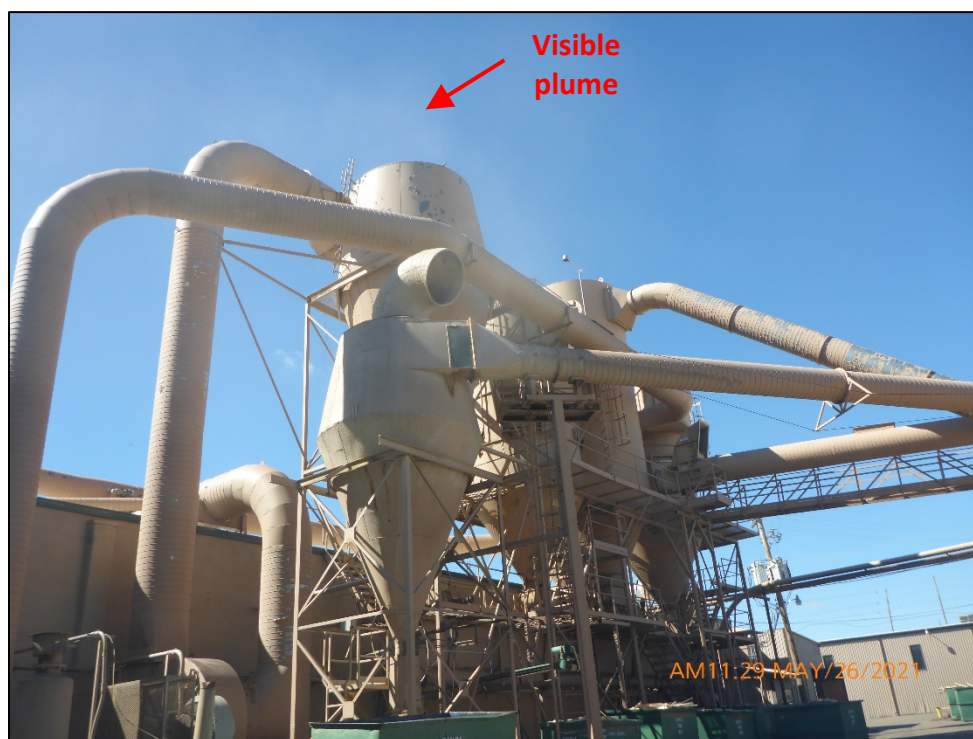
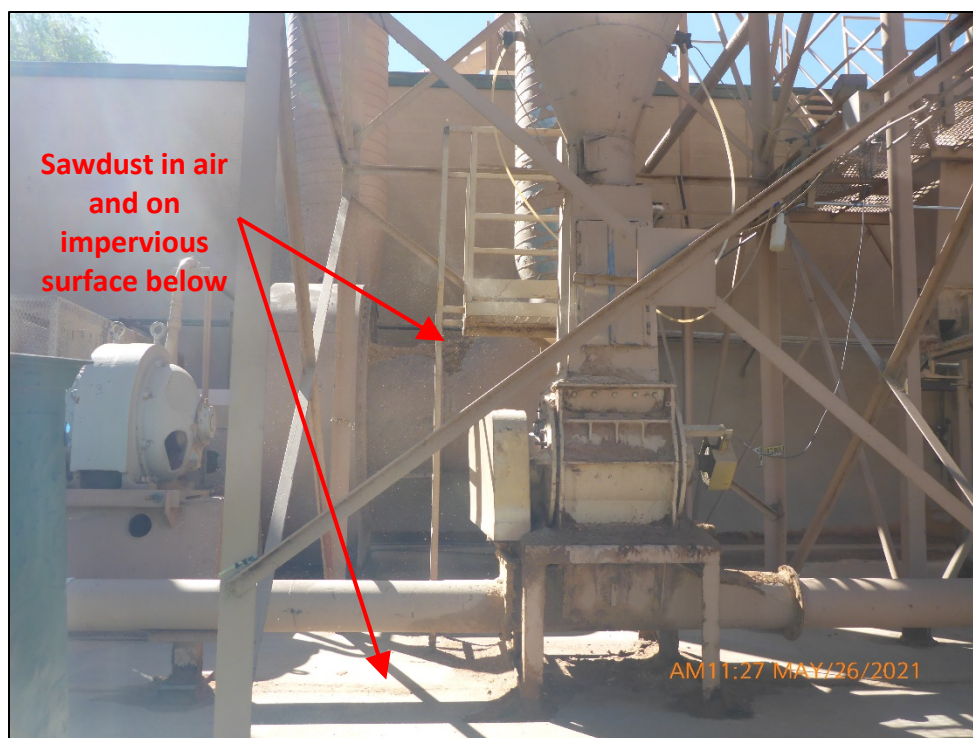
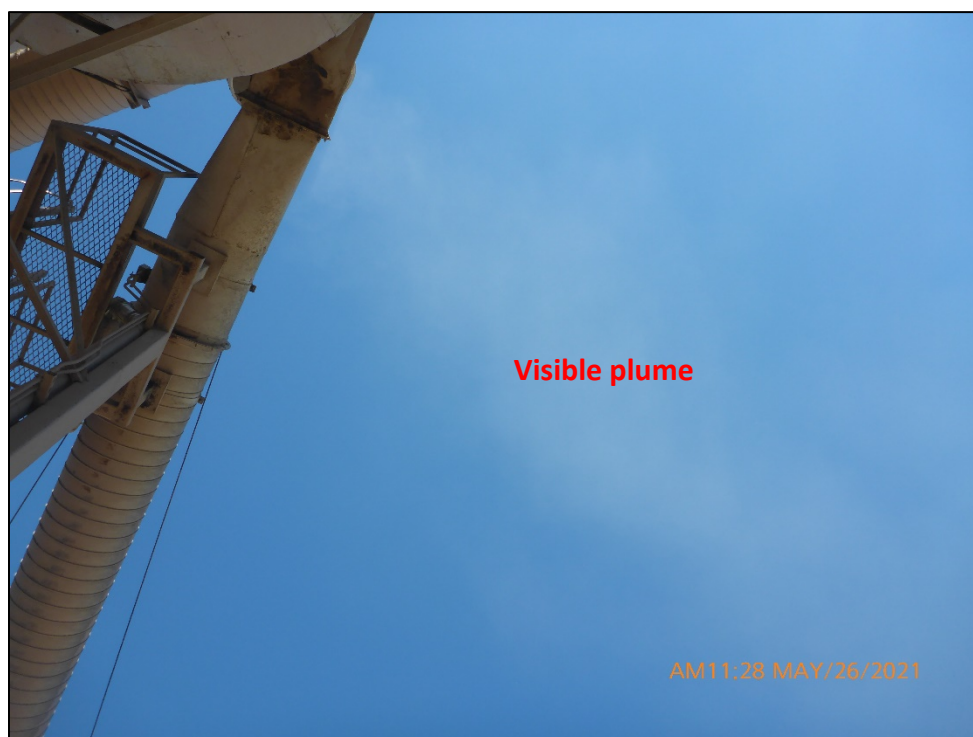
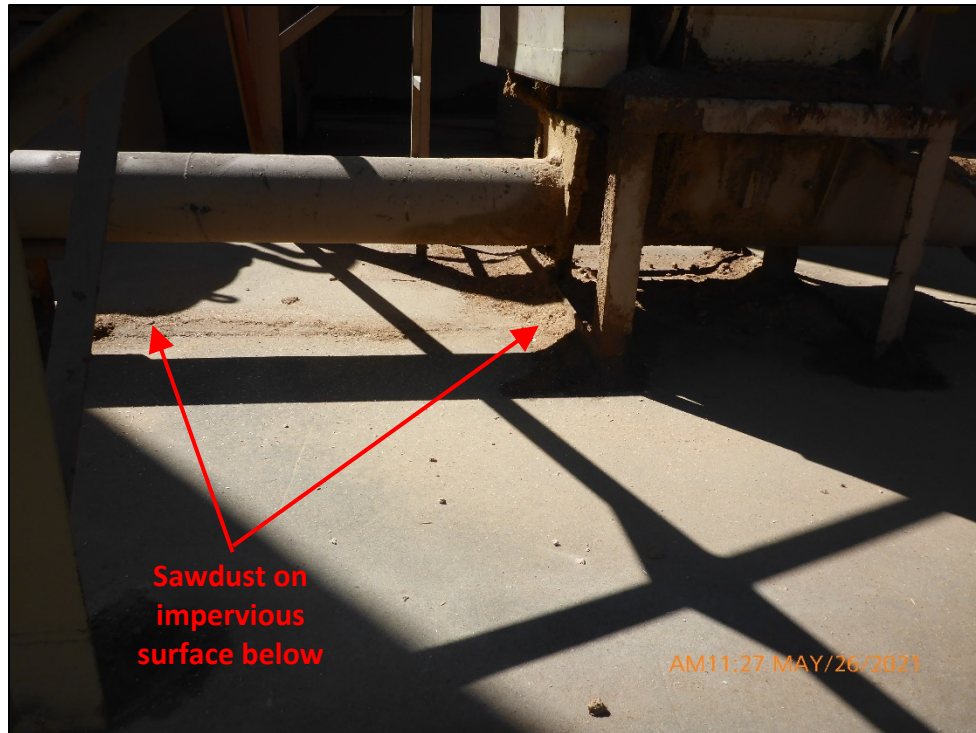
The Inspection Team observed sawdust deposition on both impervious and pervious surfaces adjacent to a baghouse located upgradient of an open pipe stormwater outfall, south of Outfall

SW1. Additionally, the Inspection Team observed a visible plume of sawdust emissions from the baghouse unit in this area of the Facility, adjacent to Indian Creek (refer to Photographs 20 through 23).

**Photograph 20.** View of the baghouse shown in Photograph 17, upgradient of the unnamed open pipe stormwater discharge point (shown in Photographs 6 and 7) south of Outfall SW1. Note the visible plume of emissions from the baghouse.

**Photograph 21.** View of sawdust in the air and on the impervious surface below the baghouse shown in Photographs 17 and 20.

**Photograph 22.** View of the visible plume from the baghouse shown in Photographs 17, 20, and 21.

**Photograph 23.** View of sawdust accumulated on the impervious surface below the baghouse shown in Photographs 17 and 20 through 22.

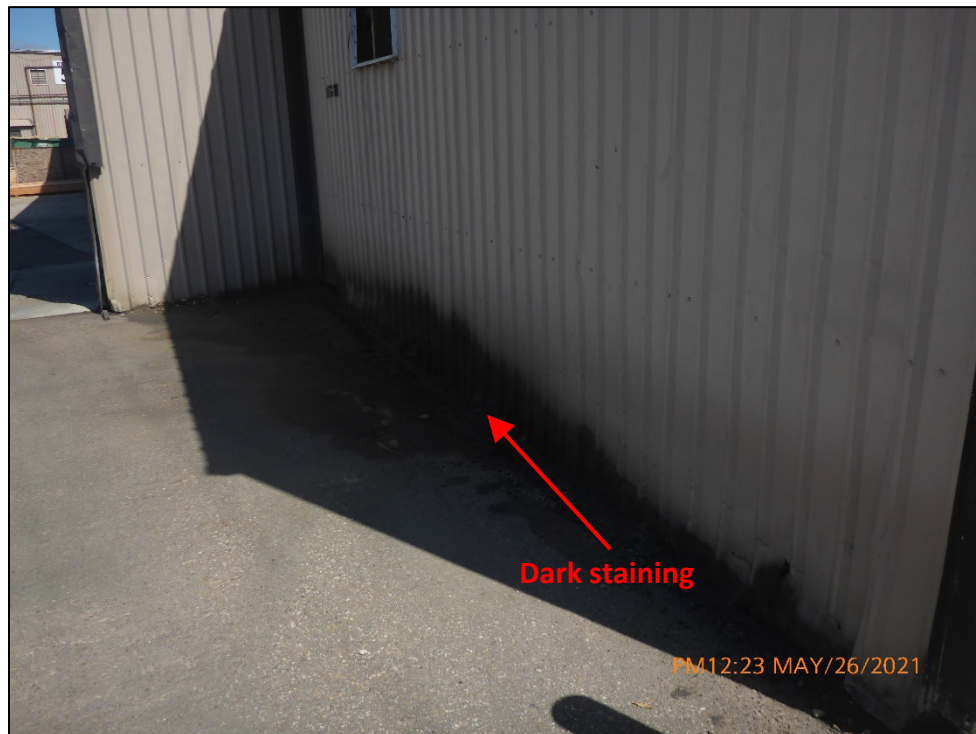
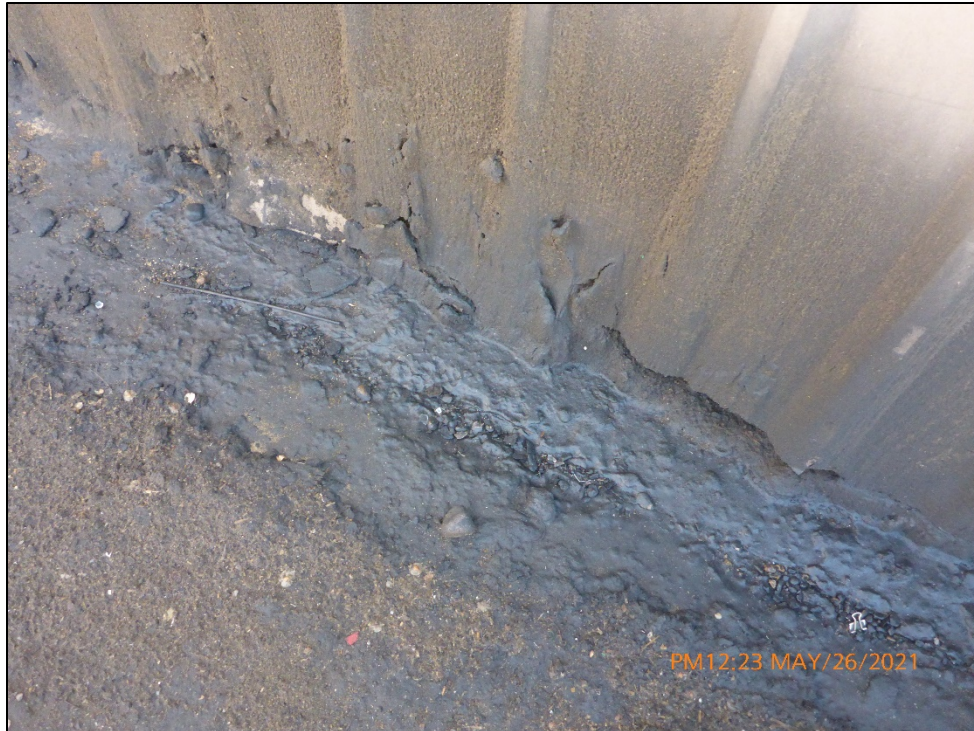
The Inspection Team observed dark, residual staining indicative of oil and grease on the pavement immediately outside a warehouse building in the central portion of the northern parcel (refer to Photographs 24 and 25). Facility representatives stated that the staining was from a generator located on the inside of the warehouse wall. Based on the amount of residual staining, this appeared to have been occurring for some time. Additionally, the Inspection Team observed wet oil staining on the ground surface between a Facility building and Indian Creek on the southeast side of the northern parcel. Absorbent material had been applied to this wet staining.

**Photograph 24.** View of dark residual staining on the pavement surface immediately outside of a warehouse building in the central portion of the northern parcel. Facility representatives stated this staining was from a generator located inside the warehouse building wall.

**Photograph 25.** Close-up view of the dark residual staining shown in Photograph 24.

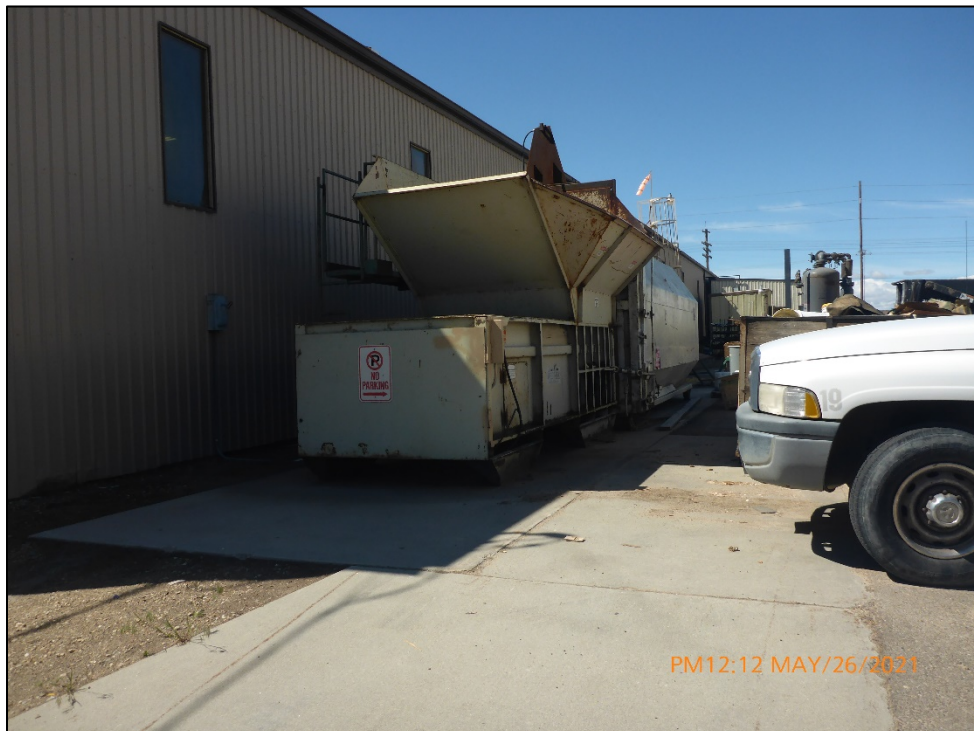
**Photograph 26.** View of the trash compactor upgradient of the storm drain shown in Photograph 5. This trash compactor was not identified on the SWPPP site map provided by the Permittee.

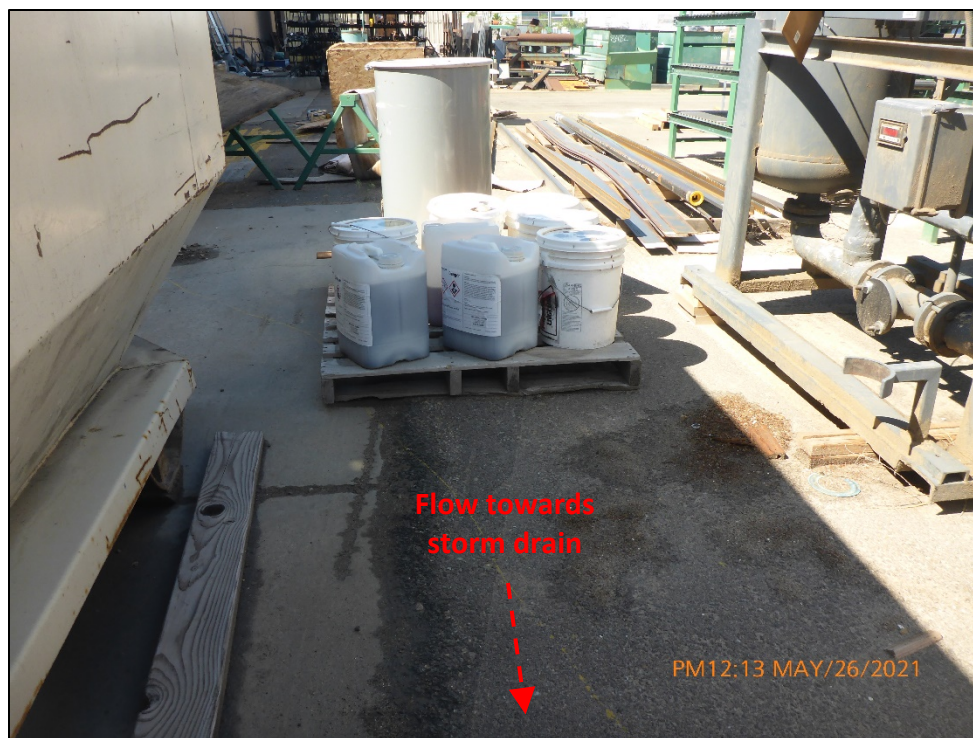
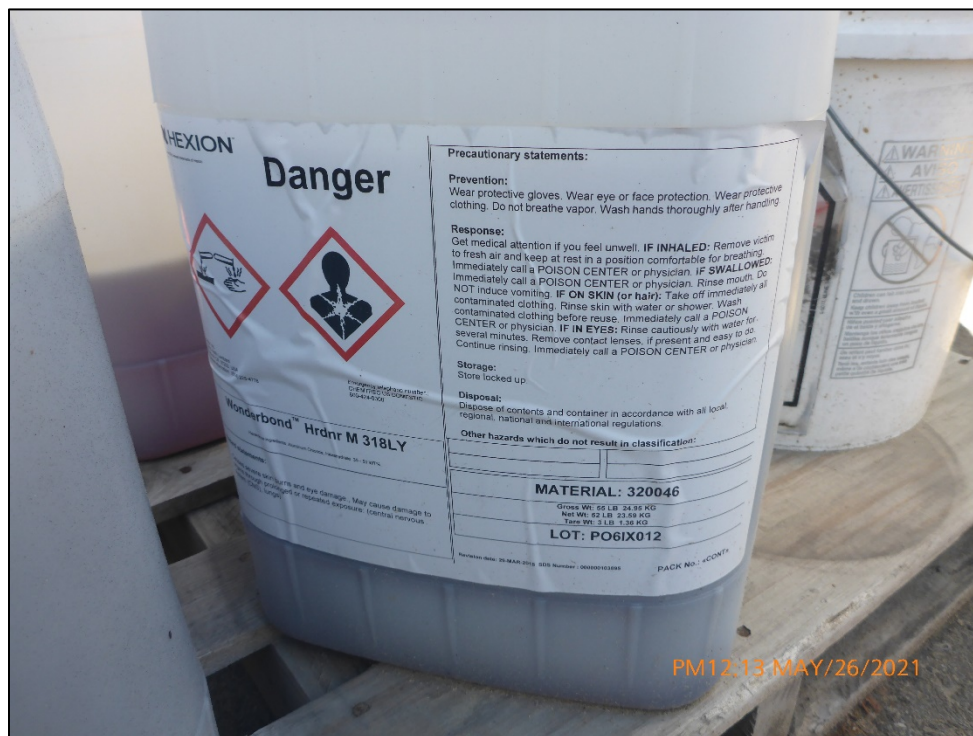
Additionally, the Inspection Team observed liquid glue containers stored outdoors near the trash compactor without secondary containment, upgradient of the storm drain connected to the Facility's sand/oil separator and Outfall SW1 (refer to Photographs 26 through 28). Mr. Wood explained these containers are typically stored indoors and most likely had just arrived at the Facility.

**Photograph 27.** View of totes of liquid glue stored outside near the trash compactor without overhead coverage or secondary containment. The totes are located upgradient of the storm drain connected to the sand/oil separator and Outfall SW1, as depicted in Photographs 4 and 5.

**Photograph 28.** Close-up view of the liquid glue tote label shown in Photograph 27.
