**INSPECTION REPORT**

| <b>Inspection Date:</b> | 05/26/2021 | |
| <b>Regulatory Program:</b> | CWA NPDES/Industrial Stormwater | |
| <b>Permittee Name(s):</b> | Woodgrain Millwork | |

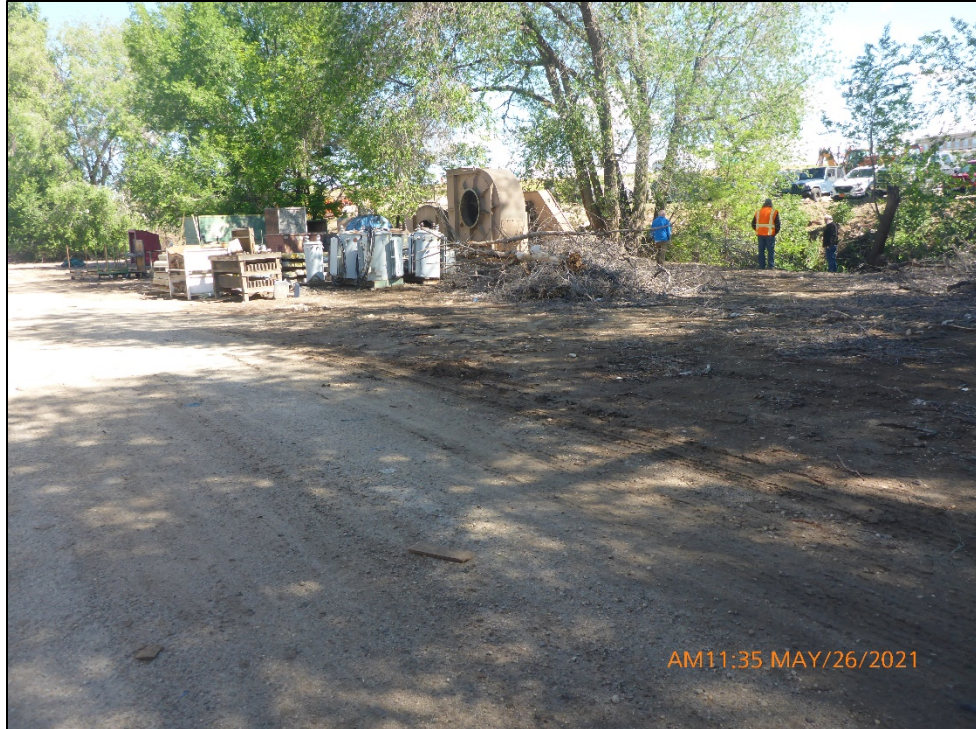
**Photograph 29.** View of an outdoor equipment storage area along the central-east perimeter of the northern parcel, near Outfall SW1 and adjacent to Indian Creek. This outdoor storage area was not identified on the site map provided by the Permittee.

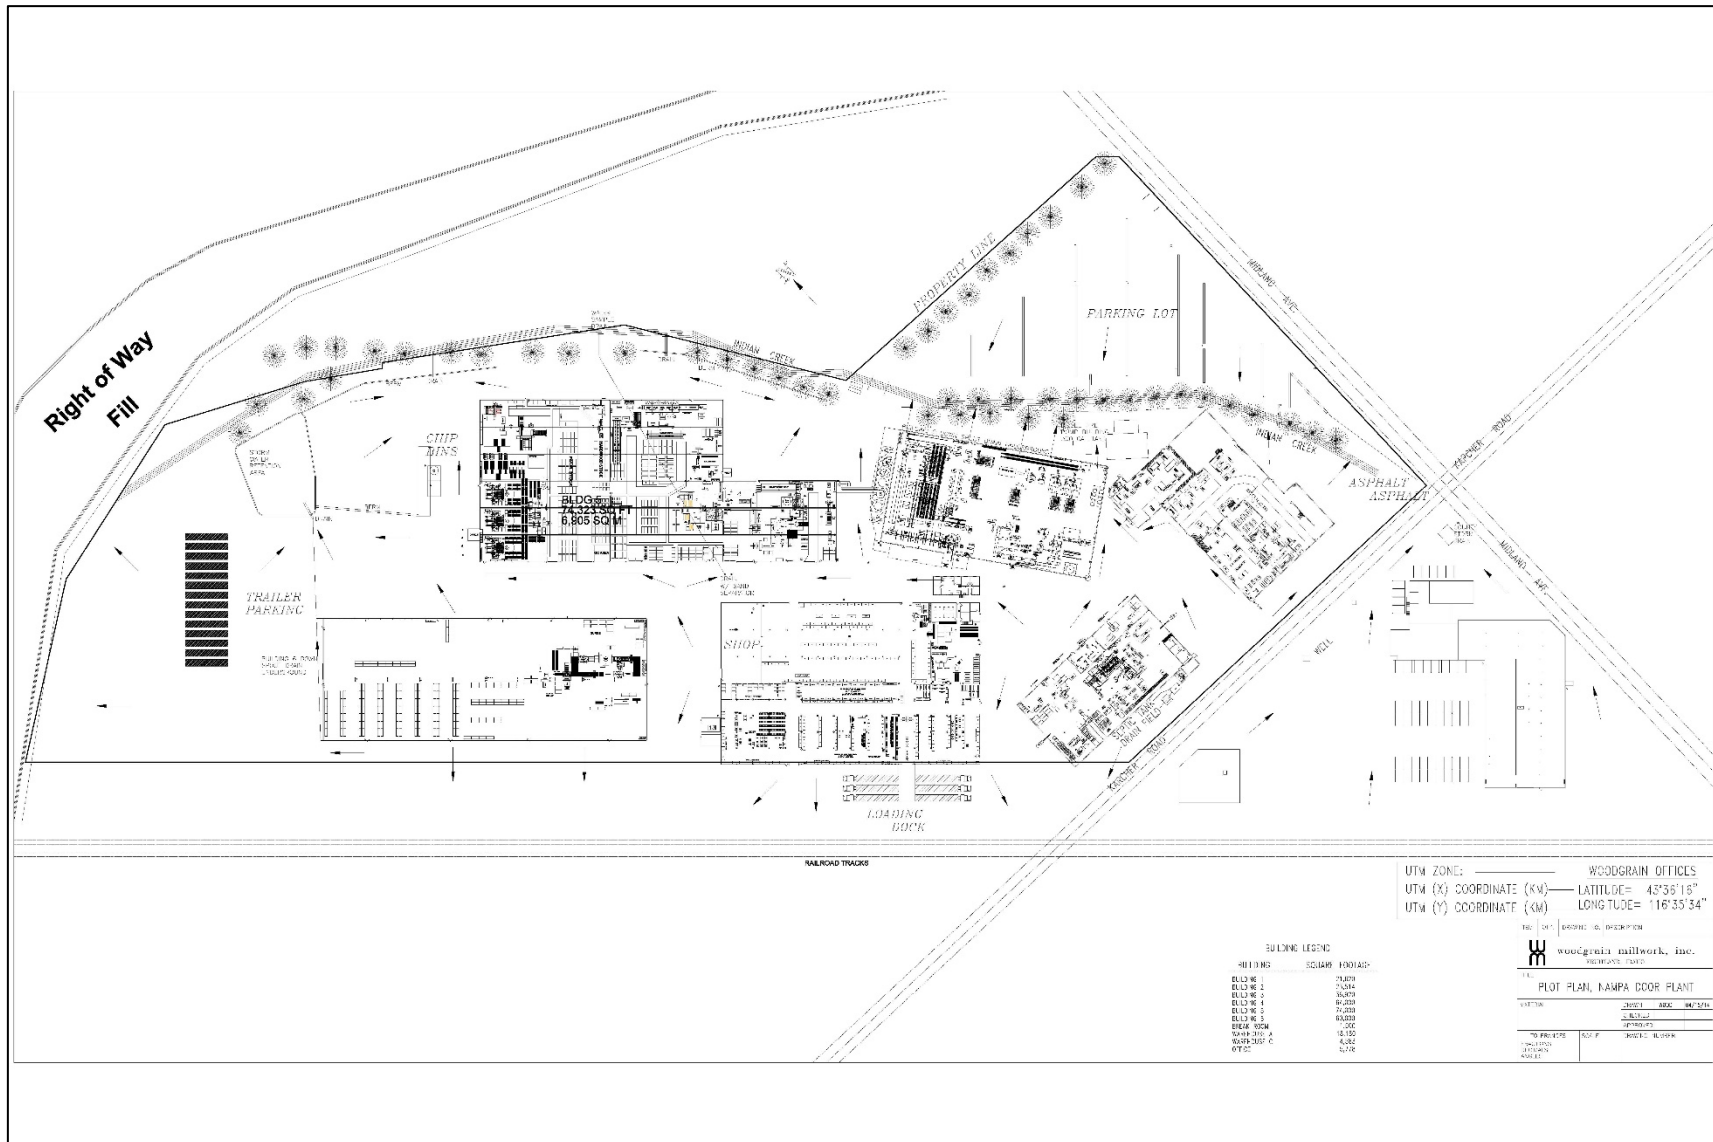
Exhibit 2. May 2021 STORM WATER RUNOFF map provided on May 28, 2021.

the inspection was in Word version and did not include the site map appendix. Instead, a separate map with the file name 'May 2021 STORM WATER RUNOFF map' was provided to the Inspection Team on May 28, 2021 (refer to Exhibit 2). This map is actually titled 'Plot Plan, Nampa Door Plant' dated April 15, 2014. This map was reviewed by the Inspection Team in detail after the inspection and did not include all elements required by the Permit, including:
