**Region 6 Compliance Assurance and Enforcement Division  
INSPECTION REPORT**

| Inspection Date(s): | 02/13/18 | | |
| Facility Name: | Busby Dairy | | |
| Identification/Permit Number: | TXG920052 | | |

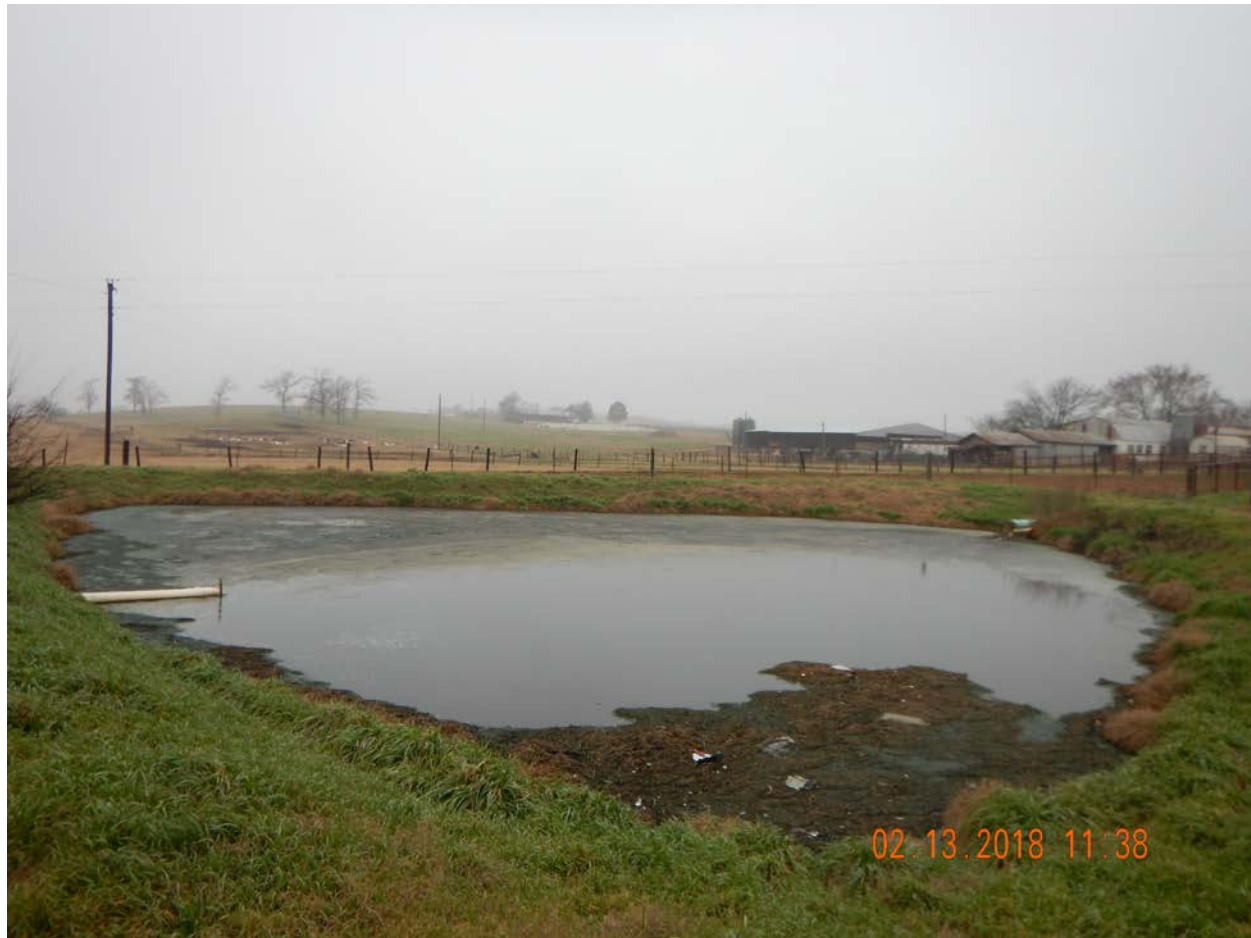
Photo No. 2

At the time of the inspection, Busby Dairy had two RCSs, one solids settling basin and one storage pond. I observed that both RCSs were in good condition, were adequately fenced-off, and met the storage capacity requirements delineated in the facility's General CAFO Permit (TXG920052 Part III.A.6(f)(6)) (Photos #2-3).

Description: The photo was taken facing northwest across the solids settling pond. The green pipe on the right side of the photo receives wastewater from the milking parlor and the white pipe on the left carries wastewater to the second RCS.

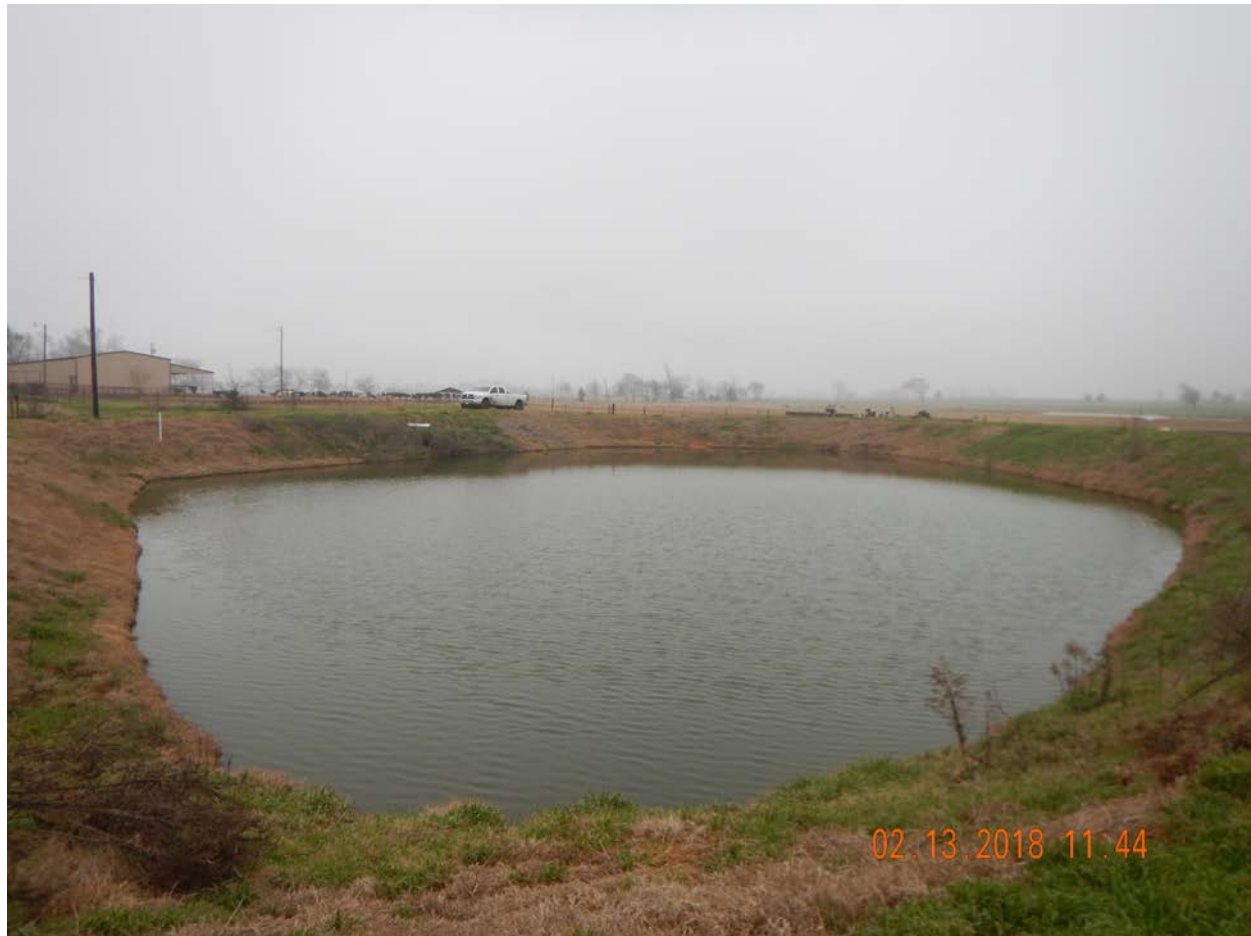
Photo No. 3

Description: The photo was taken facing northeast across the second RCS. I observed approximately six feet of available freeboard in the RCS.

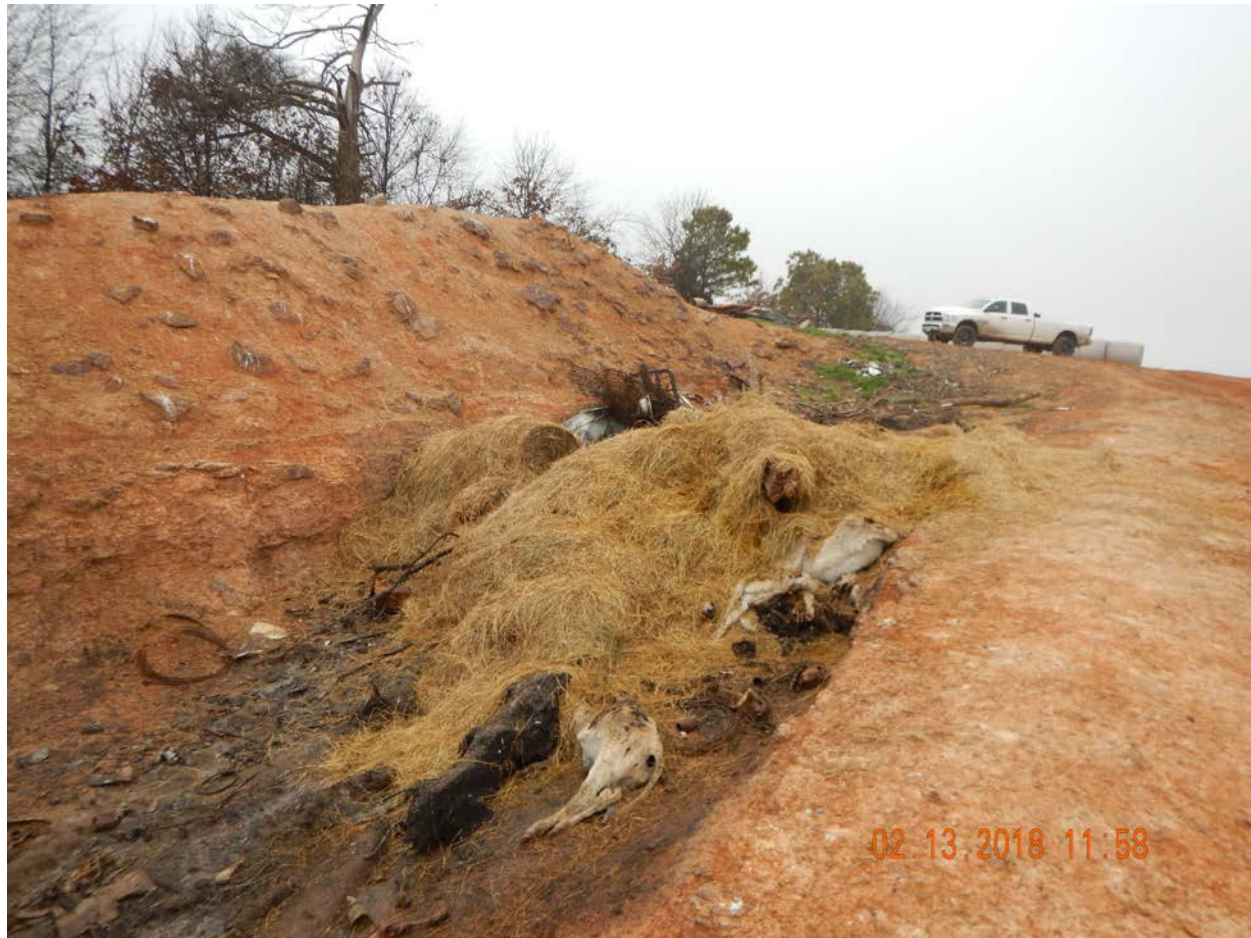
Photo No. 4

At the time of the inspection, Mr. Busby informed me that all mortalities which occur onsite are added to a burn pile onsite and burned as soon as possible. I observed the burn pile to be in adequate condition if burned soon (photo #4). Mr. Busby notified me that he intended to burn the pile as soon as weather permitted.

Description: Photo was taken facing north toward mortality burn pile. Mr. Busby informed me that he intended to burn the pile as soon as it was dry enough.

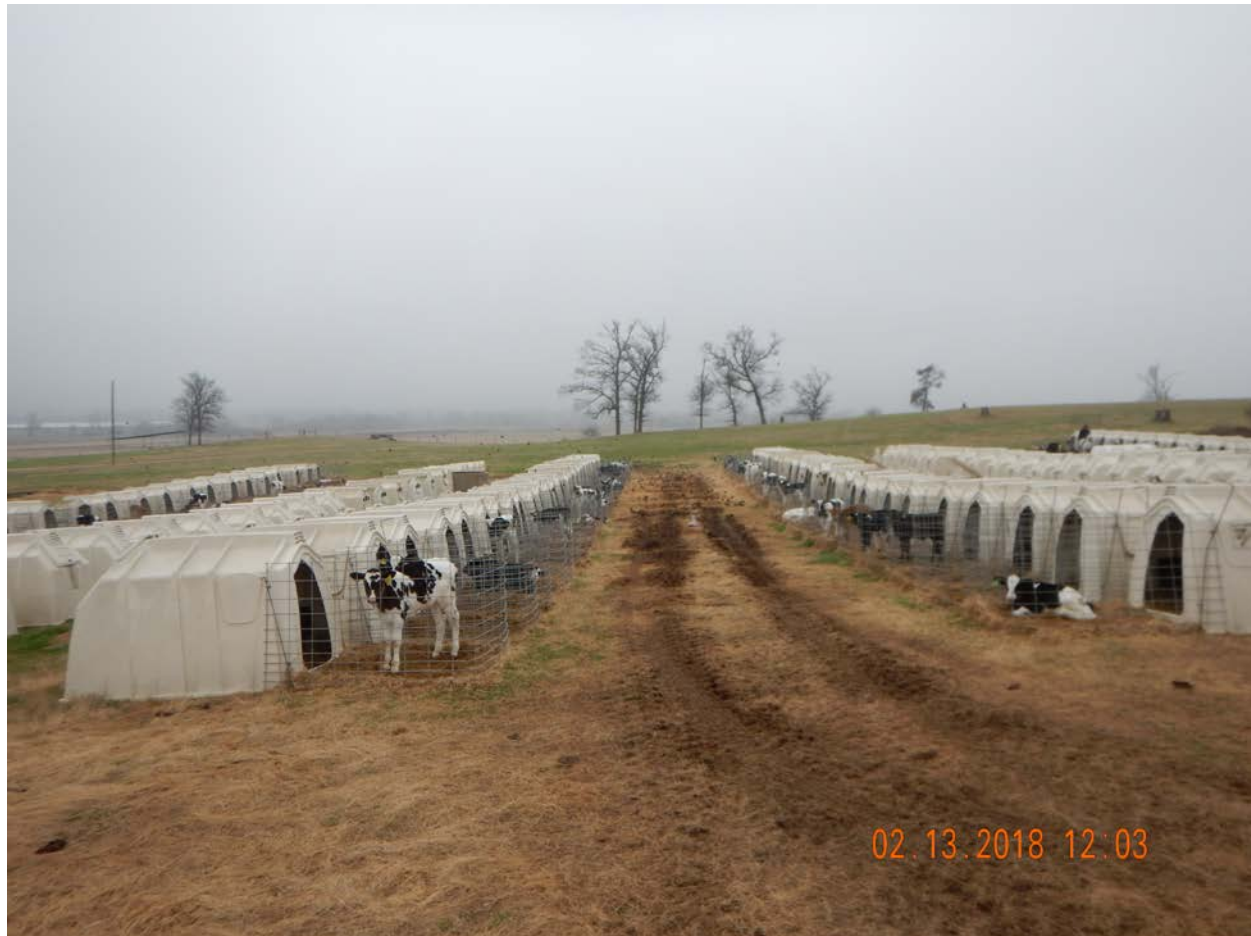
Photo No. 5

Description: Photo taken facing S toward the calf hutch area. I observed good vegetative cover present and no issues with ponding or puddling.
