## Region 6 - Enforcement & Compliance Assurance Division

### INSPECTION REPORT

| Company Name: | <b>Contango Resources, LLC</b> | |
| Facility Name: | <b>Big Eagle Lease</b> | |

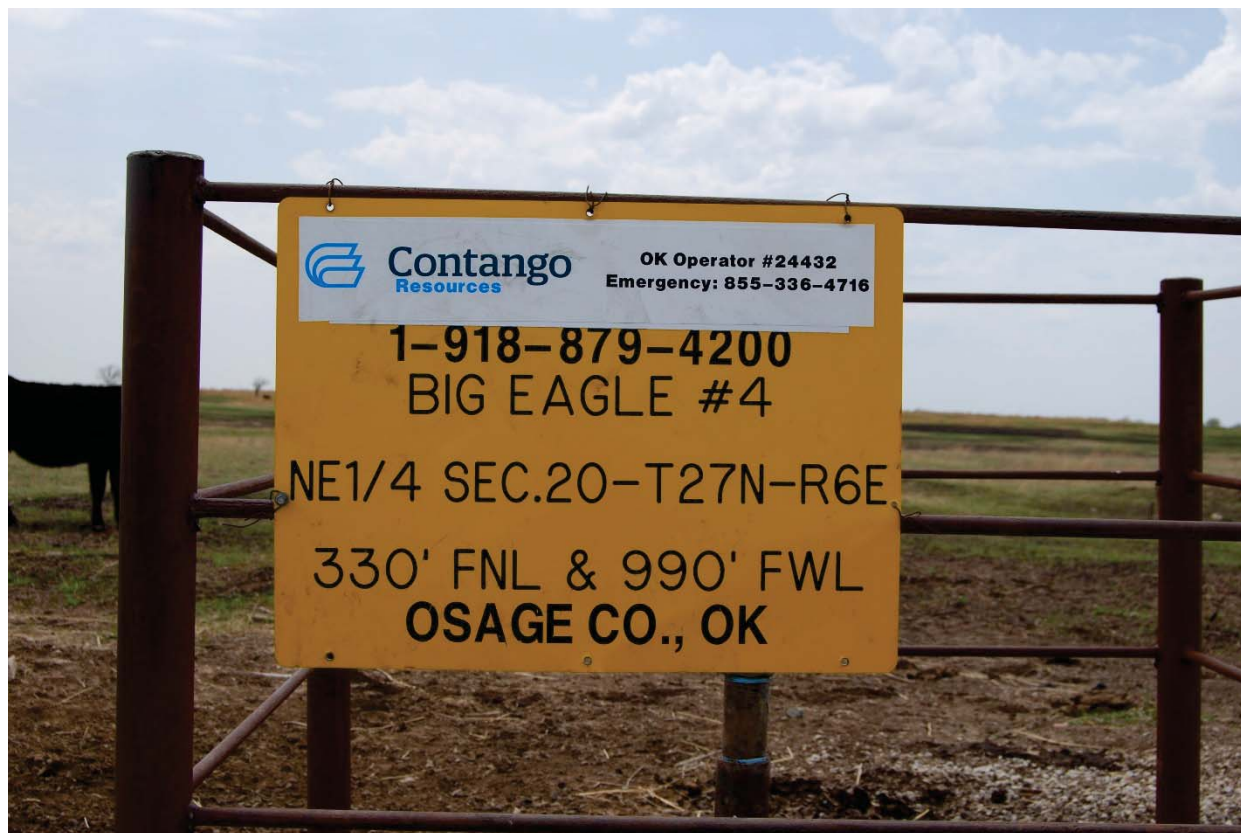
Photo No. 1

**Description:** This was a well sign showing the operator/responsible party on the Big Eagle Lease. This well was located near the point source and was on the same lease as the origin point of the spill of produced water and oil.

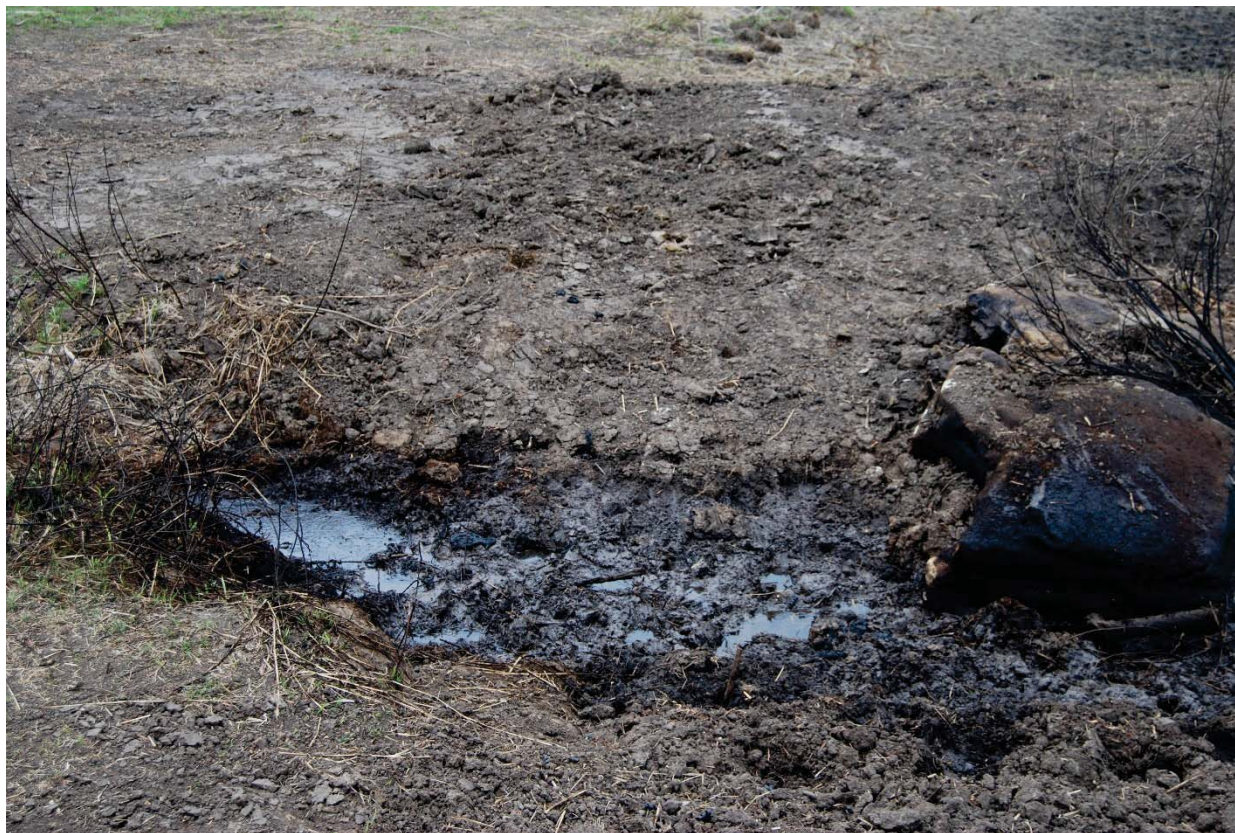
Photo No. 2

**Description:** This was the release point as well as point of entry (POE) into the tributary. During the inspection, the operator stated there was a 2" poly flowline exposed (not buried) over the streambed and there was a grass fire which weakened or ruptured the flowline causing the release. At the time of inspection, the damaged flowline had been repaired and buried to prevent recurrence. At the time of inspection, there was not enough fluid present at the POE to obtain a Total Dissolved Solids (TDS) measurement. The photograph showed oil residue and oil-soaked absorbent material which had been applied during the initial stages of cleanup activities. The oil soaked "sphagnum" or "sphag" absorbent material appeared black in the photo and is not easily distinguishable.

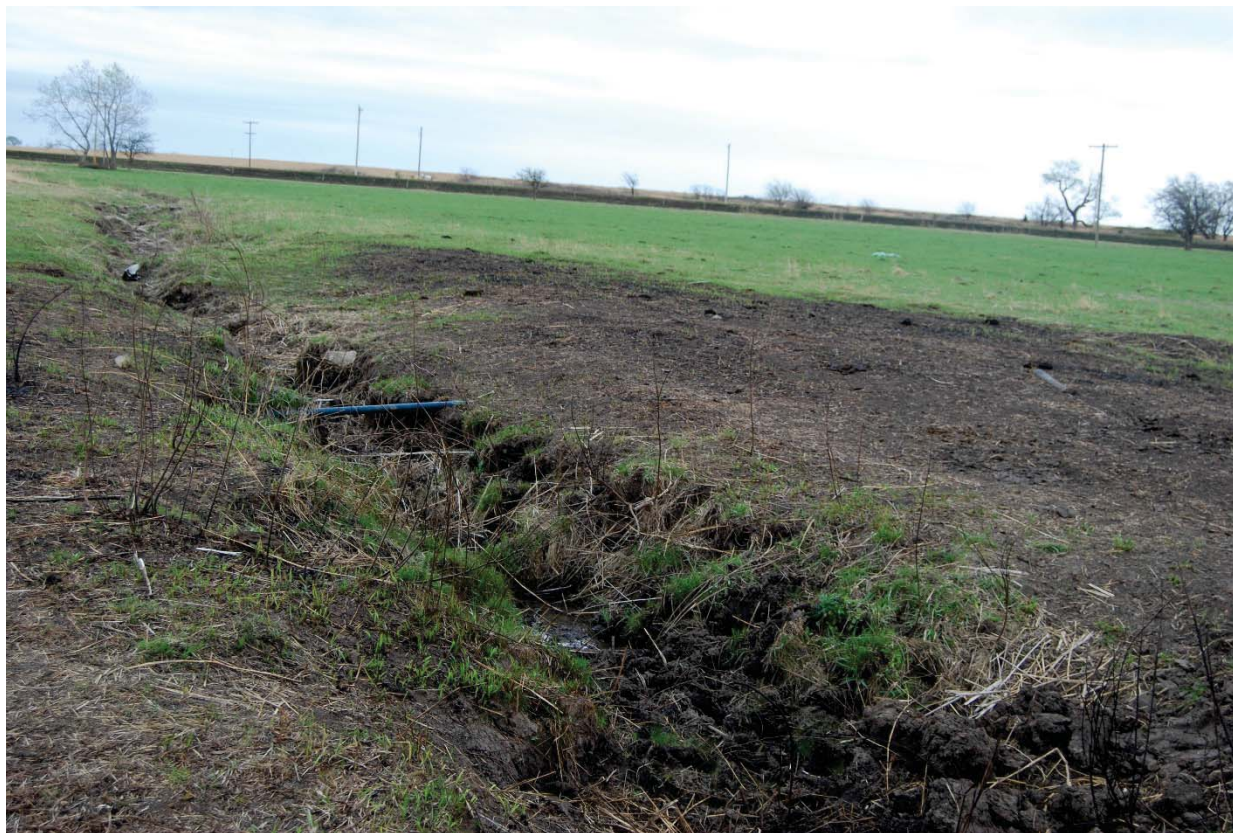
Photo No. 3

**Description:** Photo taken at POE, looking upstream. Note, the virtually dry streambed there was no water deep enough for a TDS measurement at this location at the time of the inspection.

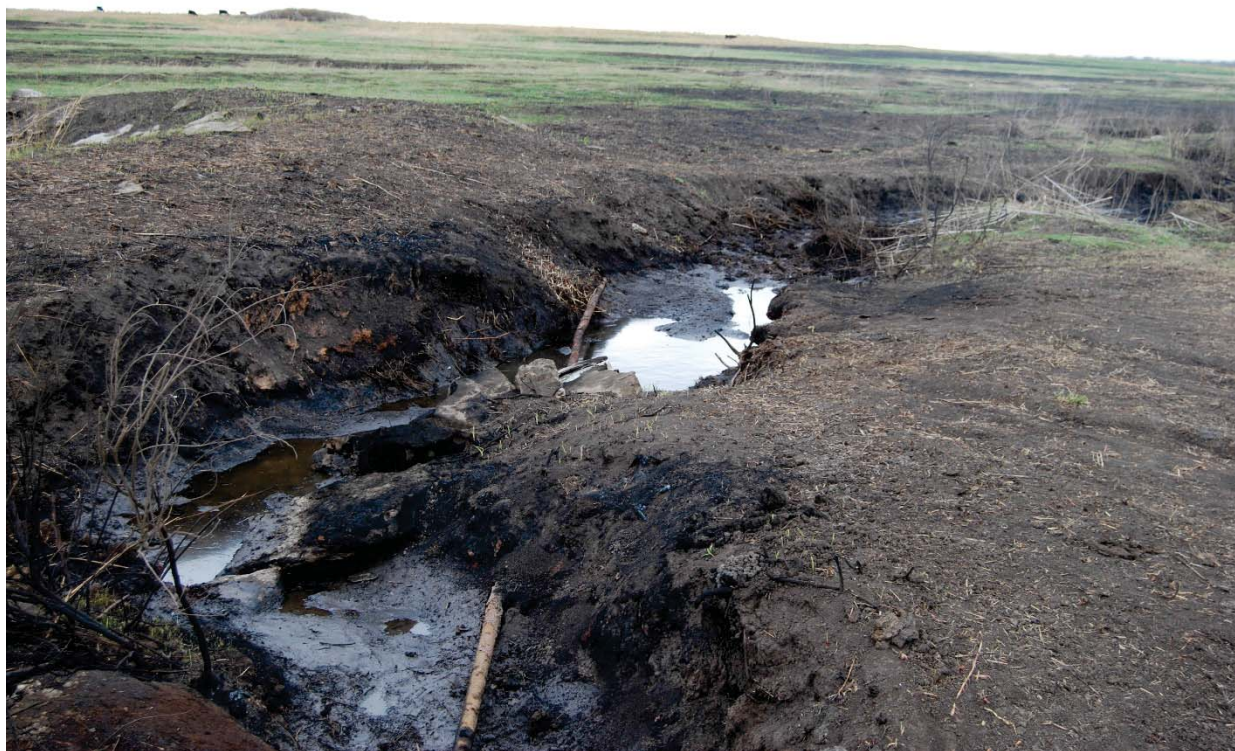
Photo No. 4

**Description:** Photo taken from POE looking downstream. Evidence of recent fire pictured with burned vegetation present along stream bank and surrounding pasture. Black rocks in the photograph looked to be both oil stained and fire charred. Tank trucks were actively flushing this section of the impacted area just before the inspection began.

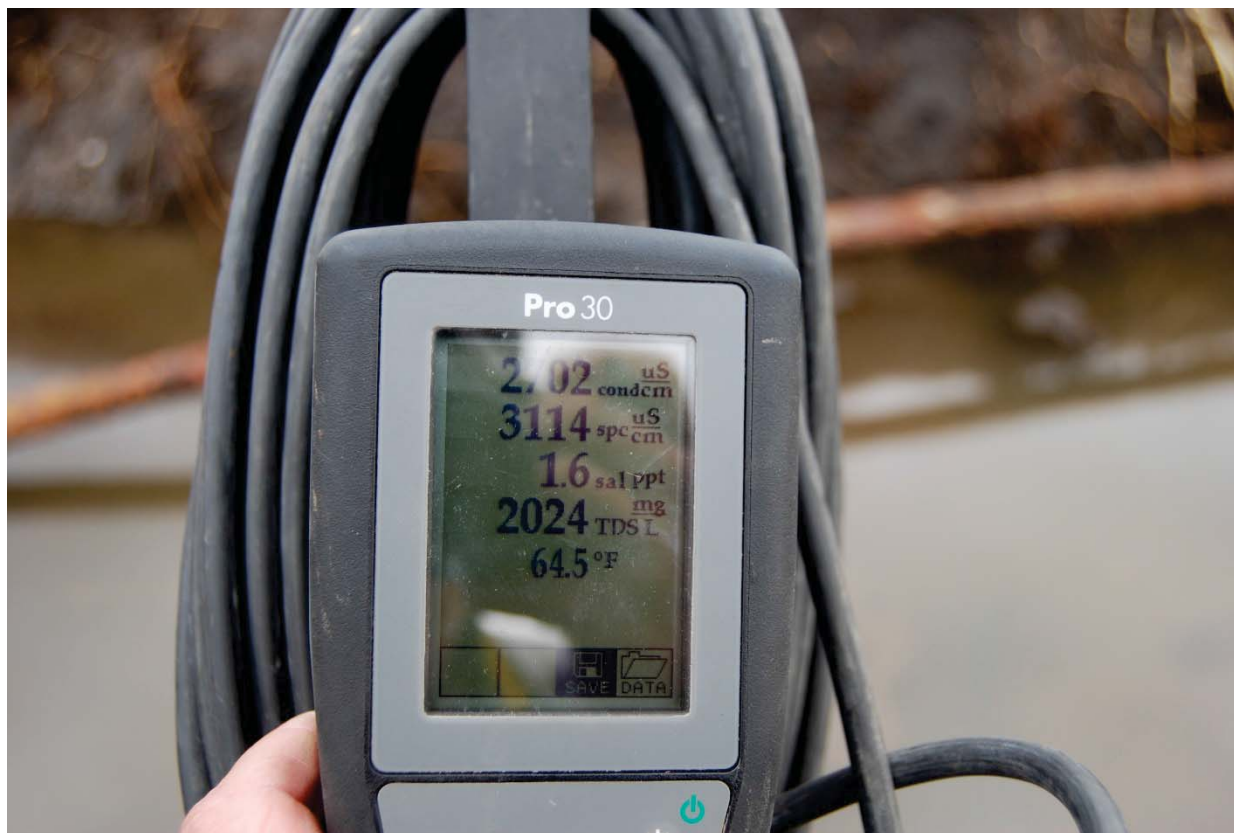
| 2,024 mg/L | Photo No. 5 |

**Description:** With a calibrated YSI Pro 30 conductivity meter, a TDS measurement of 2,024 milligrams per liter (mg/L) was taken approximately 20' feet downstream from the POE of produced water and oil into the tributary from the production flow line.

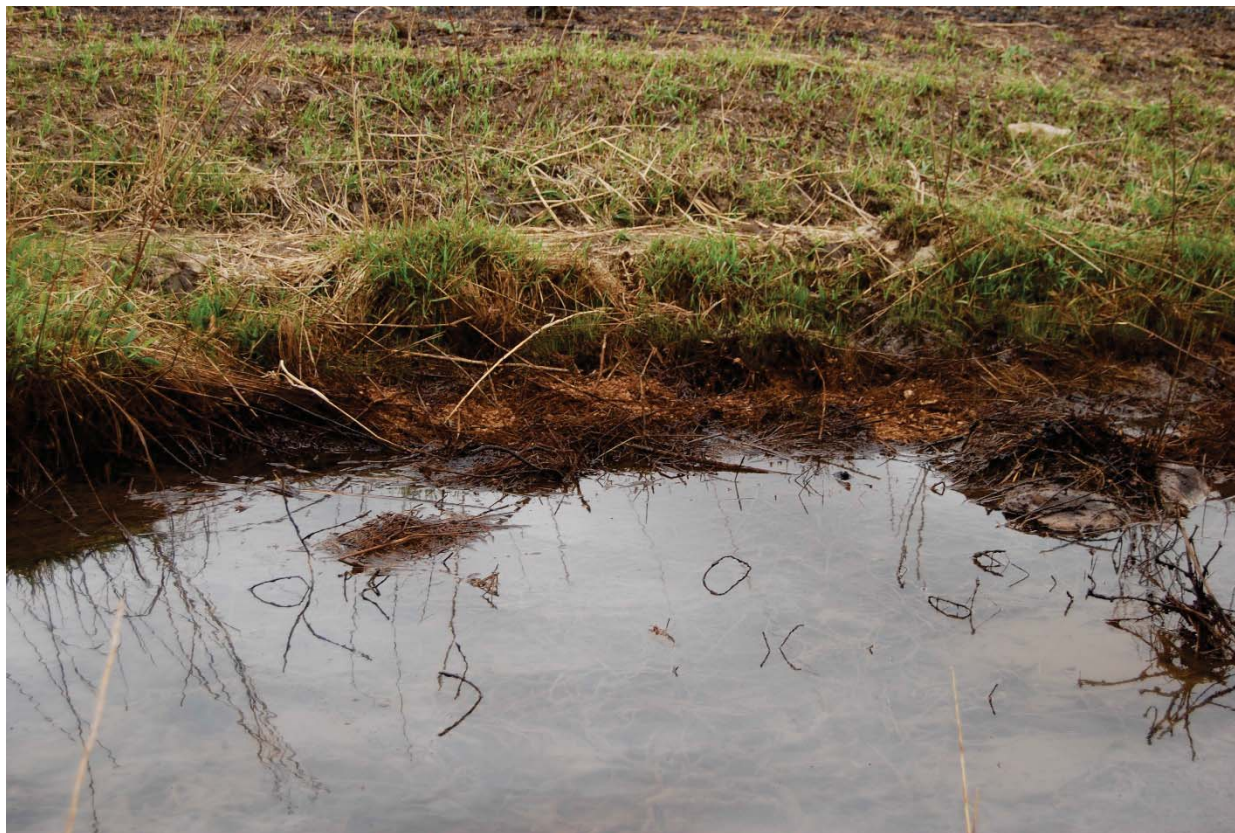
Photo No. 6

**Description:** Photo taken on tributary between photos 5 and 7 Oil-stained vegetation along the bank as well as "sphagnum sorb" oil absorbent material which had been applied in early cleanup efforts.

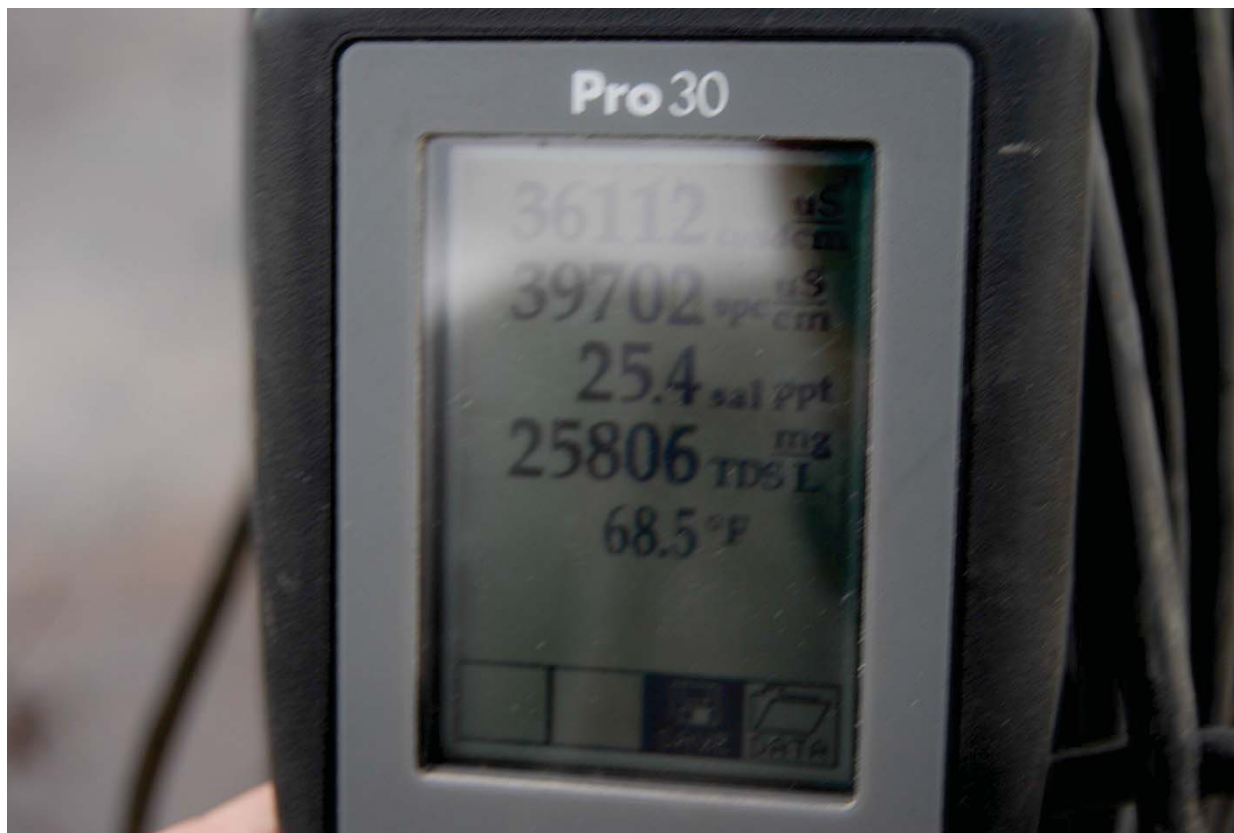
| 25,806 mg/L | Photo No. 7 |

**Description:** A TDS measurement of 25,806 mg/L was taken downstream from the POE.

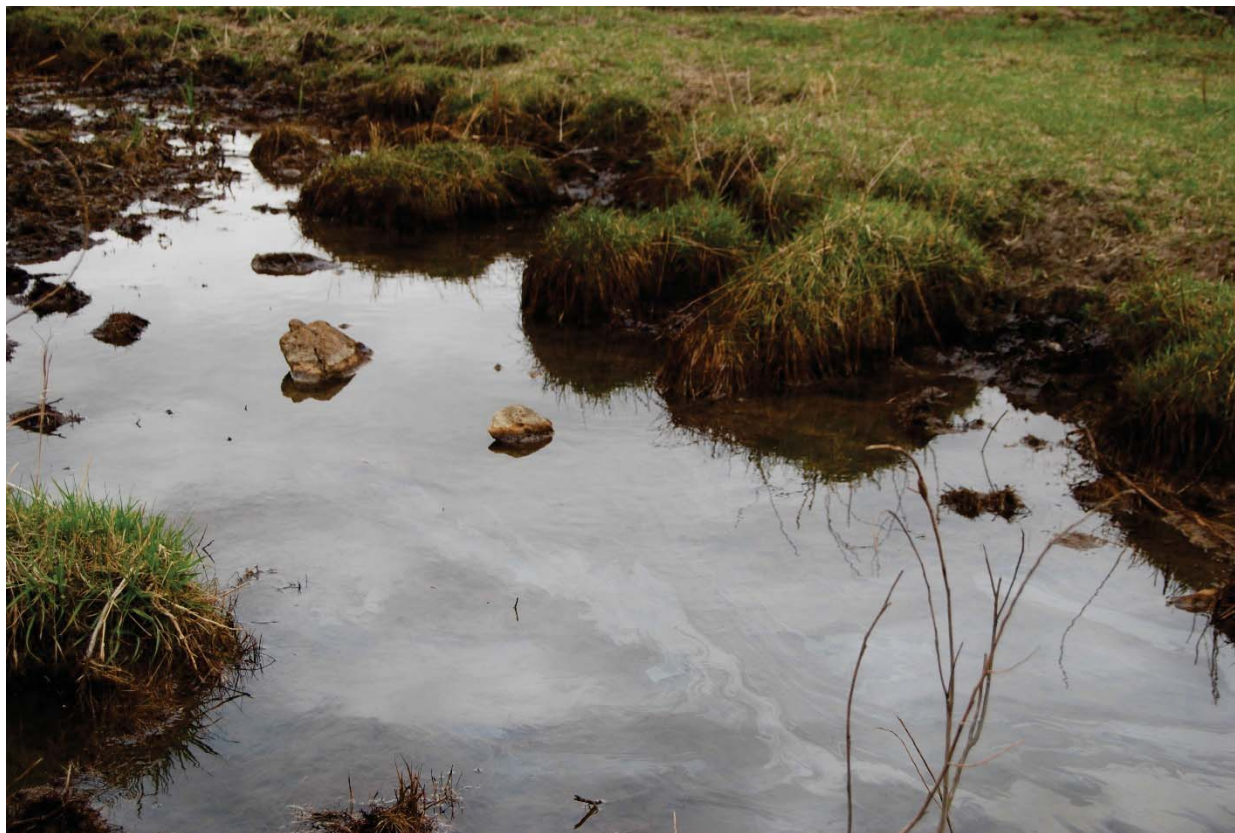
Photo No. 8

**Description:** Photo downstream from previous photos (6 and 7) showing oil sheen present on the surface of the water at the time of inspection.

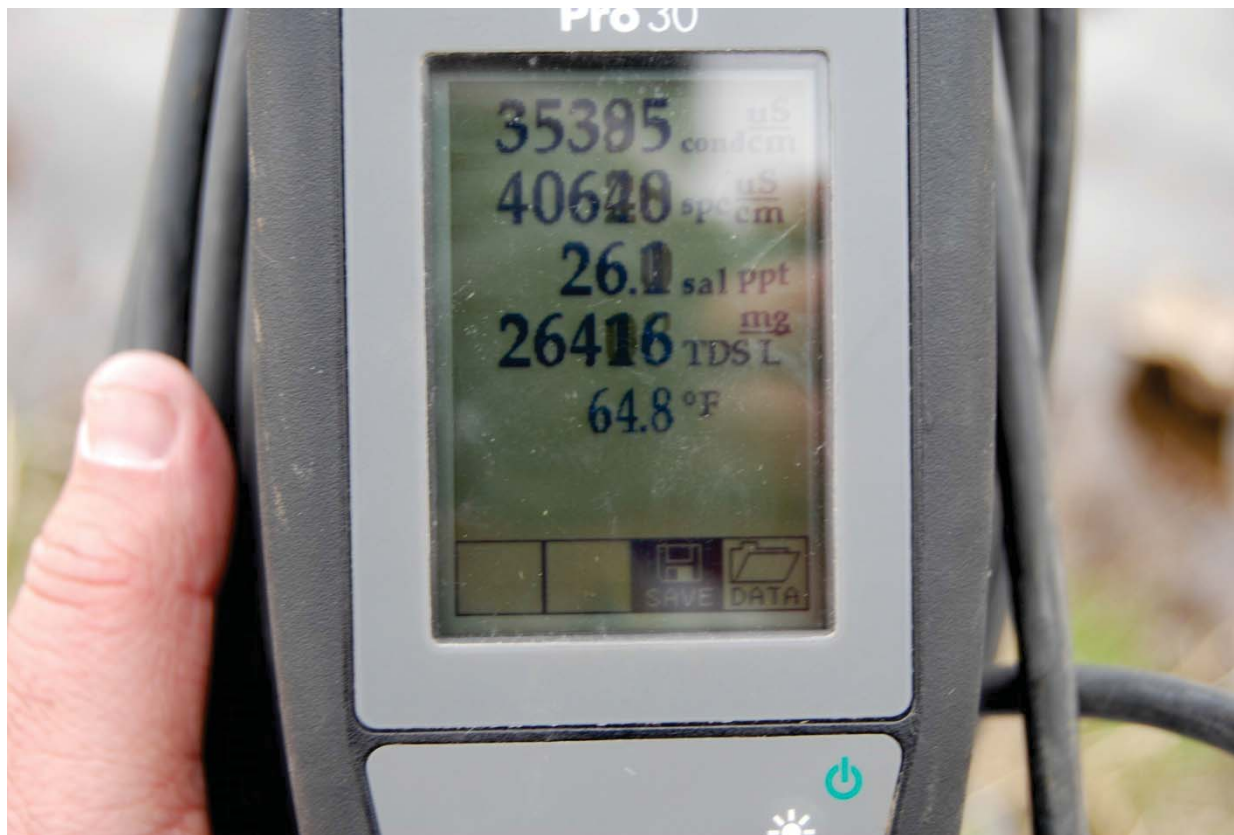
| 26,416 mg/L | Photo No. 9 |

**Description:** A TDS measurement was taken during the inspection recording 26,416 mg/L at this location. This reading was taken at the same location represented in Photo No. 8, which showed oil sheen present on the water's surface.

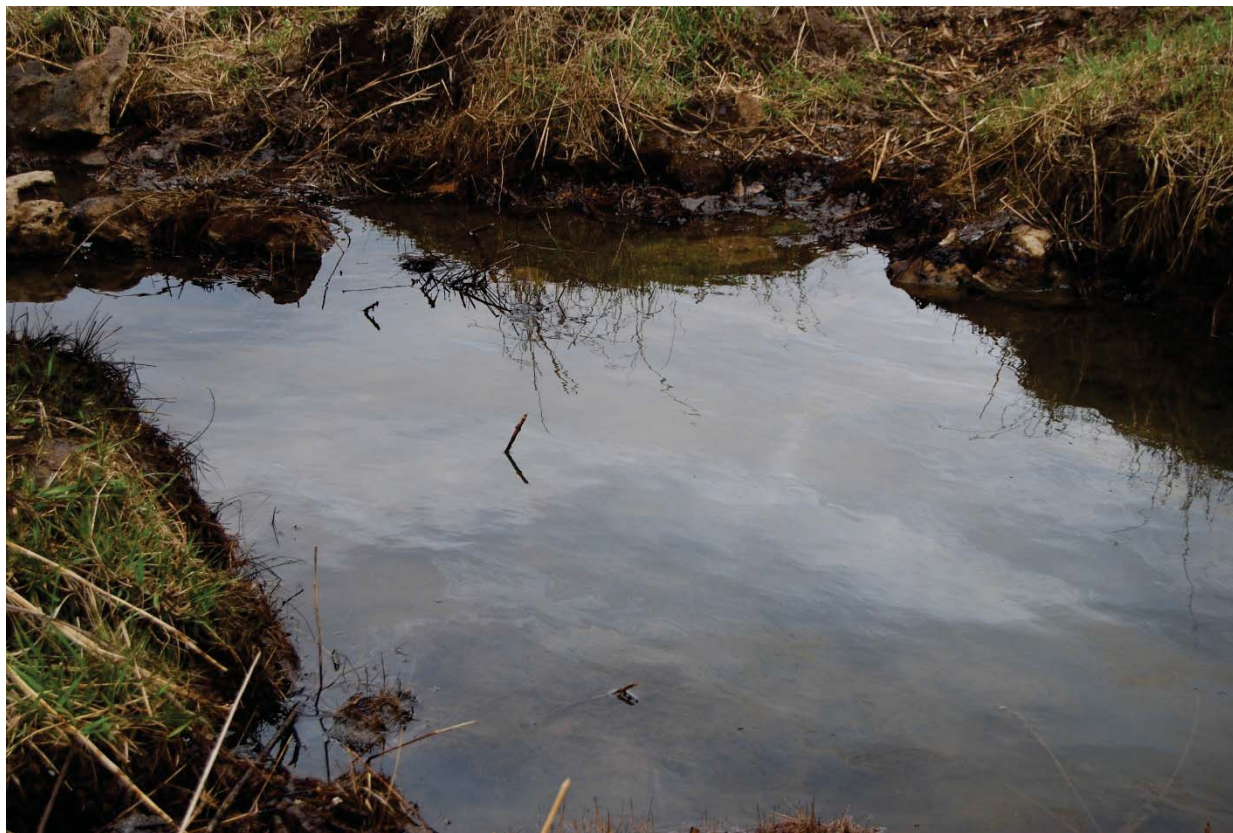
Photo No. 10

**Description:** Oil sheen was present on the surface of the water at the time of the inspection. Oil staining was present on rocks, stream bank, and vegetation pictured above. Elevated TDS measurements also captured at this location and evidenced by Photo No. 11.

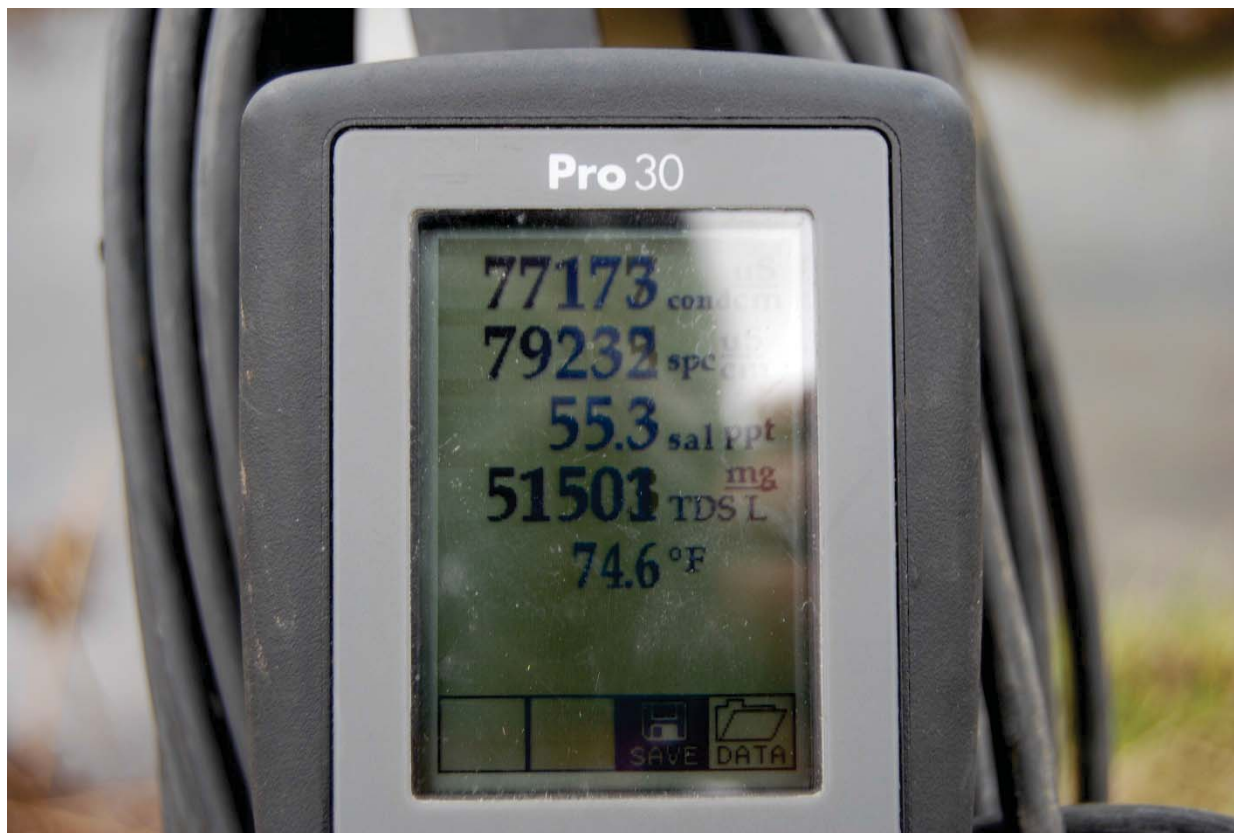
| 51,501 mg/L | Photo No. 11 |

**Description:** Elevated measurement of 51,501 mg/L TDS observed during the inspection.

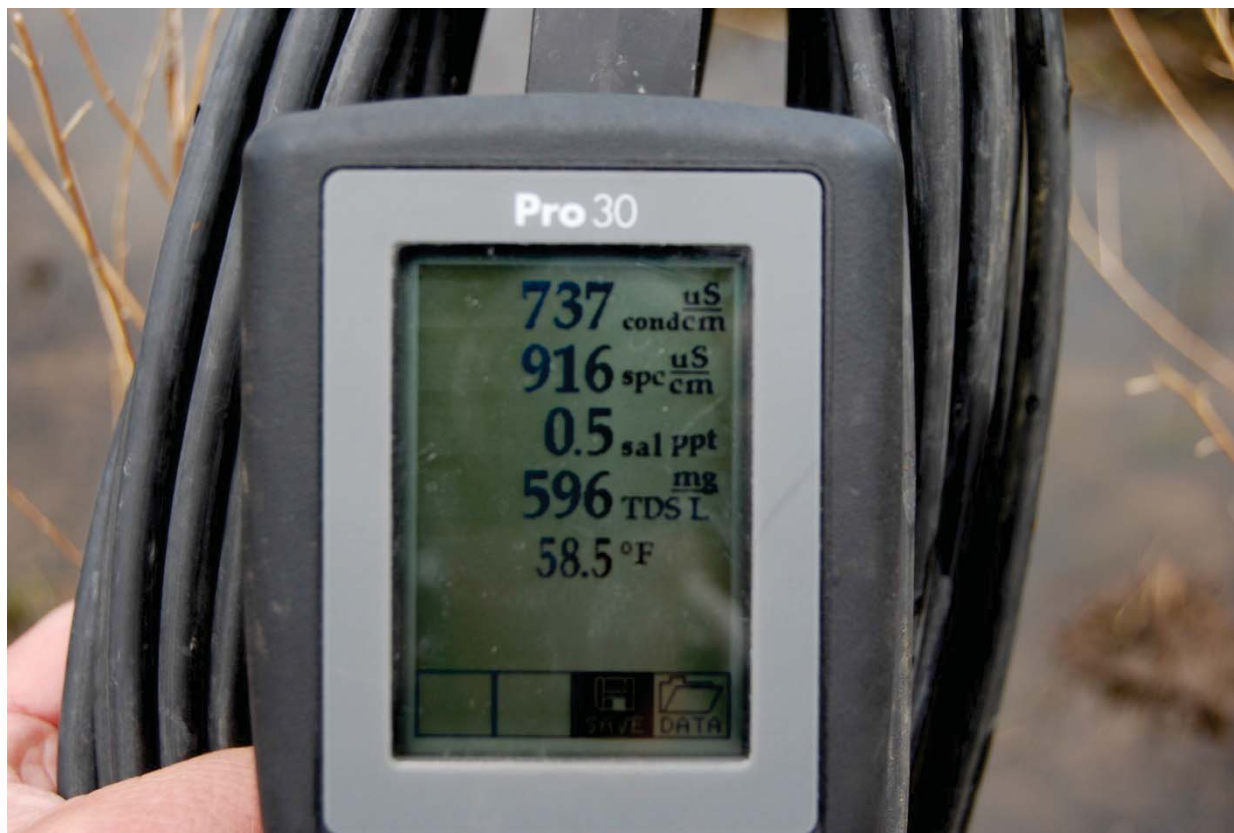
| 596 mg/L | Photo No. 12 |

**Description:** Small unnamed tributary upstream from the confluence where it joins the impacted tributary from the north. This measurement was taken in waters which were NOT impacted by the spill, this should be considered a "background" TDS measurement and read 596 mg/L.

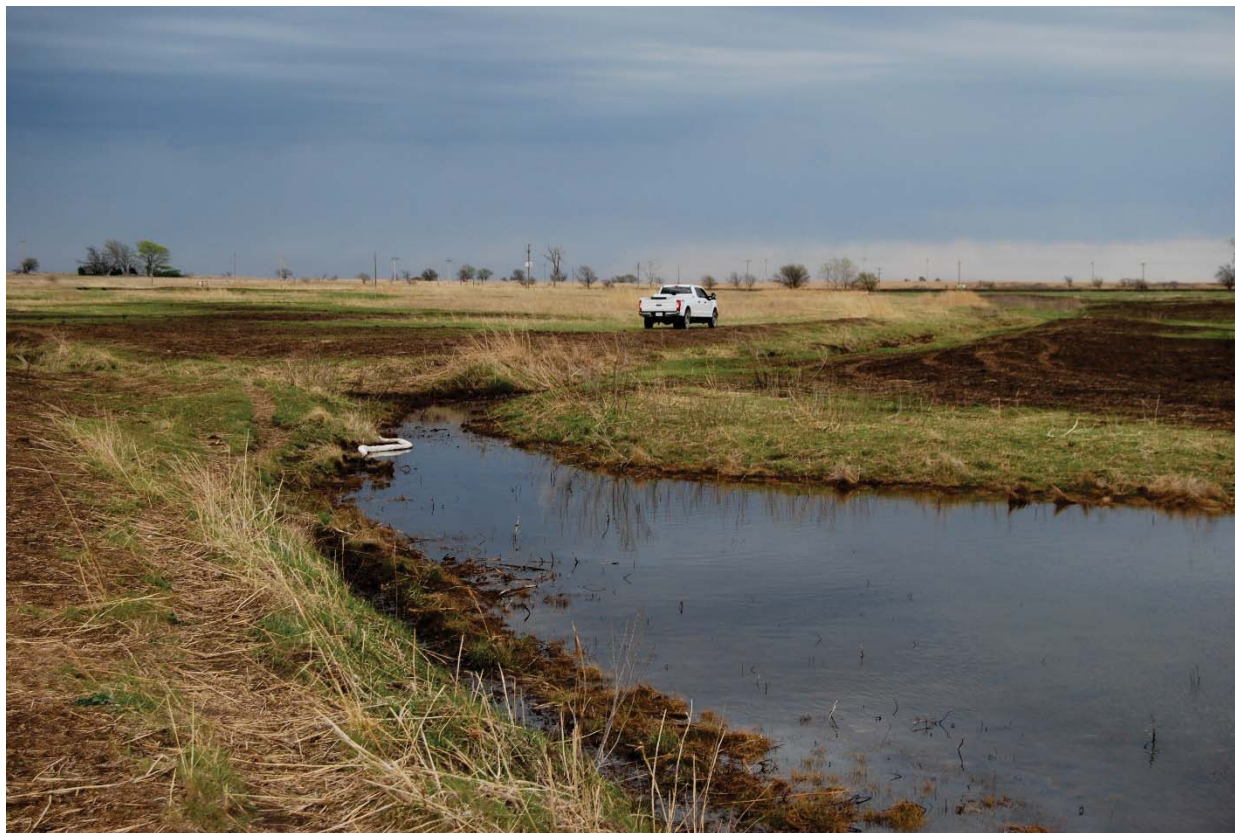
Photo No. 13

**Description:** Small pond which the impacted tributary flows through. 1 floating oil absorbent boom was seen floating on the surface. The operator stated the dam was temporarily repaired on this pond to be used as a capture point in flushing operations as part of the ongoing cleanup. TDS measured 16,090 mg/L at the time of the inspection as evidenced in Photo No. 15 of this photo log.

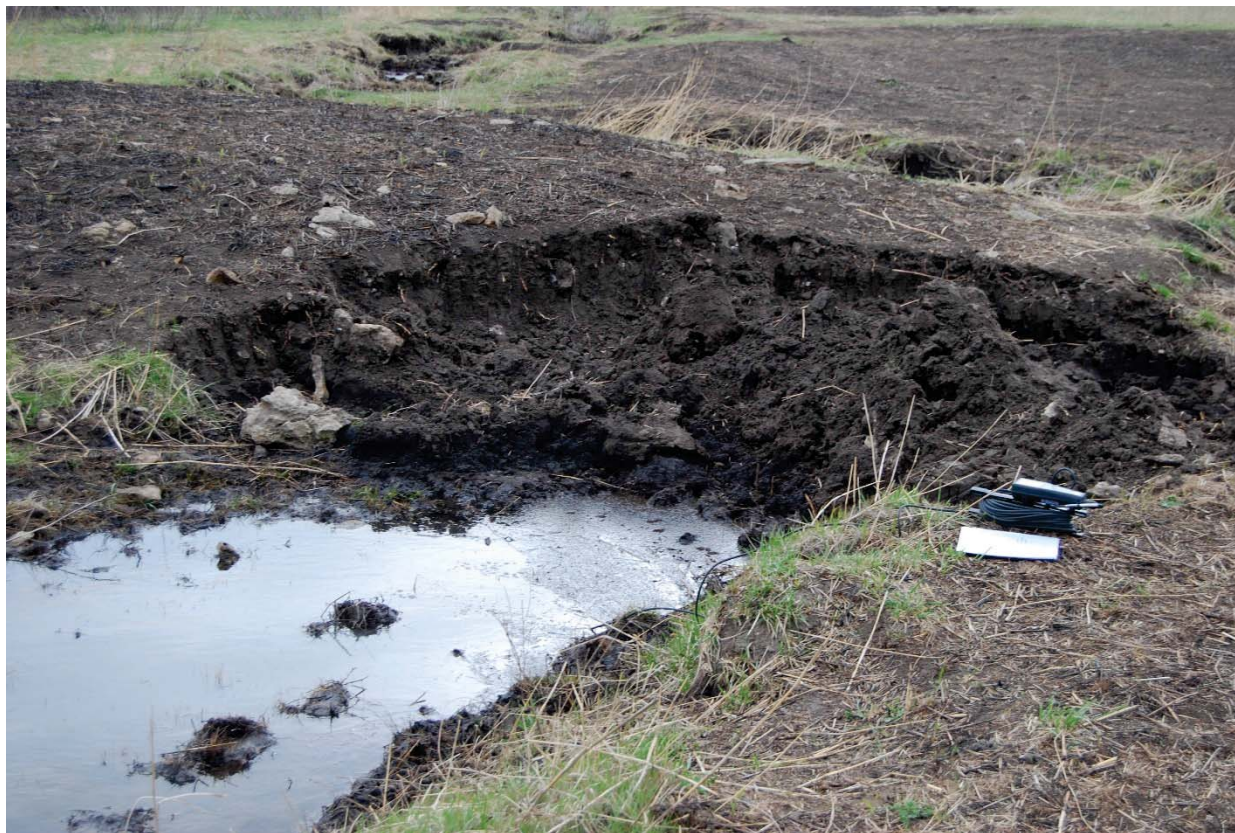
Photo No. 14

**Description:** Small pond was observed. The operator used a backhoe to temporarily repair this dam prior to this inspection and was using the pond as a catch pit during flushing operations as part of the cleanup activities. This was the first dam downstream from the POE. TDS measured 16,090 mg/L at the time of inspection as shown in Photo No. 15.

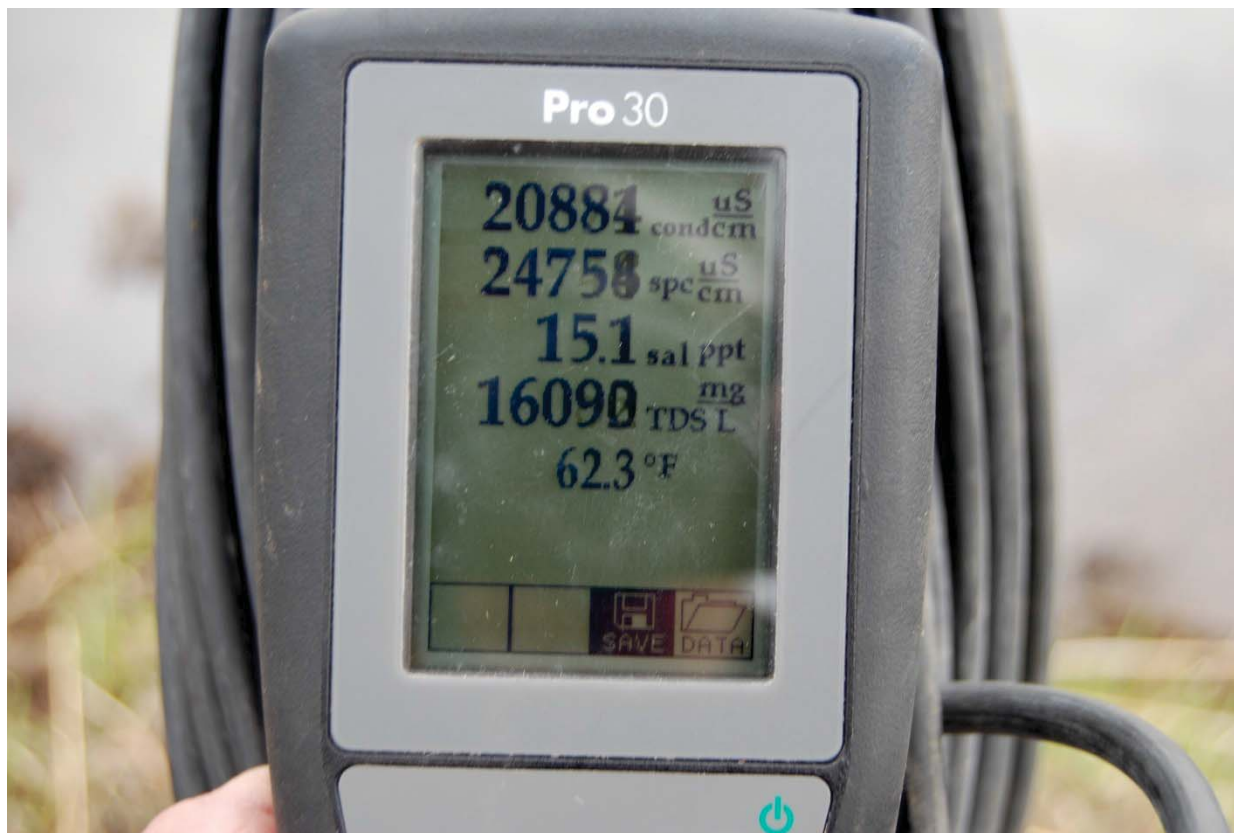
| 16,090 mg/L | Photo No. 15 |

**Description:** TDS measurement recorded 16,090 mg/L in the catchpit/pond immediately above the first dam on the impacted tributary. I saw a tank truck hauling water away from this location during the inspection.

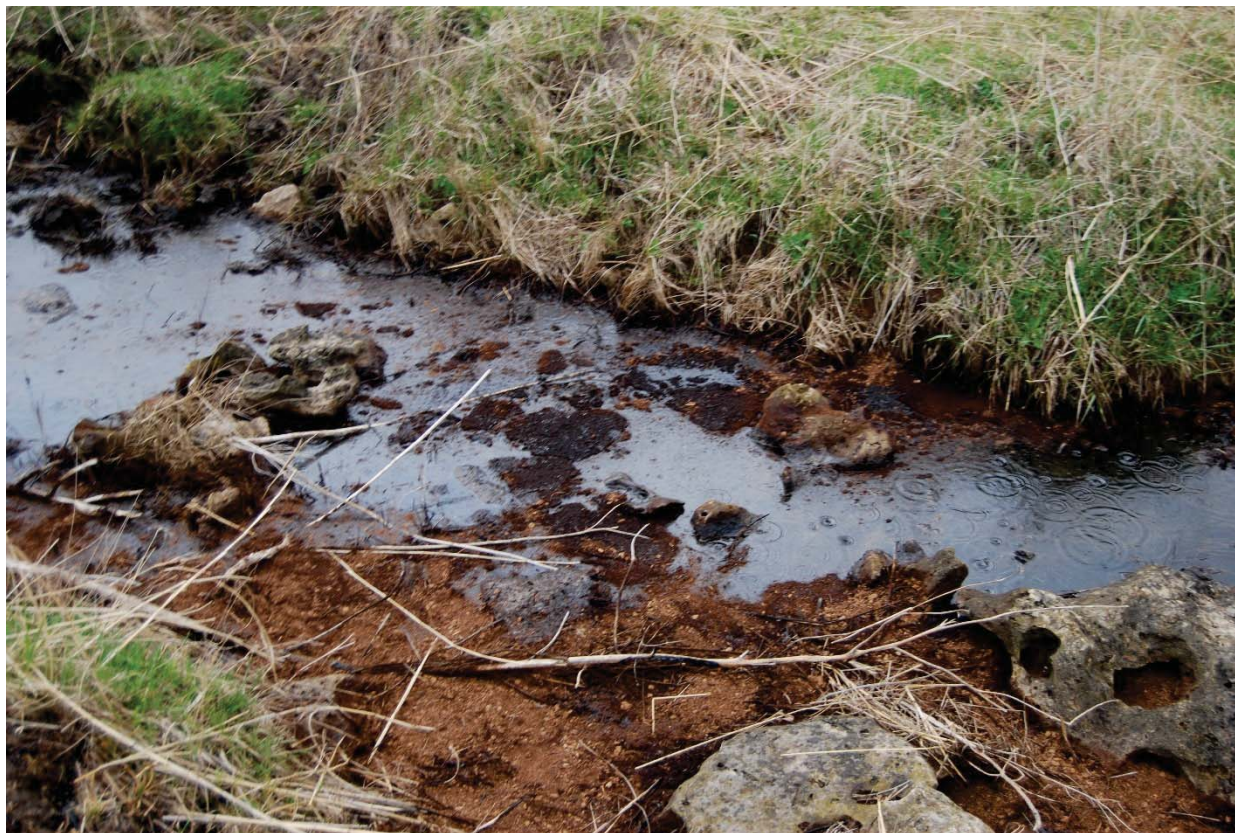
Photo No. 16

**Description:** Impacted tributary immediately below the 1<sup>st</sup> dam/catchpit. Oil absorbent material was observed along the bank, on the rocks and floating in the water. Areas of absorbent, which appear very dark brown or black, were soaked with oil and lighter brown colored areas had not been oil soaked.

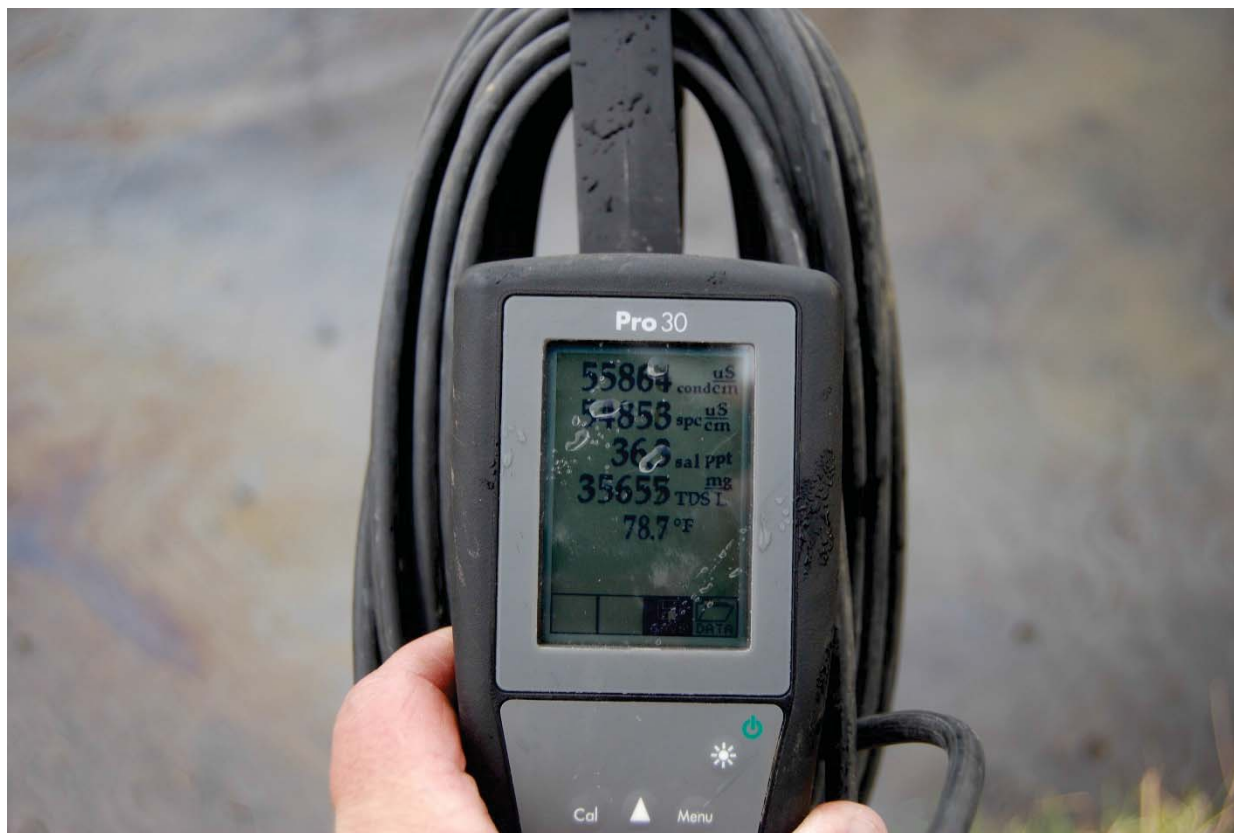
| 35,655 mg/L | Photo No. 17 |

**Description:** Elevated TDS of 35,655 mg/L measured during the inspection. This reading was taken along the impacted tributary between the first dam/catchpit and the location associated with Photo No. 18. Latitude and Longitude were estimated for this location.

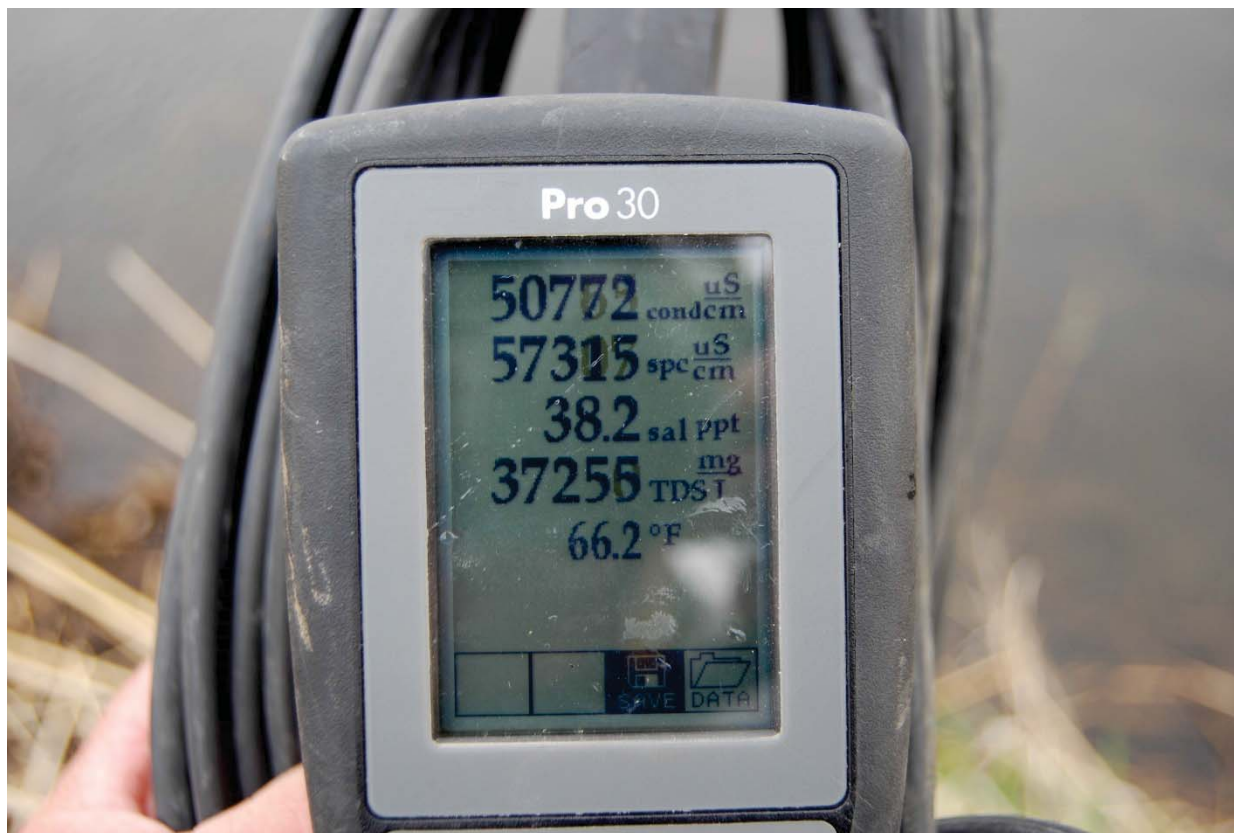
| 37,255 mg/L | Photo No. 18 |

**Description:** Elevated TDS measurement taken along the impacted tributary showing 37,255 mg/L TDS. This measurement was taken downstream from the first dam/catchpit, but upstream from the drained pond pictured in Photo No. 19.

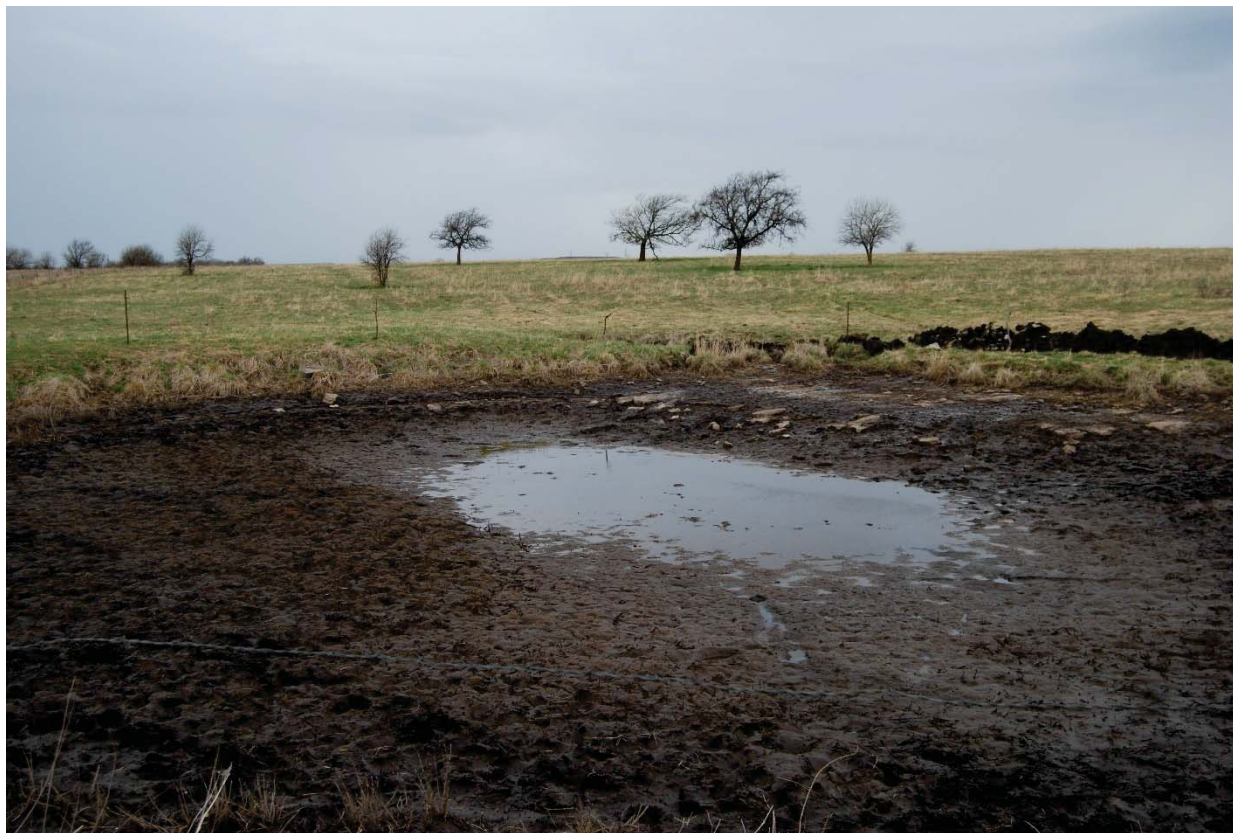
Photo No. 19

**Description:** Image shows a pond which had been nearly drained by the operator as part of the cleanup efforts. This pond was connected to the impacted tributary at the time of the spill, but the operator used a backhoe to divert the tributary away from the pond. A dirt berm can be seen middle/right side of the picture, that berm serves to re-route the impacted tributary around the pond which had been emptied and fenced off to prevent cattle from accessing water with elevated TDS.

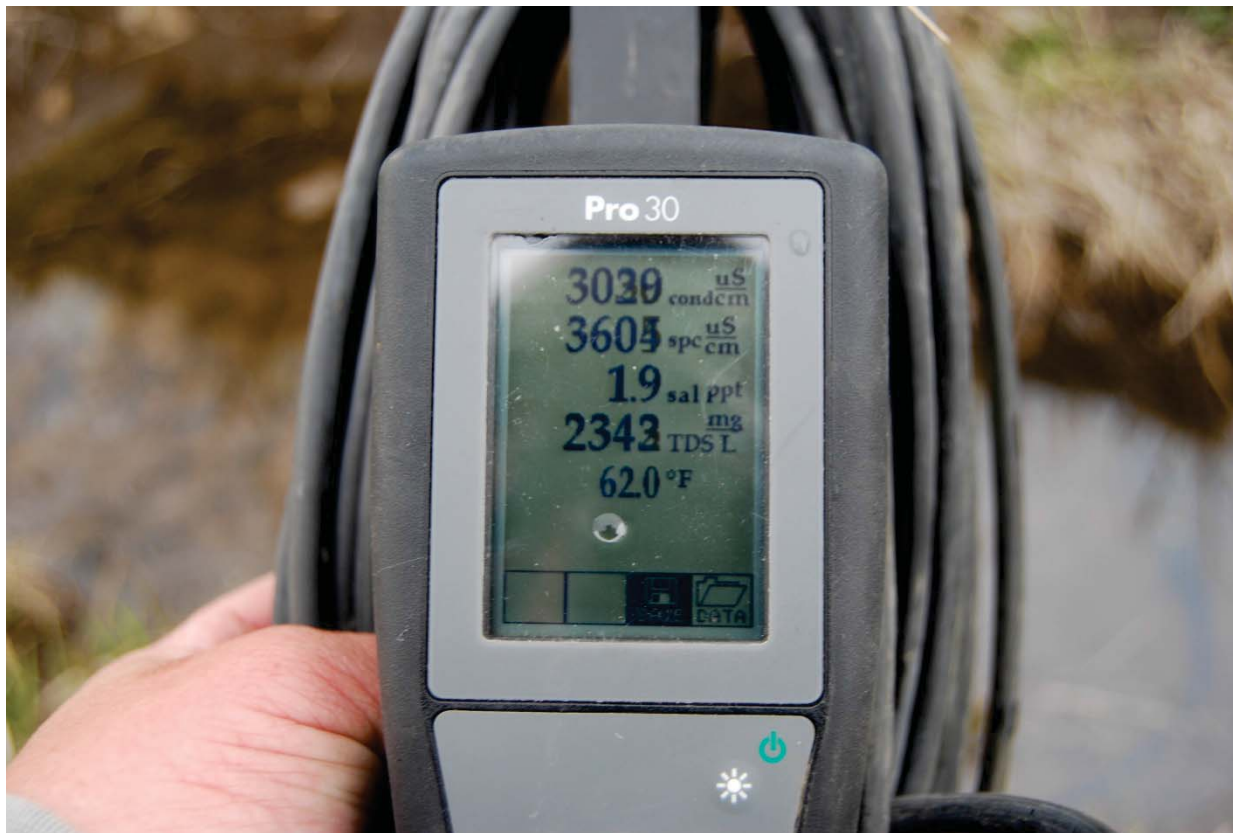
| 2,343 mg/L | Photo No. 20 |

**Description:** TDS measured 2,343 mg/L along the impacted tributary downstream from the pond pictured in Photo No. 19.

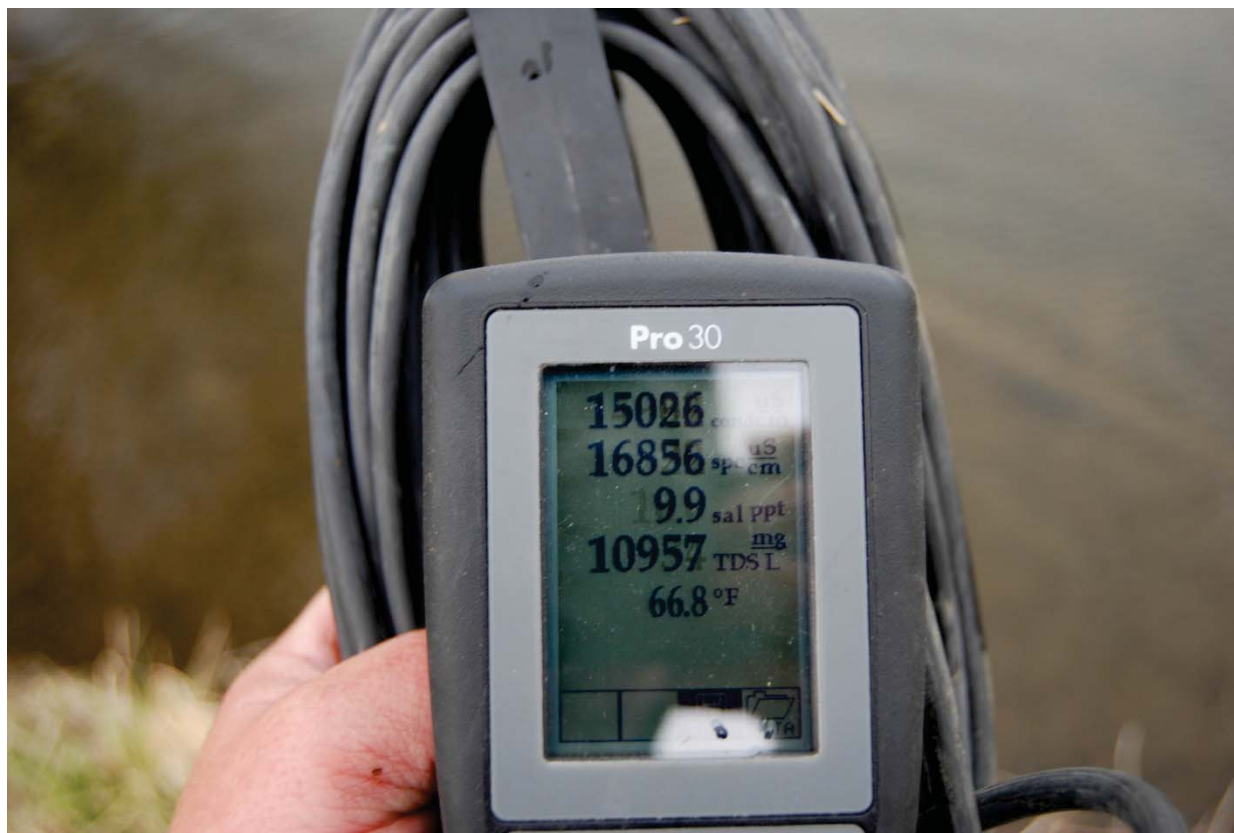
| 10,597 mg/L | Photo No. 21 |

**Description:** Elevated TDS measurement showing 10,957 mg/L was taken. This photo was taken along the impacted tributary between the pond pictured in Photo No. 19 and the final dam/catchpit in Photo No. 22. Latitude and Longitude were estimated for this location.
