## Region 6 - Enforcement & Compliance Assurance Division

### INSPECTION REPORT

| Company Name: | <b>Contango Resources, LLC</b> | |
| Facility Name: | <b>Big Eagle Lease</b> | |

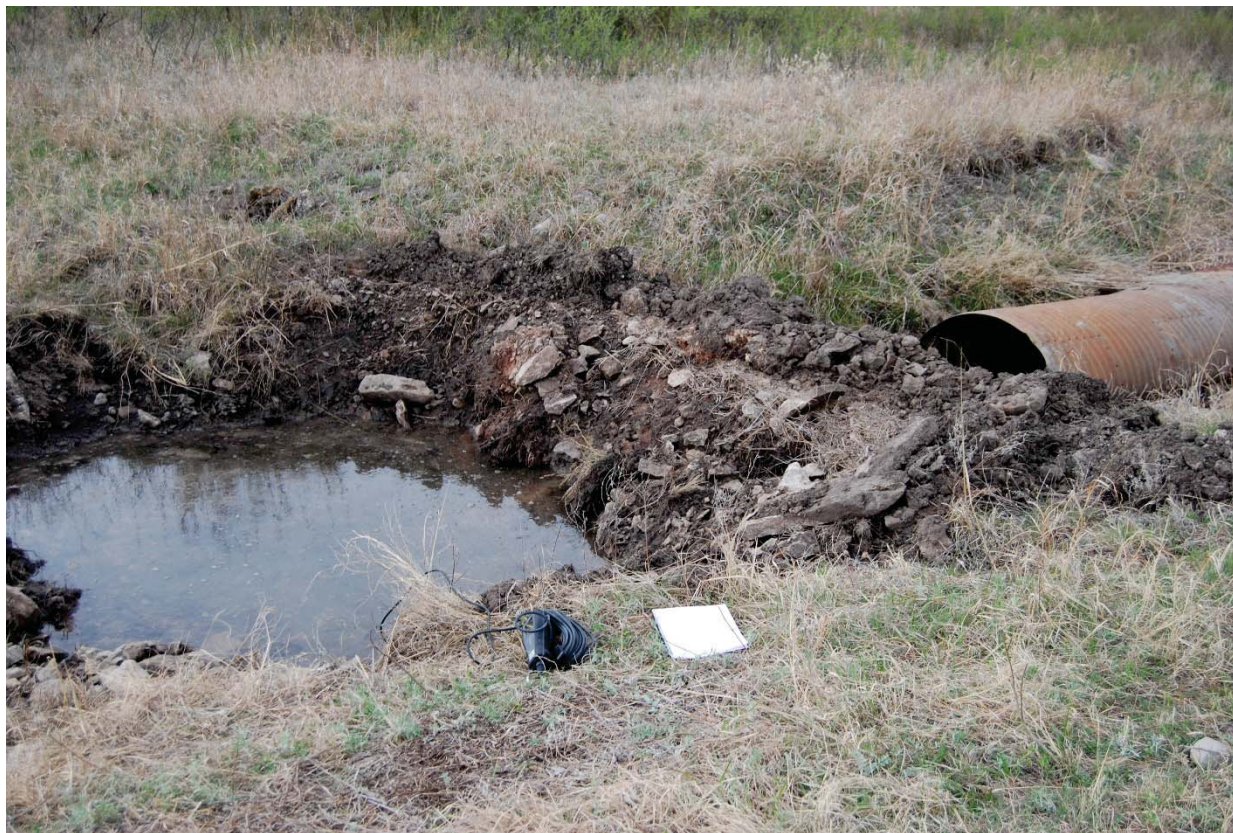
Photo No. 22

**Description:** Lowermost downstream catchpit used in cleanup/flushing operations. TDS measured 15,008 mg/L as shown in Photo No. 23.

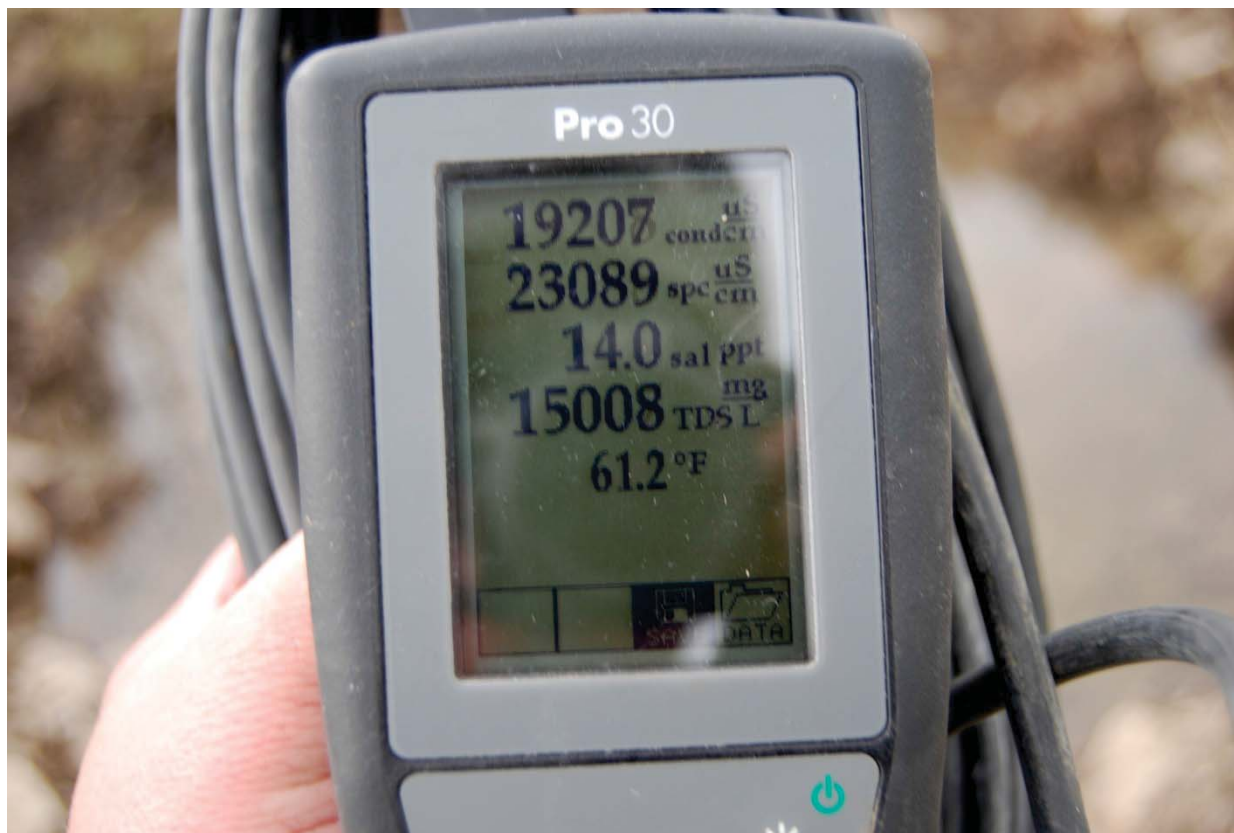
| 15,008 mg/L | Photo No. 23 |

**Description:** Elevated TDS measurement of 15,008 mg/L taken at the lowermost dam/catchpit on the impacted tributary.

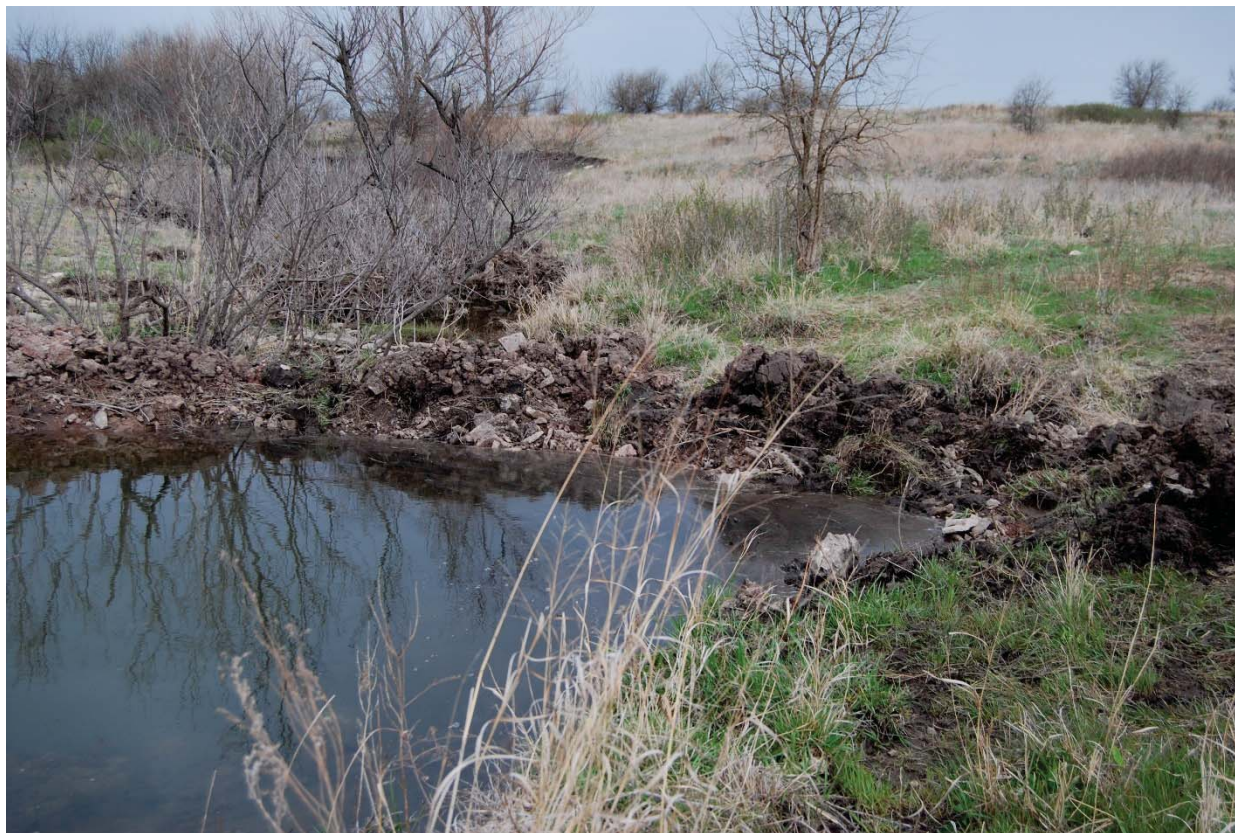
Photo No. 24

**Description:** This temporary dam has been placed by the operator to collect fresh “flush” water from a tributary which joins the impacted stream. This dam and pool of water were not impacted by the spill, and a TDS measurement of 681 mg/L was taken from this pool and is evidenced in photo DSC007 on the following page. This TDS measurement should be used to help establish “background” TDS levels for the area.

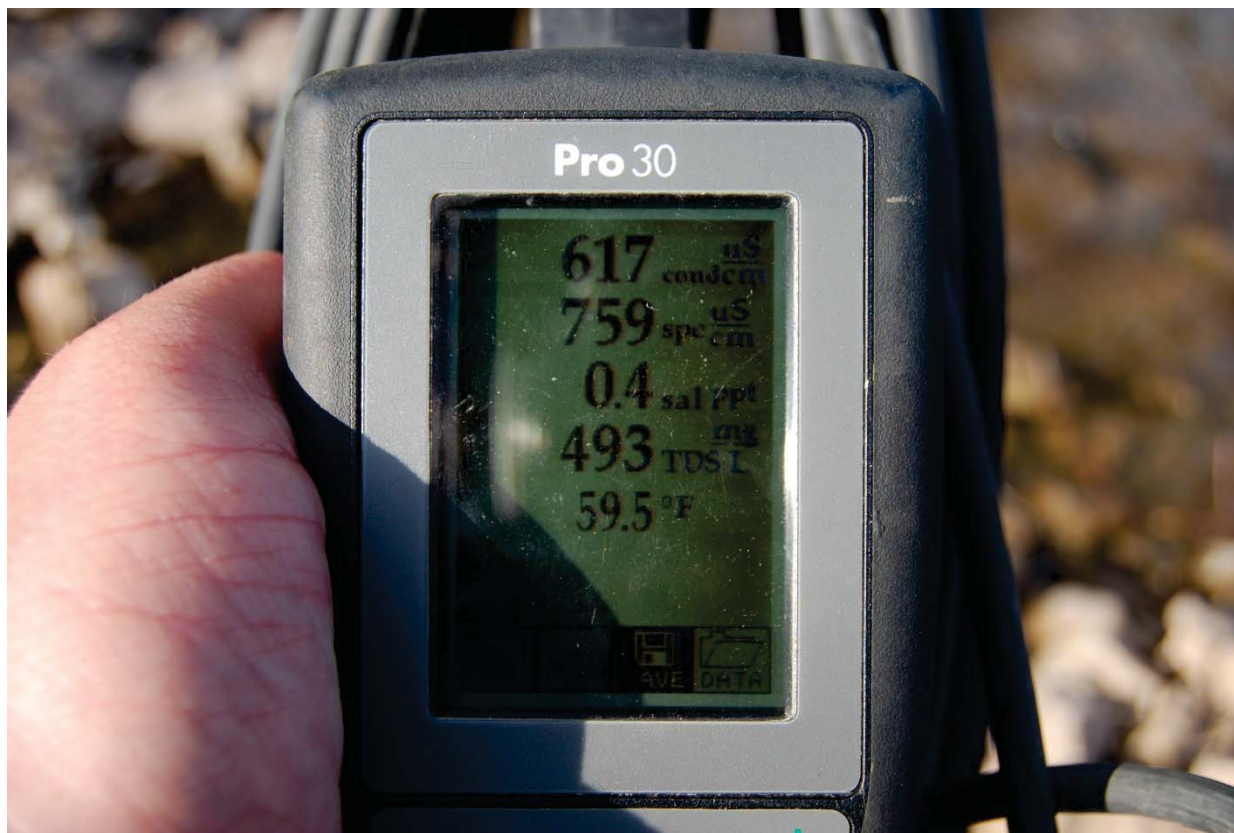
**Description:** TDS measurement taken approximately 20' upstream from confluence of Hay Creek and impacted tributary, measurement taken in the impacted tributary. TDS measurements indicated a "background" level, therefore the brine spill impacts have either diluted below detection levels or failed to reach this point downstream.

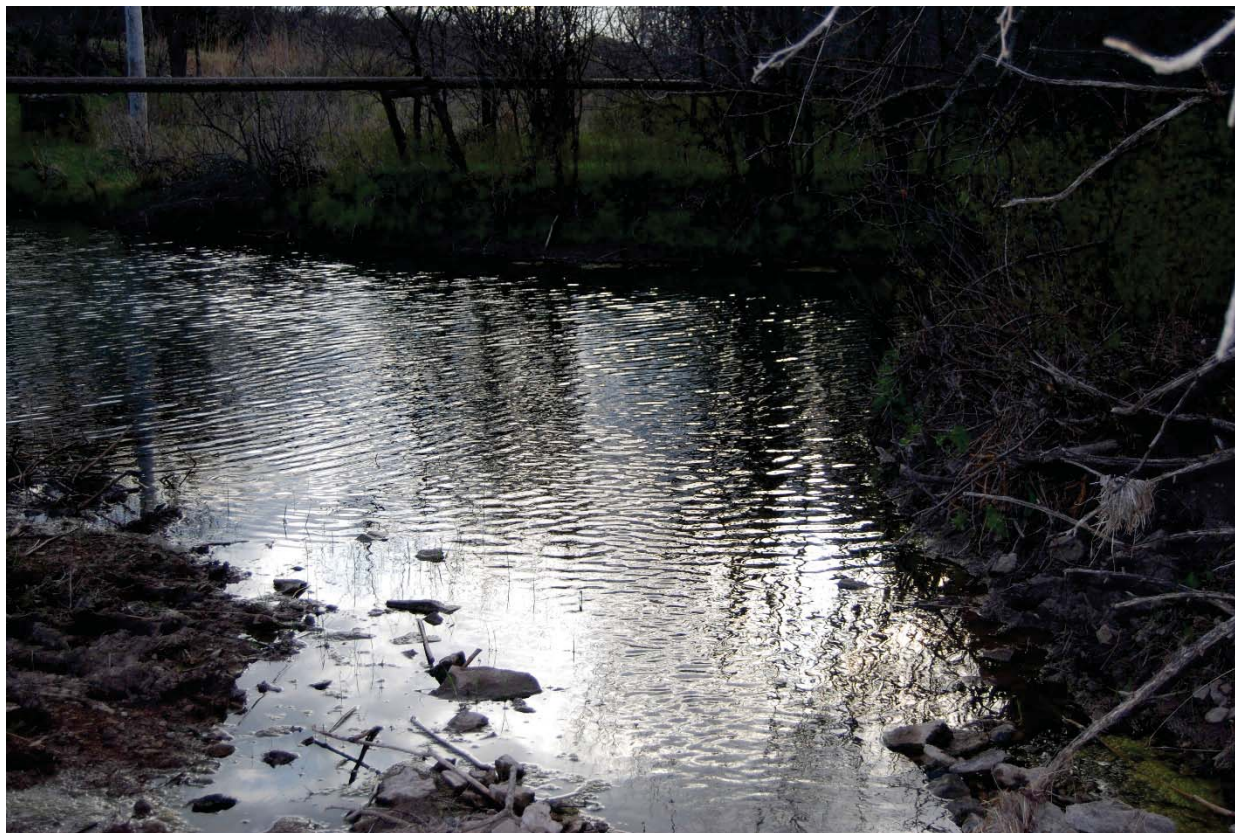
**Description:** The mouth of the impacted tributary was observed in the bottom of this photo, stream width increases as it flows west into Hay Creek. Hay Creek was flowing from right to left across the picture.
