**Region 6 - Enforcement & Compliance Assurance Division**  
**INSPECTION REPORT**

| Inspection Date(s): | 04/13/2022 | |
| Company Name: | <b>Westlake Styrene LP</b> | |
| Facility Name: | <b><i>Styrene Marine Terminal</i></b> | |

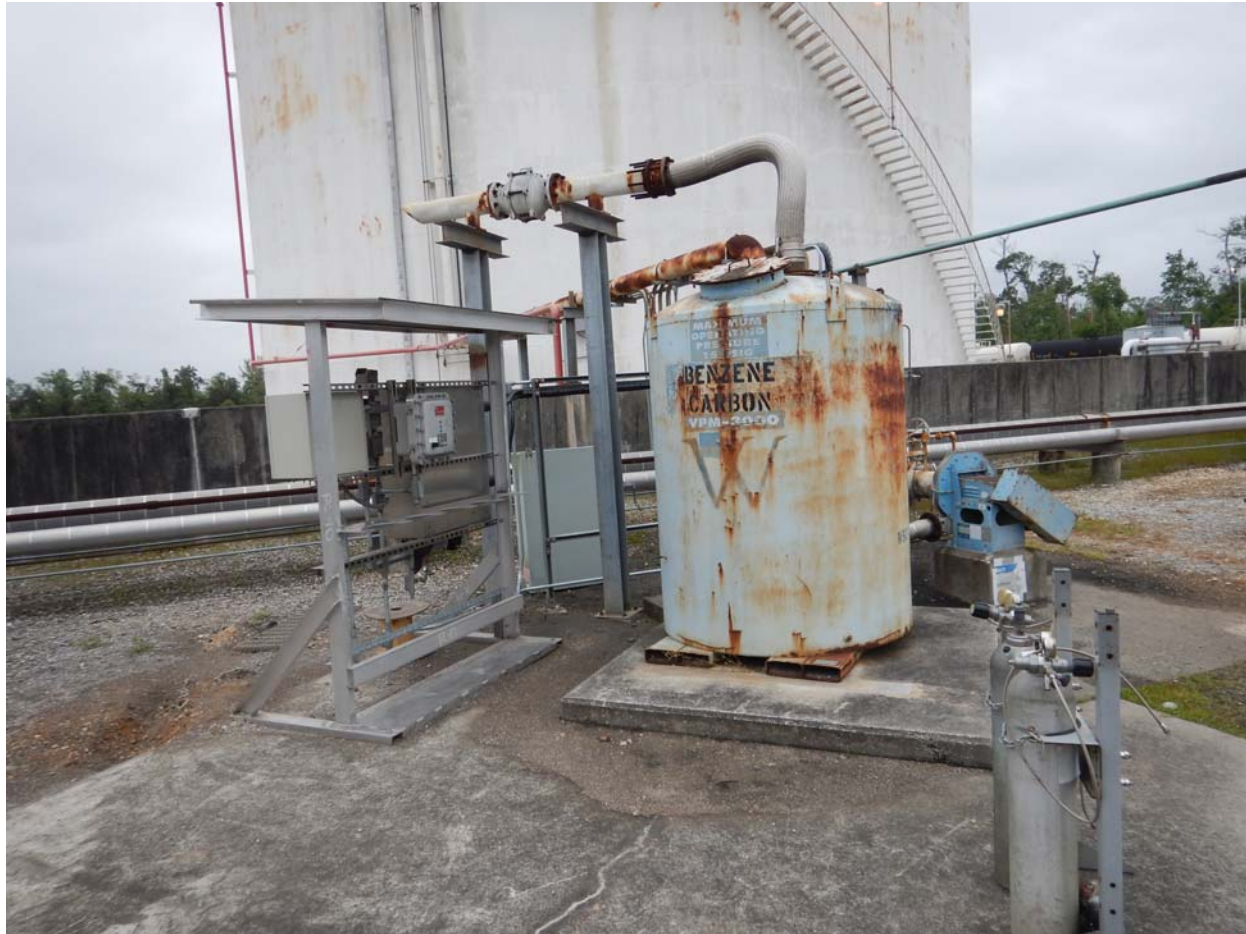
Photo No. 1

Description: Carbon canister controlling emissions from the benzene tank.

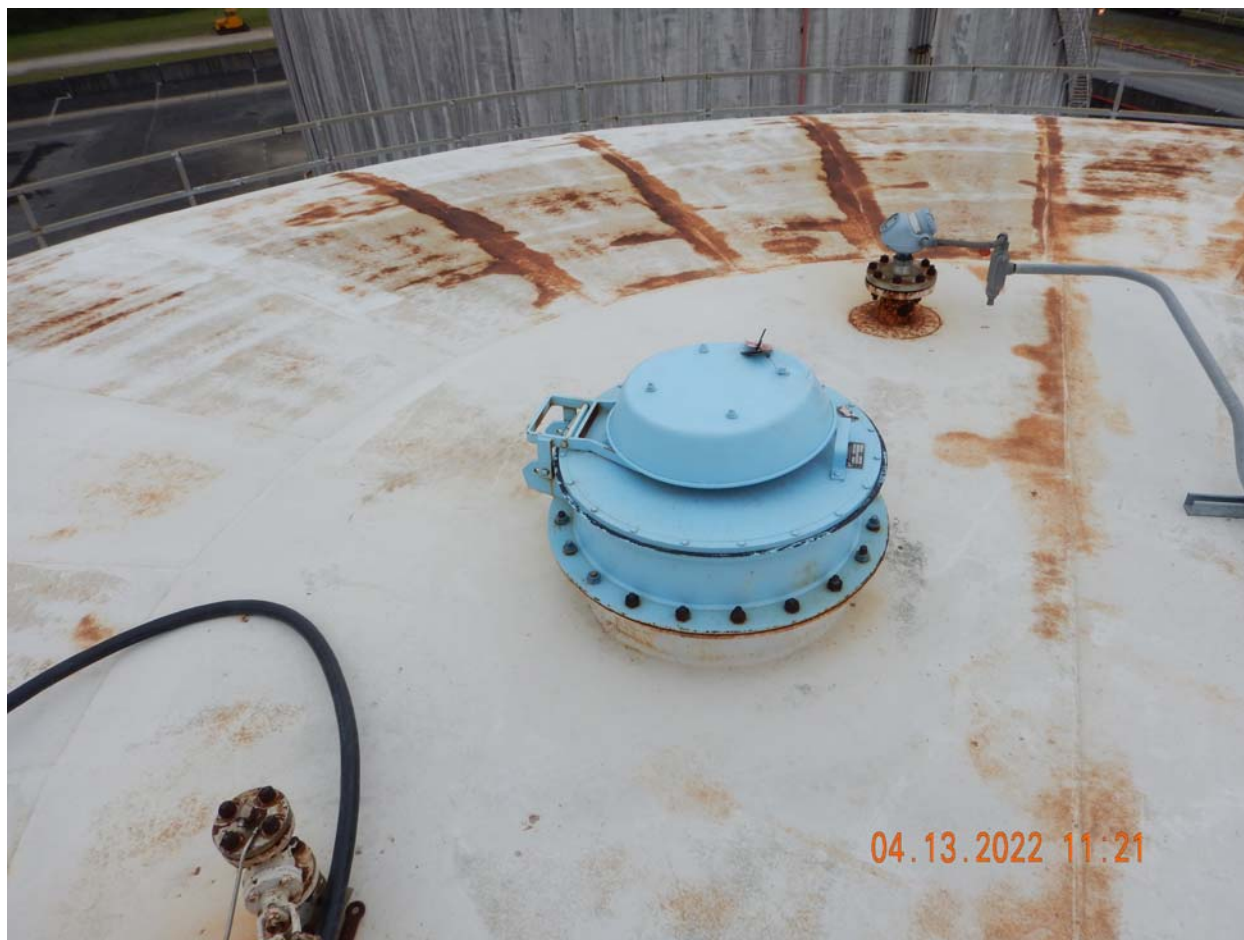
Photo No. 2

Description: Roof of the benzene tank. A blue thief hatch and sample valves are visible.
