US Environmental Protection Agency – Region 2
 Caribbean Environmental Protection Division
 Response and Remediation Branch

Resource Conservation and Recovery Act (RCRA)

Facility Name:	DCN Administrative & Recycling Corp.		
EPA ID Number:	PRN008026791		
Date of Inspection:	August 18, 2022		
Generator Status in Record:	Non-Notifier		
Generator Status at the time of inspection:	SQG		
RCRA Permitted:	No		
Basis for Inspection:	Complaint		
Corrective Action:	No		
Project ID	CEPD-RCRA-22-0425		
Facility Physical Location: (Municipality, PR, zip code)	Bo. Martin Gonzalez, Sector La Palmita, PR Road - 887, km 0.9 Carolina, Puerto Rico 00985		
Geographical Coordinates:	18° 22' 58" N and 65° 58' 17" W		
Facility Owner:	Mr. Carlos Sanchez, President	(787) 257-5003	
	acordero@dncorporation.com		
	Mailing address: P.O. Box 744 Gurabo. Puerto Rico 00778		
Facility Operator:	Ms. Andrea Cordero, CEO	(787) 318-0598	
	acordero@dncorporation.com		
	Mailing address: P.O. Box 744 Gurabo. Puerto Rico 00778		
NAICS:	423930		
SIC:	5093		
Area:	6,735.6056 m ² (1.66 acres }		
Number Employees:	Approximately 11 (F/T)

Compliance Evaluation Inspection Report
DCN Administrative & Recycling, Corp.
EPA ID: PR

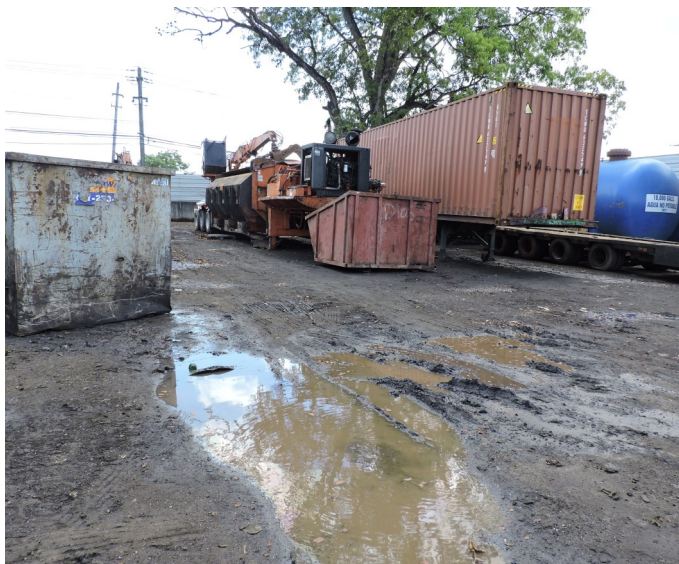
Picture 3—DCN RECYCLING, CORP. - The Facility also operates as an auto salvage yard, buying and taking in abandoned vehicles, partially dismantling, crushing, storing, then reselling as scrap steel to scrap yard metal facilities in Puerto Rico and the United States

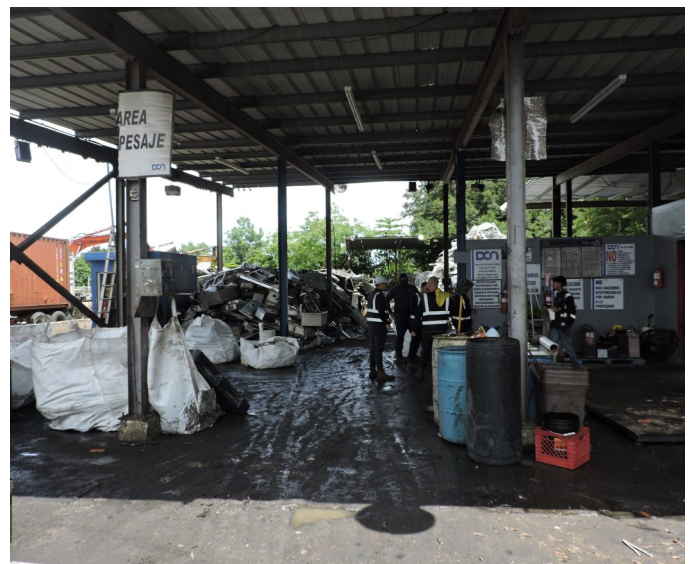
in Puerto Rico and the United States (see **Picture 3**). As part of its crushing operations, DCN Administrative & Recycling Corp. generates used oil and other vehicle fluids, some hazardous (see **Picture 4**). According to facility's records, metal recycling process an average of 5 to 6 vehicles per day and conducts auto crushing, shedding, and bailing operations at the site.

Picture 4— DCN RECYCLING, CORP. - As part of its crushing operations, DCN Administrative & Recycling Corp. generates used oil and other vehicle fluids some hazardous.

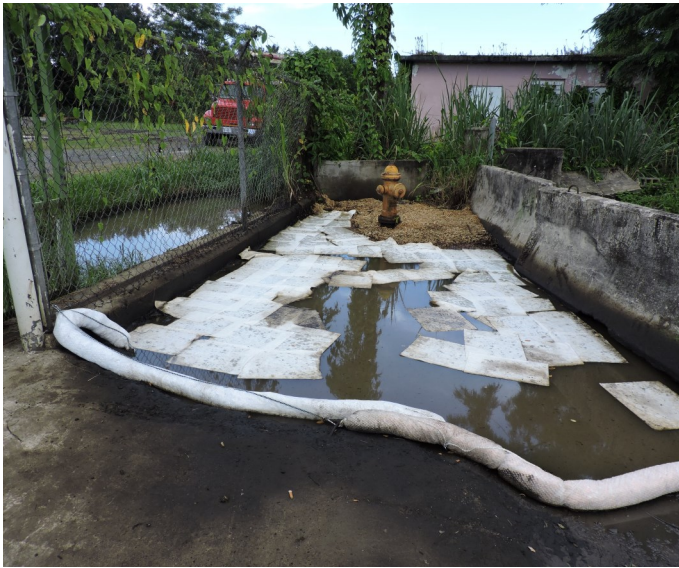
Picture 5- DCN RECYCLING, CORP. - As recorded at the Facility, any fluids generated from rainwater or auto crushing operations flow into the ground and downgradient towards the community and into an unnamed creek and flows into the Blasino Channel.

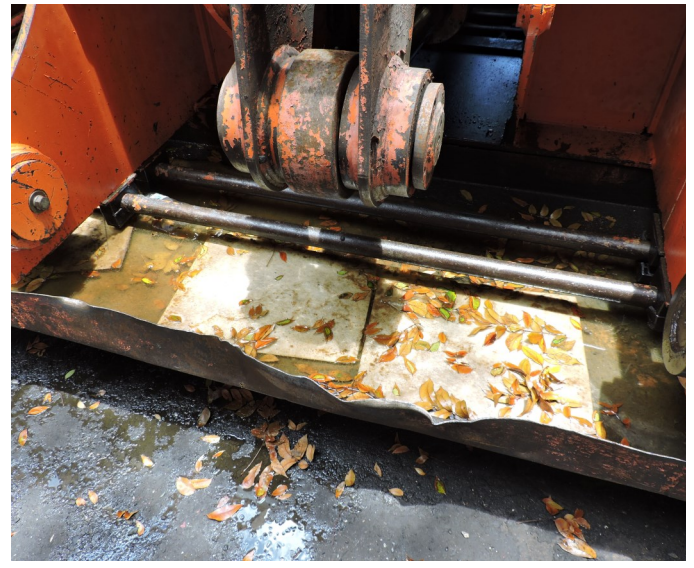
Picture 6 - DCN RECYCLING, CORP. - As observed during EPA Inspection, all mixed fluids generated from crushing and compacting operations are trapped into a metal tray-typed and collected with absorbent materials.

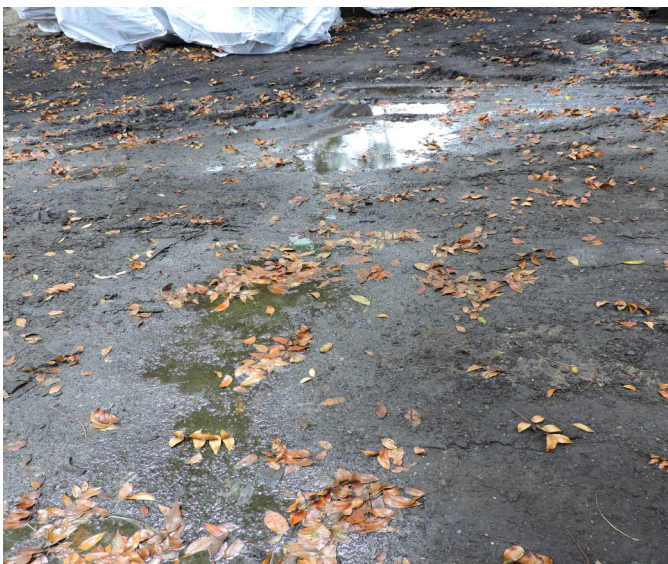
Picture 7—DCN RECYCLING, CORP. - As evidenced during EPA Inspection, once the tray is full, it leaks onto bare soils and flow downgradient and off the property.

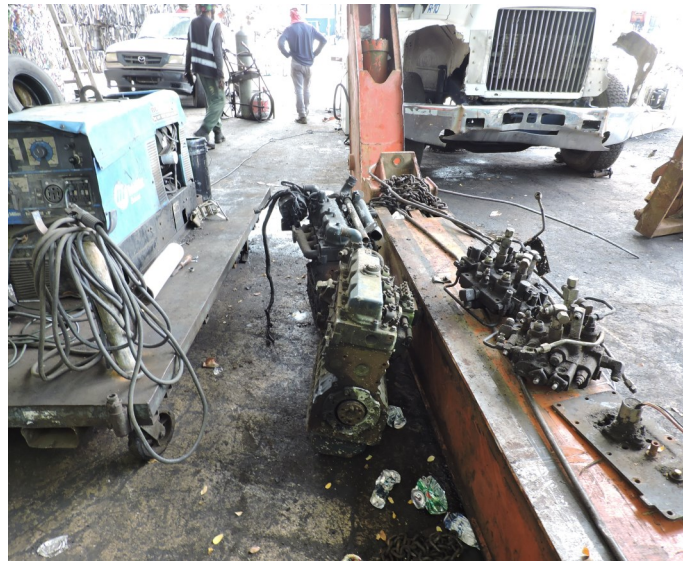
Picture 10 - DCN RECYCLING, CORP. - At the Entrance Gate and Weighing Scale Area, dismantled motor engines with no control or prevention of releases of used oil or stormwater runoff contaminated with transmission fluids, gasoline, diesel, and other motor oil fluids.

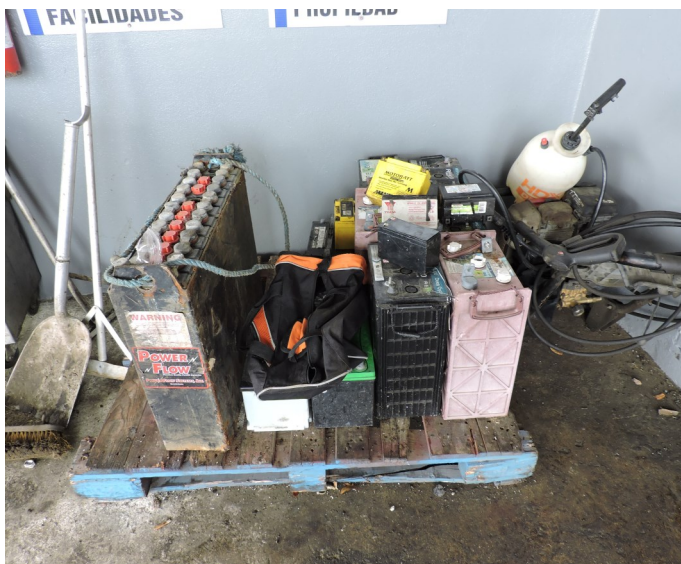
4. Discarded lead-acid batteries are recovered by the facility from most vehicles. At the time of the Inspection, approximately 25 discarded or damaged lead acid batteries were being stored and placed on a wood pallet. No waste labeling was present. In addition, lead cable ends were in evidence during the Inspection on junked cars. Facility practice is to collect all batteries and be picked up by a local battery recycling center, known as Caribbean Metals, and get paid for them. Approximately, 7,000 lbs of battery are collected on wood pallets every four month for disposal with Caribbean Metals. However, no evidence was provided by the Facility about the battery recycling company. Lead-acid batteries contain both lead and acid (sulfuric acid) and generally exhibit the toxic hazardous wastes characteristic for lead (D008) and corrosive hazardous wastes for acid (D002). No effort to remove, segregate or otherwise handle lead cable ends, sometimes left with junked cars after batteries are removed, was made by the Facility;

Picture 11—DCN RECYCLING, CORP. - Approximately twenty-five (25) discarded auto batteries placed on a wood pallet without any means of containment measures or labels. According to Ms. Cordero a battery carrier would be contacted to recycle the auto batteries at the Entrance Gate and Weighing Scale Area.

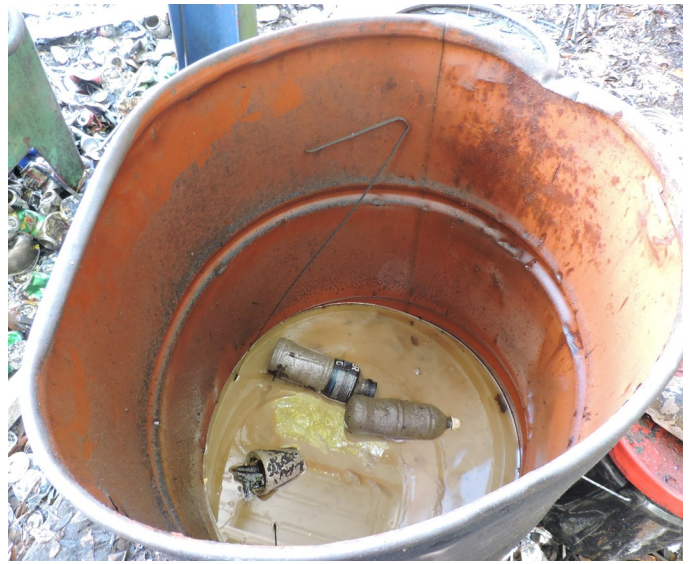
1. Two (2) 55-gallon steel drums open with used oil waste content not properly labelled with the words, “Used Oil,” and surrounded with scrap metals heavily impacted with used oil (see **Pictures 14 and 15**);
2. Two (2) 5-gallon plastic containers with used oil not properly labeled with the words, “Used Oil,” (see **Picture 16**); and,
3. There was evidence of leaks and spills incidents on the concrete floor that appear to contain used oil from crushing machines and heavily impacting soils in the backyard with used oil (see **Picture 17**).

Picture 14 - DCN RECYCLING, CORP. - As observed, at the Entrance Gate and Weighing Scale Area there two (2) 55-gallon steel drums open with used oil waste content not properly labelled with the words, "Used Oil," and surrounded with scrap metals heavily impacted with used oil.

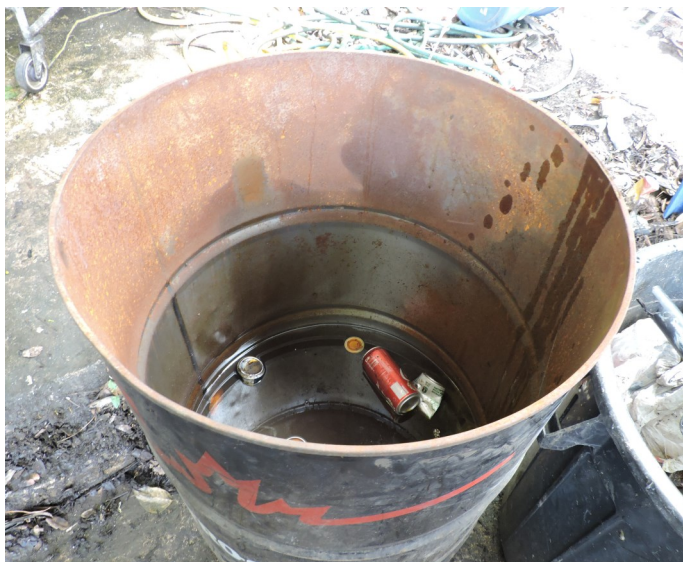
Picture 15—DCN RECYCLING, CORP. — As observed, at the Entrance Gate and Weighing Scale Area there two (2) 55-gallon steel drums open with used oil waste content not properly labelled with the words, "Used Oil," and surrounded with scrap metals heavily impacted with used oil.

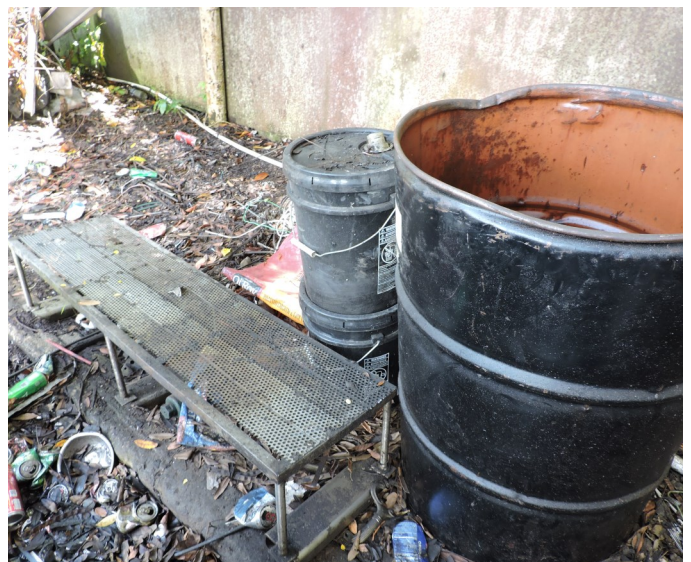
Picture 16 - DCN RECYCLING, CORP. - As observed, at the Entrance Gate and Weighing Scale Area there were two (2) 5-gallon plastic containers with used oil not properly labeled with the words, "Used Oil."

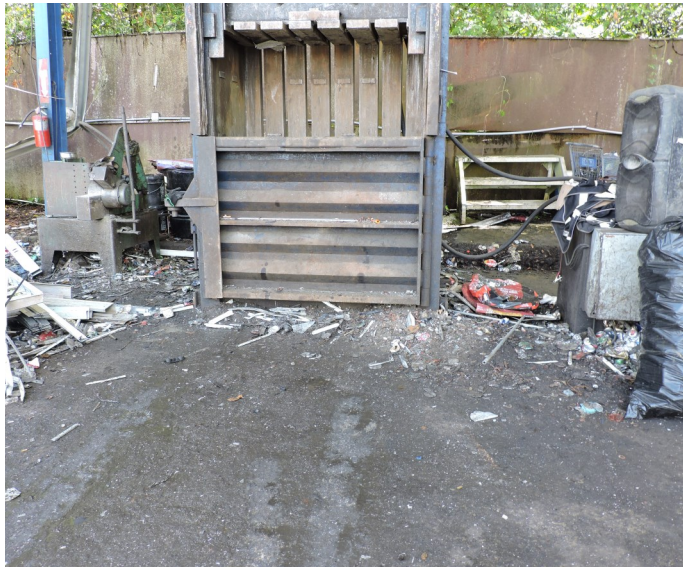
Picture 17- DCN RECYCLING, CORP. - As observed by the EPA Inspector at the Compacting Aluminum Accumulation Area, there were leaks incidents on the concrete floor that appears to contain used oil from crushing machines and heavily impacting soils in the backyard with used oil.

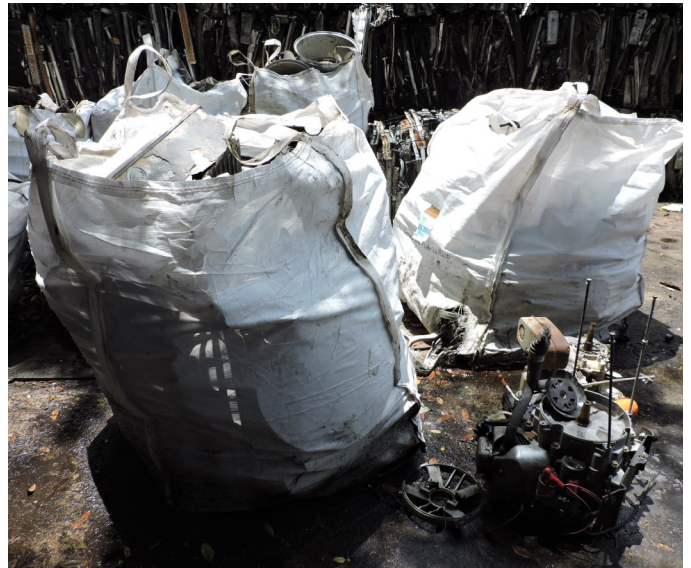
1. There were approximately four (4) 1-cy yard “white cloth” bags with motor engine parts and other metals leaking used oils on the concrete floor without any means of control (see **Picture 18**);
2. One (1) engine motor laying on the concrete floor leaking fluids on the concrete floor; and,
3. There was evidence of numerous leaks and spill incidents on the concrete floor that appear to contain motor engine fluids that migrated and heavily impacted with used oils the backyard soils near the property perimeter fence (see **Picture 19**).

Picture 18 - DCN RECYCLING, CORP. - At the Material Processing & Storage Area there were approximately four (4) 1-cy yard “white cloth” bags with motor engine parts and other metals leaking used oils on the concrete floor without any means of control.

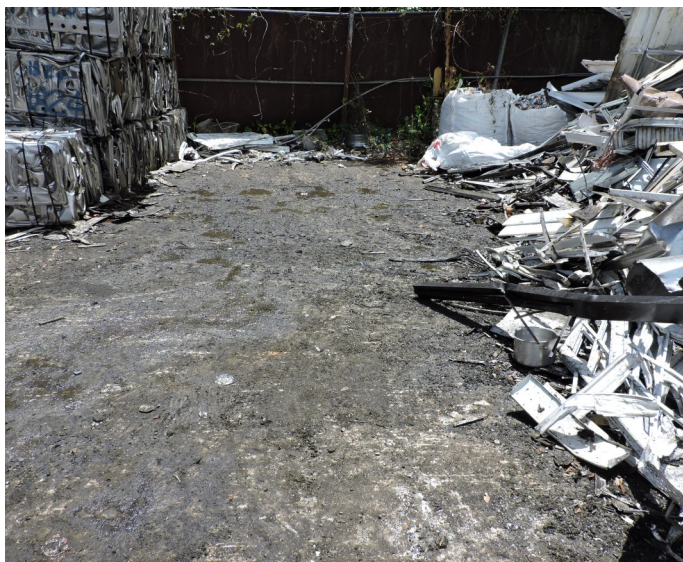
Picture 19—DCN RECYCLING, CORP. - As observed at the Material Processing & Storage Area, there were lots of leak incidents on the concrete floor that appears to contain motor engine fluids that migrated and heavily impacted with used oils the backyard soils near the property perimeter fence.

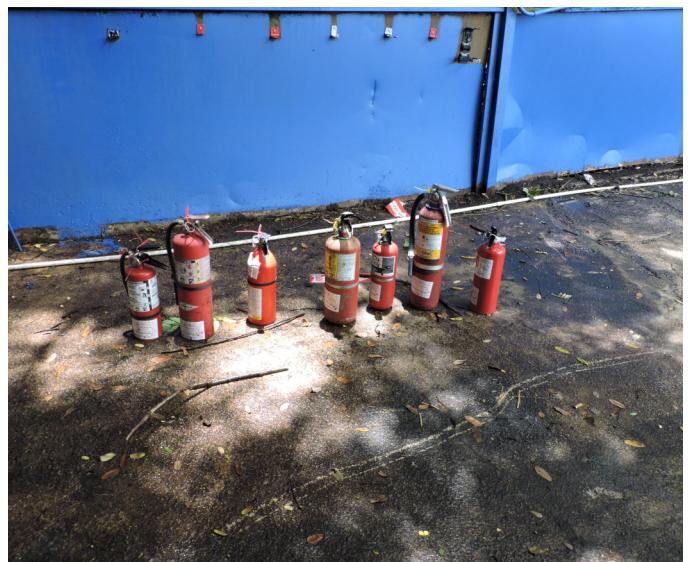
Picture 20 - DCN RECYCLING, CORP. - As observed at the Machine Shop Area , there were approximately seven (7) discarded extinguishers placed on the concrete floors without any containment measures or labels.

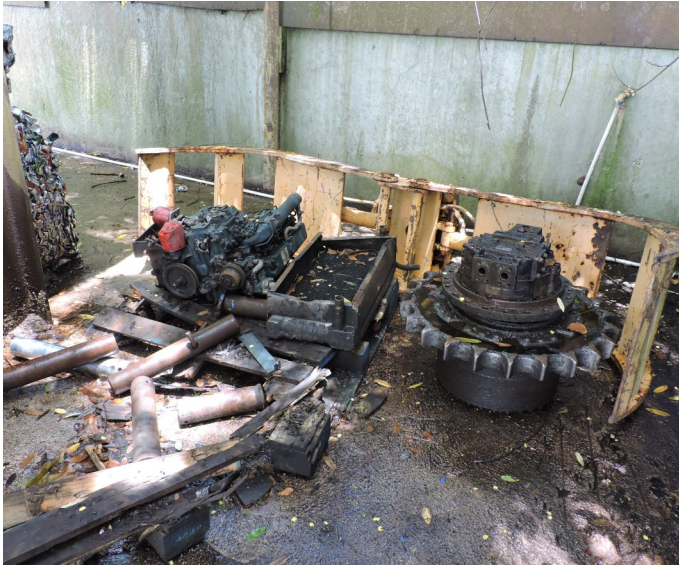
Picture 21- DCN RECYCLING, CORP. - As observed at the Machine Shop Area, dismantled motor engines with no control or prevention of releases of used oil or stormwater run-off contaminated with transmission fluids, gasoline, diesel, and other motor oil fluids.

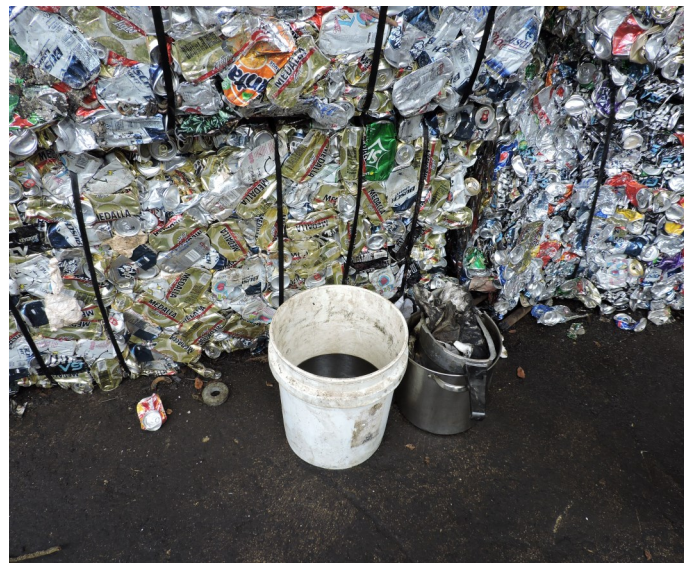
Picture 22 - DCN RECYCLING, CORP. - As observed at the Machine Shop Area, there was one (1) 5-gallon plastic container open and with used oil not properly labeled with the words, "Used Oil."

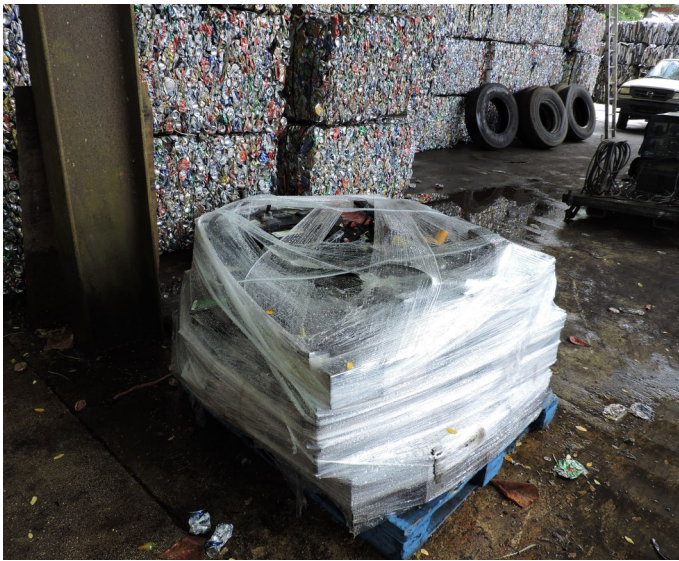
Picture 23—DCN RECYCLING, CORP. - As observed by the EPA Inspector at the Machine Shop Area, there were approximately over one hundred (100) discarded batteries rolled in plastic film and placed on a wood pallet without any means of containment measures or labels.

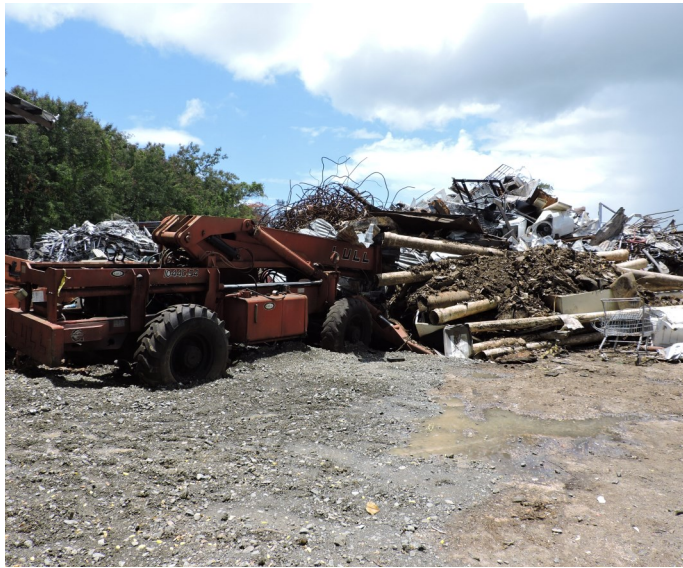
1. Two (2) abandoned heavy equipment machine “Sky Tracks” leaking engine motor fluids on soil grounds. Ms. Cordero indicated that both machines were used for repair parts of other machines (see **Picture 25**);
2. There was one water tower and seep collection sump to control and manage stormwater run-on and run-off of the property. According to Ms. Cordero, the water tower is being nonfunctional since beginning of January 2022. The collection sump has dimensions of 8’ x 12’ x 9’ deep and was observed fully filled with sediments and heavily impacted with used oils (see **Picture 26**);

Picture 25- DCN RECYCLING, CORP. - As observed by the EPA Inspector at the Ferrous Metal Collection Area, there were two (2) abandoned heavy equipment machine “Sky Tracks” leaking engine motor fluids on soil grounds.

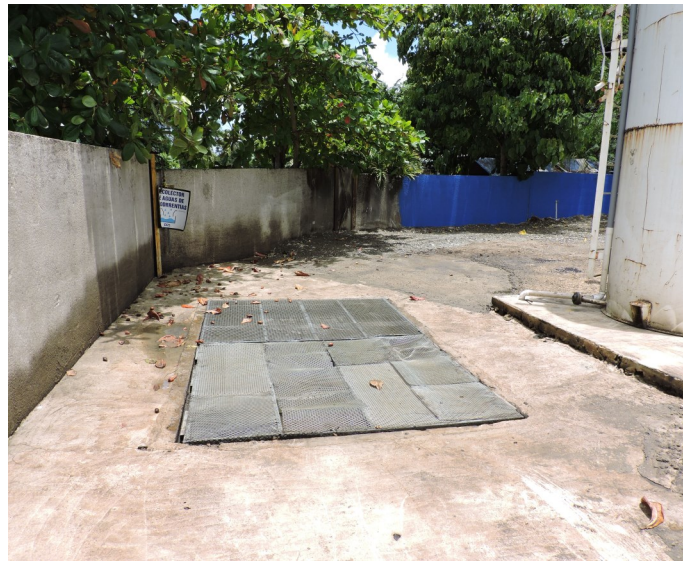
Picture 26 - DCN RECYCLING, CORP. - At the Ferrous Metal Collection Areas, there was one water tower and seep collection sump to control and manage stormwater run-on and run-off of the property. The water tower was out of service and the sump was fully filled with sediments and heavily impacted with used oils.

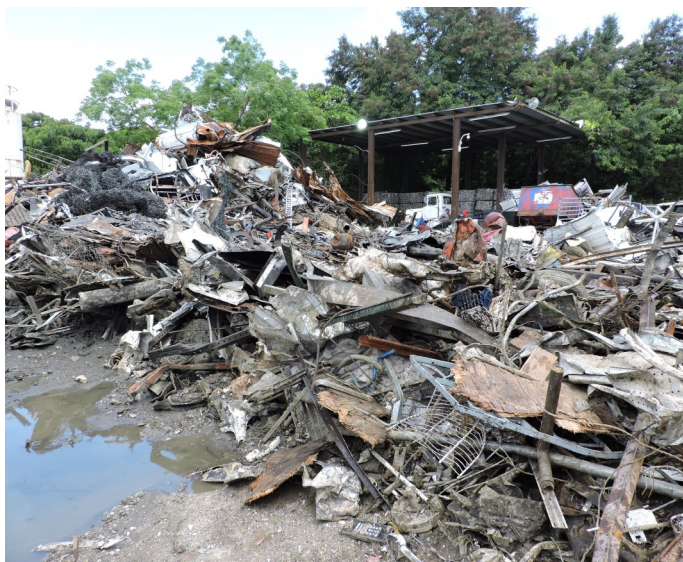
3. Piles of scrap metals placed on bare soils and being operated by an excavator leaking oily fluids on the ground (see **Picture 27**); and,
4. There were several auto wheels rims, some containing lead weights which were not removed along with gas-contained cylinders which were mixed with the scrap metals (see **Picture 28**).

Picture 27—DCN RECYCLING, CORP. - The EPA Inspector observed at the Ferrous Metal Collection Areas, piles of scrap metals placed on bare soils and being operated by an excavator leaking oily fluids on the ground.

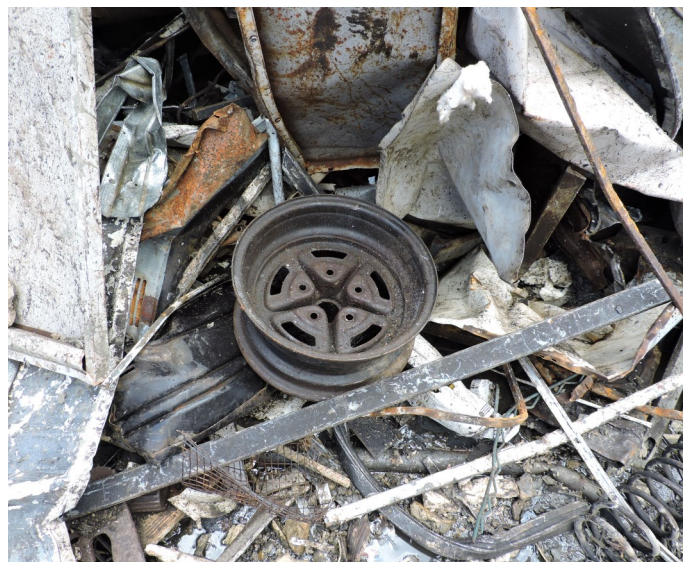
Picture 28 - DCN RECYCLING, CORP. - TThe EPA Inspector observed at the Ferrous Metal Collection Areas, several auto wheels rims some containing lead weights which were not removed along with gas-contained cylinders which were mixed with the scrap metals.

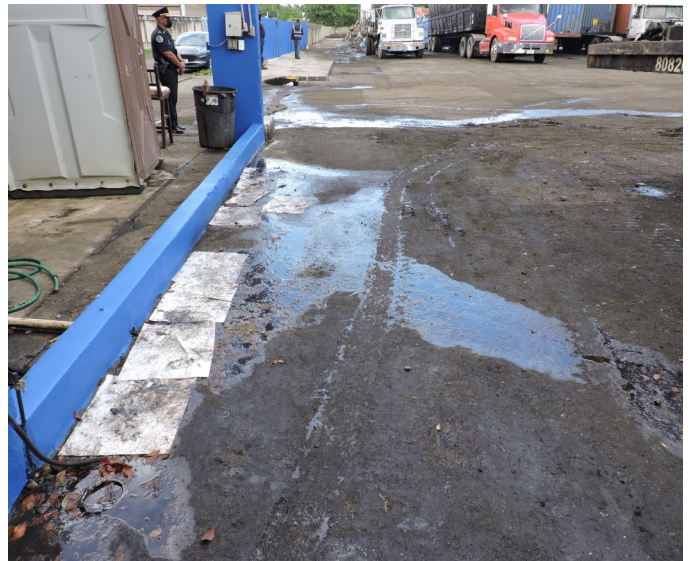
Picture 30 - DCN RECYCLING, CORP. - As observed during the EPA Inspection, there were run-offs from the Facility were accumulated at the Fuel-Oil Station during rain events and were discharged directly toward a nonfunctional sump and then into the sidewalk curb nearby water creek located northwest of the property edge.

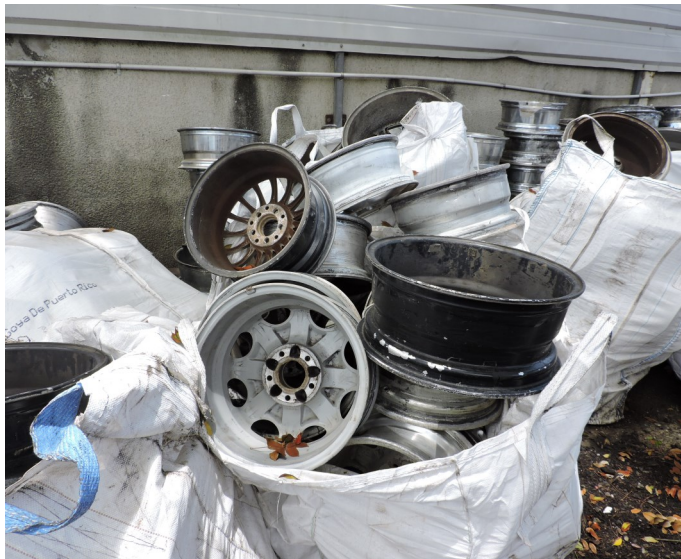
The EPA inspector proceeded to inspect the Alloy Wheel Collection Area. This area was used as a central accumulation area in which all alloy wheels received at the Facility were collected and packed in 1-cy white cloth bags. It was observed the most alloy wheel rims contained lead weights which were not properly removed before packaging (see **Picture 31**). The area was “outdoor” and did not have any concrete pad to collect or control stormwater runoff that percolated and become in direct contact with the wheel leads. As observed by the EPA Inspector, the Facility does not remove or segregate lead wheel weights for further recycling. As explained to Ms. Cordero, these lead weights may exhibit the toxic characteristic for lead (D008) and may directly percolate into the bare soils.

Picture 31—DCN RECYCLING, CORP. - At the Alloy Wheel Collection Area, all alloy wheels are received, collected and packed in 1-cy white cloth bags. It was observed the most alloy wheel rims contained lead weights were not properly removed before packaging.

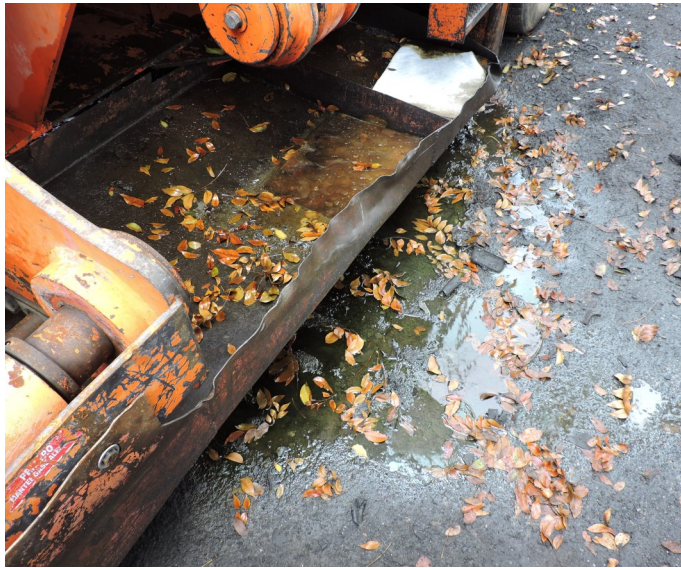
Picture 33 - DCN RECYCLING, CORP. - As stated by EPA, junked cars contained components that were potential hazardous materials such a gasoline residue in the gas tank and any fluid leaks generated during crushing is collected in the steel tray and/or 55-gallon drums.

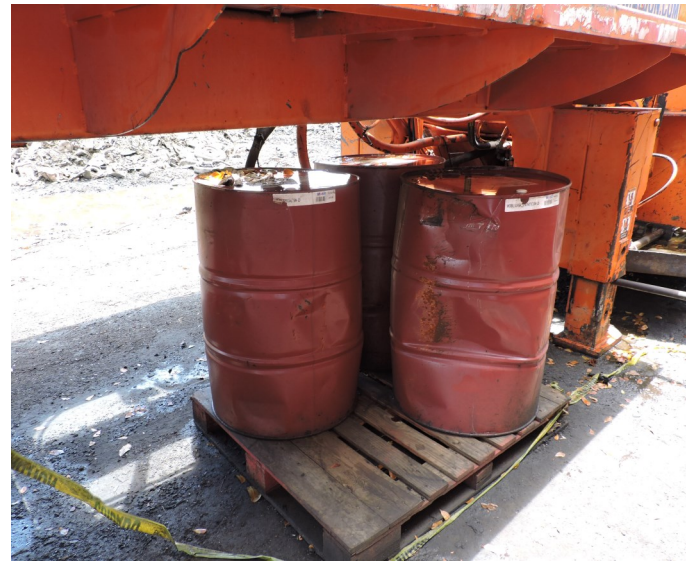
As observed during the Inspection, all leaking fluids were collected into a steel pad beneath the crushing machine. All drums containing leaking fluids from crushing operations are managed as used oil and disposed of with Ruben Martinez Used Oil Collection Services. No hazardous waste characterization is performed on the leaking fluids from the crushing operations on routine basis (see **Picture 34**).

Picture 34 - DCN RECYCLING, CORP. - As observed during the EPA Inspection, all drums containing leaking fluids from crushing operations are managed as used oil and disposed of with Ruben Martinez Used Oil Collection Services. No hazardous waste characterization is performed on the leaking fluids from the crushing operations on routine basis.

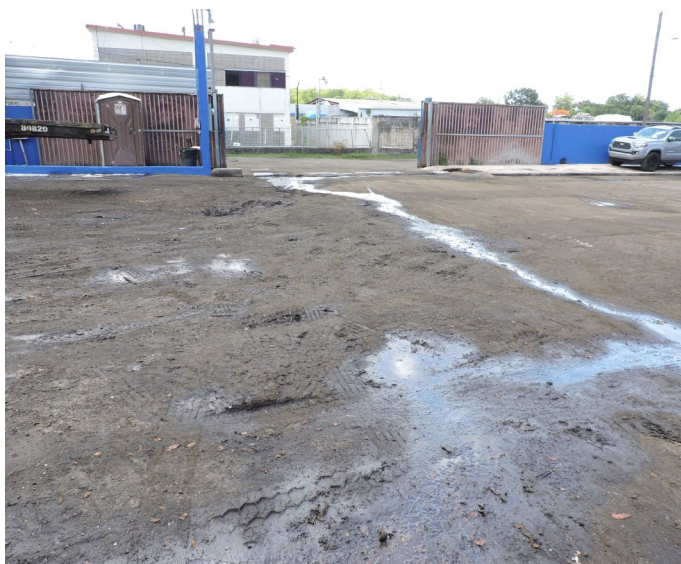
The EPA Inspector observed car fluids leaking on bare soils. Some of the leaks on the soil perceived strong odors of gasoline. EPA Inspector informed Ms. Cardona that she needed to control or prevent releases of used oil or stormwater run-off contaminated with transmission fluids, gasoline, diesel, motor oil, antifreeze/coolant, windshield washer fluid, refrigerants, brake fluid, lead form the crushing machine area. As observed by the EPA Inspectors, there were fluids leaking on the soils and pavement areas flowing toward the entrance and nearby unnamed creek situated northwest of the Facility (see **Picture 35**).

Picture 35—DCN RECYCLING, CORP. - As observed by the EPA Inspectors at the Compacting Cars Area, there were fluids leaking on the soils and pavement areas flowing toward the entrance and nearby unnamed creek situated northwest of the Facility.

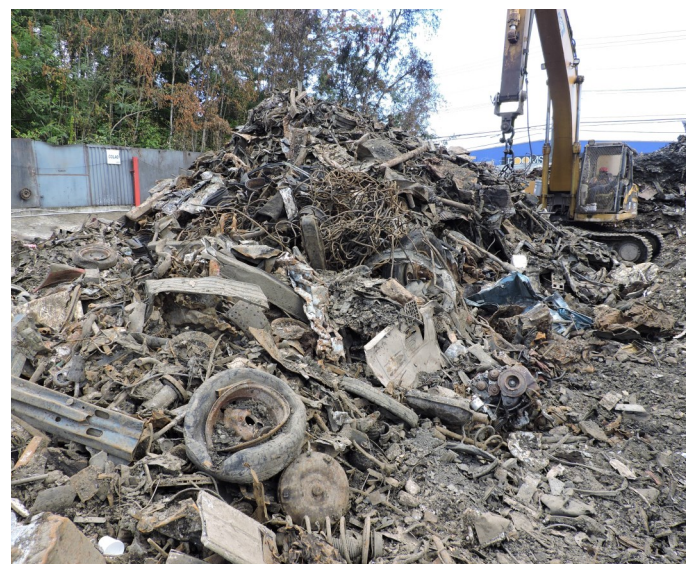
Picture 36 - DCN RECYCLING, CORP.—As observed at the Fire Incident Scrapyard Site Area, there were several piles of mixed destroyed and burned scrap metals accumulated at the site including motor engines, car fragments, spent tires, alloy wheels, seats, dashes, steel frames, and PVC pipes.

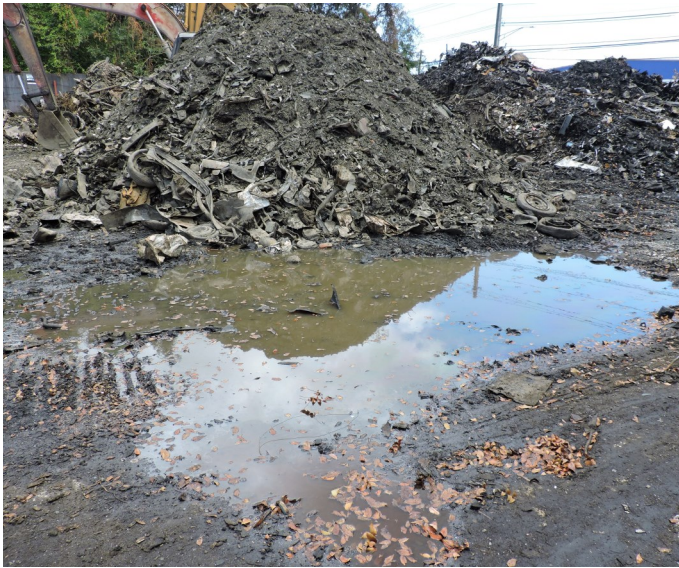
Picture 37- DCN RECYCLING, CORP. - It was also observed by the EPA Inspector at the Fire Incident Scrapyard Site Area, fluids leaking on the soils and pavement areas flowing toward the entrance and nearby unnamed creek situated northwest of the Facility.

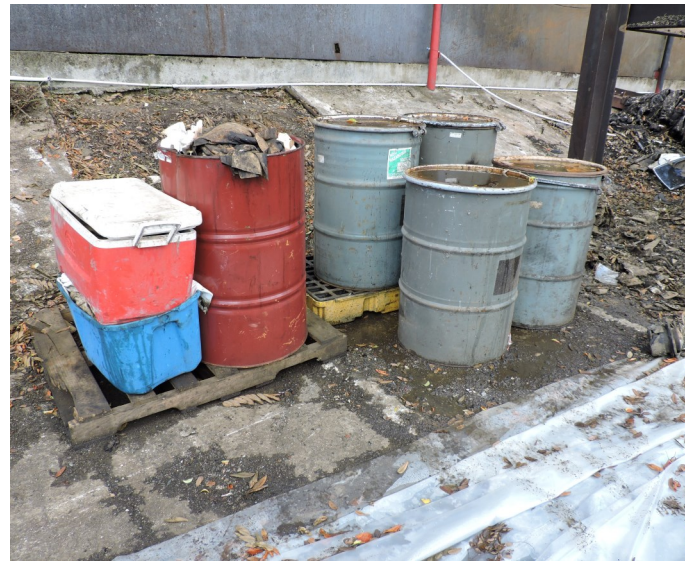
Picture 38 - DCN RECYCLING, CORP. - The EPA Inspector observed at Fire Incident, four (4) 55-gallon steel drums with used oil waste content and one (1) 55-gallon drum open and with rags heavily impacted with used not properly labeled with the words, "Used Oil."
