**Report Title:** Clean Air Act Inspection of ASF LLC dba GAB Auto Repair  
**Inspection Date(s):** December 5, 2023  
**Regulatory Program(s):** NESHAP, SIP

**Company Name:** ASF LLC  
**Facility Name:** GAB Auto Repair  
**Facility Location:** 1824 Fenwick St. NE,  
Washington, DC 20002  
**Latitude:** 38.9135 **Longitude:** -76.9842  
**County/Parish:** District of Columbia

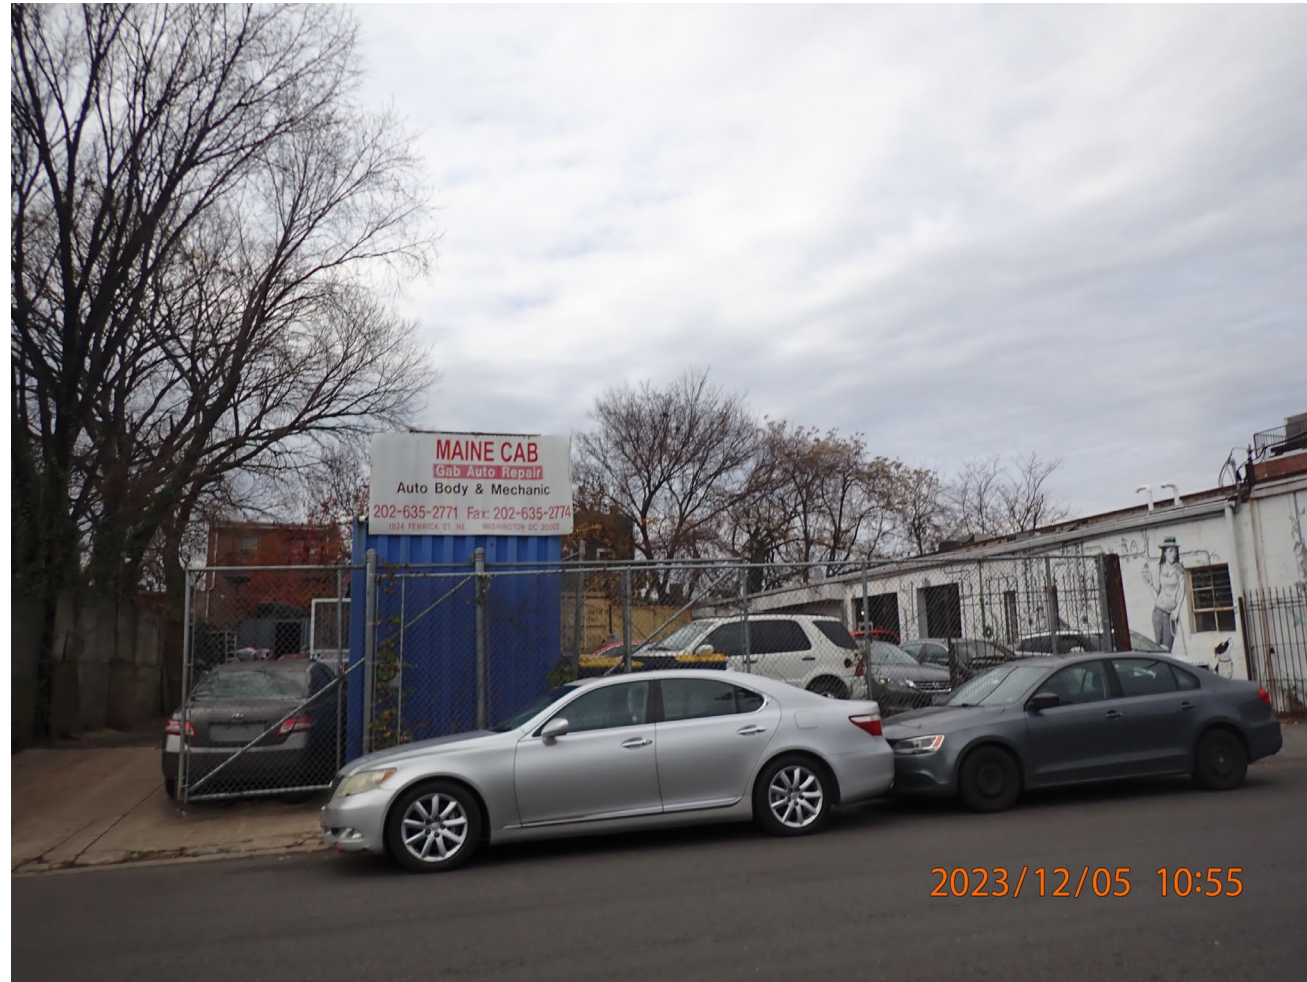
Photo Number: 10

Photo Description: Overview of Facility

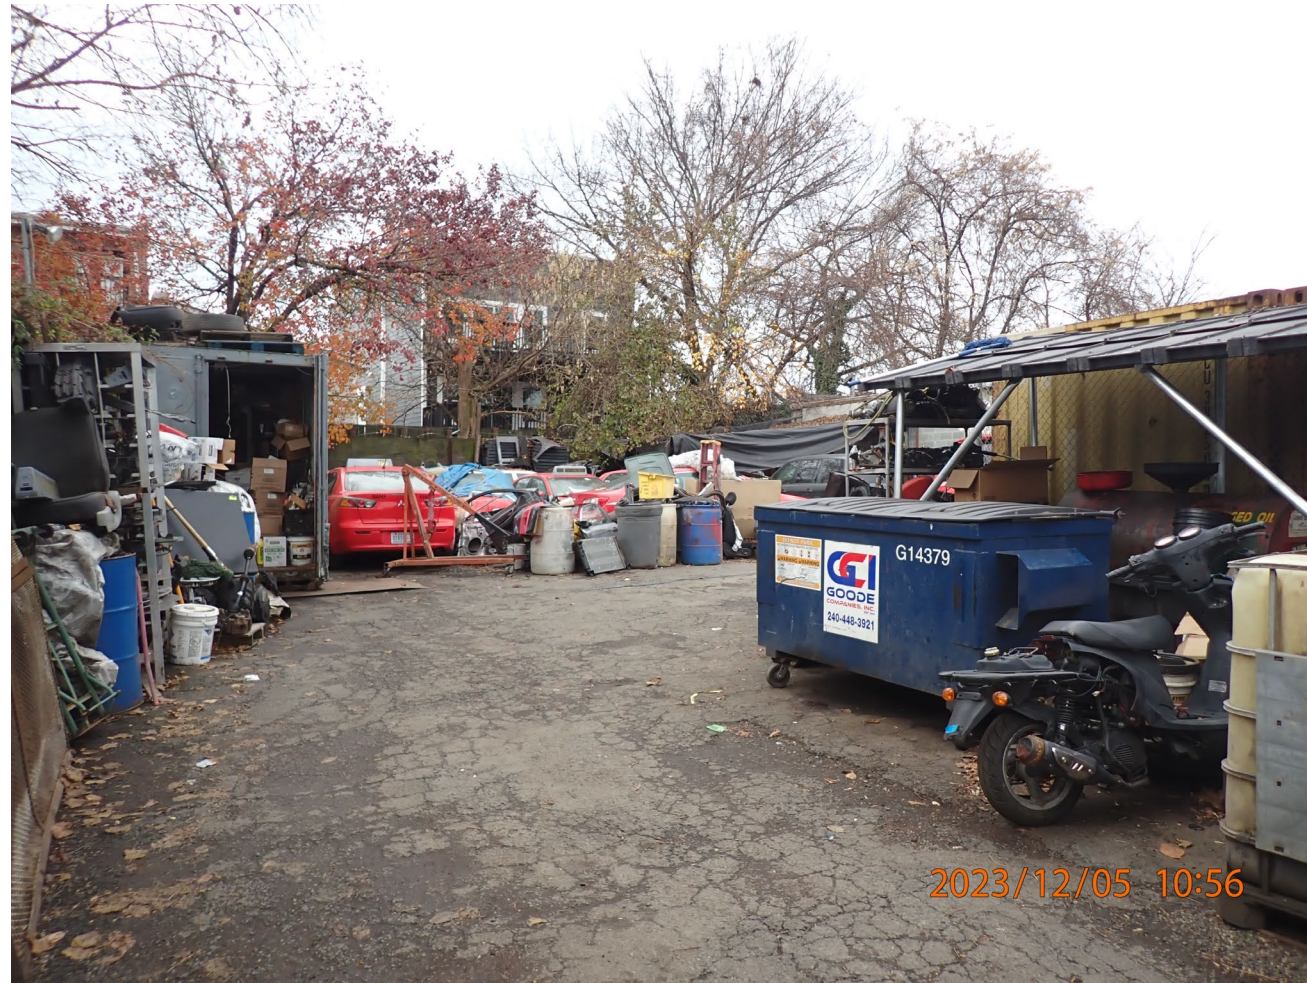
Photo Number: 11

Photo Description: Second overview of Facility

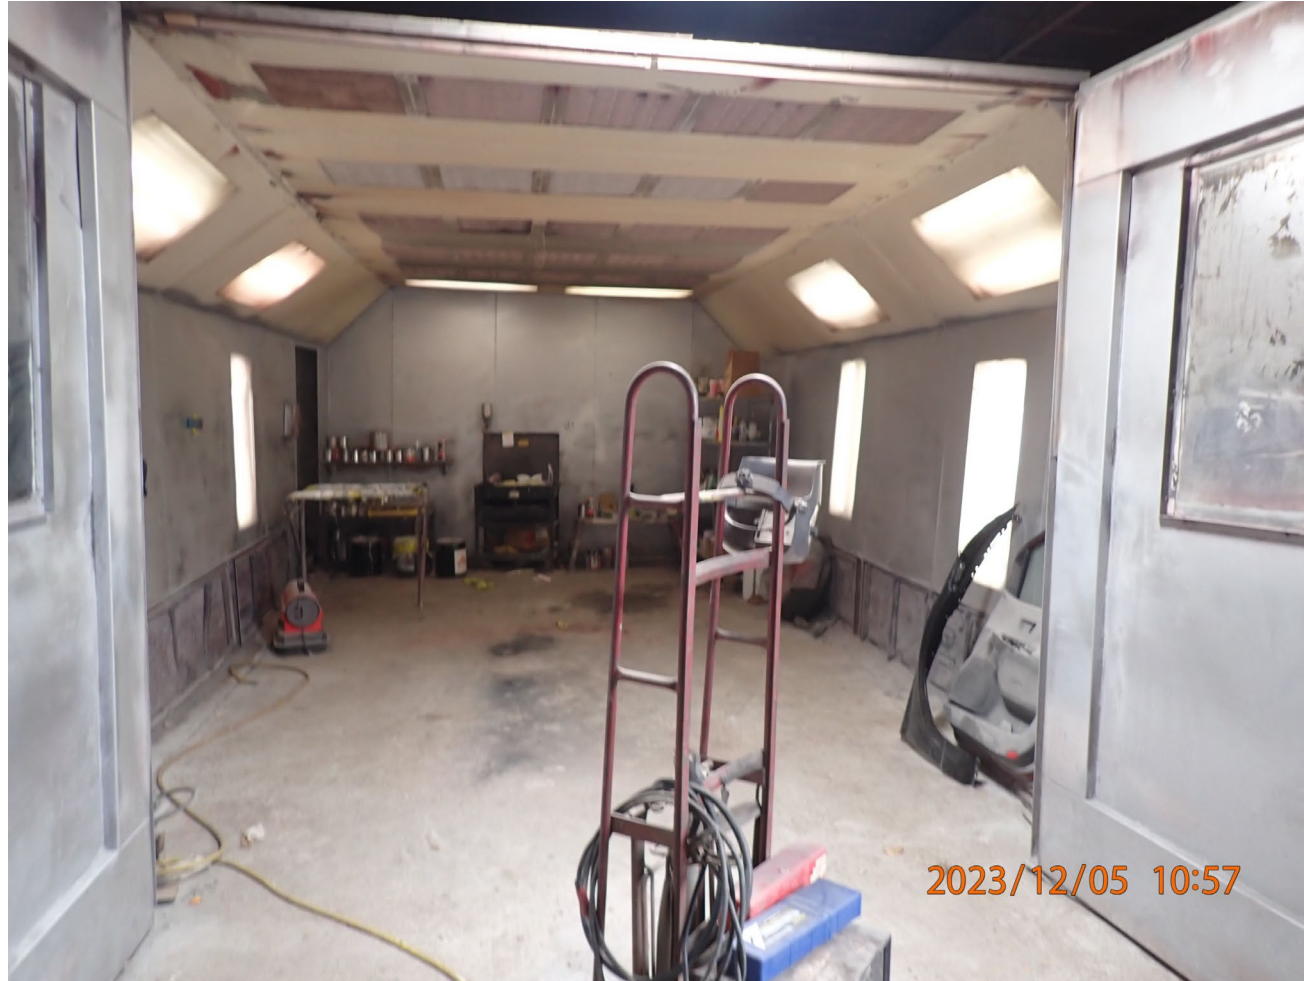
Photo Number: 12

Photo Description: Paint booth

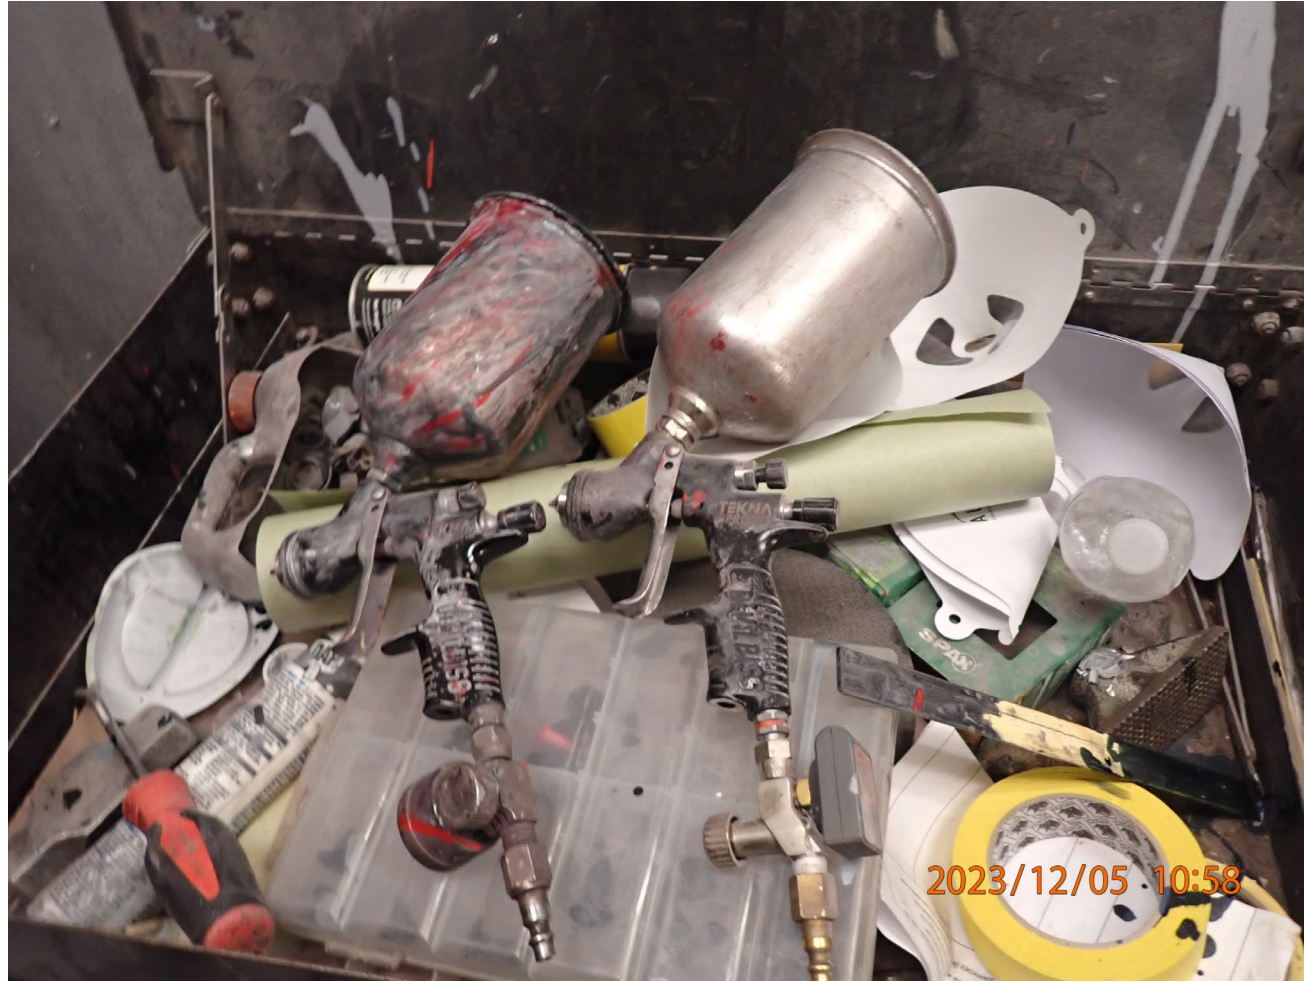
Photo Number: 13

The inspection team passed by a used oil storage tank on their way to the spray paint booth. The paint booth did not have a vehicle during the time of the inspection. Two Devilbiss Tekna Pro (or Pro-lite) spray guns were observed on-site. GAB stated they purchased paints from Penn Pro and Penn Supply which are both located in Heightsville, MD. There were some paints stored in the spray booth and others stored in a cabinet outside of the spray booth. Some of the brands on paint cans observed on-site were Limco, RM, and Dupont Chromabase.

Photo Description: Paint spray guns

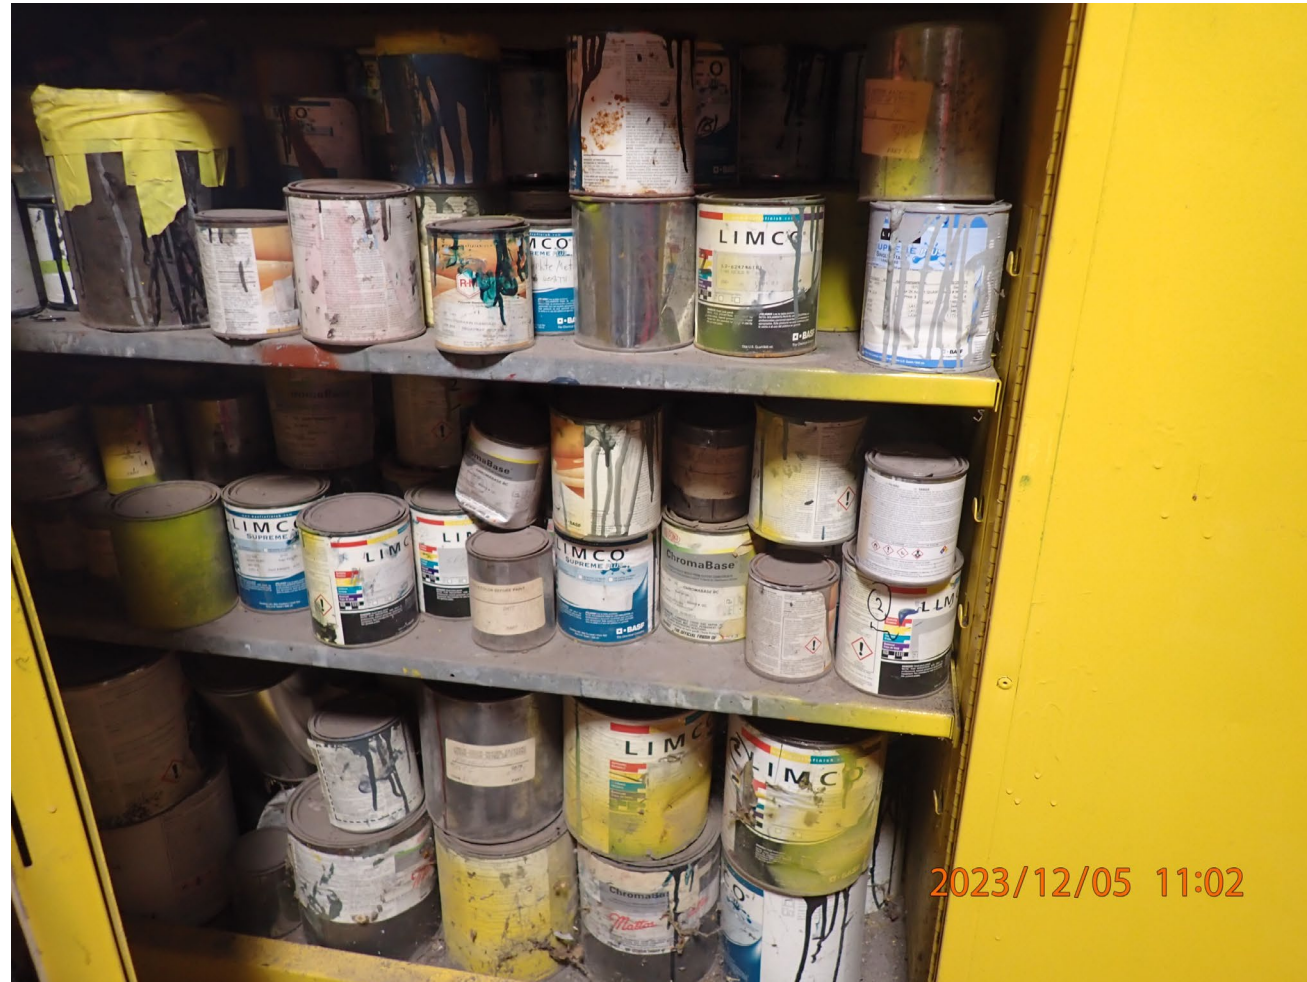
Photo Number: 14

Photo Description: Paint storage outside of booth

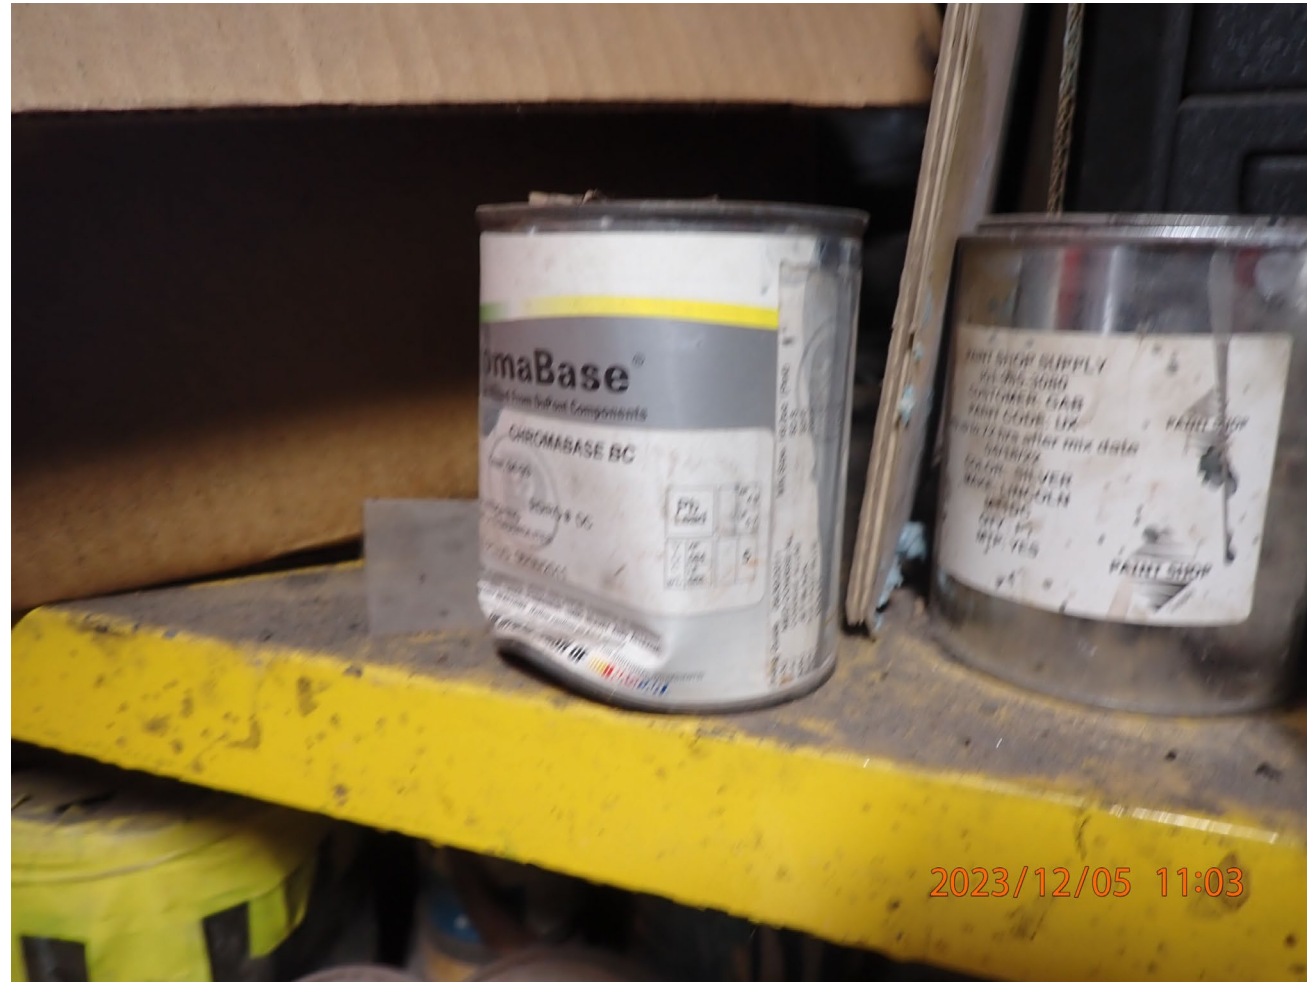
Photo Number: 15

Photo Description: Chromabase paint can

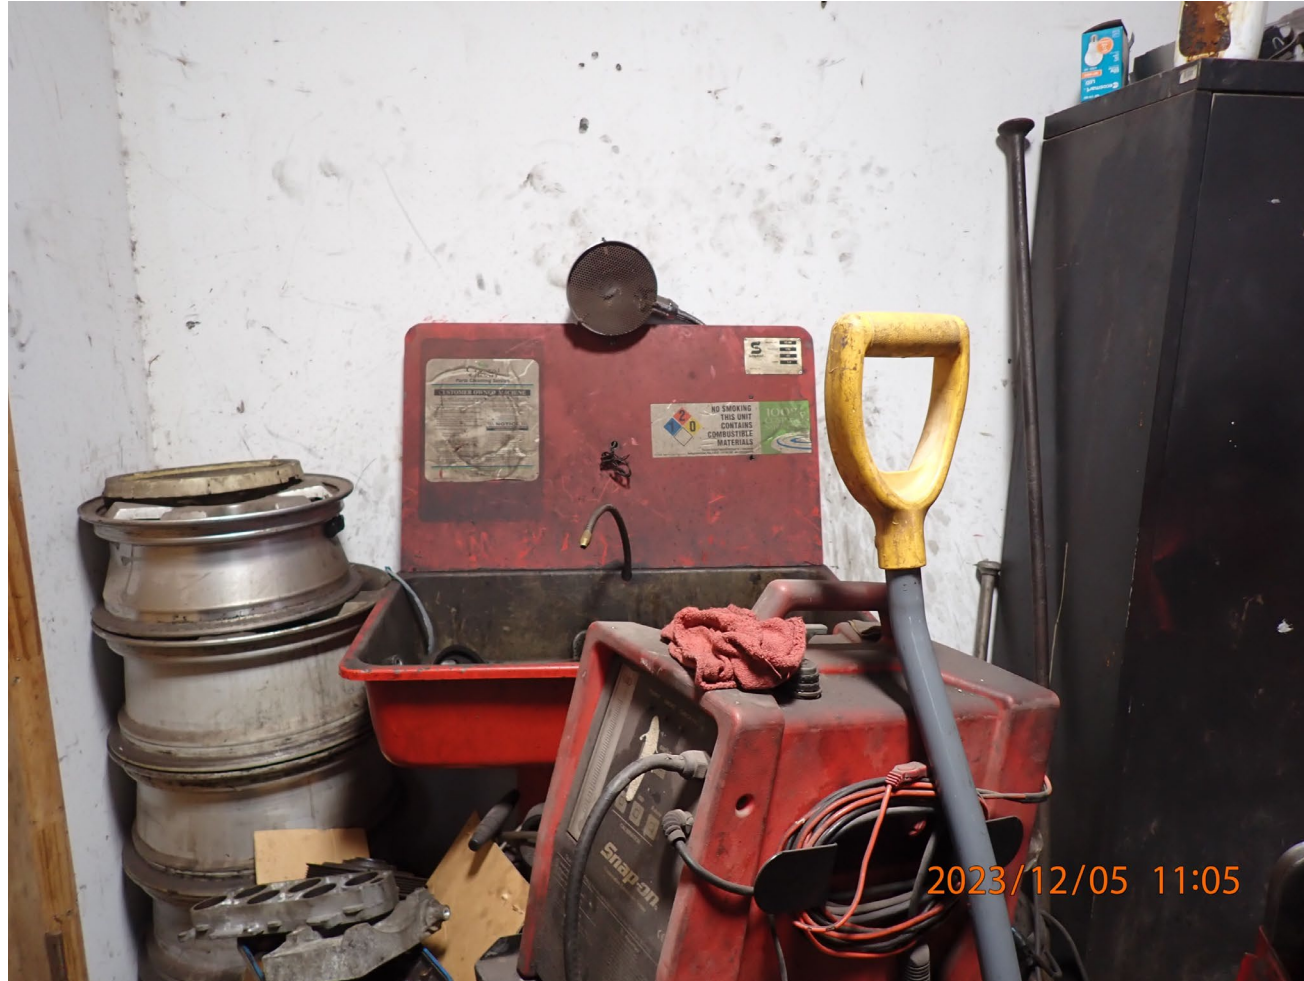
Photo Number: 16

The Facility had a Safety Kleen model No. 17.4R cold cleaning machine on-site which did not appear to be used very often. Assefa stated they use a water-based solvent from Safety Kleen. There were two 230V AC DC Infinite Amp Arc Welders located on-site. The Facility also provided two types of welding rods used on-site: USA 6013 and Fusion Flow E6013. The Facility had a draft DOEE air quality permit posted with a date of January 4, 2019.

Photo Description: Cold cleaning machine

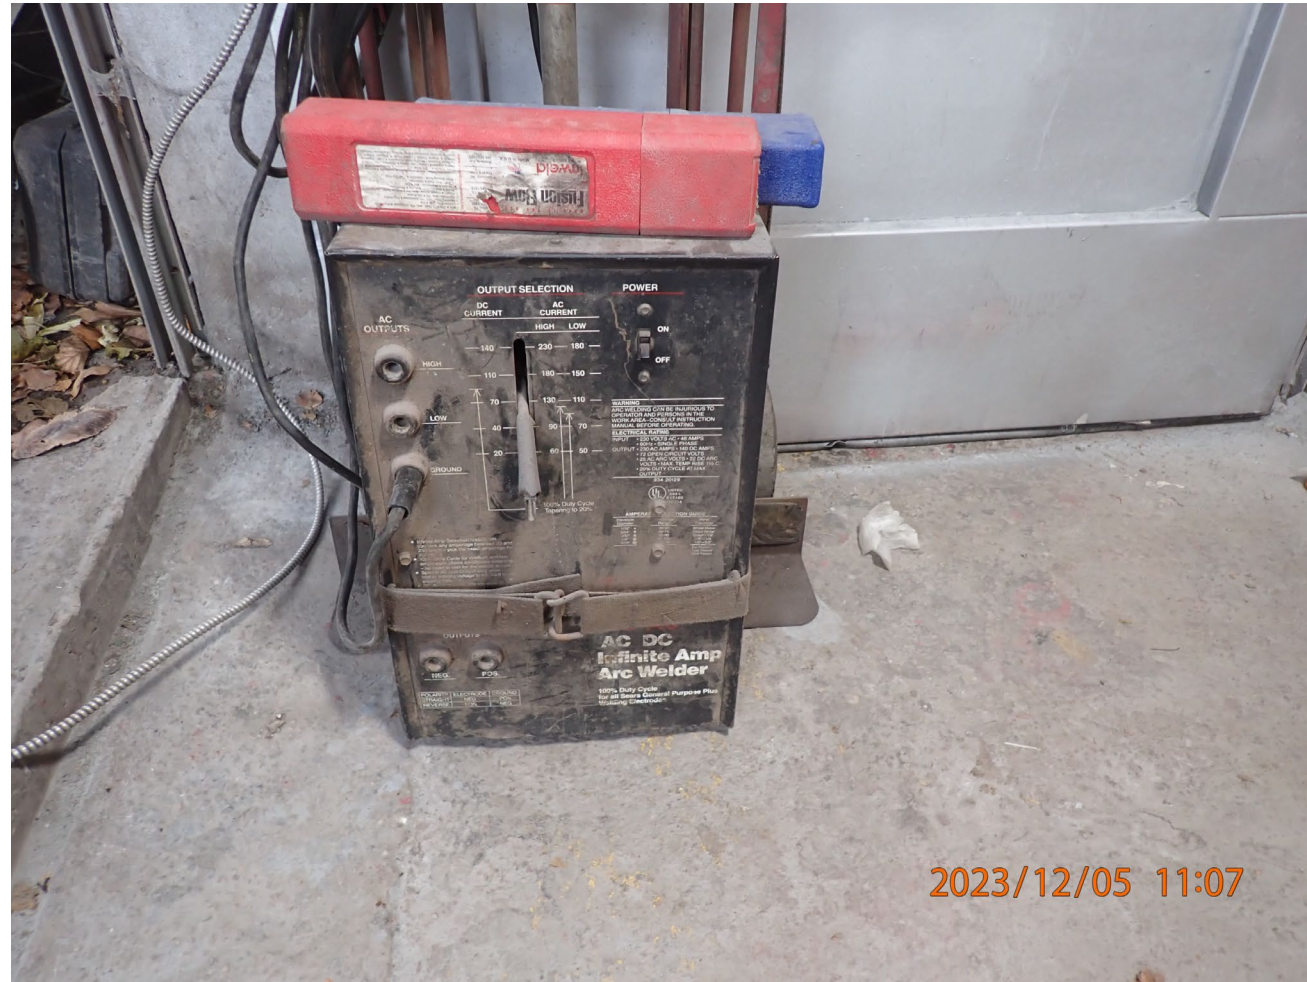
Photo Number: 17

Photo Description: Welder with welding rods on top

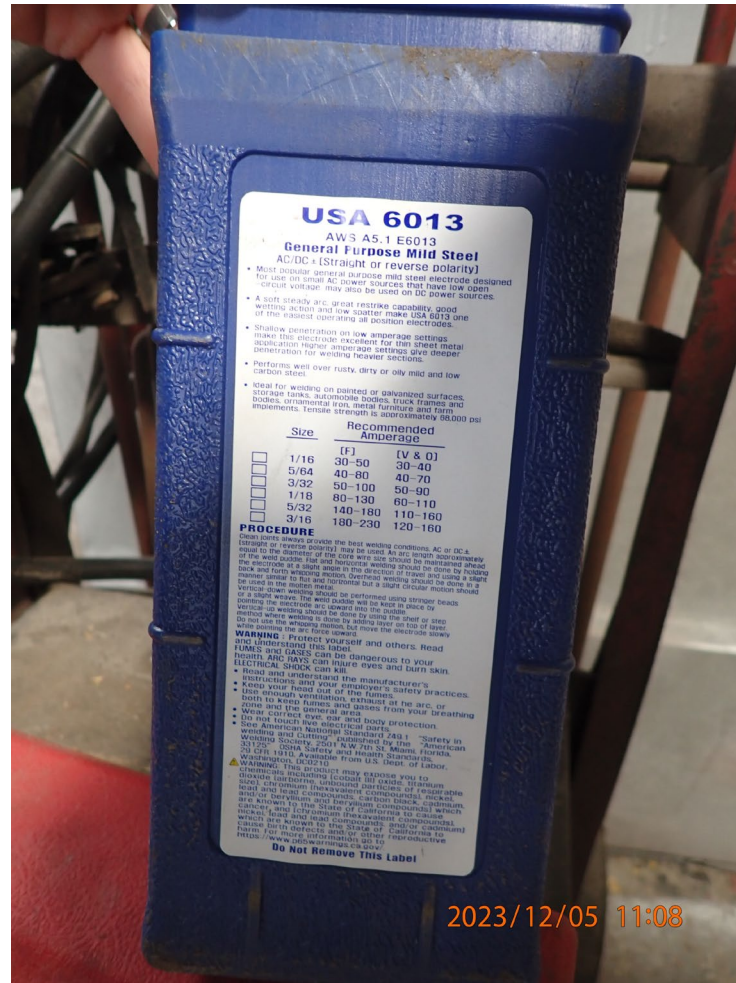
Photo Number: 18

Photo Description: USA 6013 welding rods

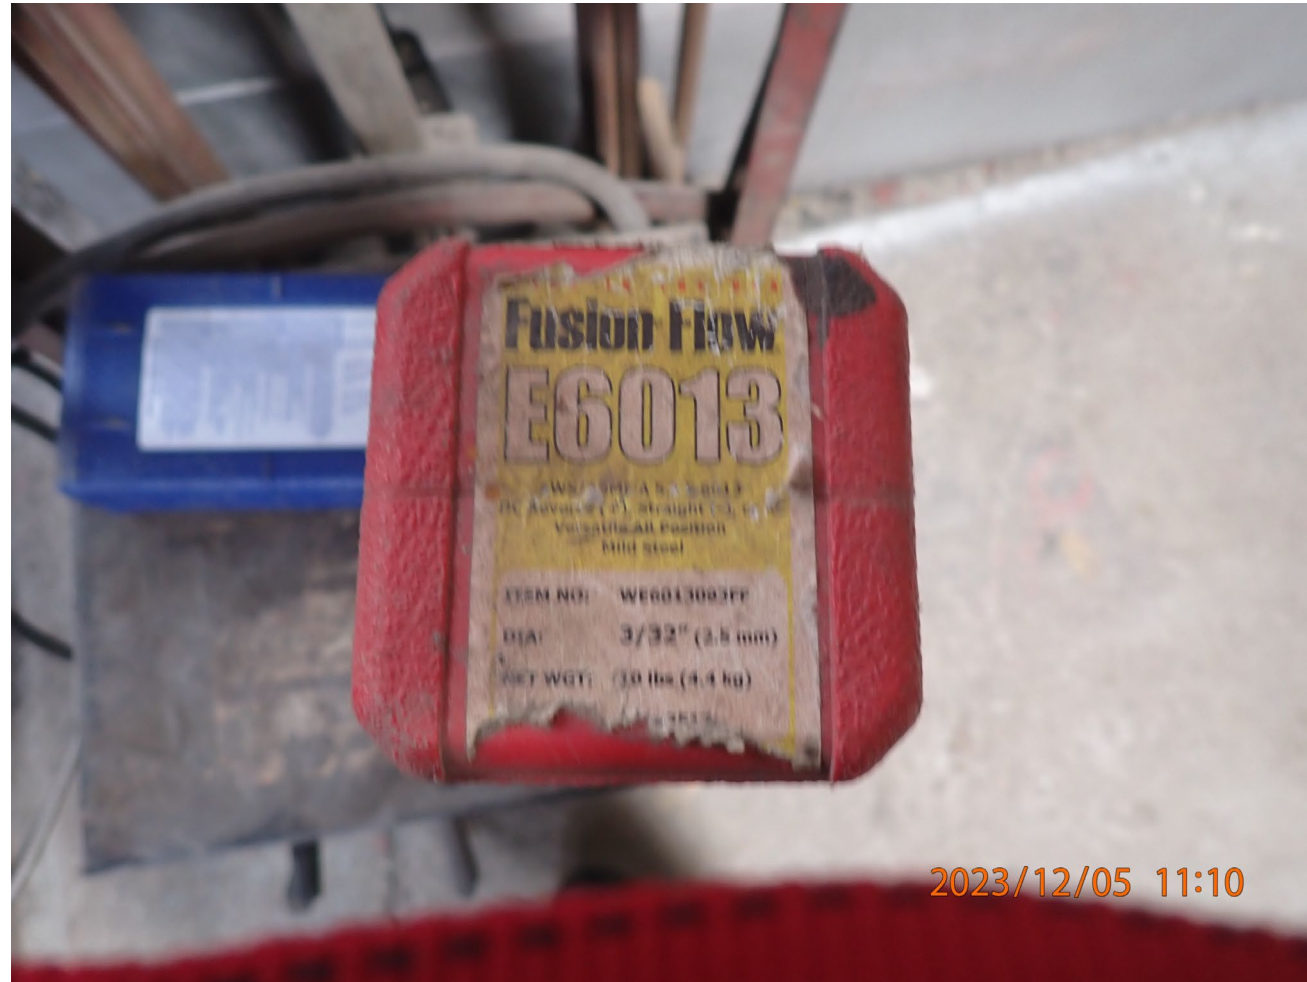
Photo Number: 19

Photo Description: Fusion Flow E6013 welding rods

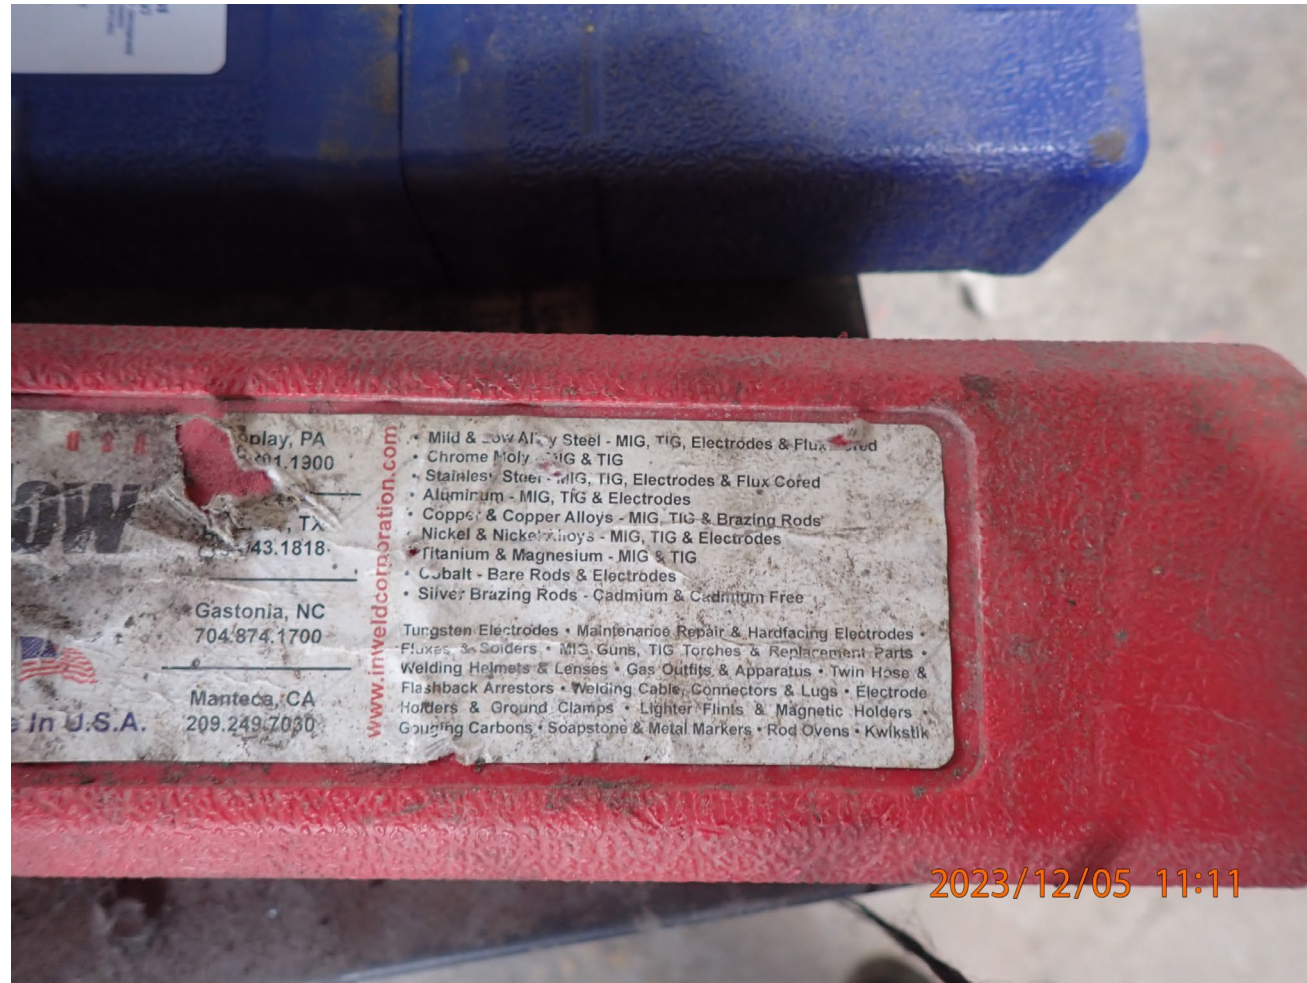
Photo Number: 20

Photo Description: Fusion Flow E6013 welding rods2

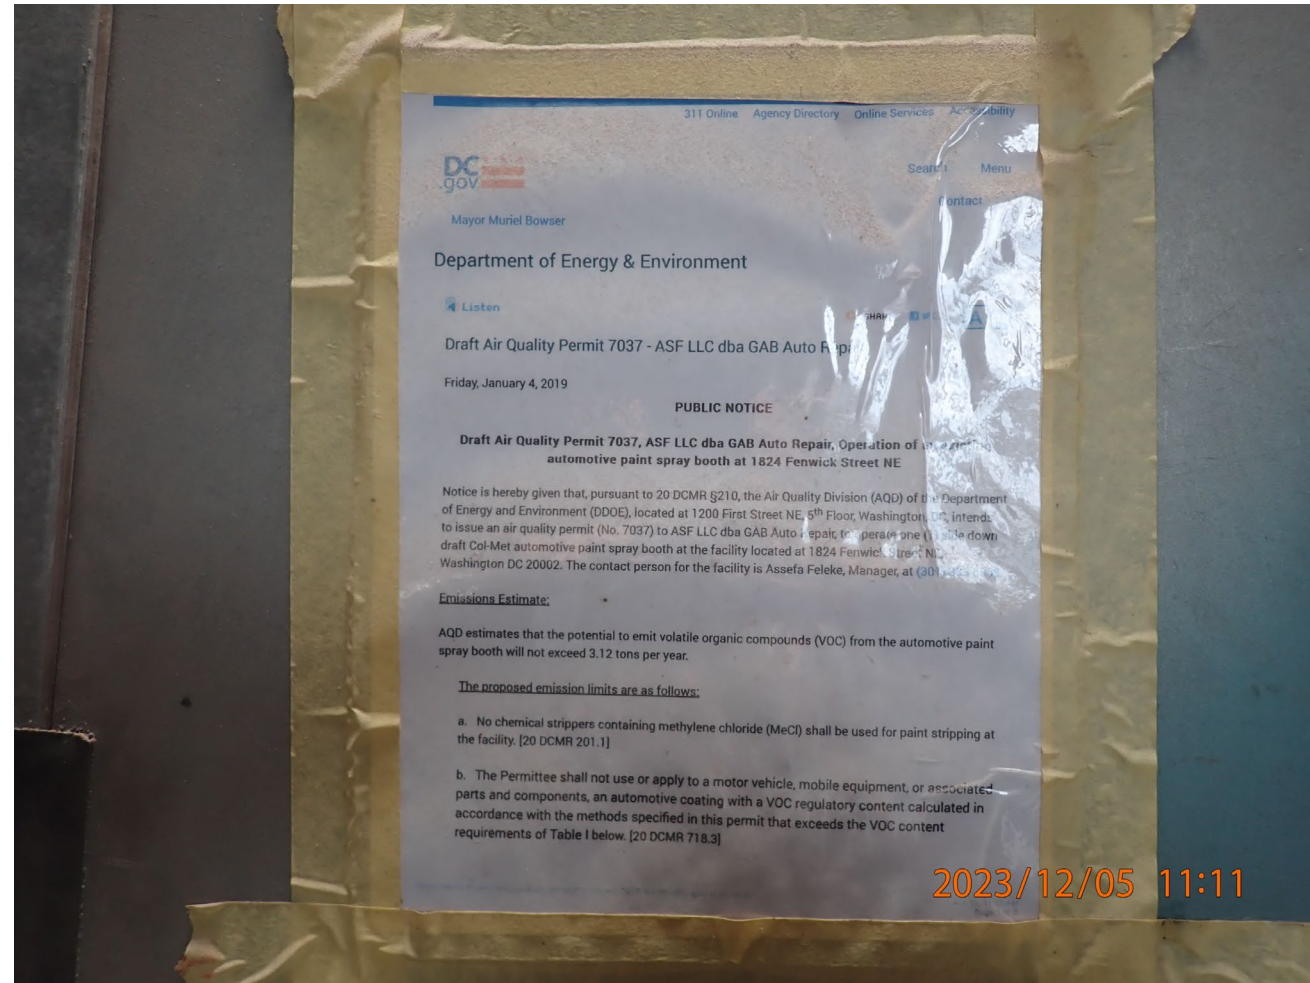
Photo Number: 21

Photo Description: Posted draft DOEE air quality permit

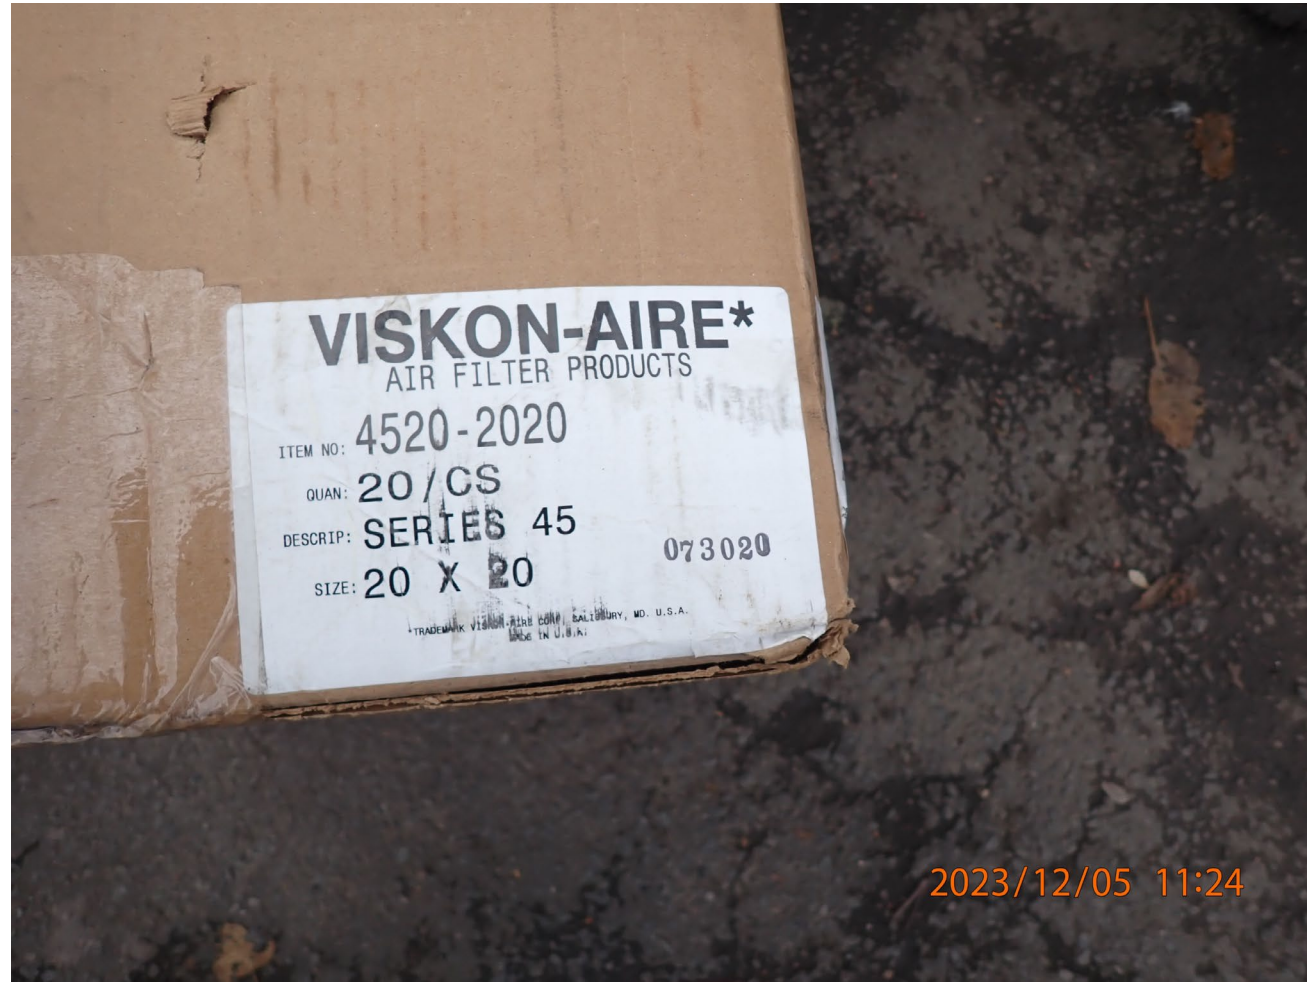
Photo Number: 22

GAB stated the spray booth filters are changed every ten or twelve cars and it could be more often if they are painting with clear coats. Assefa said that he and another painter employed at the location took a class, but they do not have any certifications at this time. The paint spray booth is a side down draft booth. The inspection team asked the Facility to turn on the booth so they could see the airflow through the booth. At the time of the inspection, the booth was operating at a negative pressure and was drawing air into the booth even when the back pedestrian was opened but was much better when that door was closed. The Facility's spray booth uses Series 45 Viskon-Aire filters.

Photo Description: Filter box
