**Well Inspection**  
**Osage DNR / Environmental Protection Agency**  
**1201 Elm Street, Suite 500**  
**Dallas, Texas 75270**

| <b>Operator Info</b> | Contango Resources, LLC<br>1717 South Boulder, Suite 900<br>Tulsa, OK 74119<br>Phone: 918-392-3396 | <b>Inventory ID</b> | OS2883000 | | |
| | | <b>Well ID</b> | 20W8 | | |

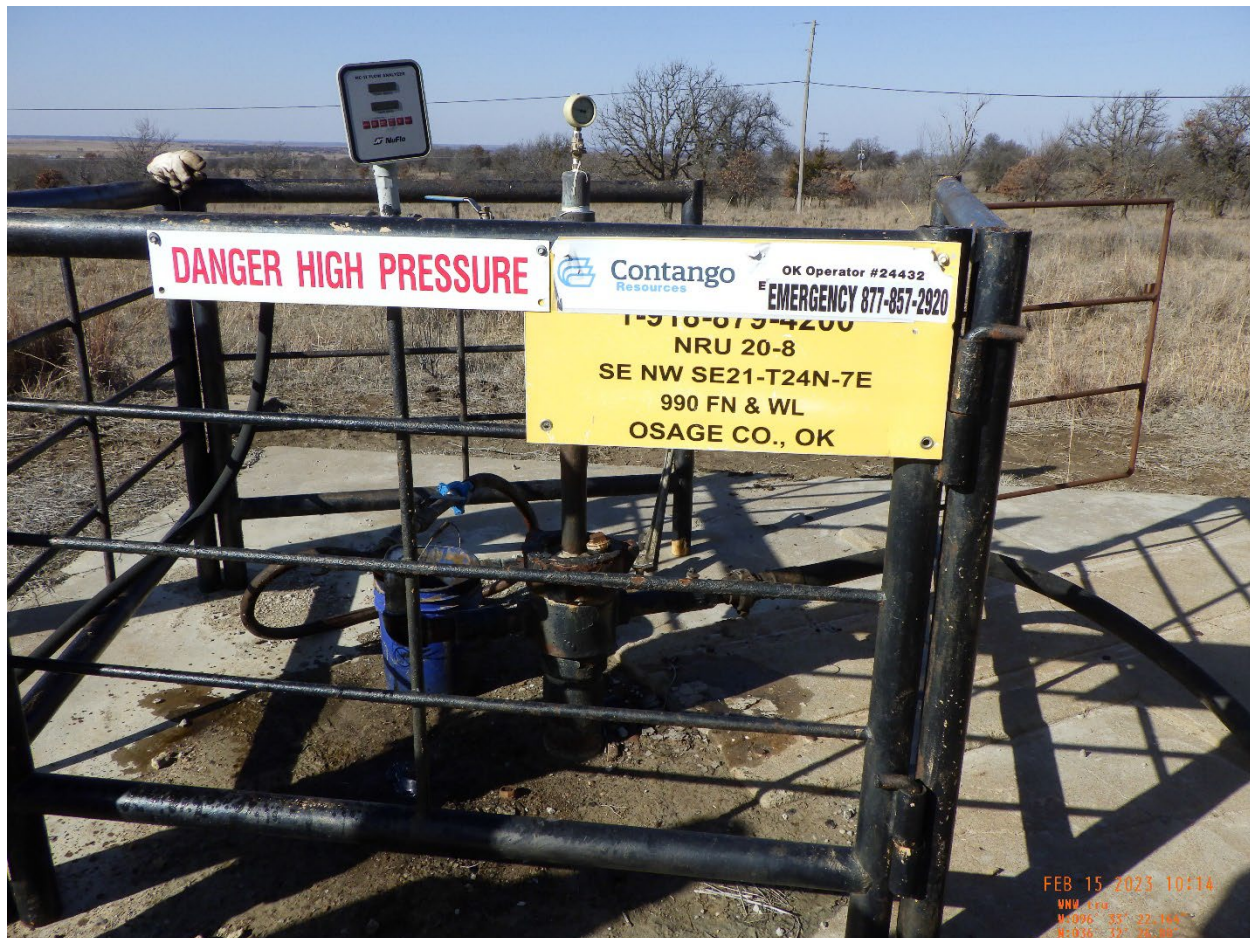
Photo No. 1

**Description:** This was well OS2883000 at the time of the inspection.
