**Region 6 - Enforcement & Compliance Assurance Division**  
**INSPECTION REPORT**

| Inspection Date(s): | 02/28/2023 | |
| Company Name: | <b>City of Las Cruces/ Las Cruces Utilities</b> | |
| Facility Name: | <b>East Mesa Water Reclamation Facility</b> | |

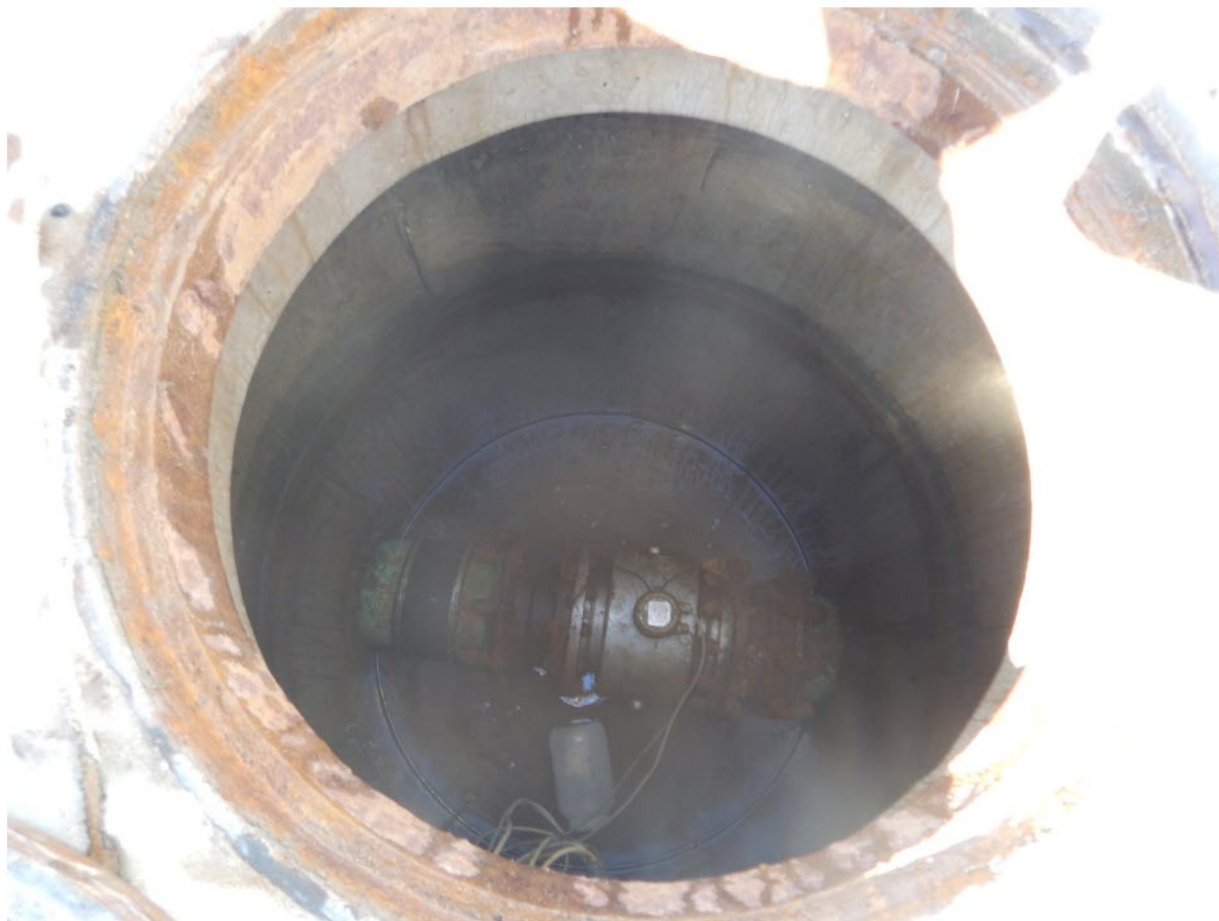
Photo No. 1

- The flow meter to the NPDES outfall is a closed-pipe transducer (see Photo Log).
- Current planned plant upgrades to the UV system will increase the plant flow capacity above the current 0.3 to 0.4 MGD, but will not exceed 1.0 MGD.

Description: View into manhole showing pipe to the NPDES outfall and outfall flow meter.
