INSPECTION REPORT

Inspection Date:	8/23/2022	Inspection Announced: No
Time:	Entry: 11:40 AM (EST)	Exit: 3:50 PM (EST)
Media:	Water	
Statute (s)/Program(s):	Clean Water Act, National Pollutant Discharge Elimination System (NPDES), Industrial	
Type of inspection:	Compliance Evaluation Inspection	
Access:	Granted	
Permittee Name:		
Plymouth Tube Co.		
Facility or Site Name:		
Plymouth Tube Co.		
Facility/Site Physical Address:		
572 W State Road 14		
(city, state, zip code)		
Winamac, Indiana 46996		
County/Parish:		
Pulaski		
Permit Number:		
INP000240

Plymouth Tube Co.

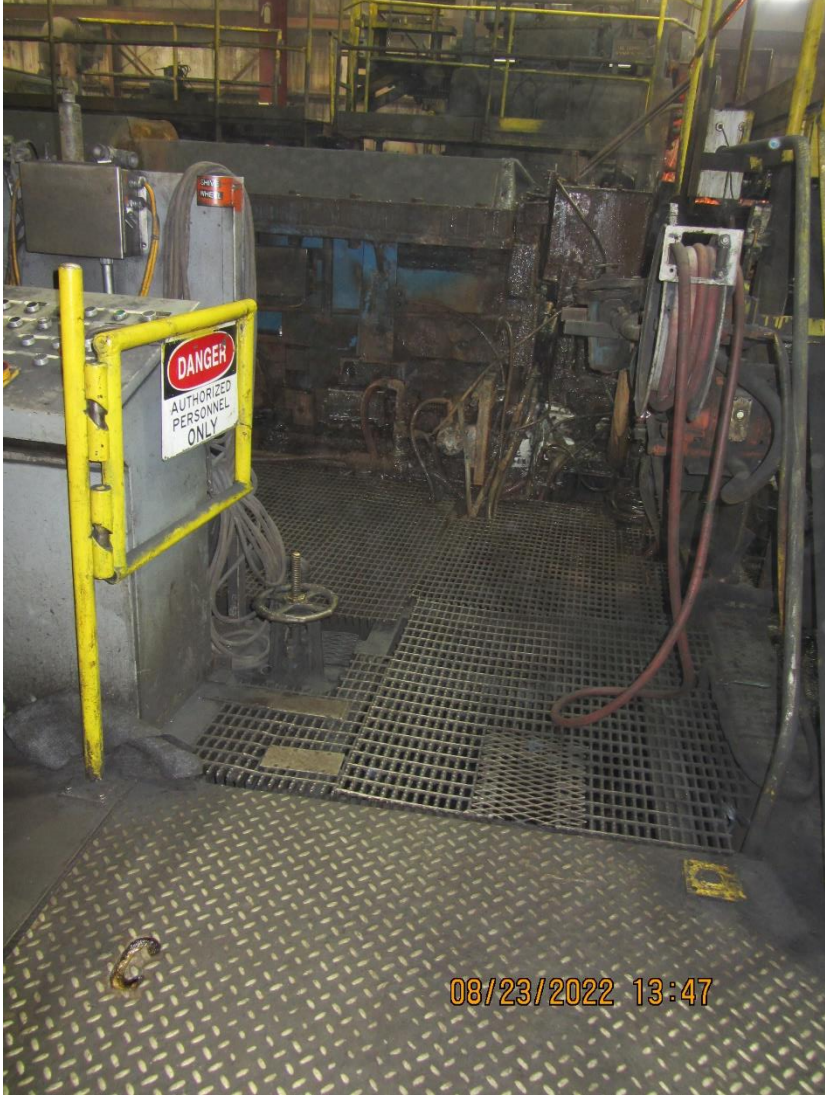
Photo No.: 1	Time: 1: 47 PM		
Direction Photo Taken:			
Photo Description: Open grating for any spills to contain water in closed loop system.			
		File: plymouth_001.JPG

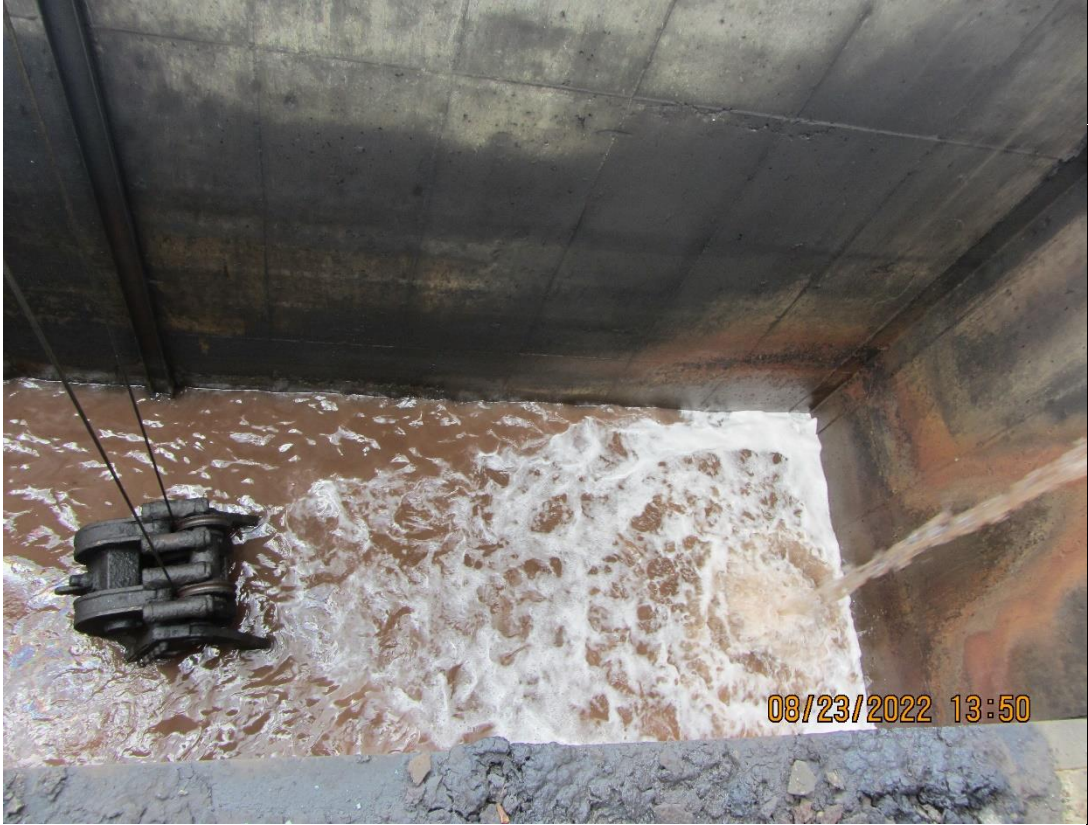
Photo No.: 2	Time: 1:50 PM		
Direction Photo Taken:			
Photo Description: Scale Pit.			
		File: plymouth_002.JPG

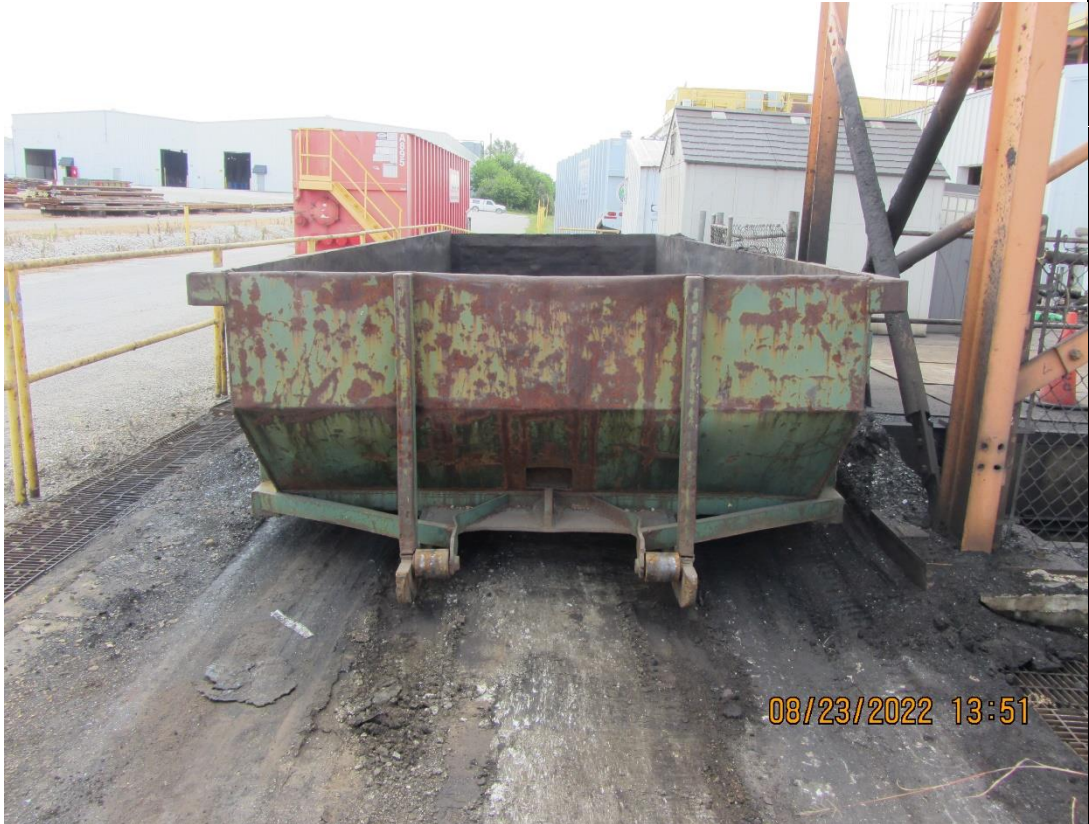
Photo No.: 3

Photo Description:
Scale Hopper hauled every 6 weeks.

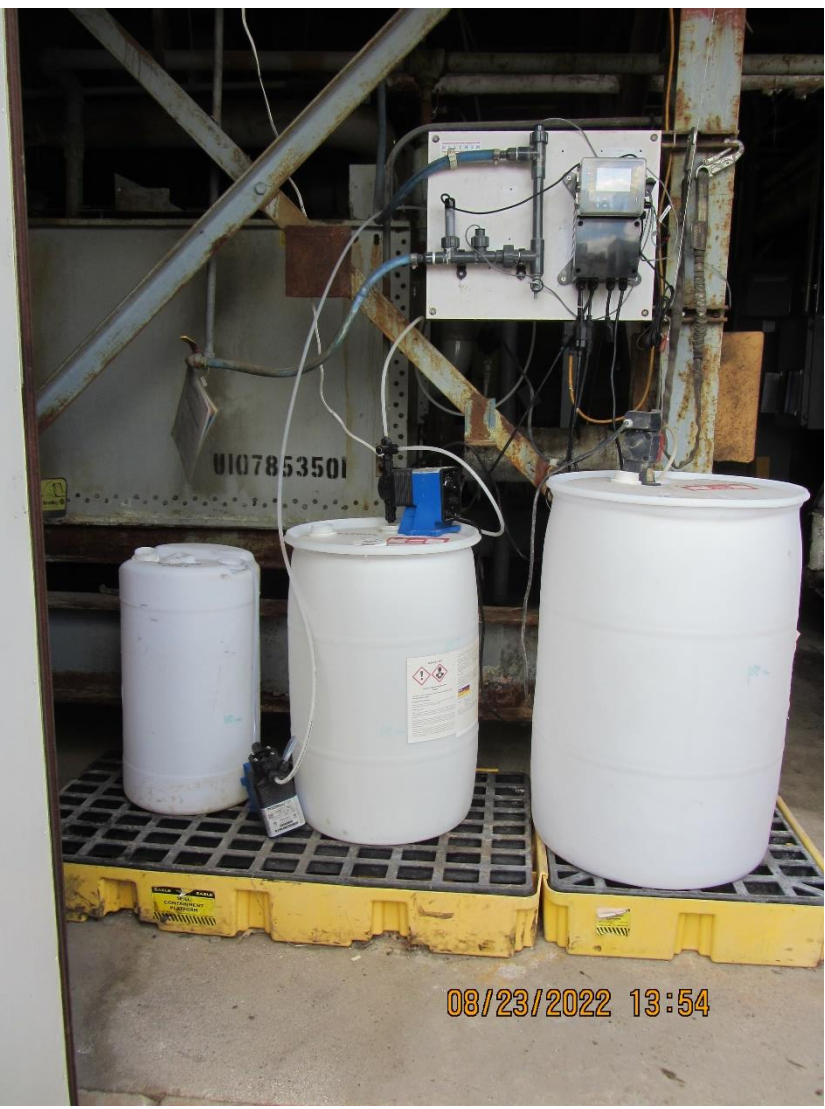
Photo No.: 4	Time: 1:54 PM
---------------------	----------------------

Photo Description:
Cooling tower automatic refuel station.

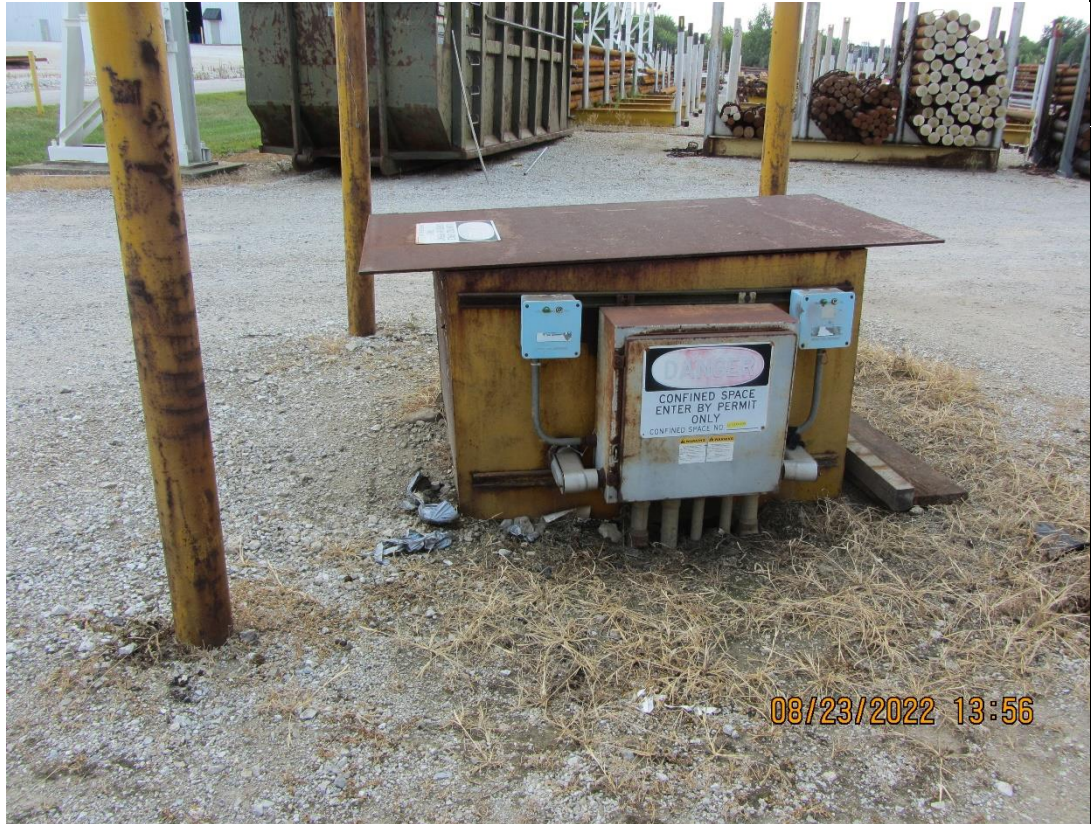
Photo No.: 5

Photo Description:
Lift station on the north side of Facility to sanitary.

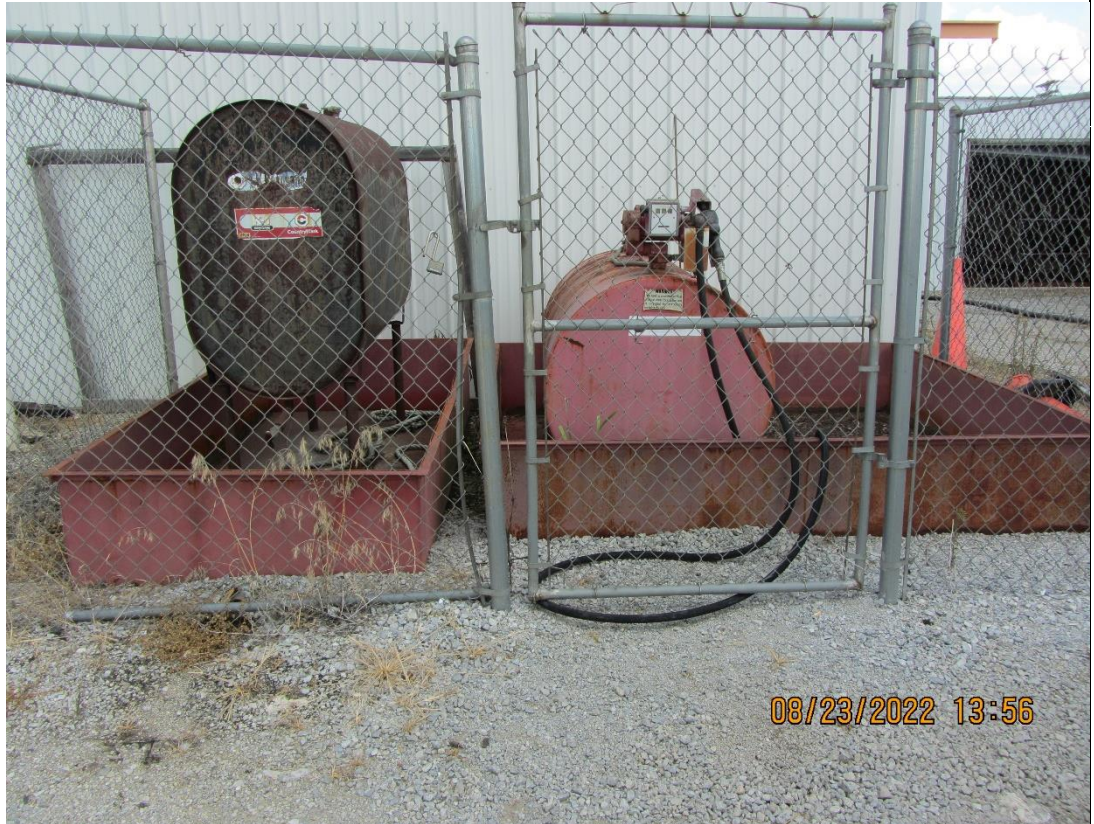
Photo No.: 6	Time: 1:56 PM
---------------------	----------------------

Photo Description:
Diesel Station with secondary containment.

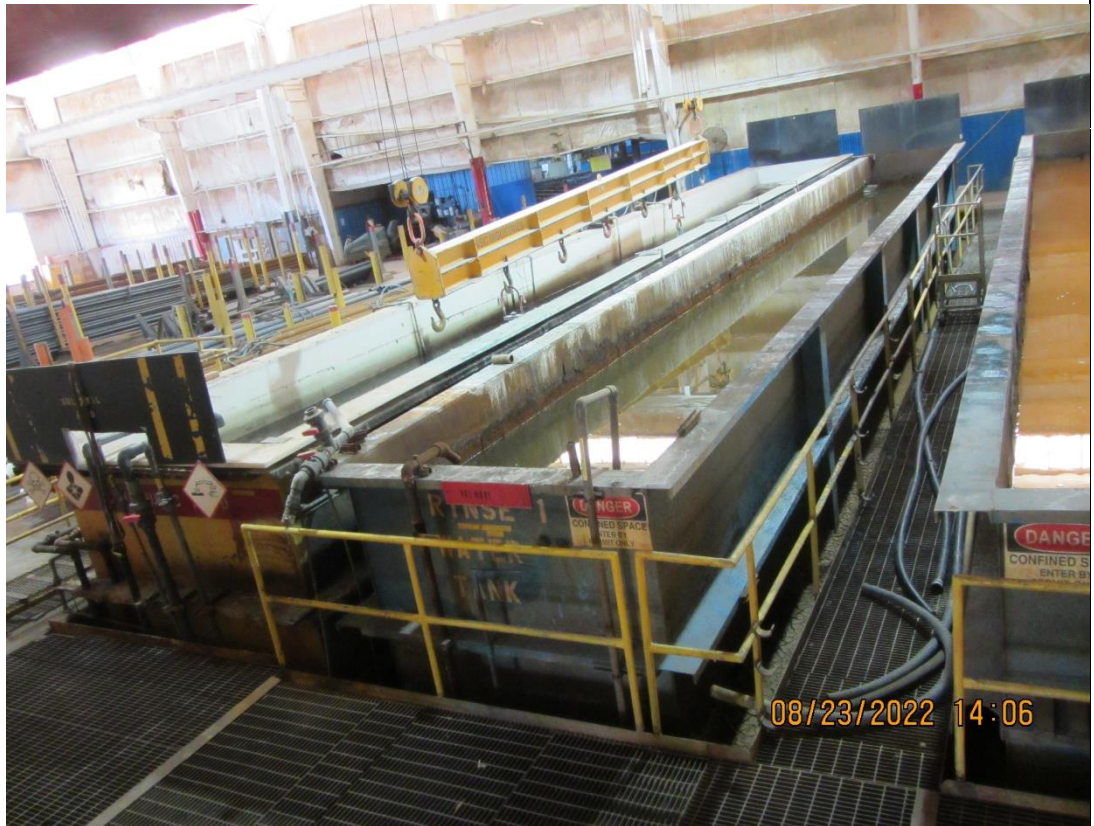
Photo No.: 7	Time: 2:06 PM
---------------------	----------------------

Photo Description:
Acid and rinse tanks with open grating to capture and hold any spills.

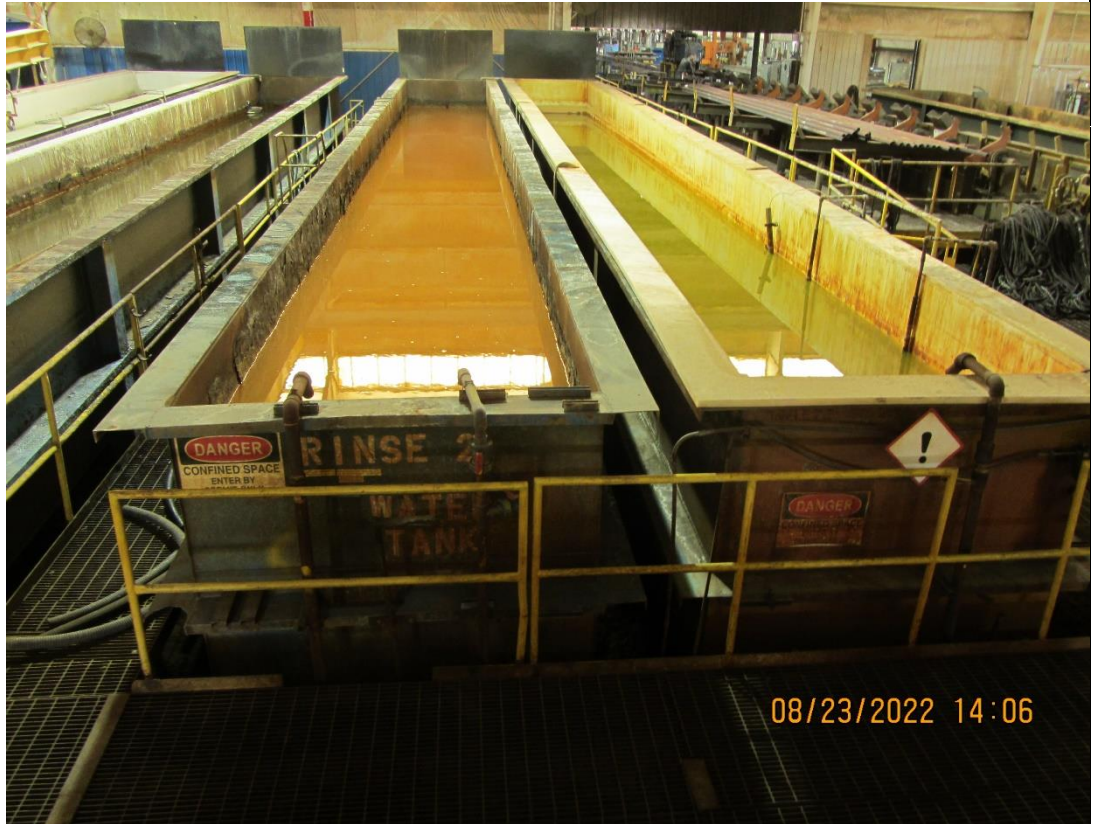
Photo No.: 8	Time: 2:06 PM
---------------------	----------------------

Photo Description:
Acid and Rinse tanks
Acid and rinse tanks with open grating to capture and hold any spills.

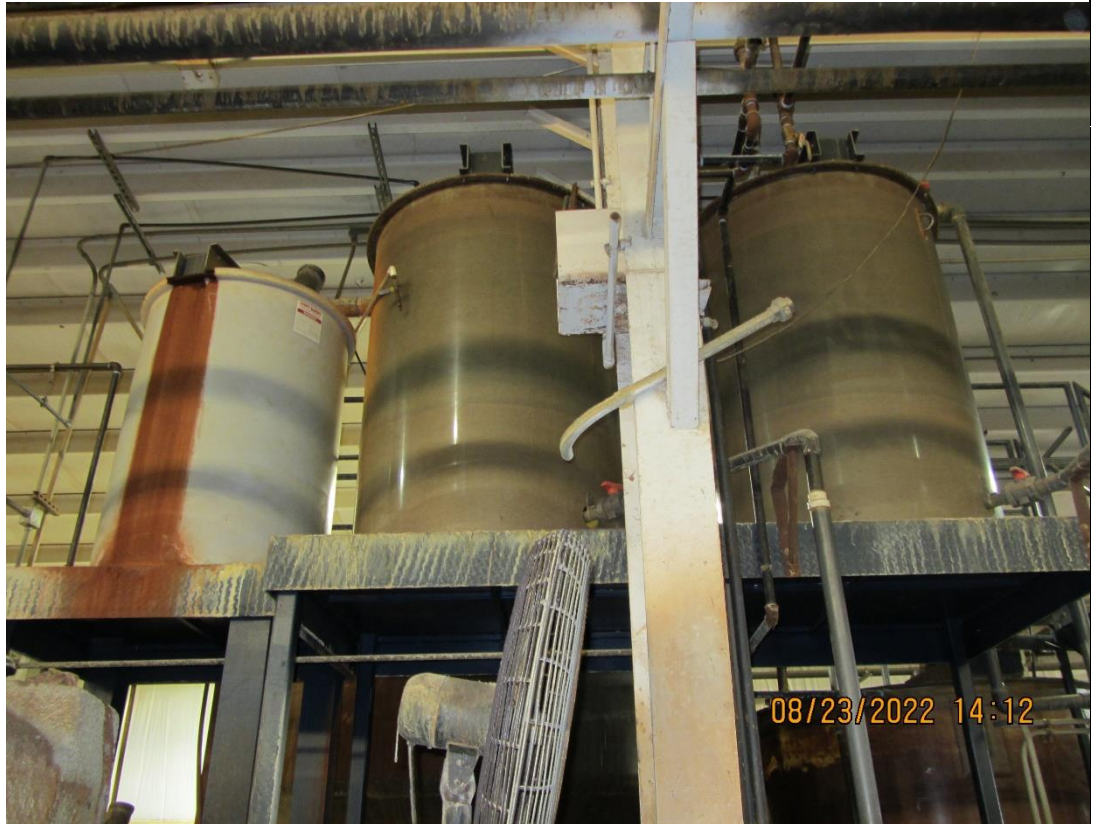
Photo No.: 9	Time: 2:14 PM
---------------------	----------------------

Photo Description:
Holding/floc/mix tanks for pH monitoring and adjustment.

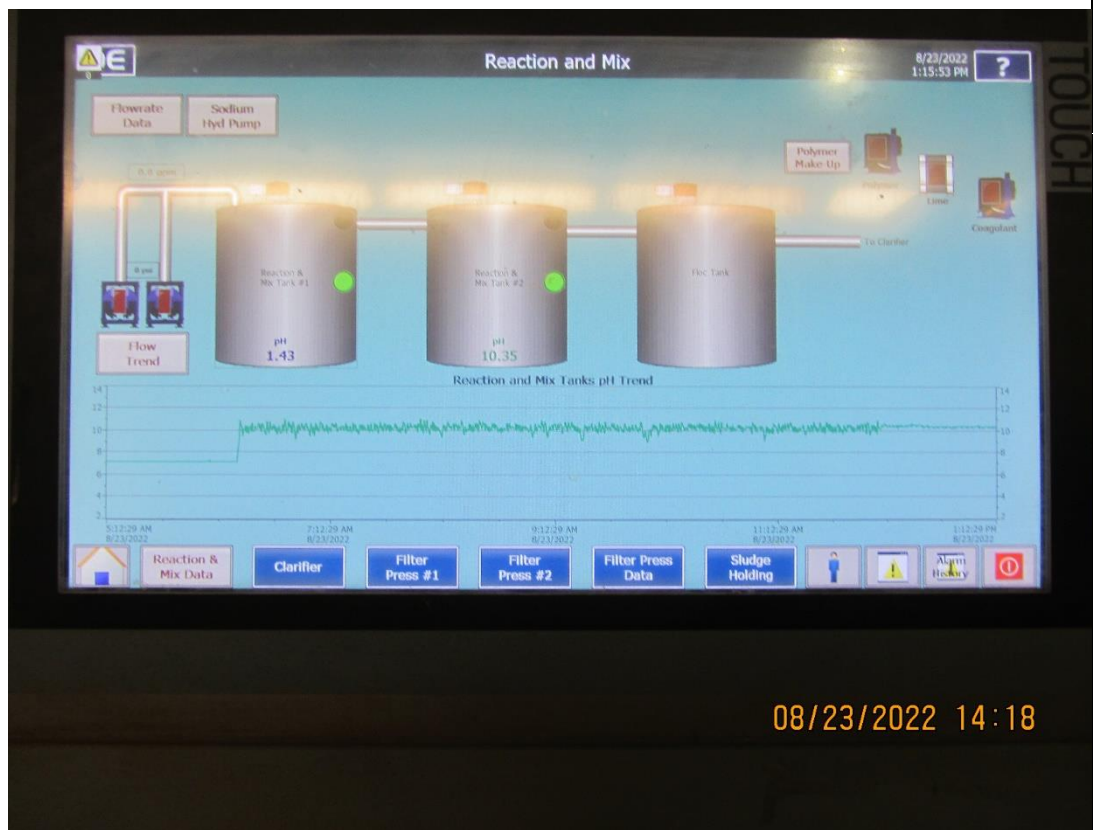
Photo No.: 11	Time: 2:18 PM
----------------------	-------------------------

Photo Description:
 Monitoring screen for reaction and mix tanks and pH monitoring.

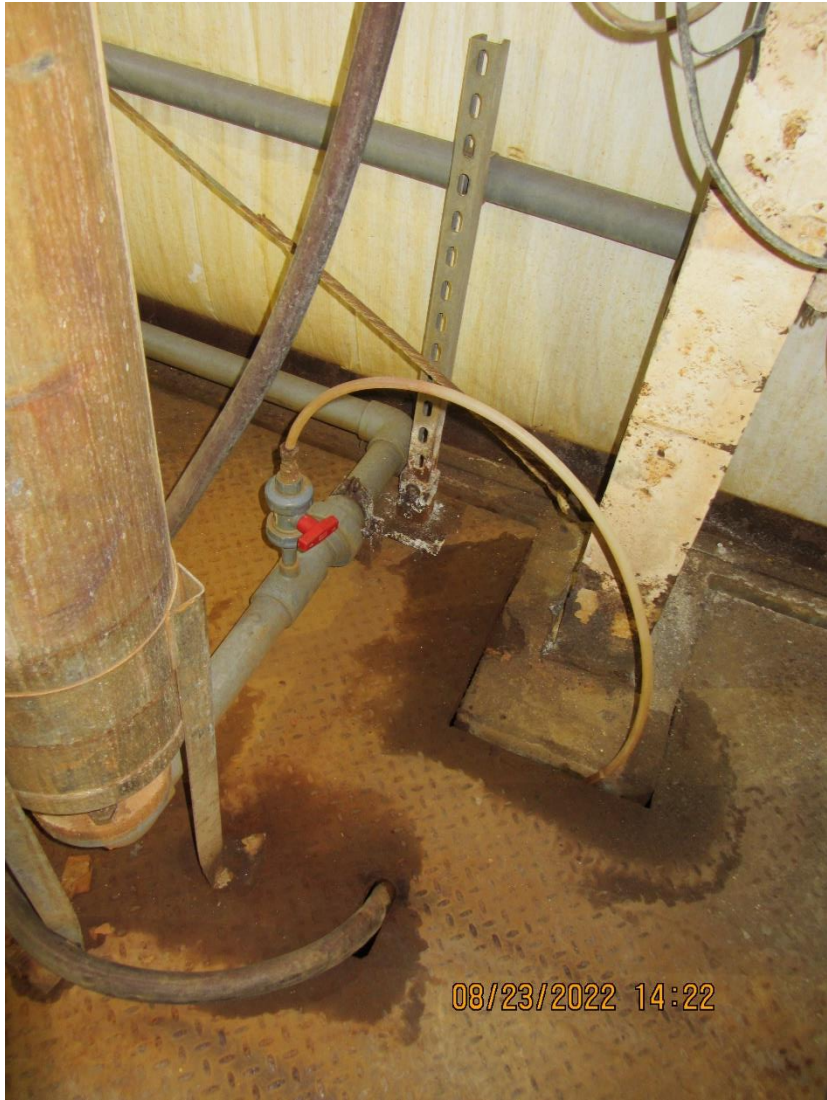
Photo No.: 12	Time: 2:22 PM		
Direction Photo Taken:			
Photo Description: Connection to monitoring equipment.			
		File: plymouth_012.JPG

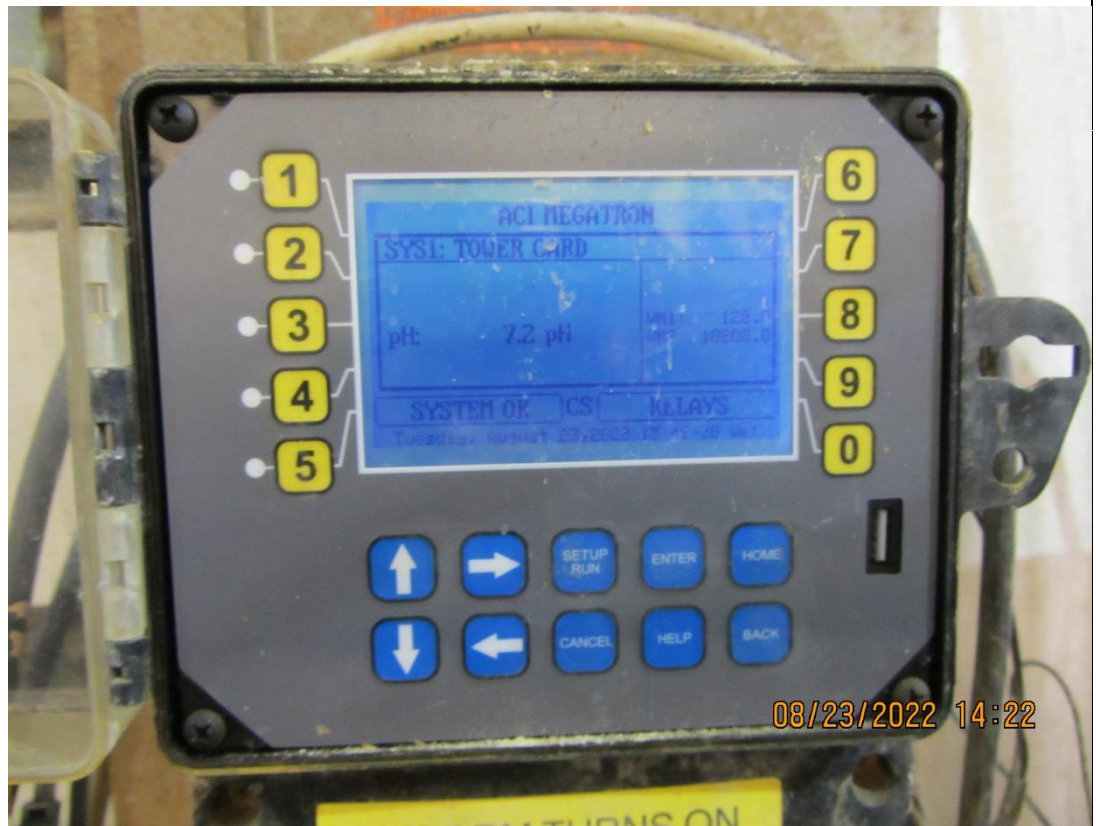
Photo No.: 13	Time: 2:22 PM
----------------------	----------------------

Photo Description: pH monitoring screen.
--

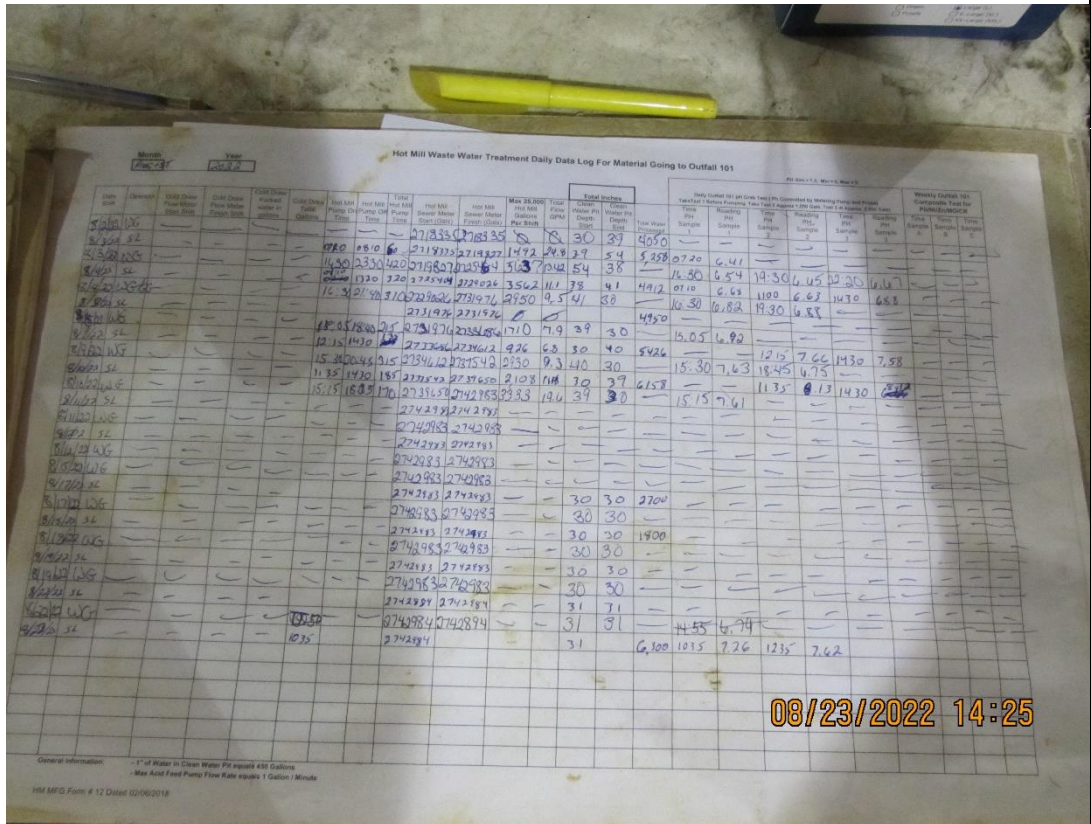
Photo No.: 15 **Time:**
 2:25 PM

Photo Description:
 Monthly city monitoring sheet.

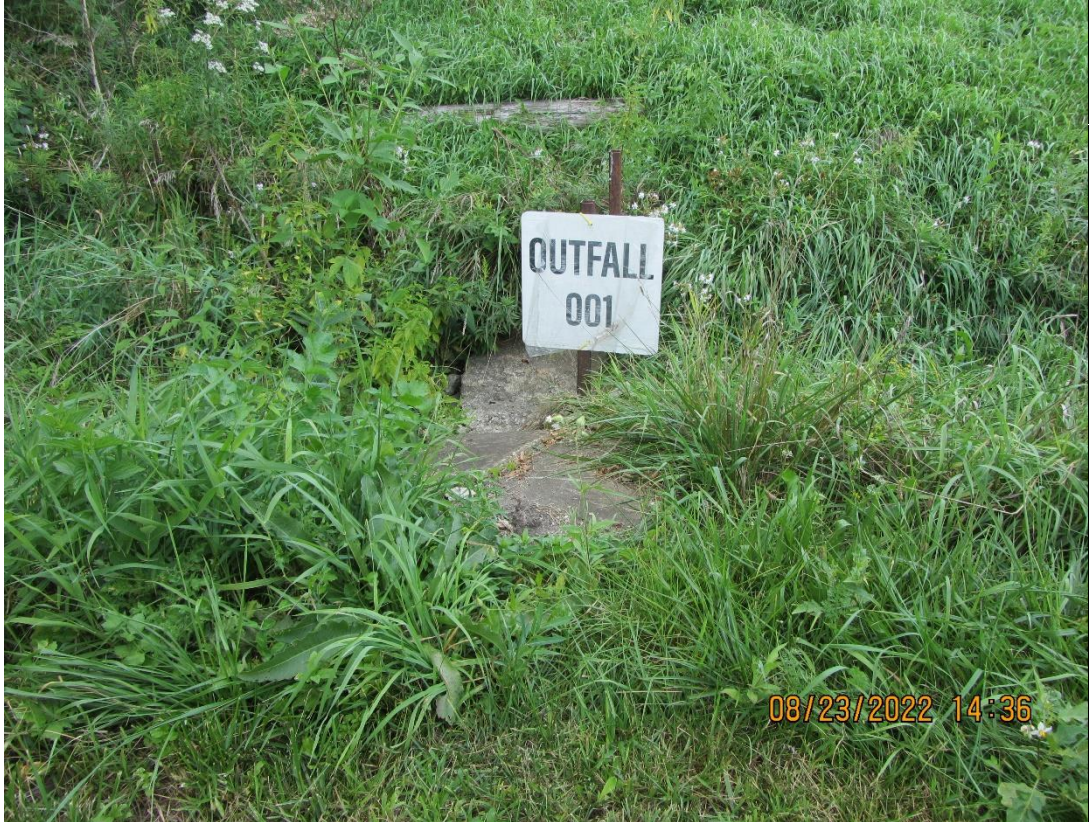
Photo No.: 17	Time: 2:36 PM
----------------------	----------------------

Photo Description:
Stormwater outfall 001 located on the North end of Facility.

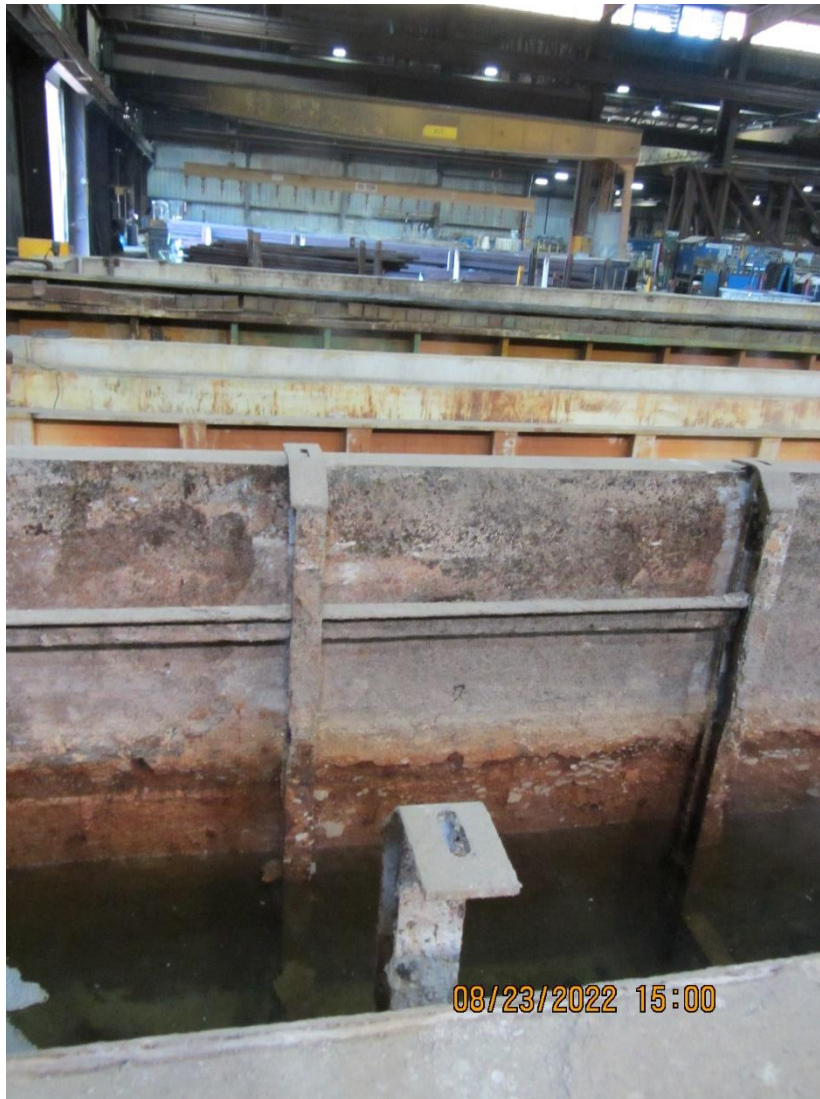
Photo No.: 19

Photo Description:
Rinse tanks with secondary containment underneath.

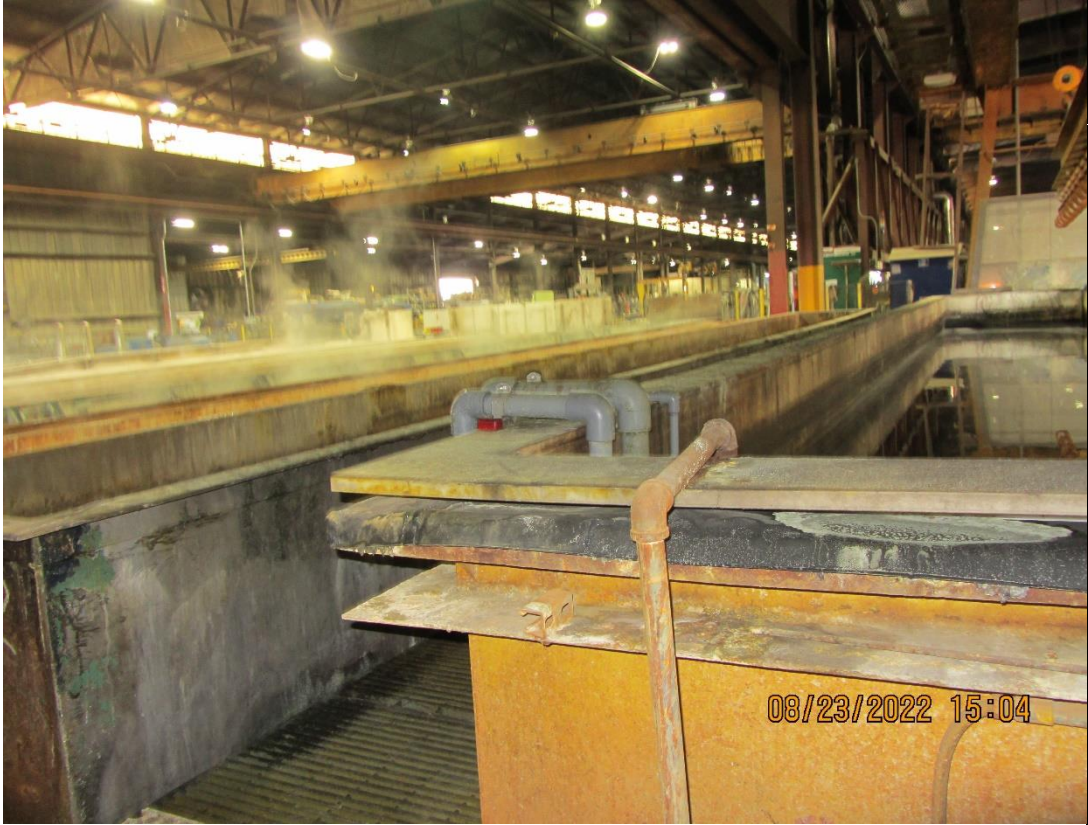
Photo No.: 20	Time: 3:04 PM		
Direction Photo Taken: South			
Photo Description: Rinse and acid tanks with secondary containment underneath.			
		File: plymouth_020.JPG

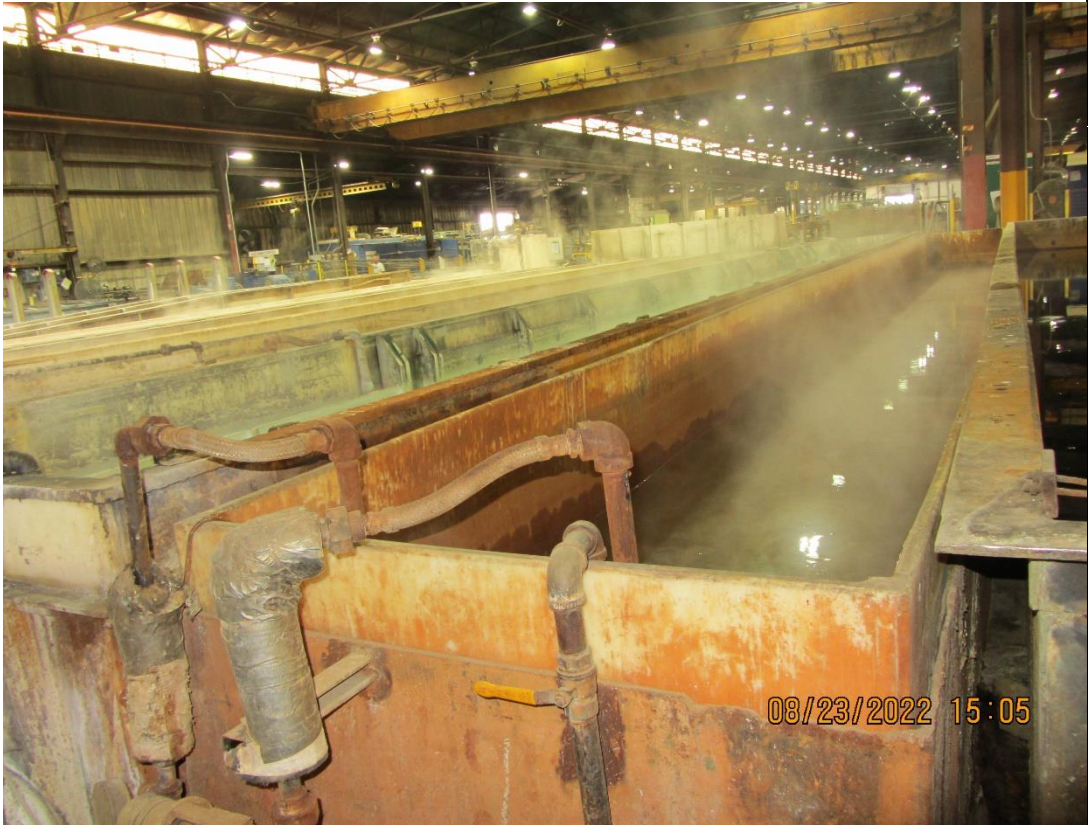
Photo No.: 21	Time: 3:05 PM		
Direction Photo Taken: South			
Photo Description: Rinse and acid tanks with secondary containment underneath.			
		File: plymouth_021.JPG
