## Region 6 Compliance Assurance and Enforcement Division

### INSPECTION REPORT

| Company Name: | <b>Diamond 3S, LLC</b> | | |
| Facility Name: | <b><i>Kennedy</i></b> | | |

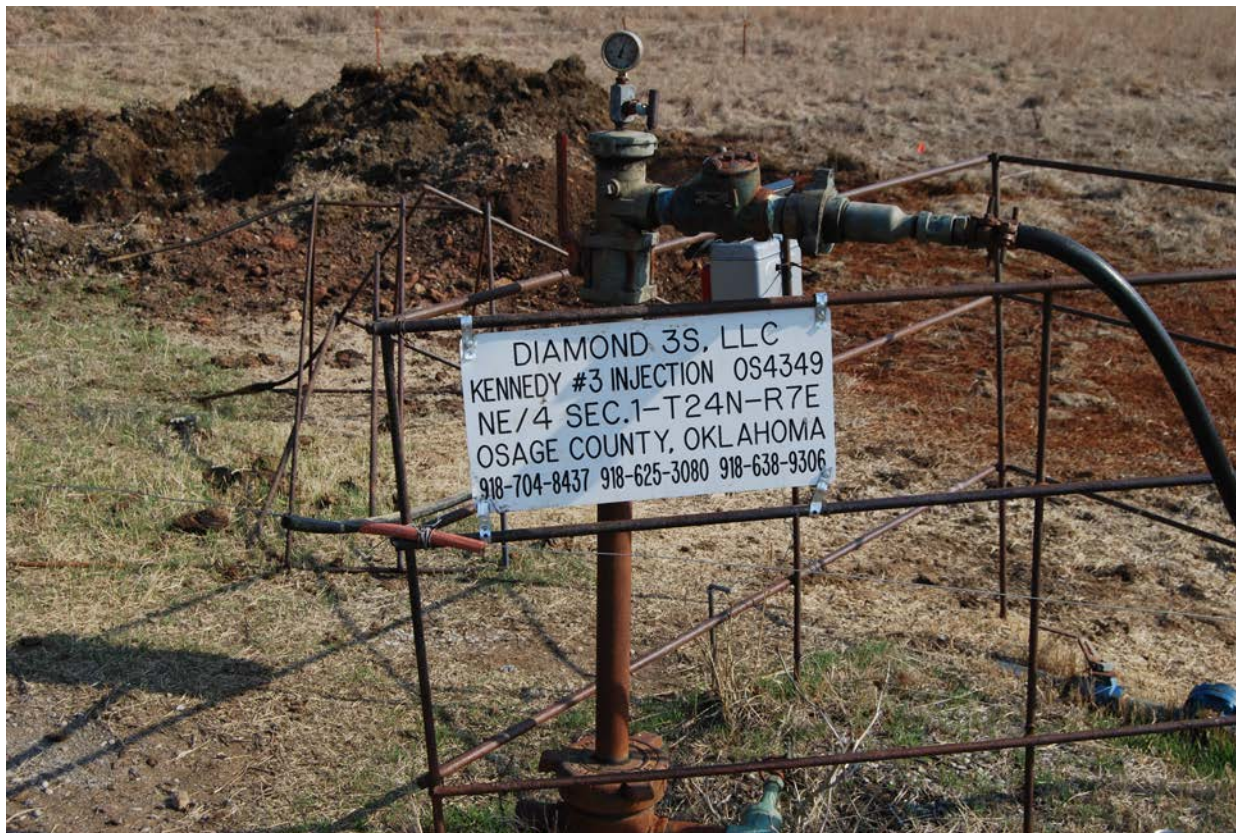
Photo No. 1

Description: This photo shows the sign for the Diamond 3S, LLC Kennedy #3 injection well, where a discharge originated from an injection flow line located about 20 yards east of this well head. The discharge occurred on or about March 14, 2018. The release contaminated a large area of soil, which continues to actively seep and was seeping during this inspection.

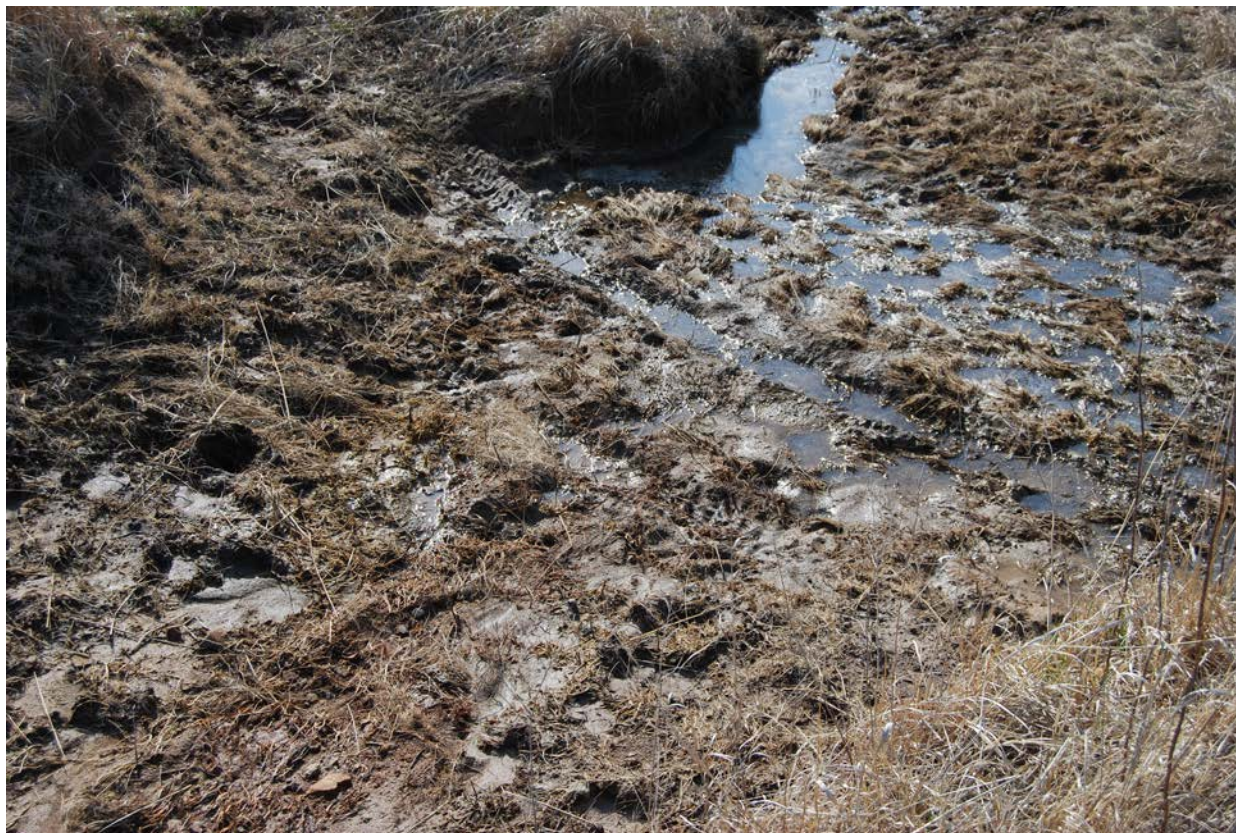
Photo No. 2

Description: Brine was seeping out of the hill side near Kennedy #3 injection well into the tributary of Daniel's Run Creek here.

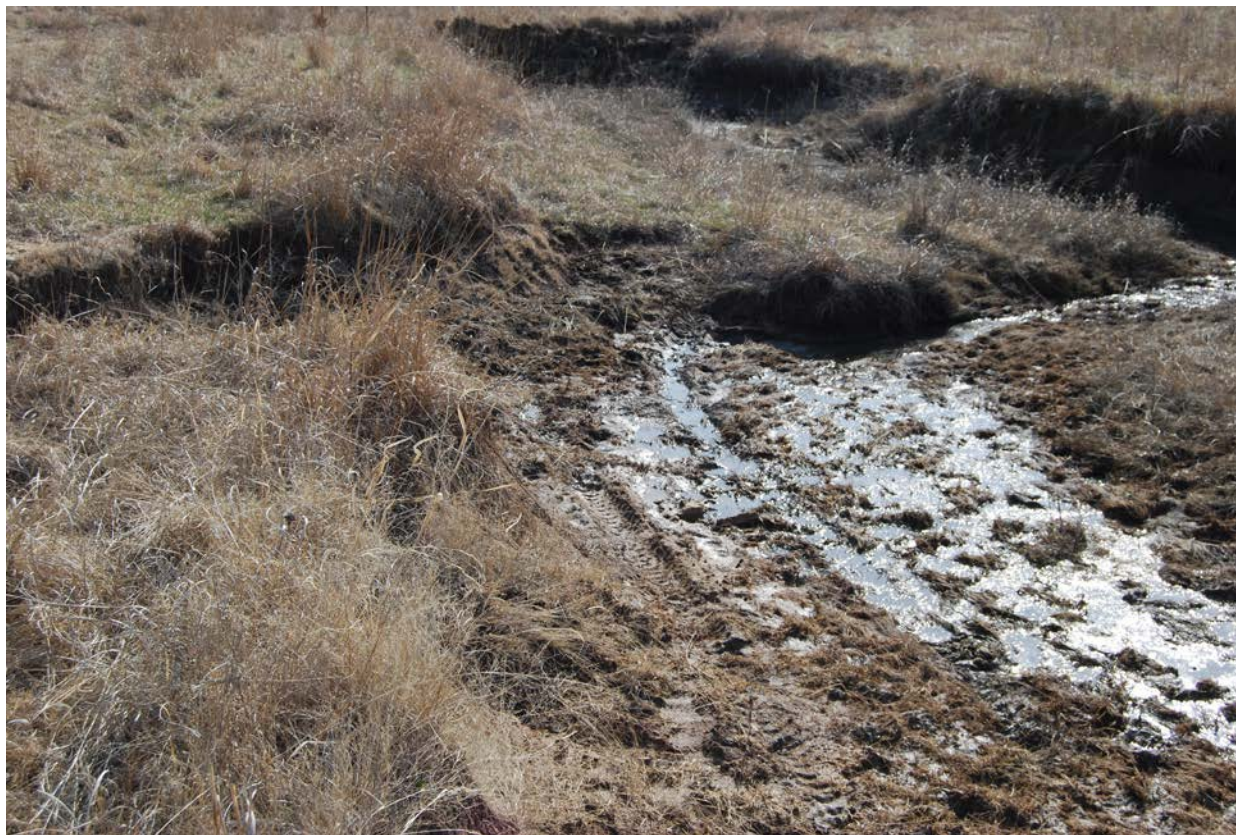
Photo No. 3

Description: The discharge and seepage from the hillside flowed to the tributary of Daniel's Run Creek and entered the tributary here.

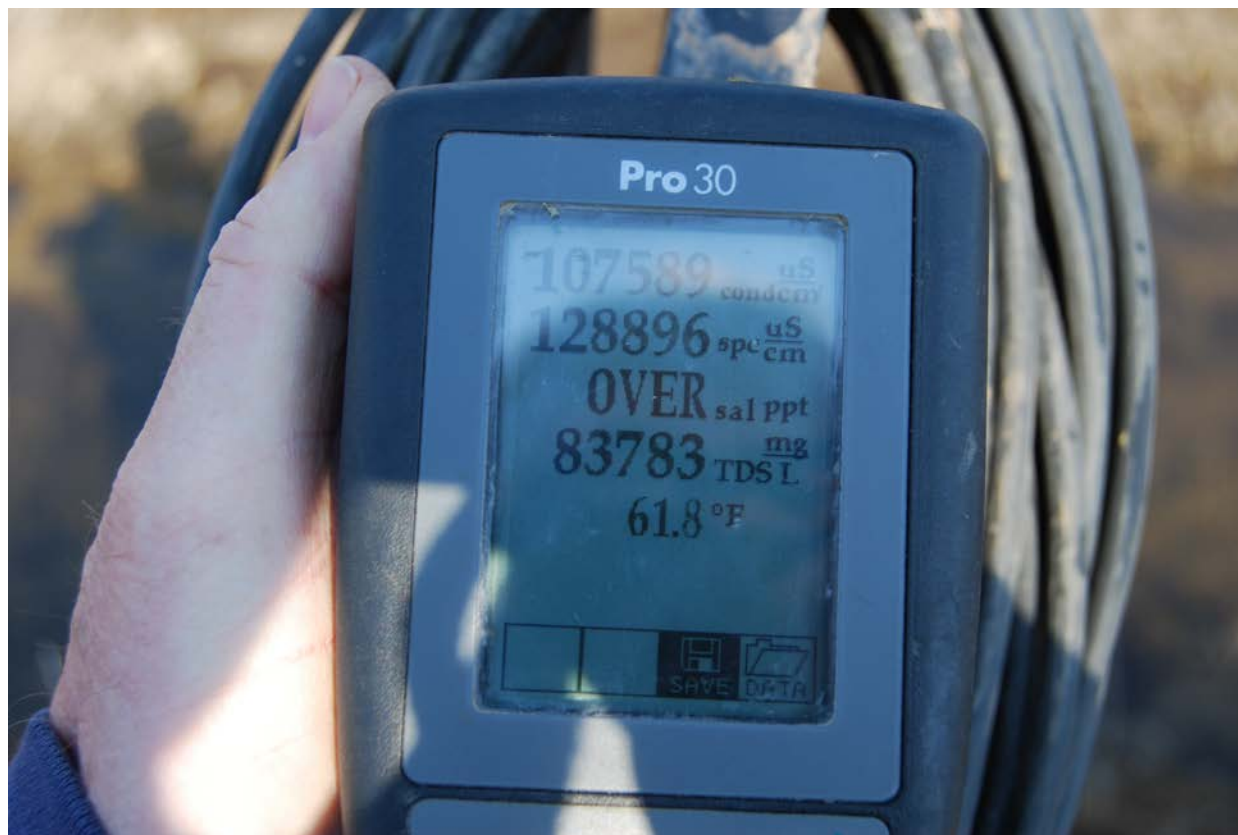
Photo No. 4

Description: With a calibrated YSI Pro 30 Conductivity Meter I took Total Dissolved Solids (TDS) readings along the tributary. The TDS at the point of entry to the tributary of Daniel's Run Creek was 83,783 mg/L.

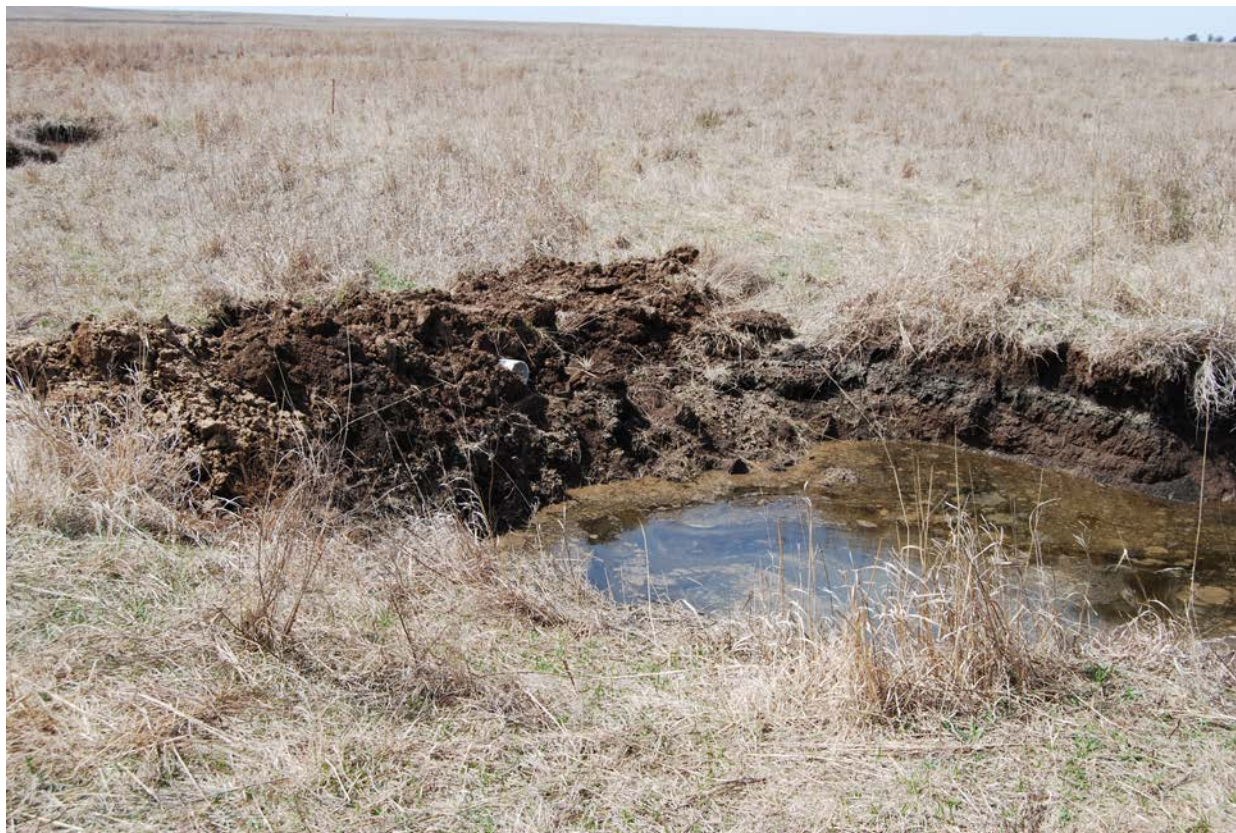
Photo No. 5

Description: This photo shows the first dam, or Dam 1. There were fluids on both sides of the dam during the inspection that had elevated levels of TDS.

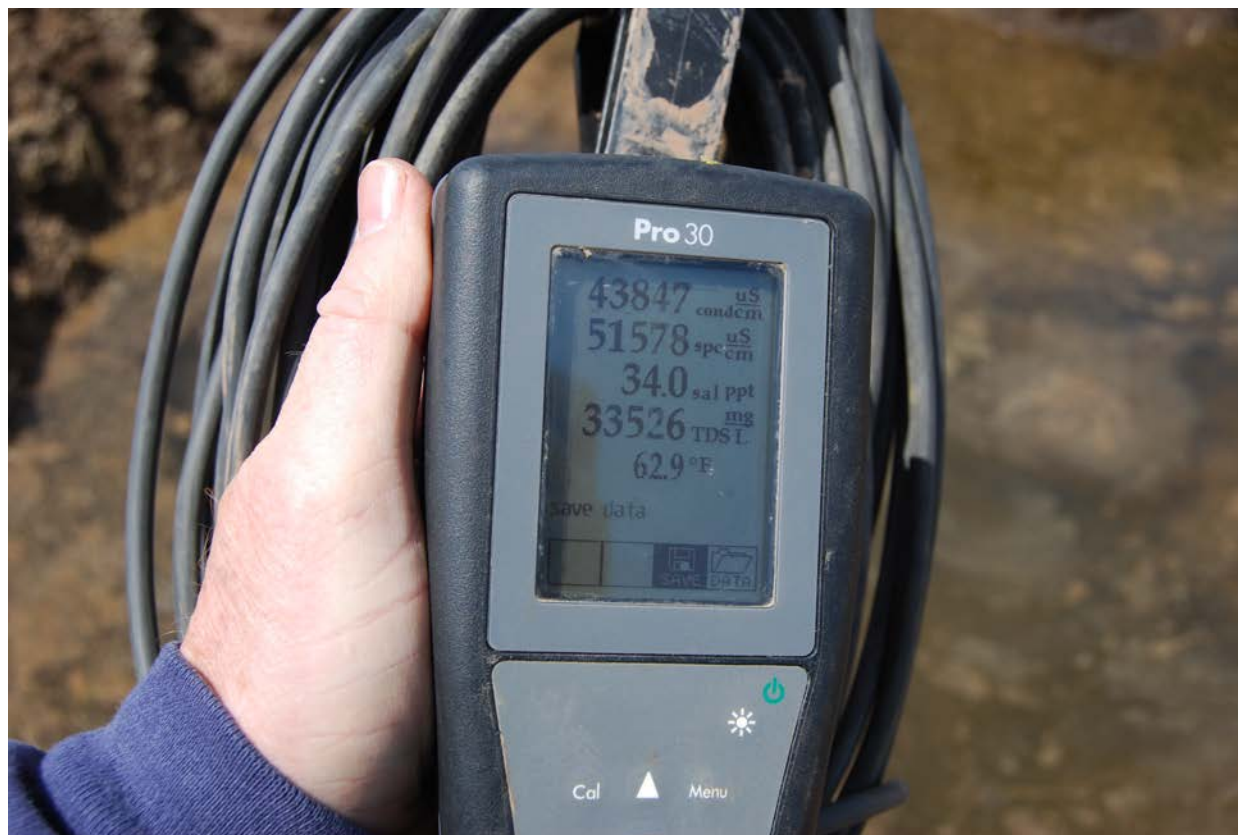
Photo No. 6

Description: TDS of the brine located at Dam 1 was 33,526 mg/L. There were fluids leaking out the base of the dam during the inspection.

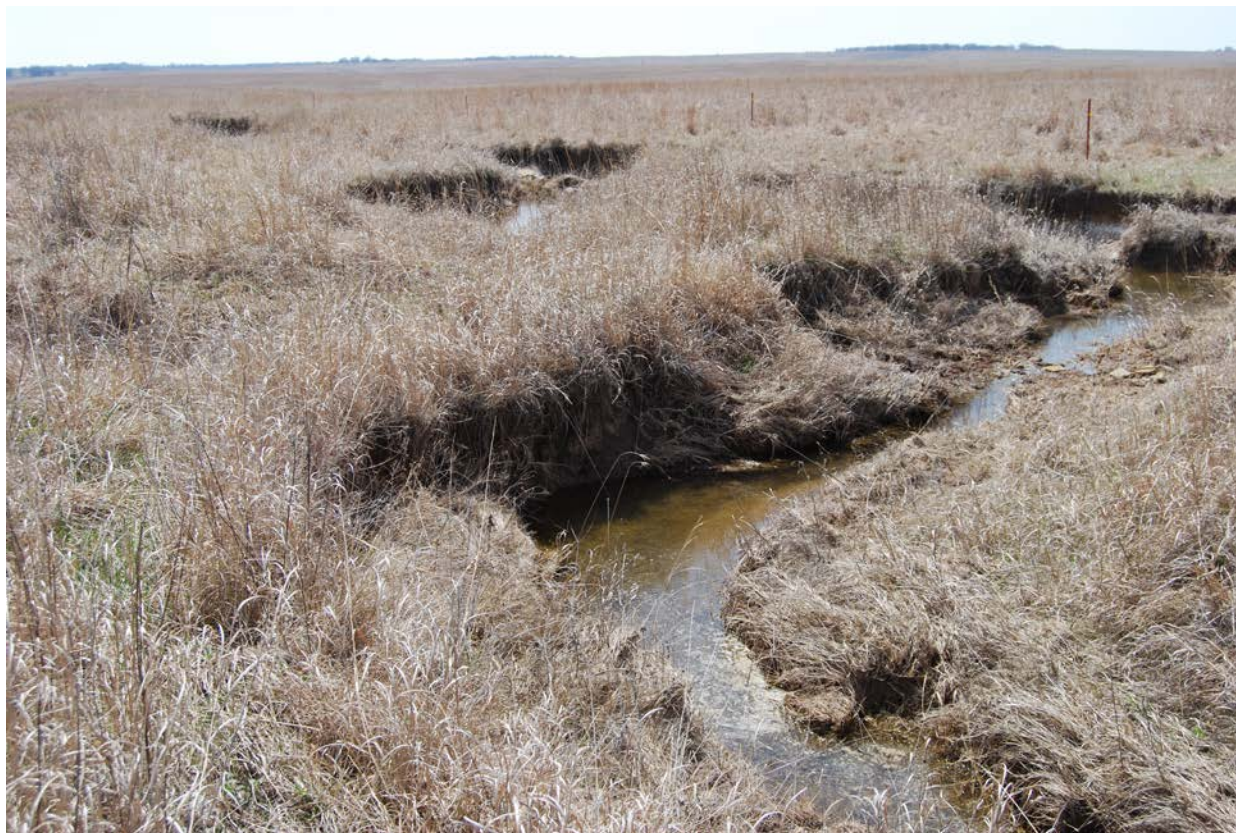
Photo No. 7

Description: This photo shows the tributary of Daniel's Run Creek downstream of Dam 1. I observed bed and bank at this location of the tributary.

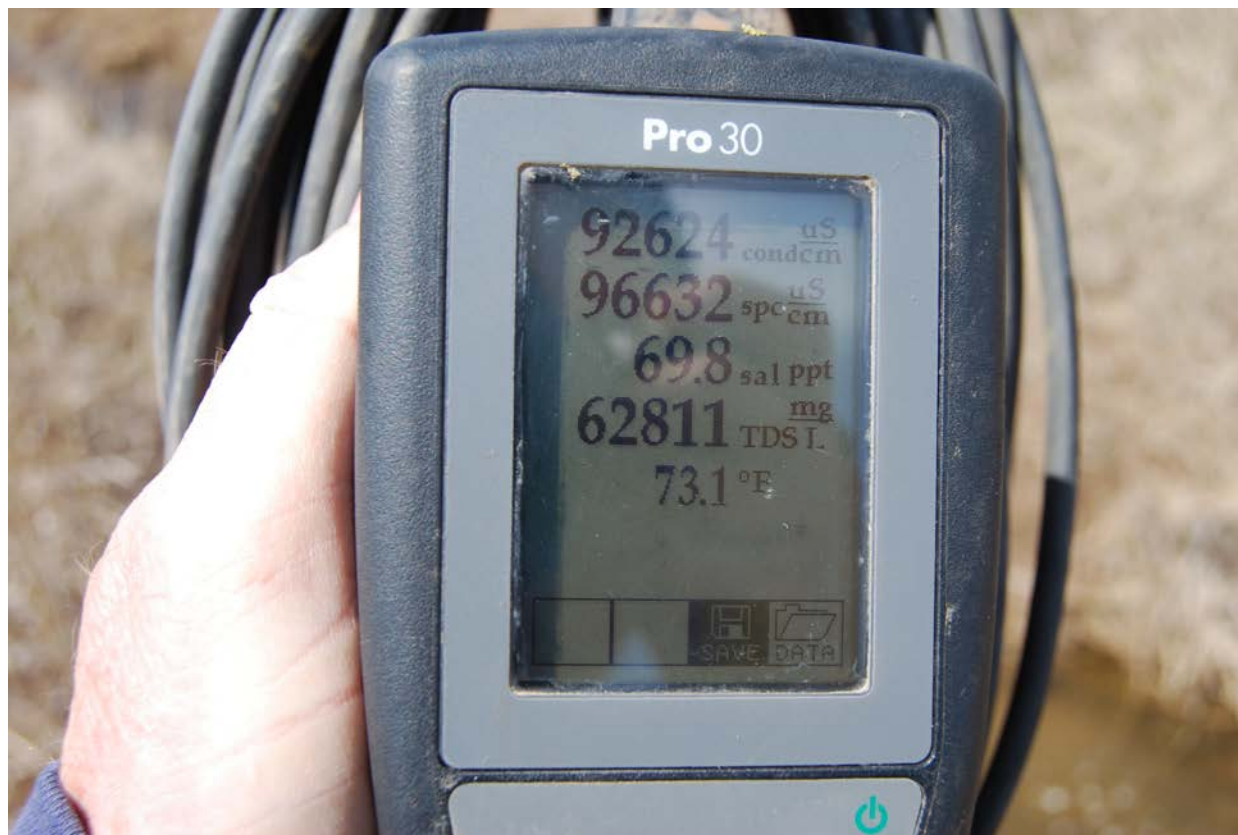
Photo No. 8

Description: TDS of the location in the tributary of Daniel's Run Creek shown in Photo 7 was 62,811 mg/L.

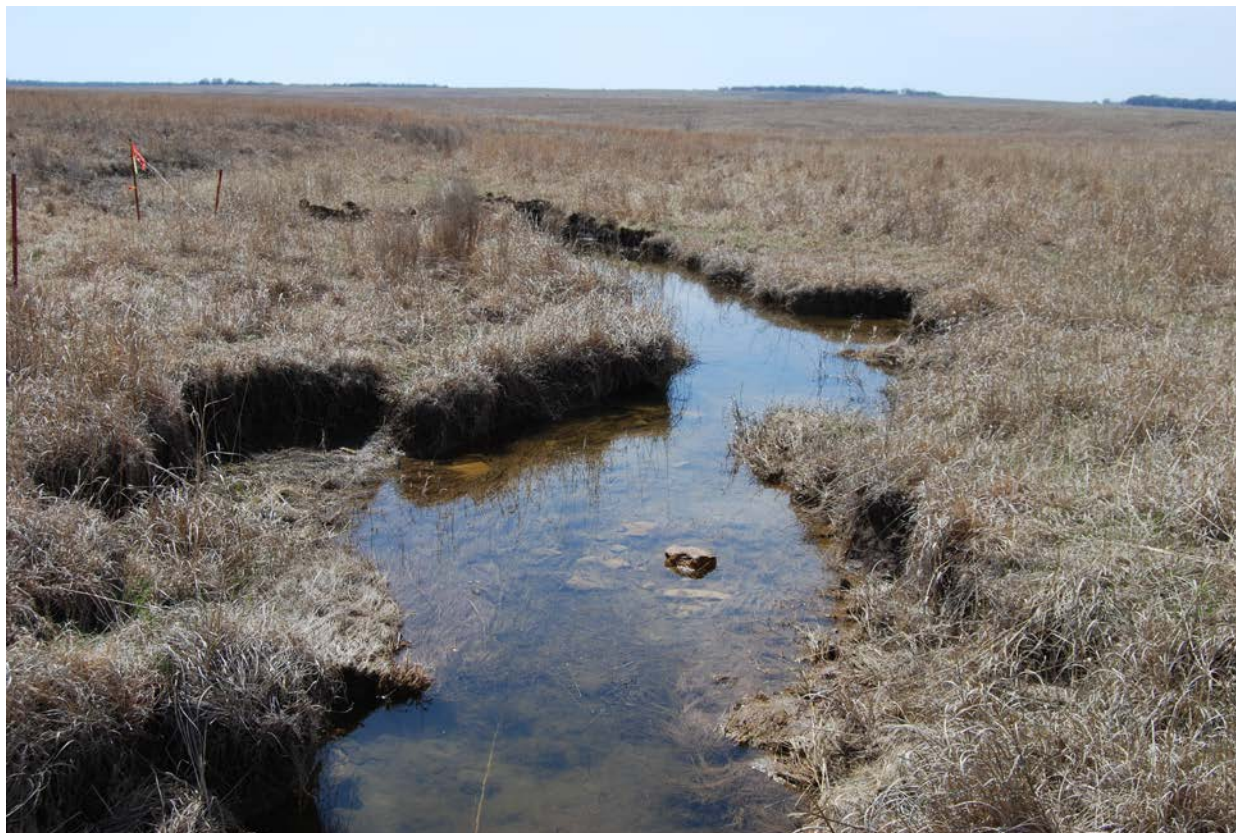
Photo No. 9

Description: I observed that water in the tributary was backed up behind Dam 2 here.

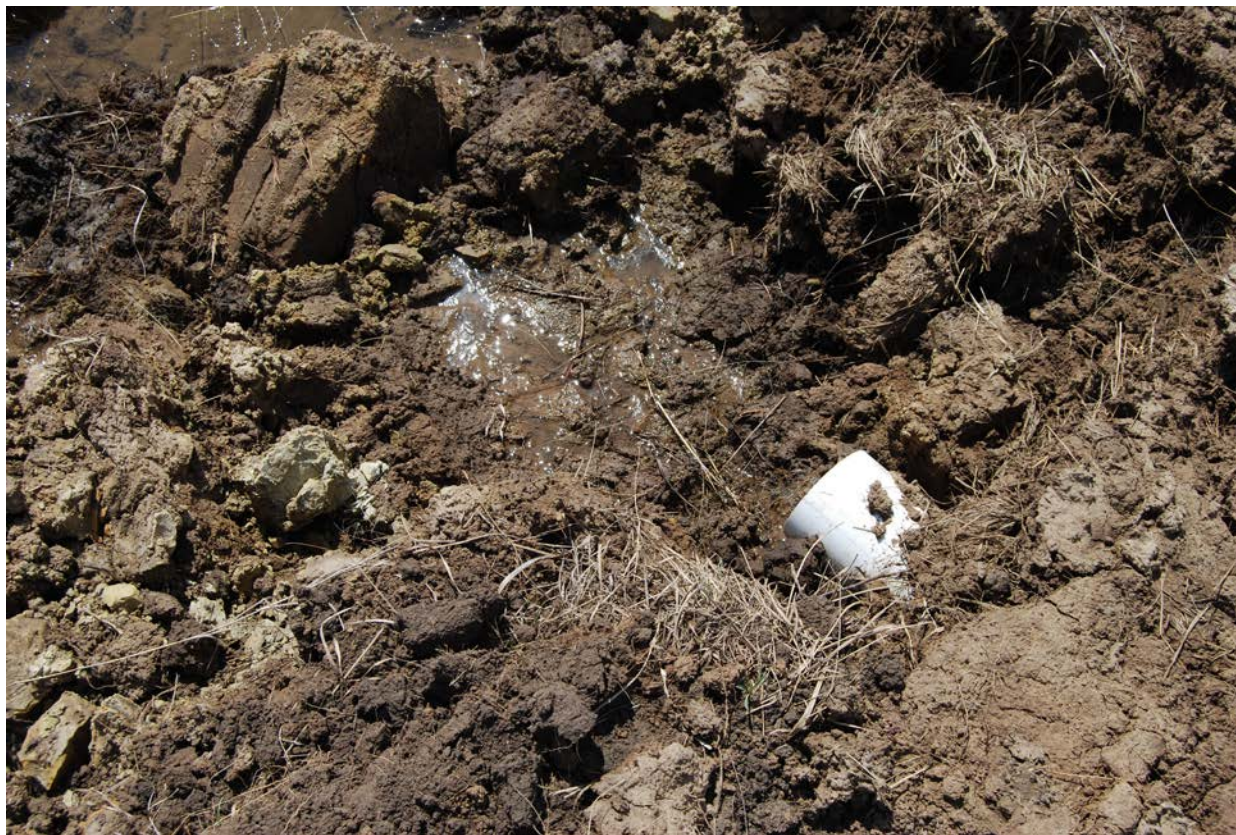
Photo No. 10

Description: I observed that brine in the tributary was flowing through the pipe in Dam 2.

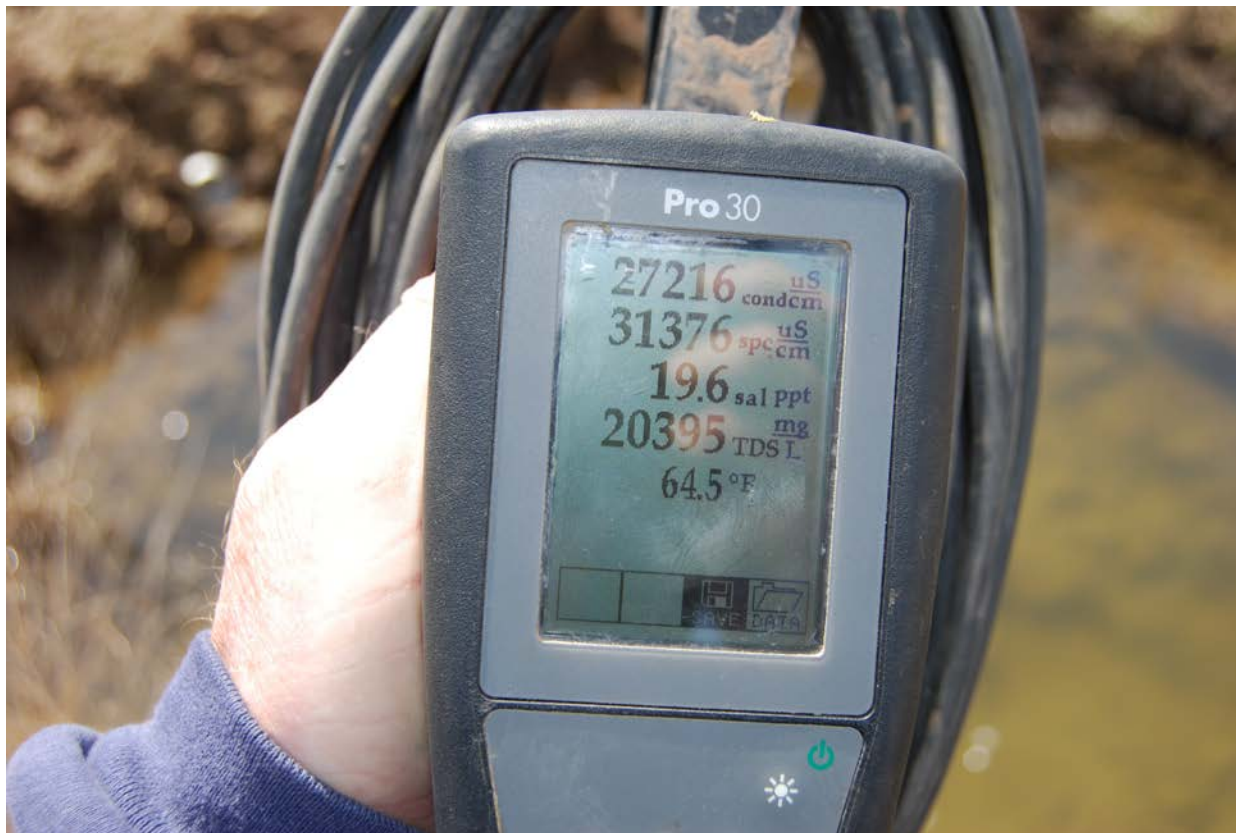
Photo No. 11

Description: The TDS of the water in the tributary of Daniel's Run Creek at Dam 2 was 20,395 mg/L.

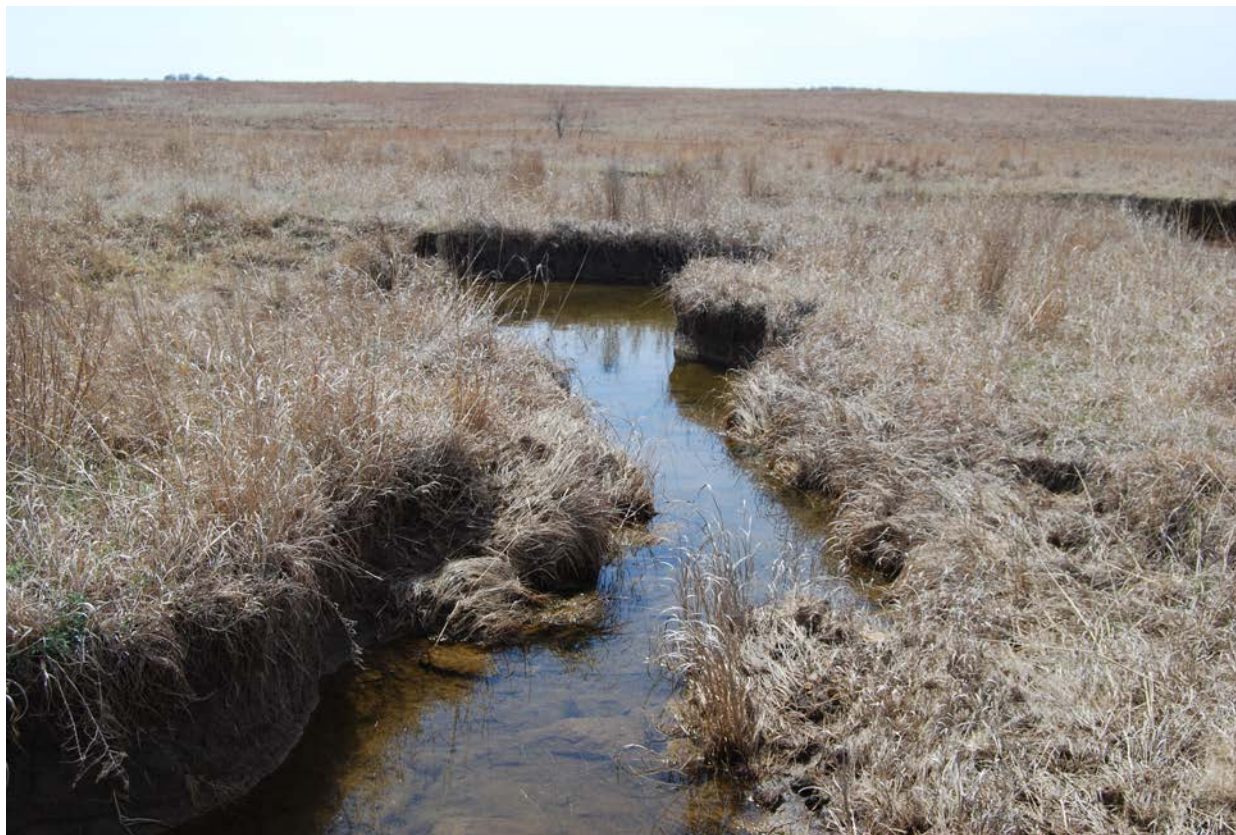
Photo No. 12

Description: The tributary of Daniel's Run Creek, here, downstream of Dam 2 had bed and bank at this location.

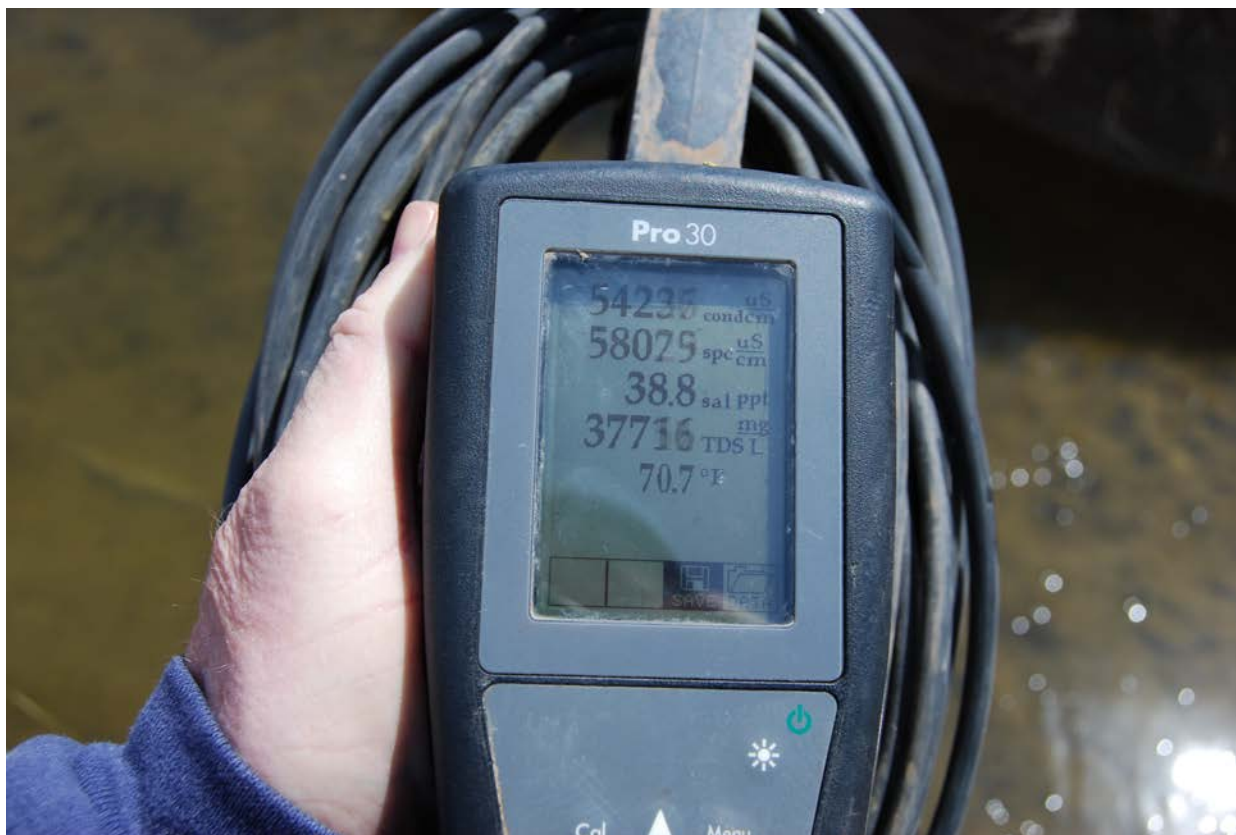
Photo No. 13

Description: The TDS of the tributary of Daniel's Run Creek shown in Photo 12 was 37,716 mg/L.

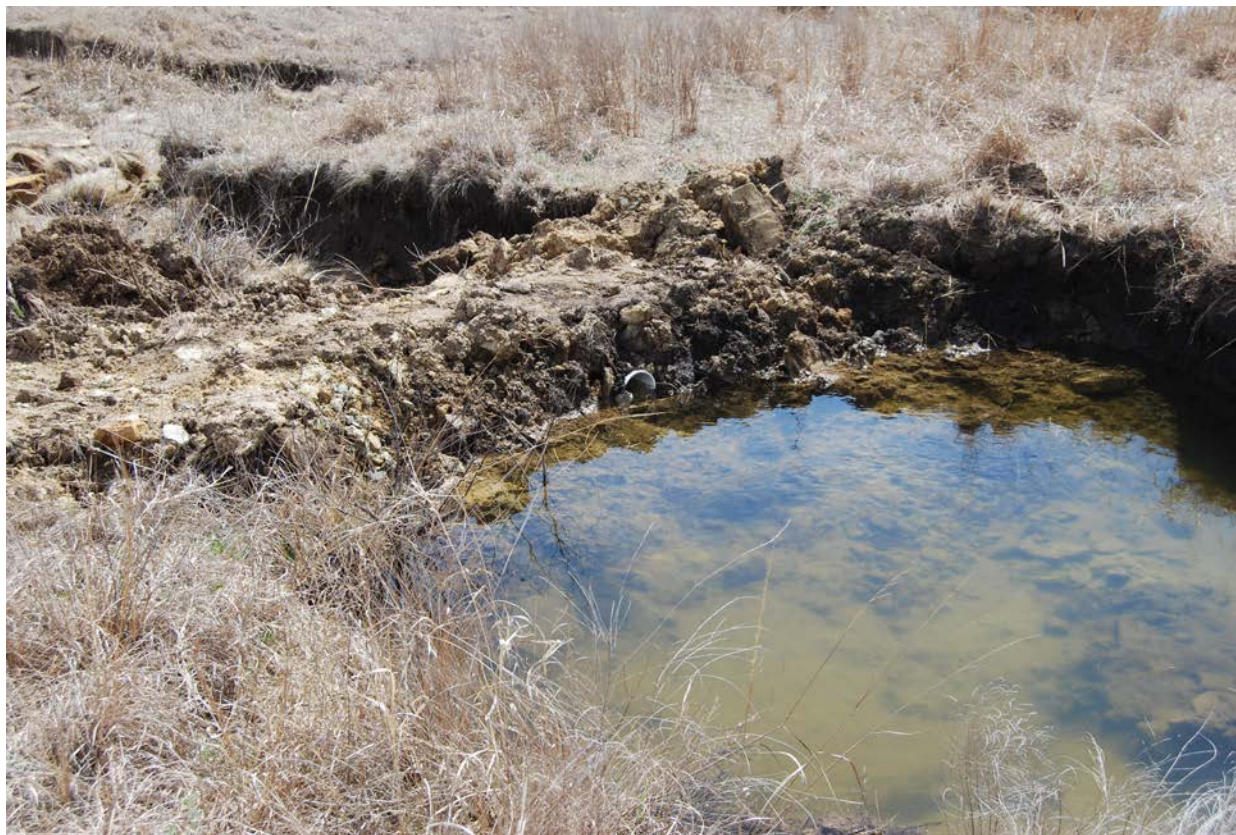
Photo No. 14

I arrived at the Diamond 3S, LLC, Kennedy lease at about 2:00 pm on April 12, 2018. I confirmed the discharge was seeping into the tributary of Daniel's Run Creek due to contaminated soil and a recent rainfall event. I observed one truck hauling water from the tributary for approximately two hours during the inspection. Photo 1 indicates the injection well sign located a few yards from the previous discharge point. The previous brine leak contaminated a large area of soil which was actively seeping into the tributary of Daniel's Run Creek. Photos 2 and 3 show the area along the flow path, downhill from the previous point of discharge, that was actively seeping during the inspection to the tributary of Daniel's Run Creek. The Total Dissolved Solids (TDS) in the tributary of Daniel's Run Creek was taken with a calibrated YSI Pro 30 Conductivity Meter at the point of entry and measured 83,783 mg/L (Photo 4). The first temporary dam is shown in Photo 5. TDS at this first dam, or Dam 1, was 33,526 mg/L (Photo 6). This first dam was also seeping brine downstream from the base of the dam. Downstream from Dam 1 (Photo 7) the tributary was full and flowing south. TDS of the tributary in Photo 7 was 62,811 mg/L (Photo 8). The tributary had fluids backed up behind the second dam, or Dam 2, shown in Photo 9. Water was flowing through the pipe (Photo 10) in the dam. TDS of the tributary at this location was 20,395 mg/L (Photo 11) at Dam 2. The tributary flowed south (Photo 12) towards the third temporary dam, or Dam 3. TDS in the tributary at the location shown in Photo 12 was 37,716 mg/L (Photo 13). The third dam, or Dam 3 was shown in Photo 14. TDS at that point was 23,587 mg/L (Photo 15). The

Description: The photo shows Dam 3. During the inspection, there was water flowing through the pipe downstream in Daniel's Run Creek.

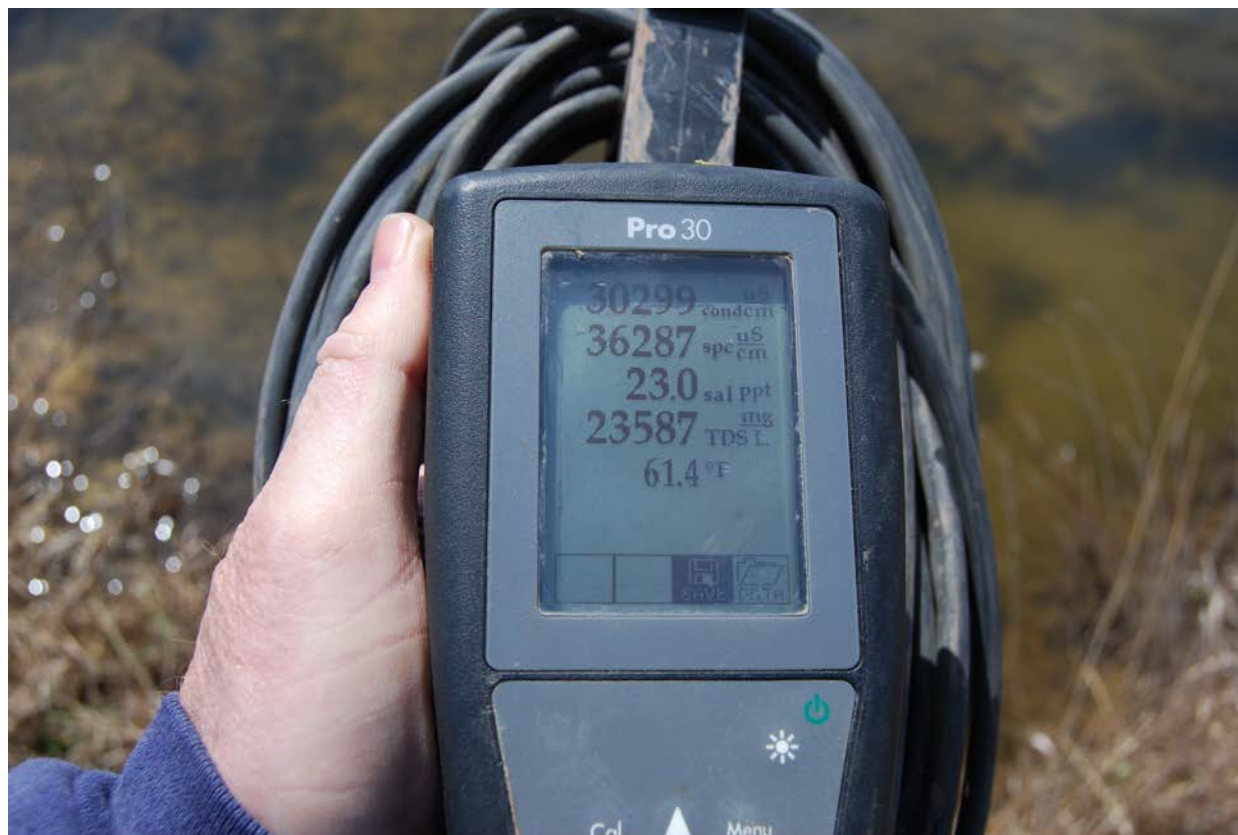
Photo No. 15

Description: The TDS at Dam 3 was 23,587 mg/L.

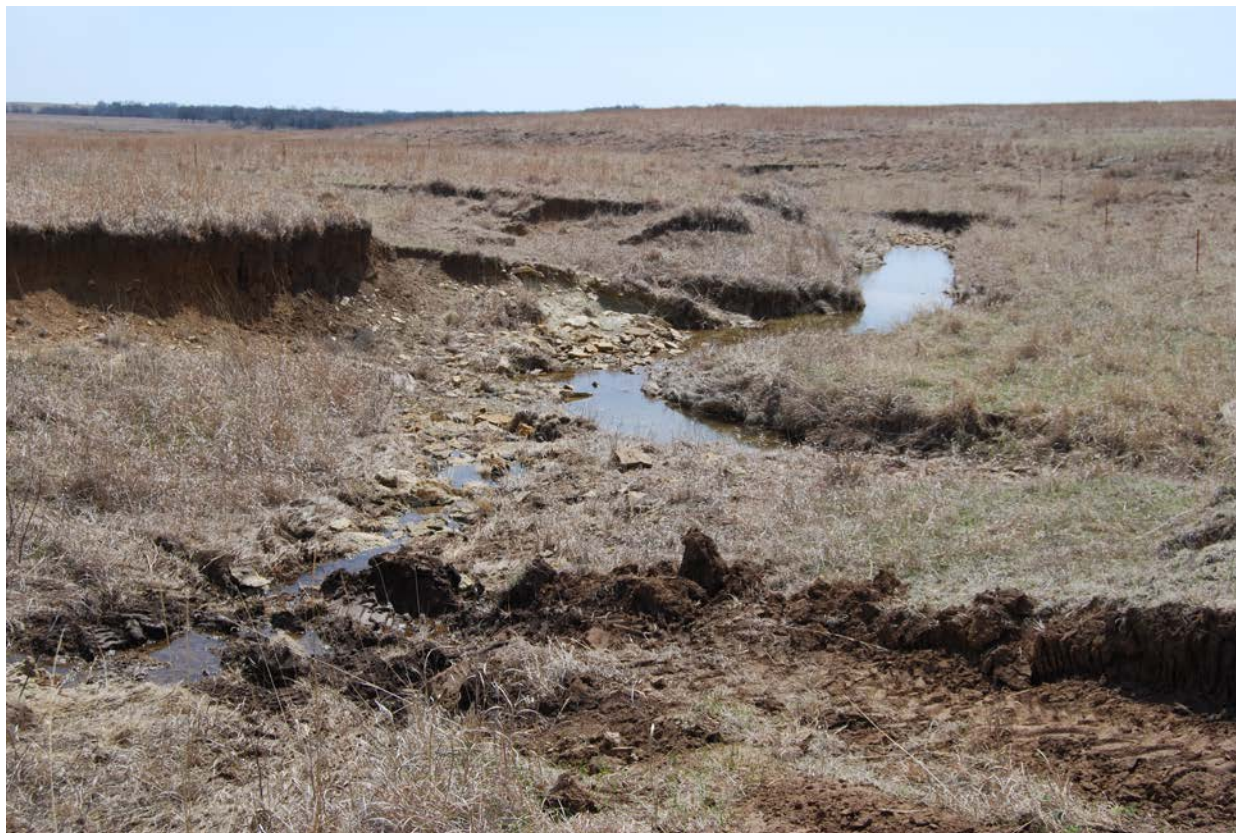
Photo No. 16

affected tributary joined another branch of the Daniel's Run Creek flowing from the west as shown in Photo 16. TDS of the contaminated water at the confluence was 11,800 mg/L (Photo 17). I observed remains of a dead crayfish at the junction of the tributaries, shown in Photo 18. The tributary continued to flow south of Dam 3 (Photo 19). The upstream portion of the tributary, north of the discharge entry point where seepage had occurred, was shown in Photo 20. TDS upstream was 917 mg/L (Photo 21).

Description: The Daniel's Run Creek meets another branch or tributary that flowed from the west shown in this photo.

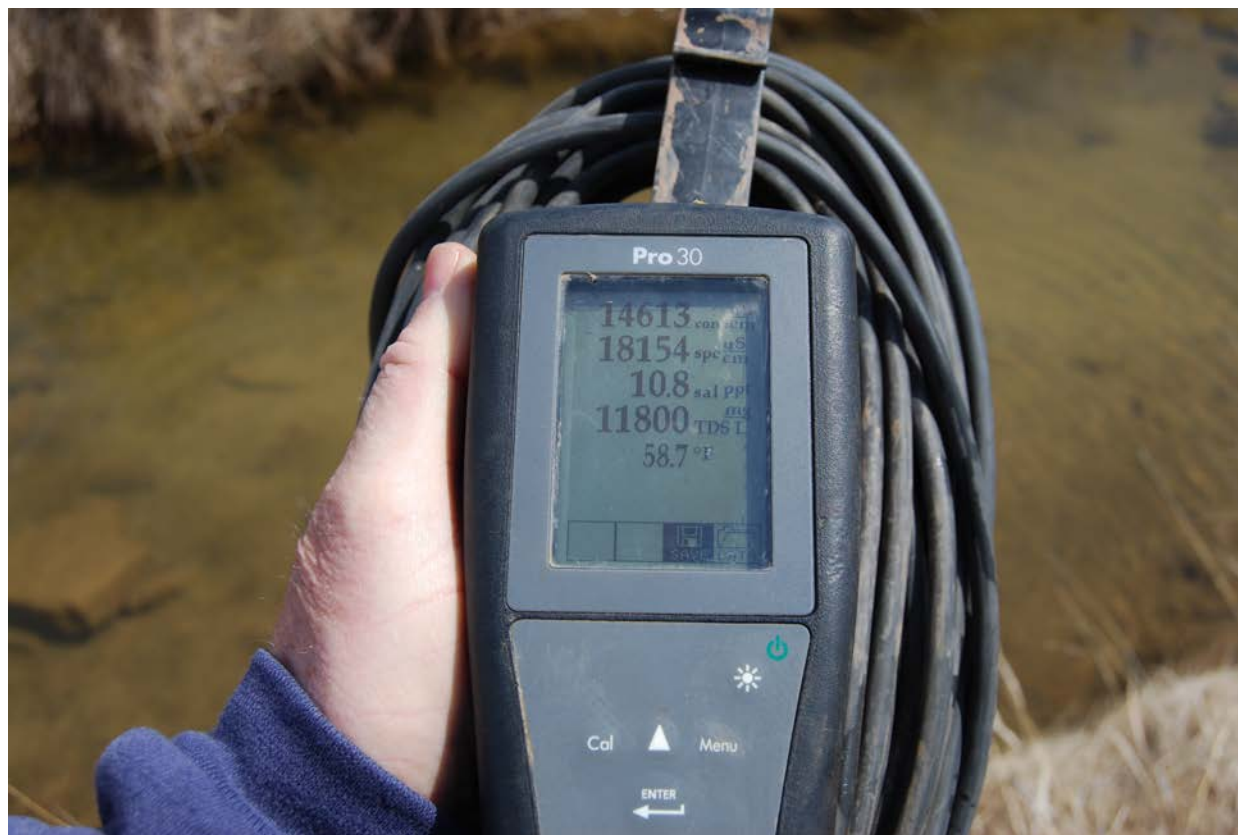
Photo No. 17

Description: The TDS of the water after the confluence of the tributary and the creek combined was 11,800 mg/L.

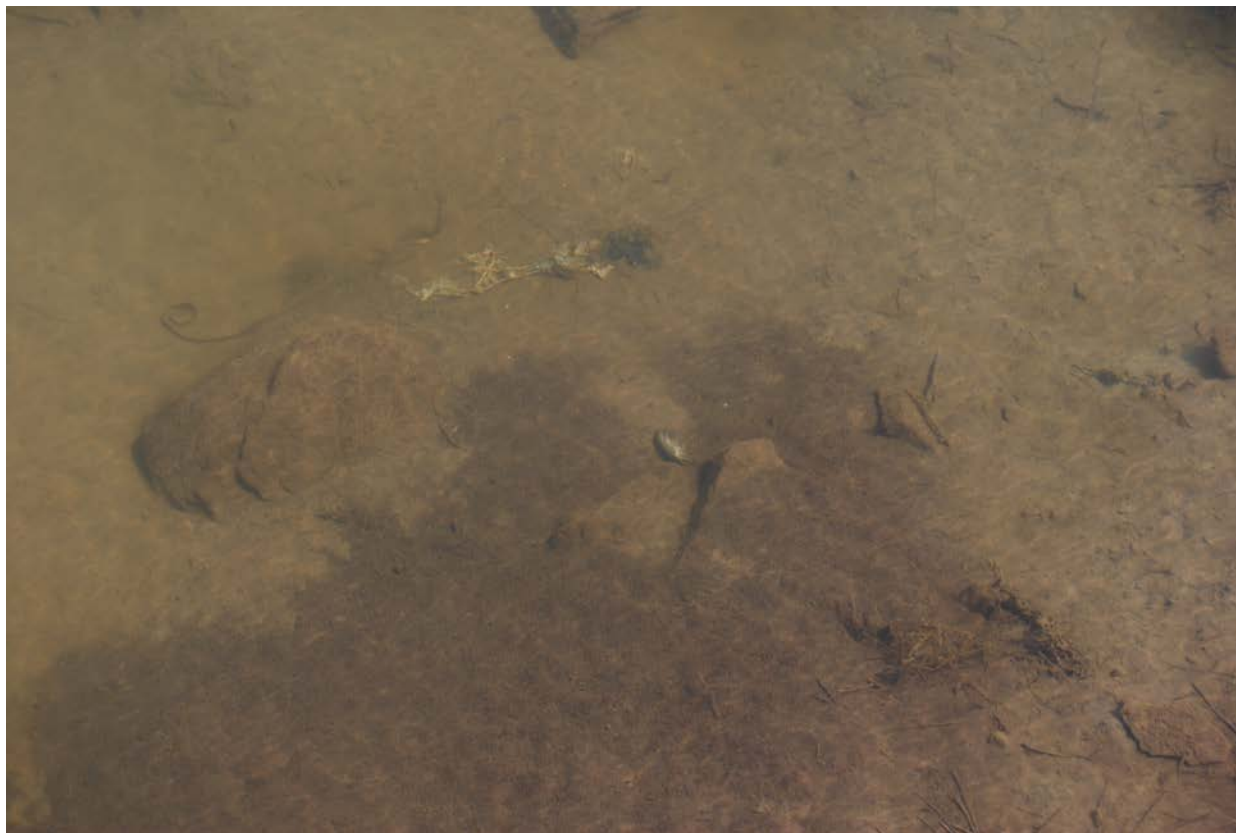
Photo No. 18

Description: A dead crayfish at the junction of the creek and the tributary of Daniel's Run Creek.

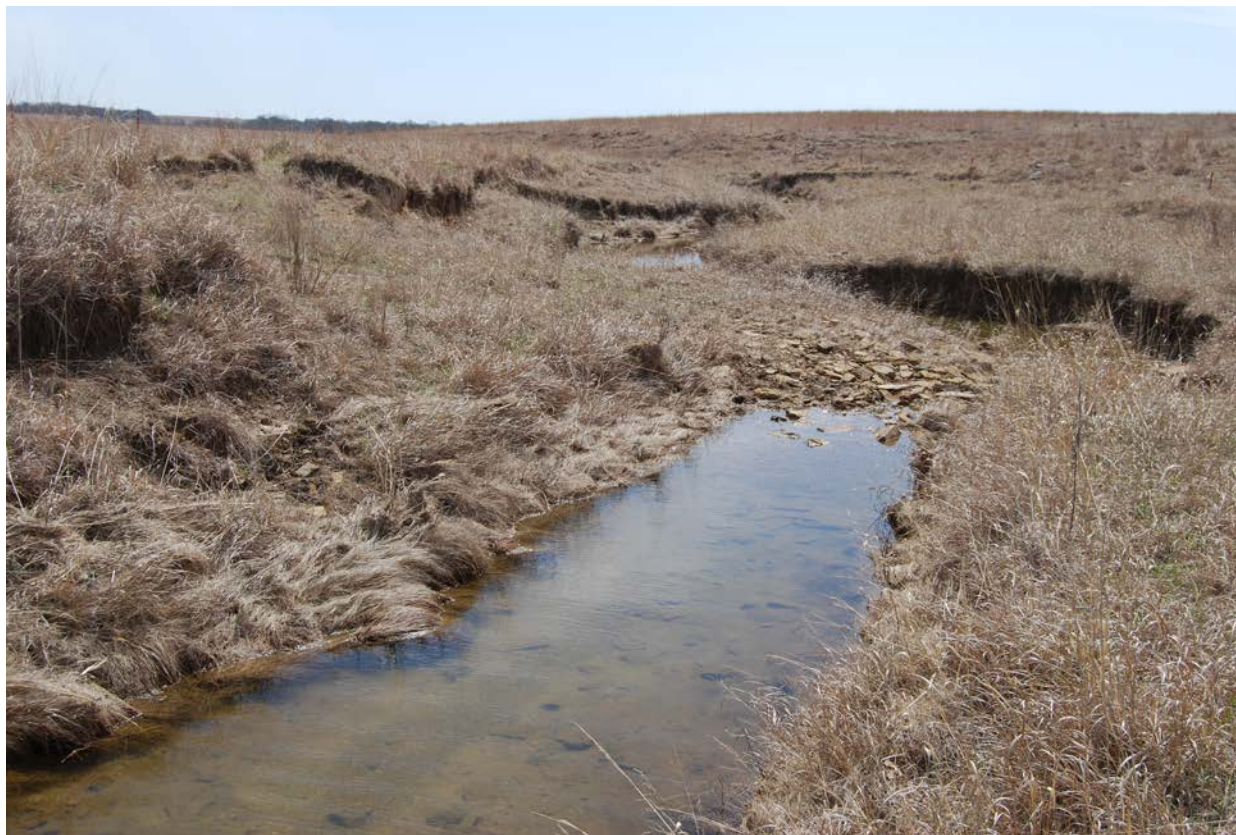
Photo No. 19

Description: This photo shows a view of the flowing creek, south of Dam 3. I observed bed and bank at this location.

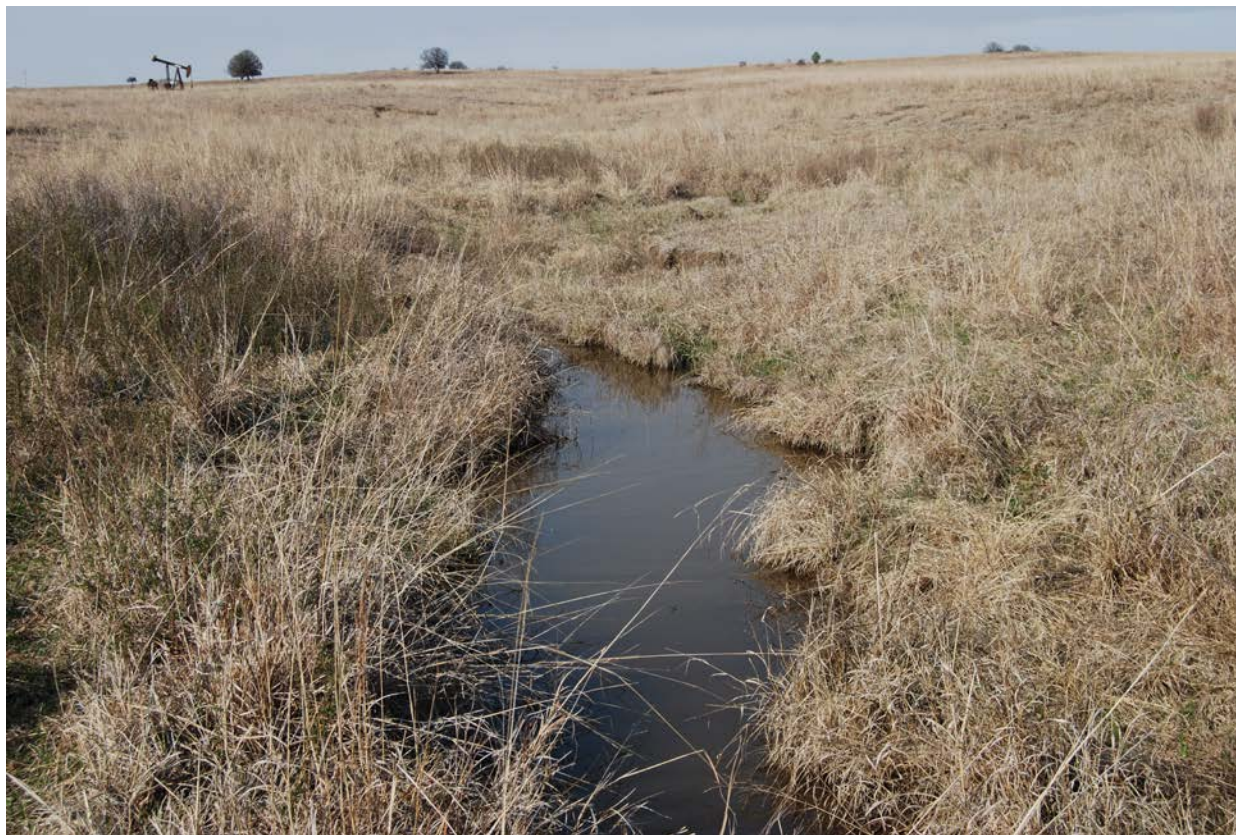
Photo No. 20

Description: This photo shows a view of the tributary of Daniel's Run Creek upstream of the discharge entry point.

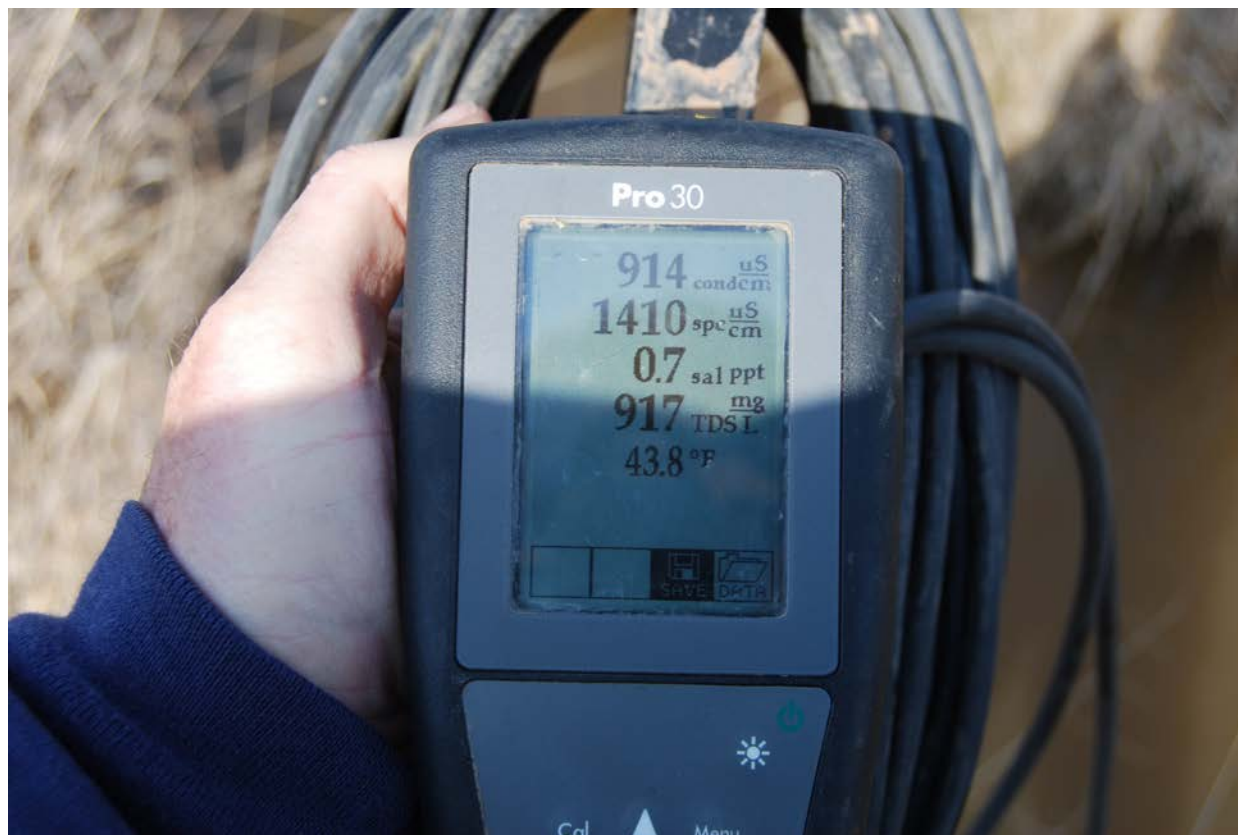
Photo No. 21

Description: The TDS of the tributary upstream of the discharge entry point was 917 mg/L.
