**SUBJECT:** CLEAN WATER ACT INSPECTION REPORT  
Calumet Specialty Products Partners, L.P., Burnham, Illinois

**Facility Name:** Calumet Specialty Products Partners, L.P.

**Facility Type:** Petroleum Products Transfer Terminal

**Date of Inspection:** May 28, 2021

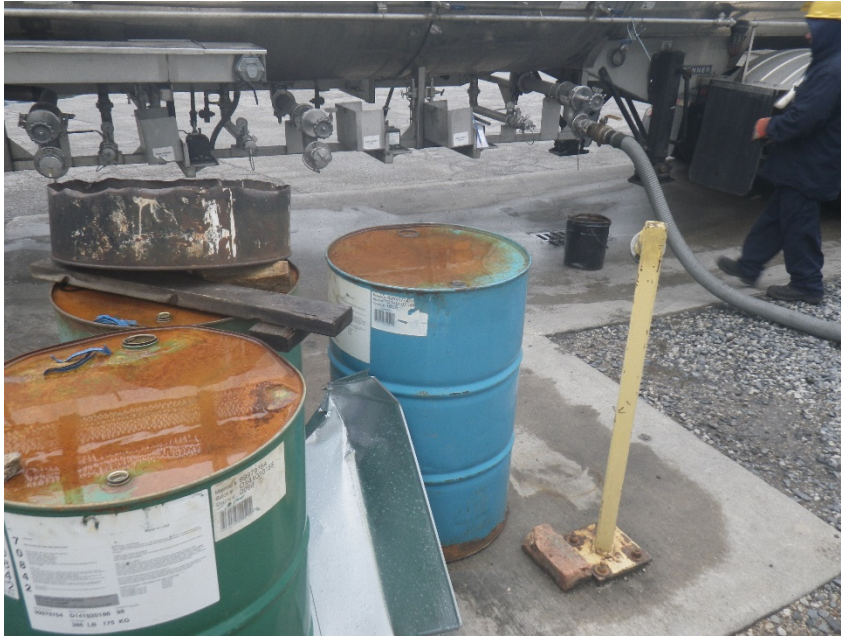
4: IMGP0004

The facility walkthrough focused on the site perimeter controls and internal stormwater sewer system. Stormwater on site gravity drains to a series of inlets which are all on an internal sewer. The internal sewer is gravity fed to a pump room and then pumped to an oil water separator, prior to being held, and then discharged to MWRD. MWRD samples at a manhole located directly to the east, off property, of the site (see image 23). The facility also has a surge wall which protects stormwater from going off site where rail cars unload (see image 1). Multiple inlets with standing water were observed, and it was noticeable that these inlets were well maintained but draining water slowly where the gravity elevation was higher (see images 2, 3, 6, 6, 8, 11, 15, 16, 17, 25, 28, 32). No trains were active on site, but trucks were present loading product near inlets (see image 4, 14). General maintenance on site was good as evidenced by lack

Description: Hose and Bucket Below Tank Truck

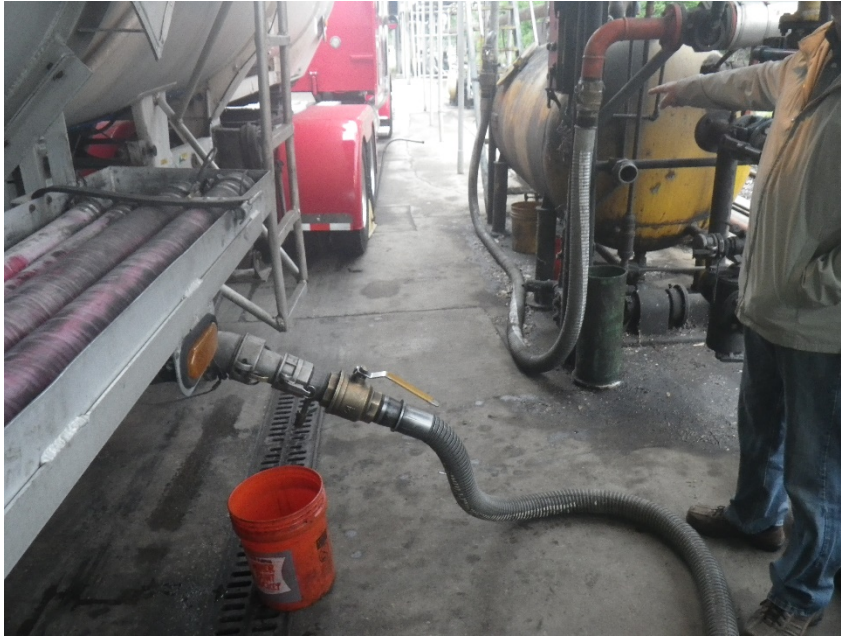
14: IMGP0014

Description: Truck over Trench Drain

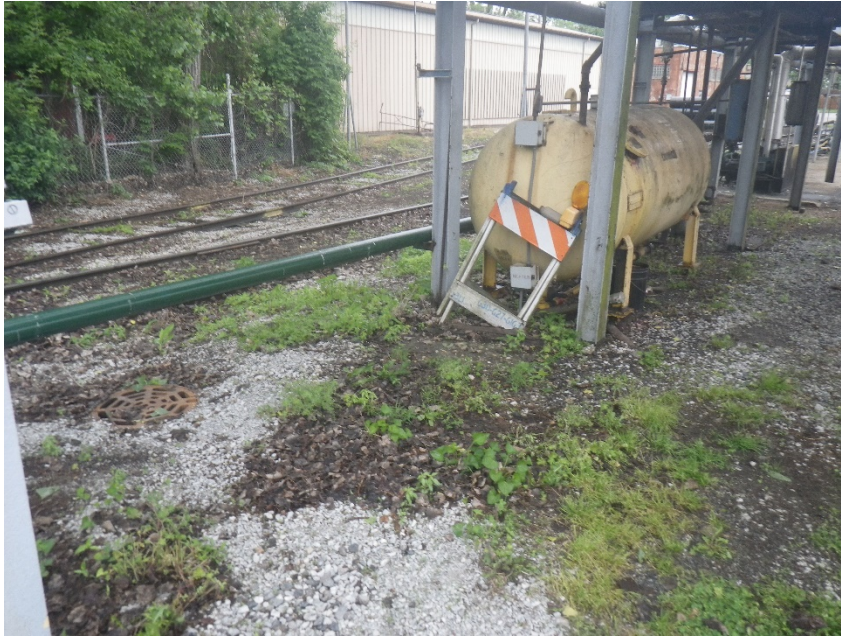
16: IMGP0016

of sheen at most inlets, although sheen was present at the most low lying area (see image 28), and site flow characteristics were acting as designed with no evidence of water leaving the site or pooling in areas without inlets. One area of the site (see image 16) upper elevation east side, may not have had the necessary elevation gradient to ensure stormwater from heavy rainfall would stay on site, but this was not verified. All industrial waste and storage containers not actively being used were enclosed in the Inside storage Building on the North end of the site (see image 13). The pump room appeared in good working order (see images 18, 19, 20), and there was no evidence of issues with the oil/water separator (see image 21).

Description: Catch Basin and Tank

It is recommended that the site conditions around the inlet identified in image 16 be checked to confirm they are to the correct gradient to keep water gravity flowing away from the property line of the site.

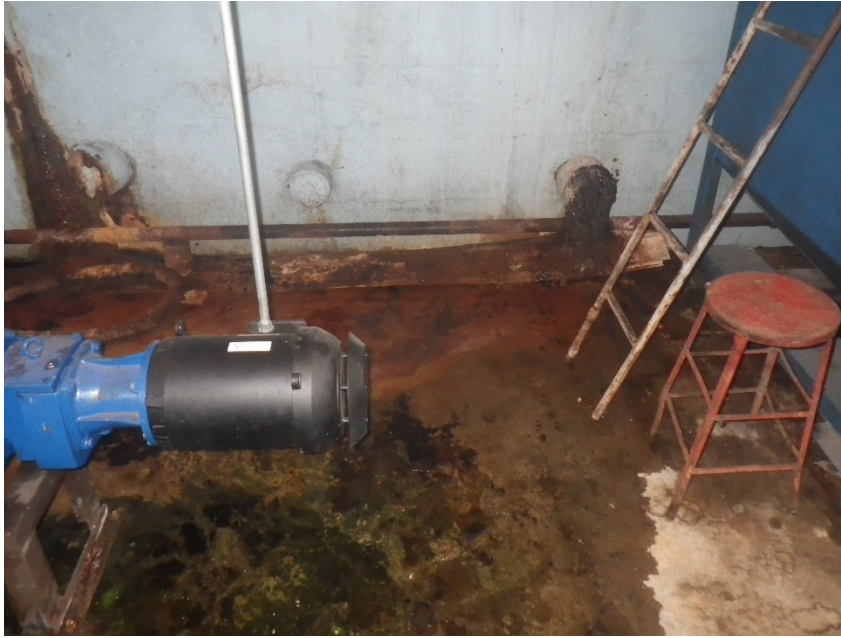
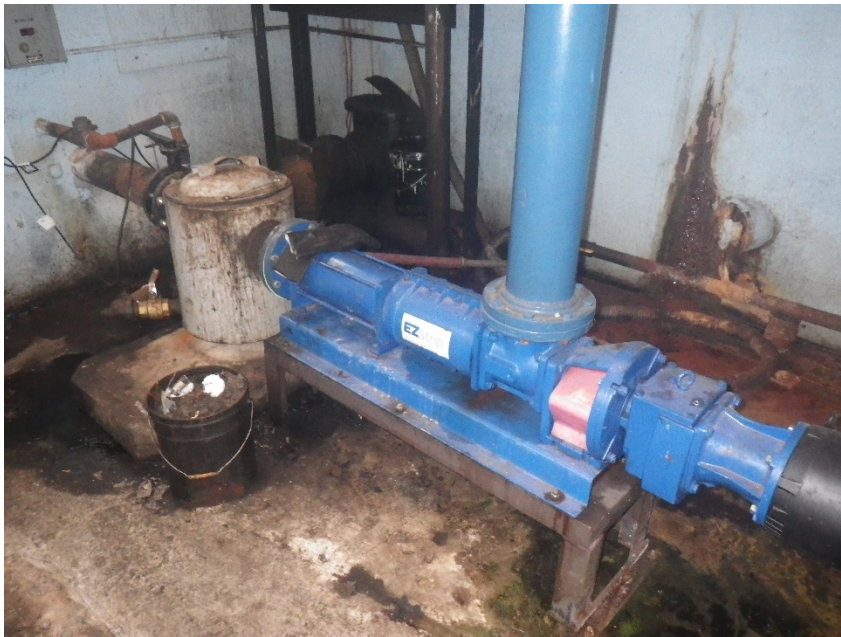
Description: Pump Room with Progressive Cavity Pump

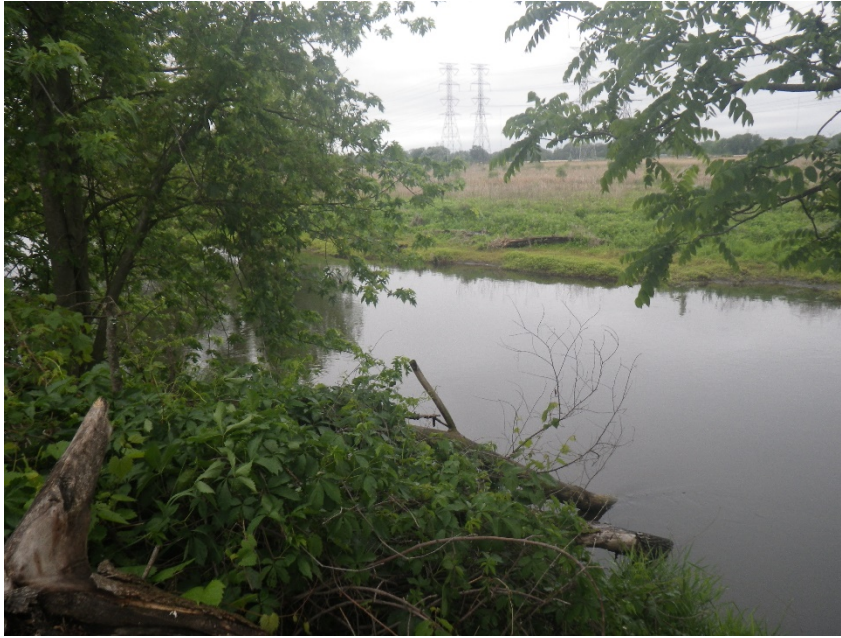
26: IMGP0026

Focusing on the low-lying areas of the site. It was evident that the height of the berm was sufficient to contain stormwater on the site (see images 24, 27, and 31) and there was no evidence of any petroleum product above the berm in the vegetation (see image 29, 30, 33, 34) or in the Grand Calumet (see image 26, 35). Also in the low lying area, the facility has a dry hydrant (see image 29 and 30) which is a non-pressurized permanent pipe system installed to allow the withdrawal of water from the Grand Calumet River to provide a water source for fire suppression close to potential areas of concern.

Description: Grand Calumet Directly Adjacent to Site

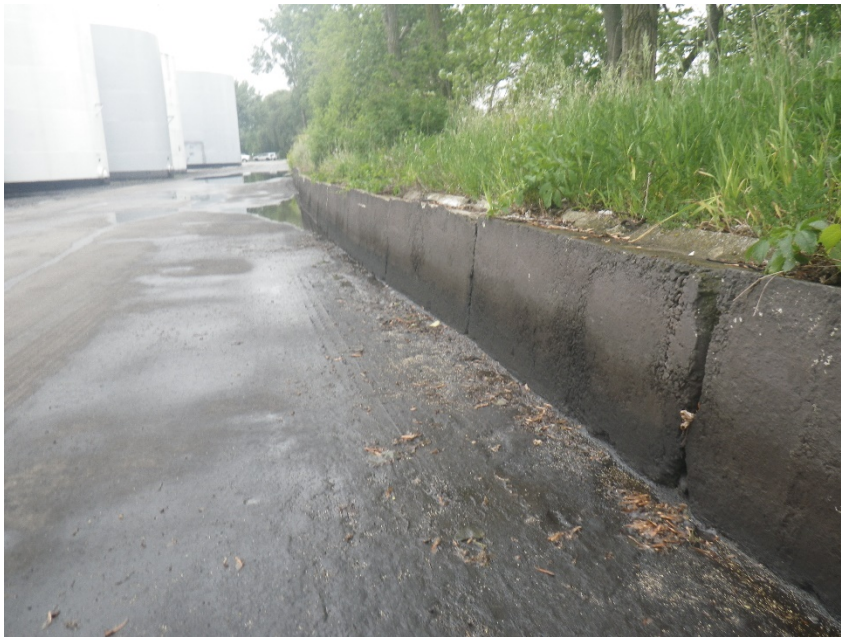
27: IMGP0027

Description: Low End of Site Berm

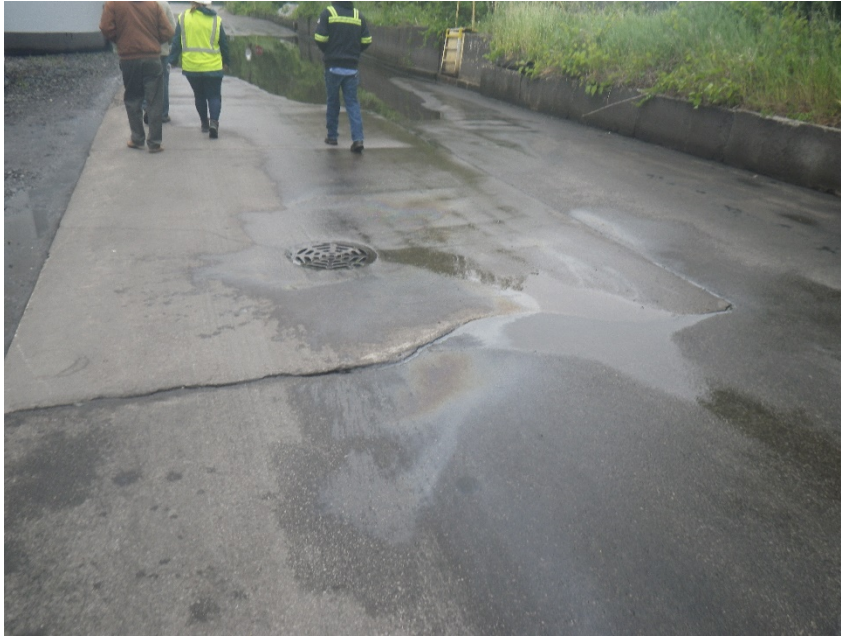
28: IMGP0028

Description: Catch Basin with Oil Sheen

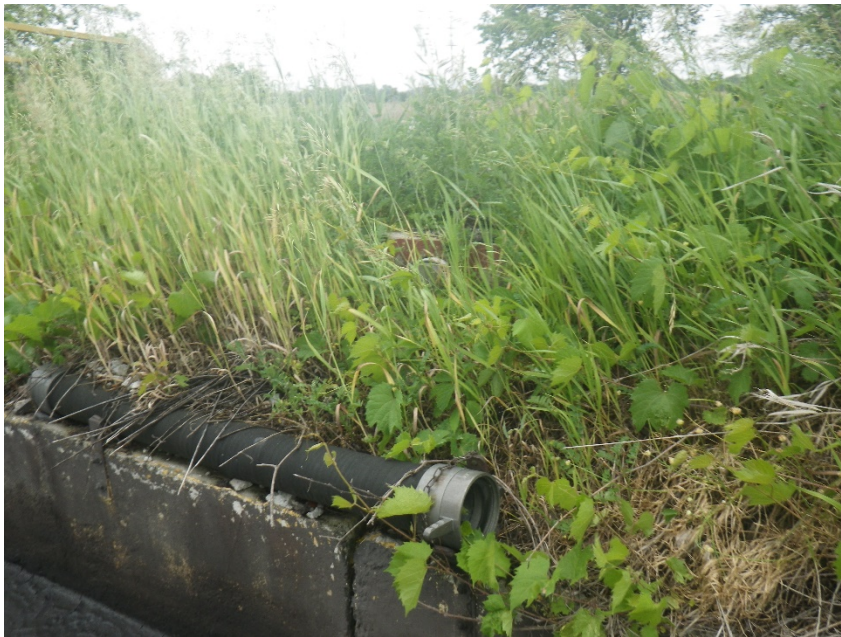
29: IMGP0029

Description: Dry Hydrant on Berm

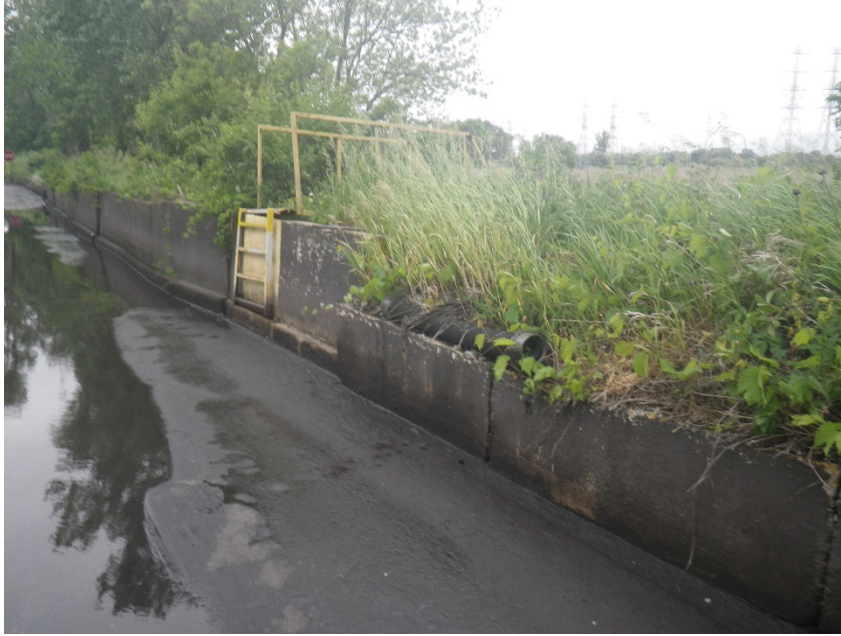
30: IMGP0030

Description: Dry Hydrant on Berm

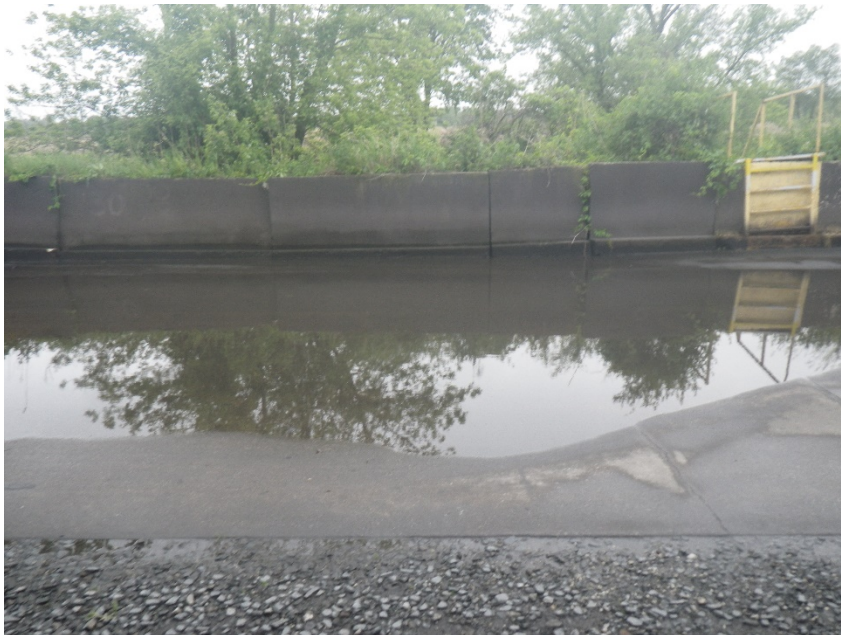
31: IMGP0031

Description: Standing water by Berm on Road

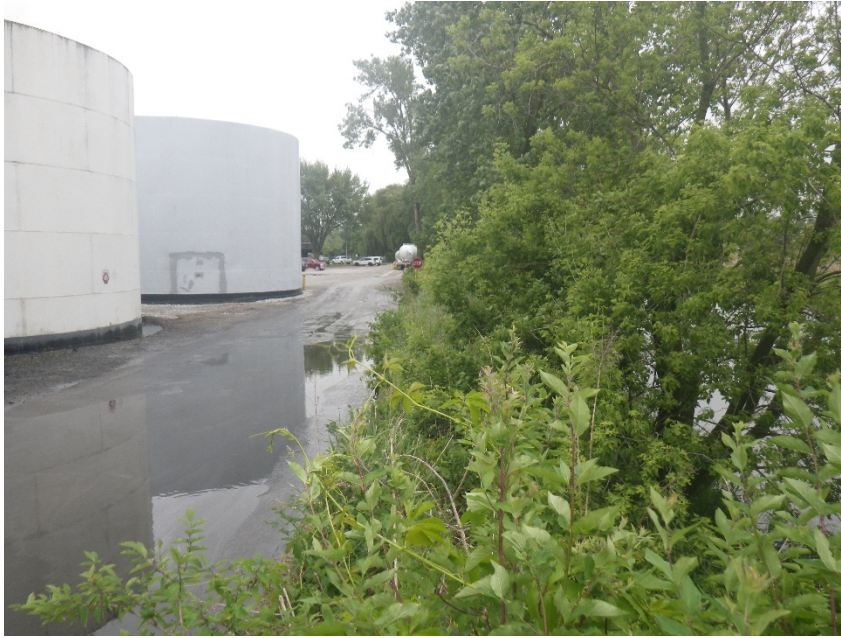
34: IMGP0034

Description: Top of Berm
