## CAA112(r) INSPECTION REPORT

| <b>Name:</b> Glycerin Traders | |
| <b>Process:</b> NAICS 325611-03, Glycerin Manufacturing | |

### SUMMARY OF OBSERVATIONS

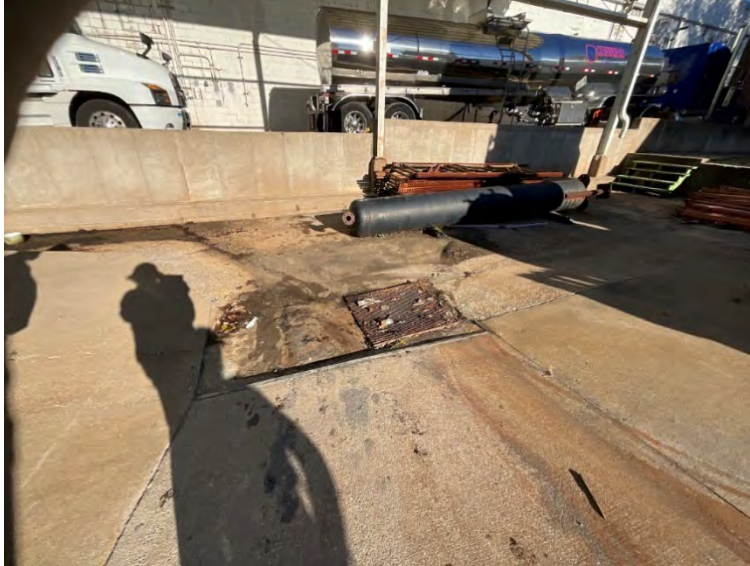
We observed and I documented by digital image evidence to chemical spill staining on the cement leading directly the stormwater drain (Appendix 1, digital image IMG\_0465.JPG).

IMG\_0465.JPG: Stormwater Drain – Goes directly to city stormwater system.

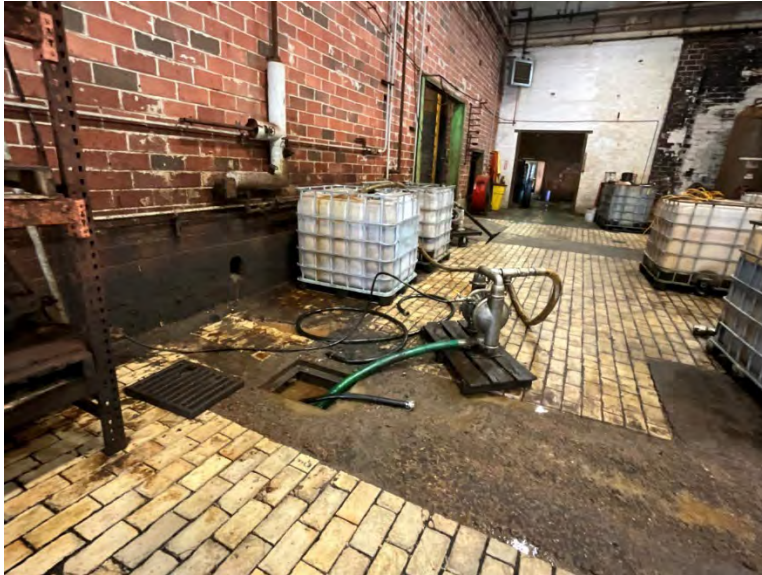
IMG\_0469.JPG: Pump for pumping spills to a tote. Entire floor area is covered in residue from spills and chemicals puddles on the floor and evidence of acid etching of cement flooring.

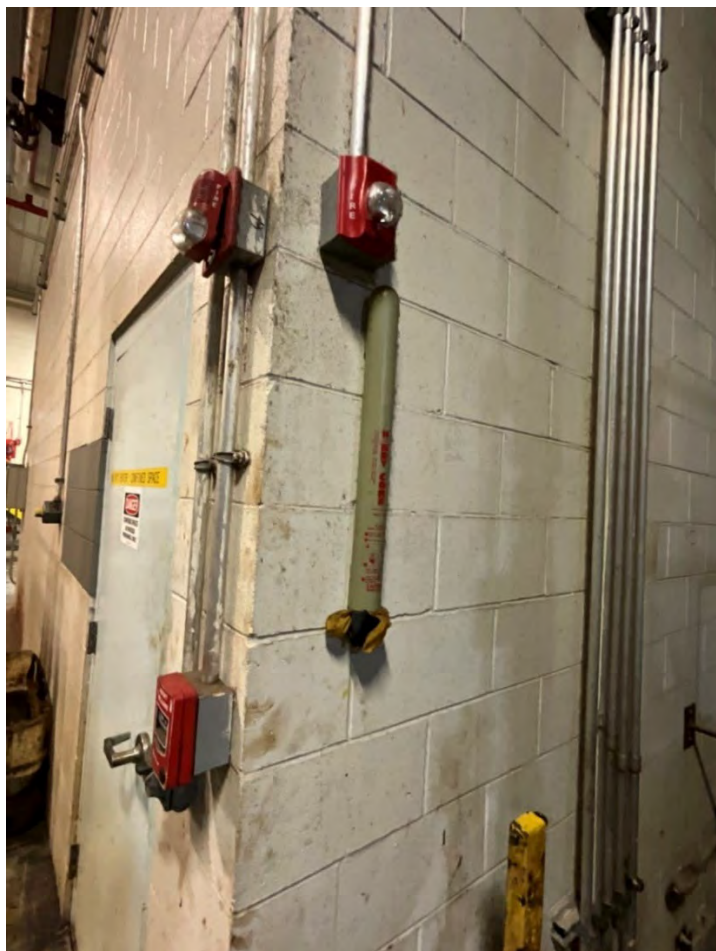
IMG\_0493.JPG: Side view of fire alarms in the area around the methanol room. Alarm to the left was said to be functional but appears to be broken.

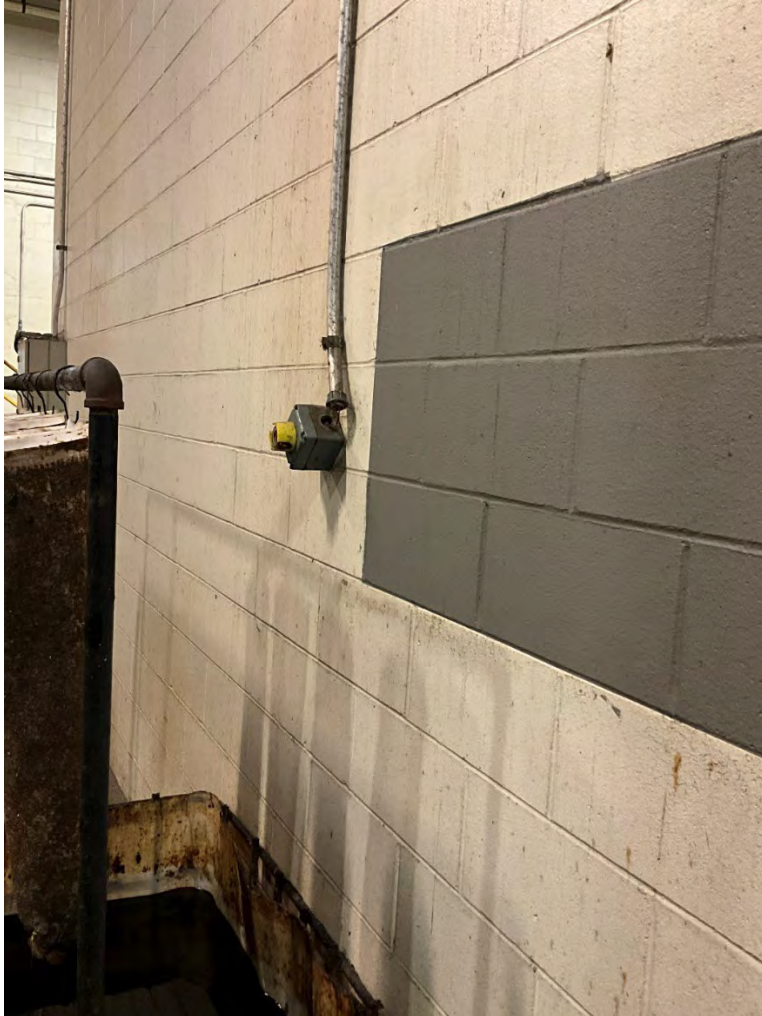
We also observed and I documented by digital image that an emergency stop button for the methanol storage room was snapped at the conduit junction and dangling by the wiring (Appendix 1, digital image IMG\_0494.JPG). We also observed and I documented by digital image a fire extinguisher maintained in the area (Appendix 1, digital image IMG\_0495.JPG).

IMG\_0494.JPG: Emergency shut off for the methanol pump. Functionality unknown. Button is hanging by its wires outside of the conduit in an area designed for electrical classification and fire/explosion prevention.

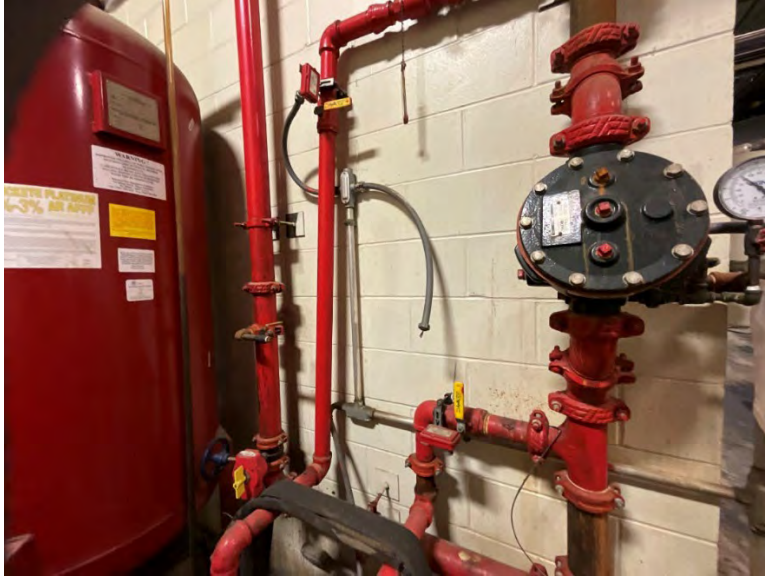
IMG\_0497.JPG: Close-up of system – electrical is disconnected and hanging with exposed wires, valves along the water line in closed positions. Water pressure gauge indicates pressure however, part of the system has been disabled and was told that the foam tank is not used.

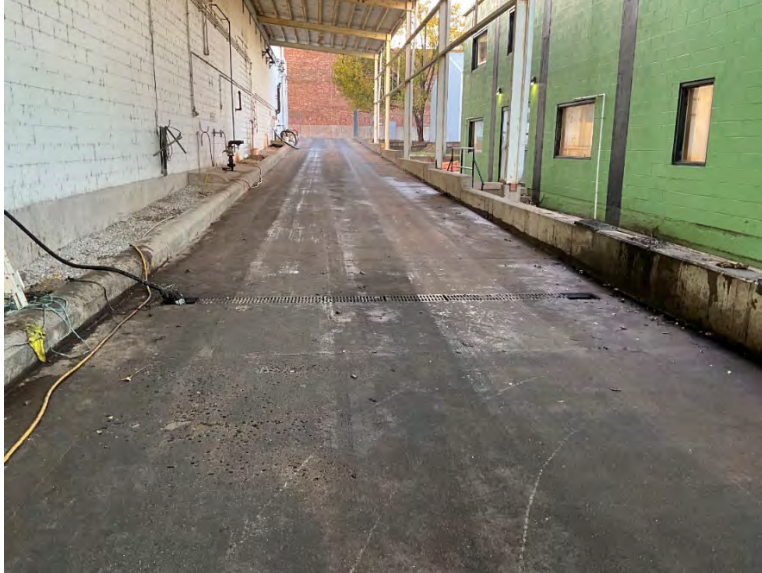
IMG\_0513.JPG: Trucks that will be loaded with methanol, glycerin, or vegoil, enter from the east or from the 5th street side of the facility and pull up to the loadout areas located on the processing buildings south wall. The grate running through the driveway is where spills from truck loading are captured and then pump via sump pump into the pit as seen in Images 42 and 43.

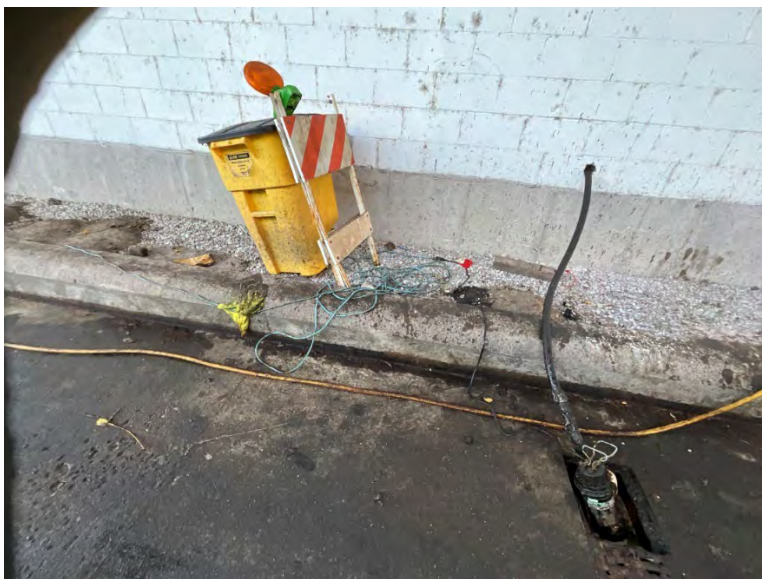
- c. **Failed to use existing fixed wiring to power electrical sump/pump equipment used to syphon chemical spills in the truck loading area, but instead used a power supply cord as a substitute, as prohibited by NFPA 70, NEC, Chapter 4, Article 400.12 (Identified after the inspection.)**

Also seen in this image is the sump pump that is powered via an extension cord and is left running to suction any spills that could occur. The residue of any spill is pumped into the pit area documented in images IMG\_0478.JPG, IMG\_0500.JPG and IMG\_0501.JPG. We observed and I took a digital image of the sump pump in the drain, the hose running through the wall to the pit and the extension cord powering the sump pump (Appendix 1, digital images IMG\_0514.JPG and IMG\_0515.JPG).

IMG\_0515.JPG: Image of sump pump, extension cord, and hose going through a hole in the facility wall to the pit that is located on the other side of the wall.

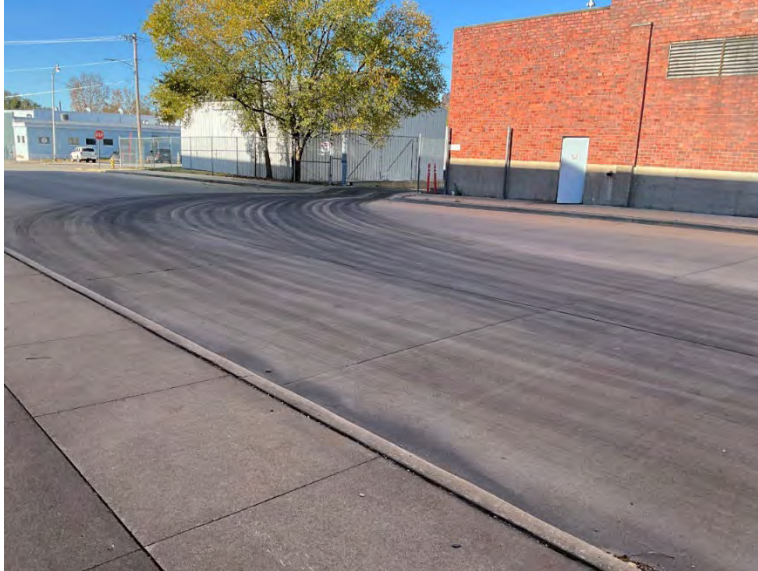
IMG\_0524.JPG: This image was taken from 4th Street that shows how the trucks track spilled glycerin or Veg Oil onto the public roadway. Also shows the fire water connection on the street side that was discussed in Image 41.

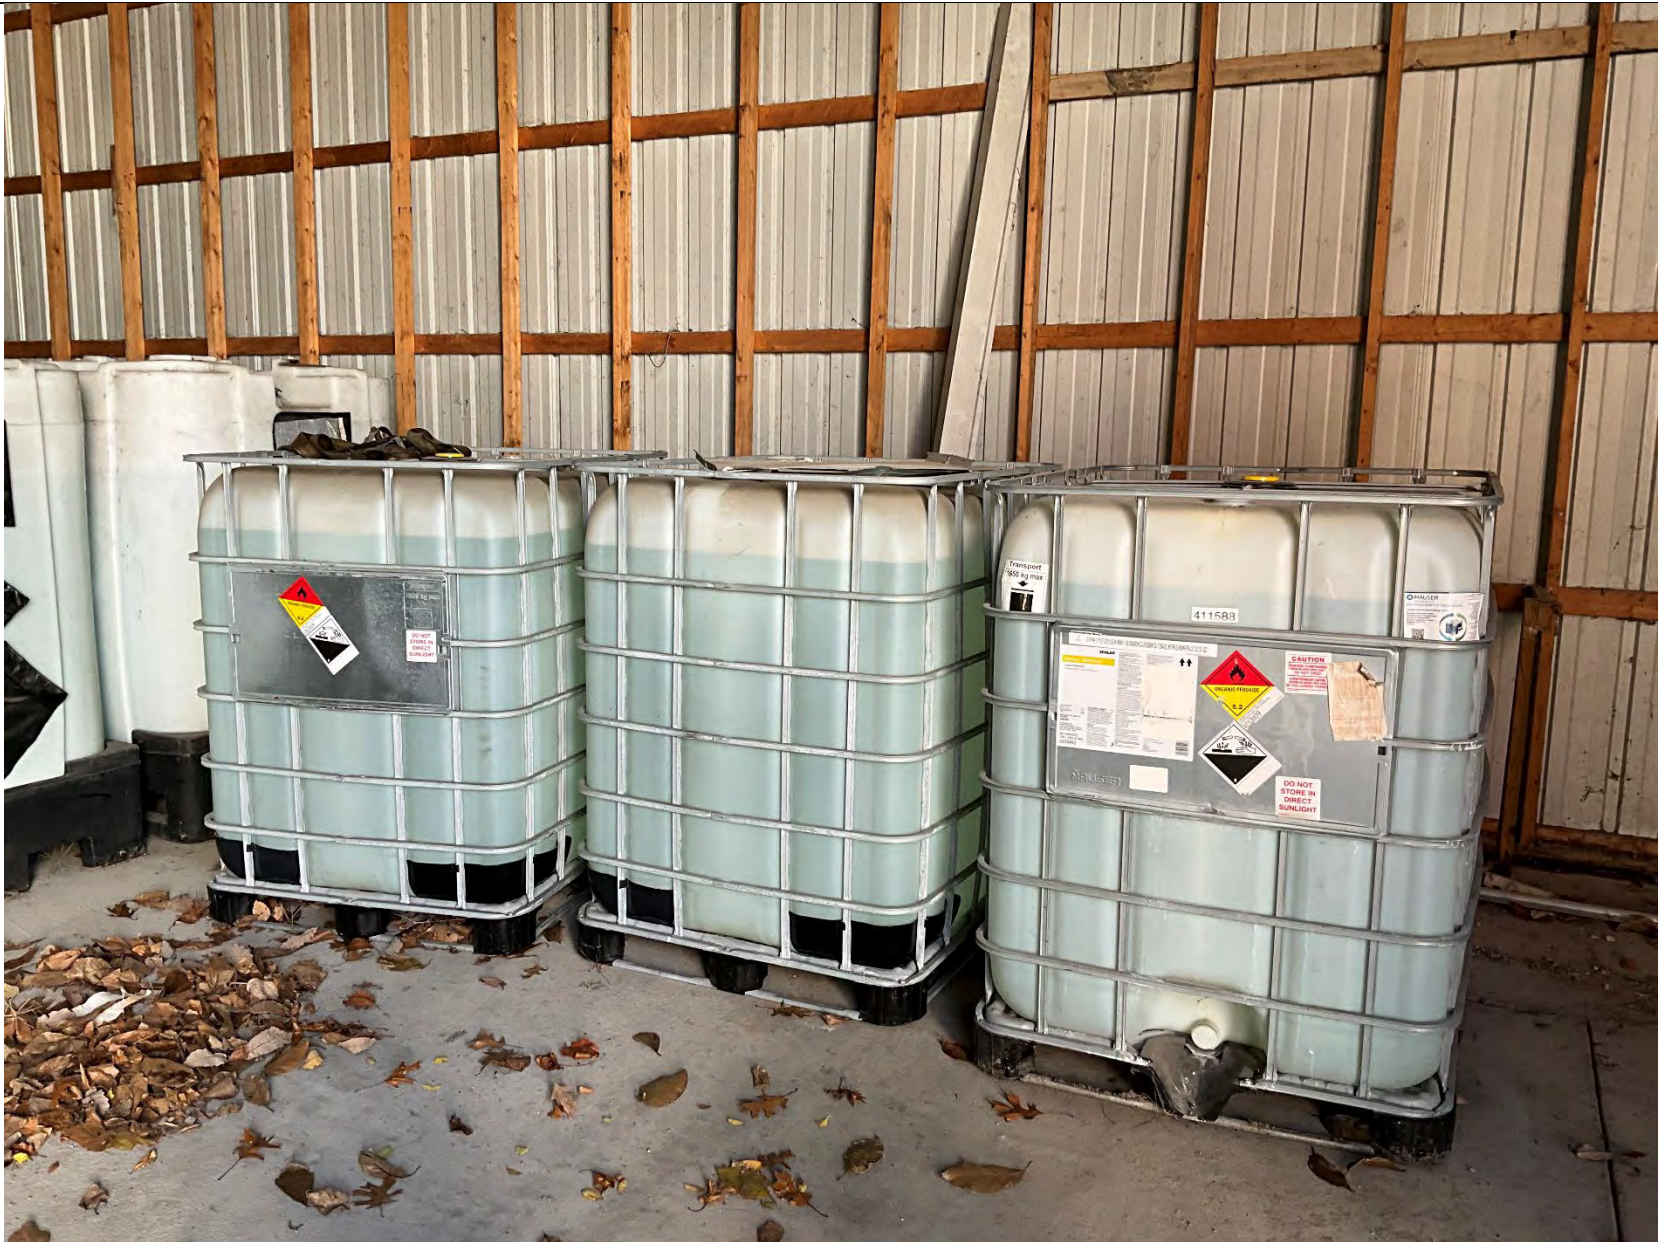
| Number | Photo |
|---|---|
| 1 | <p data-bbox="262 1382 1971 1455">Organic Peroxide located in East Pole Building. Reported to be onsite for approximately 2 months. Three totes contain approximately 275 gallons organic peroxide.</p> |

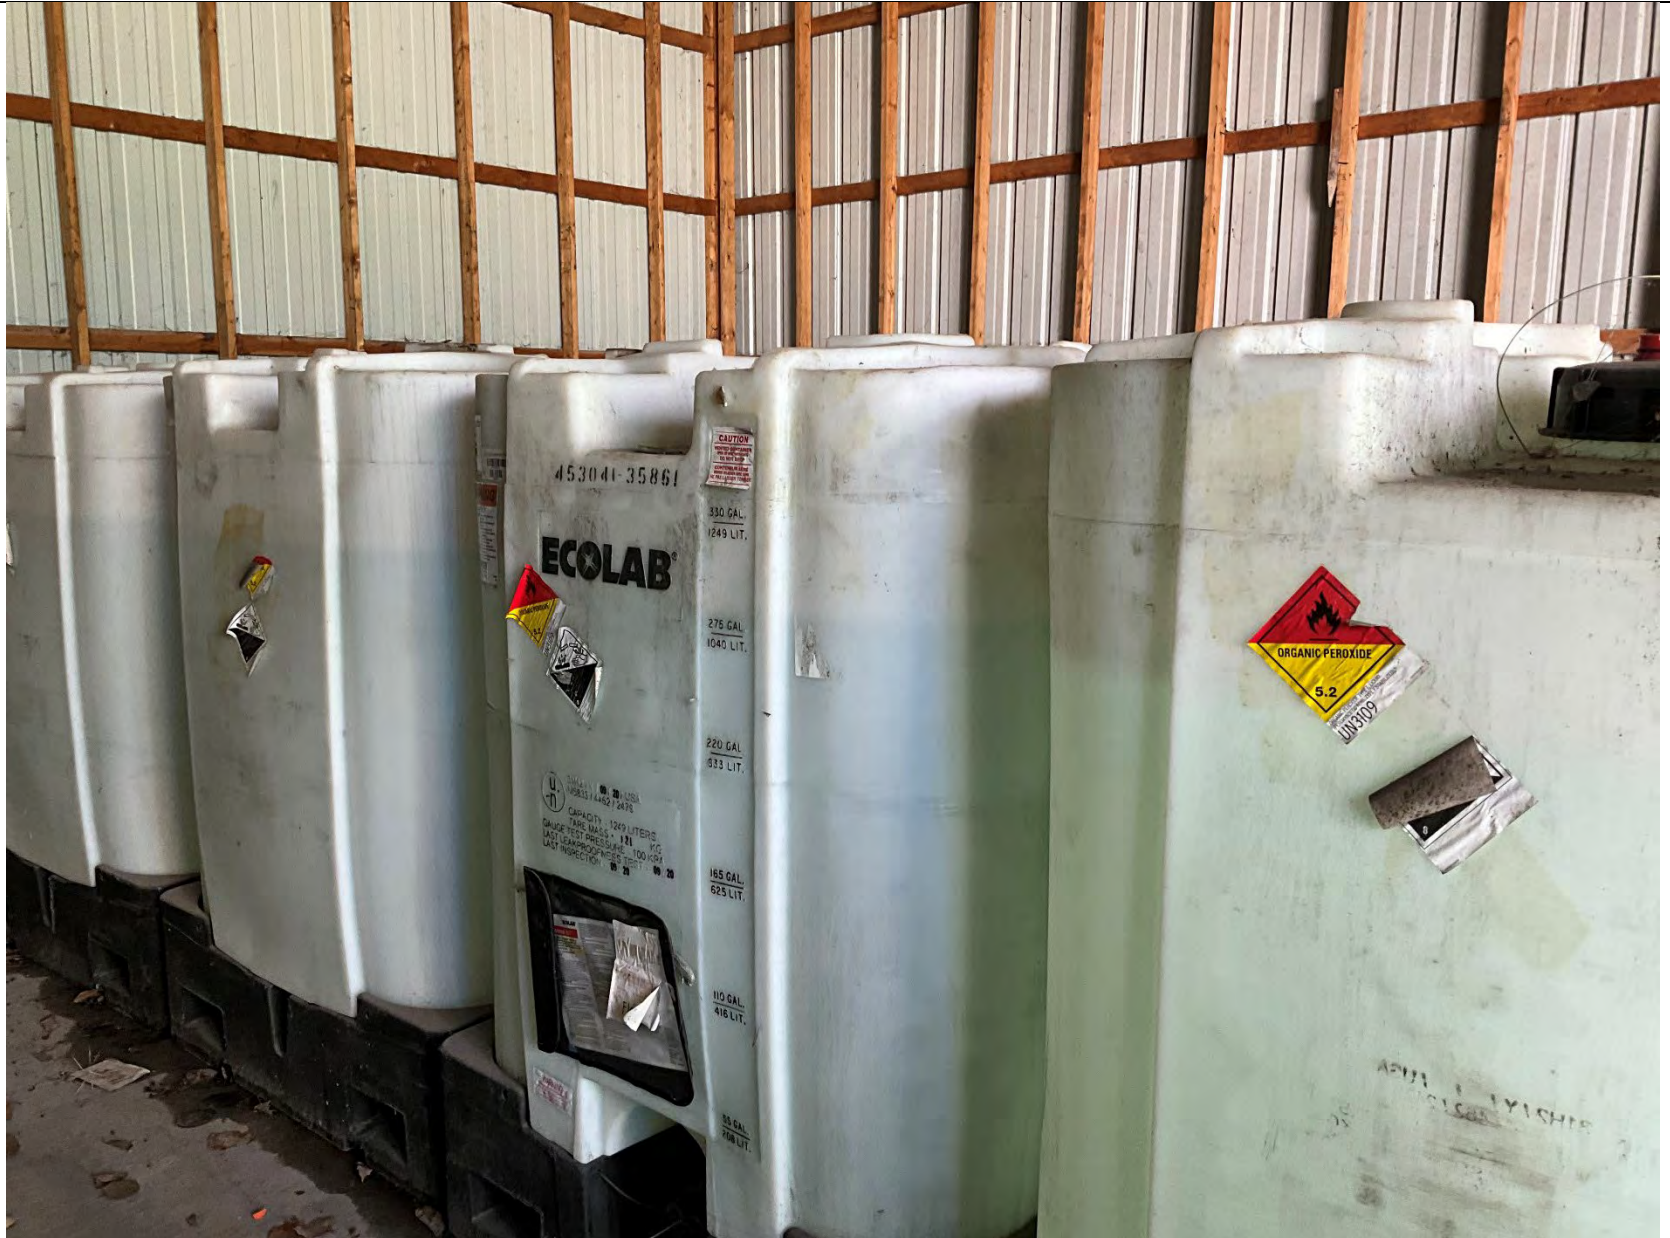
Organic Peroxide located in East Pole Building. Reported to be onsite for approximately 2 months. Nine totes contain approximately 275 gallons organic peroxide.

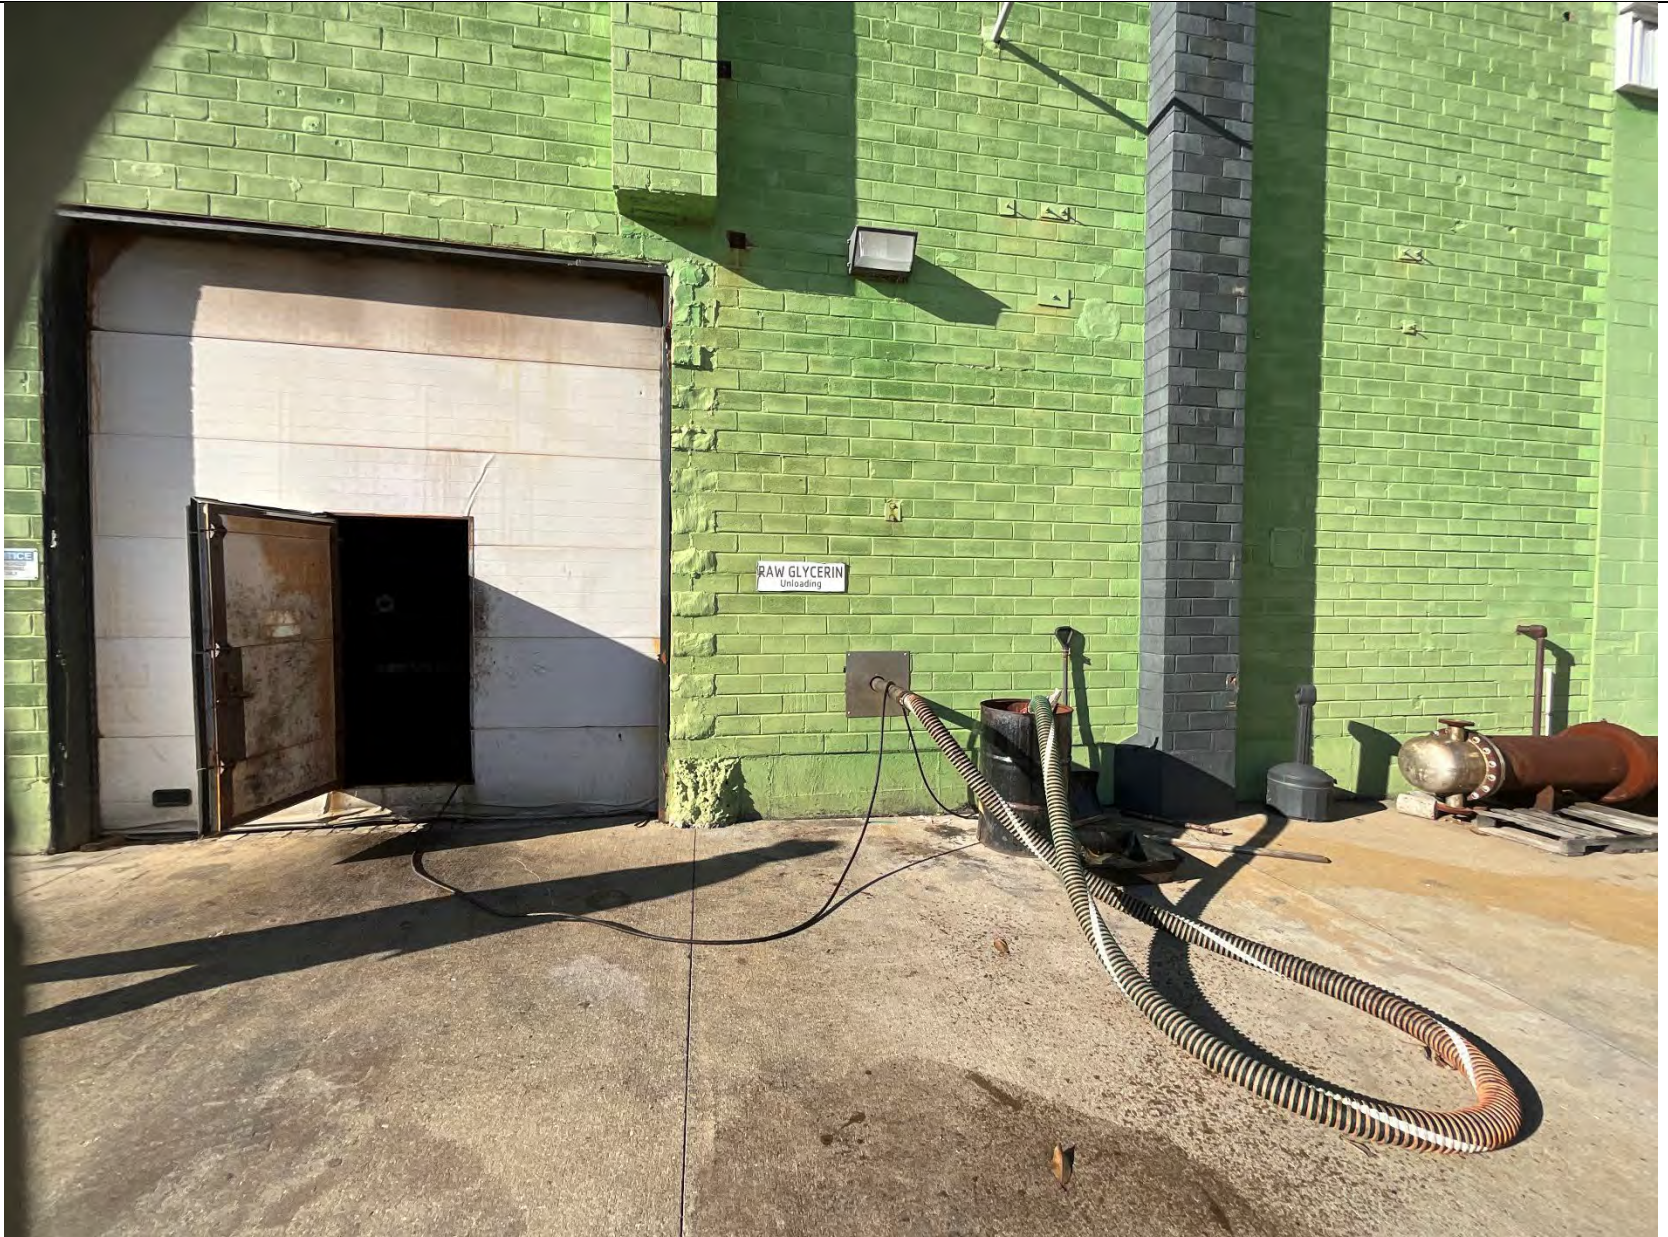
6

Raw Glycerin unloading truck unloading area. Trucks back in from Exchange Street which is on the south side of the plant complex. Evidence of spills that occur during unloading. East side of the south tank farm and warehouse building.

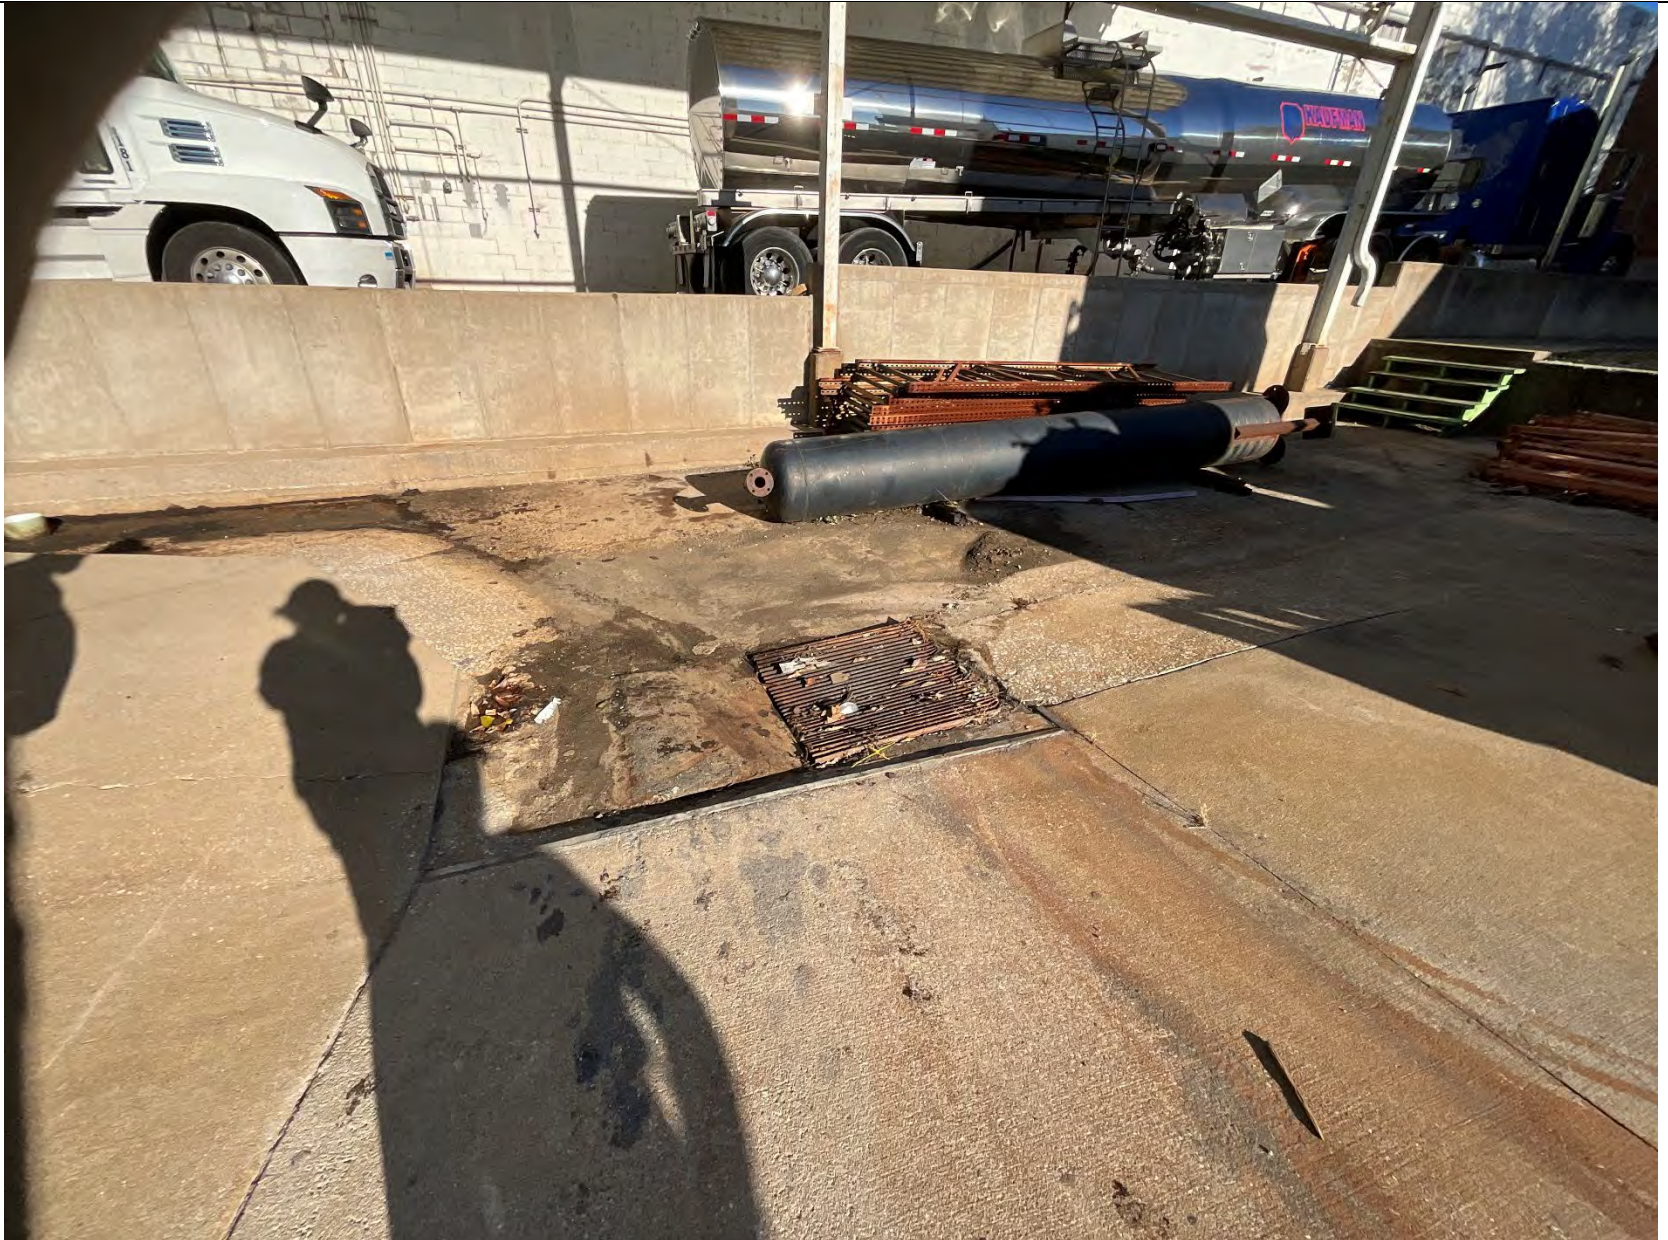
Stormwater Drain – Goes directly to city stormwater system

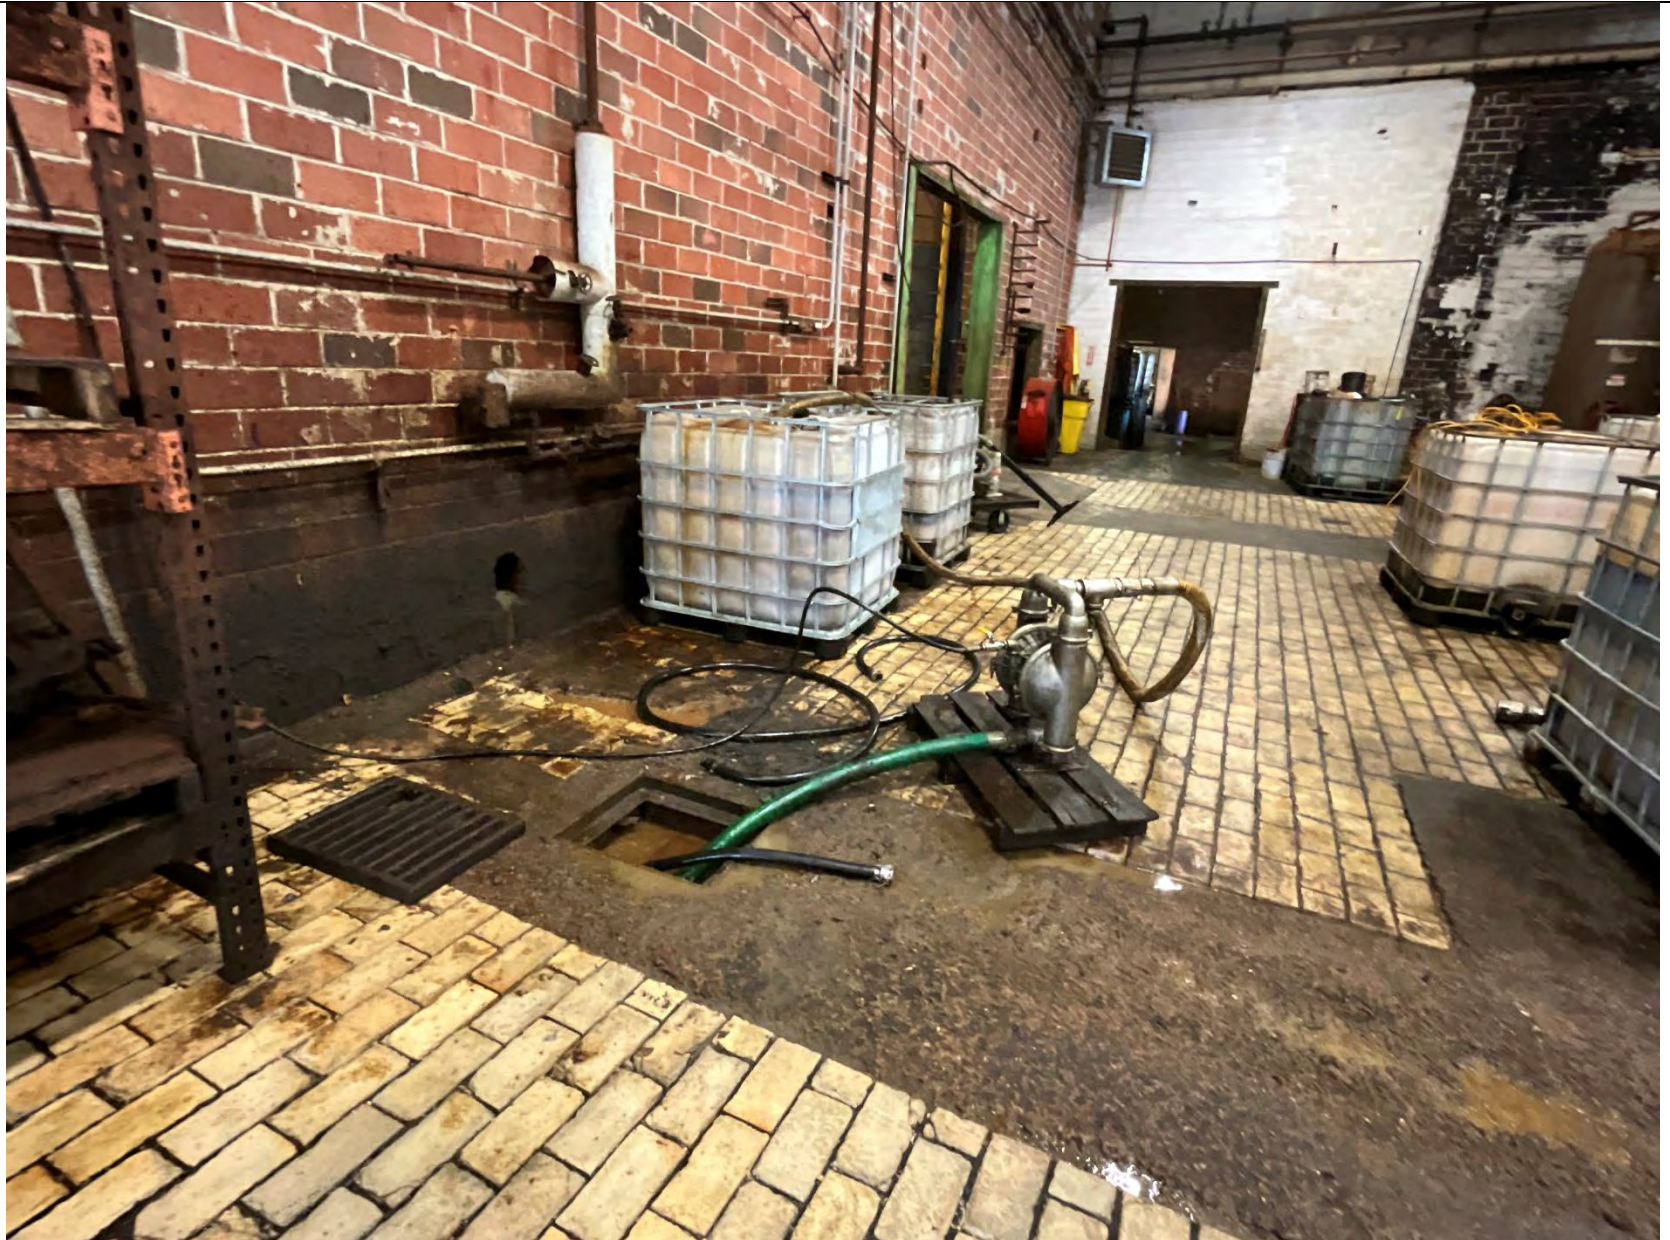
Pump for pumping spills to a tote. Entire floor area is covered in residue from spills and chemicals puddles on the floor and evidence of acid etching of cement flooring.

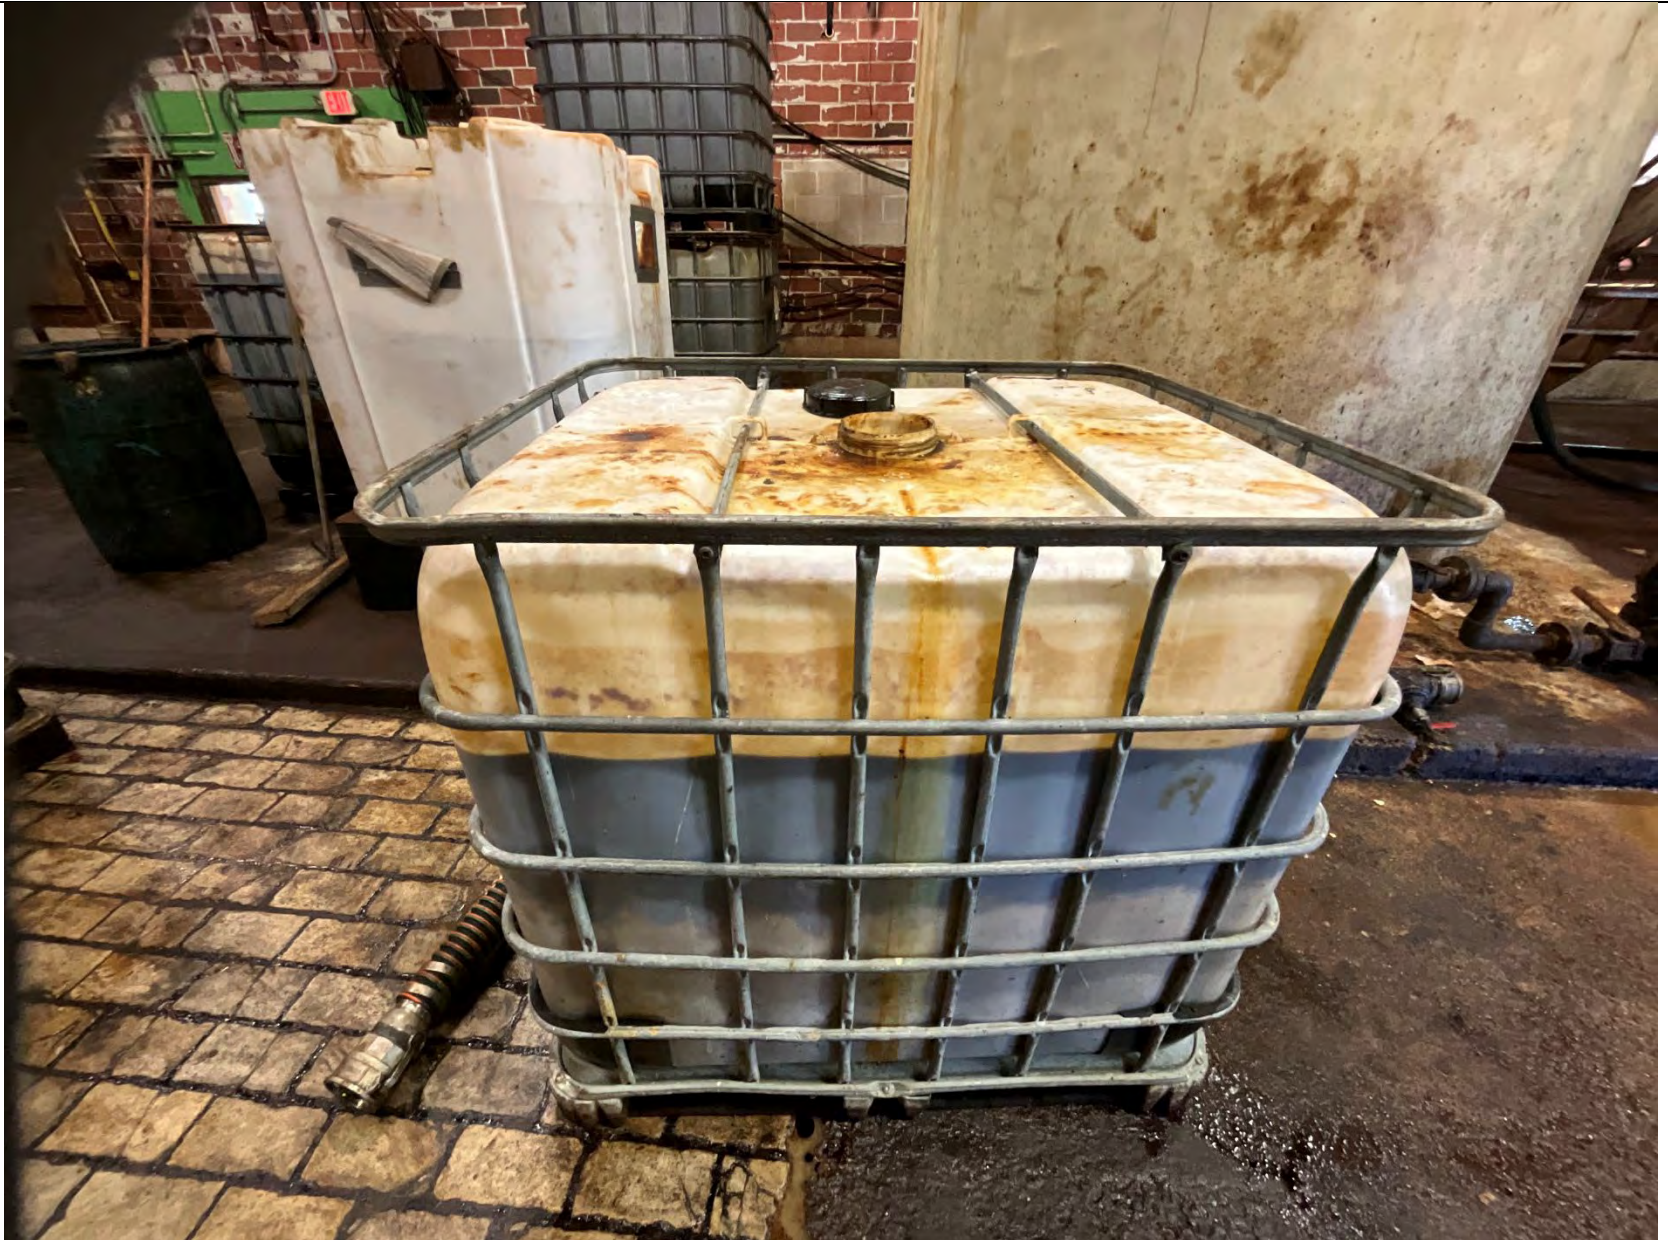
Tote containing raw glycerin from a spill cleanup. Tote appears to be actively leaking.

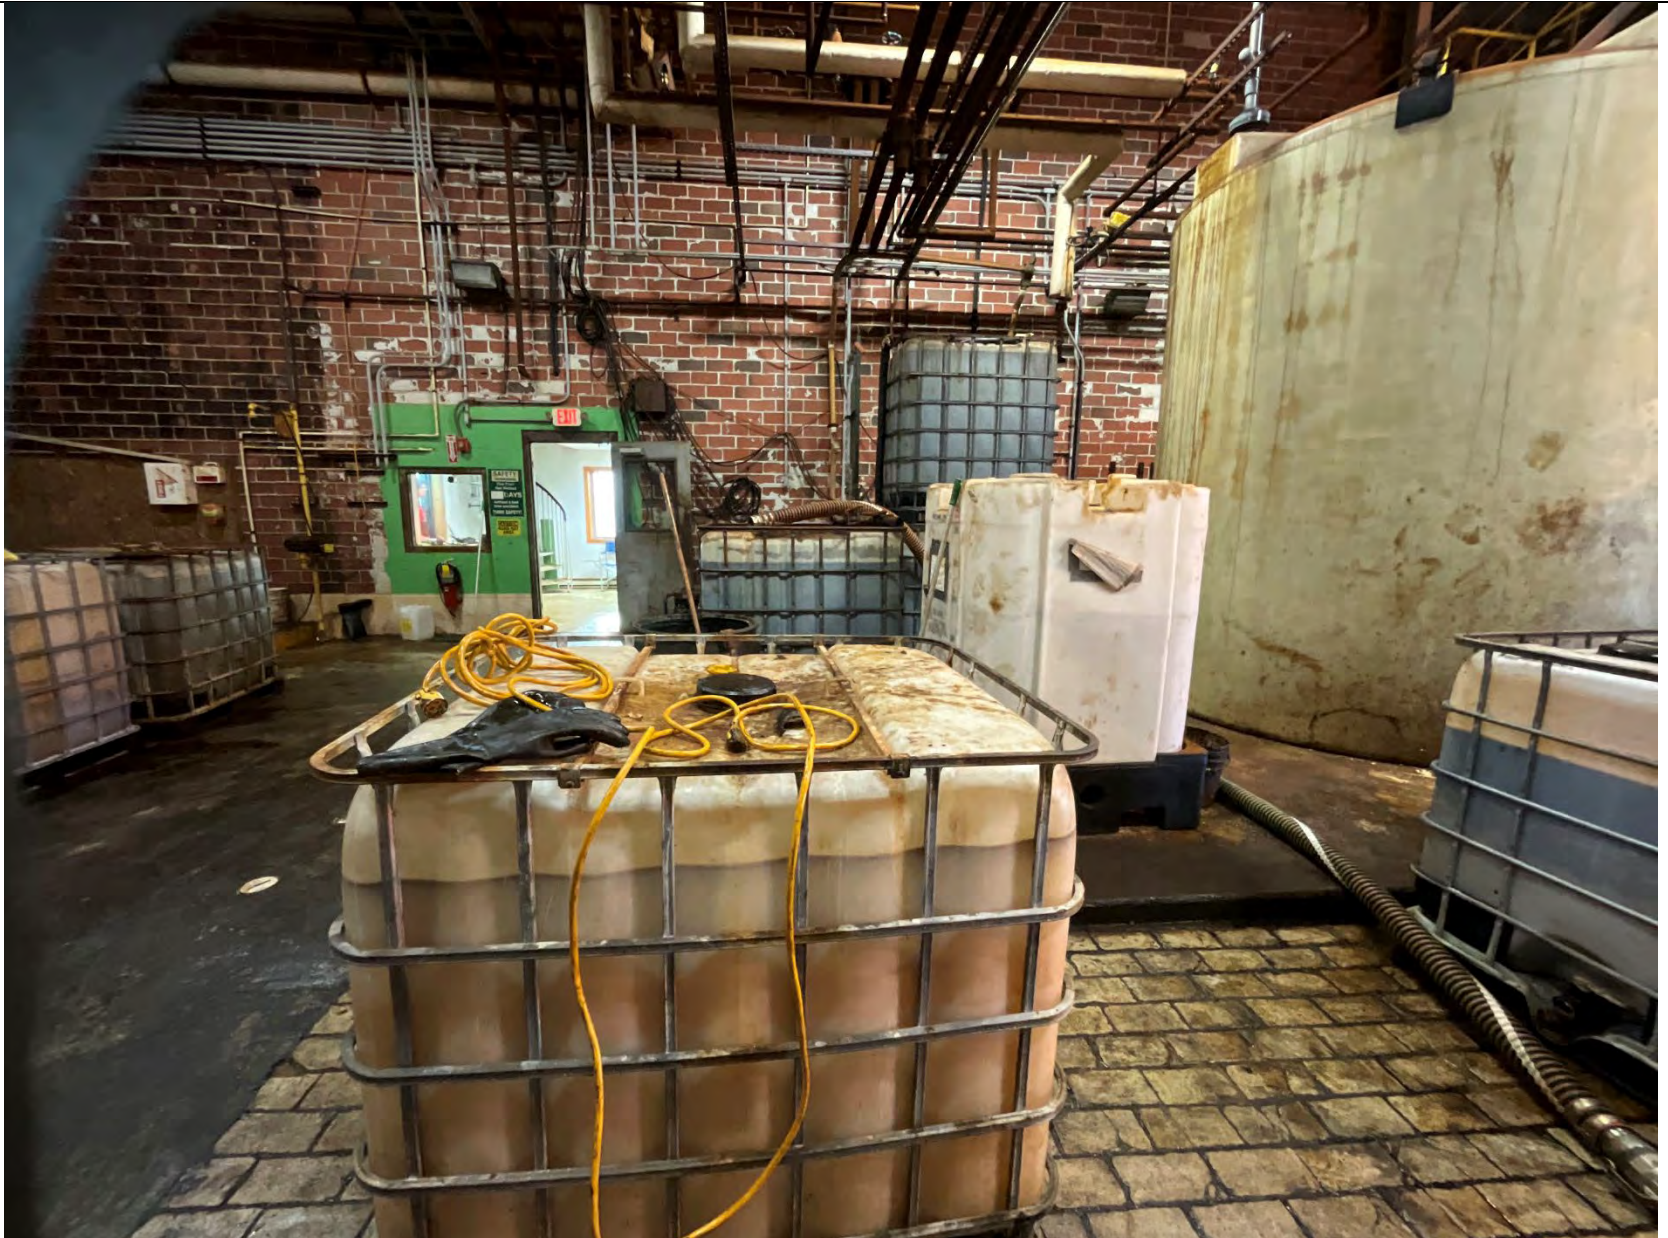
All totes seen in this image were said to contain raw glycerin that was accumulated from various spills. It was stated that the prior plant manager had a habit of directing employees to put spills residues into the totes and the totes were stored and never recycled back into the process.

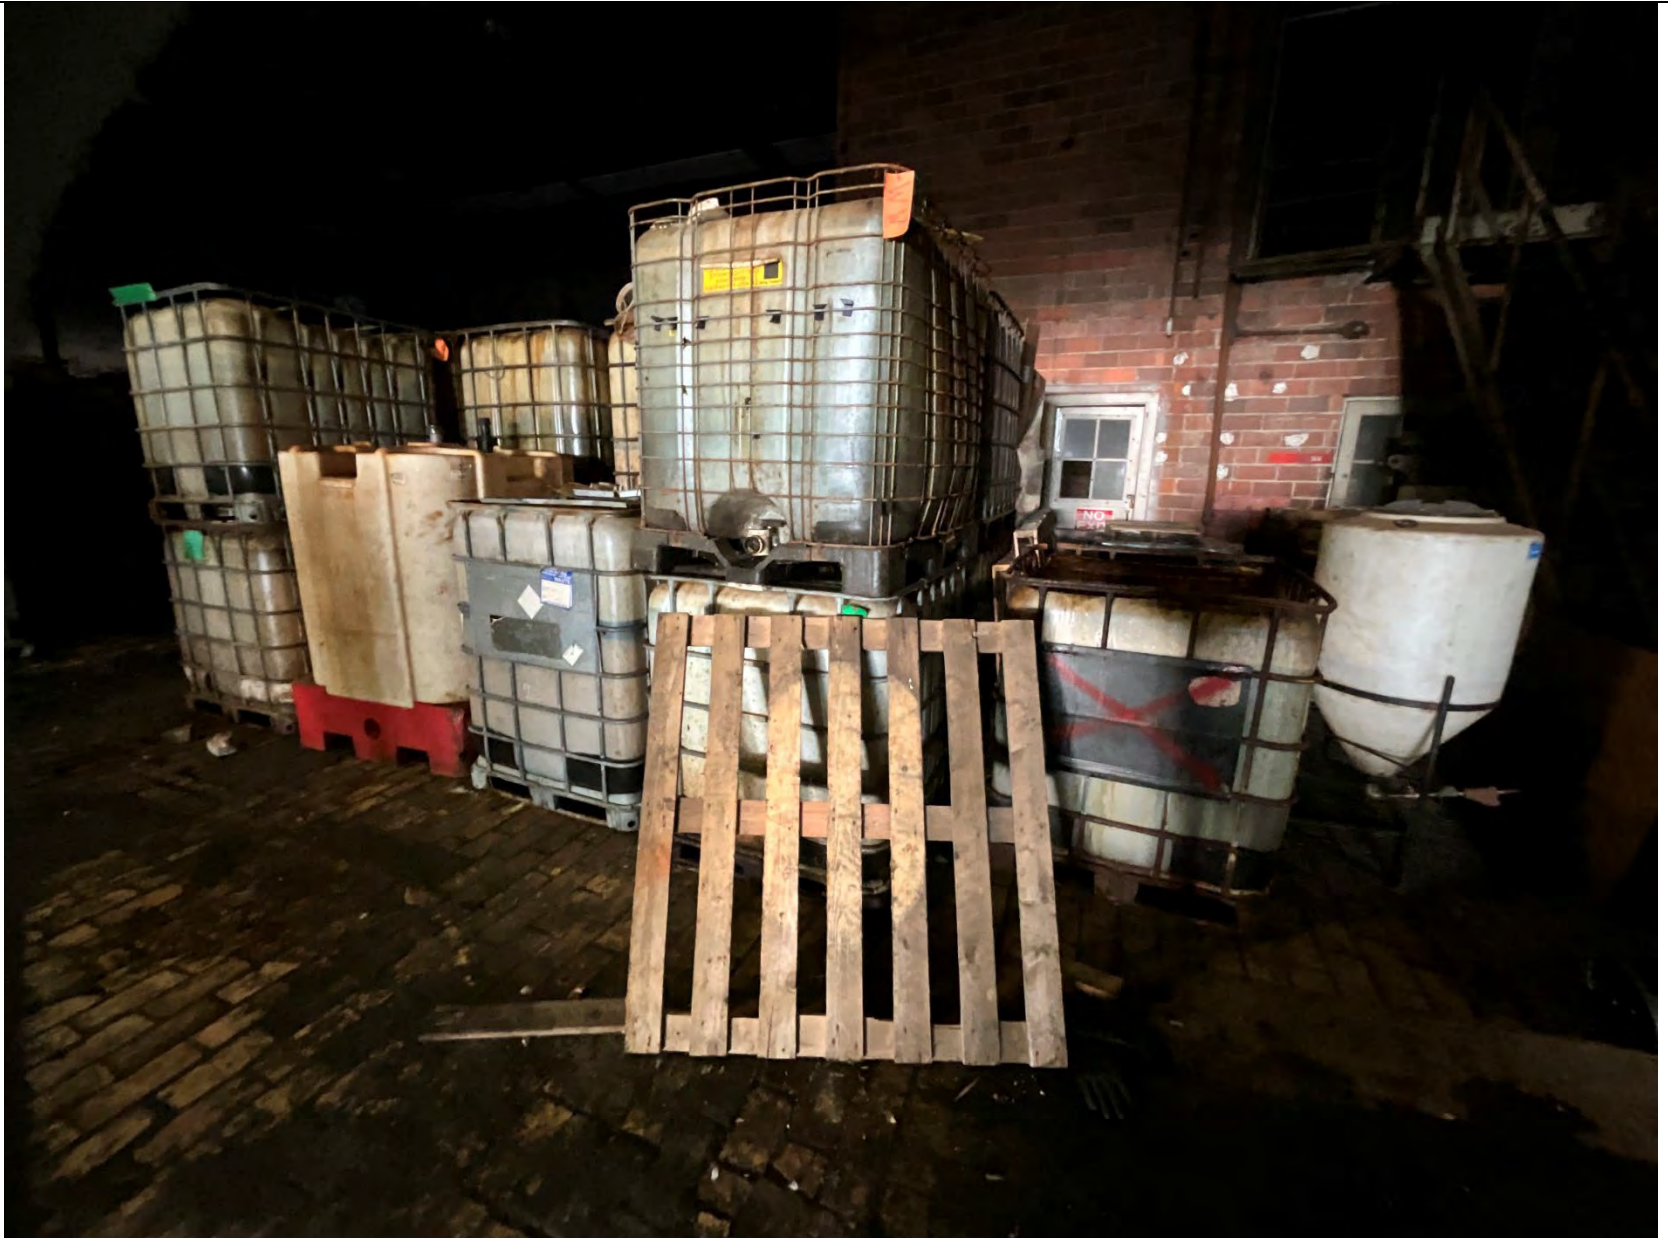
Warehouse area where approximately 125 of totes accumulating contents of raw glycerin that were said to be a result of spills and clean ups. The source maintains these are not wastes and can be recycled by the process.
