## CAA112(r) INSPECTION REPORT

| <b>Name:</b> Glycerin Traders | |
| <b>Process:</b> NAICS 325611-03, Glycerin Manufacturing | |

### SUMMARY OF OBSERVATIONS

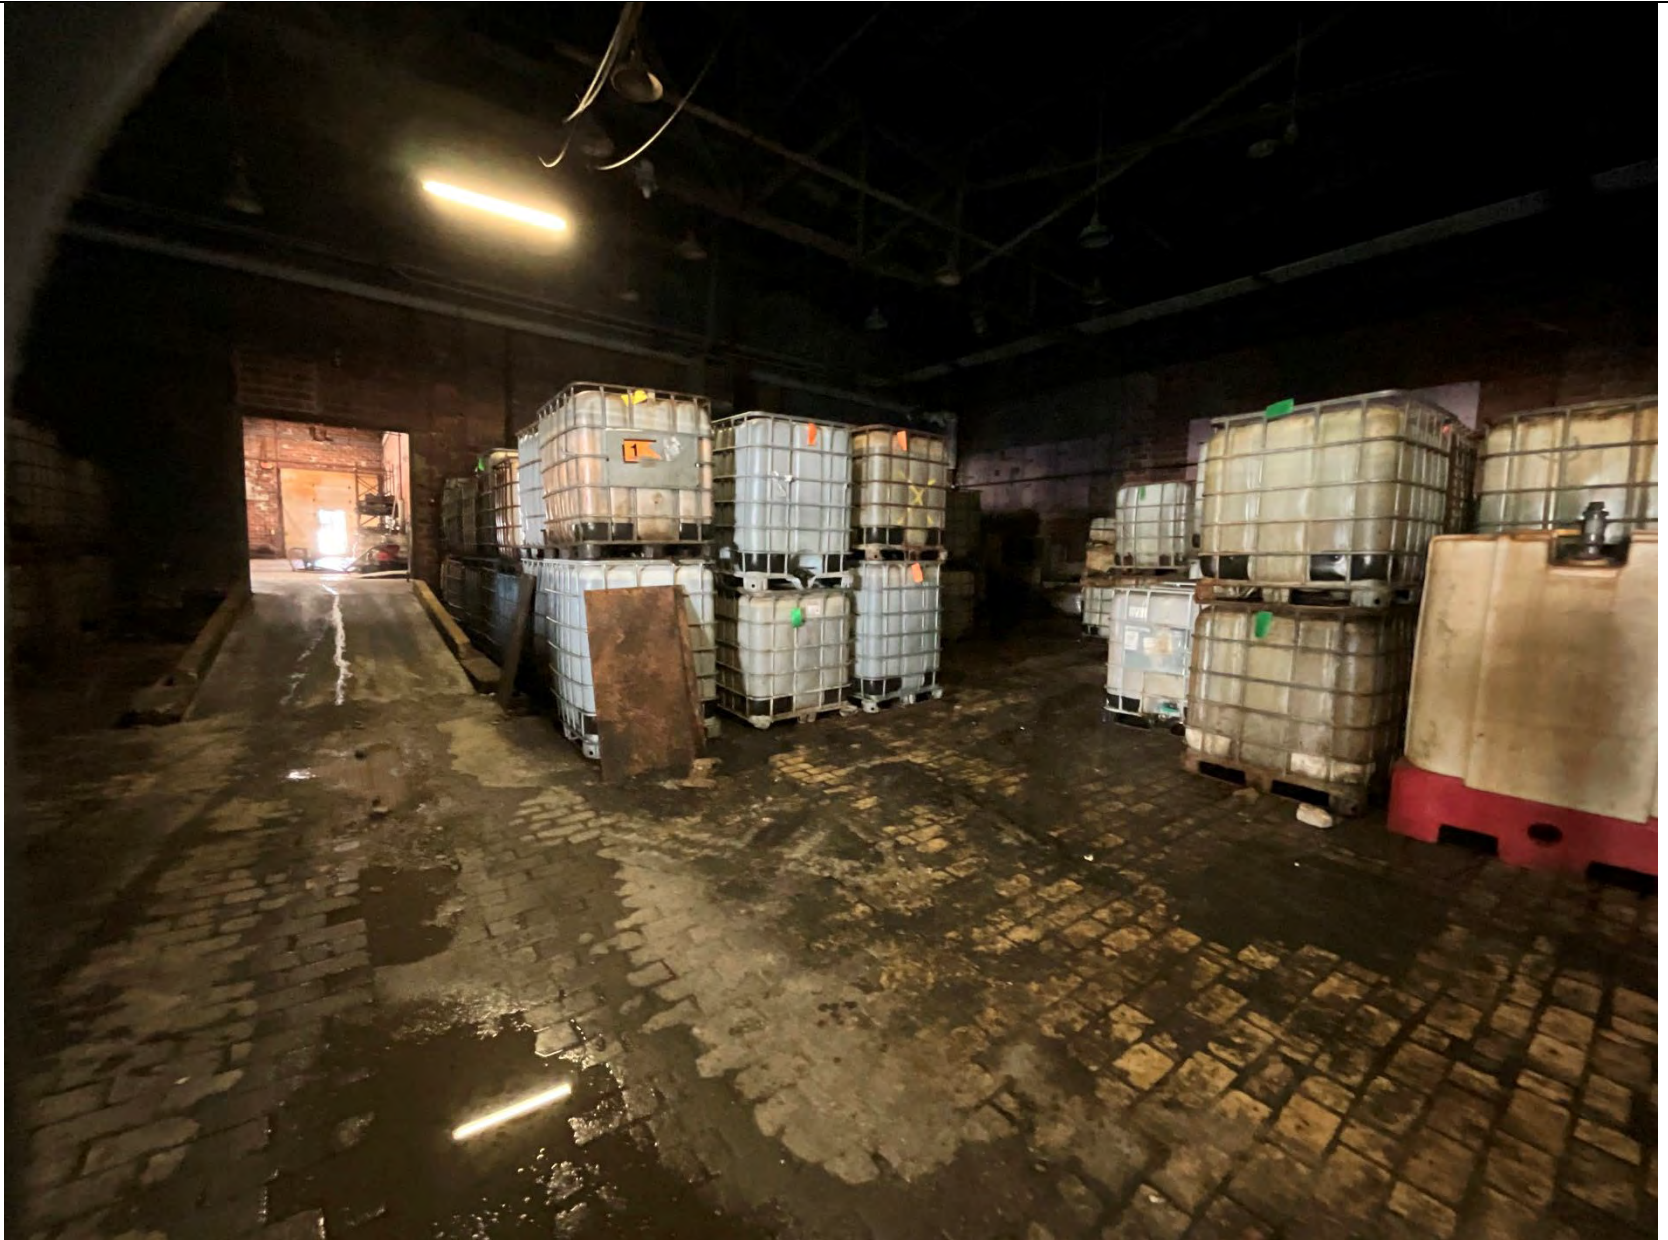
Warehouse and another view of totes accumulating contents of raw glycerin that had been spilled and cleaned up. Due to low light and conditions that indicated that the area had wet floors containing unknown chemicals, full count on totes was not performed.

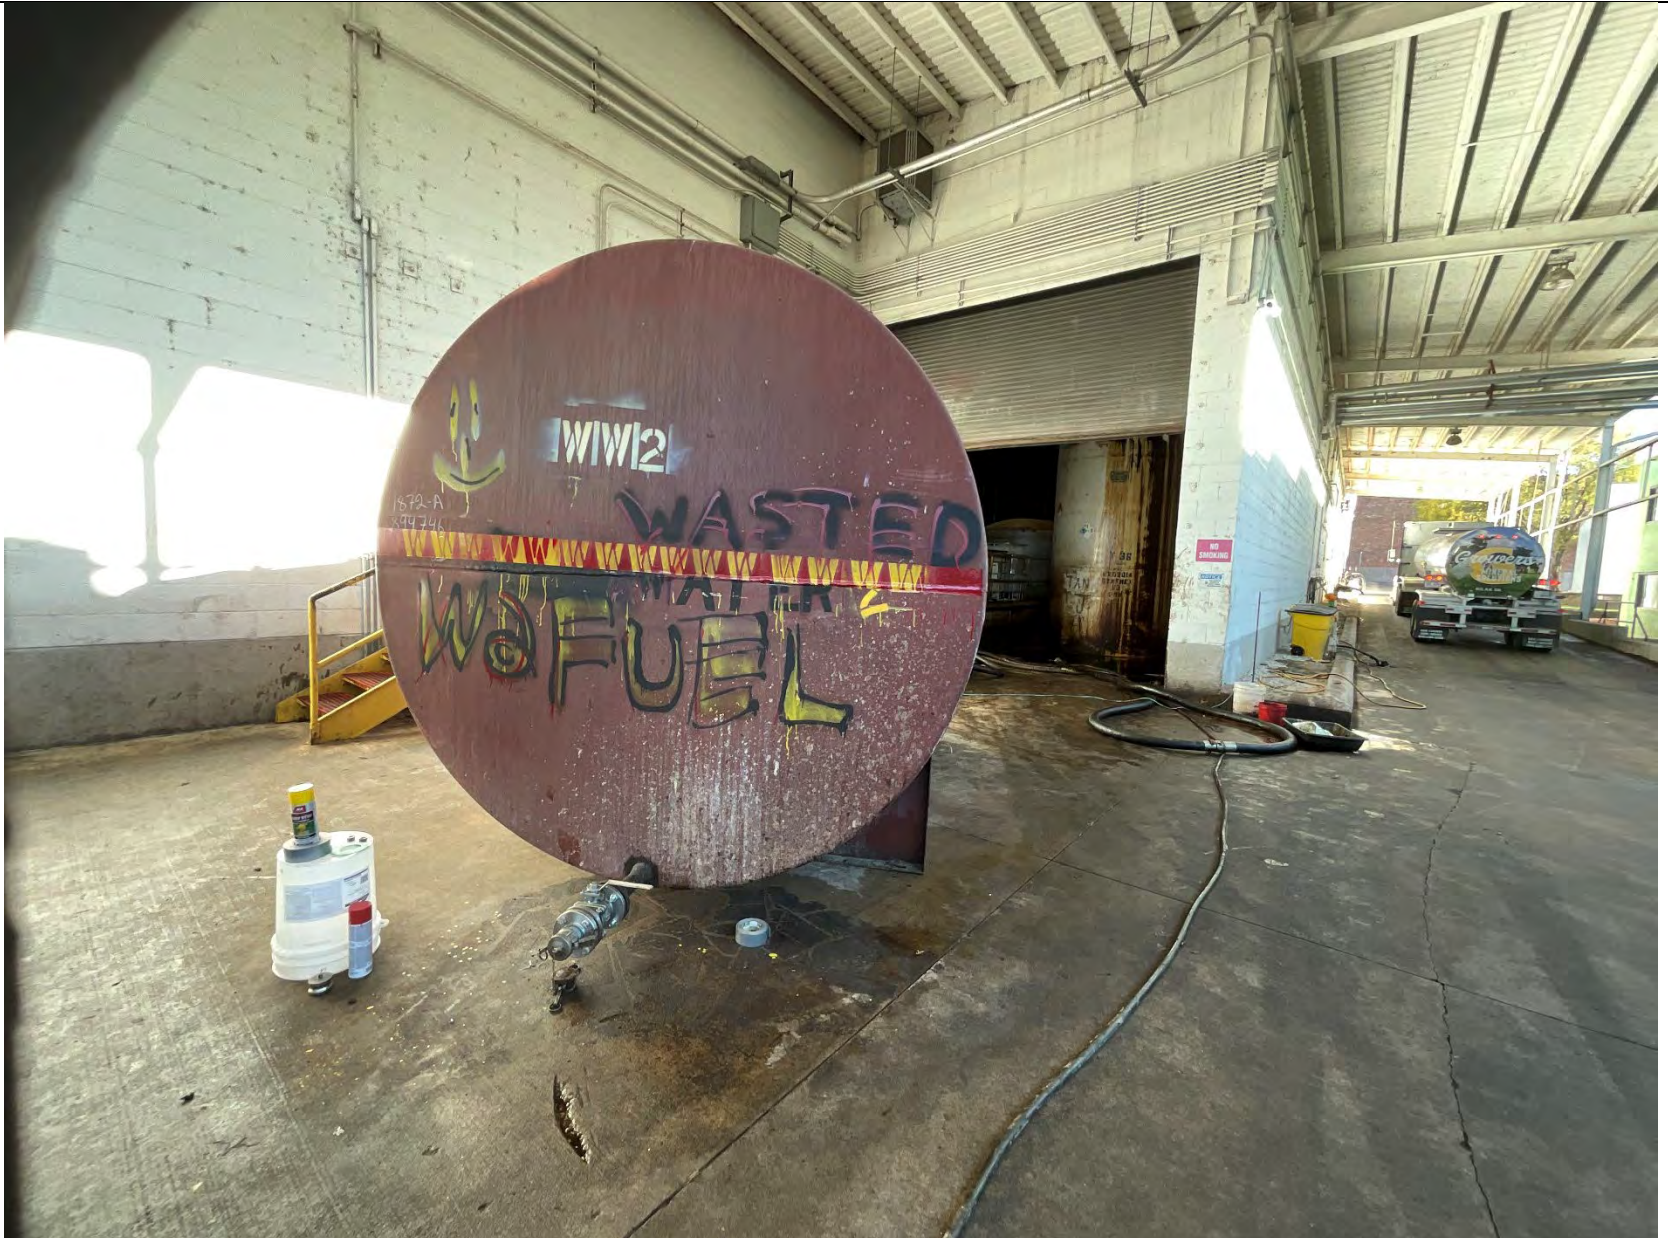
This was identified as a new tank that wasn't in use yet and would be installed inside before being used. However there appeared to be spillage of raw glycerin or their "crude oil" around the tank.

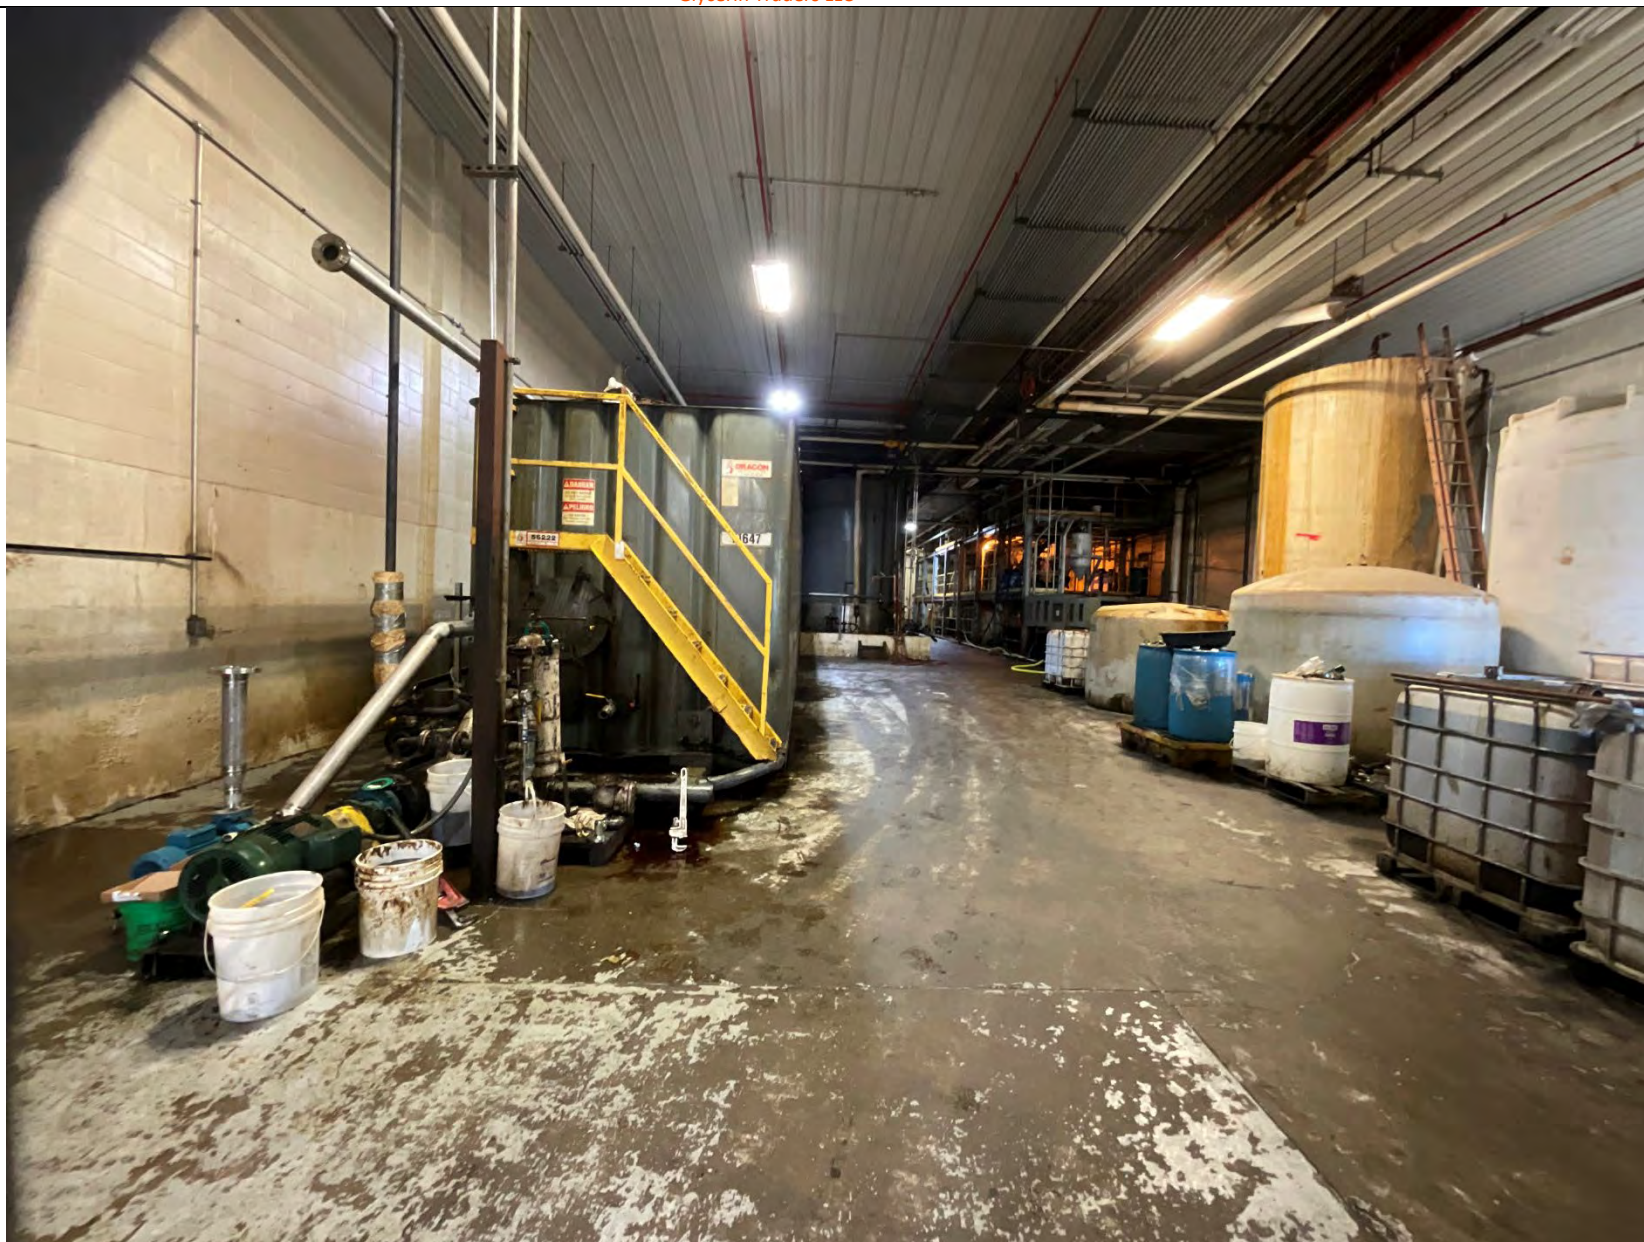
Full view of frac tank to the left and wastewater tanks to the right. Open buckets containing raw glycerin were observed in front of the frac tank and near the wastewater tanks. Beyond the frac tank on the right is a tank farm of 10 tanks that hold glycerin. To the left is the former area for processing biodiesel. Most process tanks or vessels have been removed from the area. Currently the pit is used to contain any spills that are pumped from the truck loadout capture basin.

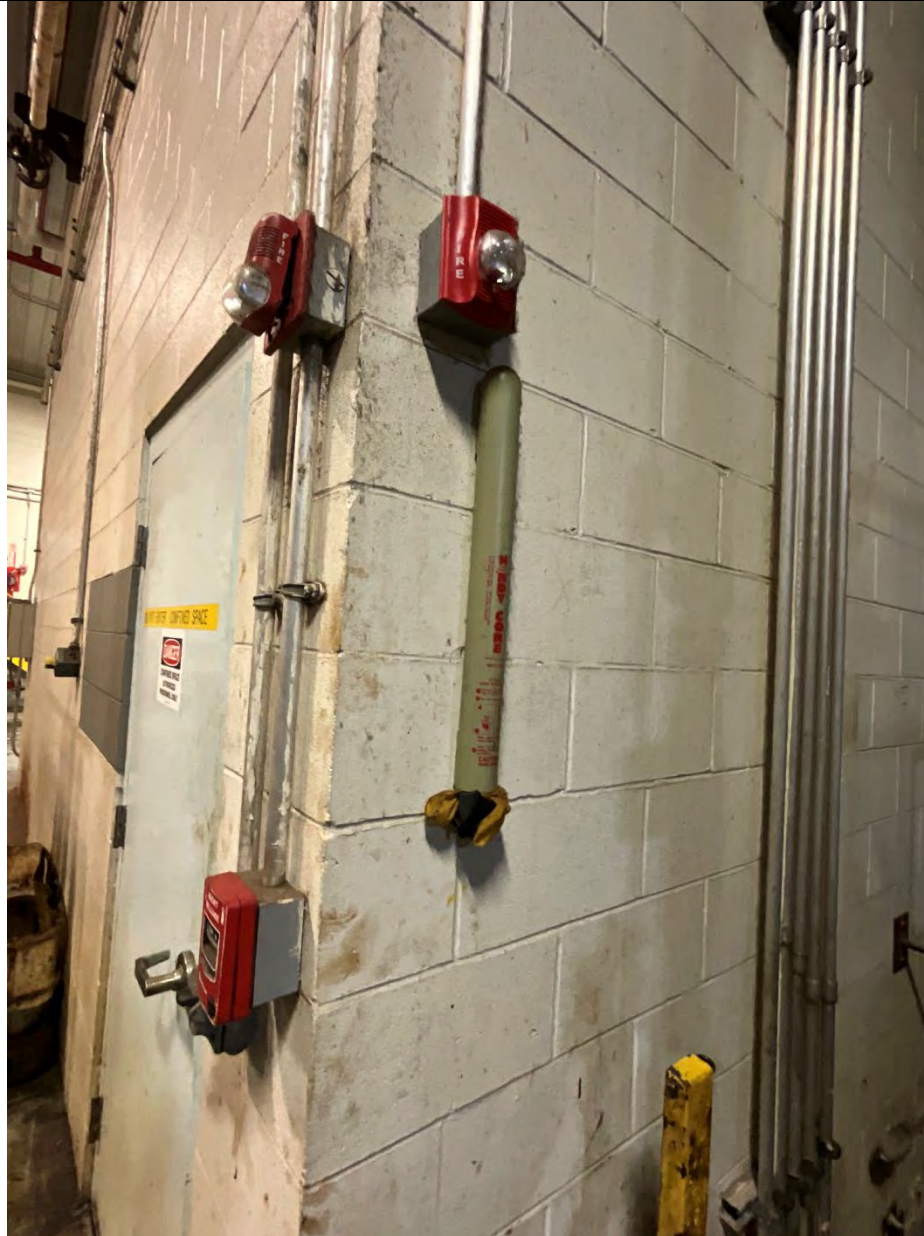
Side view of fire alarms in the area around the methanol room. Alarm to the left was said to be function but appears to be broken.

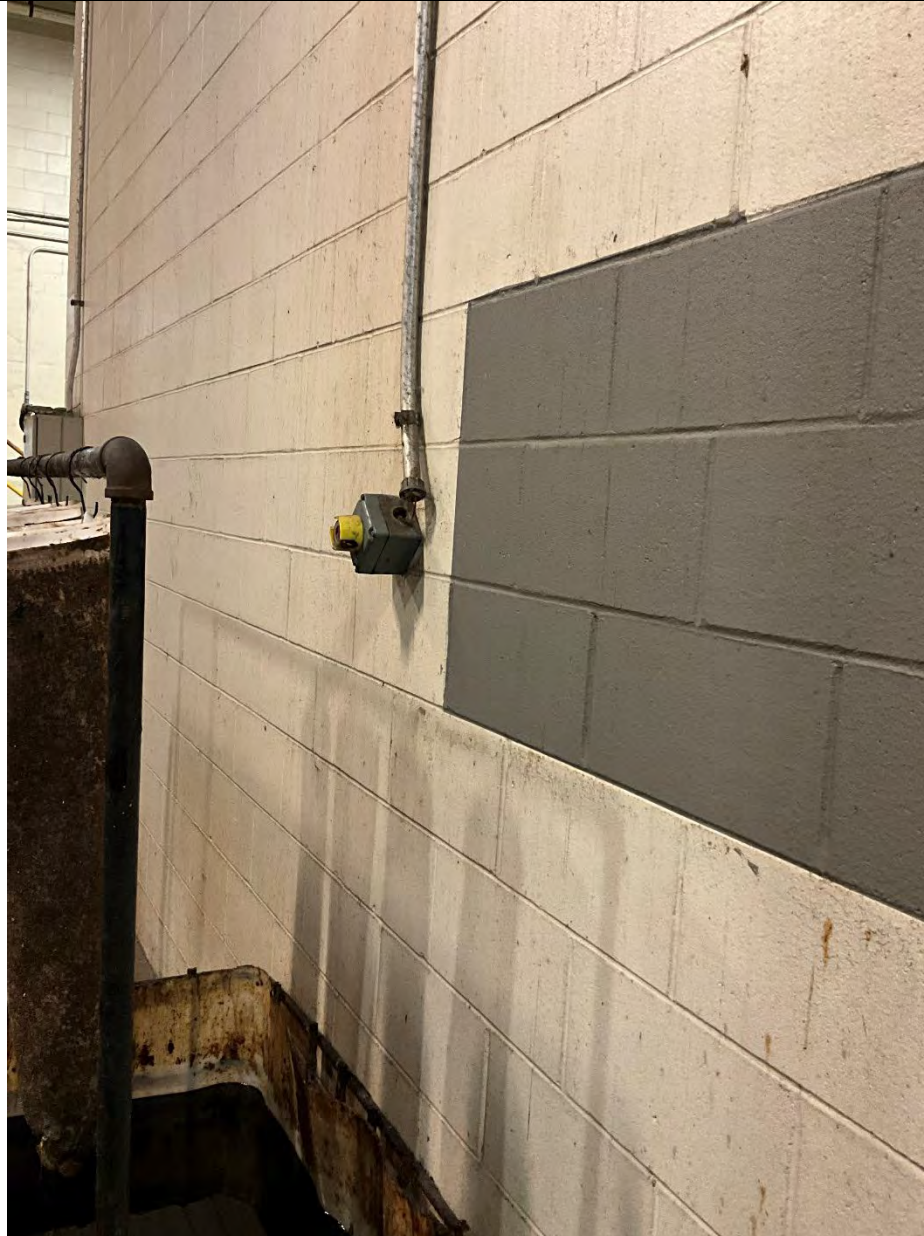
Emergency shut off for the methanol pump. Functionality unknown. Button is hanging by its wires outside of the conduit in an area designed for electrical classification and fire/explosion prevention.

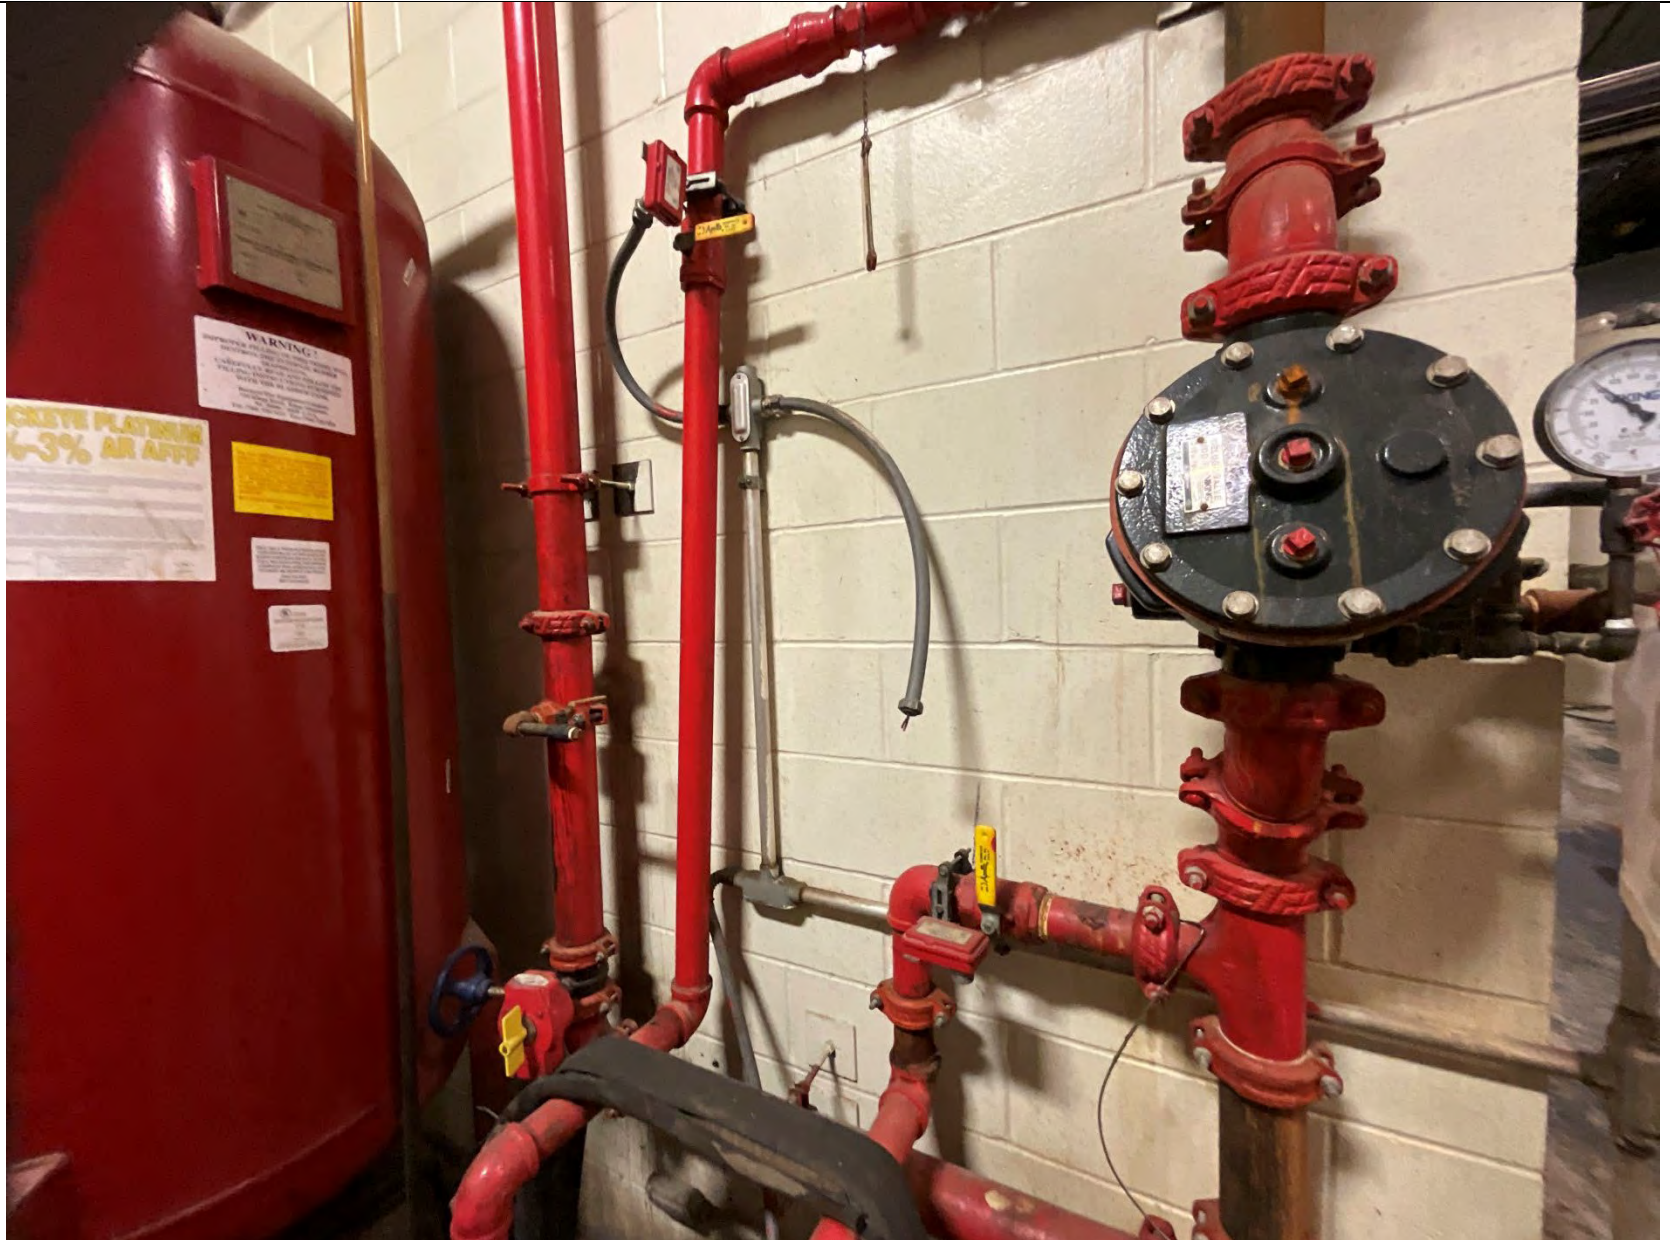
- d. Failed to implement the minimum requirements for an impairment program when performing repairs to the water fire suppression system, which includes notifications to the local fire department when making planned or emergency impairment corrections, as is required by NFPA 25, Standard for Inspection, Testing, and Maintenance of Water-Based Fire Protection Systems, Chapter 15. (Identified after the inspection.)**

Close-up of system – electrical is disconnected and hanging with exposed wires; valves along the water line in closed positions. Water pressure gauge indicates pressure however, part of the system has been disabled and was told that the foam tank is not used.

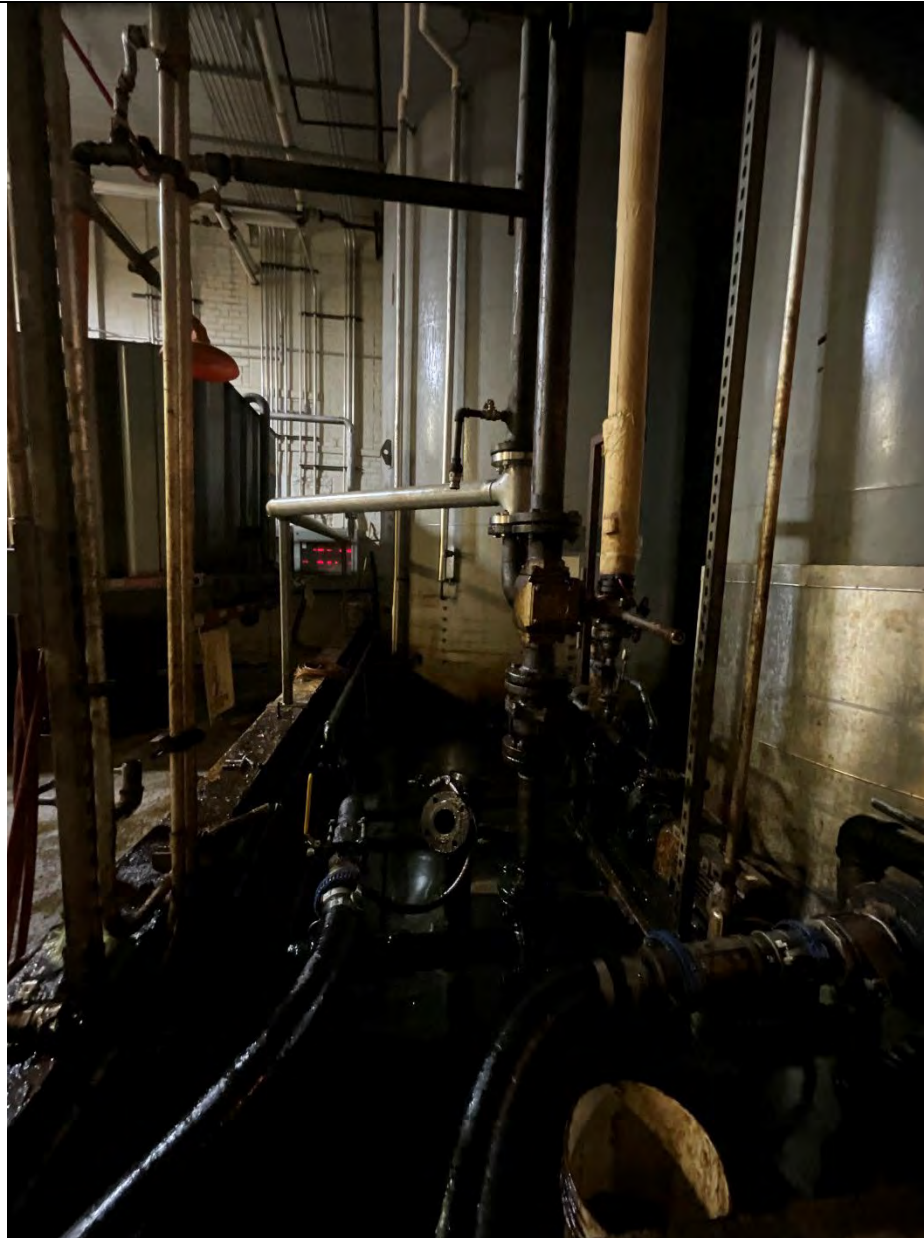
Area where an active spill occurred during the field tour. The sample port valve was open and residual raw glycerin in a transfer pipe between the frac tank and Tank 7 was flowing out into the tank farm containment area. Some of the raw glycerin has splashed on the top of the containment wall and outside of the containment wall.

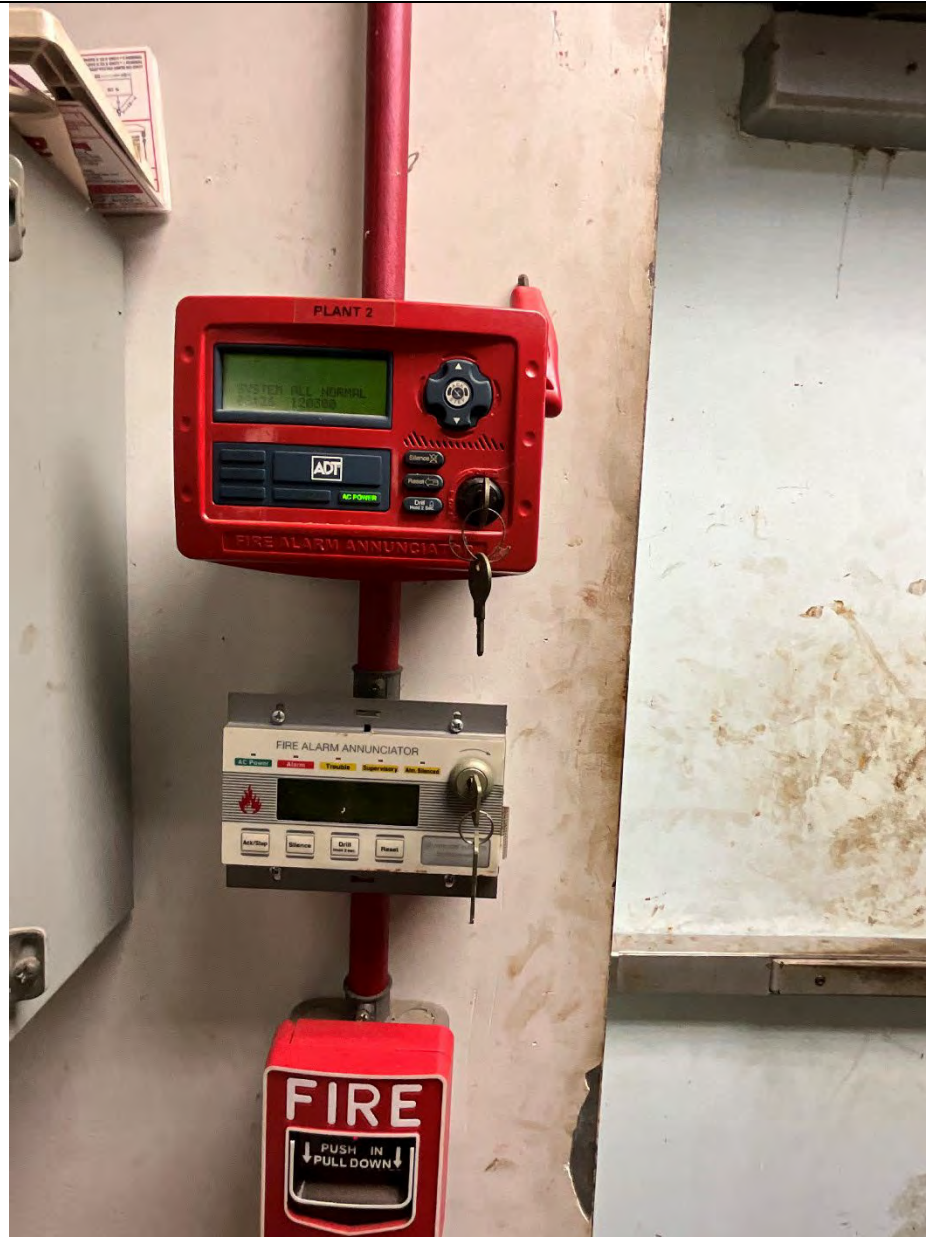
Fire alarm system controls located by the exit door of the operations control room on the south side of the building. Key is in the “Locked Off” position, which indicates that the system is off. I asked and was told that the system was not off but “locked off” which meant that it was secured from anyone changing settings. However, on Nov. 20, 2024, I was told that the contractors were removing corroded fire sprinkler systems because an insurance inspection revealed troubles with the system. So, the system was off for this work.

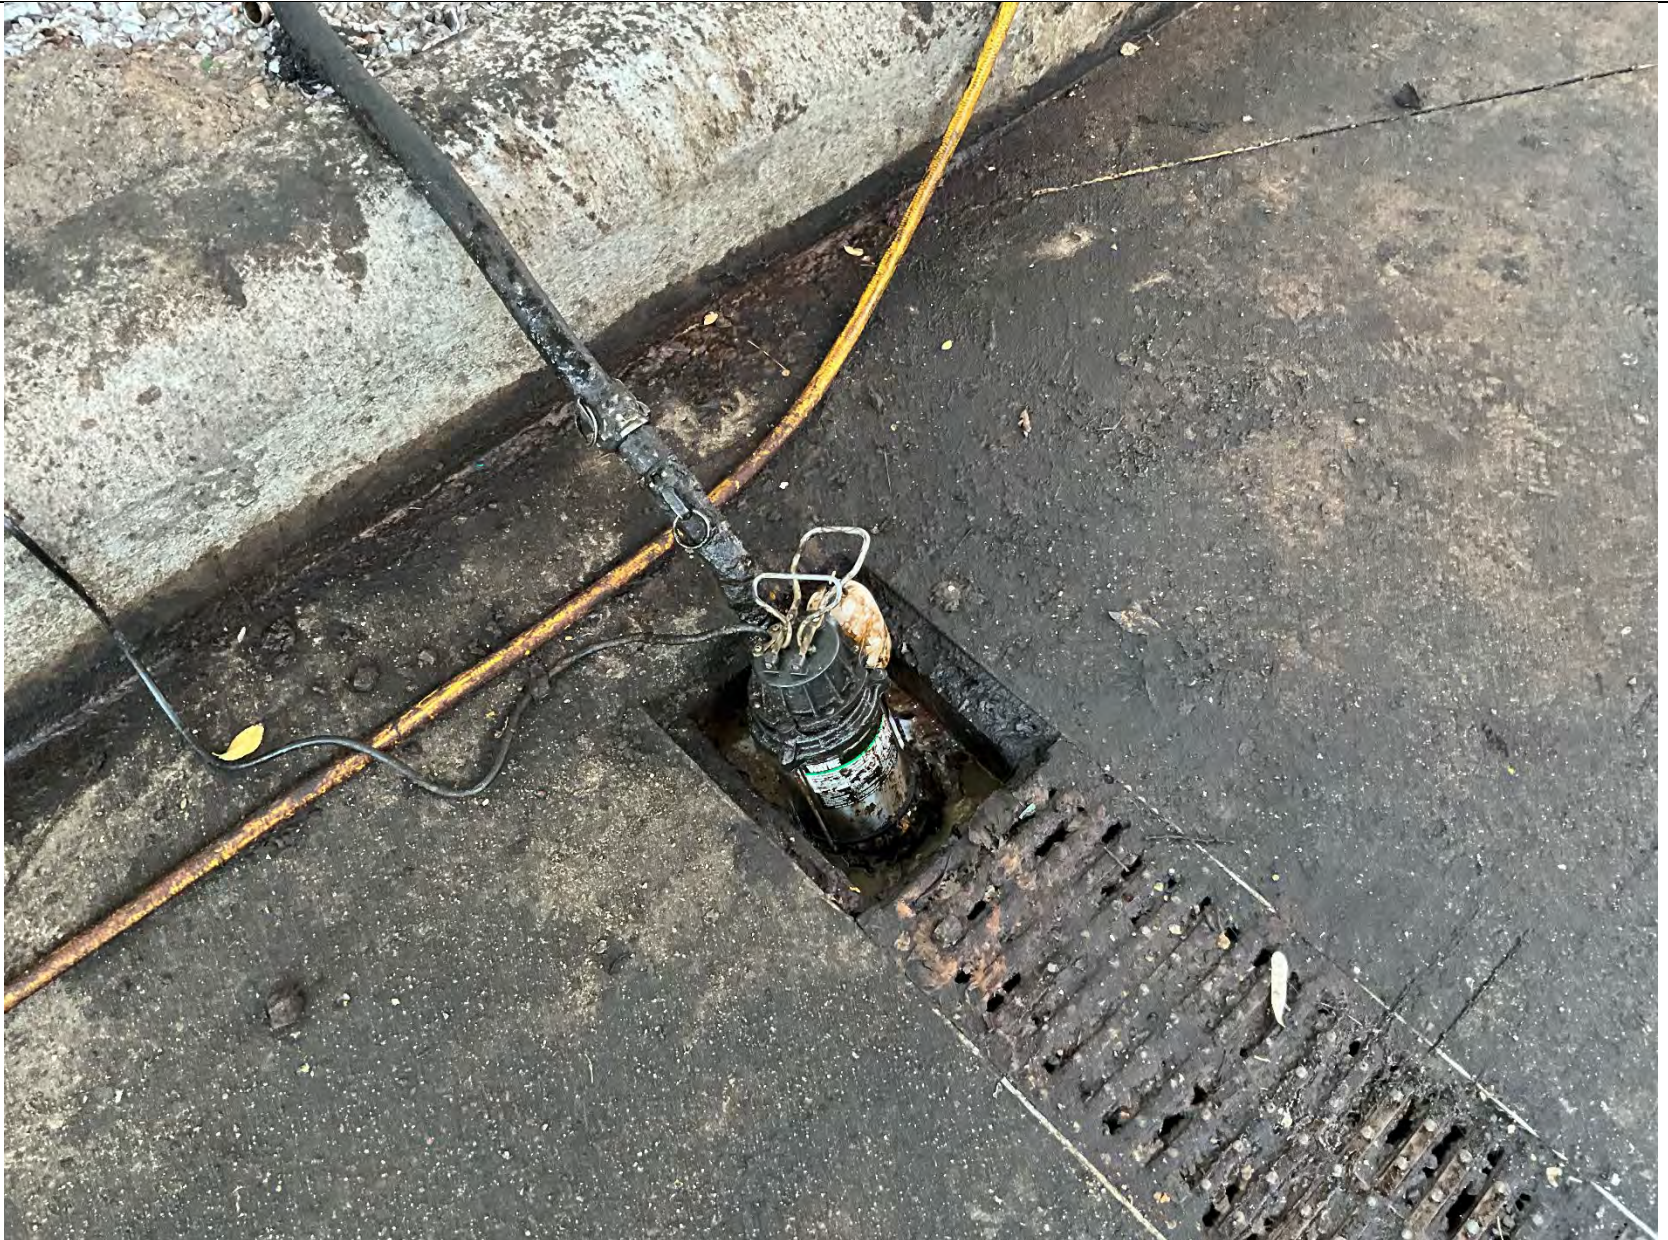
- c. **Failed to use existing fixed wiring to power electrical sump/pump equipment used to syphon chemical spills in the truck loading area, but instead used a power supply cord as a substitute, as prohibited by NFPA 70, NEC, Chapter 4, Article 400.12 (Identified after the inspection.)**

Image of the sump pump that was running at the time of the inspection. The sump pump is plugged into an extension cord that runs to an outlet.

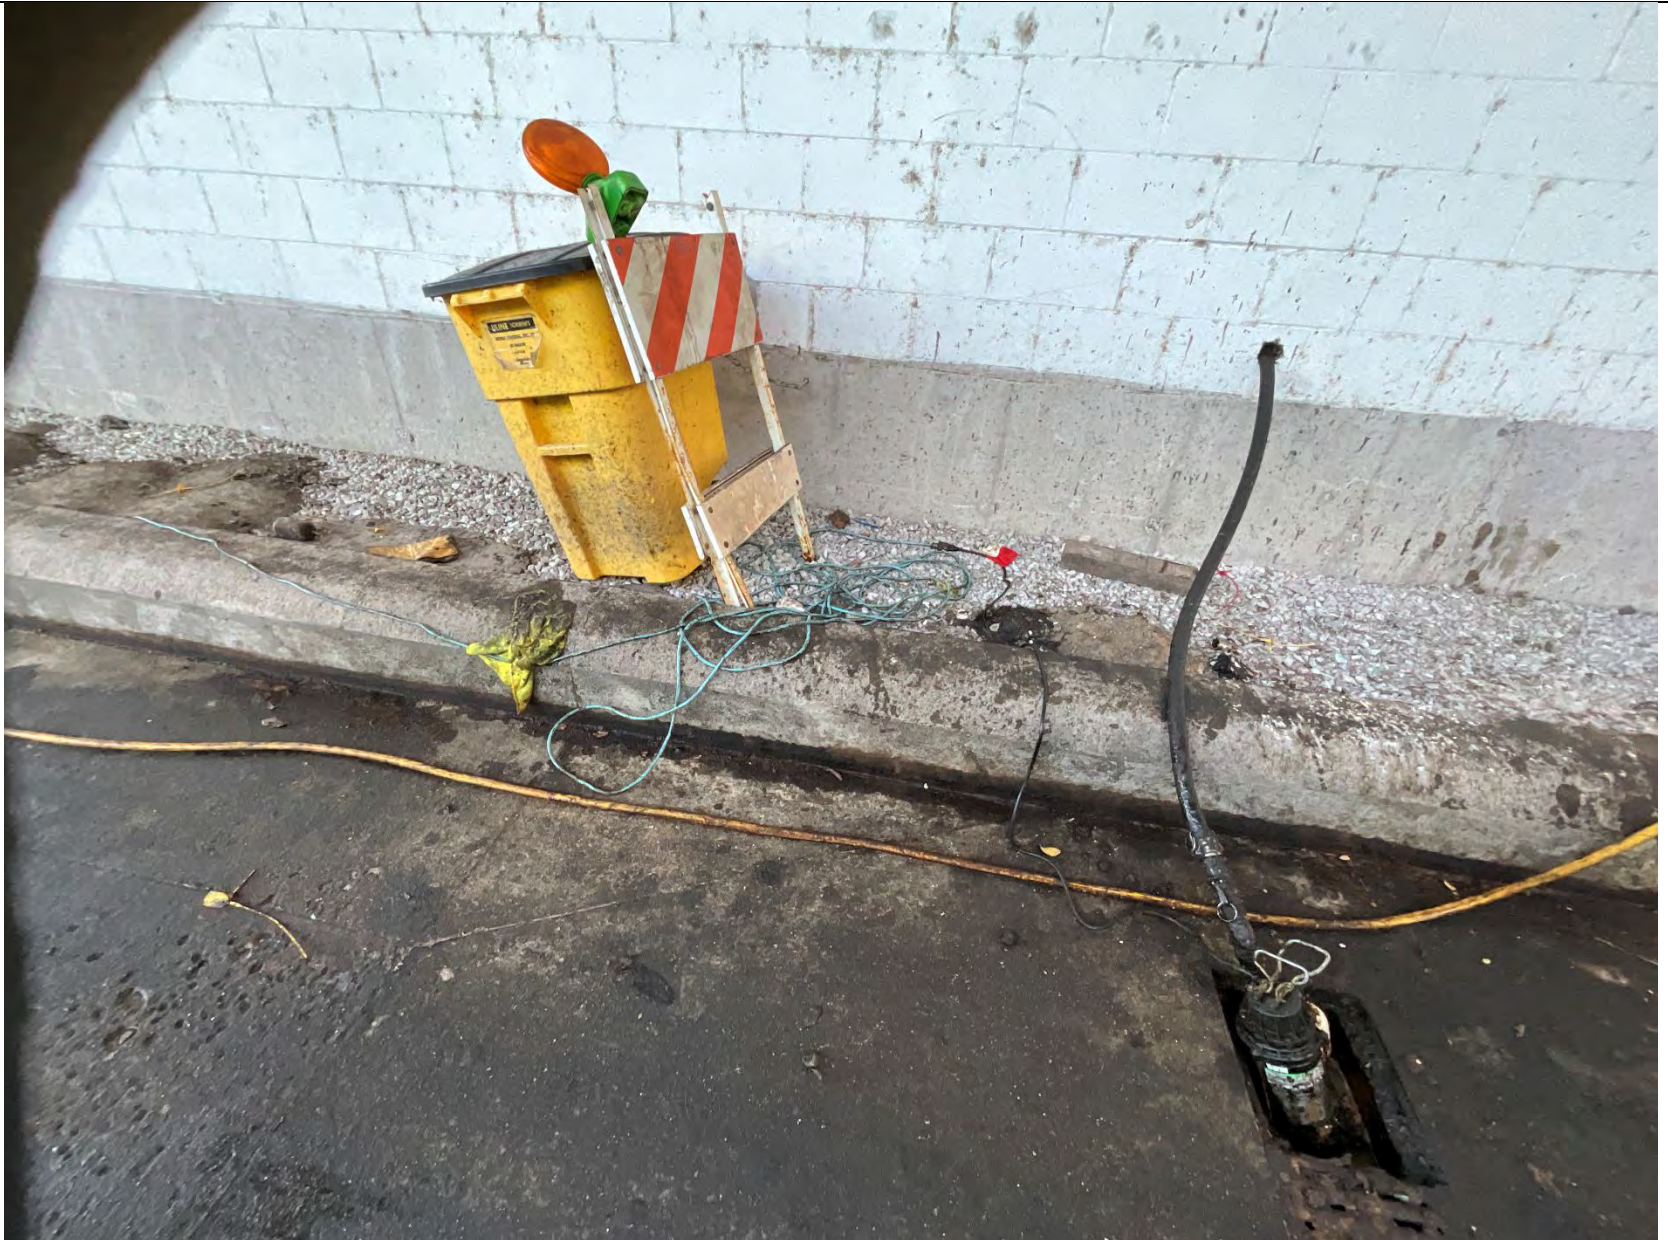
Image of sump pump, extension cord, and hose going through a hole in the facility wall to the pit that is located on the other side of the wall.

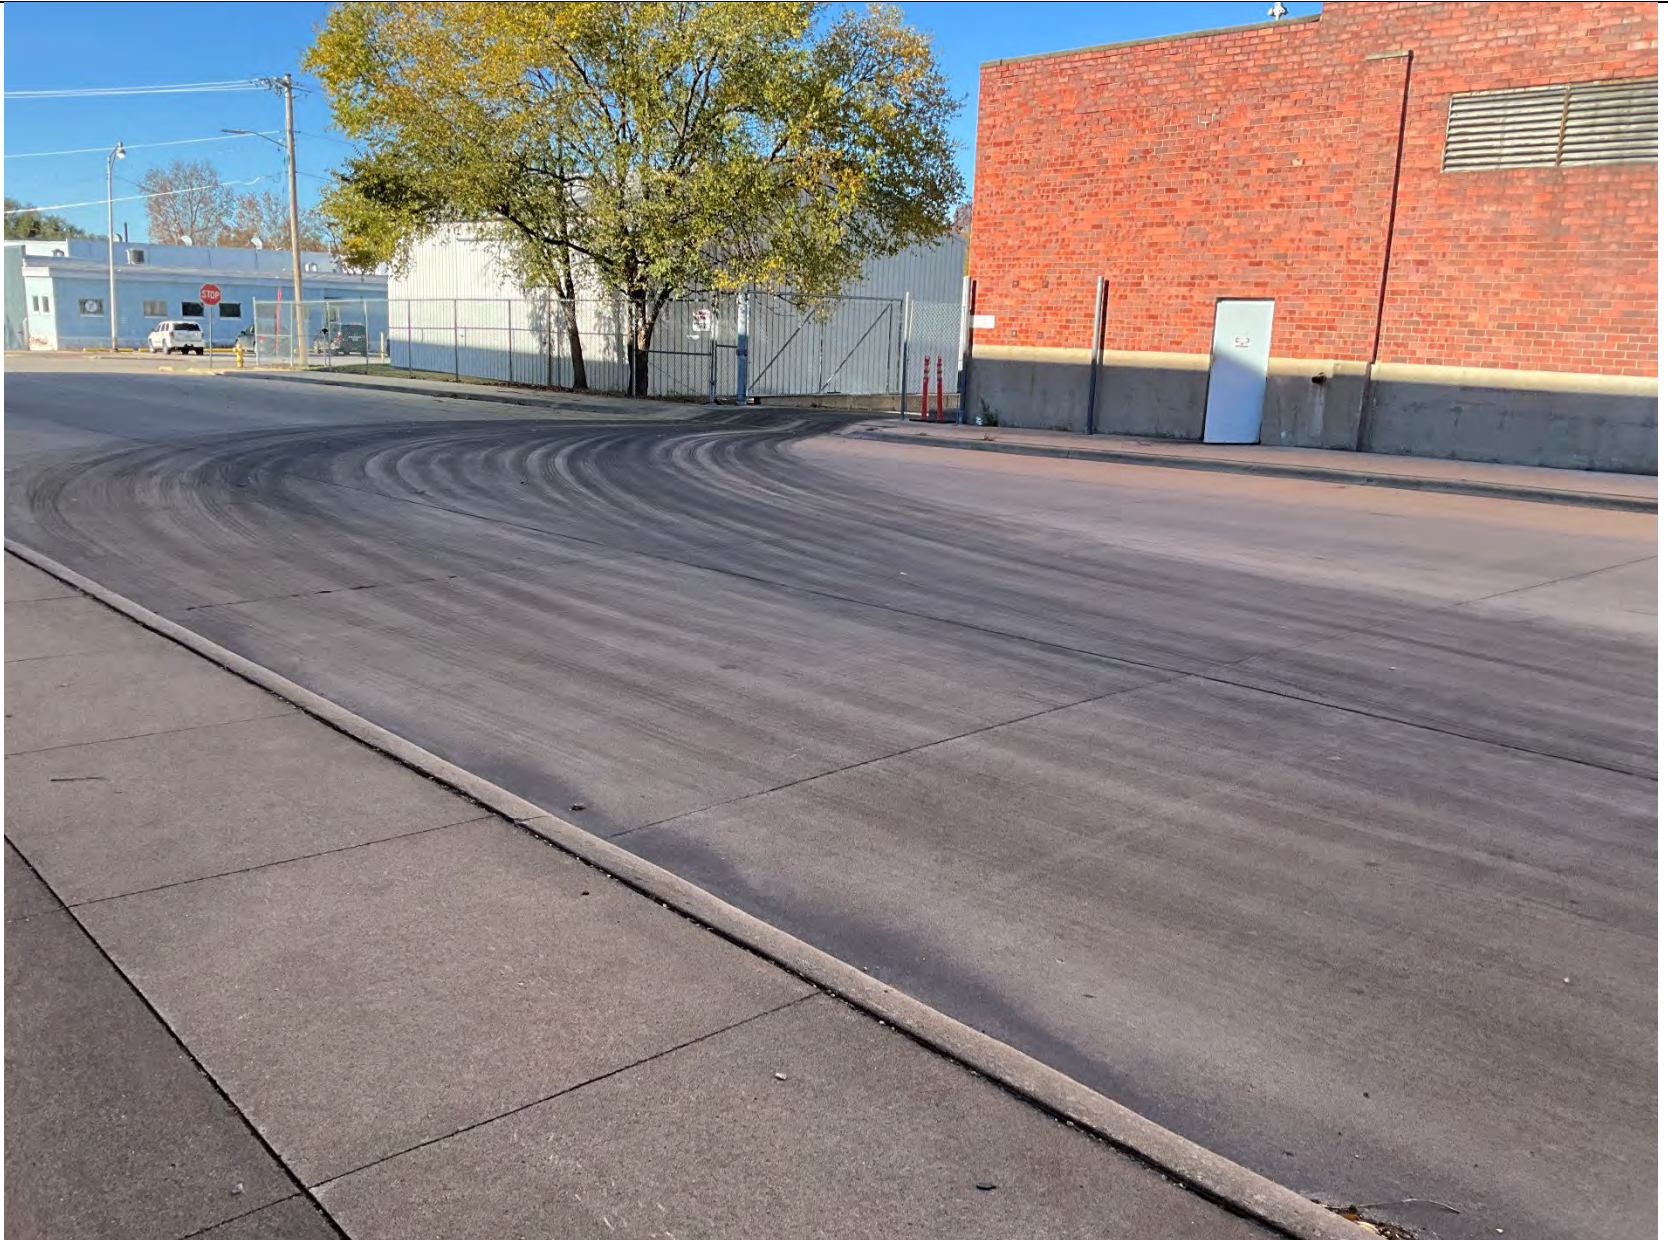
This image was taken from 4th Street that shows how the trucks track spilled glycerin or Veg Oil onto the public roadway. Also shows the fire water connection on the street side that was discussed in Image 41.
