**Region 6 Compliance Assurance and Enforcement Division  
INSPECTION REPORT**

| Inspection Date(s): | 08/8-9/2018 | | |
| Company Name: | <b>ConocoPhillips and Select Energy Services</b> | | |
| Facility Name: | <b>Conoco Phillips Pit</b> | | |

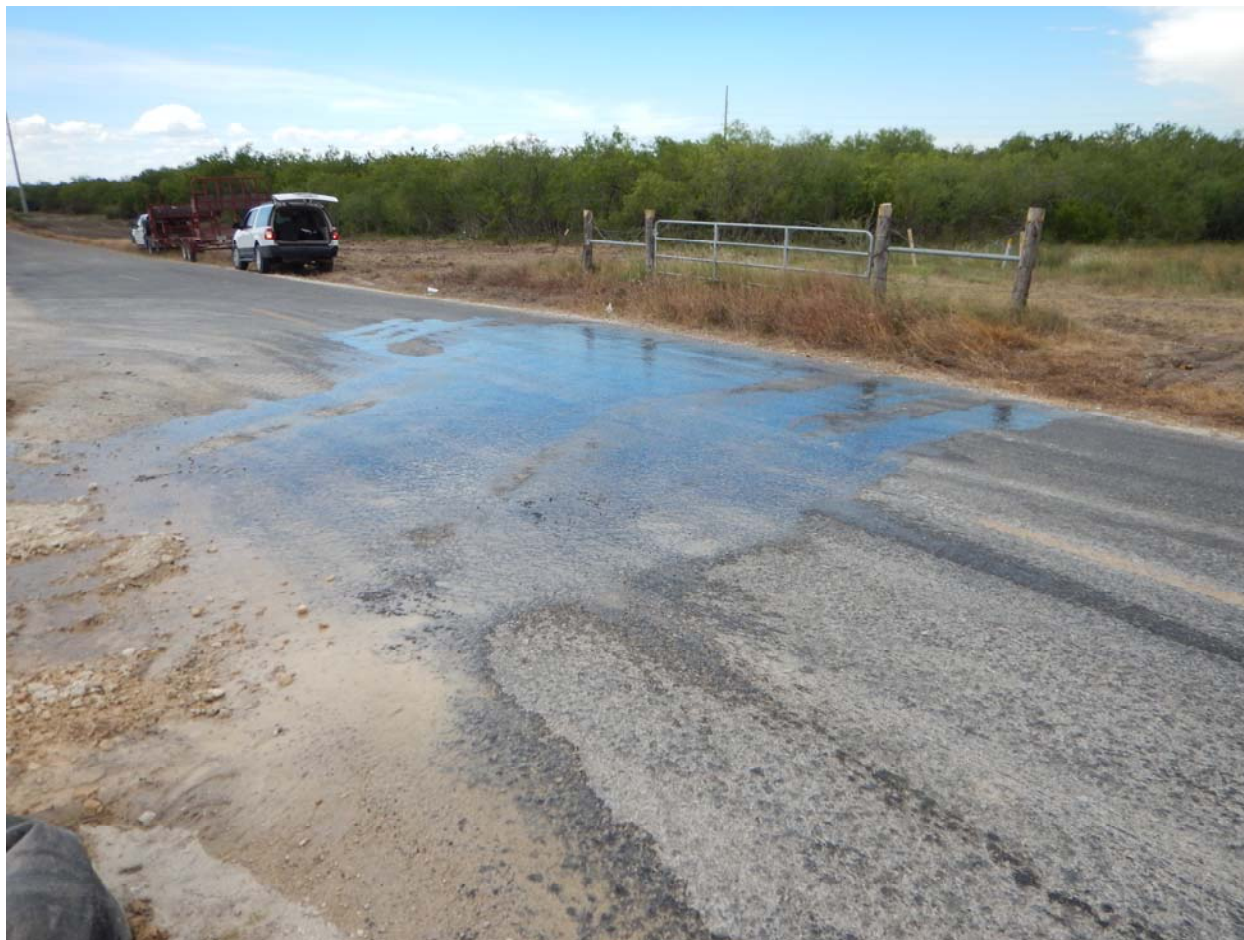
Photo No. 1

When I arrived at this facility on August 08, 2018, I conducted a preliminary evaluation of potential discharges and checked the integrity of the flowlines, pit, pumps, and well. I observed a flow path of fluids on the street going down to Dry Escondido Creek. At the time of the inspection I observed that representatives from Select Energy Services were taking apart flowlines and allowing fluids (saline water) to flow into the street and creek (See Photo Nos. 1-2 in Appendix 1). I presented my credentials and proceeded to request information about the mechanical process of flowlines separation, the

Description: This image shows a discharge and a flow path of fluids on the street going down to Dry Escondido Creek.

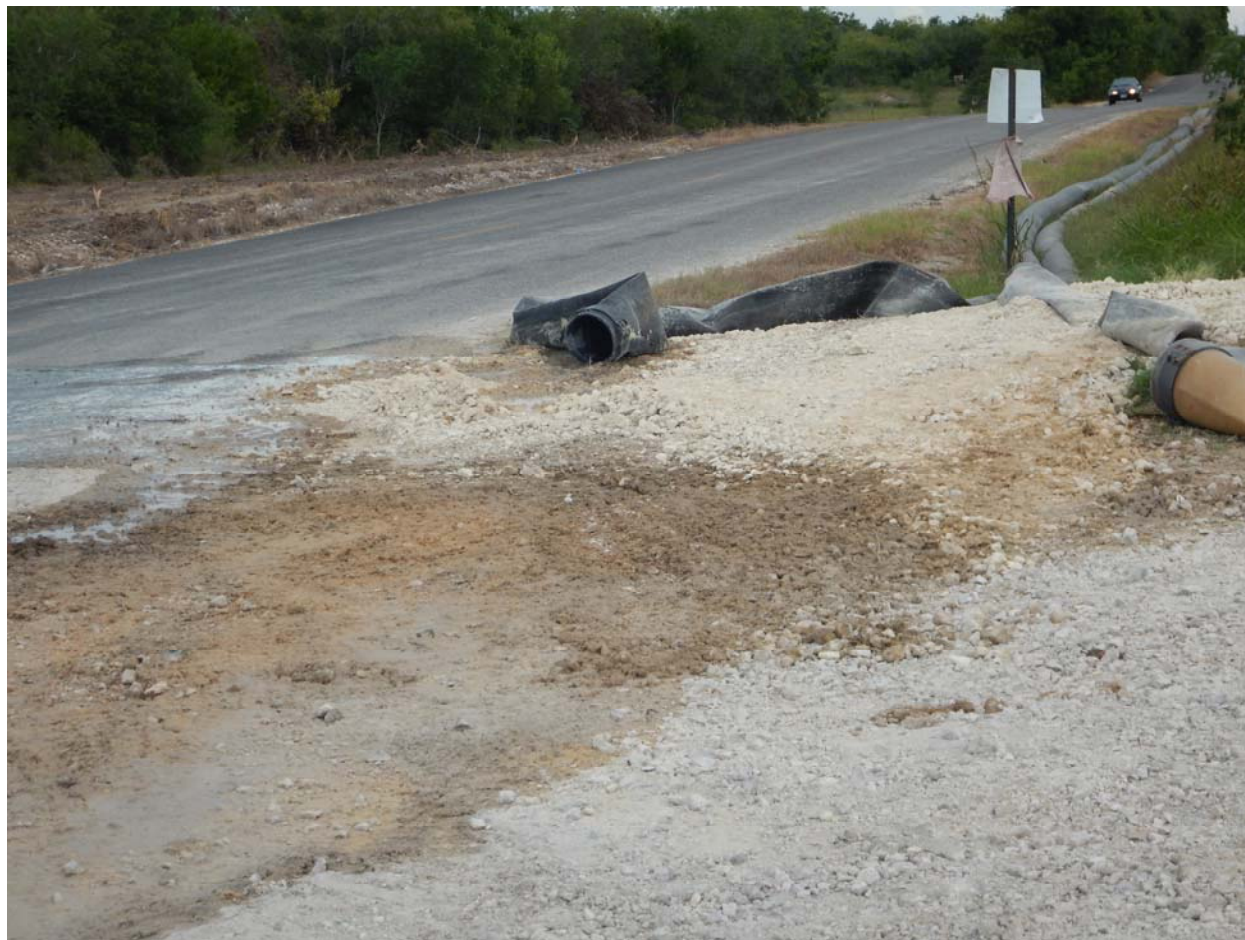
Photo No. 2

Description: This image shows a flowline discharging fluids and a flow path going down to street and creek.

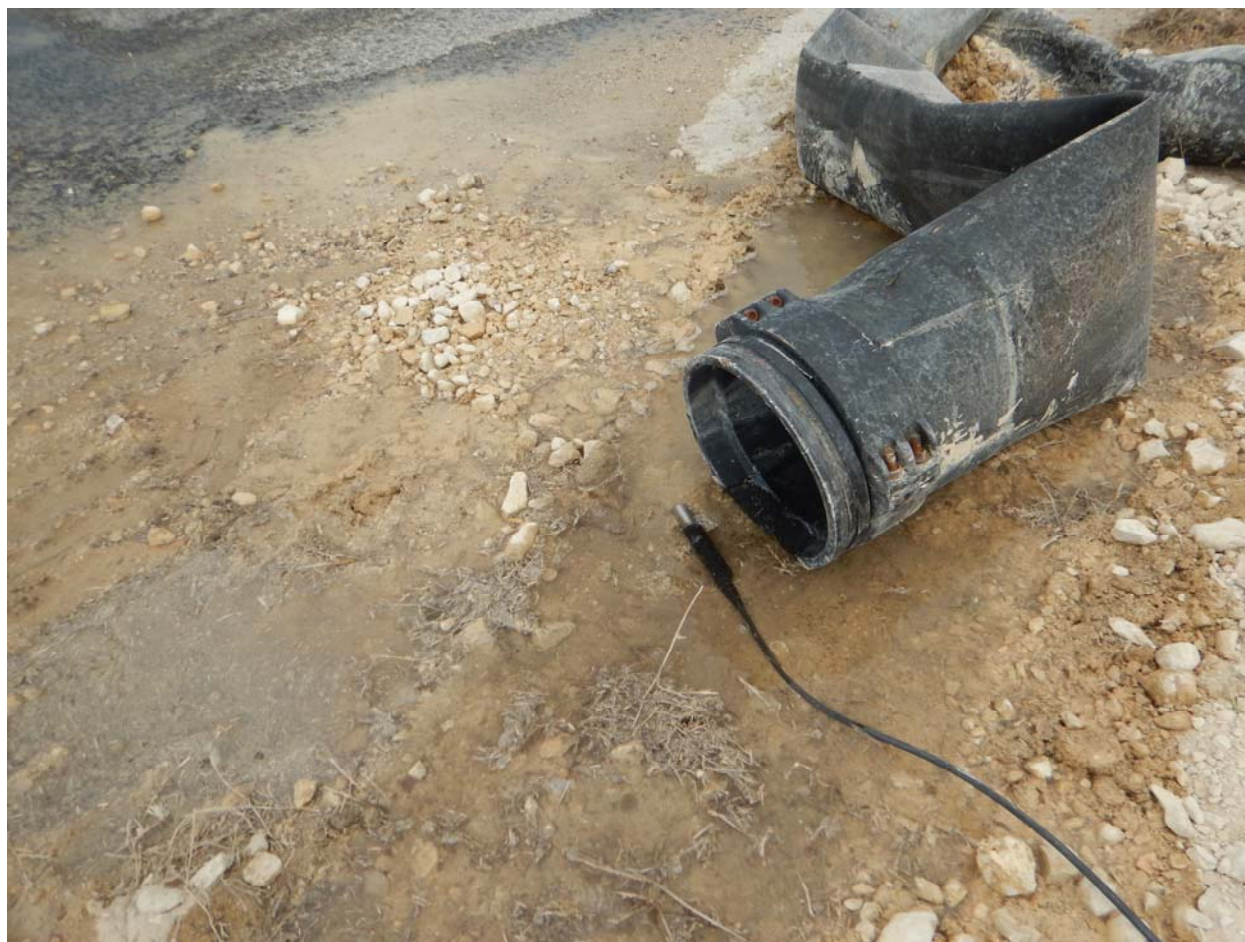
Photo No. 3

Description: This image shows the discharge of a flowline and the YSI 30 Pro in a pool of fluids.

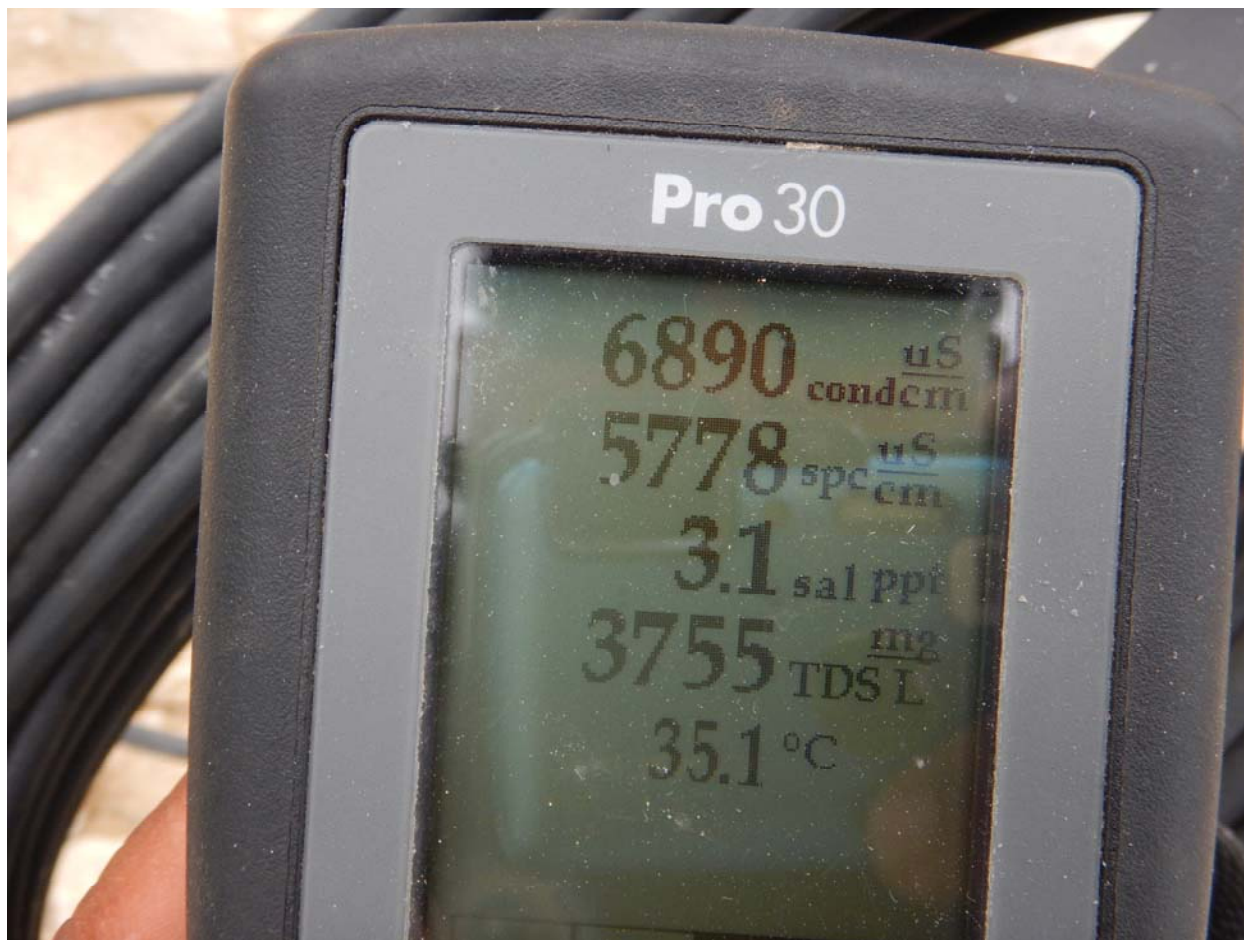
Photo No. 4

I proceeded to take a Total Dissolved Solids (TDS) measurement in fluid next to the flow line, using a calibrated YSI 30 Pro Conductivity Meter, at latitude 28.870579 N and longitude -97.874982 W. The TDS measured 3,755 ppm from this pool of fluids near the flow line (See Photo Nos. 2 - 4 in Appendix 1).

Description: This image shows a Total Dissolved Solids (TDS) measurement of 3,755 ppm from YSI 30 Pro in a pool of fluids near the flow line.

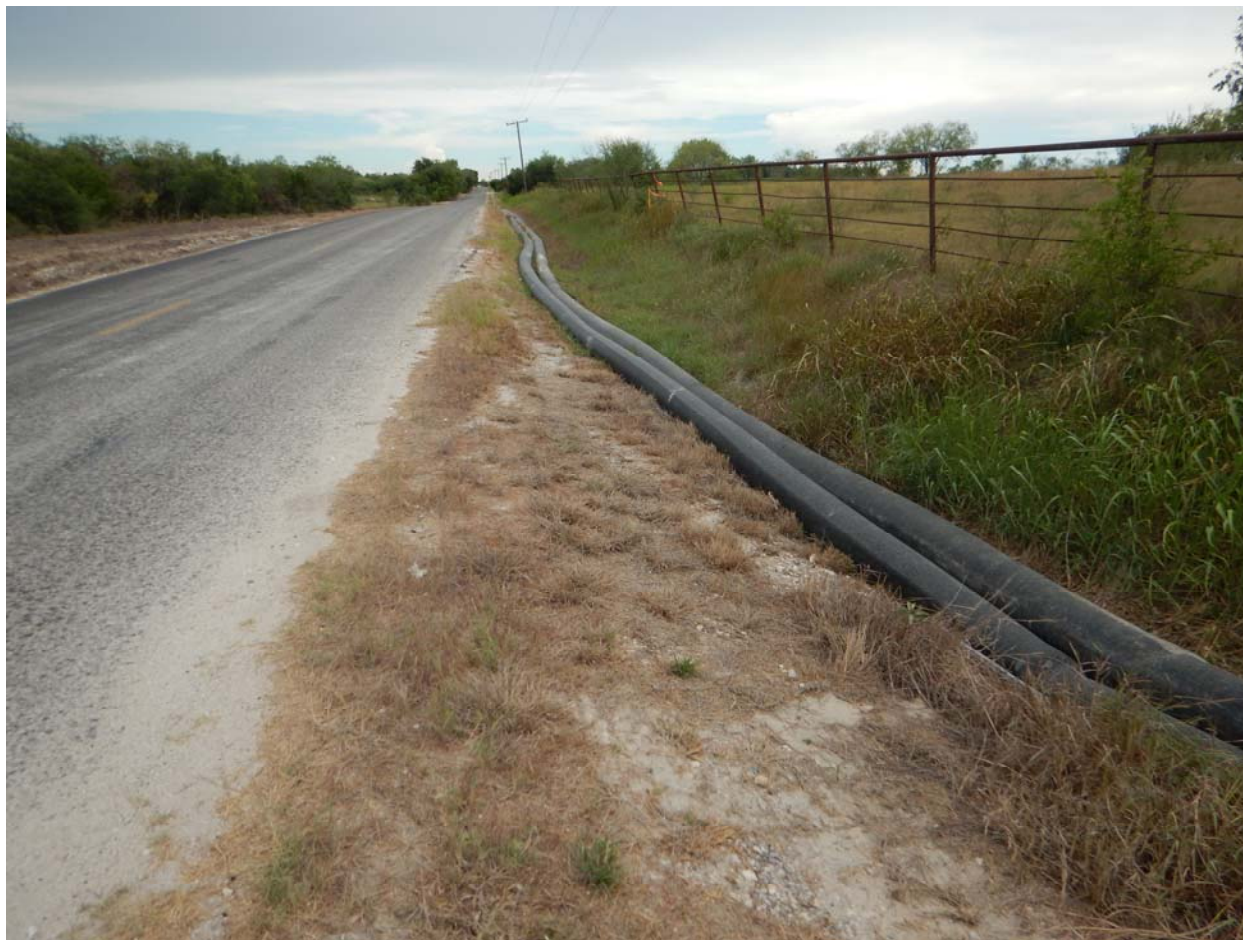
Photo No. 5

Description: This image shows flowlines going up to the ConocoPhillips pit. Flowlines contained saline water.

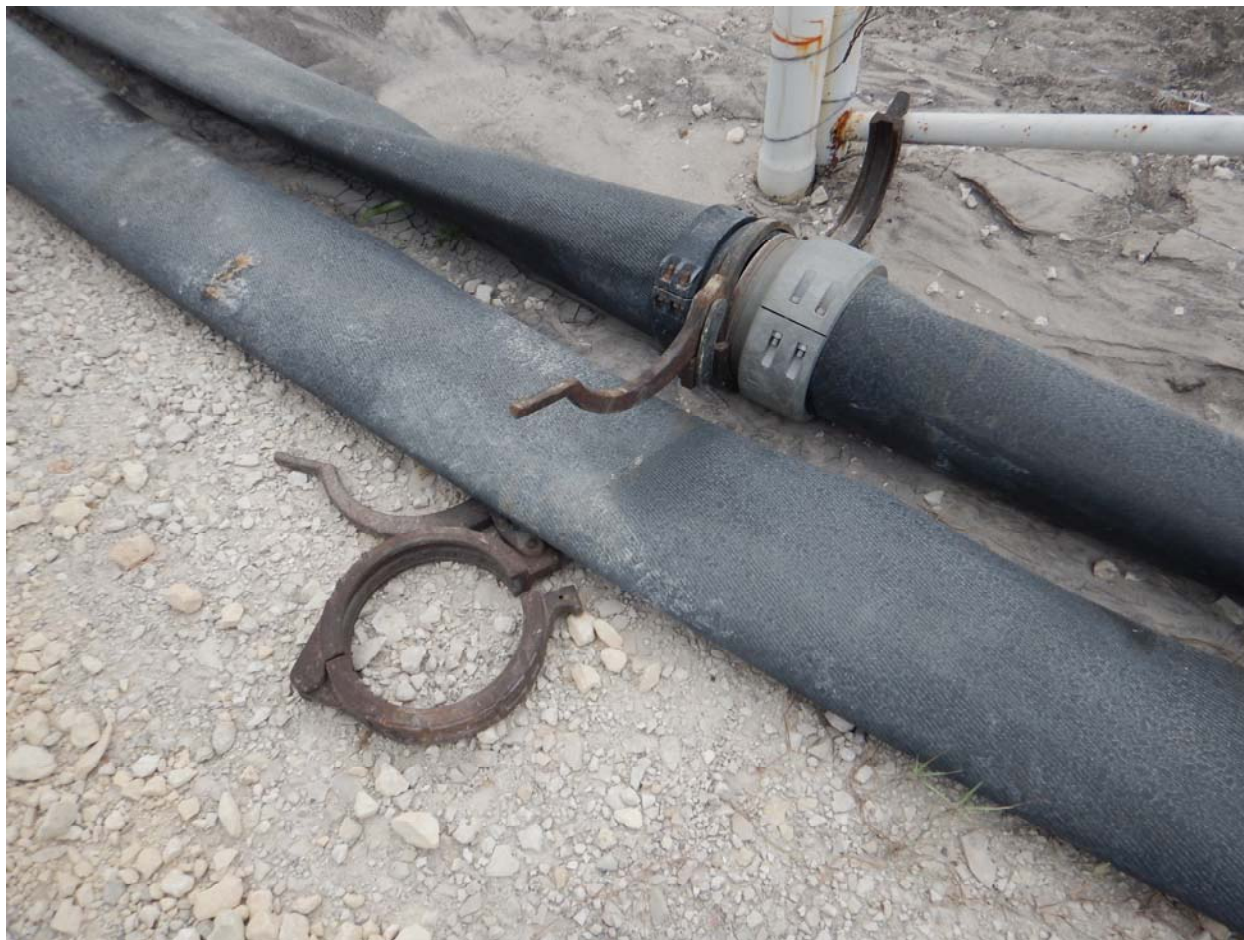
Photo No. 6

Description: This image shows how representatives of Select Energy Services were taking apart flowlines and allowing fluids to flow into the street and tributary.

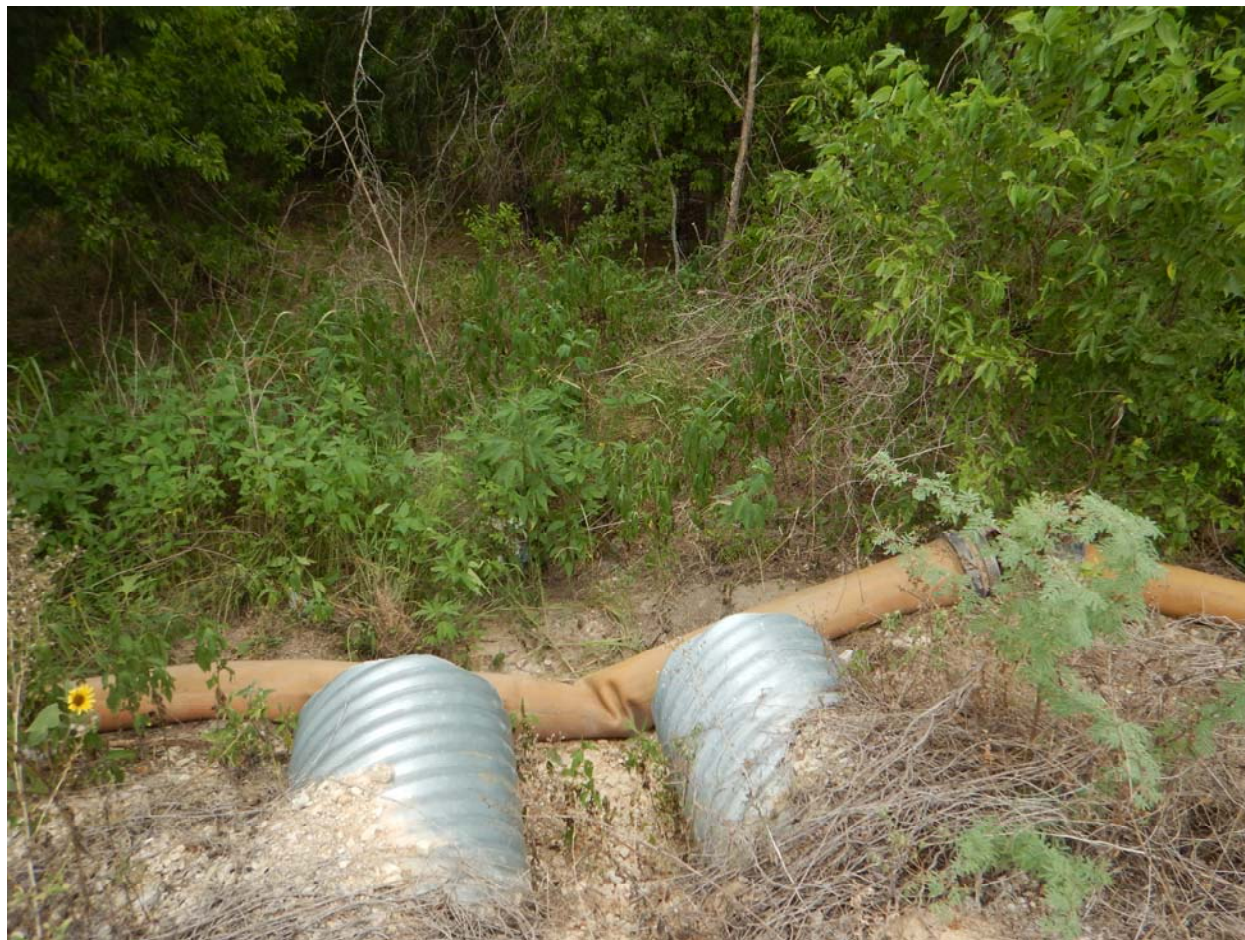
Photo No. 7

Description: This image shows a flowline that was take apart and possibly discharged fluids into the entrance to tributary connected to Dry Escondido Creek.

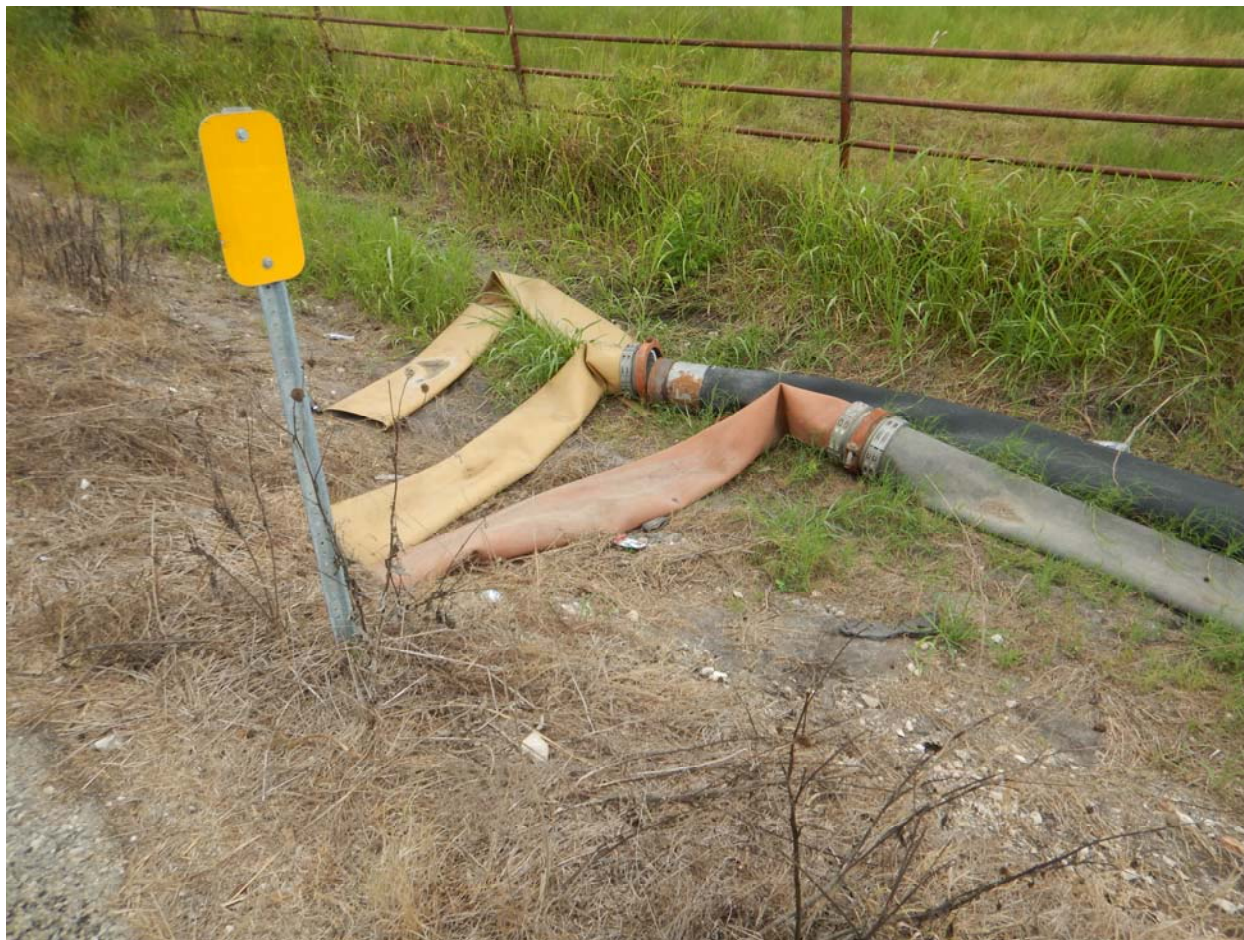
Photo No. 8

Description: This image shows a flowline that was taken apart and possibly discharge fluids into the entrance to tributary connected to Dry Escondido Creek.

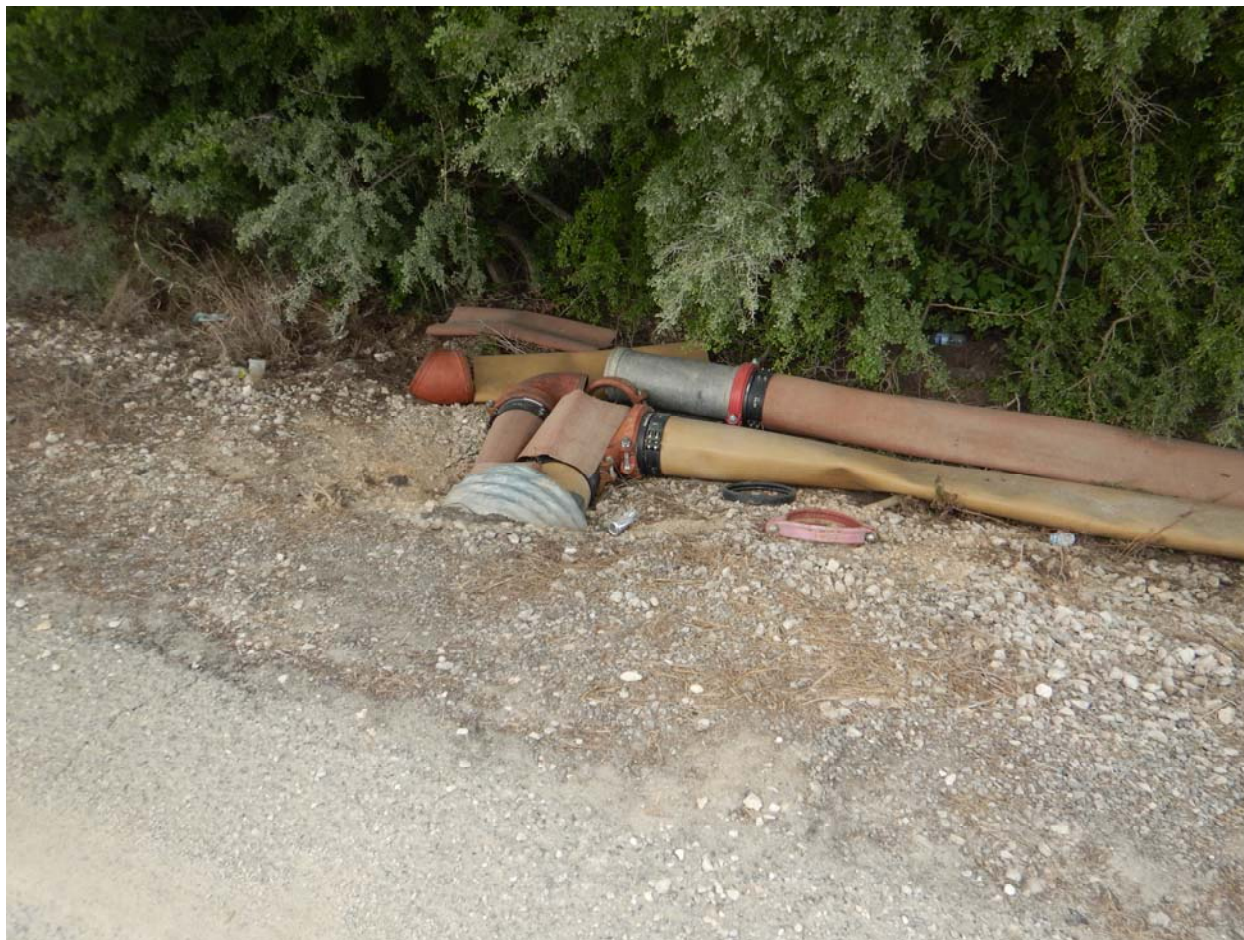
Photo No. 9

Description: This image shows flowlines that were taken apart and how they were inside the channel system lines of a tributary connected to Dry Escondido Creek .

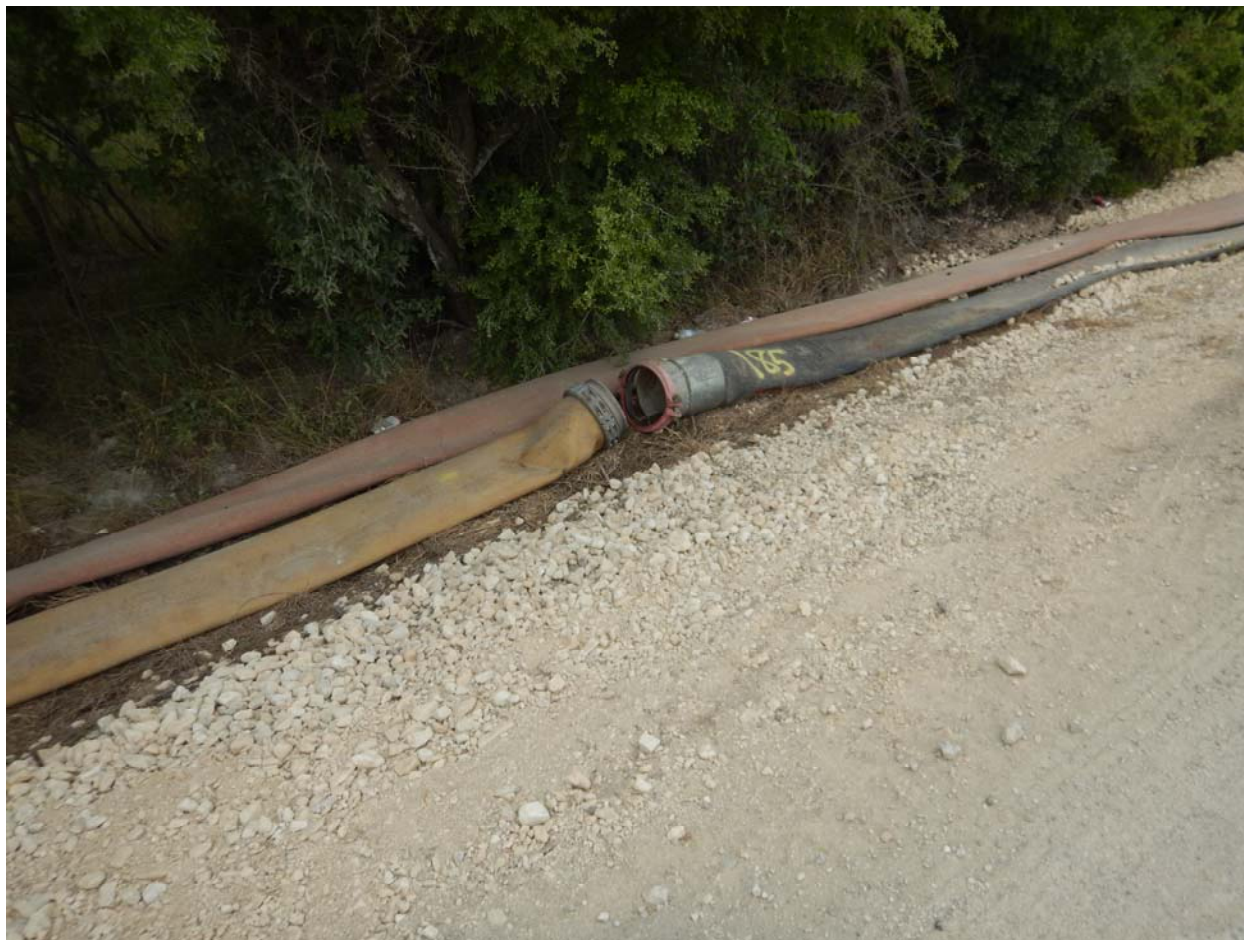
Photo No. 10

Description: This image shows a flowline that was taken apart near the entrance to a tributary connected to Dry Escondido Creek.

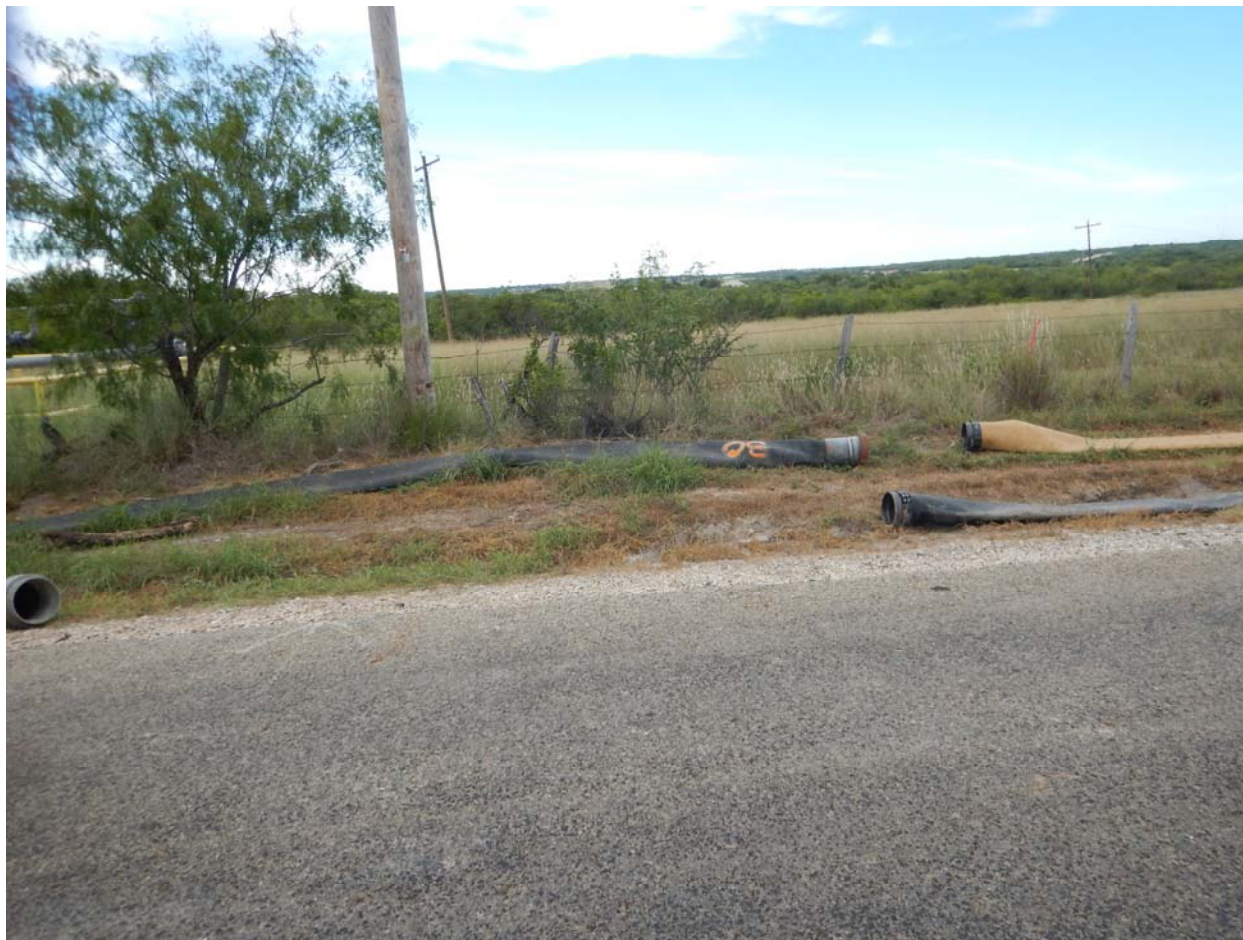
Photo No. 11

Description: This image shows some flowlines that were taken apart near the tributary of Dry Escondido Creek.

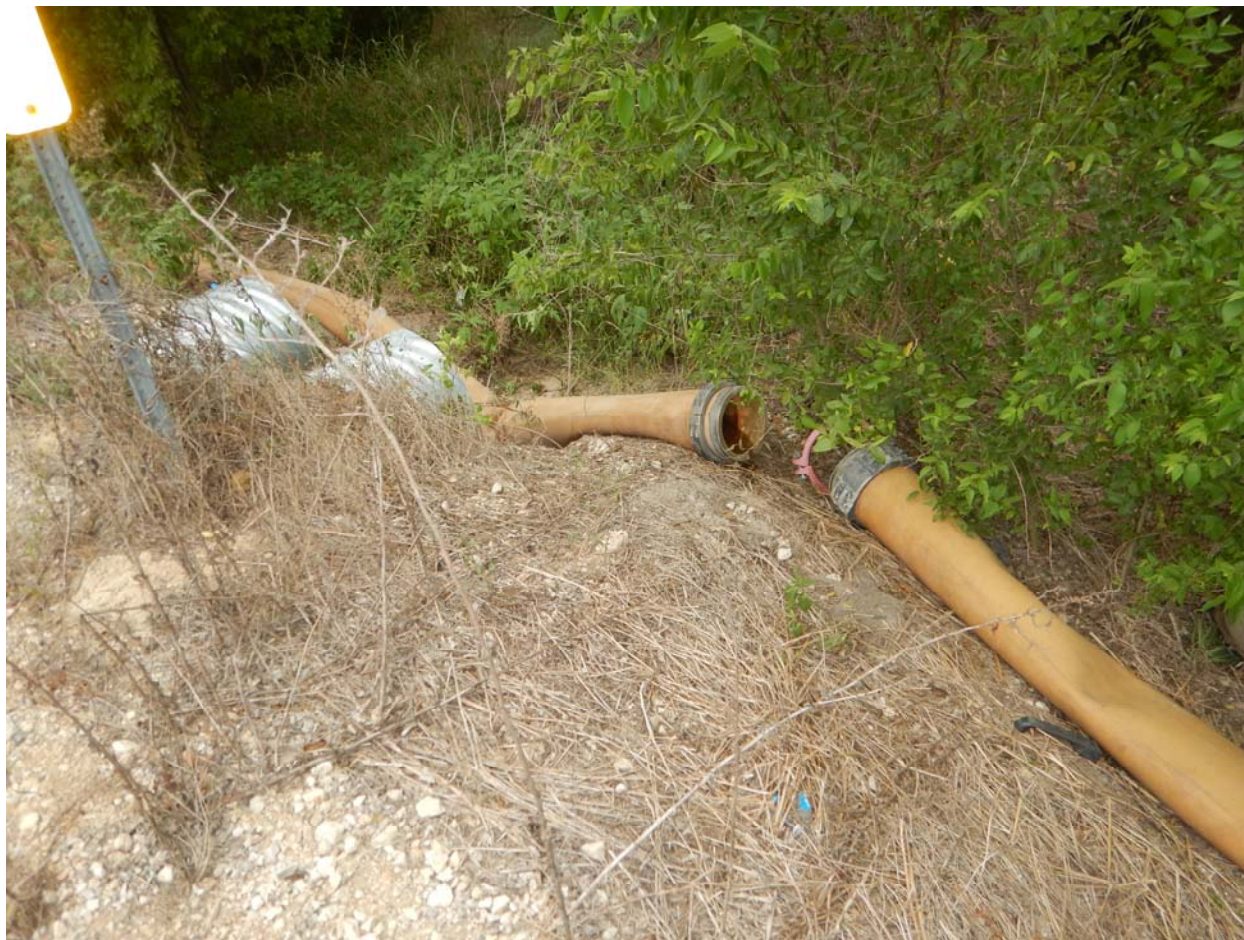
Photo No. 12

Description: This image shows a flowline that was taken apart near an entrance to a tributary connected to Dry Escondido Creek.

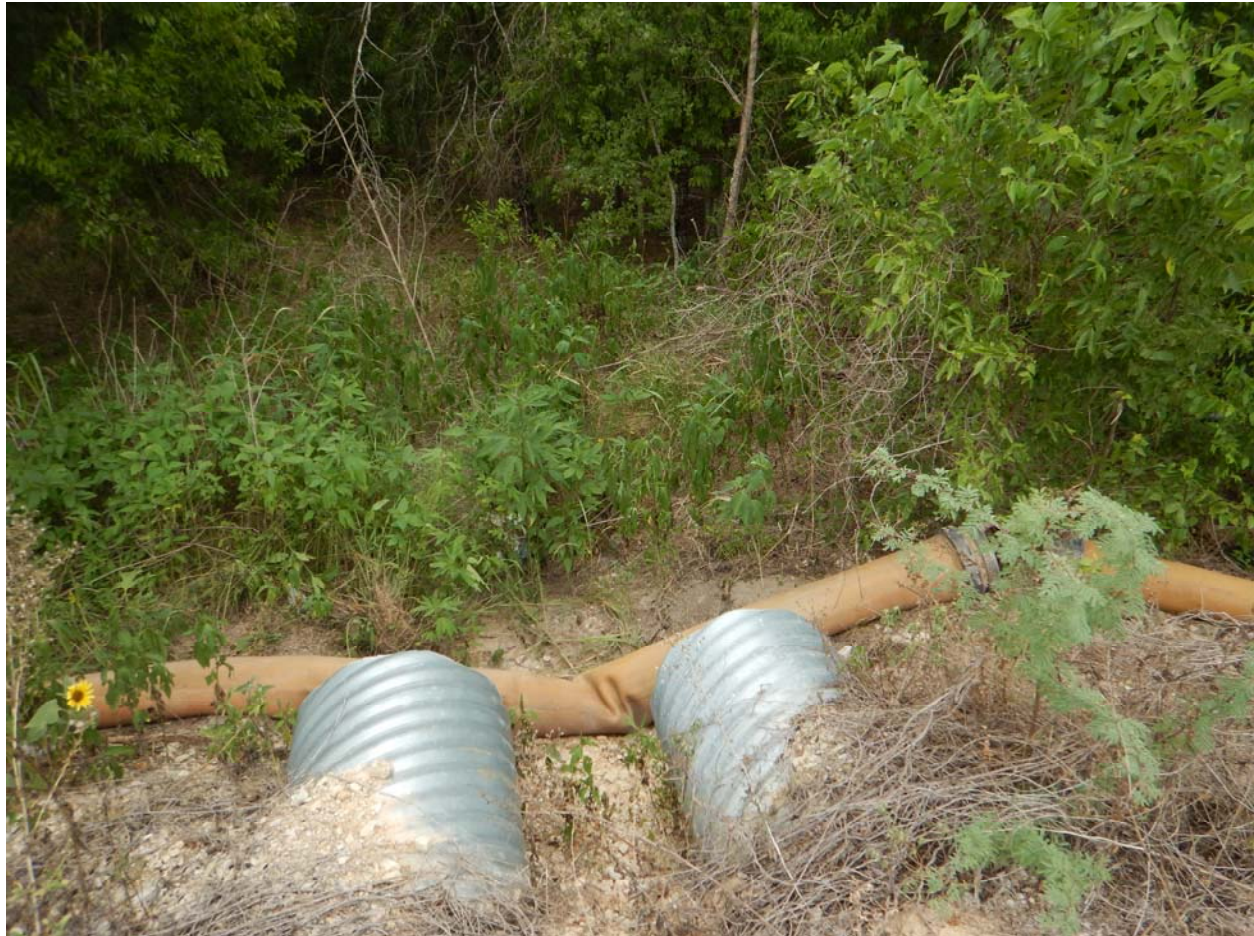
Photo No. 13

Description: This image shows a flowline that was taken apart near an entrance to a tributary connected to Dry Escondido Creek

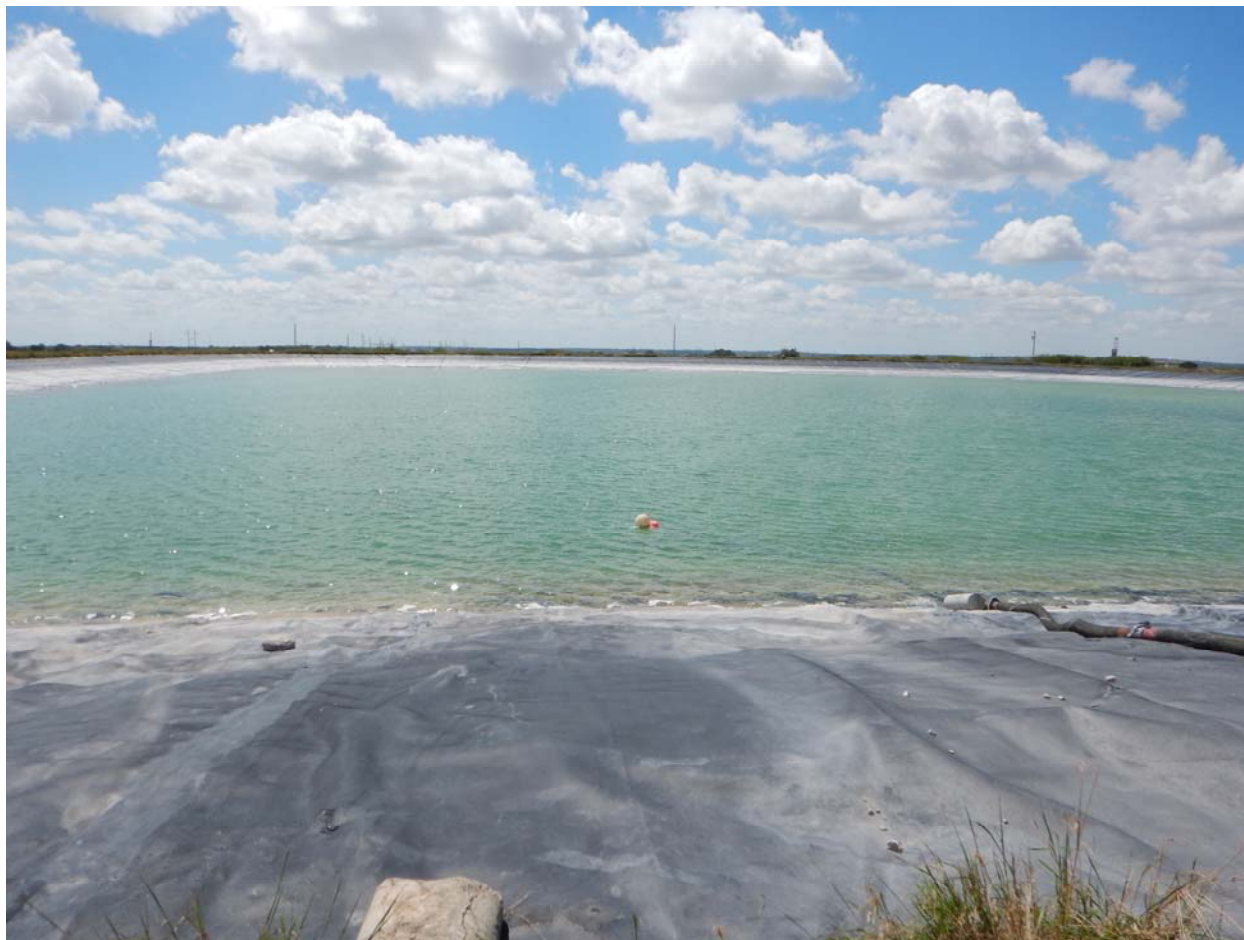
Photo No. 14

Description: This image shows a pit which area is approximately 29,000 square meters and the water level varies from 8 to 13 feet.

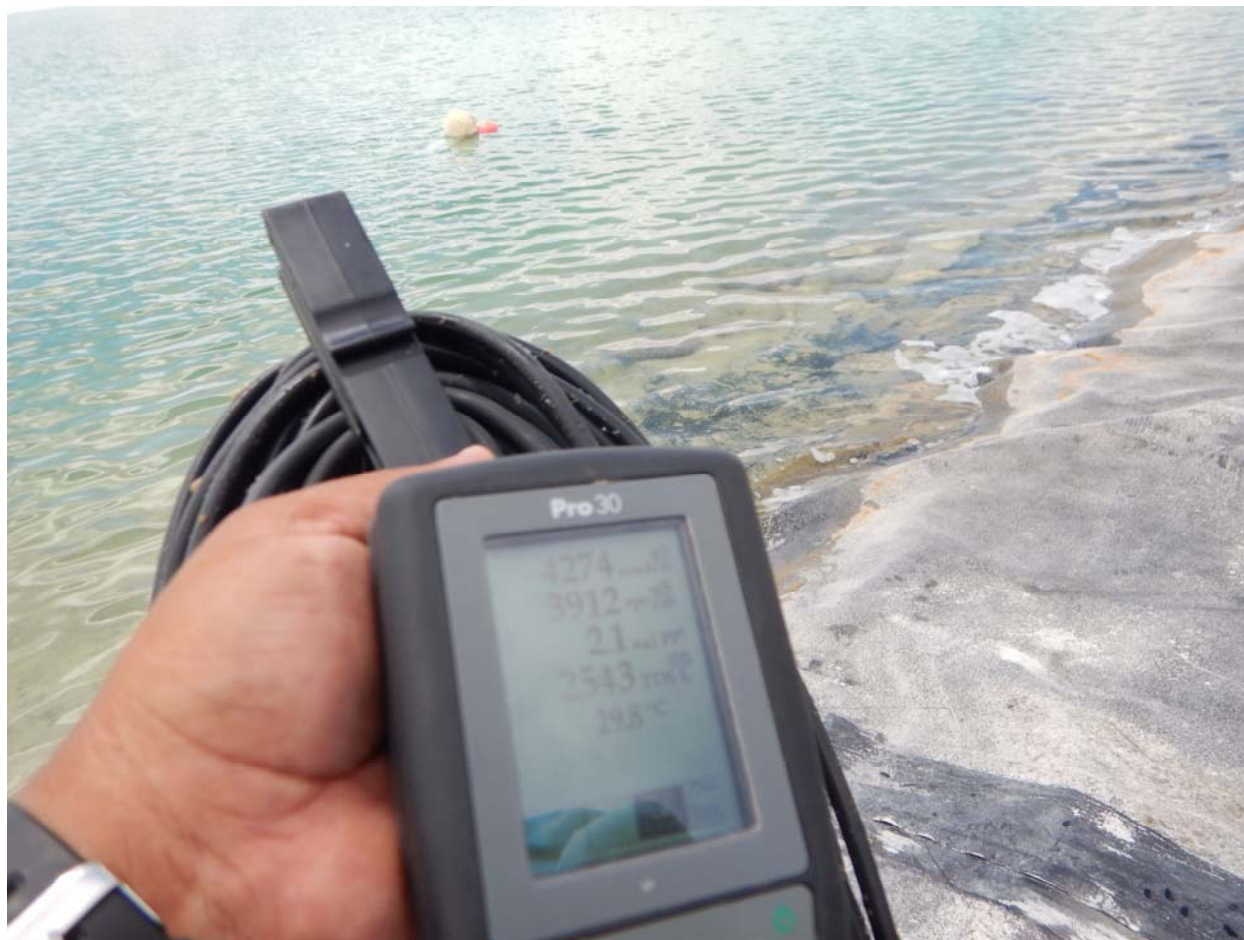
Photo No. 15

Description: This image shows a Total Dissolved Solids (TDS) measurement of 2,543 ppm at the pit.

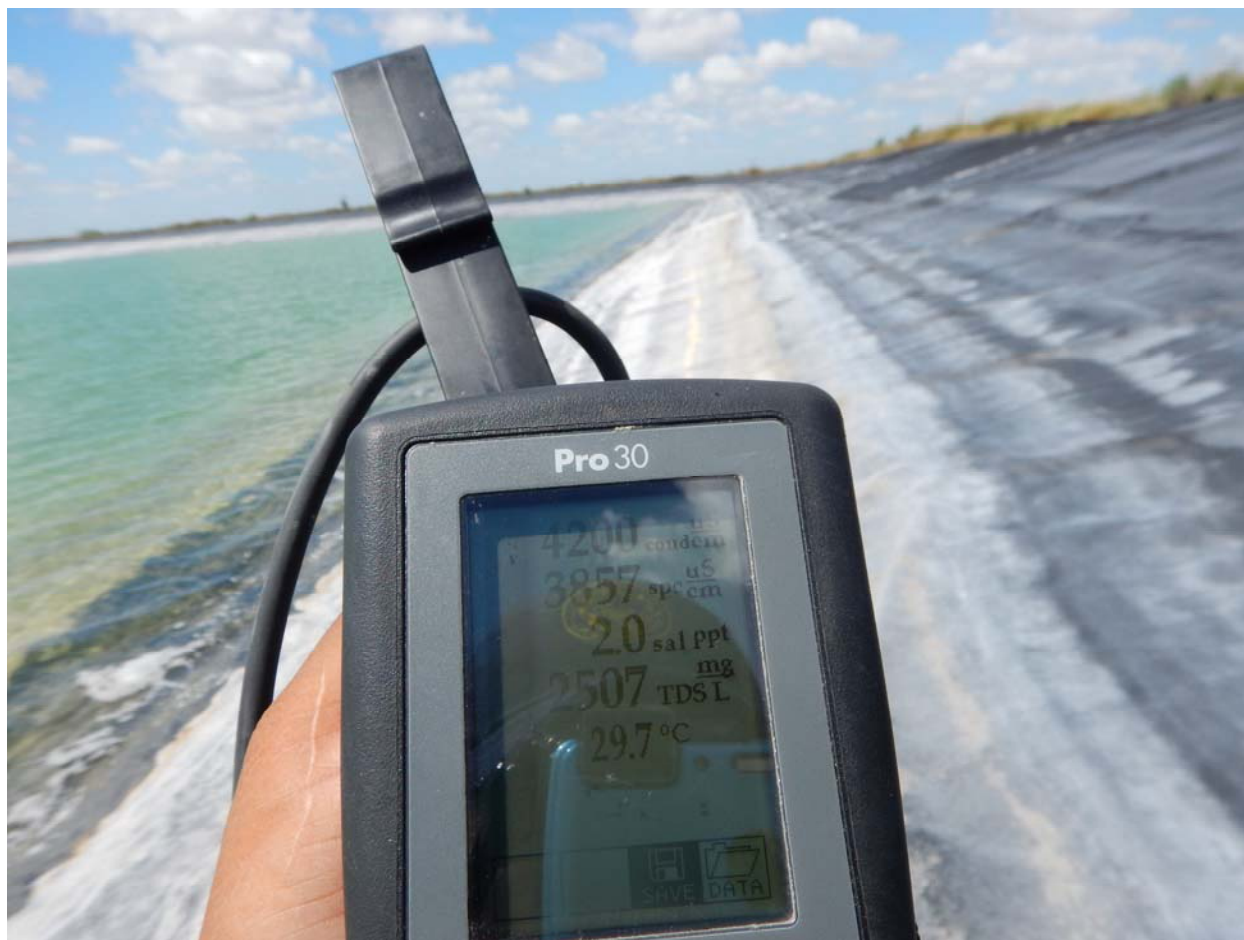
Photo No. 16

Description: This image shows a Total Dissolved Solids (TDS) measurement of 2,507 ppm at the pit.

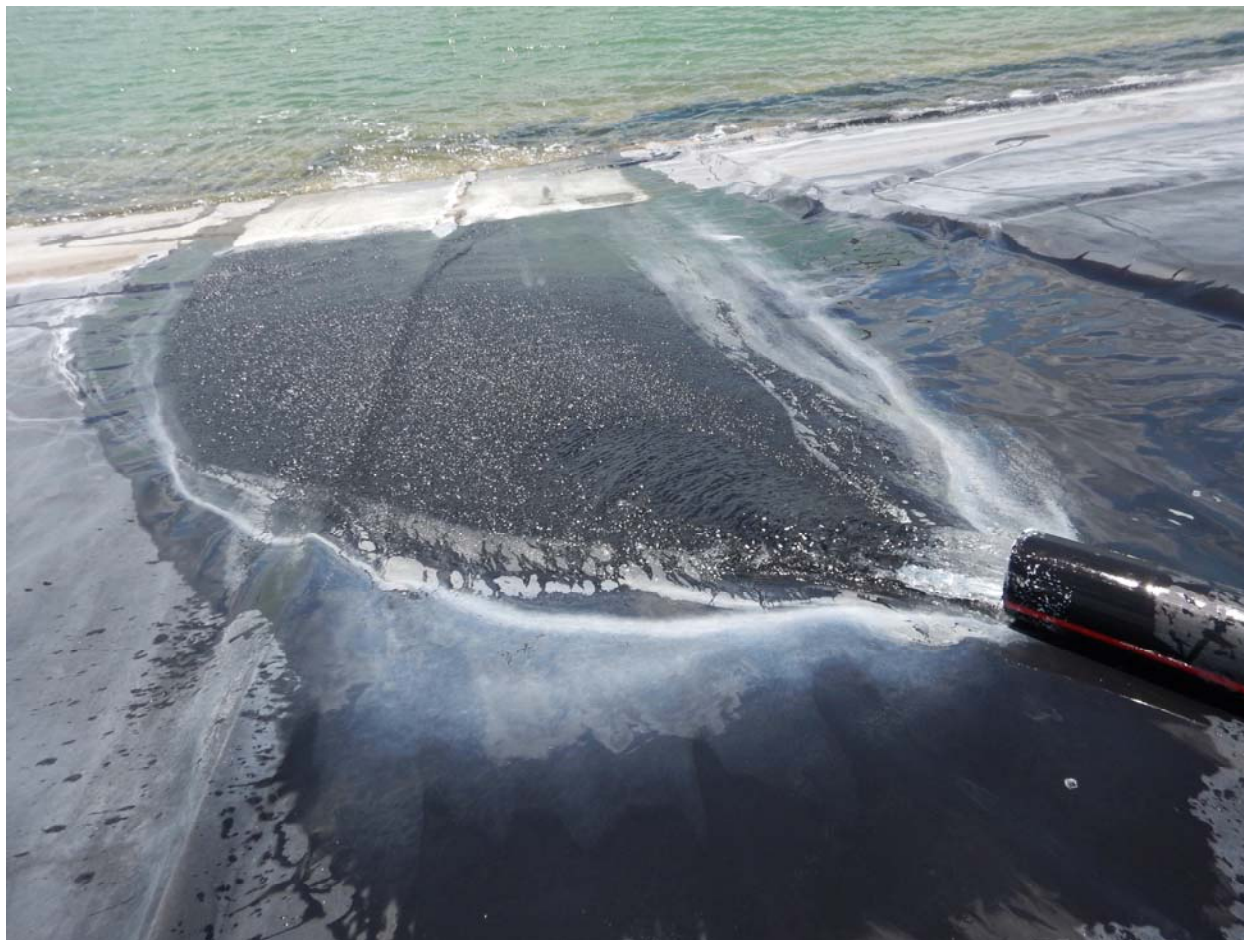
Photo No. 17

Description: This image shows the intake flowline point that recharge, the pit with saline water.

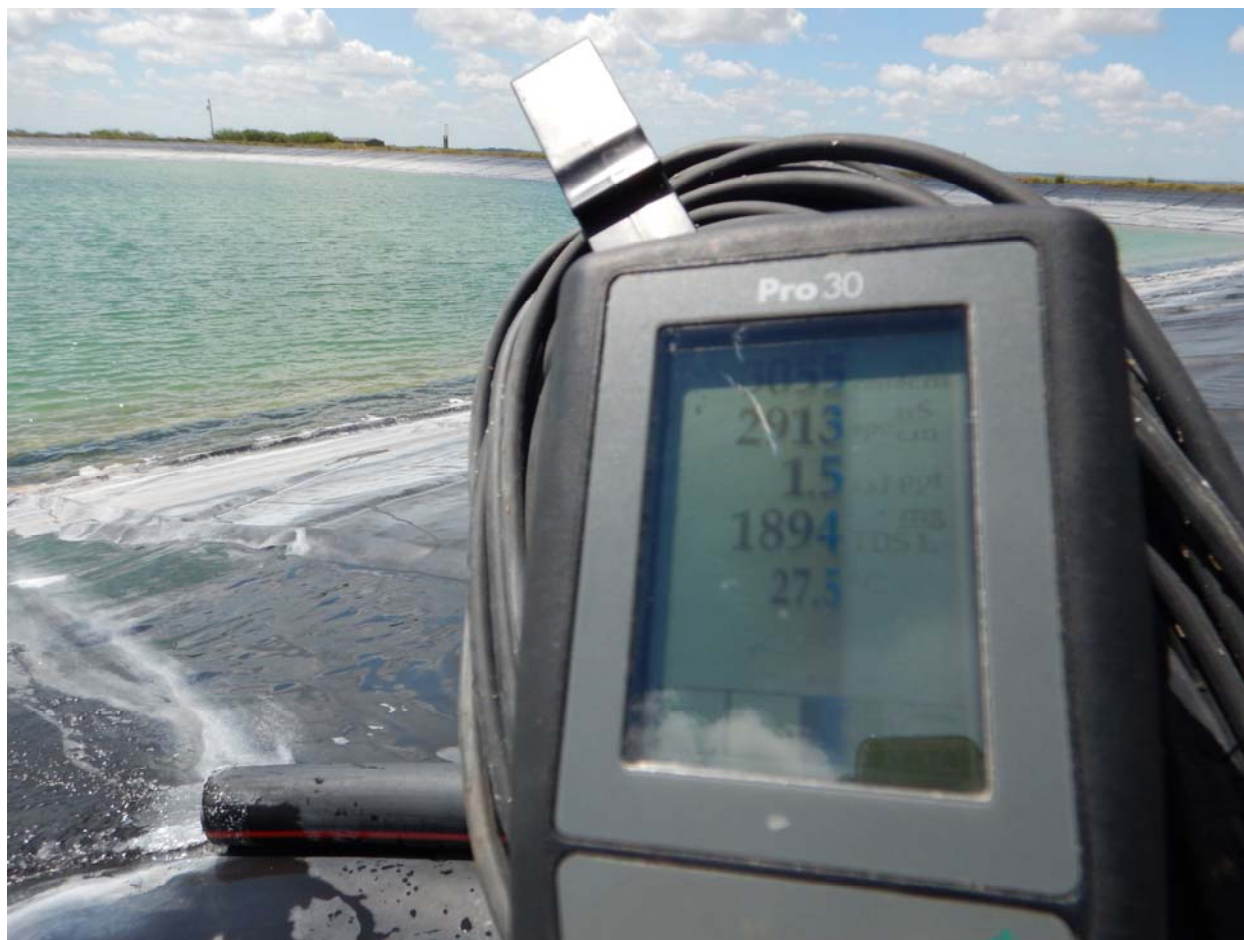
Photo No. 18

Description: This image shows a Total Dissolved Solids (TDS) measurement of 1,894 ppm at the flowline point that recharge the pit with saline water.

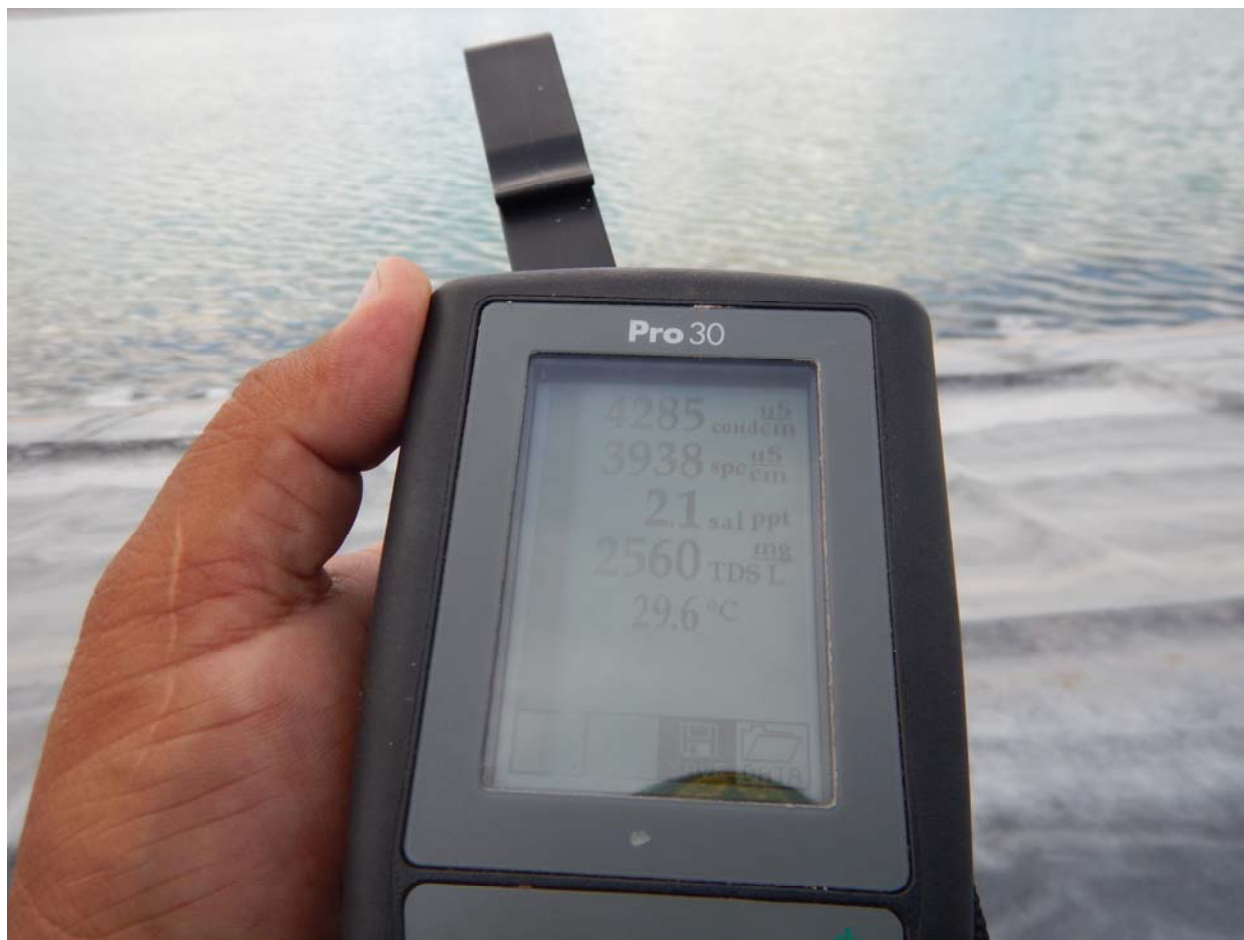
Photo No. 19

Description: This image shows a Total Dissolved Solids (TDS) measurement of 2,560 ppm at the pit.
