**Region 6 Compliance Assurance and Enforcement Division  
INSPECTION REPORT**

| Inspection Date(s): | 08/8-9/2018 | | |
| Company Name: | <b>ConocoPhillips and Select Energy Services</b> | | |
| Facility Name: | <b>Conoco Phillips Pit</b> | | |

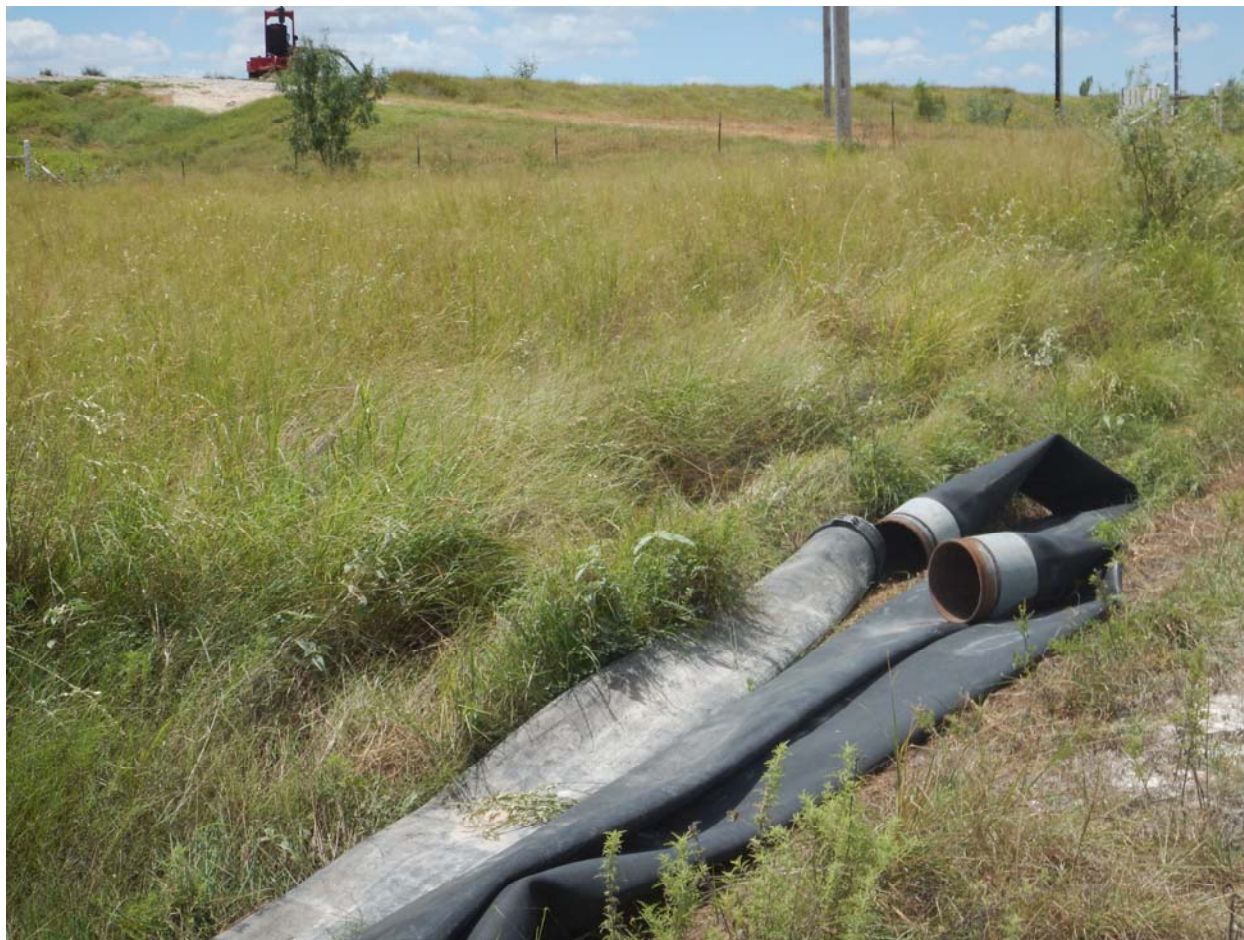
Photo No. 22

Photograph File Name: DSCN3610.JPG  
Date of Photograph: 08/09/2018  
Latitude: 28.853724 N  
Longitude: -97.853551 W  
Orientation: NE  
Map Datum: WGS-84  
Time of Photo: 12:36 PM  
Photographer: Jack Arias  
Description: This image shows flowlines that were taken apart near the pit.

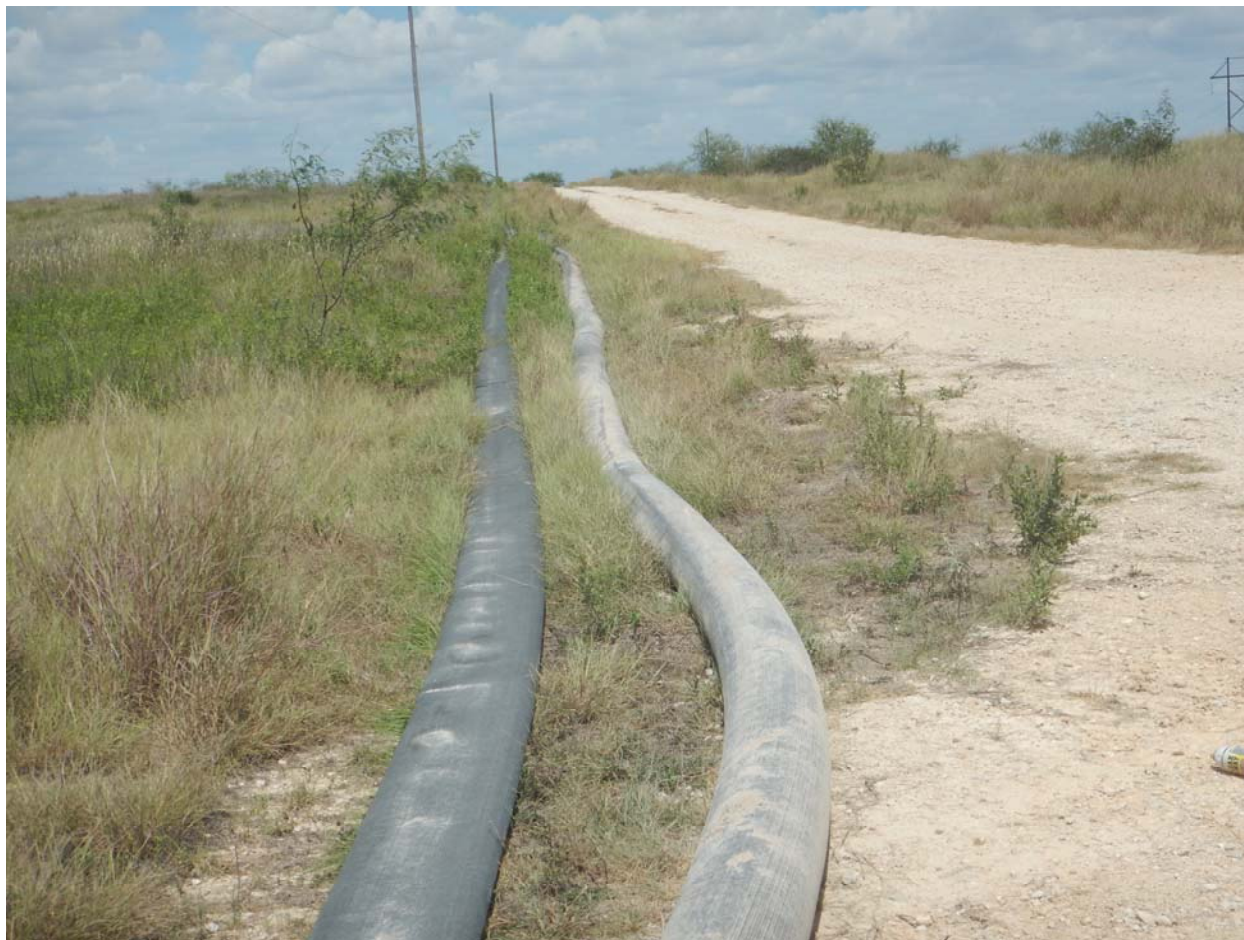
Photo No. 23

Photograph File Name: DSCN3612.JPG  
Date of Photograph: 08/09/2018  
Latitude: 28.854175 N  
Longitude: -97.853360 W  
Orientation: NE  
Map Datum: WGS-84  
Time of Photo: 12:37 PM  
Photographer: Jack Arias  
Description: This image shows some flowlines going down to the point of discharge.

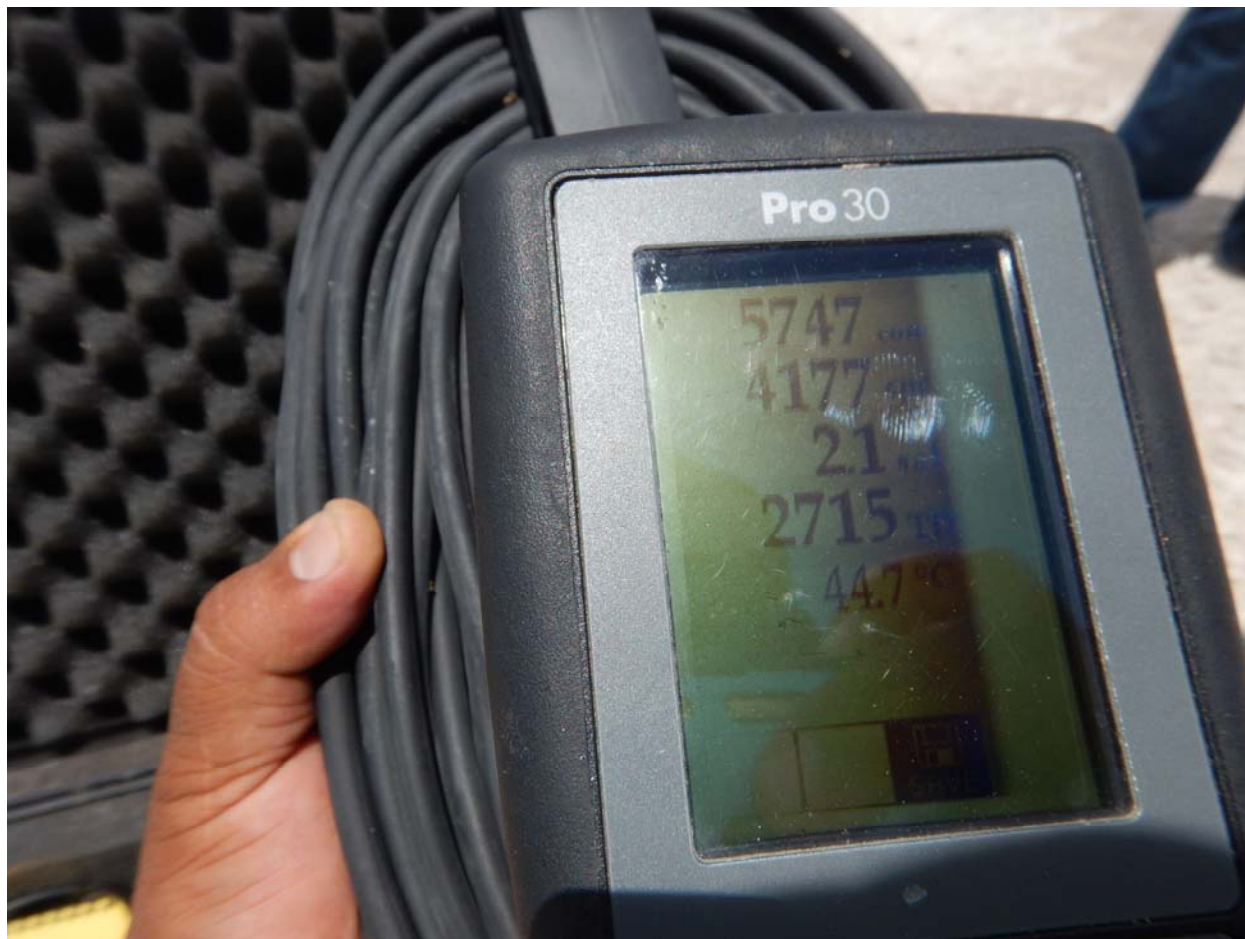
Photo No. 25

Select Energy Services and ConocoPhillips decided to return to the facility to check the information provided by EPA and confirm TDS and salinity concentrations. Subsequently EPA, Select Energy Services and ConocoPhillips followed the flowlines downstream from the pit and returned to point of entry to determine TDS and salinity concentrations and potential impacts on wildlife and vegetation by discharges. At this point, using a calibrated YSI 30 Pro Conductivity Meter, I took a TDS measurement of 2,715 ppm (See Photo Nos. 24-25 Appendix 1).

Photograph File Name: DSCN3615.JPG  
Date of Photograph: 08/09/2018  
Latitude: 28.875168 N  
Longitude: -97.880249 W  
Orientation: NE  
Map Datum: WGS-84  
Time of Photo: 2:20 PM  
Photographer: Jack Arias  
Description: This image shows a Total Dissolved Solids (TDS) measurement of 2,715 ppm at the point of discharge.
