UNITED STATES ENVIRONMENTAL PROTECTION AGENCY

**Subj:** Inspection Report  
Clean Water Act - National Pollutant Discharge Elimination  
System ("NPDES")  
Granite State Concrete Co.

- A. *Facility Name:* Granite State Concrete Co.
- B. *Facility Location:* 534 Groton Rd  
Westford, MA 01866
- C. *Facility Contacts:* John MacLellan, President  
180 Phoenix Avenue  
Lowell, MA 01852  
978-458-1223, Jmaclellan@jgmaclellan.com
- D. *NPDES ID No(s):* MA0020231, MAR053686

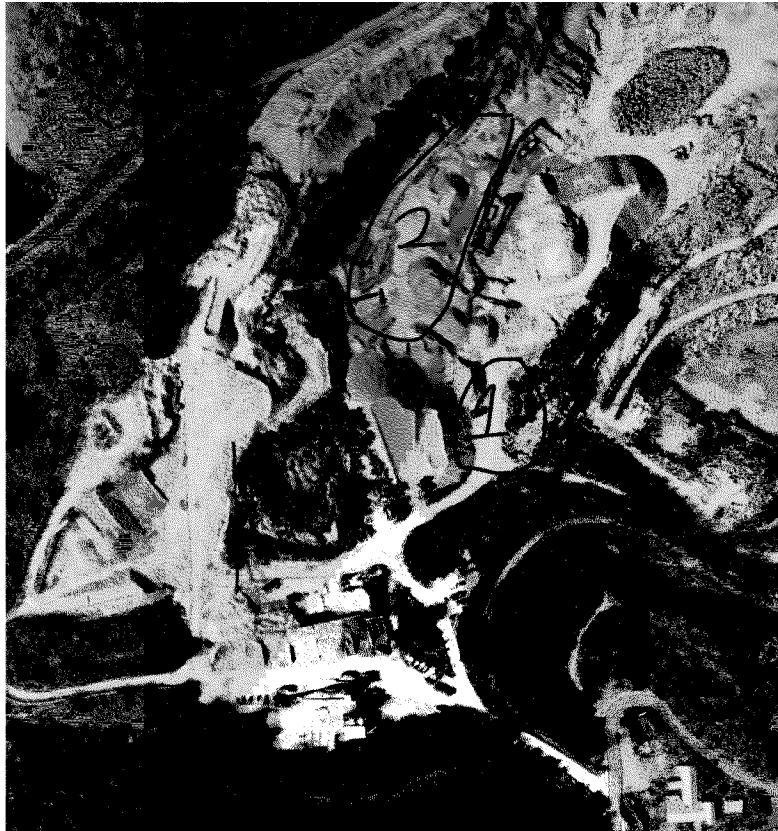
Inspectors then traveled down the access road into the stone crushing area (Section 1 on above map)(slides 31-35). This area contained crushed rock piles of various sizes and consistencies. Mr. MacLellan stated that these piles are self-contained and stabilized, although no stabilization measures were observed. Additionally, a large tank of unknown capacity that contains non-potable water pumped from Gilson Brook Pond by the spray truck, was observed in the area (slide 30). Mr. MacLellan stated that the spray truck can either take directly from the pond or from the non-potable water tank when needed (slide 36). Inspectors then moved toward the back of the gravel area (Section 2 in the above map). This area was observed to have a large body of standing water (slides 27-29) that was not listed as a settling pond in the facility's site map. Mr. MacLellan stated that this area has trucks driving in and out of it and that it is not "more than 1 foot deep". Additionally, he stated, that the water is accumulation of rain and snowmelt, and that it is contained in the area. GSC does not pump or remove the water from here, they allow it to infiltrate to the ground or to evaporate. The flooded area reached to the far back of the quarry wall and represented a large percentage of the gravel processing area. A cap of unbroken ice was observed at the far back of the area and it did not seem to be disturbed.

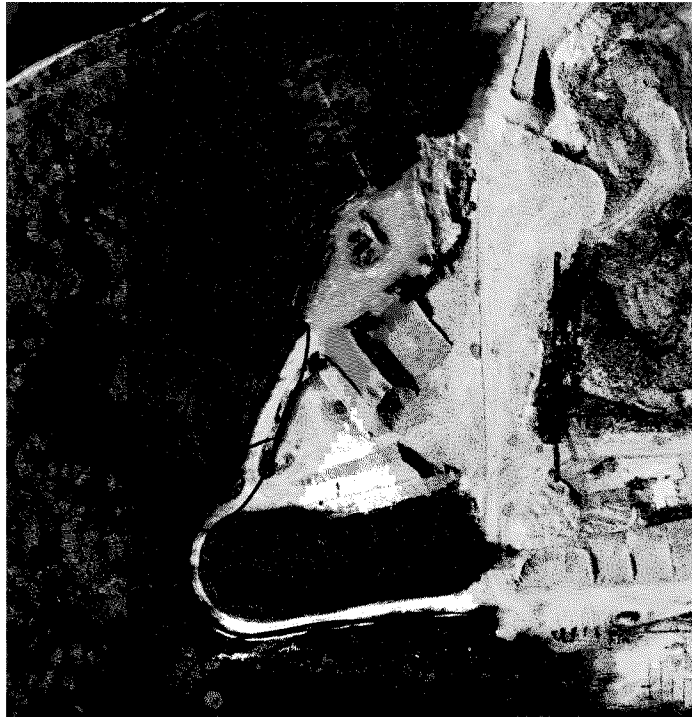
Leaving the gravel area, the inspection team moved toward the rear of the facility to inspect old outfalls and ready-mix concrete operations (slide 37). In Section 1 of the above map, we observed standing water sections that flow to the stormwater outfall (slide 38-39). The stormwater outfall 001 pipe was observed on Gilson Brook Pond (slide 40).

Section 2 led up to the wooded paths leading above the quarry wall, though a marshy area going toward Fletchers Pond (body of water at the top northwest point of the above map). Inside Section 3 there was observed an old foundation that Mr. MacLellan stated was used by the former owner of the property, Fletcher Granite, to pump water from the quarry to a pond on the far northwest side of the inspection area. This pond is owned by the Town of Westford and the public has access to it. The pump is no longer in use and the foundation is dilapidated. There was an observed container and debris at this site that was overgrown and difficult to get to. At the far back of the property, the inspection team tried to find a way of getting to the top of the back quarry wall. This attempt failed due to deep snow and lack of navigable path. Mr. MacLellan stated that the back area of the quarry was close to the property line and that the land parcels behind the quarry wall were not owned by his company.

Additionally, a culvert was observed in Section 2, with a heavy flow into the wetlands present in that area (slide 41). Mr. MacLellan stated that he did not know the source of the water flowing, but though it was just run off from higher areas. No inlets to the culvert were observed during the inspection.

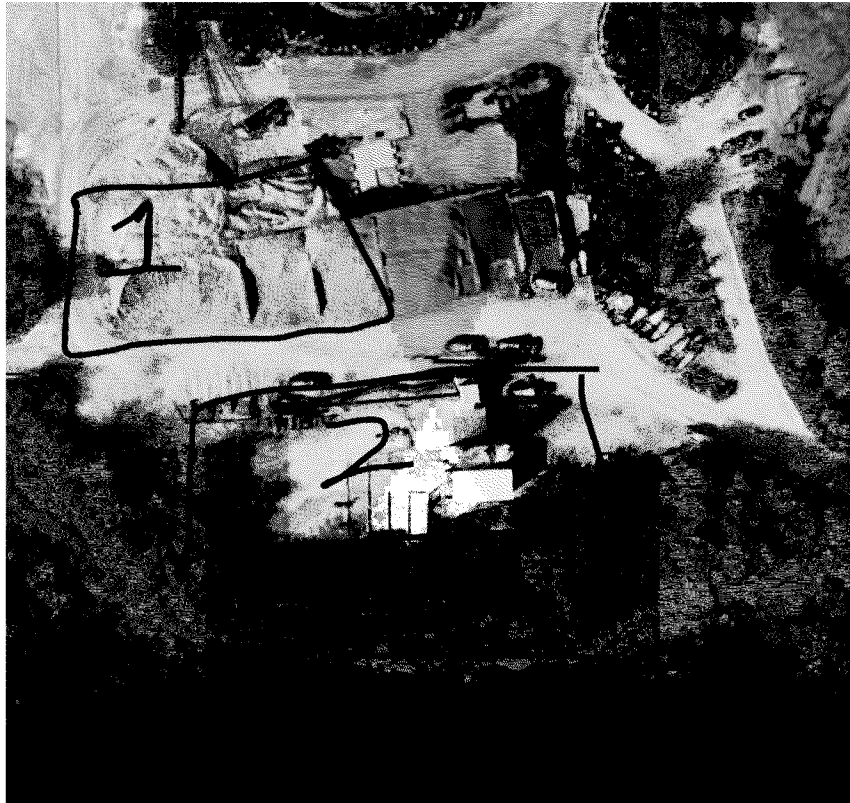
Upon entering the washing area, in Section 1 of the above map, containers with different materials exposed to stormwater were observed to be rusted and several sections of the metal containers were bulged or split, allowing material to escape (slide 43-44). At the post-inspection meeting, Mr. MacLellan stated that this was due to their machinery having to constantly push and pull material from the containers and bulging them.

The inspection then proceeded to Section 2 in the above map and observed the water adding process directly into the trucks. This is also the area where the four washout pits collect processed wash water (slides 46-47). This water is drained through a large drain system (slides 65-66) and is pumped into each of the pits. The washout pits are lined in concrete and were full of water during the inspection. There was a sheet of ice on all of the pits the day of the inspection. Cement trucks were lined up along the road between sections 1 and 2 on the map above, so inspectors were able to directly observe the trucks taking in hot water into the concrete mixers as well as seeing a strong flow in the drainage system (slides 47-48). The washout pit pumps were not moving water across the pits on the day of the inspection.

Directly behind these washout pits, in Section 3, it was observed by the inspection team that the area of Gilson Brook Pond was thawed approximately 10 feet out from the shore (slides 49, 62) Over the course of the inspection, the team had the opportunity to observe

the ice conditions on the pond and this thawed area was not typical. Therefore, the team moved to the small, wooded area directly between the four settling pits and the pond. Behind the pits, there is significant debris from earlier pumping operations, including pipes that lead into the pond itself (slide 63-64). Furthermore, there is a pipe that is in use for pumping pond water into the “fill building”, which is what the site calls the building where cement trucks take on water for their mixing (building at the far right of Section 2 in the above map) (slides 54-61). This pipe runs from the pond, up and over the truck entrance, and then to an outlet pipe that can be fitted with a hose that would then lead into the adjacent building for tank storage. At the moment of the inspection the pipes were not connected (slide 56).

At this point the inspection team met Mr. Steve Fox, the site Operations Manager. Mr. Fox and Mr. MacLellan informed the inspection team that the majority of the pipes in the area behind the settling pits were not in use. It was observed that these pipes are uncapped and many were below the snow line on the day of the inspection. When asked if it was possible the warm water being used in the fill building could be the cause of the observed thawing in Gilson Brook Lake, he stated that he didn’t believe it was possible due to the water capture system previously observed. It was recommended to Mr. MacLellan to remove all old equipment not in used from this area as a best management practice.

The inspection team and Mr. MacLellan returned to the converted office for the closing conference. The inspection team had several housekeeping BMP recommendations, which included: removing the unused pipes from behind the washout pits; labeling of in-use pipes; general cleaning around the site to remove scrap metal and processed stone materials; and fixing corroded or split containers. Further, the site was notified that their sampling location on their individual permit would be changed from where water exits Gilson Brook Pond to the correct location, where the water enters into Gilson Brook Pond, as it was in their 1986 permit. This is because the current sampling location is “not representative of what [the site] is discharging” as the sampling currently occurs after the sample is diluted by the pond.
