# **REPORT OF PUBLIC WATER SYSTEM COMPLIANCE INSPECTION**

**AT**  
**City of Weeping Water Public Water Supply**  
**101 West Eldora Street,**  
**Weeping Water, Nebraska 68463**

**Public Water Supply ID#: NE3102506**

**October 20, 2025**

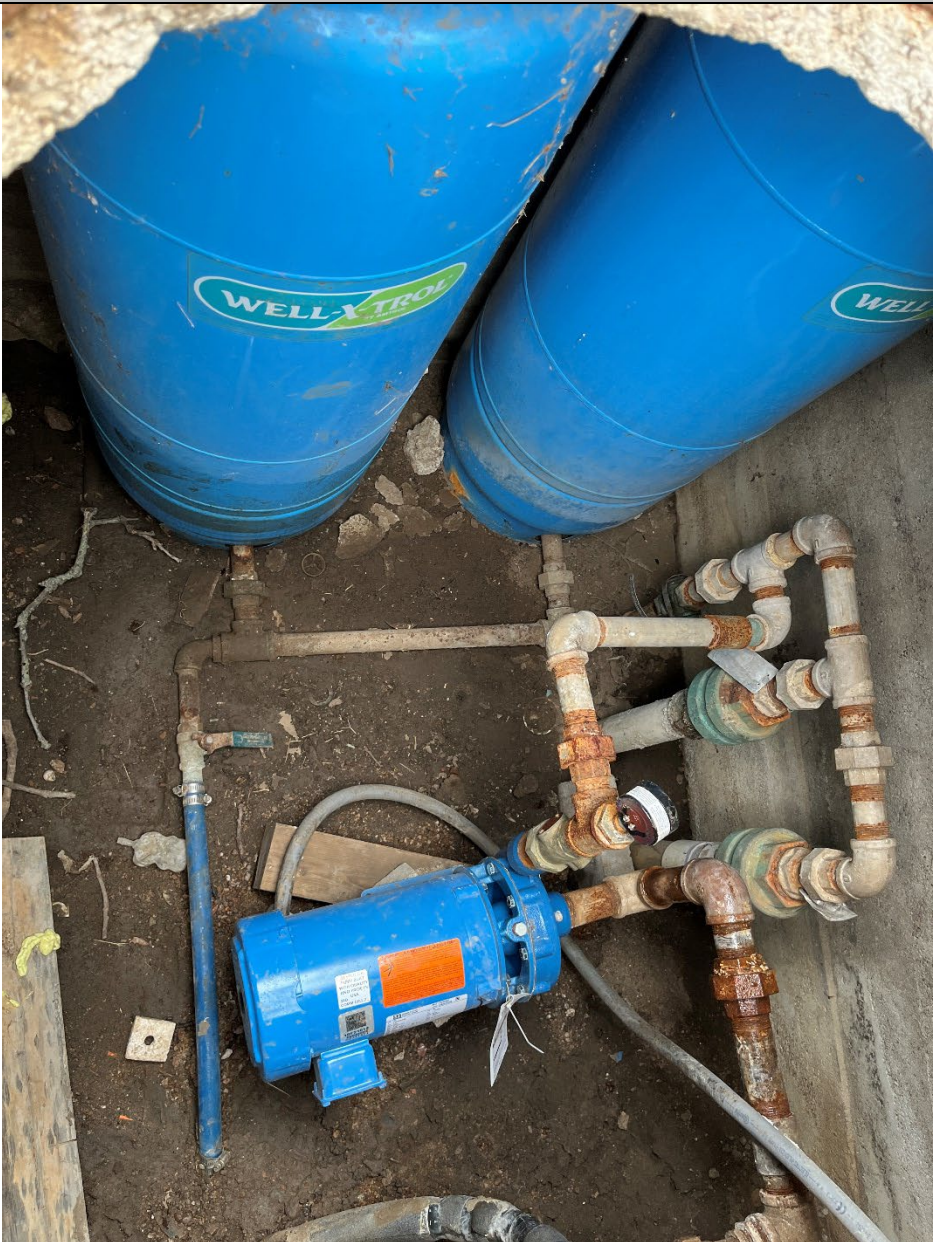
The system has three booster stations within the distribution system (Photos 1-3). I inspected each booster station and found hydropneumatic tanks connected to the system at each facility. I asked Mr. Pike if the tanks were currently in use by the system. Mr. Pike stated they have not been used in over 10 years. The hydropneumatic tanks were not used by the system but had not been physically disconnected from the system (Finding 1, Photos 1-3). System components that are no longer in use and not being properly maintained should be physically disconnected from

- 1) The Booster stations contained hydropneumatic tanks that were not used by the system but had not been physically disconnected from the system.**

| Number | Photo |
|---|---|
| | <p data-bbox="653 1382 1579 1417">Booster Station West P and South Commercial with connected pressure tanks.</p> <p data-bbox="1018 1453 1207 1484">IMG 0262.JPG</p> |

System's Response: Gunnar and additional staff will be disconnecting the pressure tanks in all booster stations within the next 60 days.

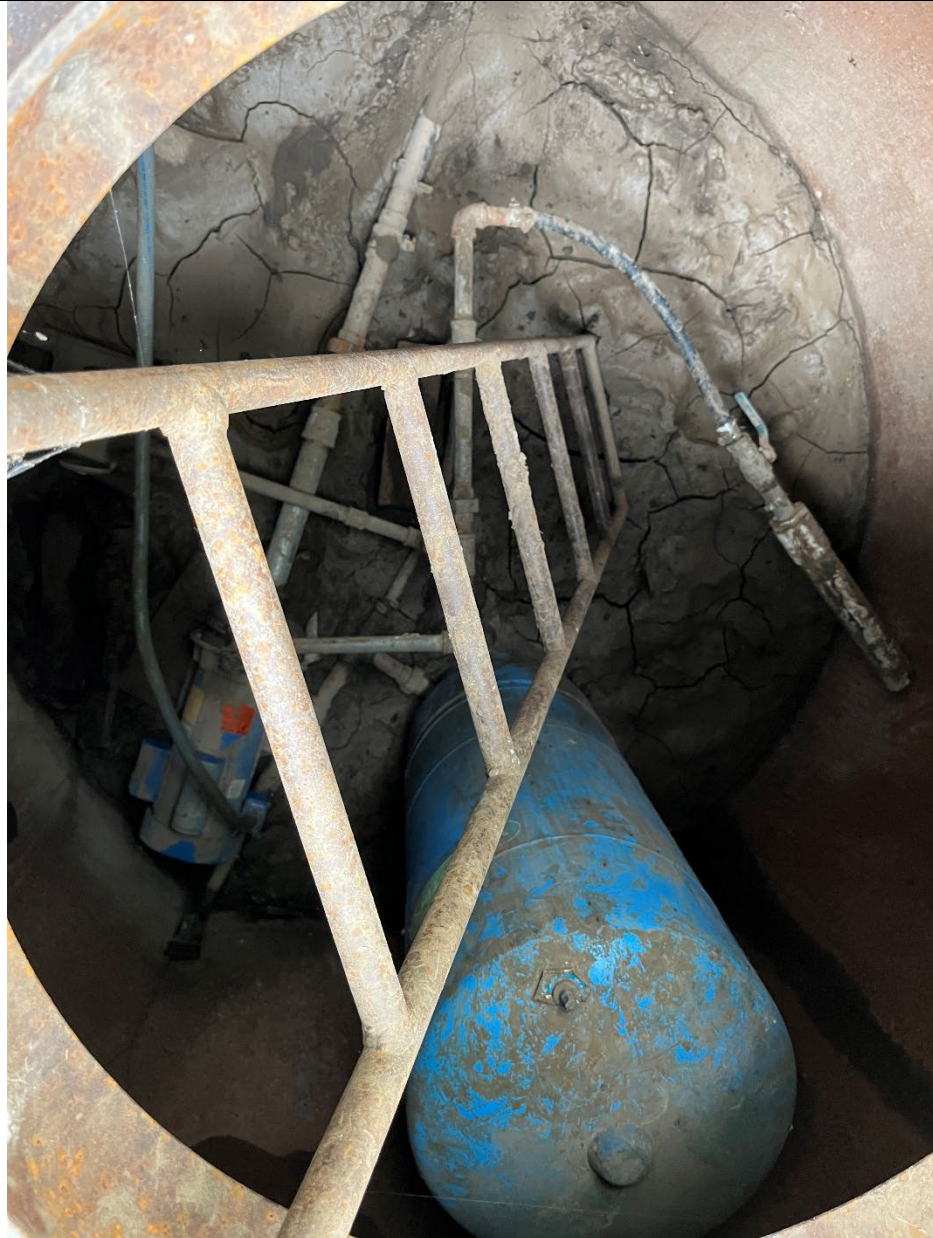
2

the system so they cannot introduce contaminants into the system. At the North Commercial booster station there was evidence of water flooding over system components (Finding 2, Photo 2). The components of the booster station are not designed to be submerged and could allow contaminants to enter the system if submerged. The system should work to ensure that the water level in the booster station does not rise to the level of system components.

- 2) At the North Commercial booster station there was evidence of water flooding over system components.**

North Commercial Booster Station showing signs of flowing and with connected pressure tank.

System's Response: The corrections to the booster station to avoid flooding is in the planning stages, within 60 days we will have a plan of action for this as this takes some construction and planning.

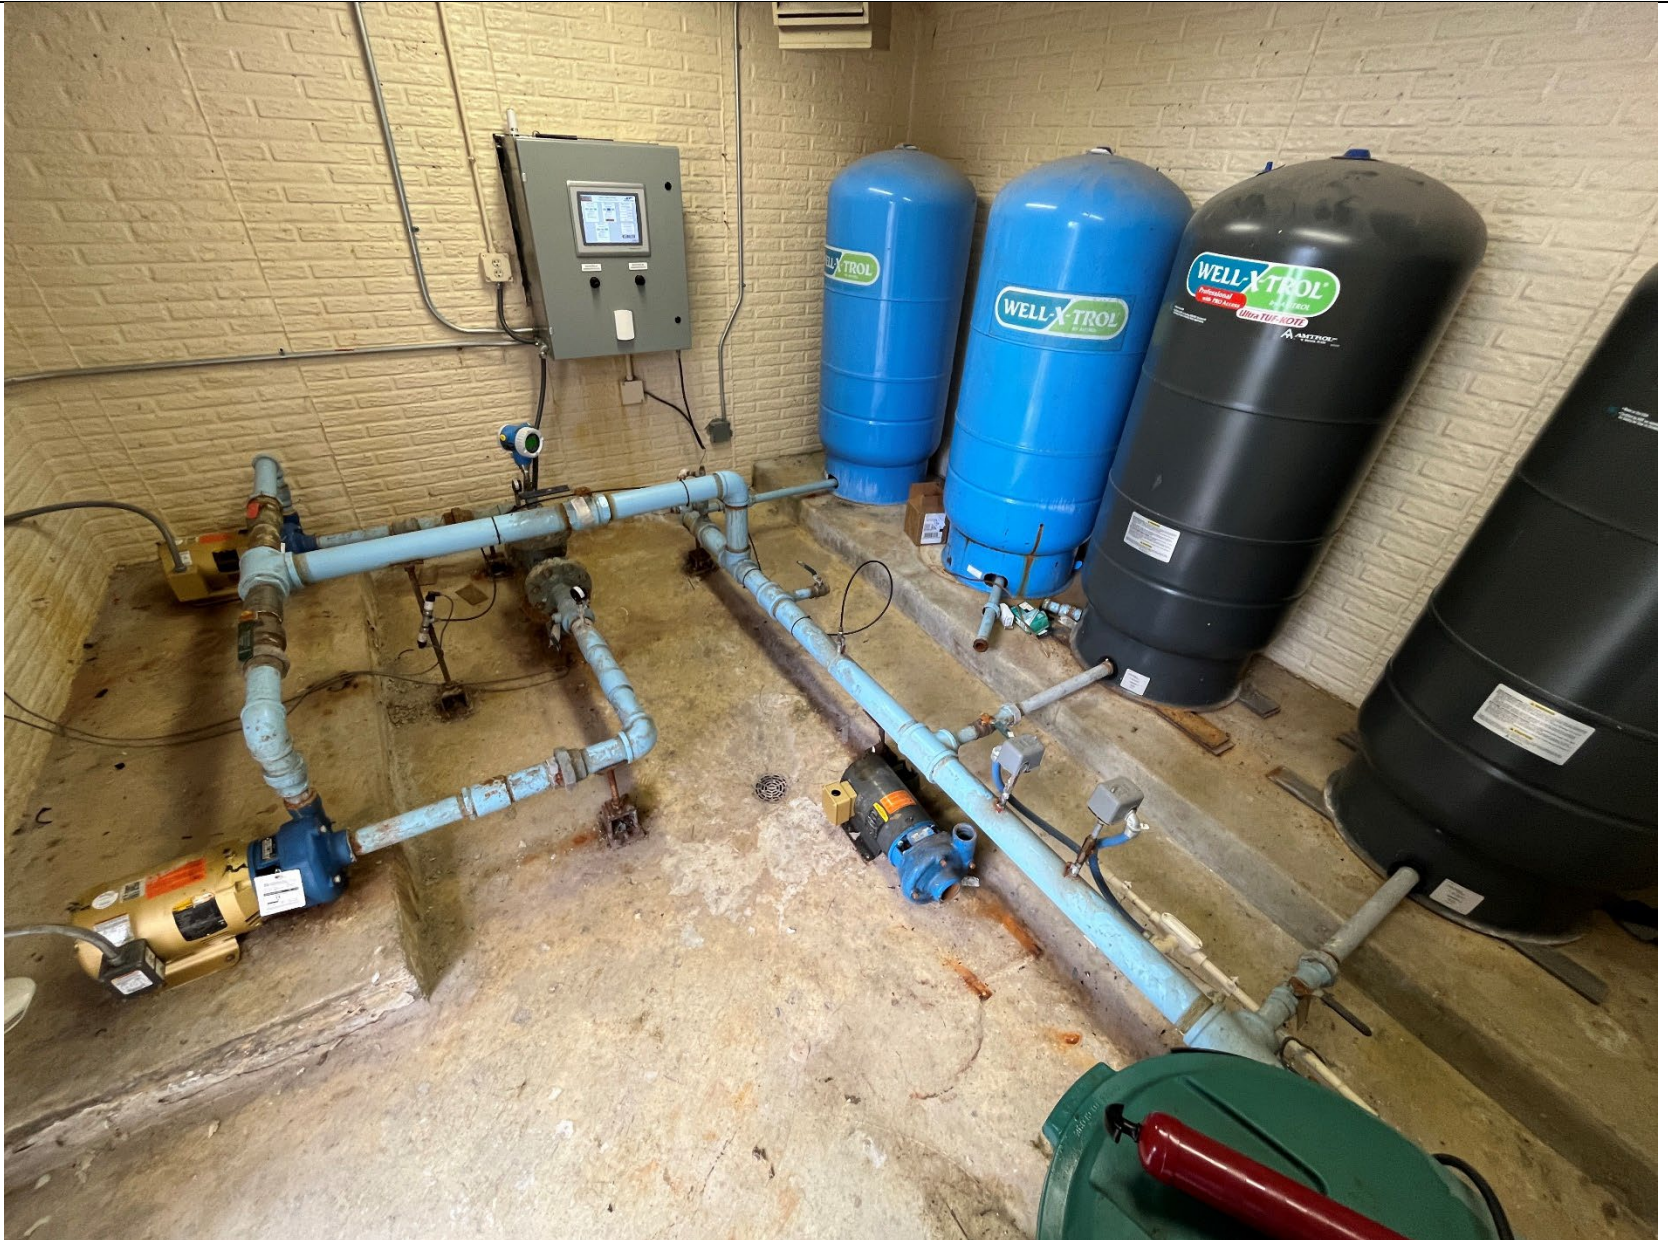
3

Booster station with connected pressure tank.

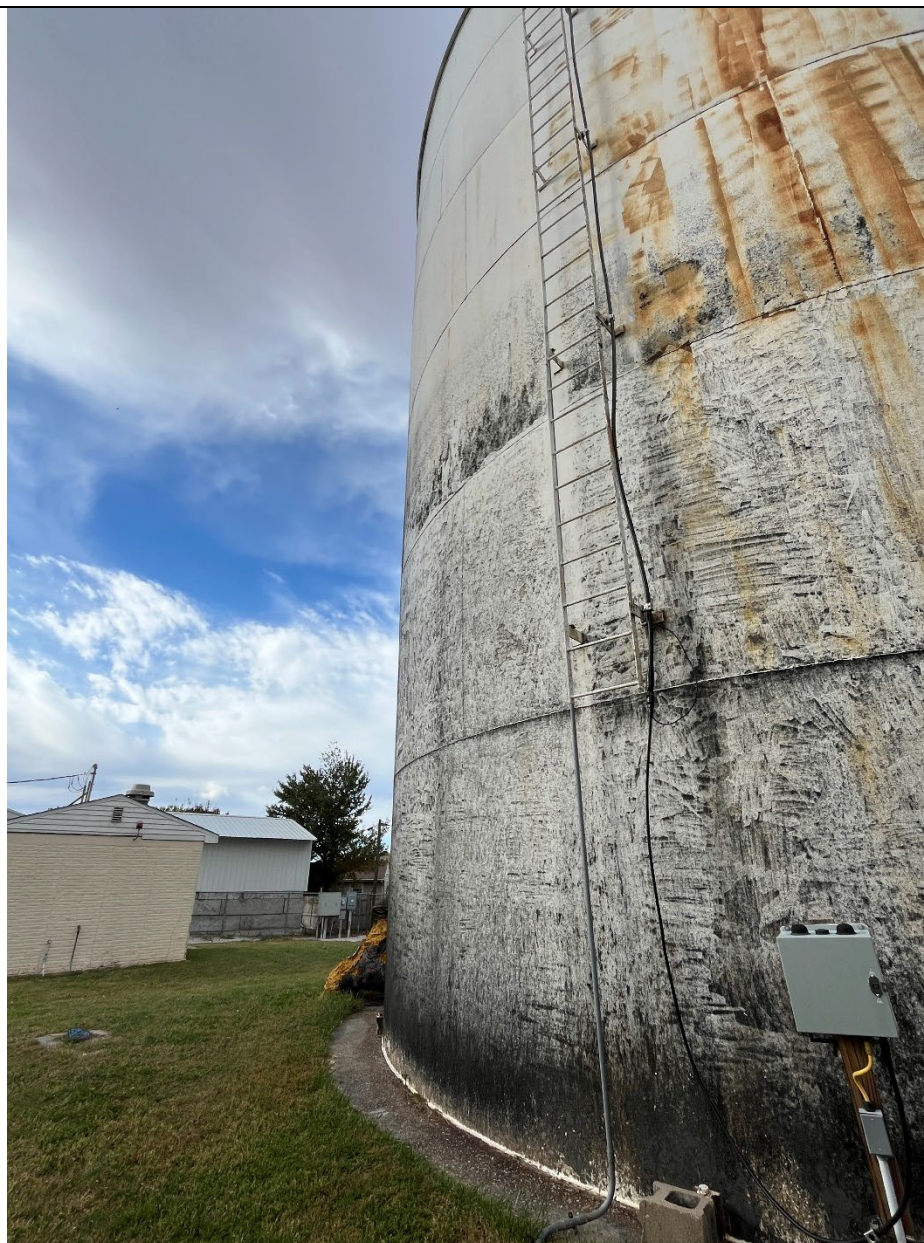
4

I visually inspected the exterior of the storage structure and noted the lack of a ladder guard (Finding 3, Photo 4) and missing caulking around the base of the tank (Finding 5, Photo 6). A ladder guard is an essential security feature of towers that can help prevent people without access from being able to climb the tower. Missing caulking around the base of a ground storage tank can lead to structural failure if not repaired.

- 3) Ground finished water storage tank does not have a ladder guard over end of ladder.**

Ground Storage Tank showing no ladder guard at base of ladder.

System's Response: "The ladder guard will be put in place in conjunction with the tower maintenance that is being considered now."

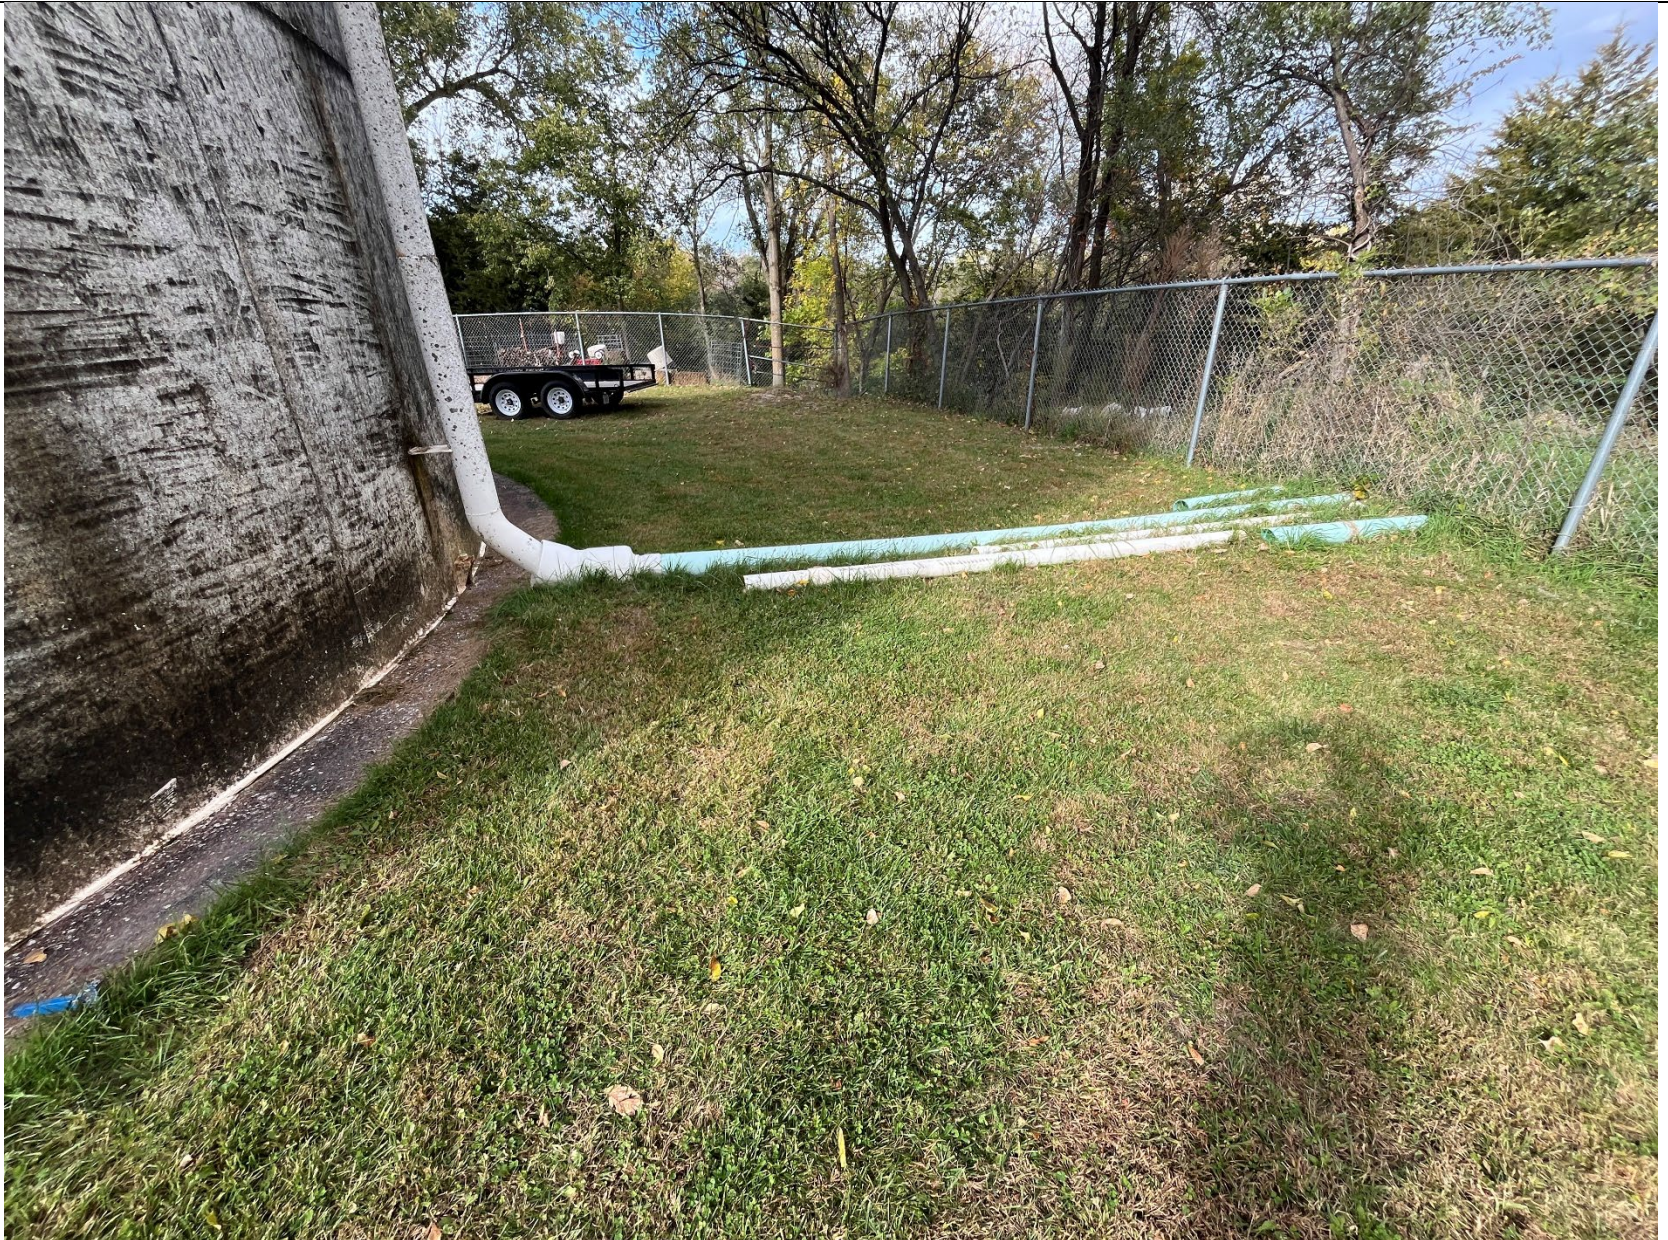
5

I also noted the overflow pipe discharged into a PVC extension and could not be easily viewed. I was able to reach into the extension and felt the screen covering the end of the discharge pipe. The screen was broken and was only an approximately #4 mesh (Finding 4, Photo 5). Nebraska

Title 179 Chapter 22-008 states all water systems must, “Provide and maintain a corrosion resistant screen of effective mesh size and/or a self-closing flap valve installed near or at the termination of all overflow lines on water storage structures.” The EPA’s How to Conduct a Sanitary Survey of Drinking Water Systems states that finished water storage structures should have a non-corrodible #24 mesh screen. Discharge pipes should not be connected to extensions that do not allow easy viewing of the screen. The facility should ensure the sanitary findings noted in the tank inspection reports are addressed (Finding 14). Sediment build-up in storage tanks can lead to decreasing water quality and Nebraska Title 179 Chapter 22-008 states that every system must “Inspect, and clean, if necessary, water storage facilities equipped for accessibility, no less than once every five years.” Allowing corrosion to develop on the inside and outside of finished water storage structures can greatly decrease the lifespan of the storage tank.

- 4) The overflow pipe discharged into a PVC extension and could not be easily viewed and the screen was broken and only an approximately #4 mesh.**

Ground Storage Tank showing overflow discharge pipes.

System's Response: "The #4 mesh screen will be replaced and moved to have better access within 60 days."

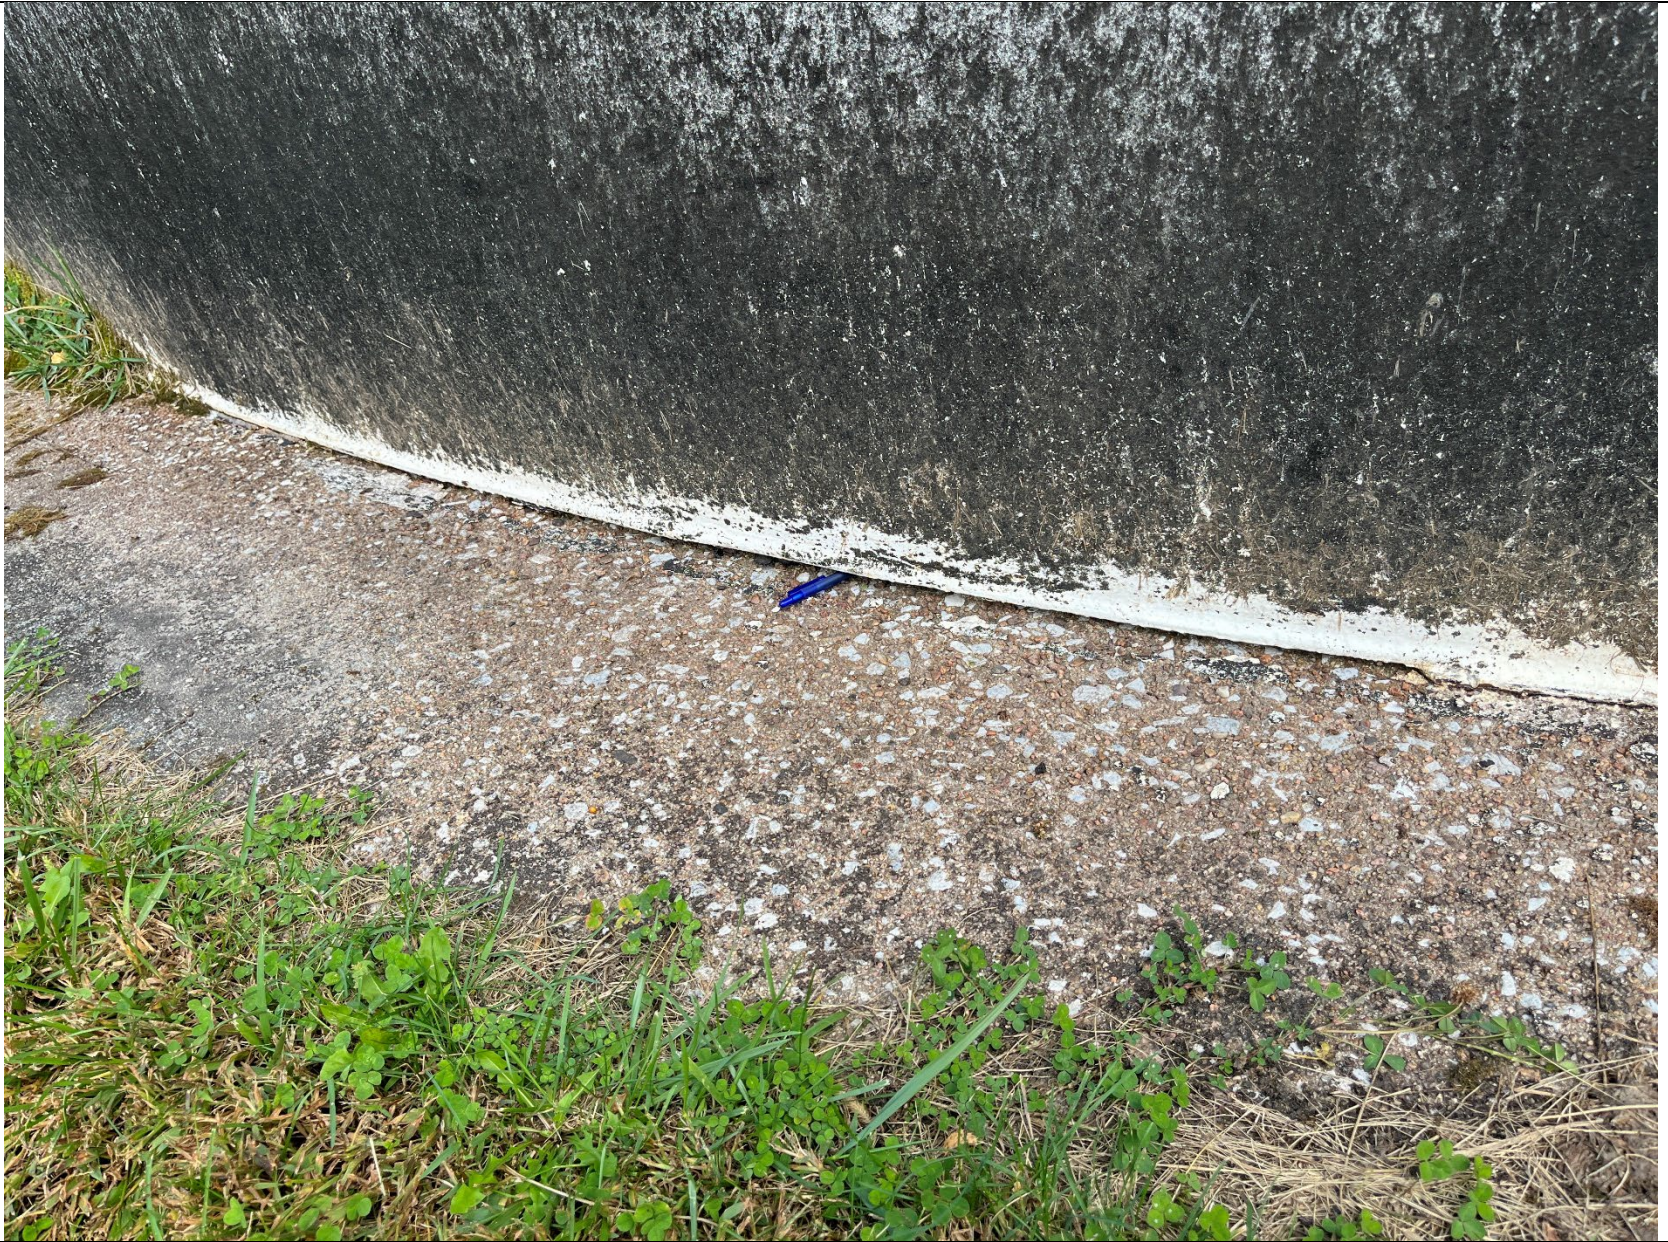
6

- 5) Most of the caulking around the base of the tower was missing.**

Ground Storage Tank showing missing caulk at base of tank.

System's Response: "The caulking will be put in place in conjunction with the tower maintenance that is being considered now."

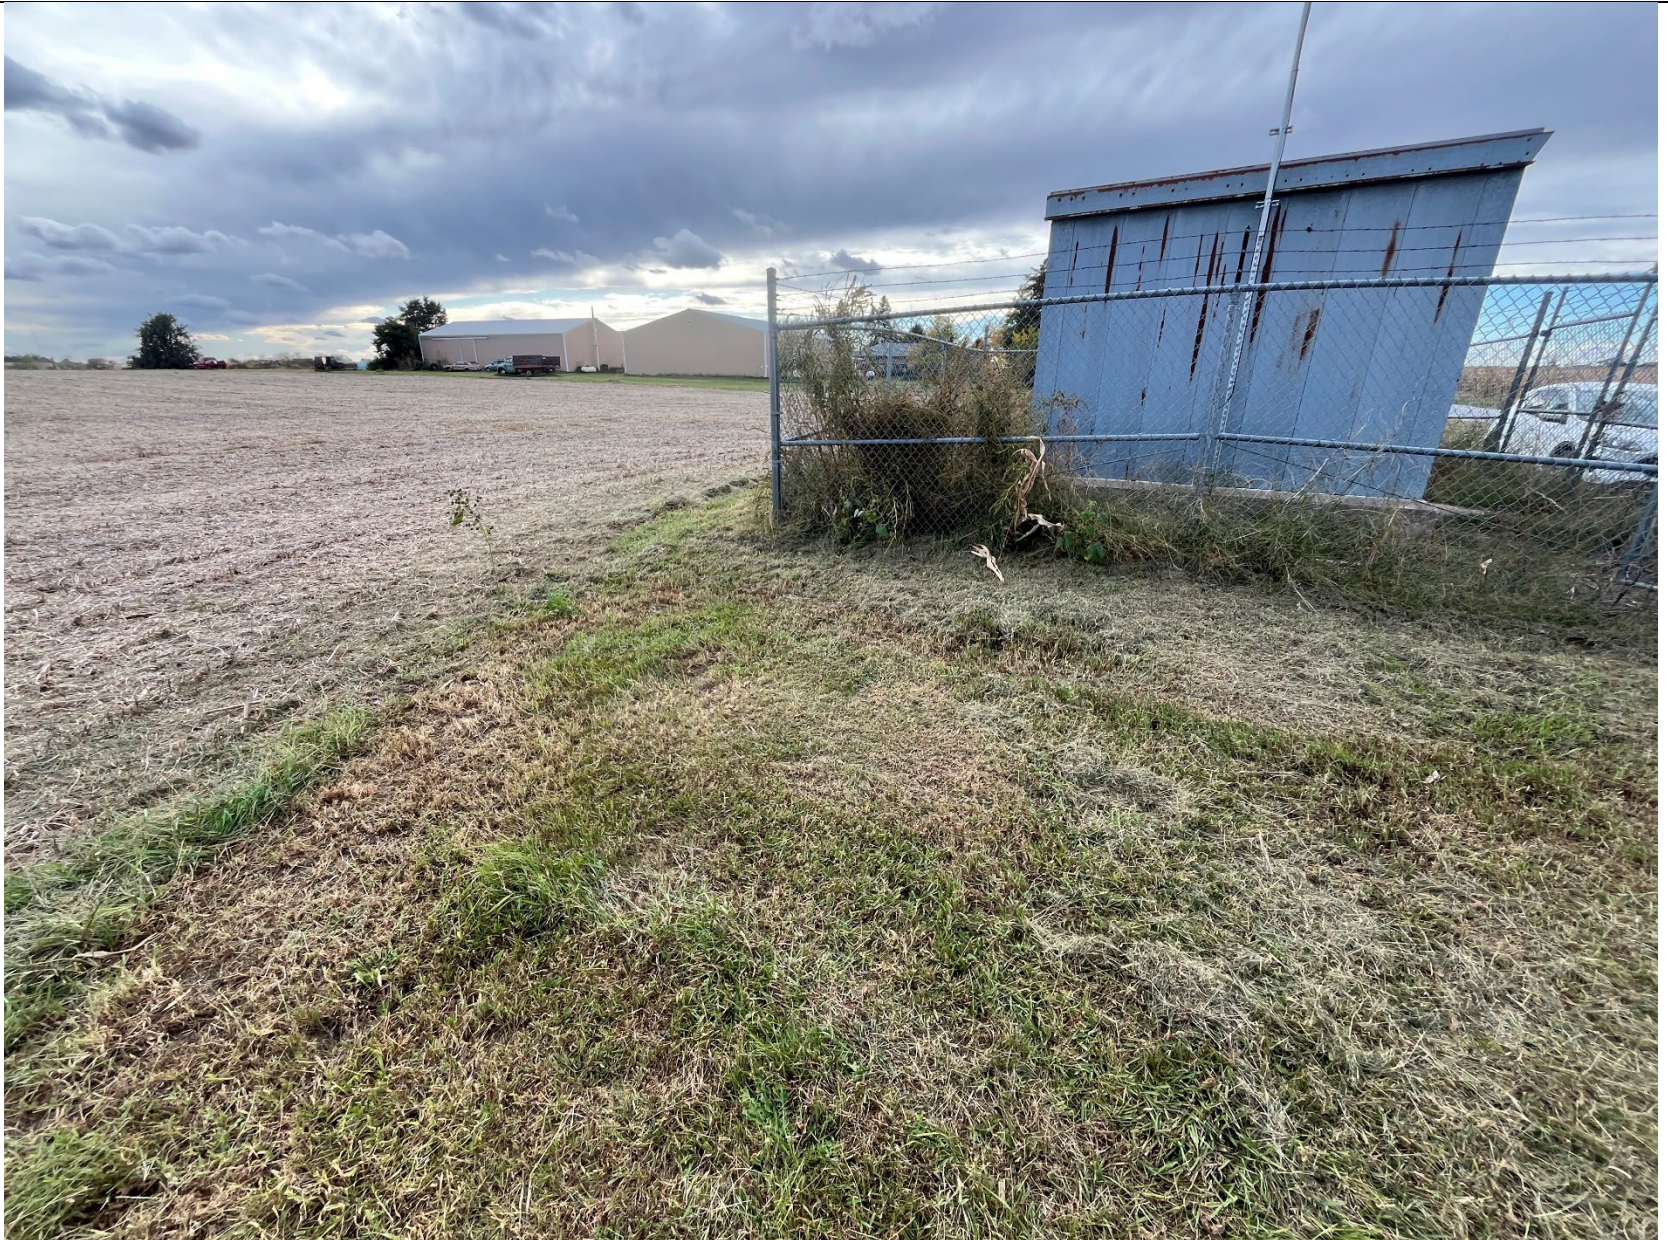
During the inspection, I observed all four of the system's wells. When I asked about the system's coliform positive results, Mr. Adair stated these were the result of Well #3 introducing contaminants into the system after heavy rains. (Finding 15) Mr. Adair stated that as a result the system had inactivated Well #3 and did not currently have any plans to use the well. Well #3 did not have a well house and was located in between two crop fields with little to no buffer between the well and the crop fields (Finding 16). Since the well was showing signs of contamination during heavy rains this well should not be used unless treated as Groundwater Under the Direct Influence of Surface Water (GWUDI). Using this well could cause acute contaminants to enter system. The system should evaluate this well to determine its serviceability or if it should be permanently abandoned and plugged.

**15) While in use, Well #3 introduced contaminants into the system after heavy rains.** This finding was identified after the in-person inspection and not discussed during the exit briefing.

**16) Well #3 did not have a well house and was located in between two crop fields with little to no buffer between the well and the crop fields.** This finding was identified after the in-person inspection and not discussed during the exit briefing.

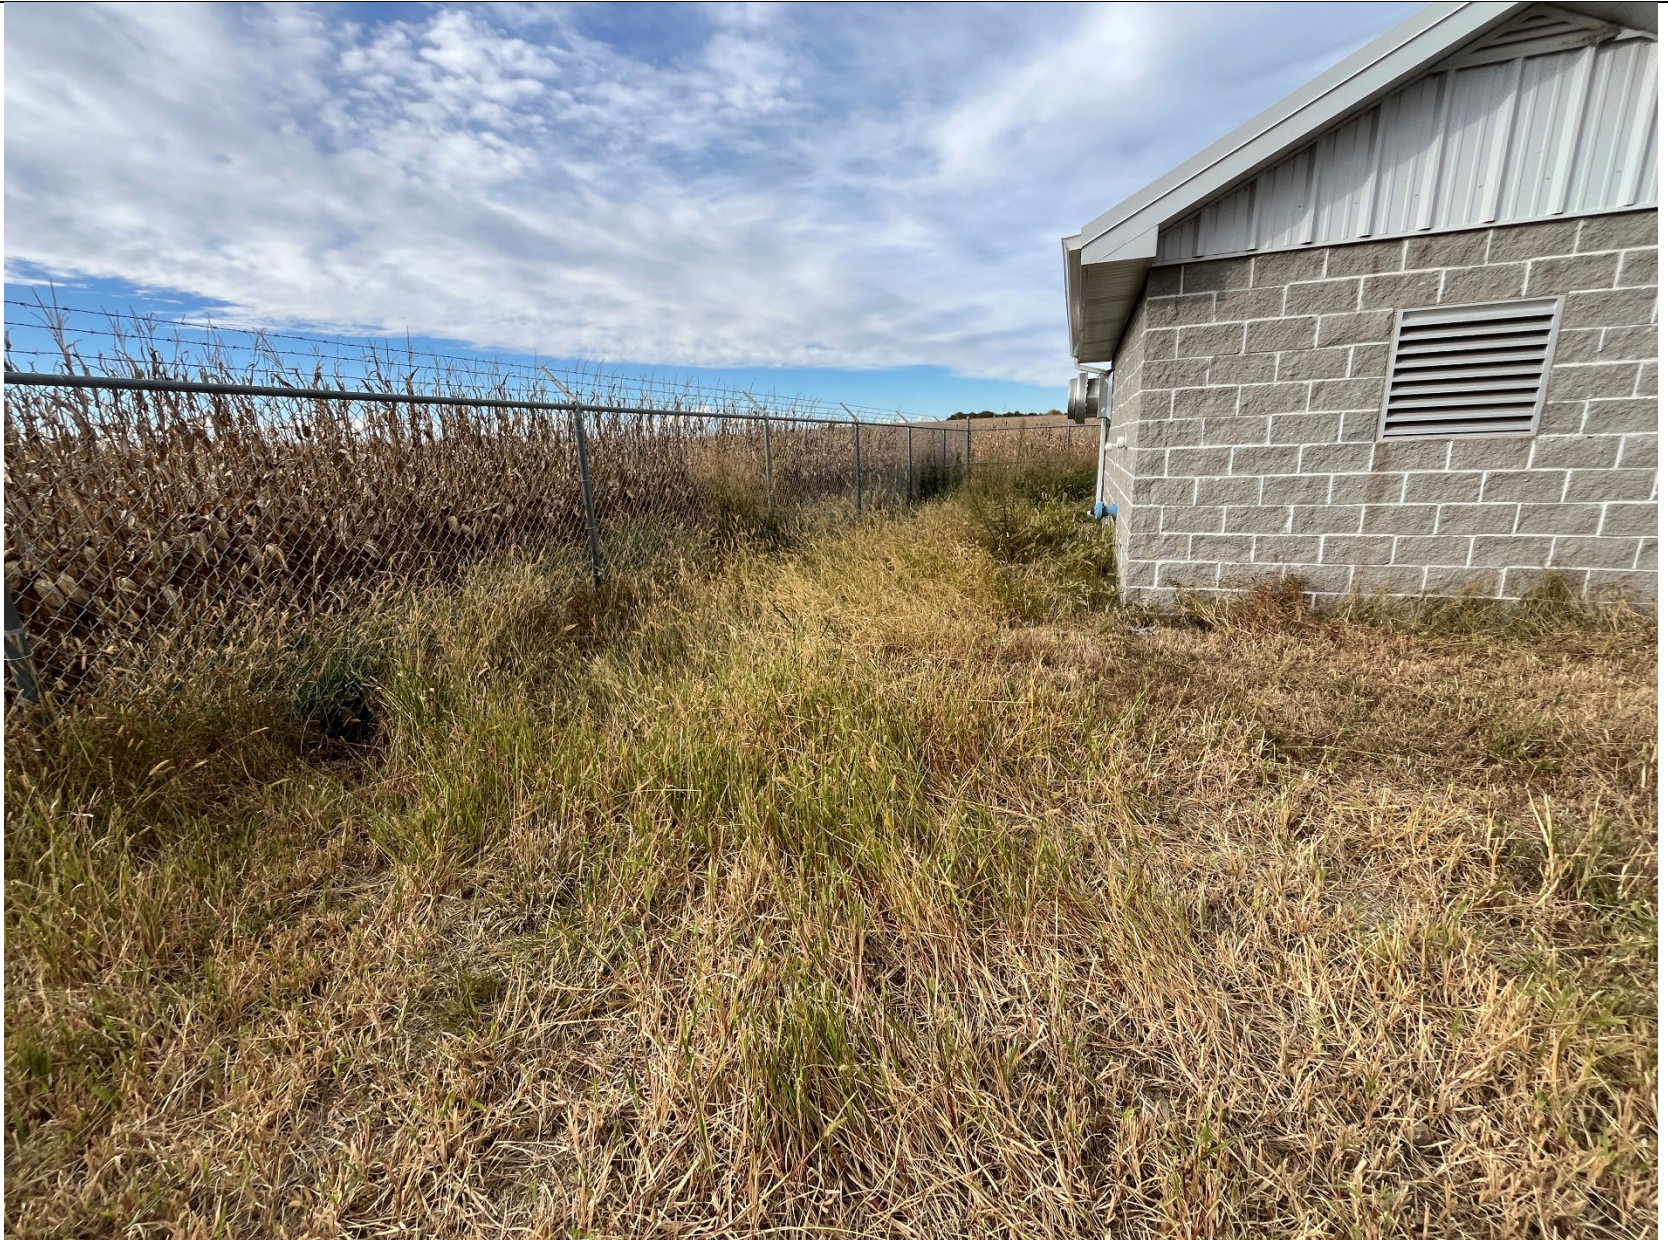
Well #4

- 6) Row crops were growing less than 15 feet from the # 2, 3, and 4 wells.**

System's Response: "The crops growing with 15 feet of the wells will have to go in front of council and I am sure their legal representatives will have to be involved so I will ask that this be put on the next agenda to begin that process."
