Re: **Sanitary Sewer System Compliance Evaluation Inspection**
Willingboro Township Municipal Utilities Authority, Sanitary Sewer System
NJPDES Tracking ID No. NJ0023361

Clean Water Act (CWA) Inspection Report

Program: Sanitary Sewer System		Inspection Type: Compliance Evaluation Inspection	
Permittee Name: Willingboro Township Municipal Utilities Authority		NPDES/ICIS No.: NJ0023361	
Inspection Entry Date: August 27, 2024 Inspection Entry Time: 9:00 AM		Inspection Exit Date: August 27, 2024 Inspection Exit Time: 3:15 PM	
Facility Inspected: Willingboro Water Pollution Control Facility Ironsides Court Willingboro Township, New Jersey, 08046		Lat, Long: Outfall 001A Latitude: 40° 01' 41.1" Longitude: 74° 55' 16.8" NAICS / SIC Code: NAICS Code: 221320 (Sewerage Treatment Facilities) SIC Code: 4952 (Sewerage Systems)	
EPA Representative(s): Zarine Ali, Physical Scientist, U.S. EPA Region 2, (212) 637-3919			
State Representative(s): None			
On-Site Facility Representative(s): Kara Weekly, Director of Operations and Maintenance, (609) 877-2900 Doug Borger, Sewer Superintendent, S3/C3 Operator, (609) 877-2900 Daryl James, Assistant PCP Operator, (609) 877-2900

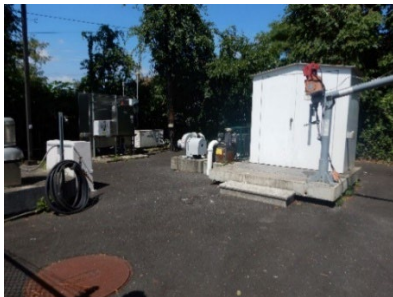
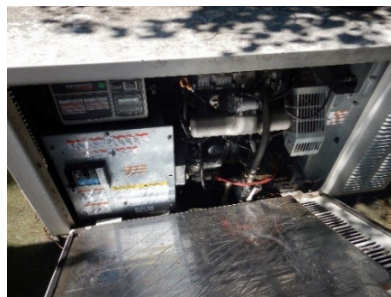
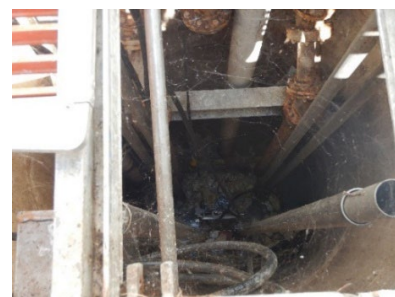
1. Lake Drive Pump Station

Drive Pump Station, Windsor Pump Station, and Tweedstone Pump Station. Please provide a response to the following:

A view of the station, its on-site generator, and wet well. At the time of the CEI, the wet well had an accumulation of grease. The wet well is cleaned as needed (3 Photographs).

- a). Does the Authority or Willingboro Township have Best Management Practices in place to ensure the proper disposal of grease from food establishments?
- b). Who is responsible for inspecting grease traps/interceptors at food establishments?
- c). What steps will the Authority take to ensure that an accumulation of grease from food establishments does not enter its sewer system?

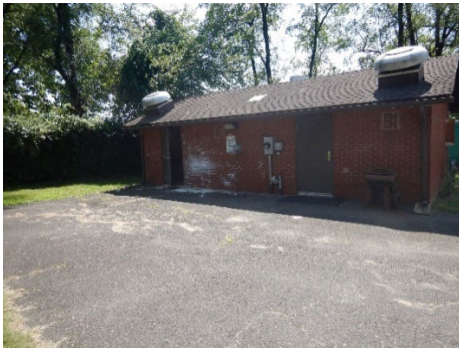
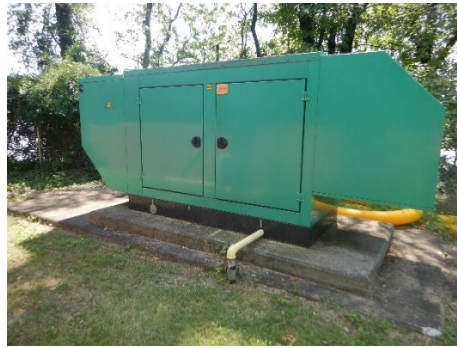
2. Windsor Pump Station. A view of the station, and its on-site generator (2 Photographs).

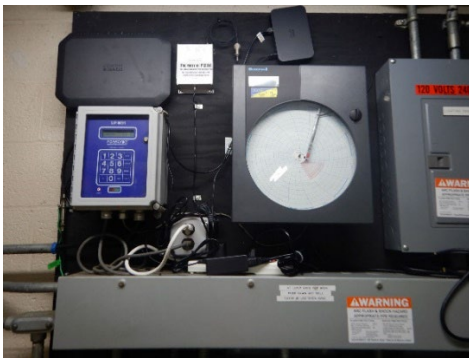
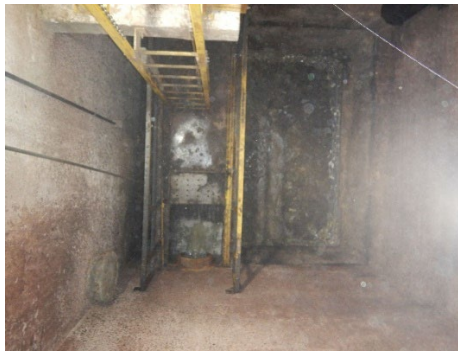
Windsor Pump Station's flow meter, and wet well (2 Photographs). At the time of the CEI, the wet well had an accumulation of grease. The wet well was cleaned about 2 months before EPA's inspection.

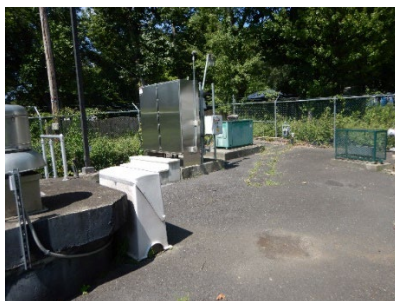
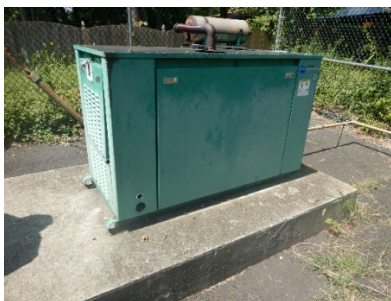
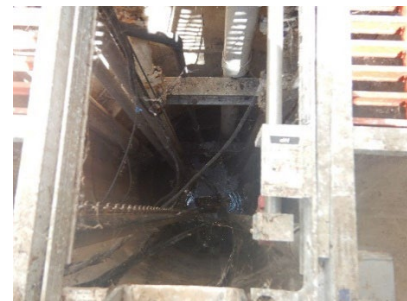
3. Beechnut Pump Station

A view of the station, its on-site generator, and wet well (3 Photographs).

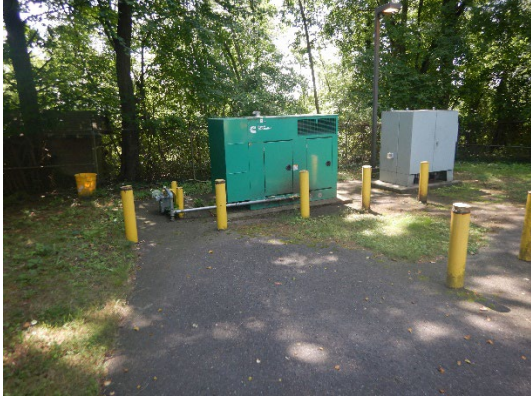
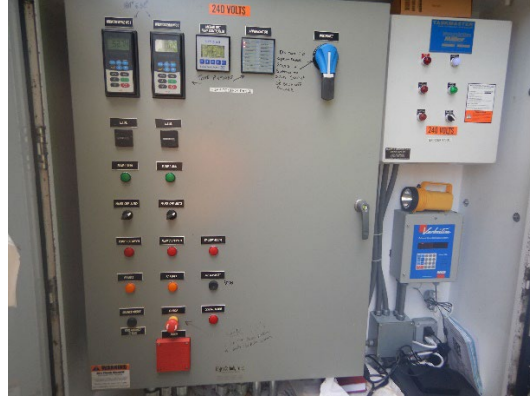
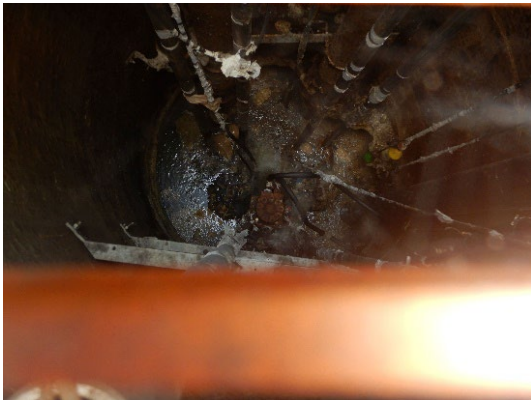
4. Tweedstone Pump Station

The station's on-site generator, control panel with alarm system, and wet well. At the time of the CEI, the wet well had an accumulation of grease (3 Photographs).

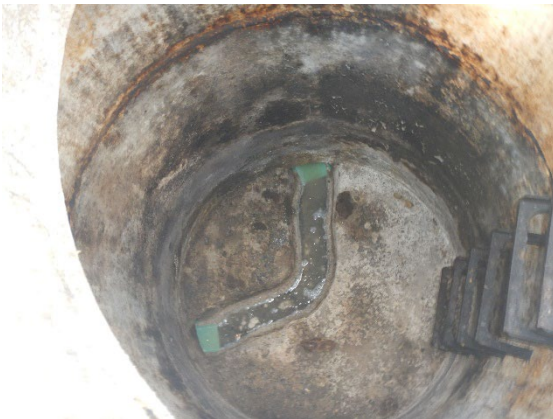
5. Manhole that receives flow from Mr. Cheng's restaurant and a few additional restaurants.

The manhole is located at the back of the building (1 Photograph).

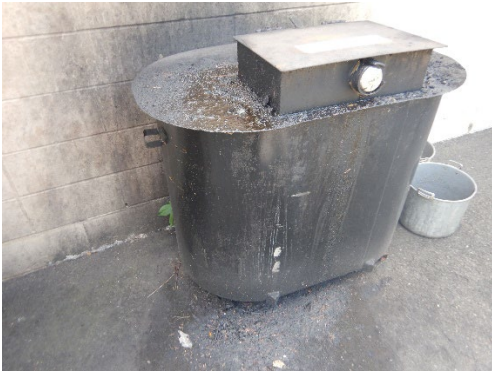
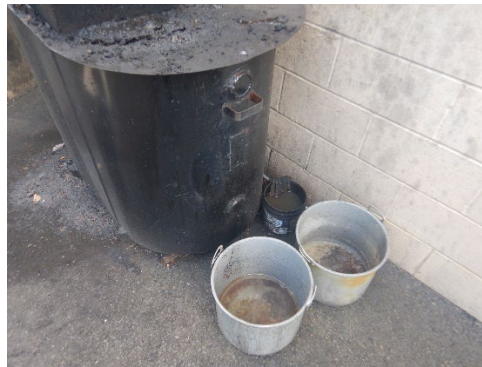
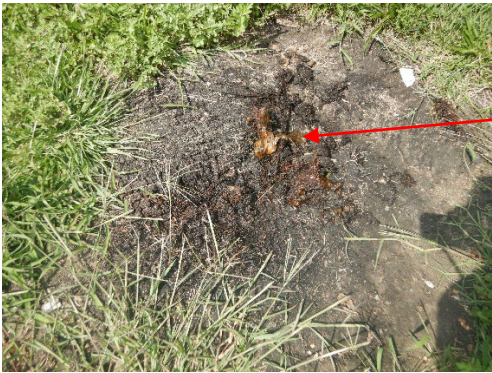
1. At the time of the CEI, the Authority was not conducting inspections of grease traps/interceptors at restaurants. During the fieldwork component of EPA's inspection, photographs were taken of a grease disposal container with grease spilled on the outside and evidence that grease was dumped on a grass area that is close to a storm drain (field work photograph #6). An accumulation of grease was also observed in the wet wells of the Lake

6. Grease disposal container behind Mr. Cheng's restaurant, and evidence that grease was dumped on a grass area (3 Photographs).

Grease on a grass area.

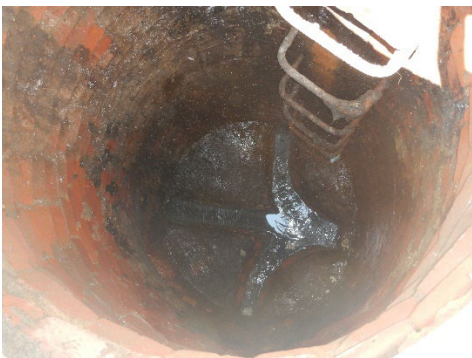
7. Manhole at Echo Lane and Echohill Lane (1 Photograph).

At the time of the CEI, this manhole was clean. The Authority said in this area the street floods and has received flash flood warnings.

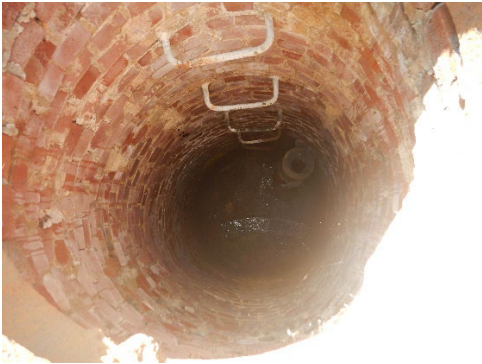
8. Manhole behind the Kennedy Shopping Center. At the time of the CEI, the manhole was clean (1 Photograph).

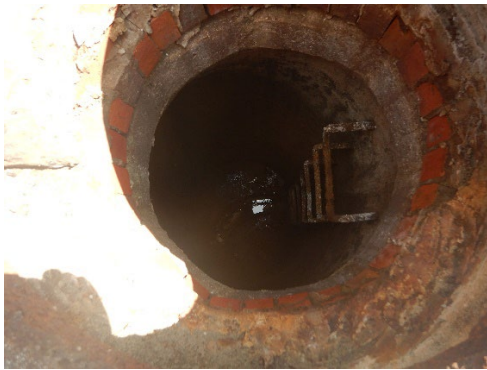
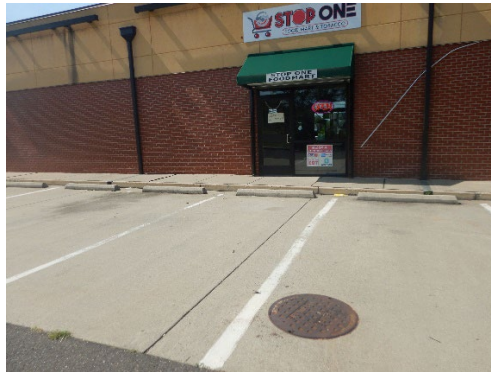
9. Manhole behind Stop One. At the time of the CEI, the manhole was clean (2 Photographs).

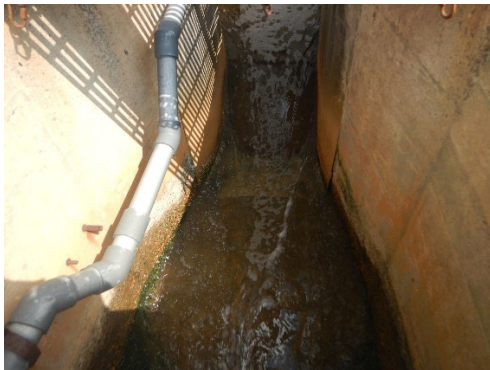
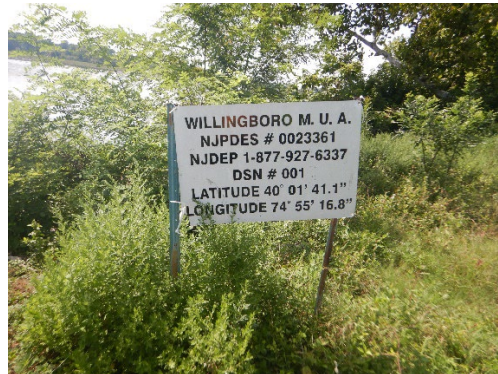
10. Treated Effluent leaving the WPCF, and outfall sign (2 Photographs).
