**Region 6 - Enforcement & Compliance Assurance Division**  
**INSPECTION REPORT**

| Company Name: | <b>Calgary Energy, LLC</b> | |
| Facility Name: | <b>Tidal Osage</b> | |
| Identification/Permit Number: | OKU000893 | |

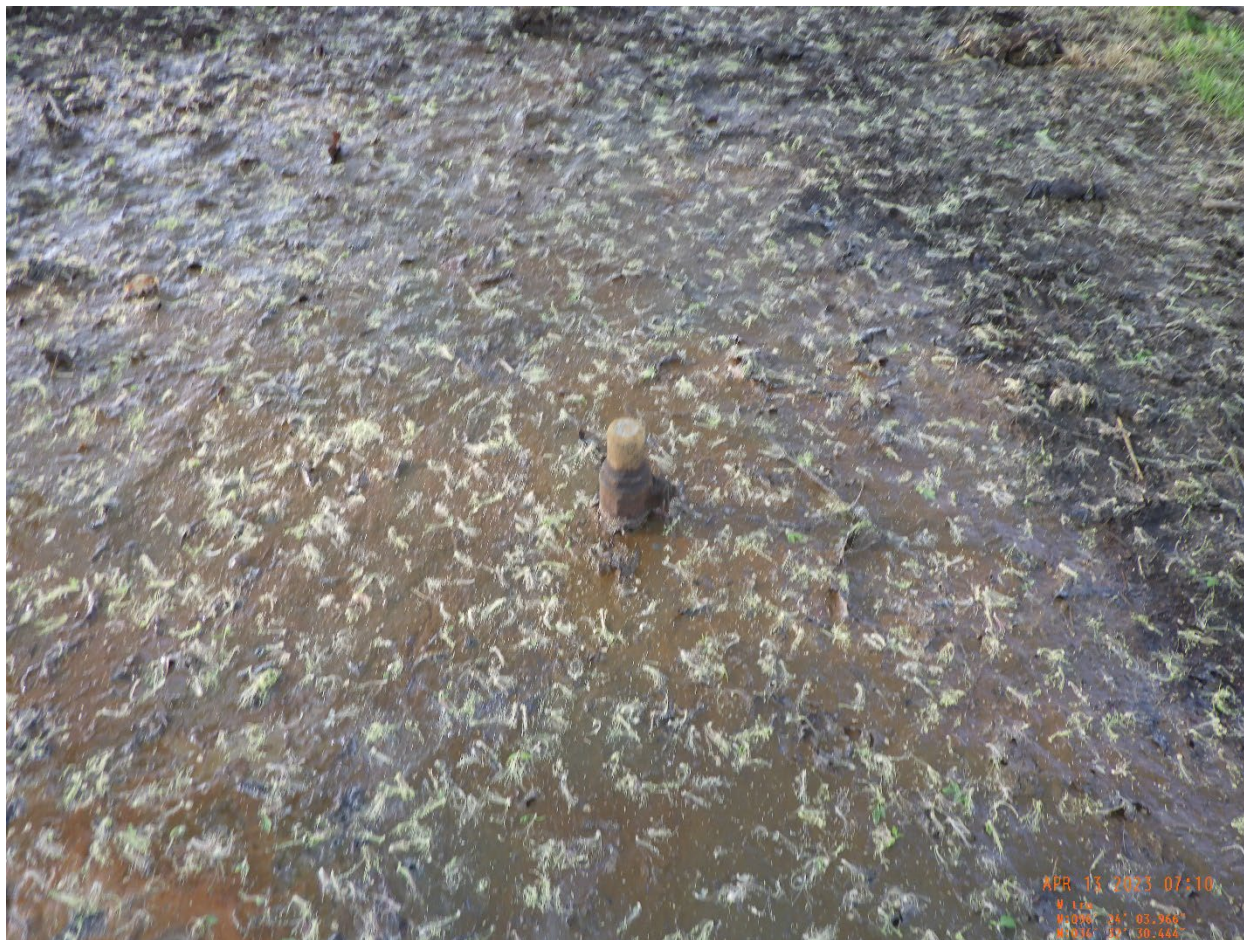
Photo No. 1

I observed the capped well and the area of brine saturated soil around the well, which can be seen in photos No. 1 and 2 of Appendix 1 (photo log). All photos in the inspection were taken within 30 feet of GPS location (36.541797, -96.401344).

**Description:** This was the capped, unmarked well that was leaking brine to the surface.

The primary area of concern is to immediately stop the well from purging brine and prevent brine from entering nearby Little Hominy Creek.

As a closing conference, inspector contacted Blaine Haag and Duane Easley, Calgary Energy representatives, and requested immediate action related to the areas of concern and to prevent additional brine being released from the well. Calgary Energy responded within an hour, dug around the well and replaced the leaking fittings to prevent further brine from escaping the well. Calgary Energy also agreed to seek emergency approval from the Bureau of Indian Affairs (BIA) to properly plug the well to prevent future recurrence.

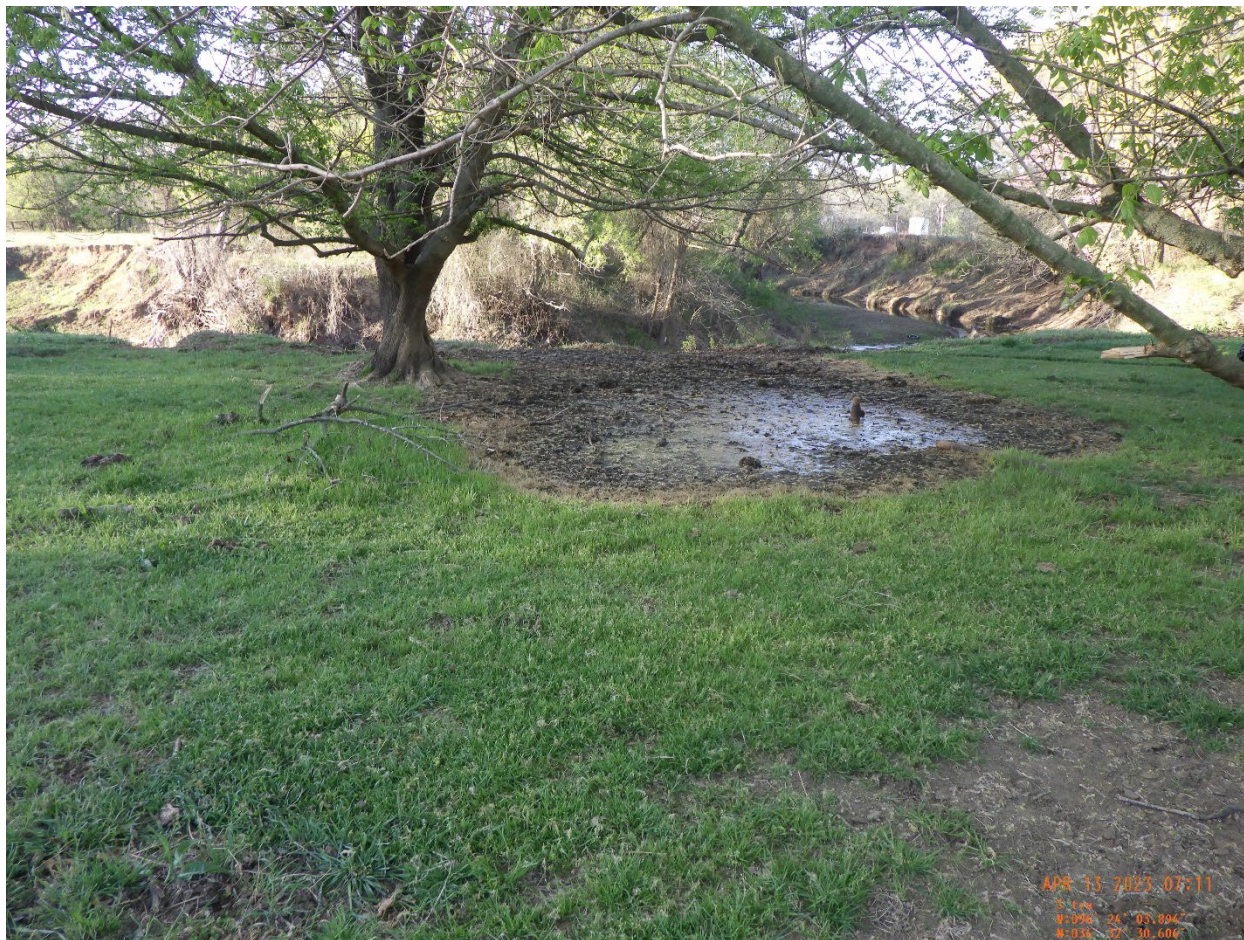
Photo No. 2

**Description:** This was an overview showing the purging well, brine impacted area around the well and the proximity of the location in relation to Little Hominy Creek which was seen in background.

Brine impacted soil should be removed from the location to prevent brine washing into the waterway during future rainfall events.

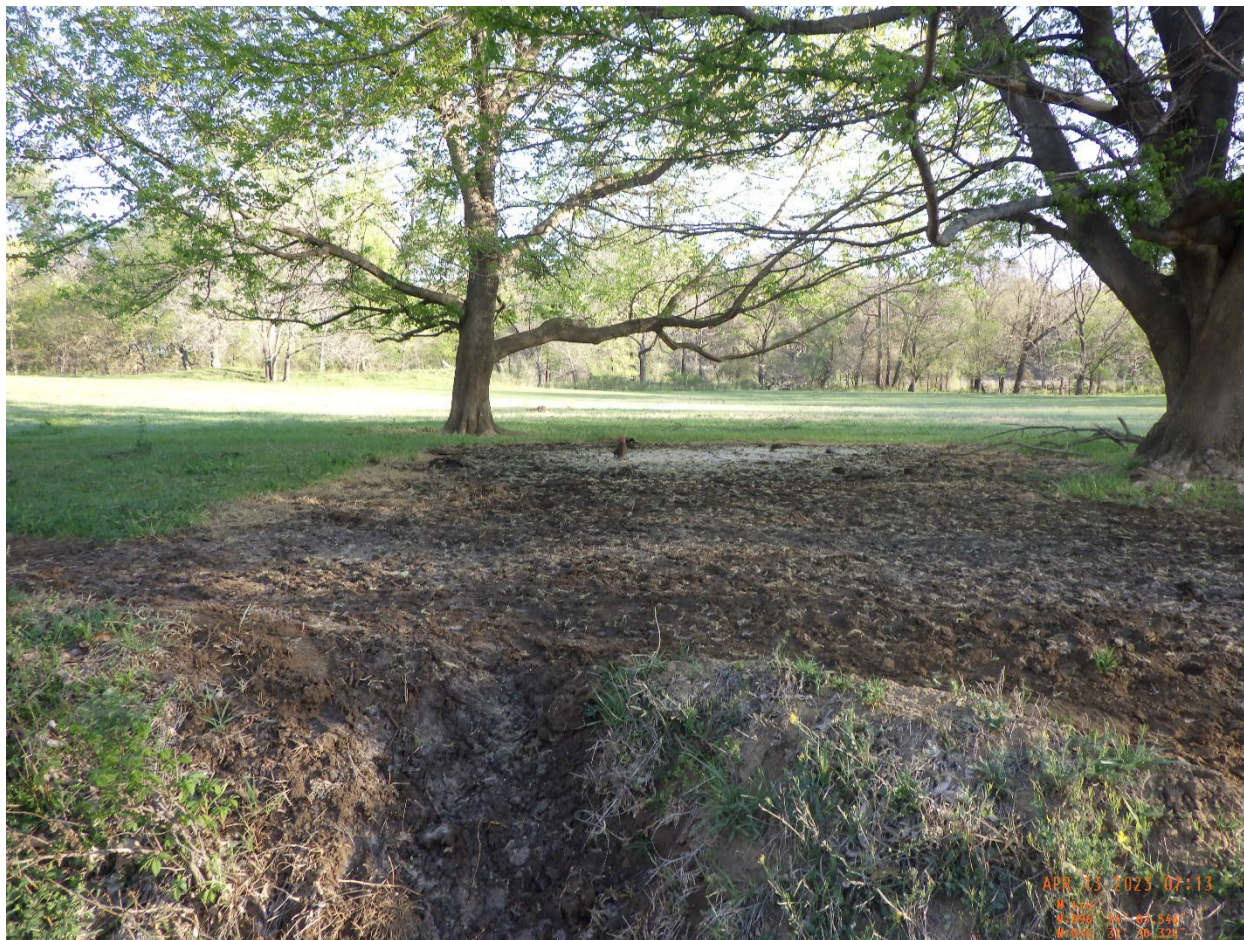
Photo No. 3

I observed the area where brine impacts travelled over the bank and migrated downgrade toward Little Hominy Creek. Damp soil and white crystalized brine was visible across the impacted area. See photos No. 3 and 4 in the attached photo log.

**Description:** This was a photo taken from just off the edge of the bank leading to Little Hominy Creek, with a view to the north showing the brine impacted area and the capped well.

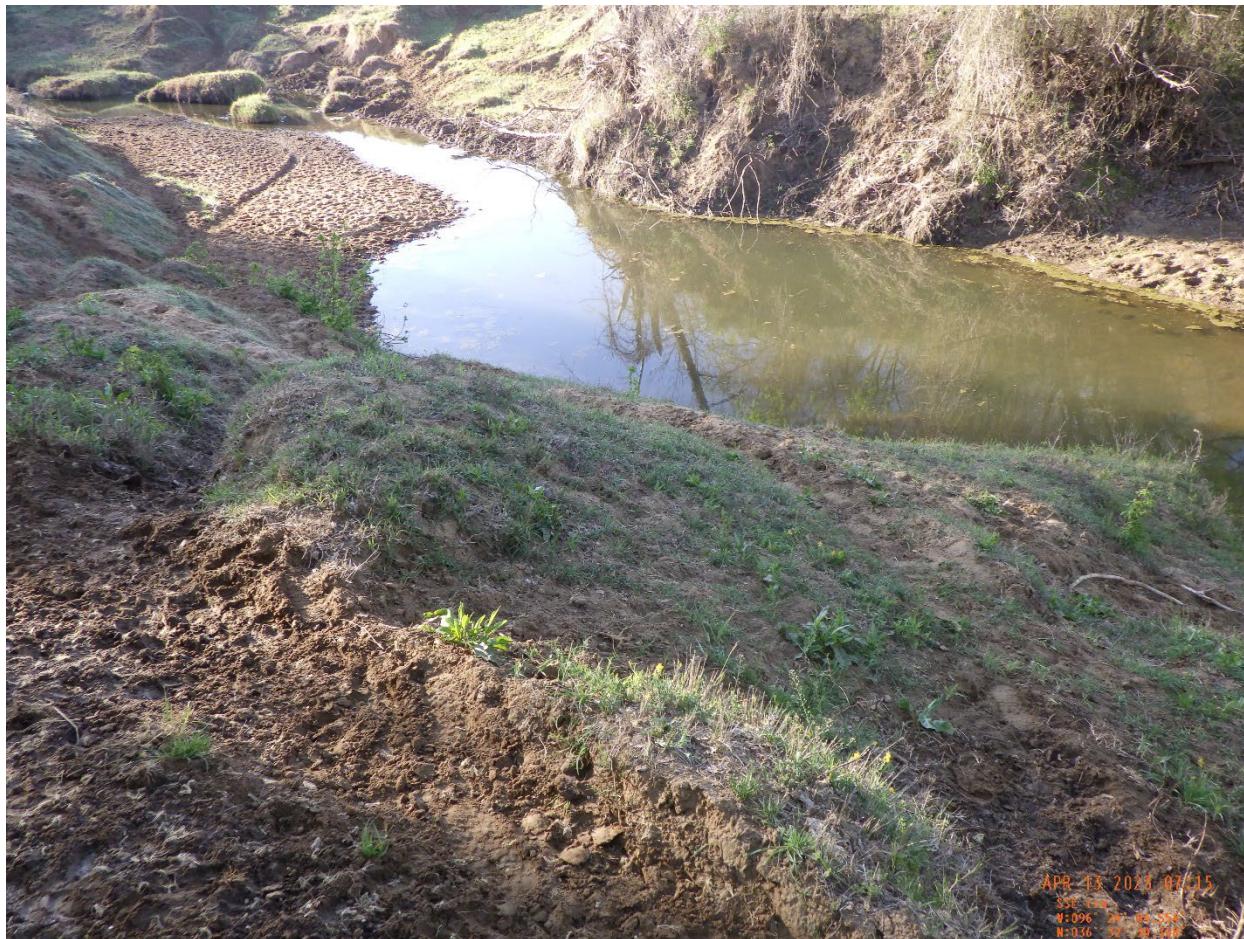
Photo No. 4

**Description:** This was a photo taken from the same locating as photo No. 3 on the previous page, with a view toward the ESE. Brine soaked soil was present in the lower left hand corner of the photo, brine impacts were within 20 feet of Little Hominy Creek in this photo.

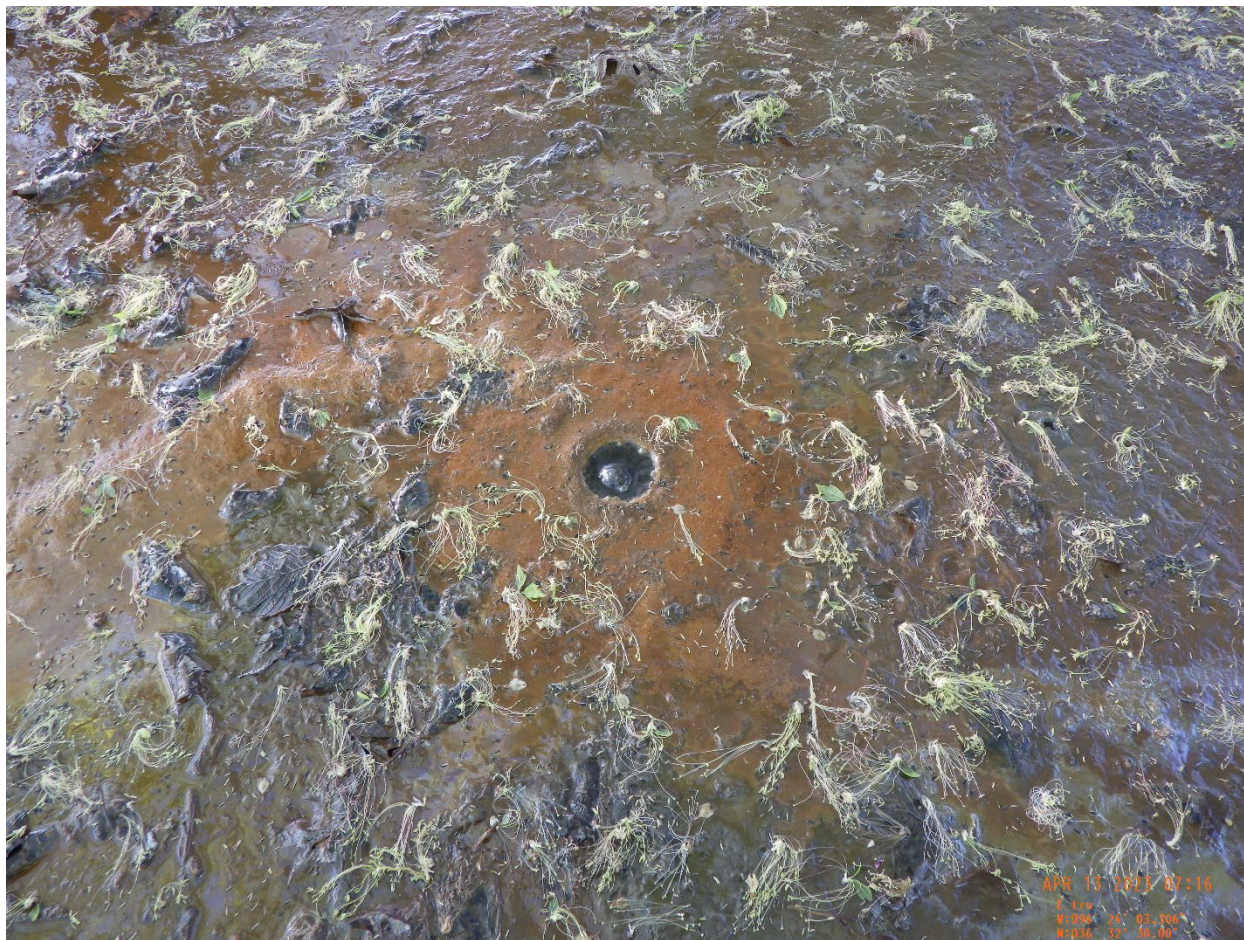
Photo No. 5

I observed a small area where brine/air/gas was bubbling up approximately 5 feet from the capped well, evidence of an ongoing leak from the well. See photo No. 5.

**Description:** This was a photo of brine/air/gas bubbling up to the surface approximately 5 feet from the capped well.
