Region 2 Caribbean Environmental Protection Division
Multimedia Permits and Compliance Branch

CAA Inspection Report

Inspection Date: 5/1/2024

Facility Name: El Coqui Landfill

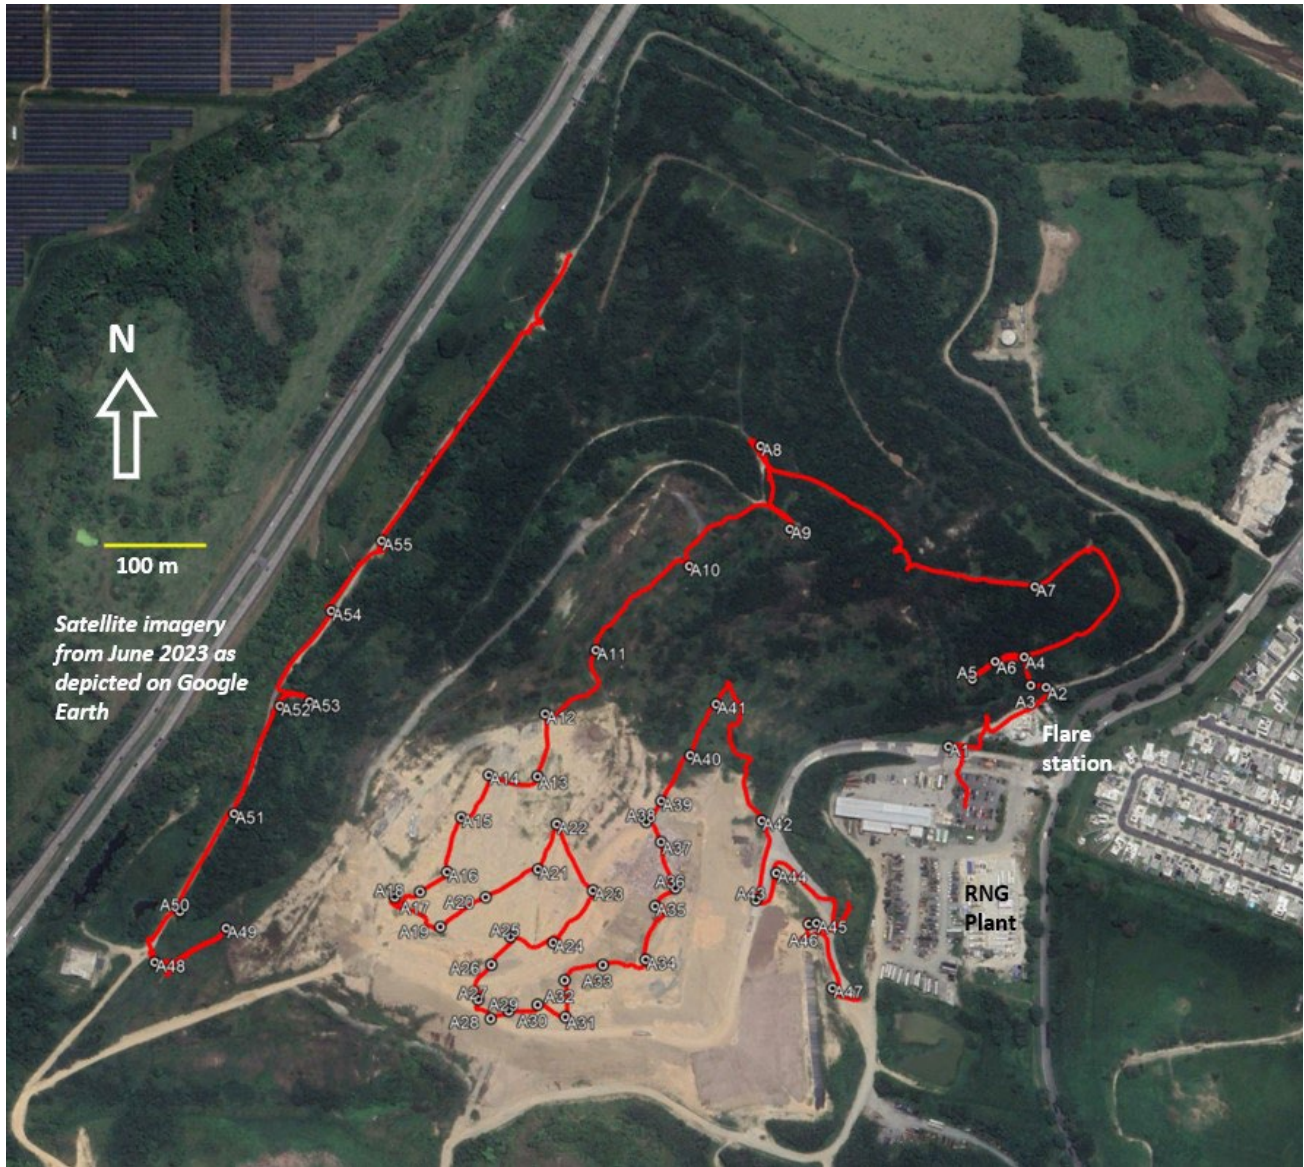
Appendix B: Map

Red lines trace monitoring path. Exceedances are plotted and labeled as described in Appendix B. Path on western perimeter includes some stretches in vehicle driving between risers/wells. Coverage on the northern vegetated areas was primarily limited to access road/paths due to thick vegetation.

The survey covered less than 40 acres of the landfill.
