## Region 6 Compliance Assurance and Enforcement Division

### INSPECTION REPORT

| Company Name: | Jamie Oil Inc. | | |
| Facility Name: | Ezzell B-2 | | |

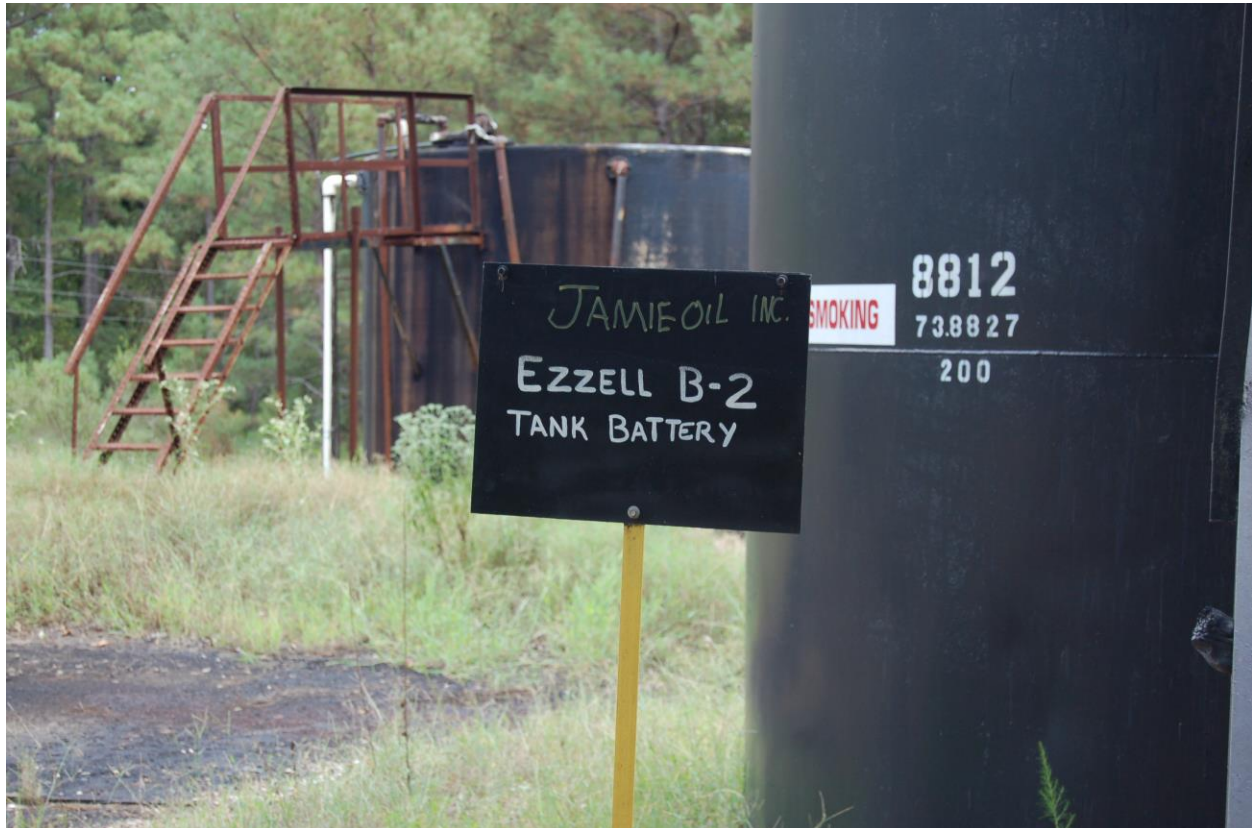
Photo File Name: Photo 1 taken east.  
Date of Photo: 09/15/15  
Time of Photo: 2:43pm  
Photographer: Sanborn  
Description: Shows the facility sign at the tank battery.

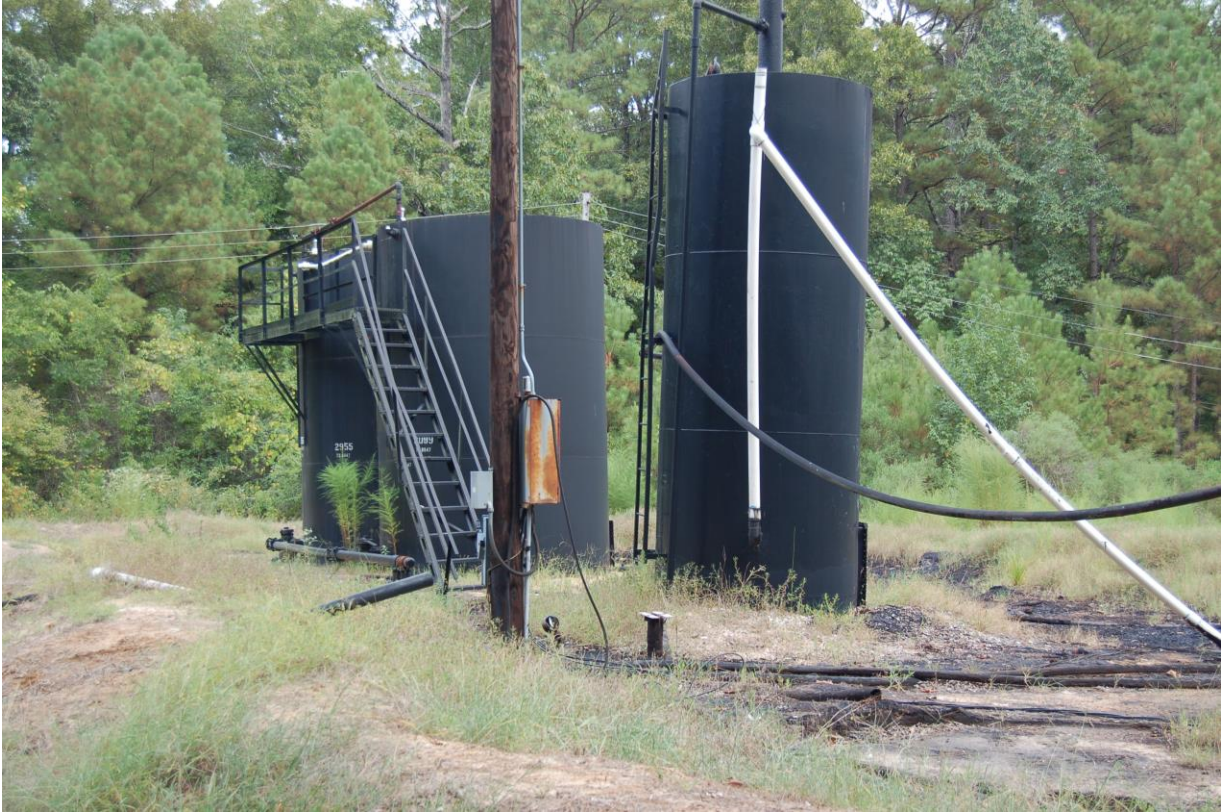
Photo File Name: Photo 2 taken southeast.

Description: Shows the main Ezzell tank battery located a few yards east of the brine facility.

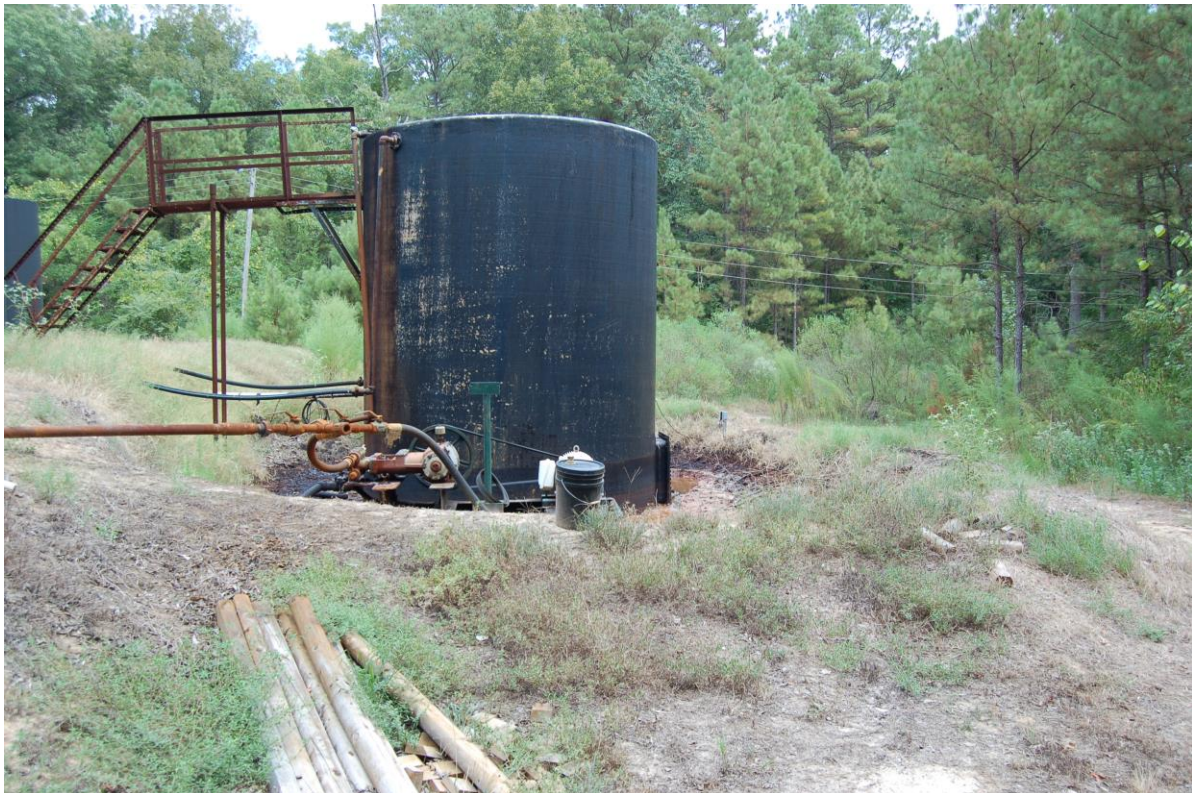
Photo File Name: Photo 3 taken east.

It appears that brine and oil were discharged from the tank battery pit through a pipe and valve into a ditch which flows into a tributary of Salt Creek.

Description: The brine and oil were discharged from the pit located at this brine facility.

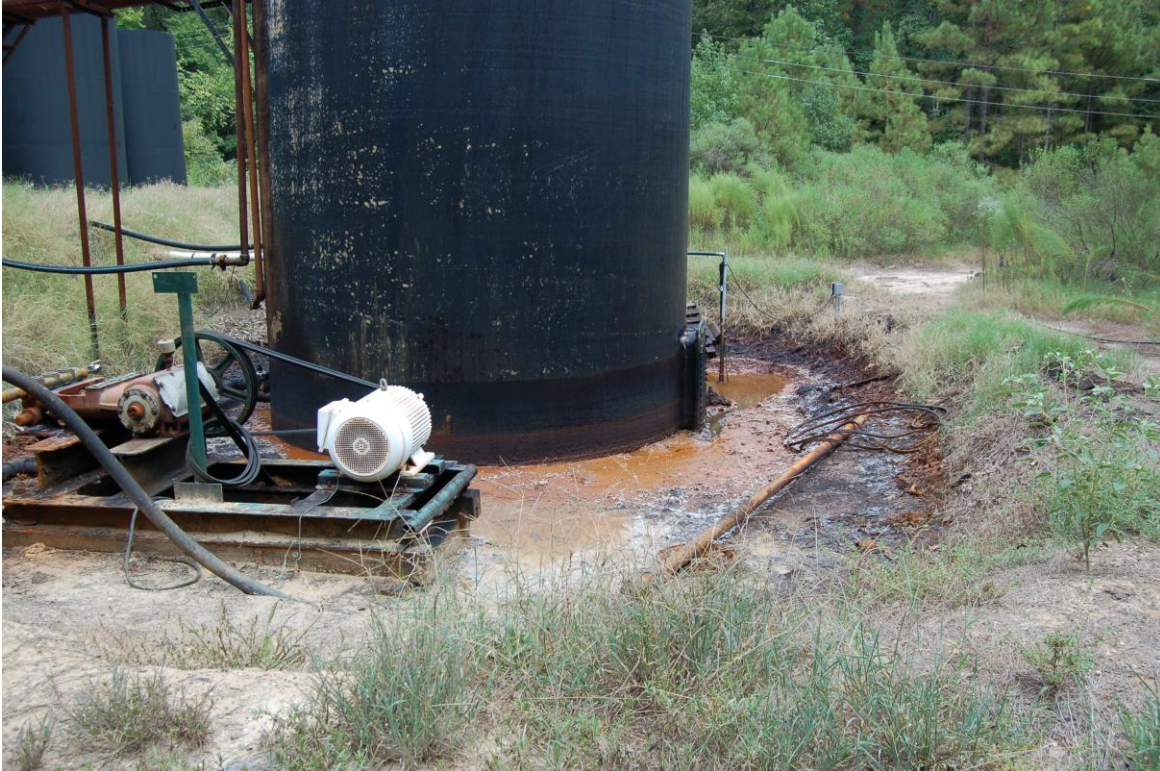
Photo File Name: Photo 4 taken east.

Description: Shows an overview of the brine tank, pump, and pit at the facility.

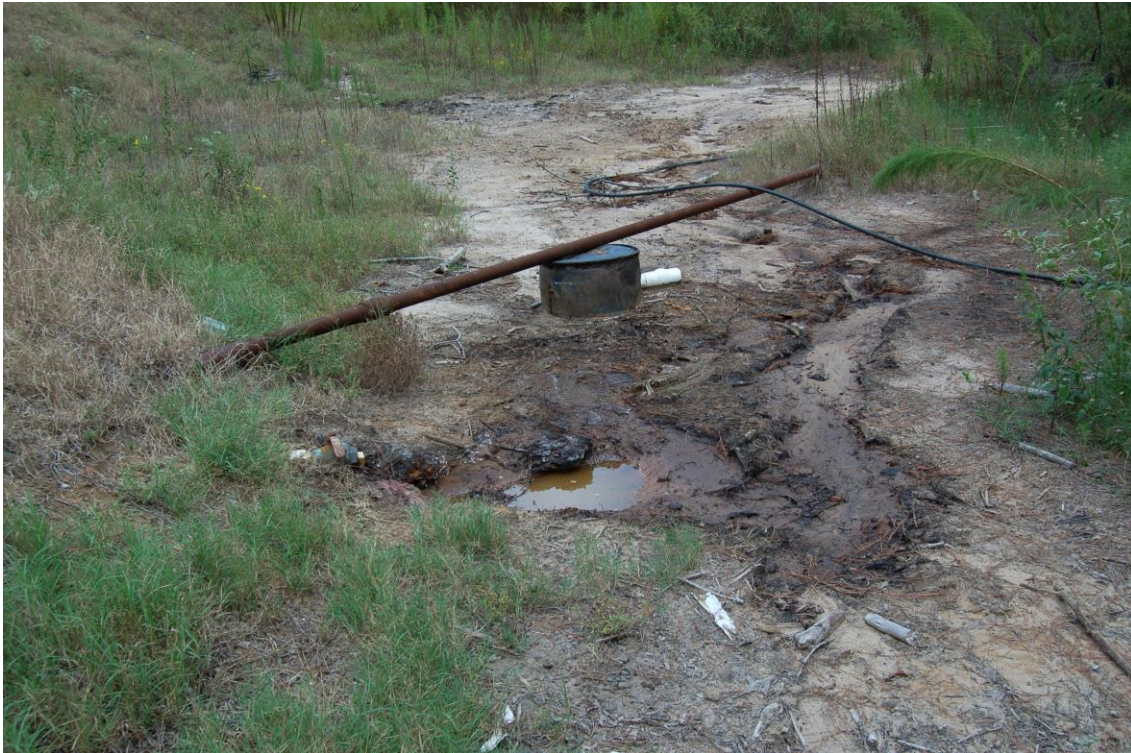
Photo File Name: Photo 5 taken east.

Description: Shows a drain pipe that is used to empty the oil and brine contents of the pit from the tank battery.

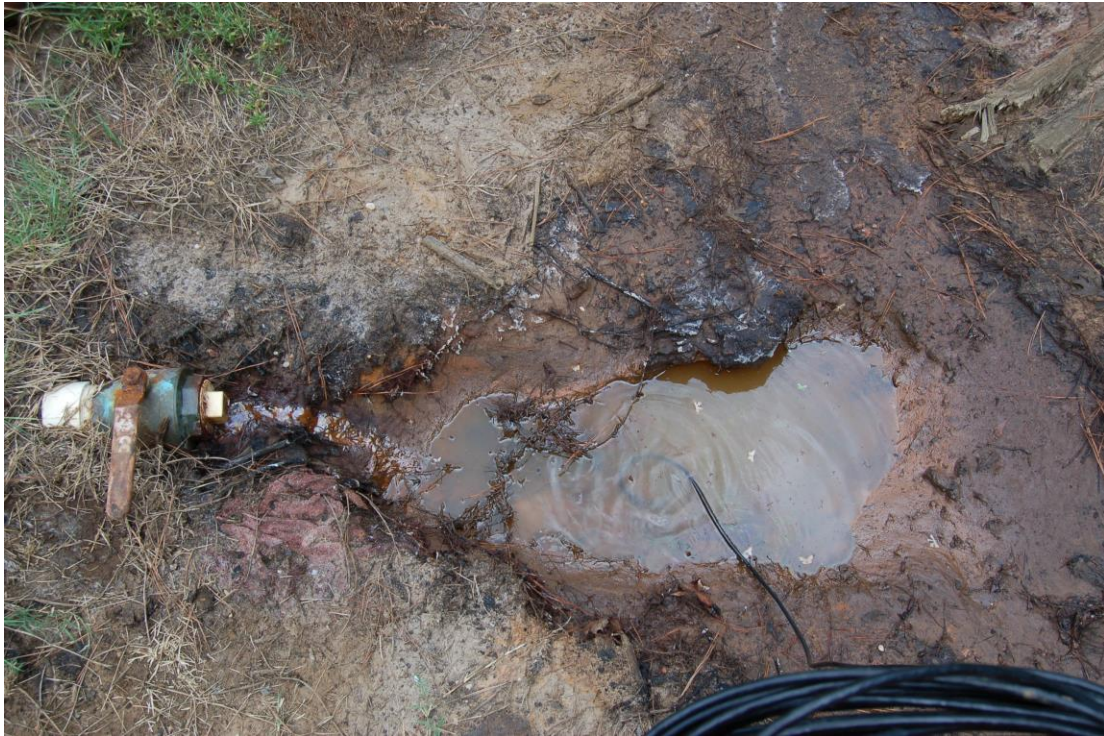
Photo File Name: Photo 6 taken north.

Description: Shows a close-up of the pipe and valve used to drain the contents of the pit into the creek. The valve is still leaking oily brine.

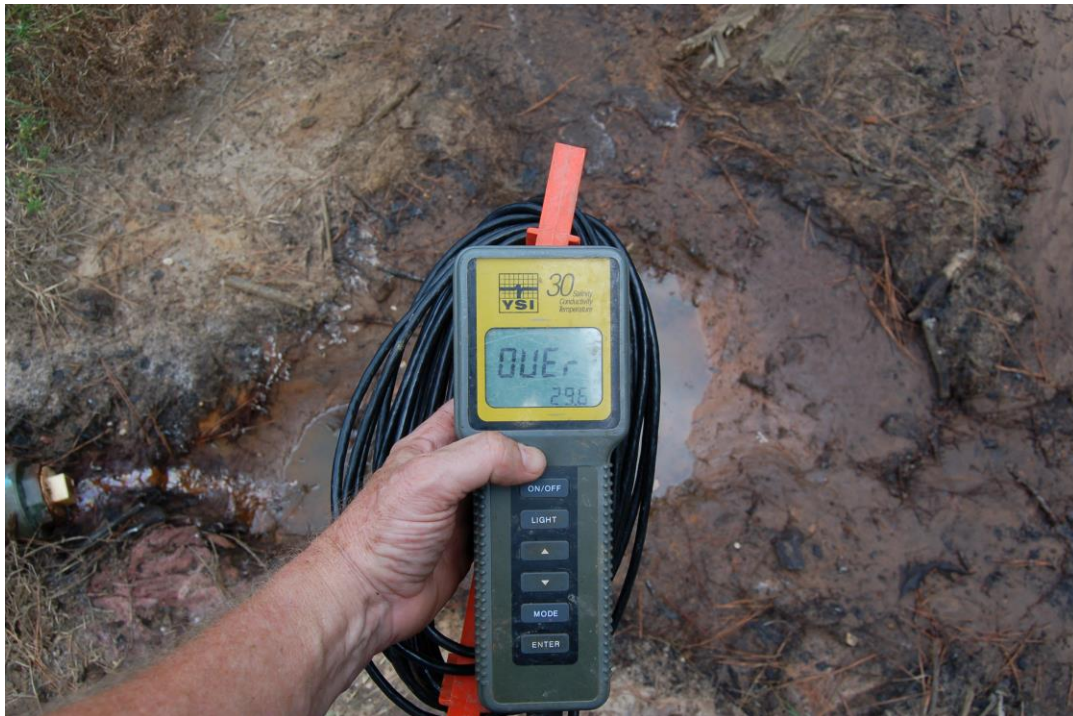
Photo File Name: Photo 7 taken east.

Description: Shows a YSI reading of over 80,000 ppm TSS at the discharge point from the pit shown in the previous photo.

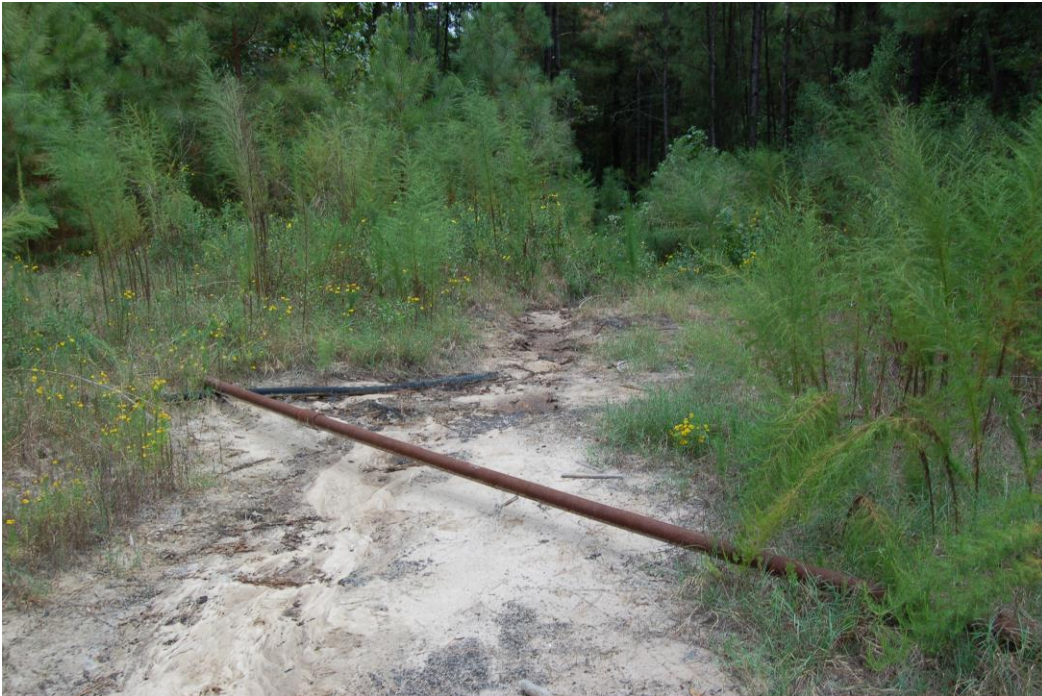
Photo File Name: Photo 8 taken east.

Description: Shows the salty discharge path from the facility to a ditch that joins the creek and marsh.

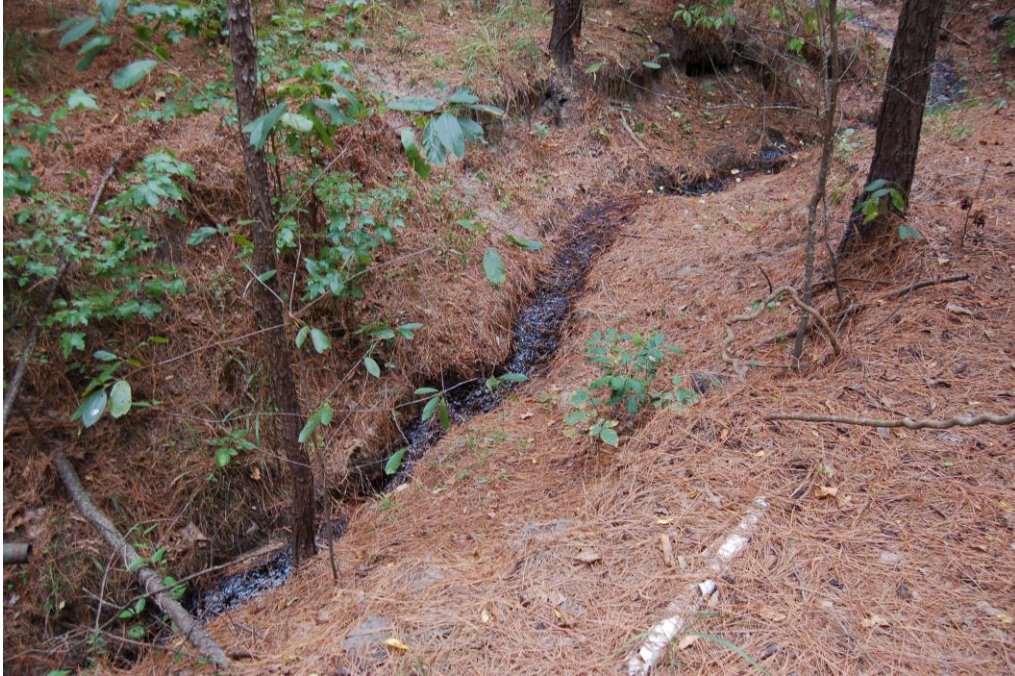
Photo File Name: Photo 9 taken south.

Description: The point of entry of the oil and brine is shown here and then it continues southward to the creek. Notice the oil staining is still present.

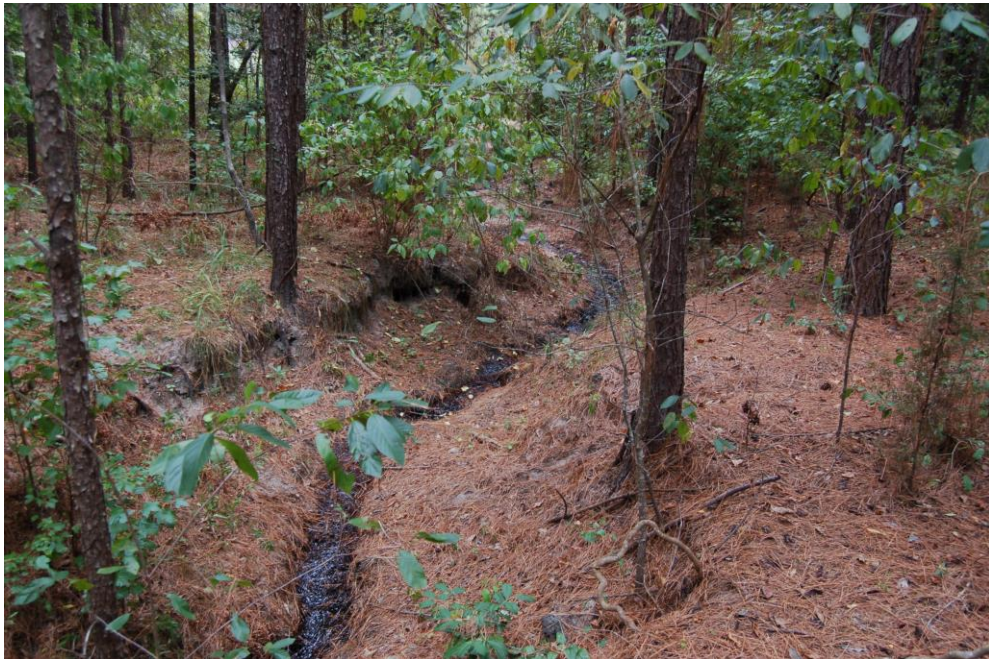
Photo File Name: Photo 10 taken south.

Description: This is another view of the oil stained ditch near the point of entry to the creek.

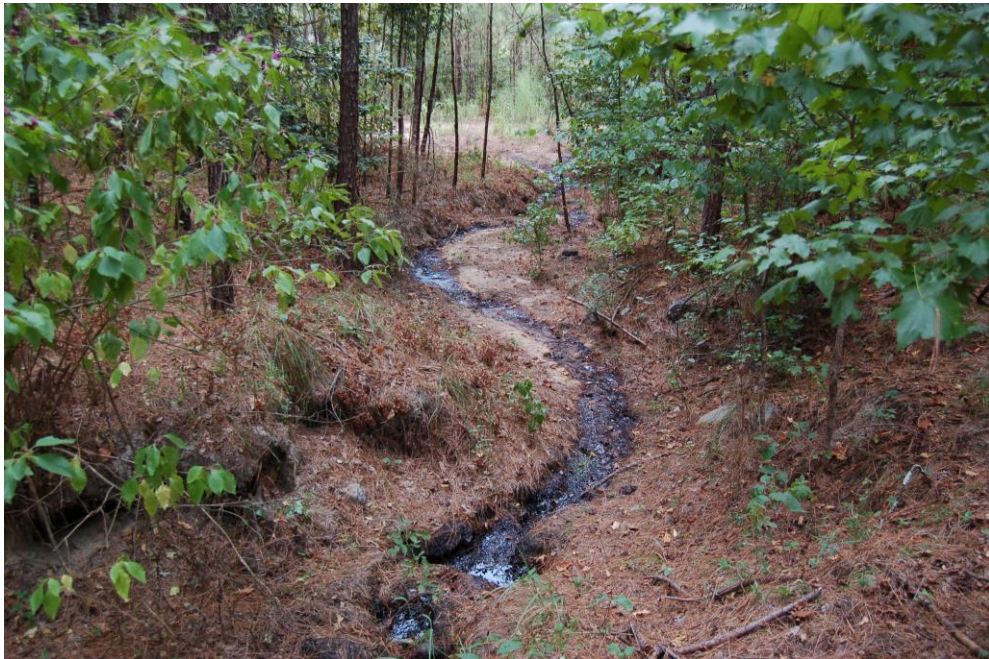
Photo File Name: Photo 11 taken south.

Point of entry to the tributary of Salt Creek: Latitude 33.2328N, Longitude -92.5948W. TSS is 9600 ppm.

Description: Shows the actual point of entry into the creek and marsh.

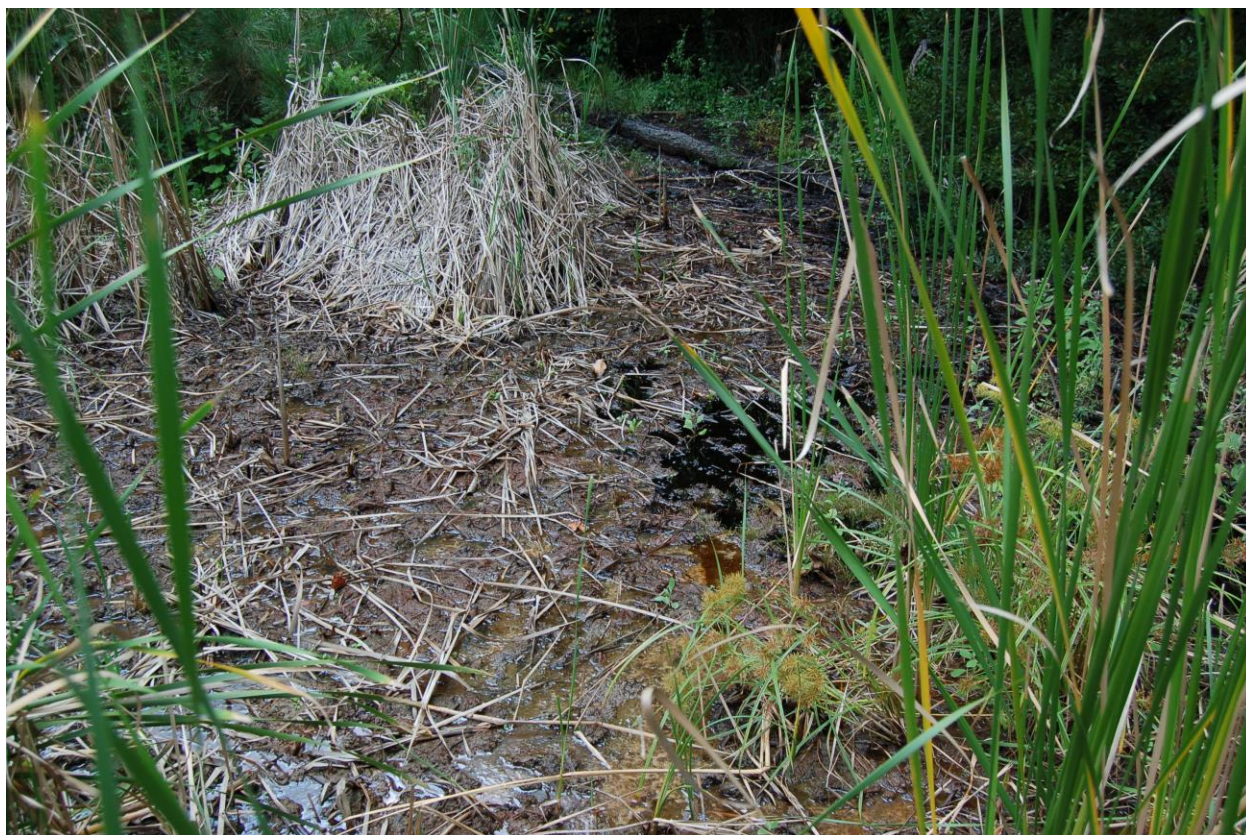
Photo File Name: Photo 12 taken west.

Description: Shows that oil and brine that has been discharged into the creek and marsh.

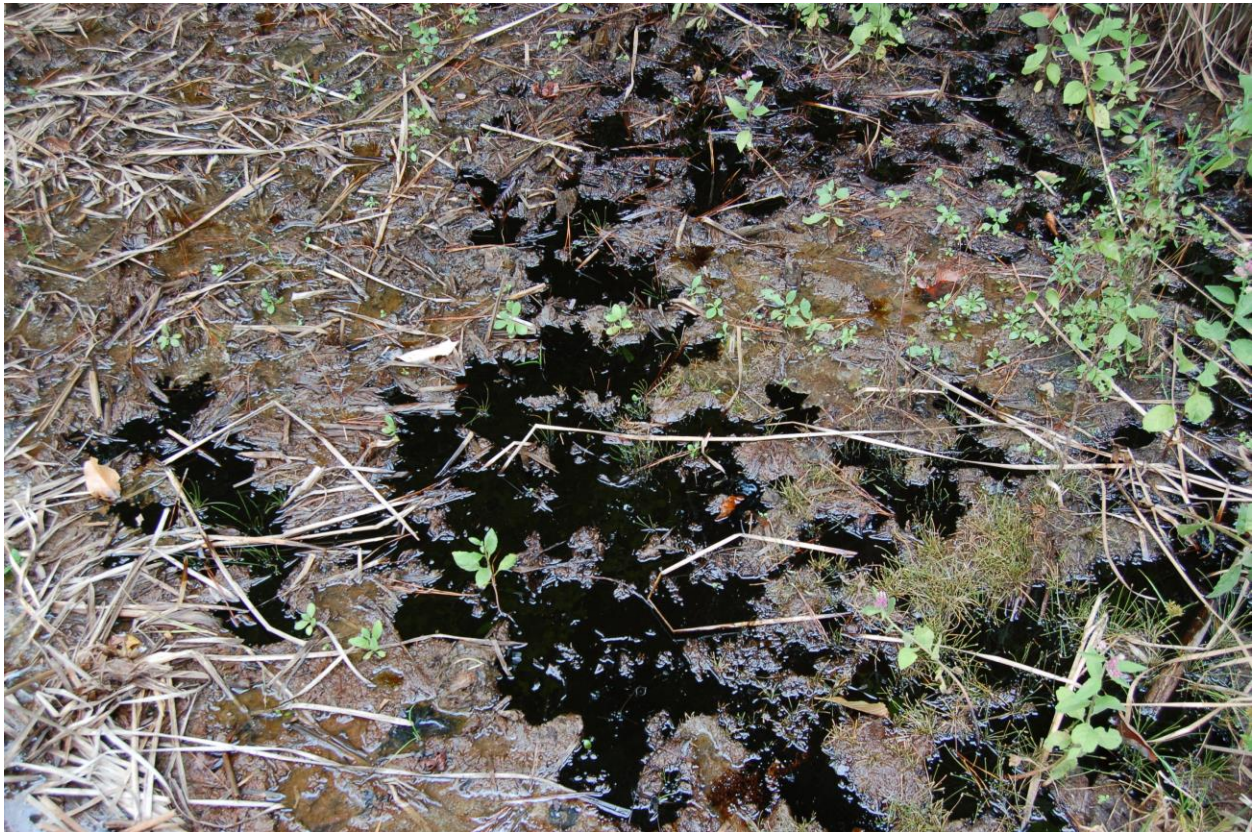
Photo File Name: Photo 13 taken west.

Description: Shows a close-up of oil and brine in the creek.

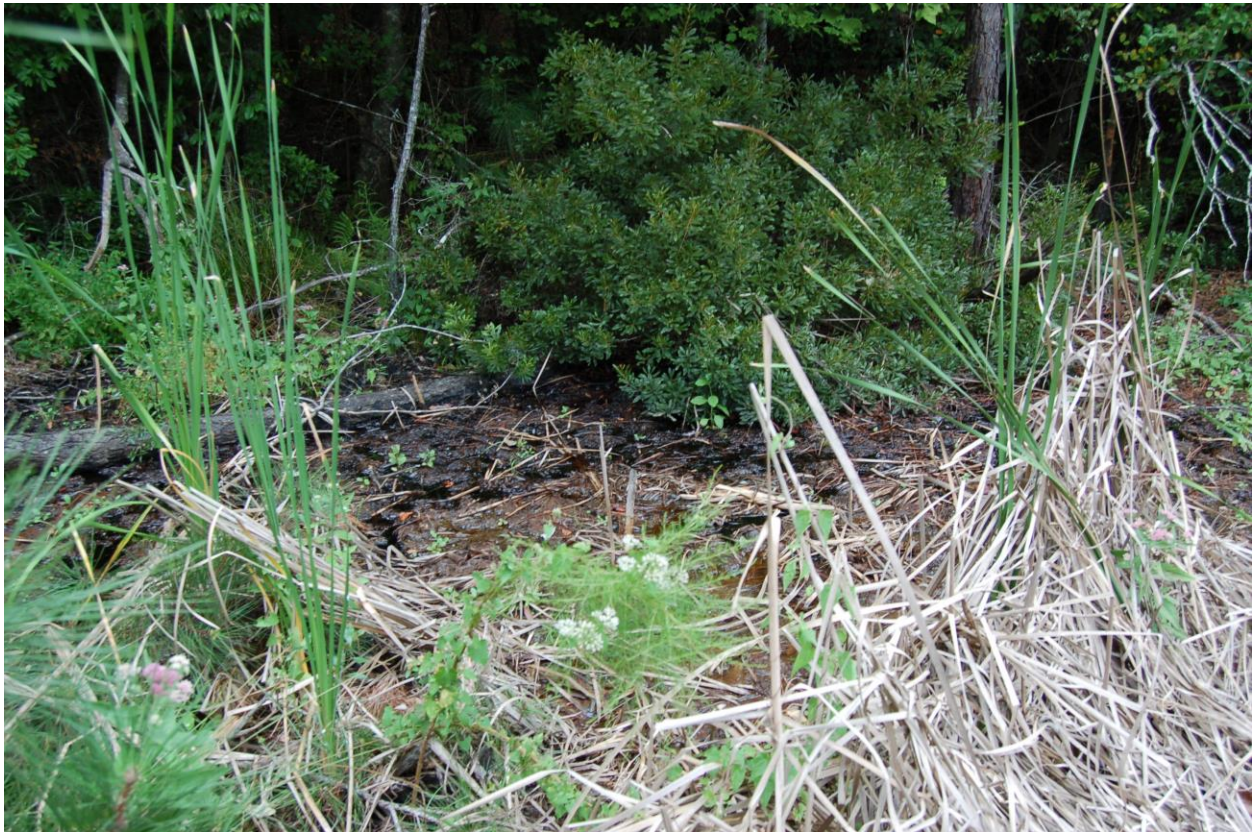
Photo File Name: Photo 14 taken west.

Description: Shows more oil and brine located 50 feet downstream of the entry point.

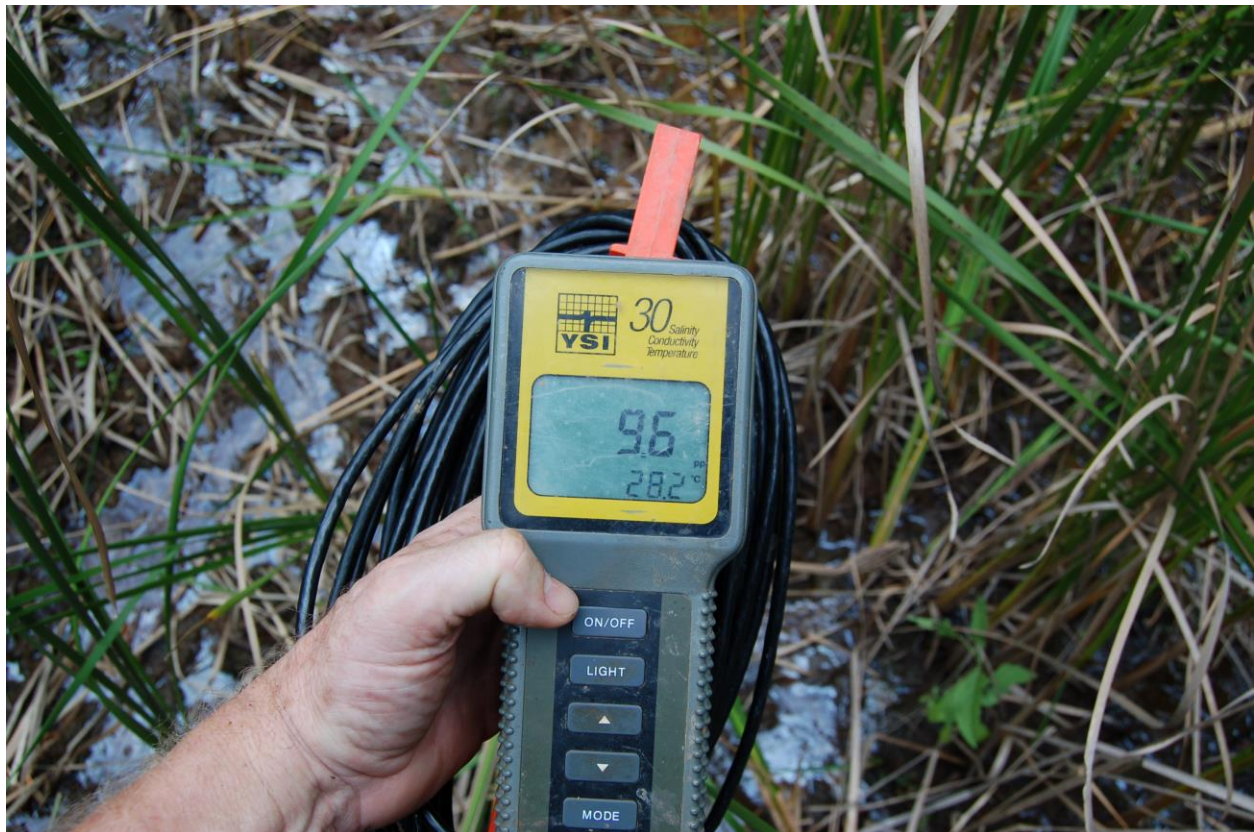
Photo File Name: Photo 15 taken west.

Description: Shows a YSI meter reading of 9600 ppm TSS in the creek and marsh.

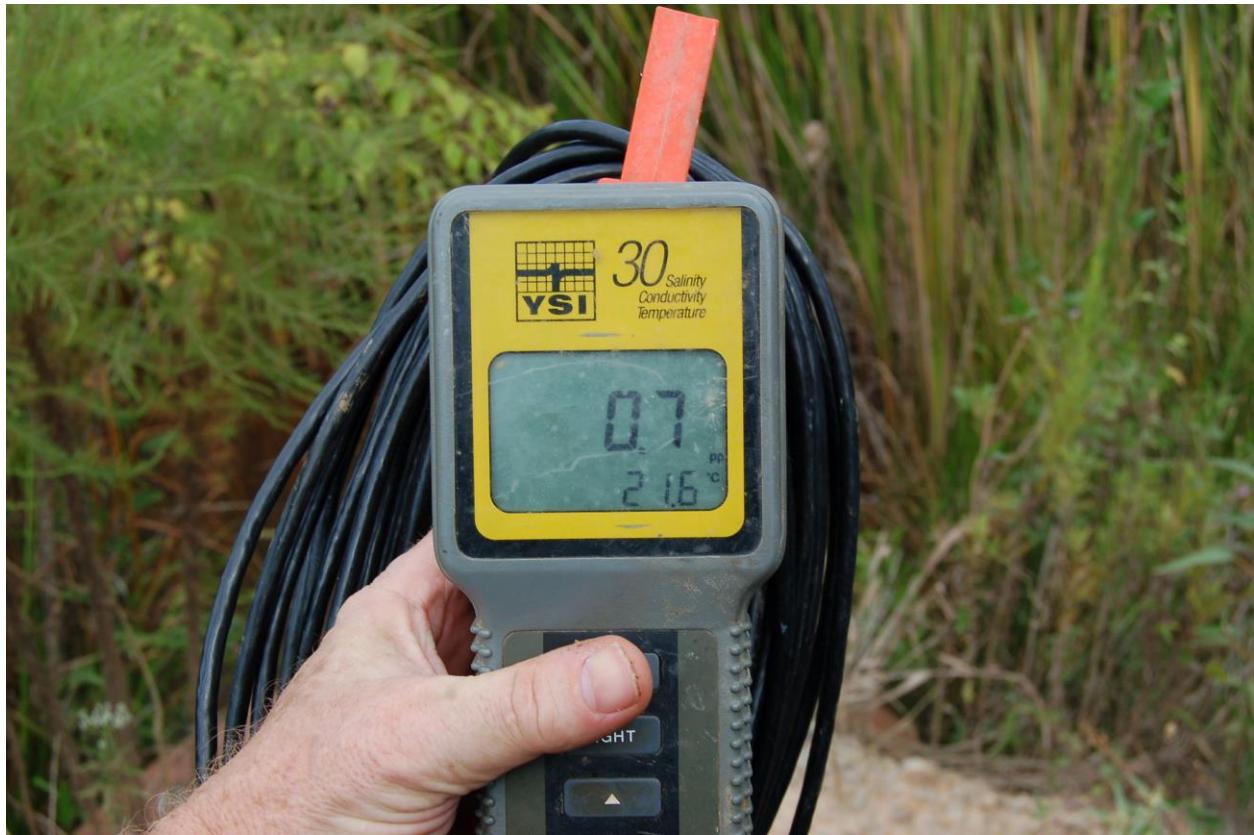
Photo File Name: Photo 17 taken north.

Description: Shows a YSI meter reading TSS of 700 ppm in the unaffected portion of the creek upstream.
