**Region 6 - Enforcement & Compliance Assurance Division**  
**INSPECTION REPORT**

| Inspection Date(s): | 01/18/2022 | |
| Facility Name: | <b>Angel Fire WWTF</b> | |
| Identification/Permit Number: | NM0030503 | |

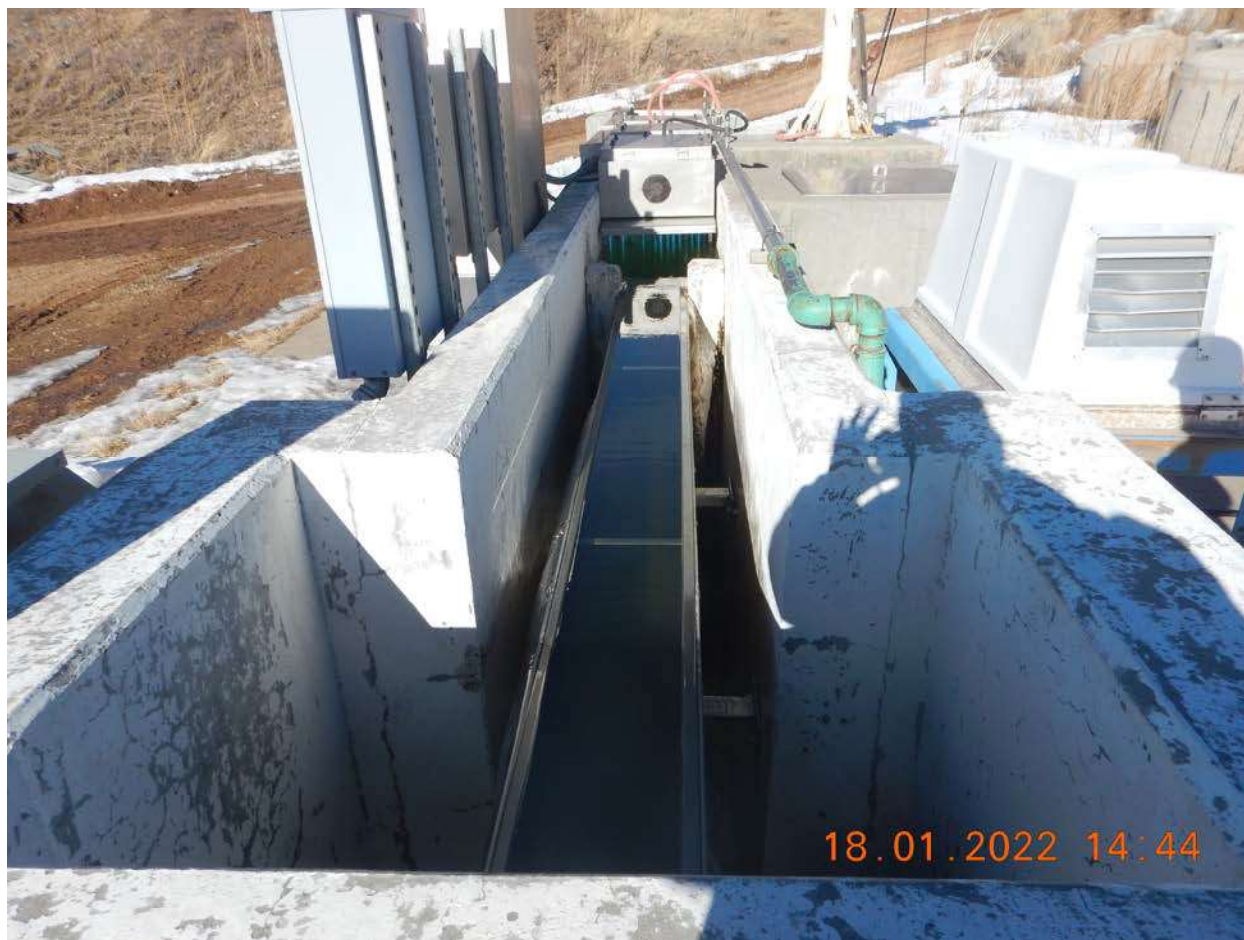
Photo No. 1

The UV system an Aqua Ray 40 HO vertical lamp system (manufactured by Degremont Technologies) consists of five (5) banks of lights situated over a concrete channel. According to a December 2020, HDR Preliminary Engineering Report (PER), “the existing UV disinfection needs replacement due to age”. The disinfected effluent is stored in a pond prior to being discharged to the La Cieneguilla

View of the Ultraviolet (UV) disinfection system situated over the concrete channels. (DSCN2087)  
Photographed by D. Esparza

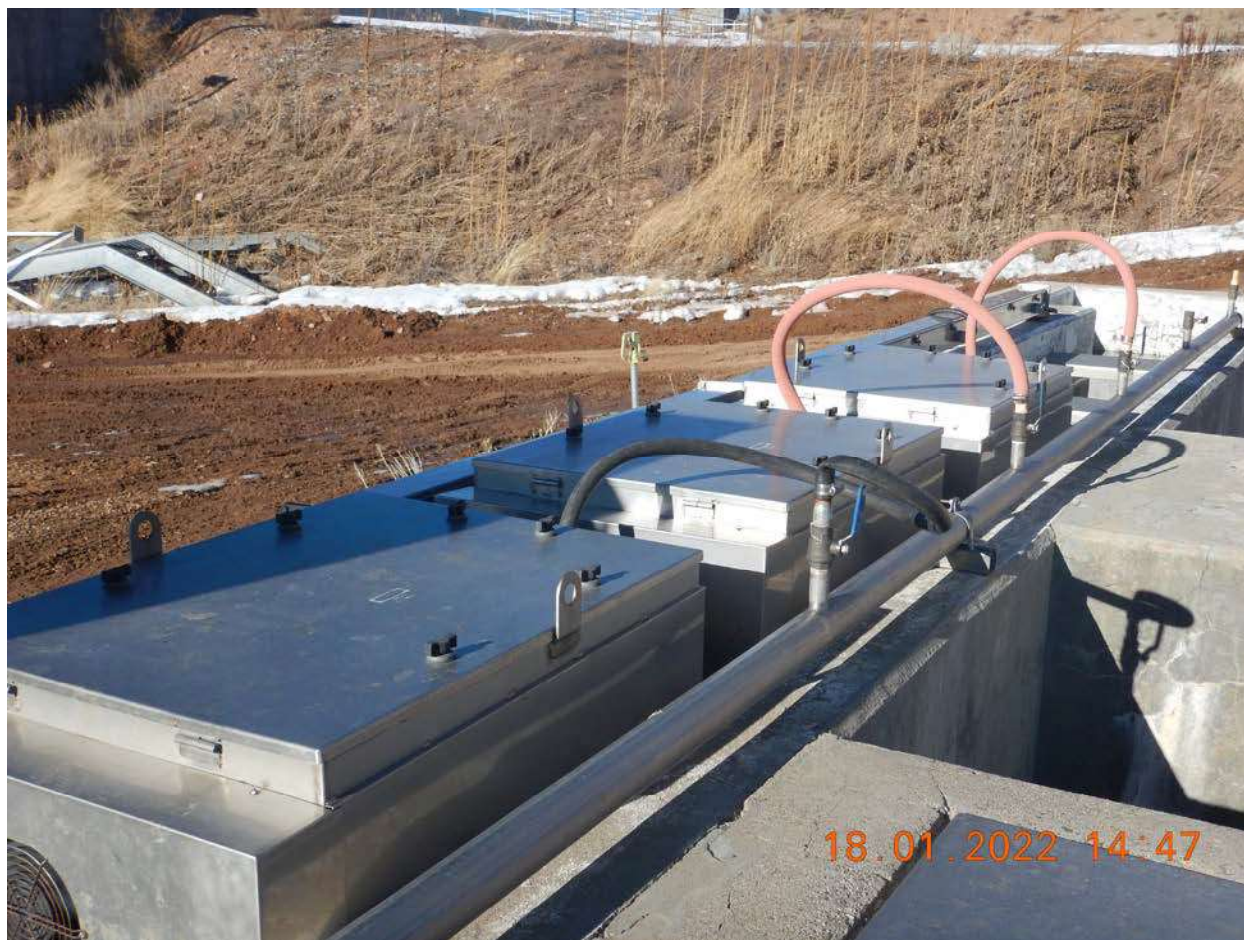
Photo No. 2

Another view of the UV disinfection system. (DSCN2089). Photographed by D. Esparza

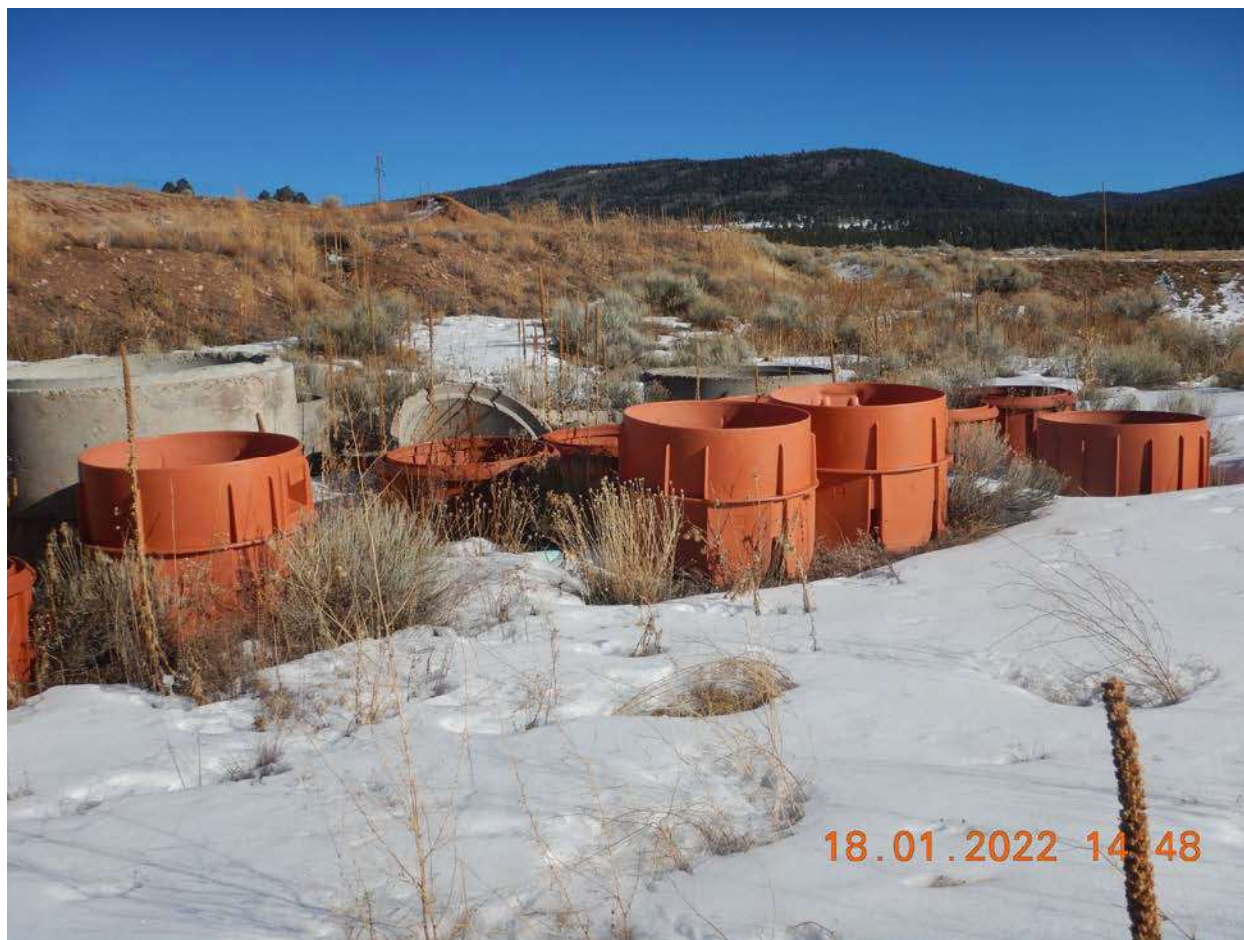
Photo No. 3

View of the location of the proposed new influent equalization (EQ) basin adjacent to the SBR basins. This location is approximately on the northside of the SBR basins. (DSCN2090). Photographed by D. Esparza

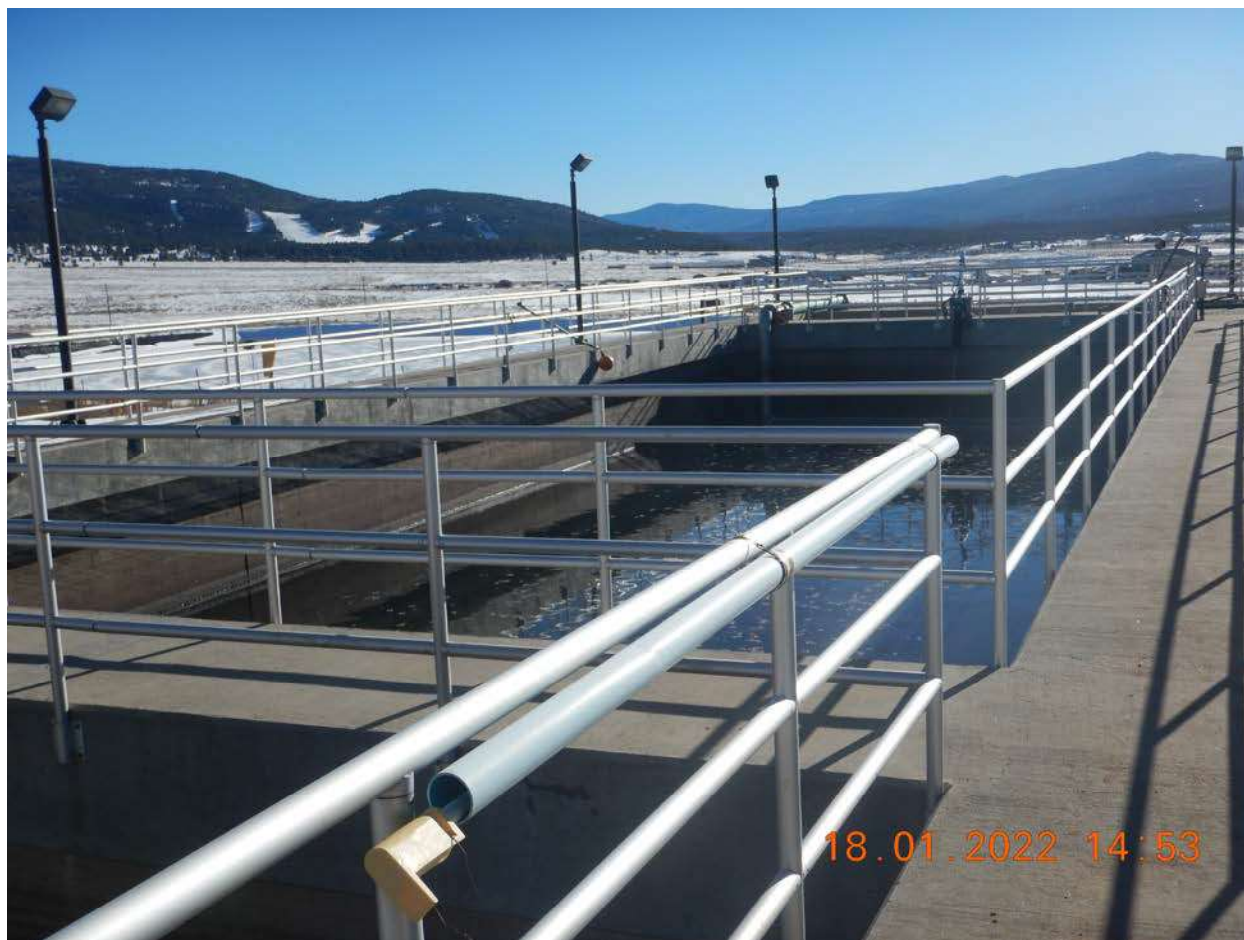
Photo No. 4

View of the approximate northside SBE basin. (DSCN 2091). Photographed by D. Esparza

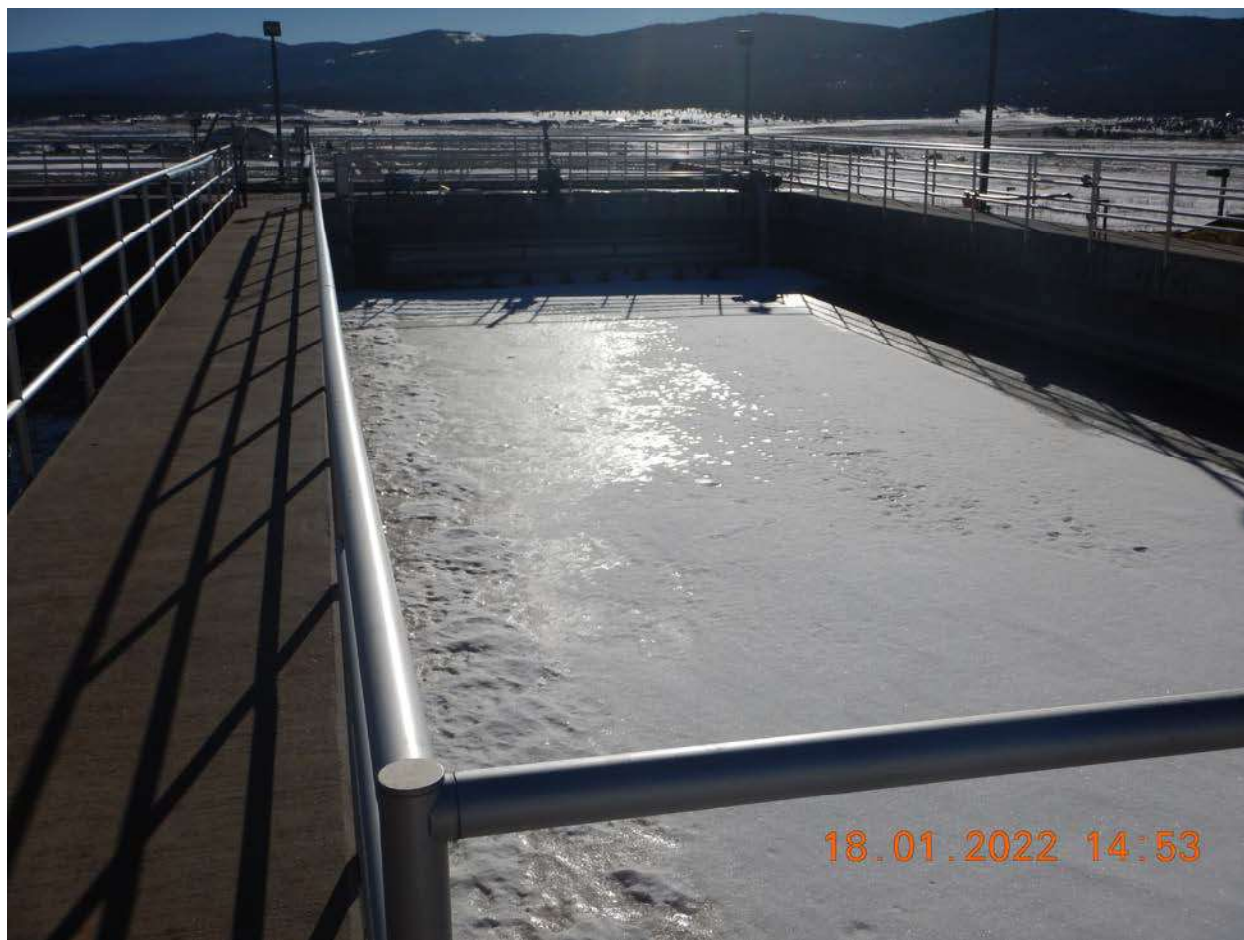
Photo No. 5

View of the approximate southside SBR currently used for treatment and storage of sludge. (DSCN 2093). Photographed by D. Esparza

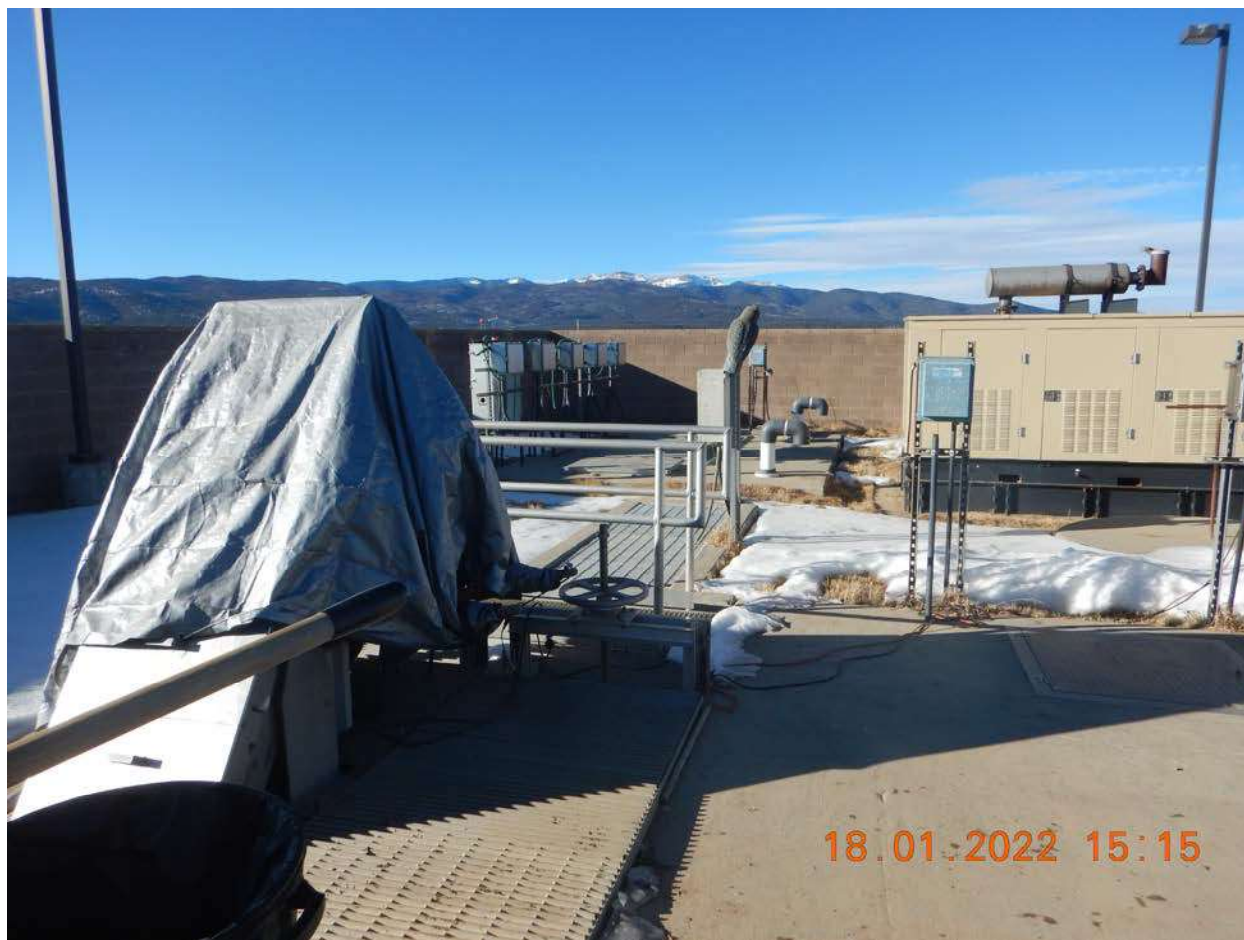
Photo No. 6

- It was also stated the electrical controls for the SBR's, and headworks are outdated, and WWTF staff has difficulty with manufacturer service and obtaining replacement parts.

View of the headwork at the Main Lift Station. Note: The WWTF is scheduled to upgrade the exiting headworks building and install new isolation valves. (DSCN 2096). Photographed by D. Esparza
