## Clean Water Act (CWA) Inspection Report

| <b>Type of Inspection</b> | CEI - Compliance Evaluation Inspection | | | |
| <b>Facility Name</b> | Lamb Weston, Inc. – Boardman West Plant | | | |

## **Photograph Log**

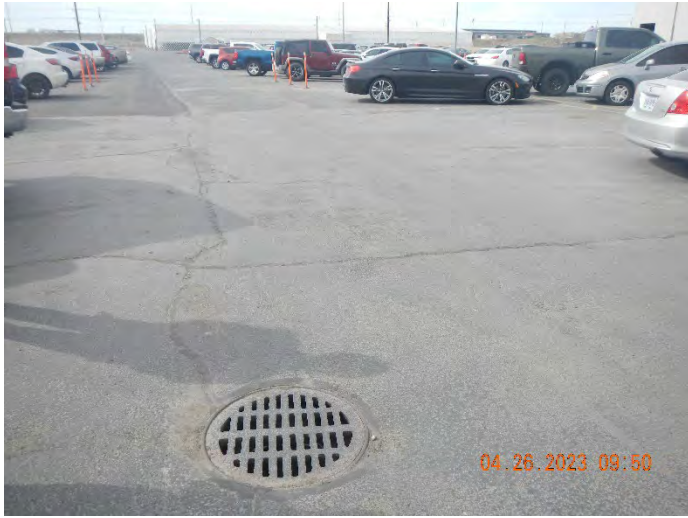
Photo #:01 (DSCN3218)

Description: Facing south, photo of a stormwater catch basin within the facility parking lot. According to Mr. Murrey and the SWPCP, the parking lot stormwater catch basins are routed north to the pump station and associated northwest infiltration basin.

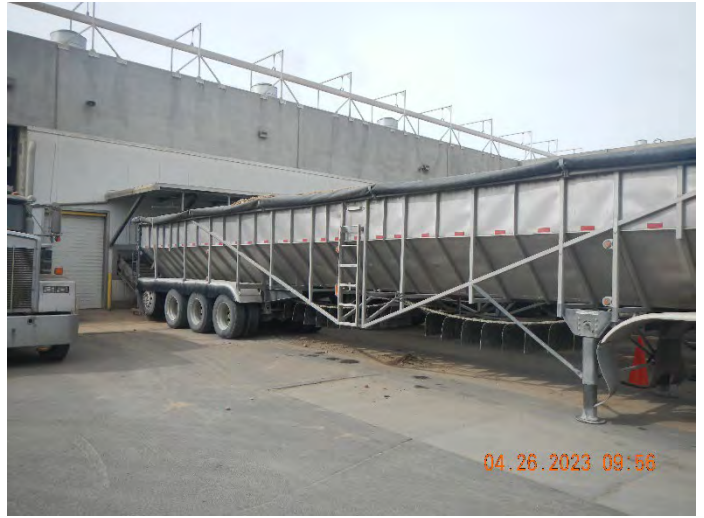
Photo #:02 (DSCN3219)

As discussed earlier in this report, during the walk-through we observed several areas with accumulated sediment/debris, specifically at the raw product receiving area (**Photo 2**), potato residual staging area (**Photo 4**), dumpster area (**Photo 11**) and the used cooking oil filter storage bin area (**Photo 17**). At the time of inspection, Mr. Murrey was not aware of any sweeping practices or sweeping contracts utilized at the Facility, including at these industrial areas.

The concern is the accumulated sediment observed within these areas when compared to the language in the permit. Although the Facility has reported no recent discharge with the implementation of the infiltration basins, sediment/debris/pollutants entering the stormwater system could have the potential to accumulate within the pump station and/or infiltration basins impacting their performance.

Description: Facing south, photo of the raw product receiving area. Observed areas with accumulated sediment.

2. Regarding the raw material unloading area, what are the current sediment control practices in the outdoor parking/receiving area. At the time of inspection, sweeping practices were unknown and we observed some accumulated sediment piles and some raw potatoes.

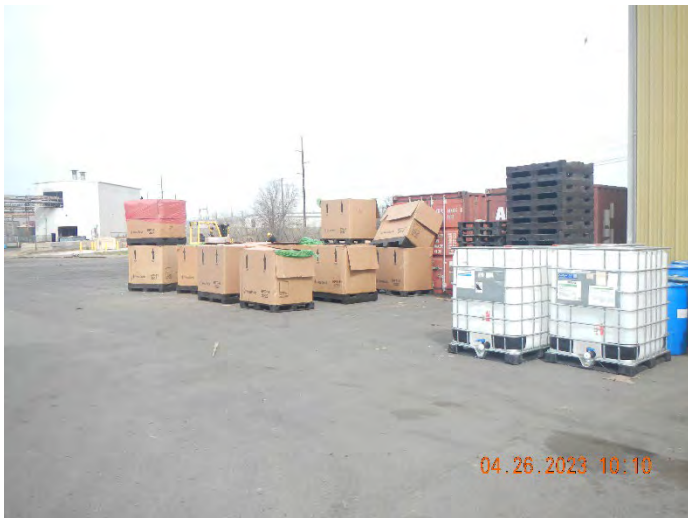
Photo #:03 (DSCN3220)

Description: Facing northwest, photo of empty chemical totes and the discarded product storage/staging area.

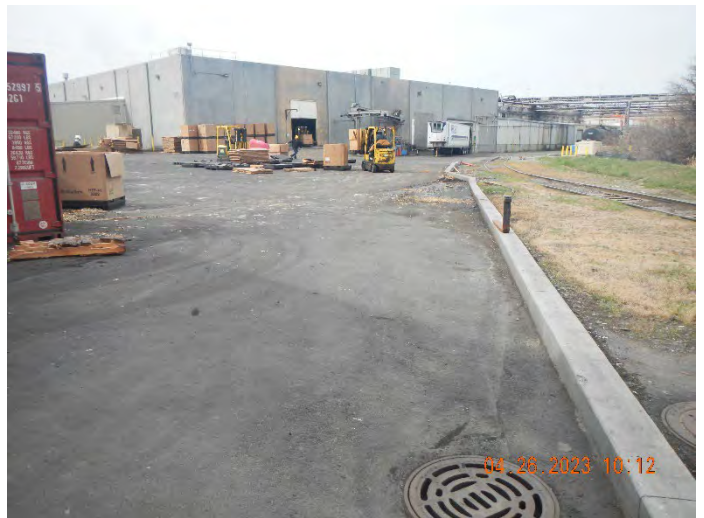
Photo #:04 (DSCN3221)

At the time of inspection, we observed discarded potato residuals on the surface of several loading areas. We also observed accumulated sediment north of the loading area, near the rail spur curbing (**Photo 4**).

Description: Facing southwest, photo of the stormwater catchment area and catch basin near the discarded product storage/staging area.

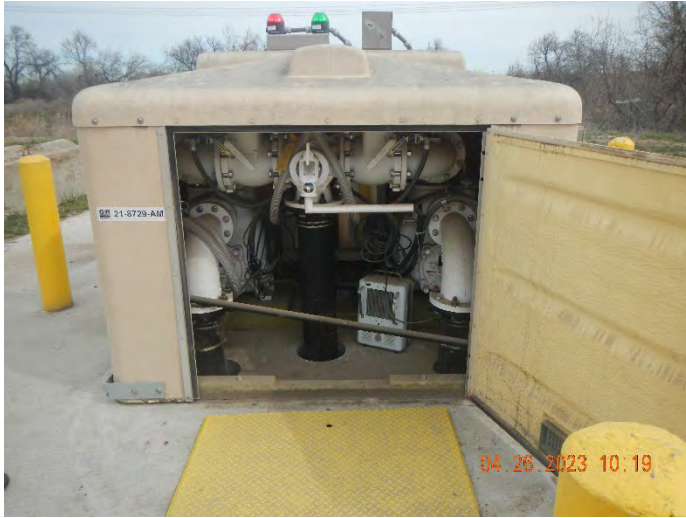
Photo #:05 (DSCN3222)

Mr. Murrey lifted the cover of the wet-well, we observed a slight trickle of flow entering the wet-well from one of the influent pipes. When asked about the source of the influent flow during the current dry weather conditions, Mr. Murrey discussed that he would have to follow-up as he was not certain of the source, possibly residual flow from a recent broken water pipe. Mr. Murrey explained that earlier in the day, he was informed that a pipe leak associated with some ongoing interior construction had occurred within the Facility's main office entrance area. Mr. Murrey was going to confirm the source of the water and if it entered the nearby stormwater catch basin in the parking area.

As discussed earlier in the report, during the walk-through while at the stormwater pump station we observed both a red and green light illuminated on the top of the pump/lift station (**Photo 5**). When asked about the station’s alarm system and illuminated indicator lights, Mr. Murrey discussed that being relatively new to the Facility, he would have to follow-up post-inspection regarding specifics of the pump station and alarm system.

The concern is that the alarm system associated with the stormwater pump/lift station may not be currently operating as designed. In the event of a pump failure, the pump station would overflow to the surface water pond.

As discussed earlier in the report, during the walk-through at the stormwater pump/lift station we observed a slight trickle of influent flow during dry weather conditions. When asked about the source of the influent flow during the current dry weather conditions, Mr. Murrey discussed that he would have to follow-up as he was not certain of the source, and indicated it was possibly residual flow from a recent broken water pipe. Mr. Murrey

explained that earlier in the day, he was informed that a pipe leak associated with some ongoing interior construction had occurred within the Facility's main office entrance area. Mr. Murrey was going to confirm the source of the water and if it entered the nearby stormwater catch basin in the parking area.

Description: Facing north, photo of the Gorman Rupp stormwater lift station associated with the northwest infiltration basin.

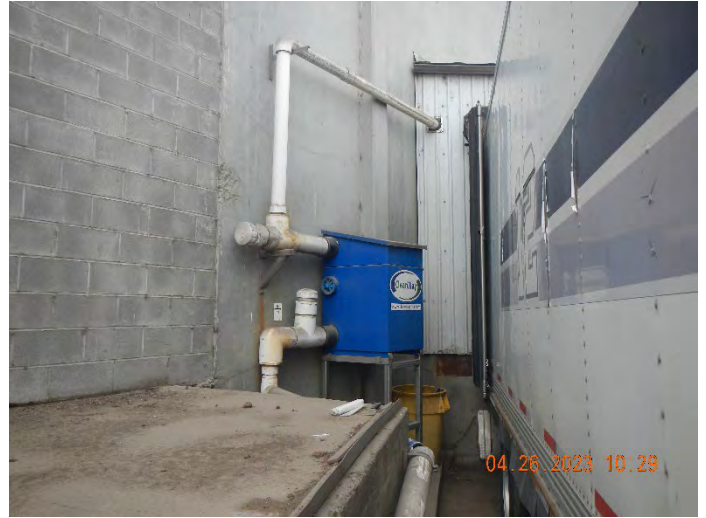
Photo #:06 (DSCN3223)

The walk-through continued west, to the raw product/residual storage bunkers and surrounding areas. We observed a roof downspout filtration unit attached to a production building (**Photo 6**). According to Mr. Murrey, the roof downspout is routed to the stormwater pump station that was just observed. Mr. Murrey was unsure when the filtration unit was installed or last serviced.

Description: Facing west, photo of a roof downspout filtration unit manufactured by Clean Way.

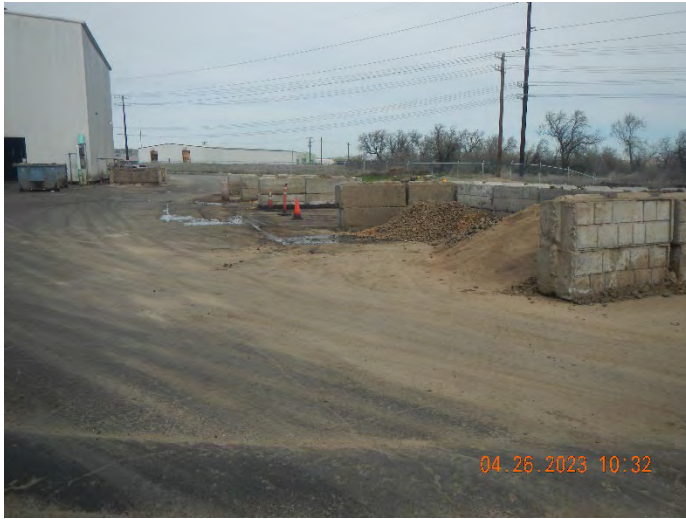
Photo #:07 (DSCN3224)

Description: Facing northwest, photo of residual storage area. Stormwater captured within this area is collected separately and routed to wastewater treatment system for reuse and/or discharge to the Port of Morrow wastewater treatment plant.

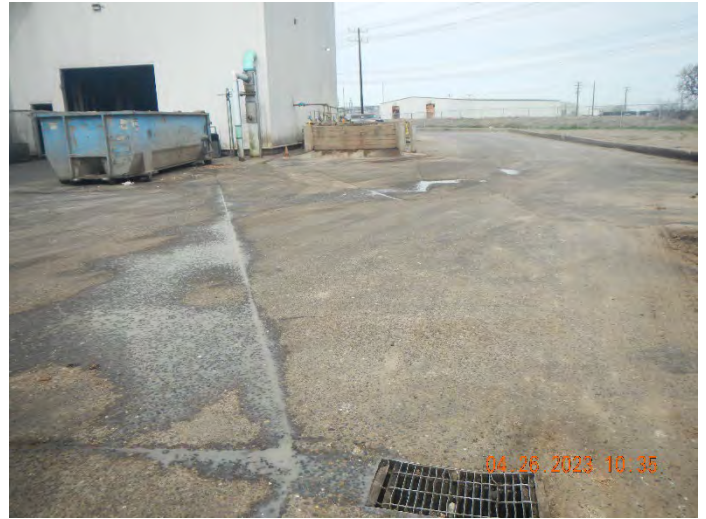
Photo #:08 (DSCN3225)

Description: Facing northwest, photo of catch basins serving the residual storage area. Catch basins are plumbed to the process wastewater treatment system.

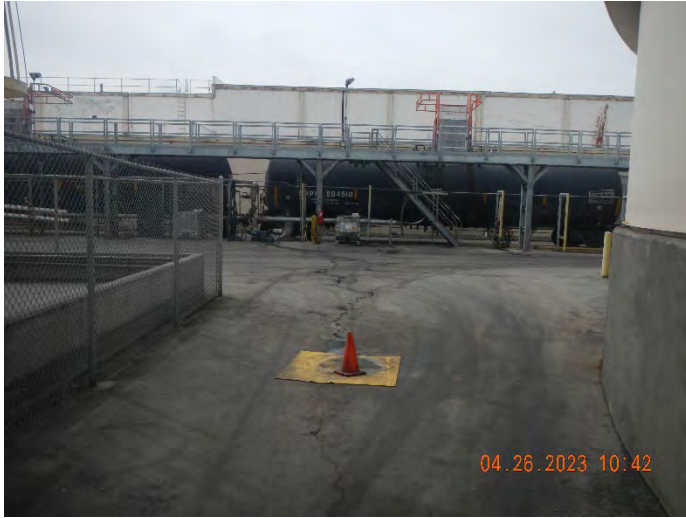
Photo #:09 (DSCN3226)

Description: Facing south, photo of the cooking oil unloading area (rail). Stormwater catch basin is located just north and covered with a drain cover mat.

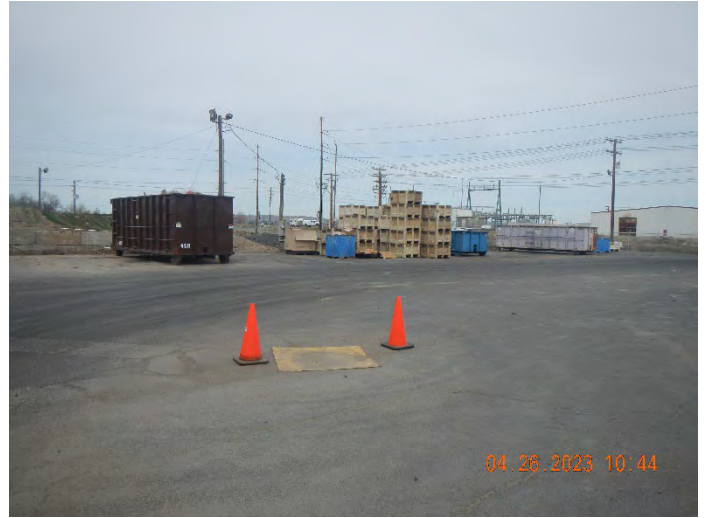
Photo #:10 (DSCN3227)

As discussed earlier in the report, during the walk-through within the designated dumpster area we observed dumpsters used for general garbage and scrap metal to be without covers or lids (**Photo 10 & Photo 11**). Along the southern edge of the Facility, we also observed the used cooking oil filter discard bin without cover or containment in a southern area of the facility. Additionally, oil staining was observed throughout the area containing the cooking oil discard bin (**Photo 17**).

The concern is the observed lack of cover(s) or lid(s) on the waste dumpsters when compared to the language in the permit. It is recognized that the nearest stormwater catch basin to dumpster area was equipped with a drain cover/mat. As the inspection occurred during dry weather conditions, the seal/effectiveness of the drain cover/mat was unknown. Although the Facility has reported no recent discharge with the implementation of the infiltration basins, sediment/debris/pollutants entering the stormwater system could have the potential to accumulate within the pump station and/or infiltration basins impacting their performance.

Description: Facing northwest, photo of the scrap metal dumpster and general garbage/dumpster storage area, just east of the northwest bioswale. The adjacent stormwater catch basin was covered with a drain cover mat.

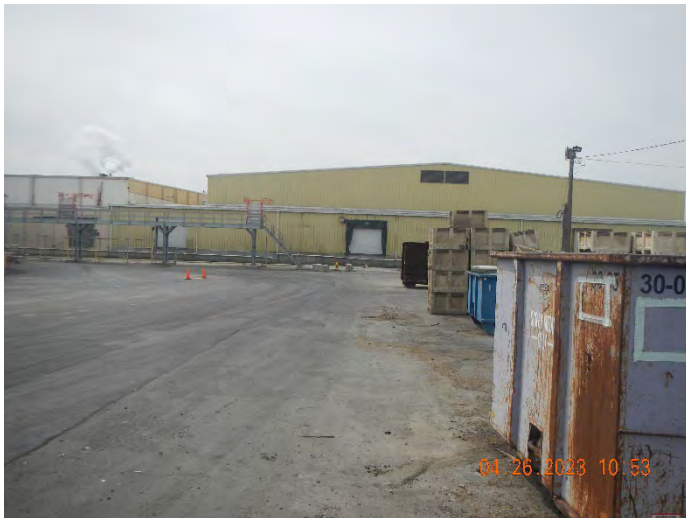
Photo #:11 (DSCN3229)

Description: Facing south, photo of the scrap metal dumpster and other dumpsters used for garbage/waste storage. No lids observed. Accumulated sediment observed within the area.

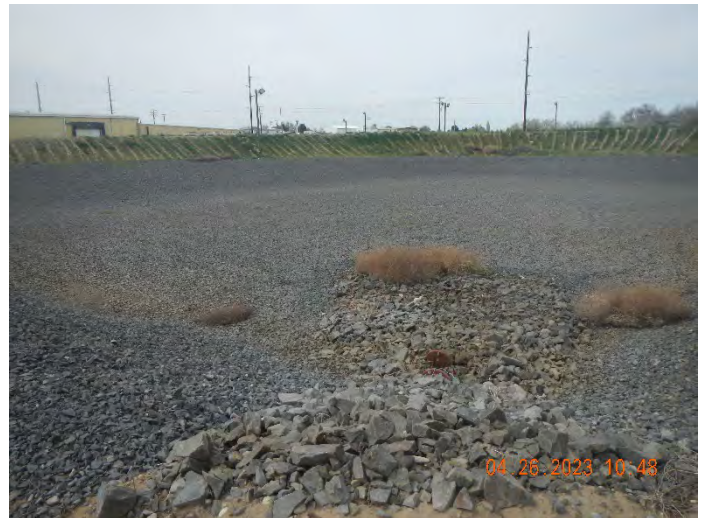
Photo #:12 (DSCN3228)

We then observed the northwest infiltration basin that receives stormwater from the northern pump station (**Photo 12**). As discussed earlier in the report, stormwater previously discharged to the northern surface water pond now discharges to the northwest infiltration basin. Mr. Murrey discussed that he believes the infiltration basin is currently operating as designed and showed a recent picture on his phone of stormwater within the infiltration basin that had since infiltrated/evaporated.

Description: Facing southwest, photo of the northwest infiltration basin that receives stormwater from the pump station.

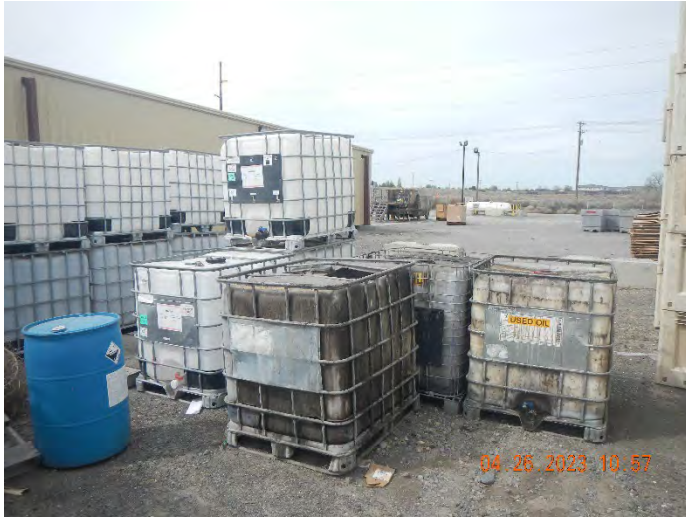
Photo #:13 (DSCN3230)

As discussed earlier in the report, during the walk-through within the empty tote storage area we observed a full tote containing used cooking oil according to Mr. Murrey. The top of the tote had been cut open and was exposed without a lid. The concern is the full tote of used oil observed without a functioning lid/cover and potentially exposed to stormwater during rain events. It is recognized that the nearest stormwater catch basin was equipped with a drain cover/mat, however, the seal/effectiveness of the drain cover/mat was unknown due to the dry weather conditions. Although the Facility has reported no recent discharge with the implementation of the NW infiltration basin, cooking oil entering the stormwater system could have the potential to accumulate within the pump station and/or infiltration basins impacting their performance.

Description: Facing west, photo of empty tote storage area. One tote was marked "used oil" and was full of used cooking oil.

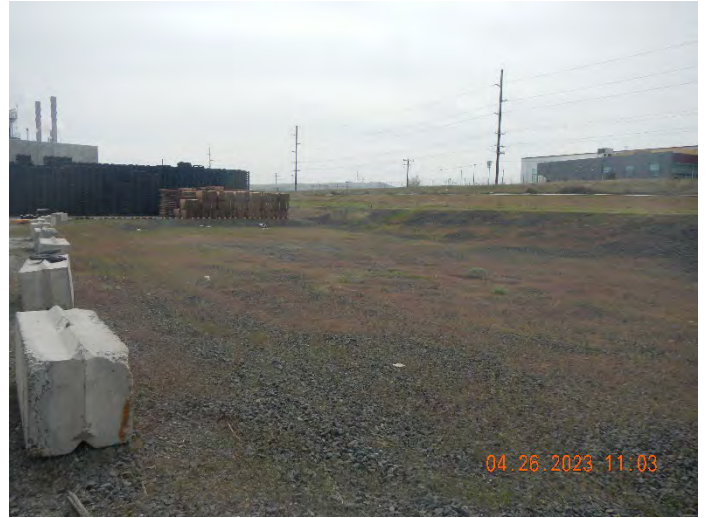
Photo #:14 (DSCN3231)

Description: Facing southeast, photo of the southeast infiltration basin. Receives stormwater from southern areas and the southeast building roof drain.

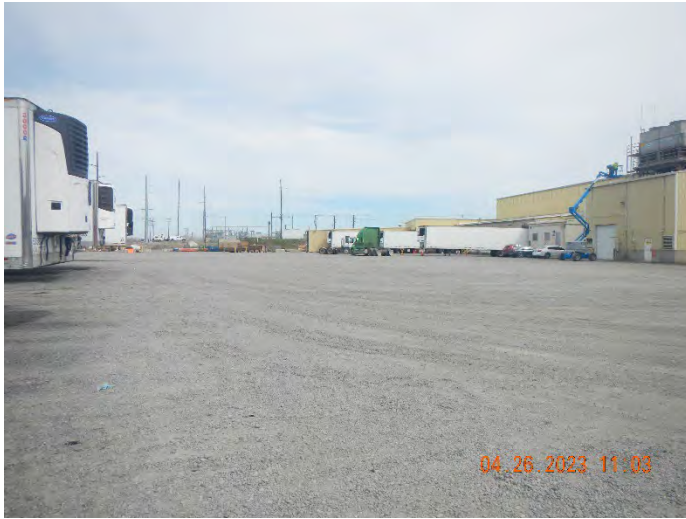
Photo #:15 (DSCN3232)

Description: Facing north, photo of the final product shipping area.

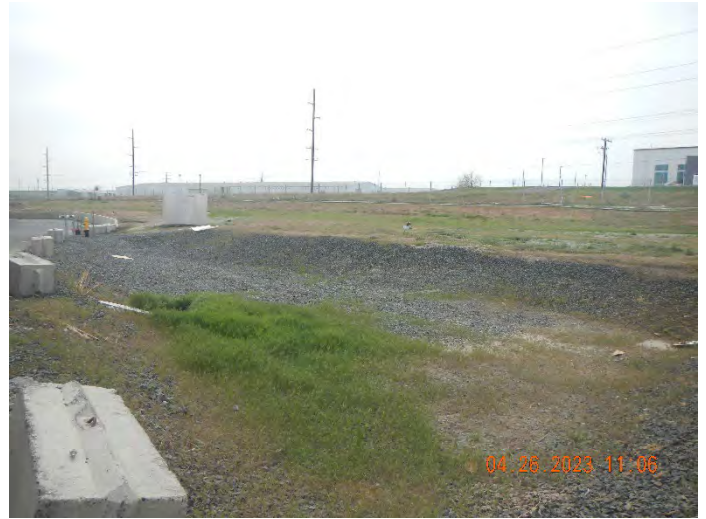
Photo #:16 (DSCN3233)

Description: Facing southwest, photo of the southern infiltration basins that receives stormwater from the southern areas outside of the boiler building.

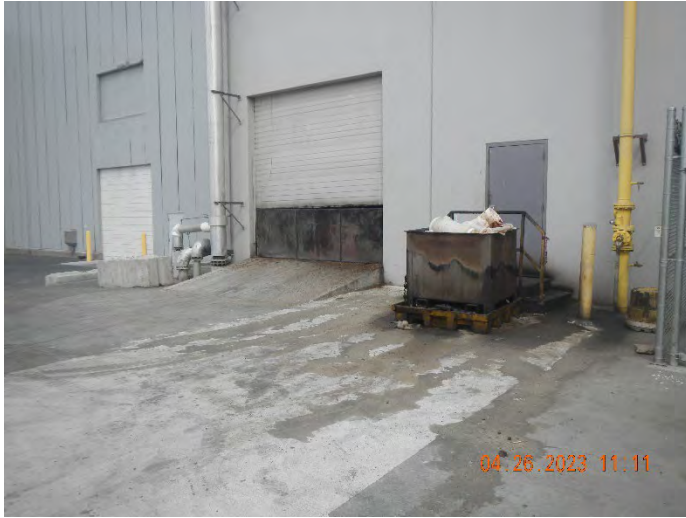
Photo #:17 (DSCN3234)

Description: Facing north, photo of used cooking oil filters contained within an uncovered dumpster. Used oil residuals were observed outside of the containment bin.

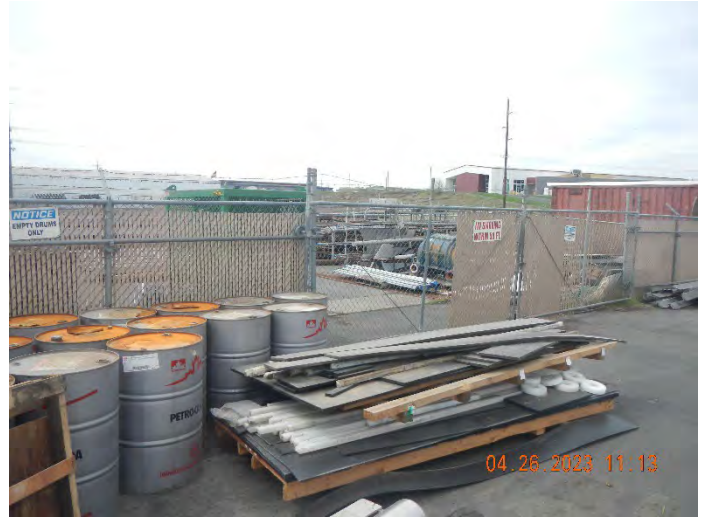
Photo #:18 (DSCN3234)

Facing south, photo of an empty drum storage area and "boneyard area."

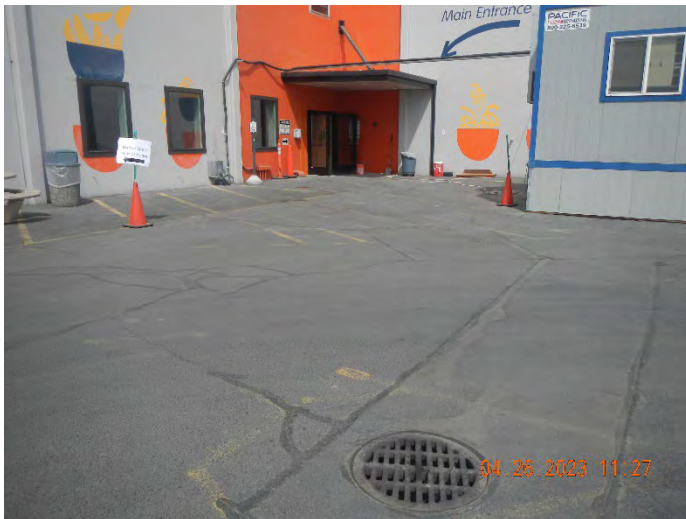
Photo #:19 (DSCN3236)

Description: Facing north, photo of northwest parking lot catch basin.
