# NPDES Compliance Inspection Report

## Port of Toledo Boatyard Toledo, Oregon

NPDES Permit Tracking Number  
# ORR203146

Inspection Date: December 20, 2023

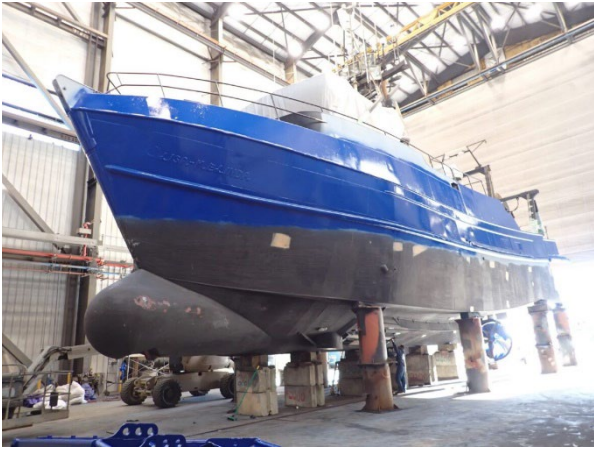
Photo #:01 (PC200101)

We began the facility walkthrough with Ms. Scacco starting inside the Facility's main work building that served as the large vessel building where a boat was being worked on (**Photo 1**). We then walked outside to the southern entrance/exit of the large vessel building where vehicle traffic occurs (**Photo 2**) in Drainage Basin B. We continued walking South into Drainage Basin A observing a vessel and equipment outside, including the Facility's large lift (**Photo 3 and Photo 5**). We walked along the western perimeter to observe the Facility's curtain drain, however, the drain that runs along the western perimeter was located in a ditch covered by dense vegetation and was not visible (**Photo 4**). Stormwater in Drainage Basin A collects in this curtain drain and flows through a 1,500-gallon vault filled with biochar filter bags (**Photo 6**) and then through an underground 18-inch culvert to Outfall 001 on the eastern perimeter of the Facility. As we continued South along the Facility's western perimeter, Ms. Scacco explained the possibility of the Facility receiving run-on from a residence up the hill that has dogs (**Photo 7**). Any run-on from up the hill may discharge into the Facility's curtain drain. We then observed some uncovered metal and wooden materials and empty

Description: Photo of a boat being worked on inside the Facility's main work building that serves as the large vessel building.

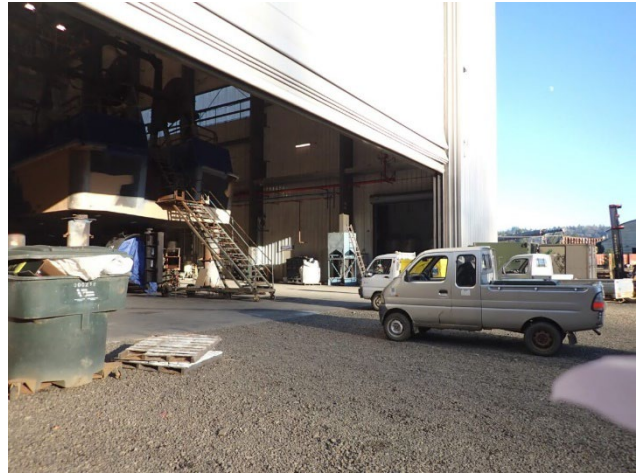
Photo #:02 (PC200104)

Description: Facing northeast, photo of the southern entrance/exit into the Facility's large vessel building.

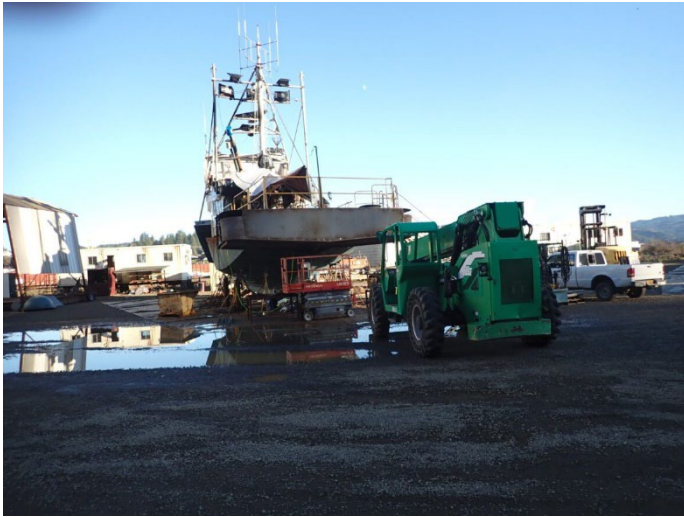
Photo #:03 (PC200105)

Description: Facing east, photo of a vessel outside that will receive repair and maintenance work.

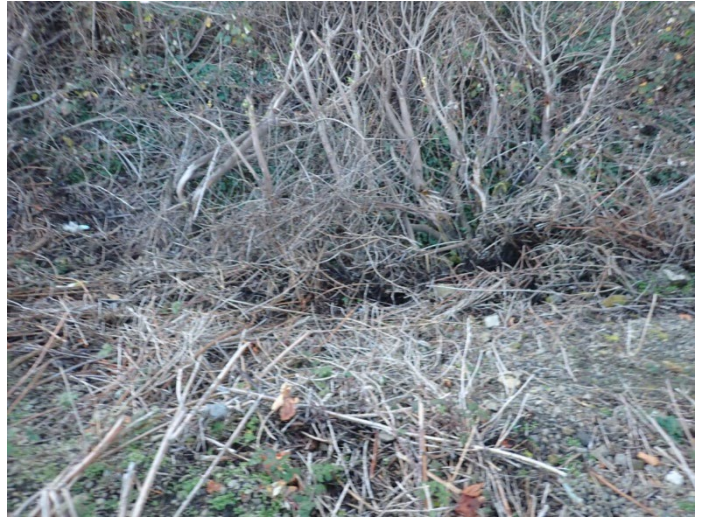
Photo #:04 (PC200110)

Description: Facing west, photo of ditch overgrown with vegetation hiding the Facility's curtain drain that runs along the Facility's western perimeter.

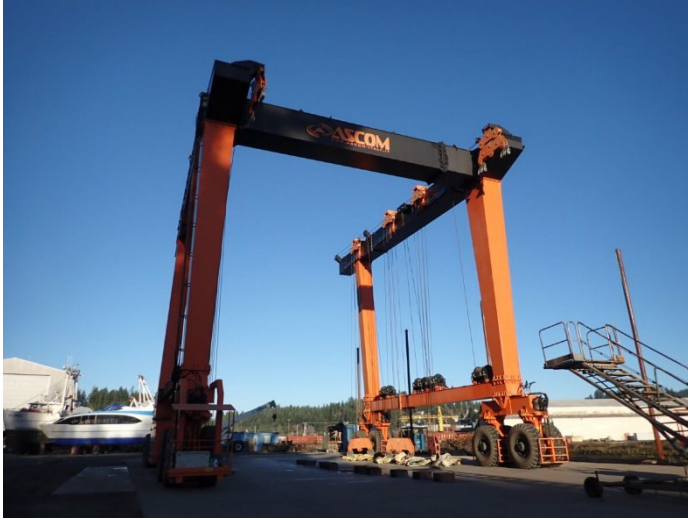
Photo #:05 (PC200113)

Description: Facing north, photo of the Facility's large lift.

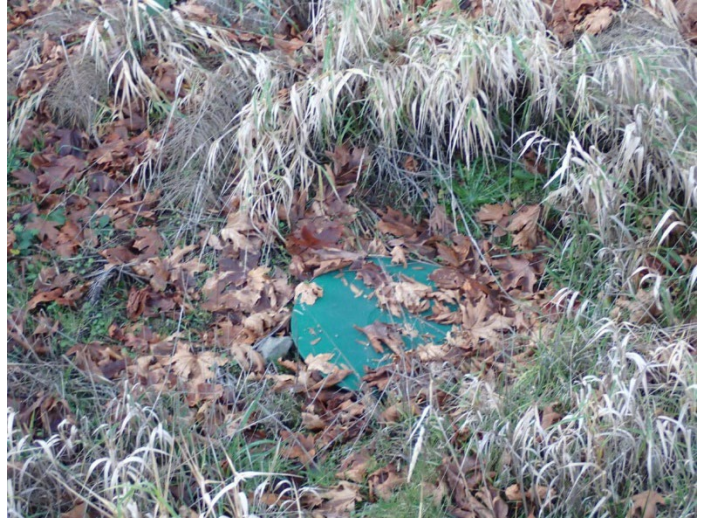
Photo #:06 (PC200114)

Description: Facing west, photo of the lid containing the Facility's biochar filter vault.

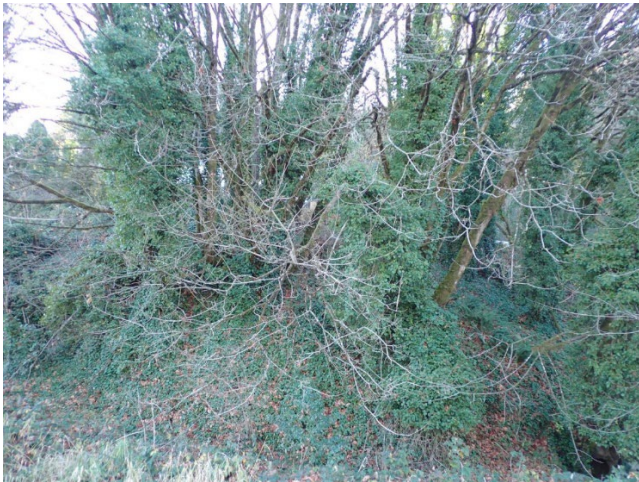
Photo #:07 (PC200115)

The SWPCP site maps did not include locations of loading/unloading areas, some material storage areas (metal) observed during the inspection and previously described in Area of Concern A “Minimize Exposure,” and locations and sources of run-on to the site from adjacent property (hillside residence). The revised SWPCP in response to Tier 2 corrective action requirements did not include a sufficient operation and maintenance plan for the Biochar vault being used as a treatment system.

Description: Facing west, photo of up a hill where a residence is located potentially contributing run-on to the Facility's curtain drain.

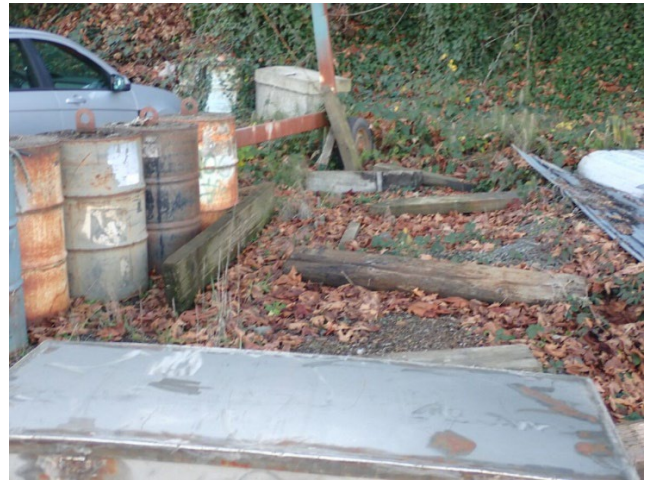
Photo #:08 (PC200118)

drums near the Facility's curtain drain (**Photo 8**).

Description: Facing west, photo of uncovered metal and wooden materials and drums adjacent to ditch where the Facility's curtain drain is located.

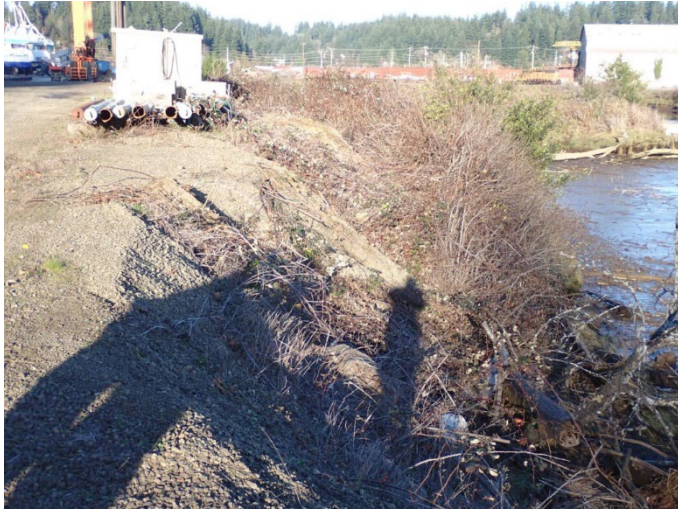
Photo #:09 (PC200122)

We then cut across the Facility to observe uncovered metal material where the property slopes down on the eastern perimeter adjacent to Tokyo Slough that connects with the Yaquina River (**Photo 9**). We continued South along the Facility's eastern perimeter and observed more uncovered metal material adjacent to Tokyo Slough (**Photo 10**). We observed the Facility's closed loop wash system on a concrete pad in which active washing discharges into an open washwater drain while the stormwater drain is closed, which helps recover pollutants from contacting with stormwater (**Photo 11, Photo 12 and Photo 13**). This washwater is pumped into water storage tanks, treated with clay, and trucked offsite to a city of Toledo sewer. As we continued South touring Drainage Basin A, we observed a couple of outdoor small boat work areas utilizing tarping procedures in the middle of the property and on the western perimeter to contain any particulates from sand blasting or hand sanding activities (**Photo 14 and Photo 19**). Some of the sanding and painting work is conducted in a covered hangar (**Photo 20**). Spent sand blast sand in tarped areas is swept, placed in double plastic bags and disposed of offsite by Kleen Industrial Services or Dahl Disposal. We also observed an uncovered garbage bin missing a lid (**Photo 15**) and Drainage Basin A's main work building that served as the Facility's fabrication and retail sales shops (**Photo 16**). No vehicle or equipment with leaks are repaired in these shops. Vehicles or equipment with leaks are removed from service and taken to an offsite shop for repairs.

Multiple areas of uncovered material along the Facility’s eastern perimeter were observed in which there was potential to discharge pollutants in stormwater into the receiving waterbody that was located adjacent to this edge (the river bank).

During the inspection, multiple areas of uncovered, unlabeled, and disorderly material along the Facility’s eastern perimeter were observed in which there was potential to discharge pollutants in stormwater into the receiving waterbody that was located adjacent to this edge. There was also a garbage bin missing a lid. According to an email sent on February 2, 2024, the Facility replaced the lid the day following the inspection.

Description: Facing north, photo of uncovered metal materials on the Facility's eastern perimeter/edge with Tokyo Slough adjacent to this edge. Tokyo Slough connects with the Yaquina River.

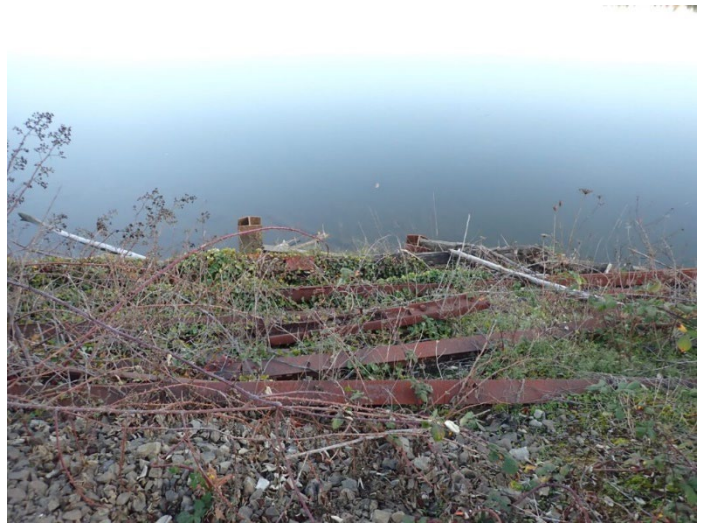
Photo #:10 (PC200131)

Description: Facing east, photo of uncovered metal material on the eastern perimeter/edge with Tokyo Slough adjacent to this edge. Tokyo Slough connects with the Yaquina River.

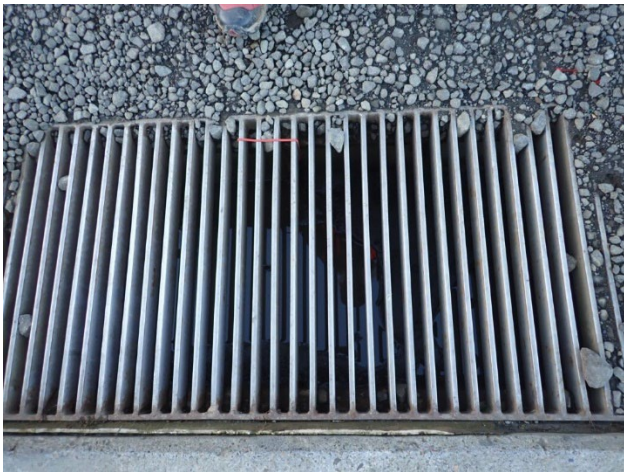
Photo #:11 (PC200137)

Description: Facing north, photo of one of the Facility's catch basins that is closed when a boat washwater drain is open.

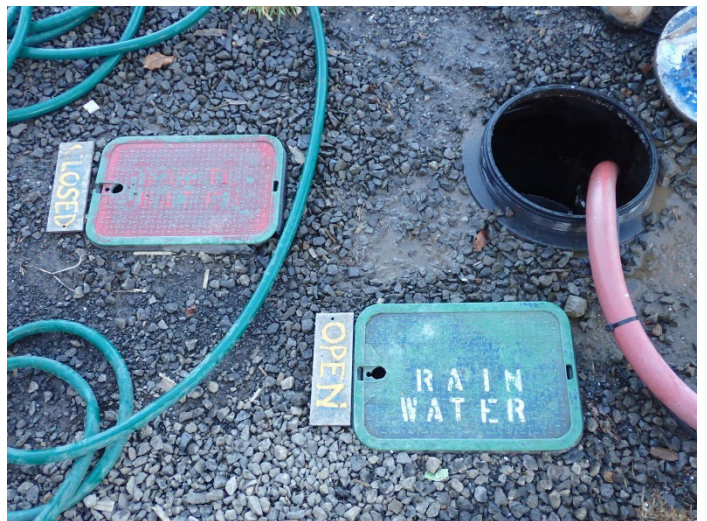
Photo #:12 (PC200139)

Description: Facing north, photo of the Facility's storm and boat washwater drain system in which one is closed while the other is open (closed-loop system).

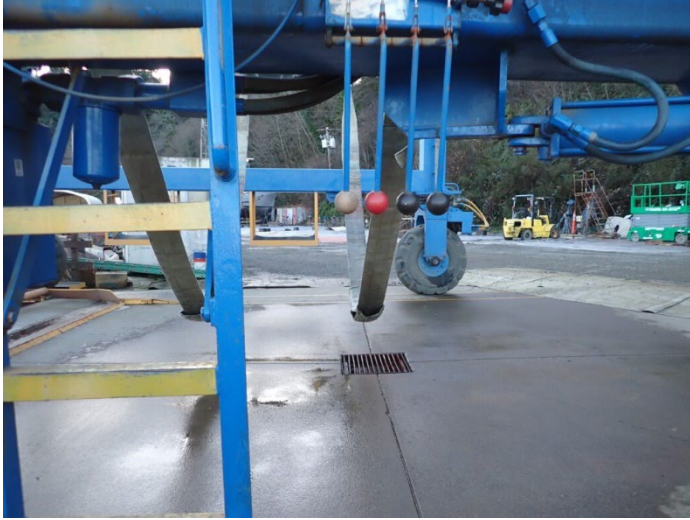
Photo #:13 (PC200140)

Description: Facing south, photo of the boat washwater drain.

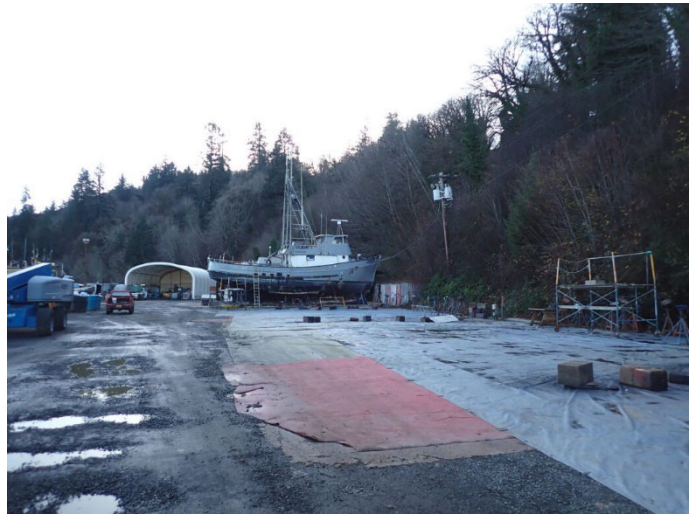
Photo #:14 (PC200141)

Description: Facing south, photo of the Facility's outdoor vessel repair and maintenance work area.

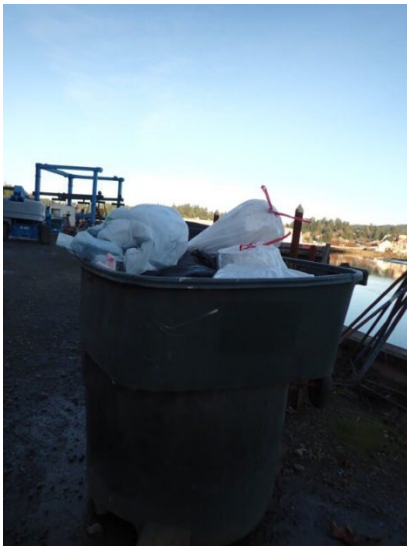
Photo #:15 (PC200142)

During the inspection we observed a full garbage container without a lid. According to an email sent on February 2, 2024, the Facility replaced the lid the day following the inspection.

Description: Facing northeast, photo of one of the Facility's garbage containers that was uncovered at the time of inspection.

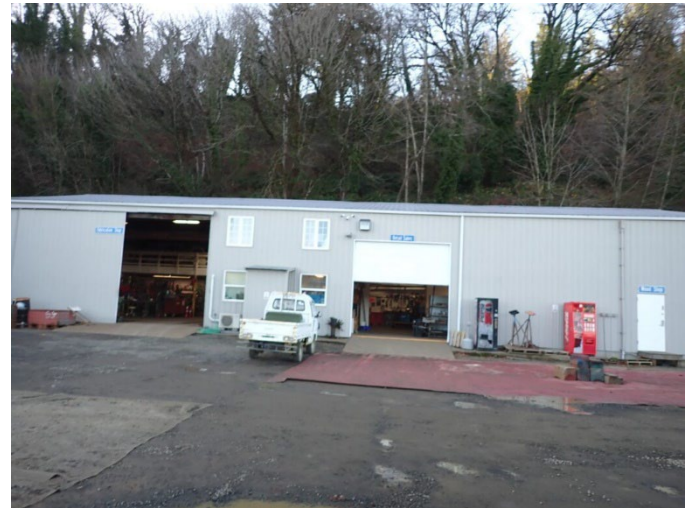
Photo #:16 (PC200145)

Description: Facing west, photo of the Facility's fabrication and retail sales shops.

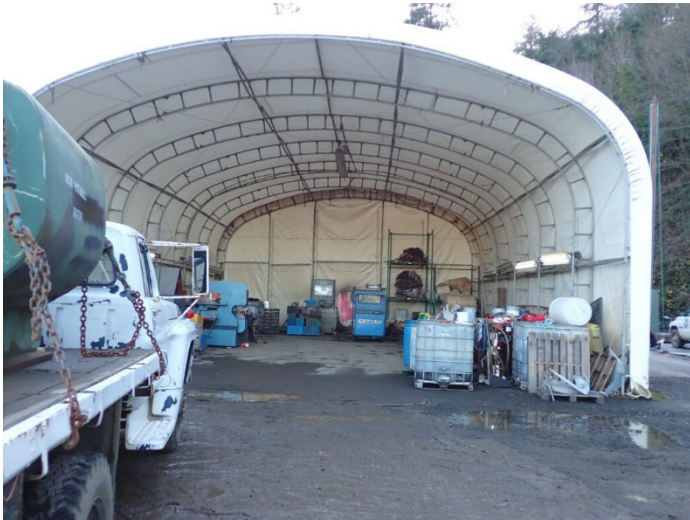
Photo #:17 (PC200149)

We continued South coming back to the eastern perimeter where we observed the Facility's main chemical storage under a tent as well as the Facility's paint thinner storage with built-in secondary containment (**Photo 17 and Photo 21**). In between the chemical storage tent and the Facility's eastern perimeter was some worn tarping material (**Photo 18**). Behind the chemical storage tent and along the Facility's eastern perimeter, we observed more uncovered metal material (**Photo 22, Photo 23 and Photo 24**). At the Facility's southernmost point, we observed empty chemical barrels and stacked totes that are picked up and recycled by the local licensed recycling company (**Photo 25**). We then headed back toward the Facility's main building in Drainage Basin B walking along the eastern perimeter where we observed additional material storage, including zinc anode storage (**Photo 26 and Photo 28**). Spent zinc anodes are recycled by the local recycling company. We stopped at Outfall 001 and Outfall 002 and did not observe any active discharges (**Photo 27, Photo 31 and Photo 32**). Sampling and monitoring are conducted at each outfall pipe during active discharge. Samples are placed in coolers and taken to Newport, Oregon to be shipped to the HGS Analytical lab in Eugene, Oregon. We walked past an area with raw materials, equipment, and a small vessel slated to be worked on (**Photo 29**) and then observed a lynch style catch basin with grates at the washdown pad that discharges into an 18-inch culvert to Outfall 002 (**Photo 30**). We then proceeded back to the main building where we held the closing conference and discussed next steps including offsite records review and inspection report transmittal.

Description: Facing south, photo of the Facility's outdoor tent covered chemical storage area.

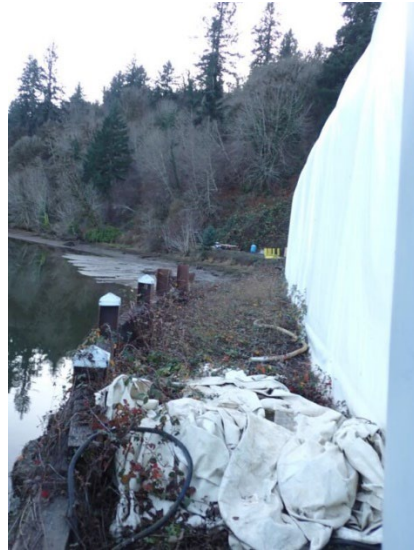
Photo #:18 (PC200151)

Description: Facing south, photo of uncovered tarping material along the Facility's eastern perimeter/edge with the Yaquina River adjacent to this edge.

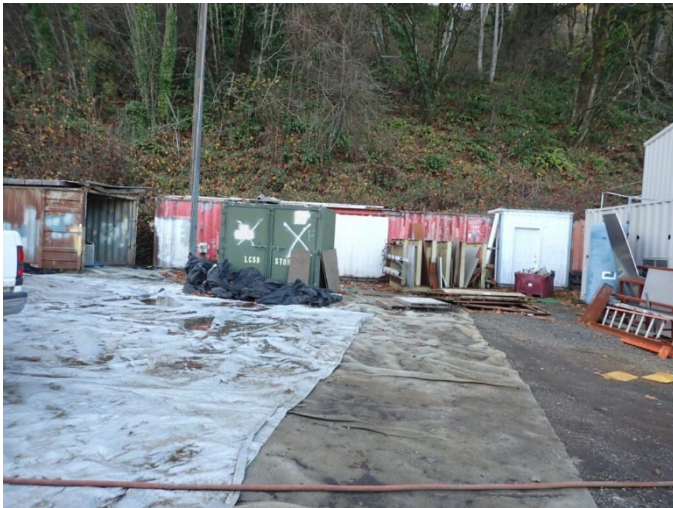
Photo #:19 (PC200155)

Description: Facing west, photo of tarped area of the Facility where paint chips can be produced from work performed in it.

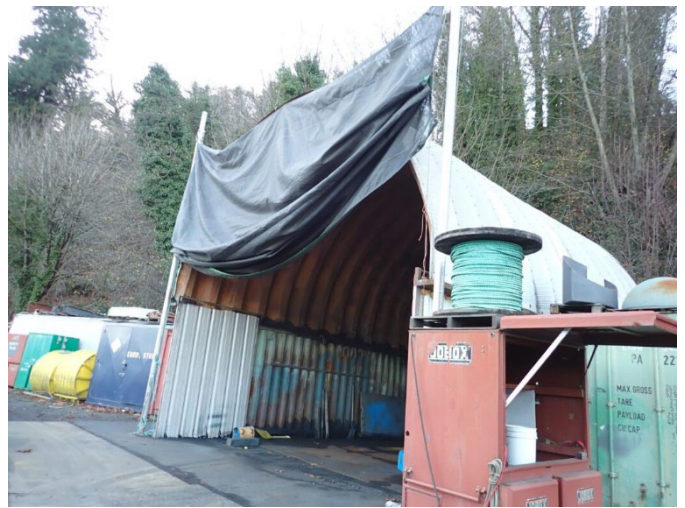
Photo #:20 (PC200156)

Description: Facing southwest, photo of a covered area at the Facility where painting and other work is performed.

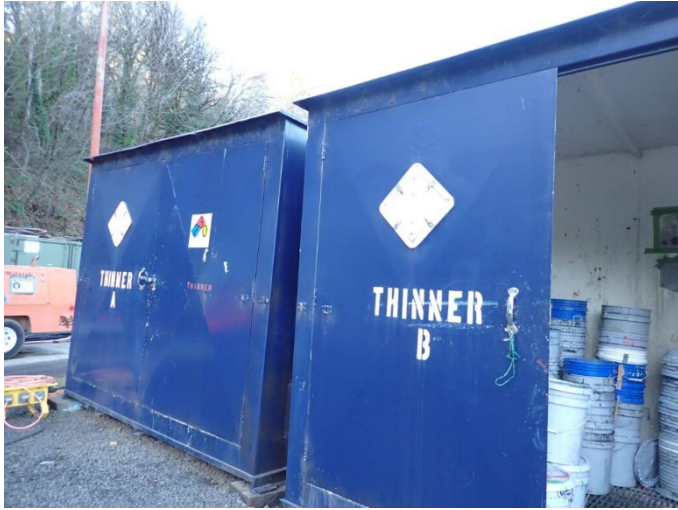
Photo #:21 (PC200157)

Description: Facing northwest, photo one of the Facility's paint thinner storage containers with built-in secondary containment.

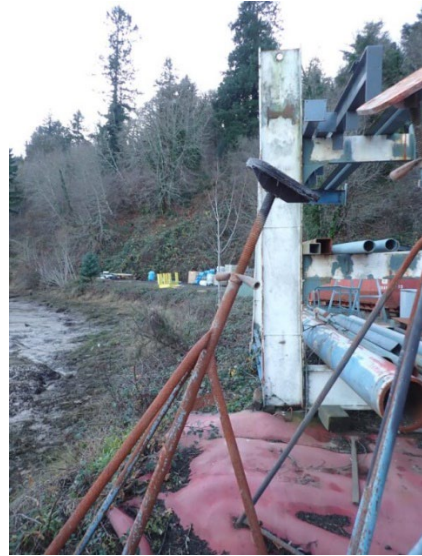
Photo #:22 (PC200158)

Description: Facing south, photo of uncovered metal material along the Facility's eastern perimeter/edge with the Yaquina River adjacent to this edge.

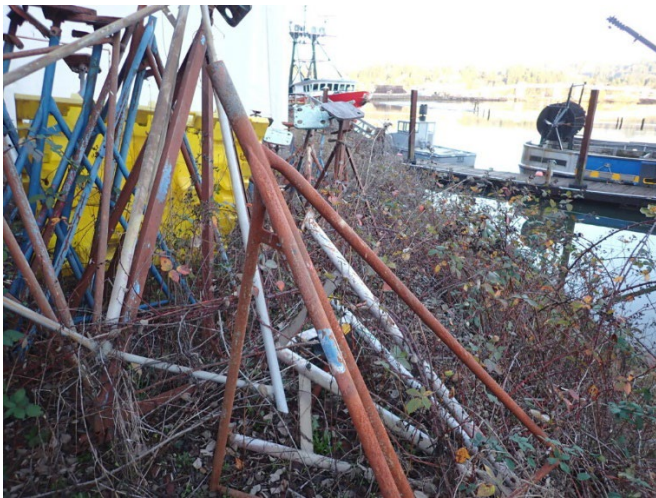
Photo #:23 (PC200160)

Description: Facing northeast, photo of uncovered metal material along the Facility's eastern perimeter/edge with the Yaquina River adjacent to this edge.

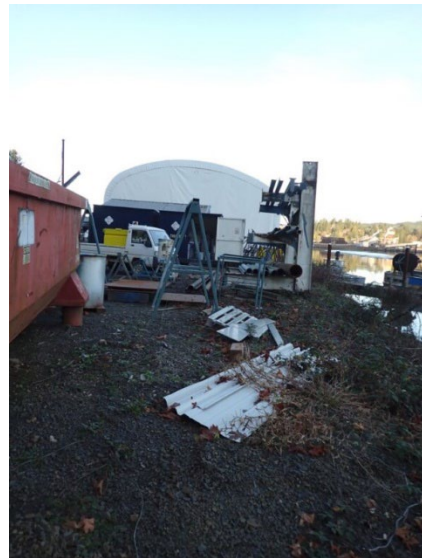
Photo #:24 (PC200163)

Description: Facing north, photo of additional uncovered metal material behind the storage tent and near the Facility's eastern perimeter/edge with the Yaquina River adjacent to this edge.

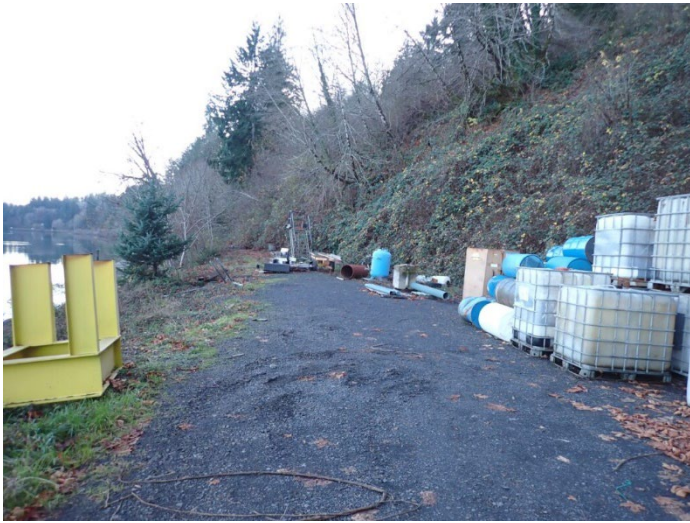
Photo #:25 (PC200166)

Description: Facing south, photo of the gravel road extending into the southern-most point of the Facility with empty chemical barrels and totes stacked for service pick-up.

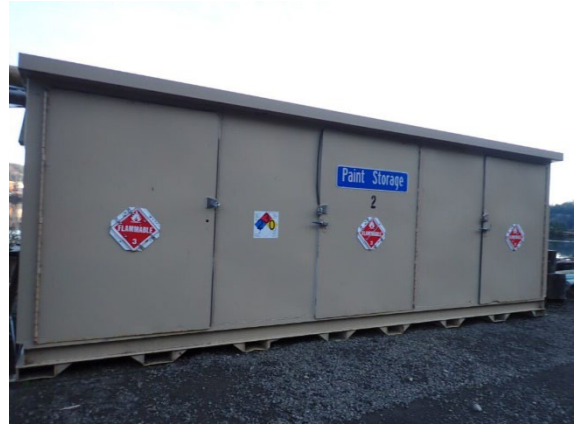
Photo #:26 (PC200168)

Description: Facing southeast, photo of additional paint storage at the Facility.

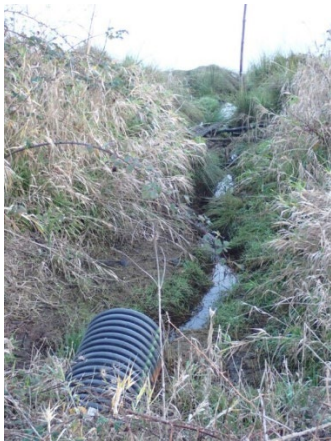
Photo #:27 (PC200170)

Description: Facing east, photo of the Facility's Outfall 001. No active discharge at the time of inspection.

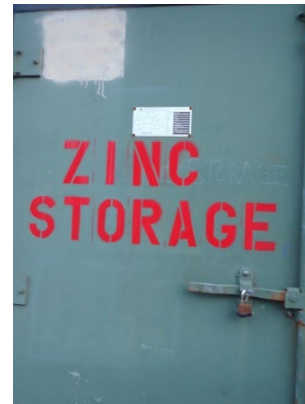
Photo #:28 (PC200173)

Description: Facing east, photo of zinc anode storage at the Facility.

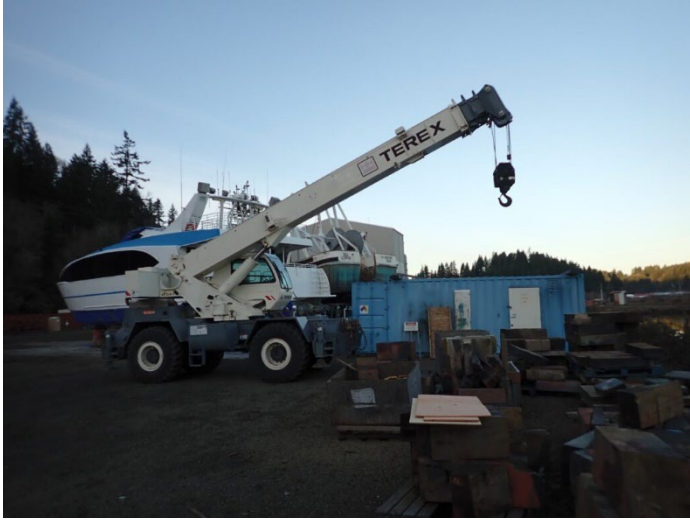
Photo #:29 (PC200174)

Description: Facing north, photo of raw materials and equipment and vessel getting ready to be worked on at the Facility.

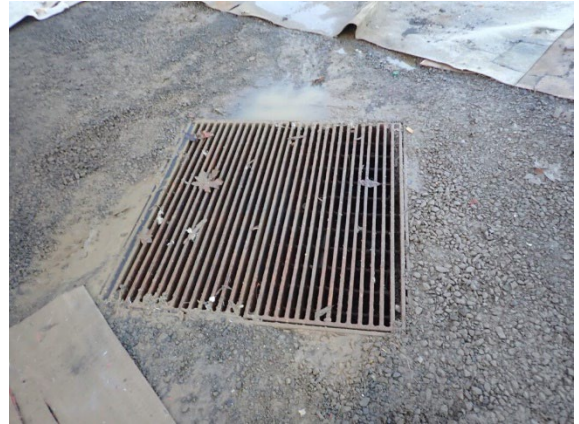
Photo #:30 (PC200176)

Description: Facing north, photo of the Facility's catch basin with perforation to catch debris leading to Outfall 002.

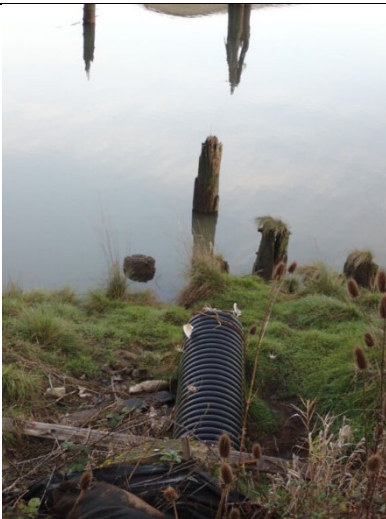
Photo #:31 (PC200178)

Description: Facing east, photo of the Facility's Outfall 002. No active discharge at the time of inspection.

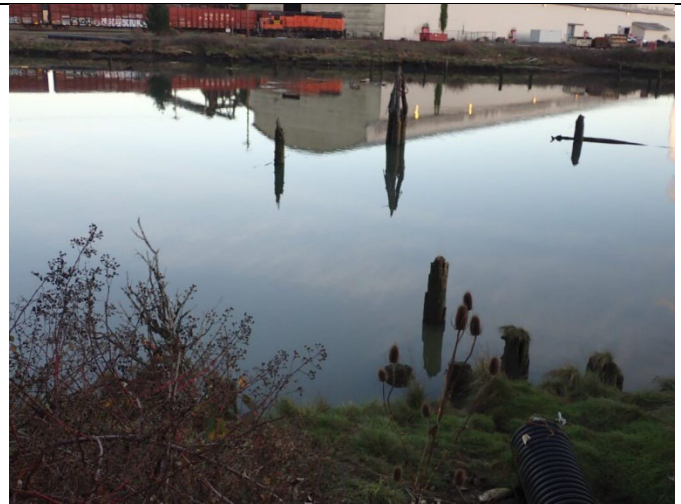
Photo #:32 (PC200181)

Description: Facing east, photo of the area immediately downstream into Tokyo Slough from Outfall 002.
