# NPDES Compliance Inspection Report

## LKQ Barger Auto Parts – Nampa Nampa, Idaho

**Permit #: IDR05J000**

**Inspection Date: May 10, 2021**

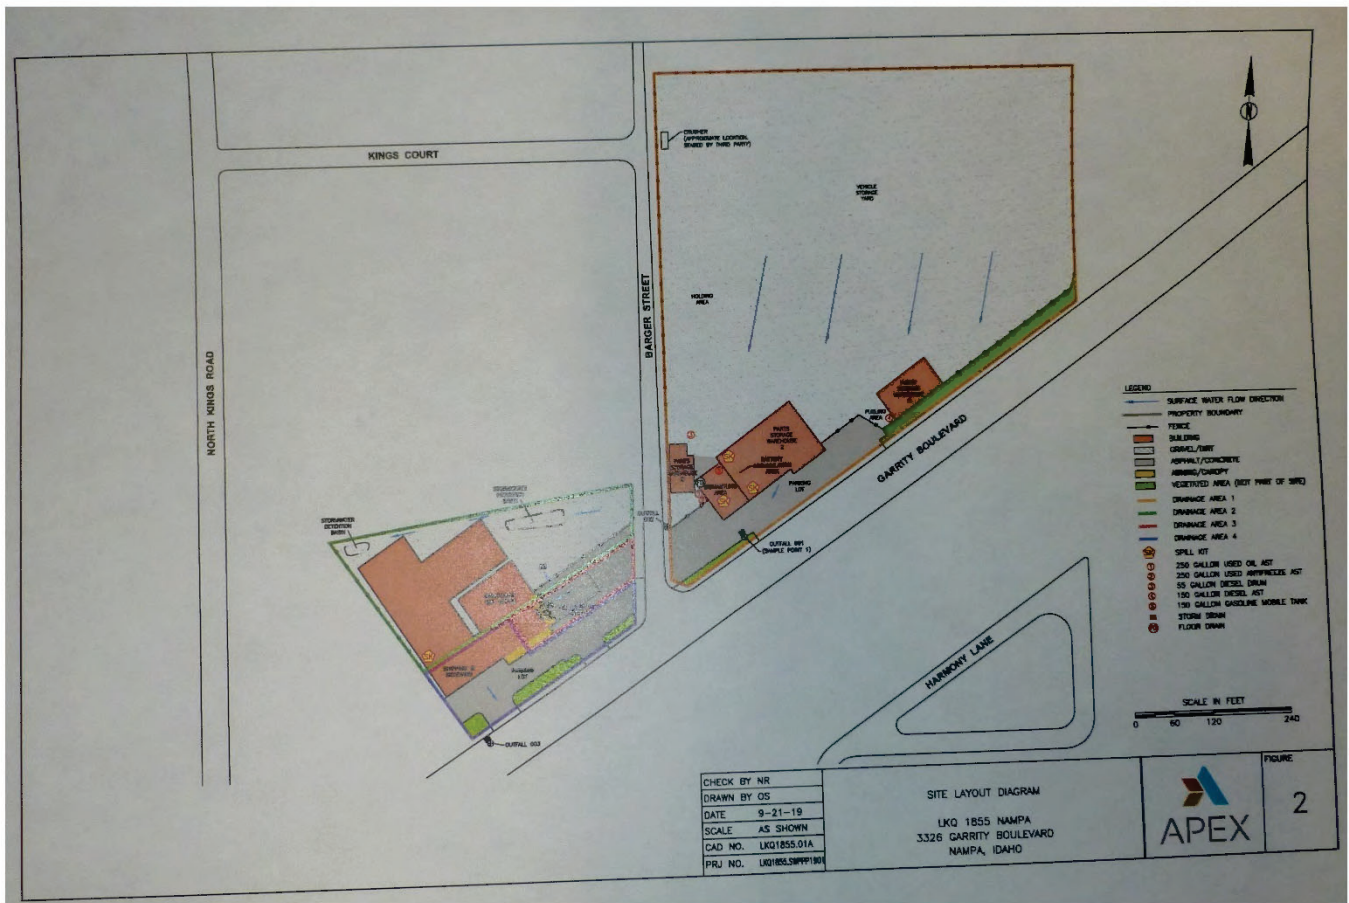
# Site Diagram Provided by Facility

At the time of the inspection, I reviewed the SWPPP site map. The map did not contain the required items quoted above. The map can be found in Appendix A.

At the time of the inspection, I reviewed the SWPPP map. The SWPPP map shows three outfalls, labeled 001 – 003, however, the Representatives indicated that only Outfall 001 was monitored.

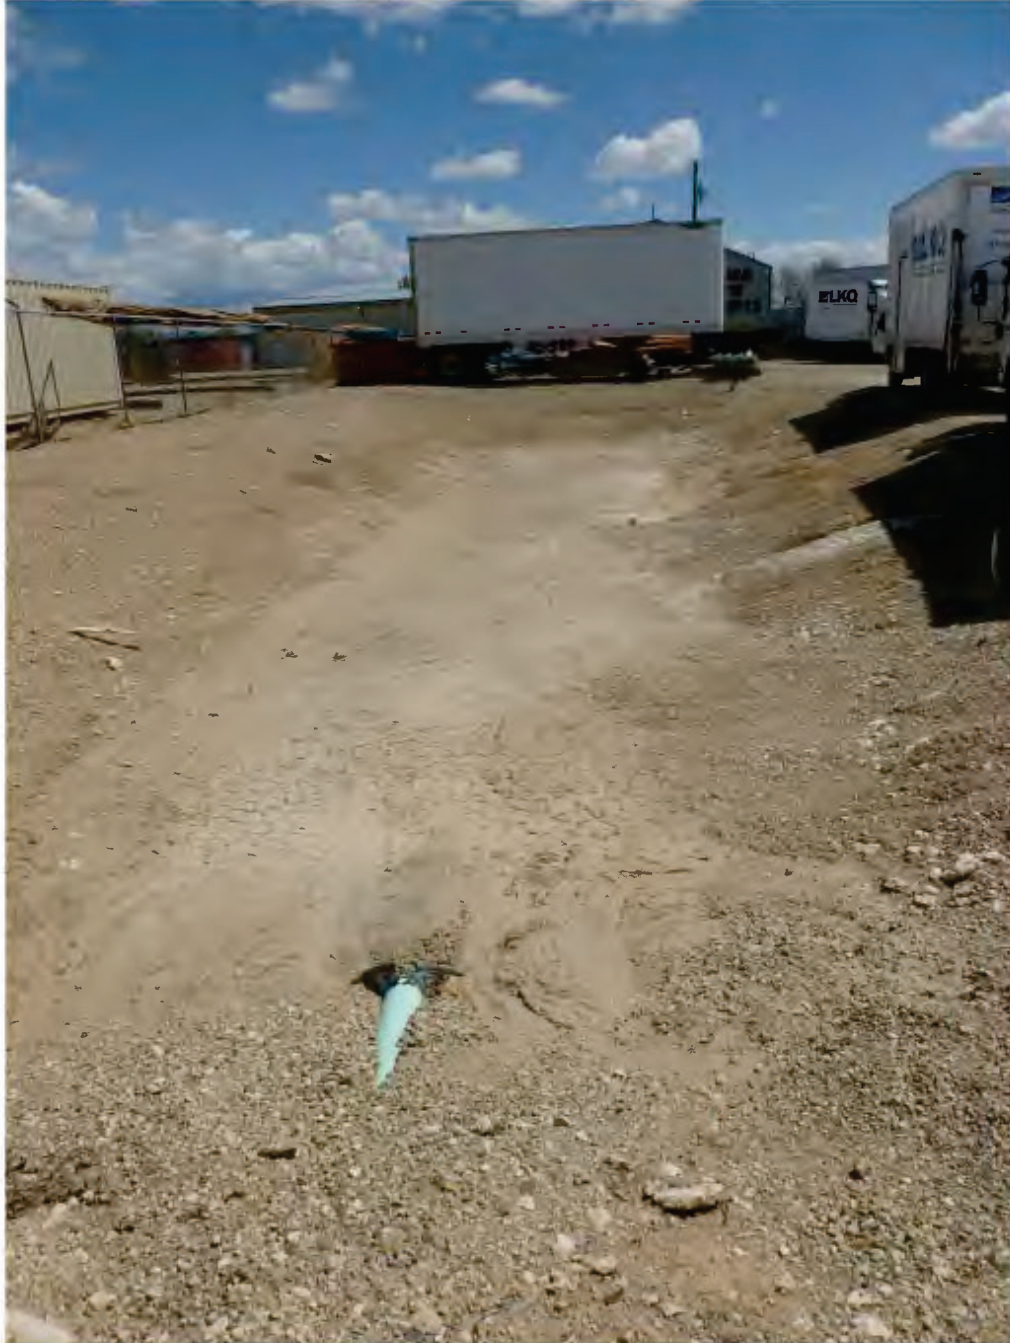
From the office, located on the portion of the property west of Barger Street, we walked to the stormwater detention basin on the northeast side. The basin was dry at the time of inspection (**Photo 1**). There was an inlet pipe that transports water from the buildings' gutter system (**Photo 2**). There was a second detention basin on the northwest side of the warehouse (**Photo 3**) that stormwater from the rooftops and surrounding area. The Representatives said the detention basins did not have an outlet and all water collected infiltrates into the ground. I did not observe any evidence to indicate otherwise.

**Photo 1 / P1000866** – Detention Pond, NE detention pond

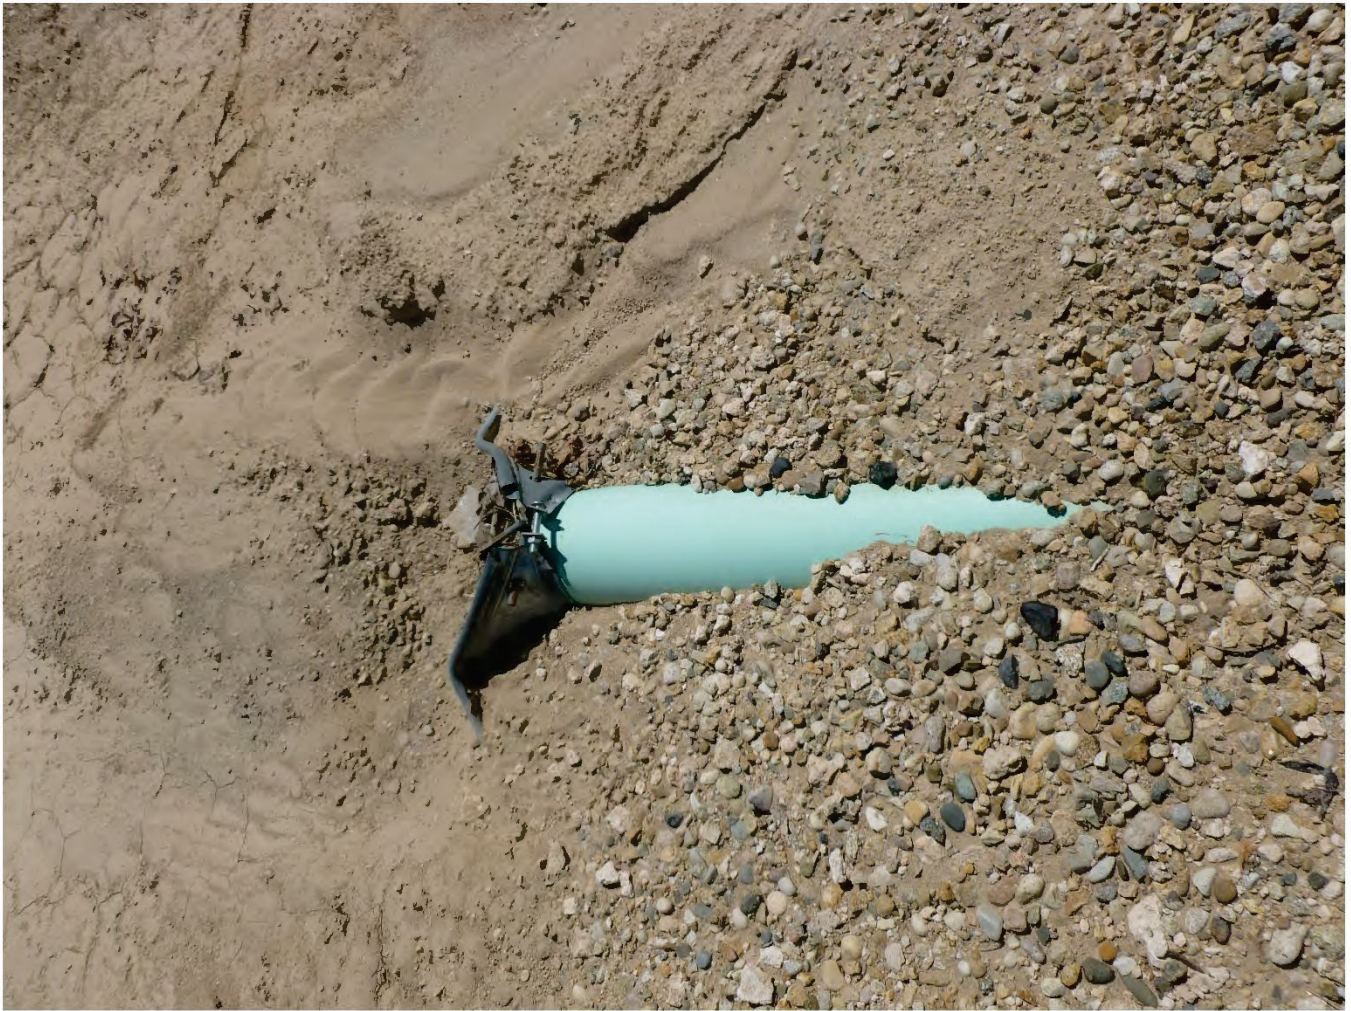
**Photo 2 / P1000865** – Detention Pond Inlet

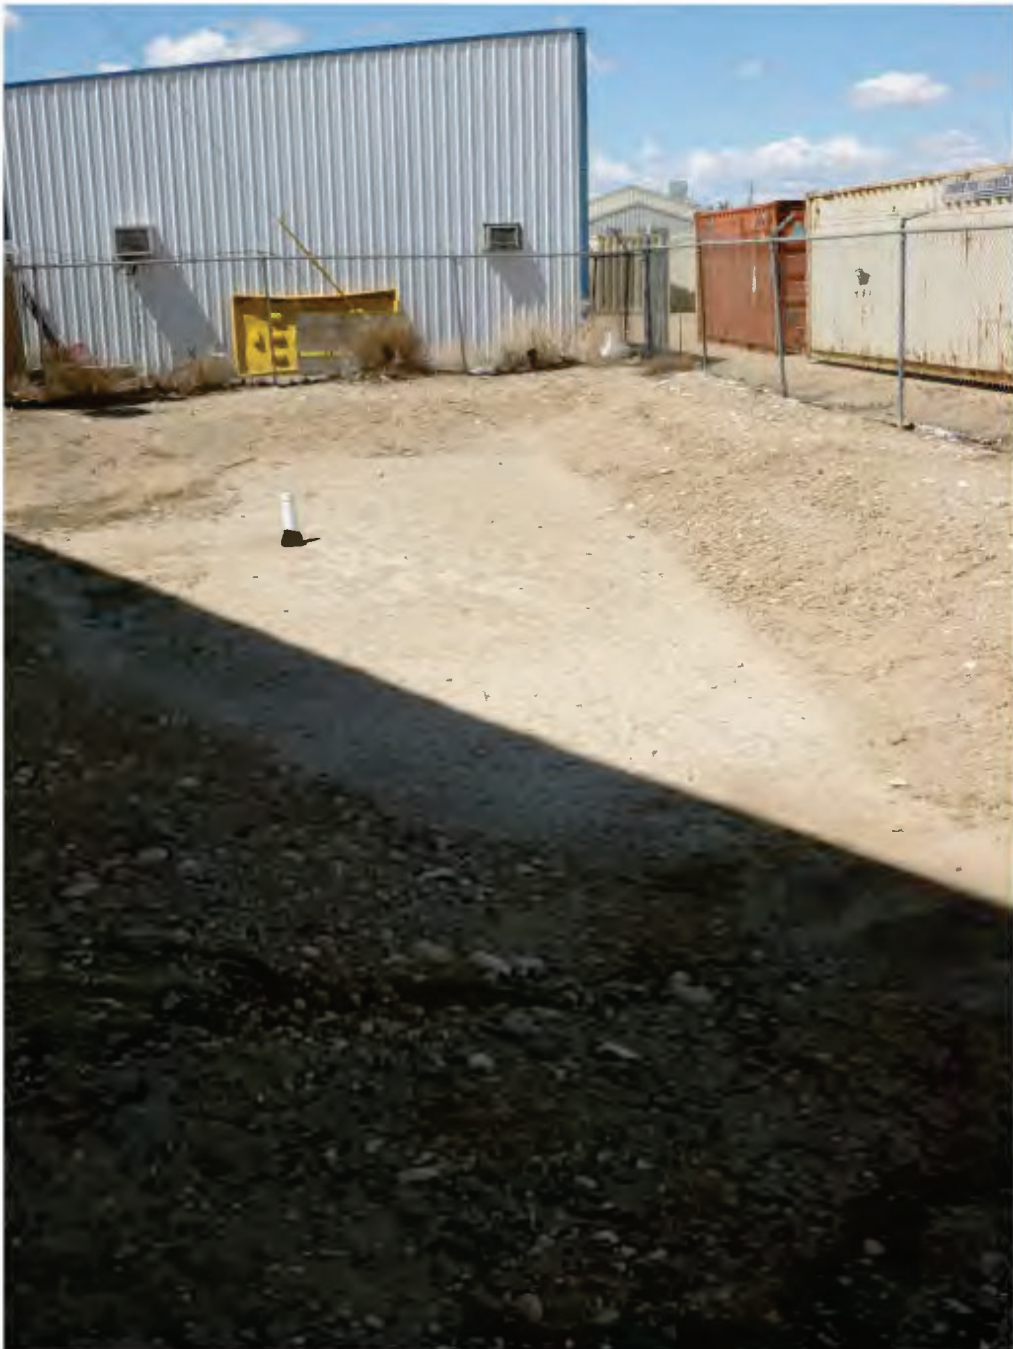
**Photo 3 / P1000867** – Detention Pond, NW detention pond

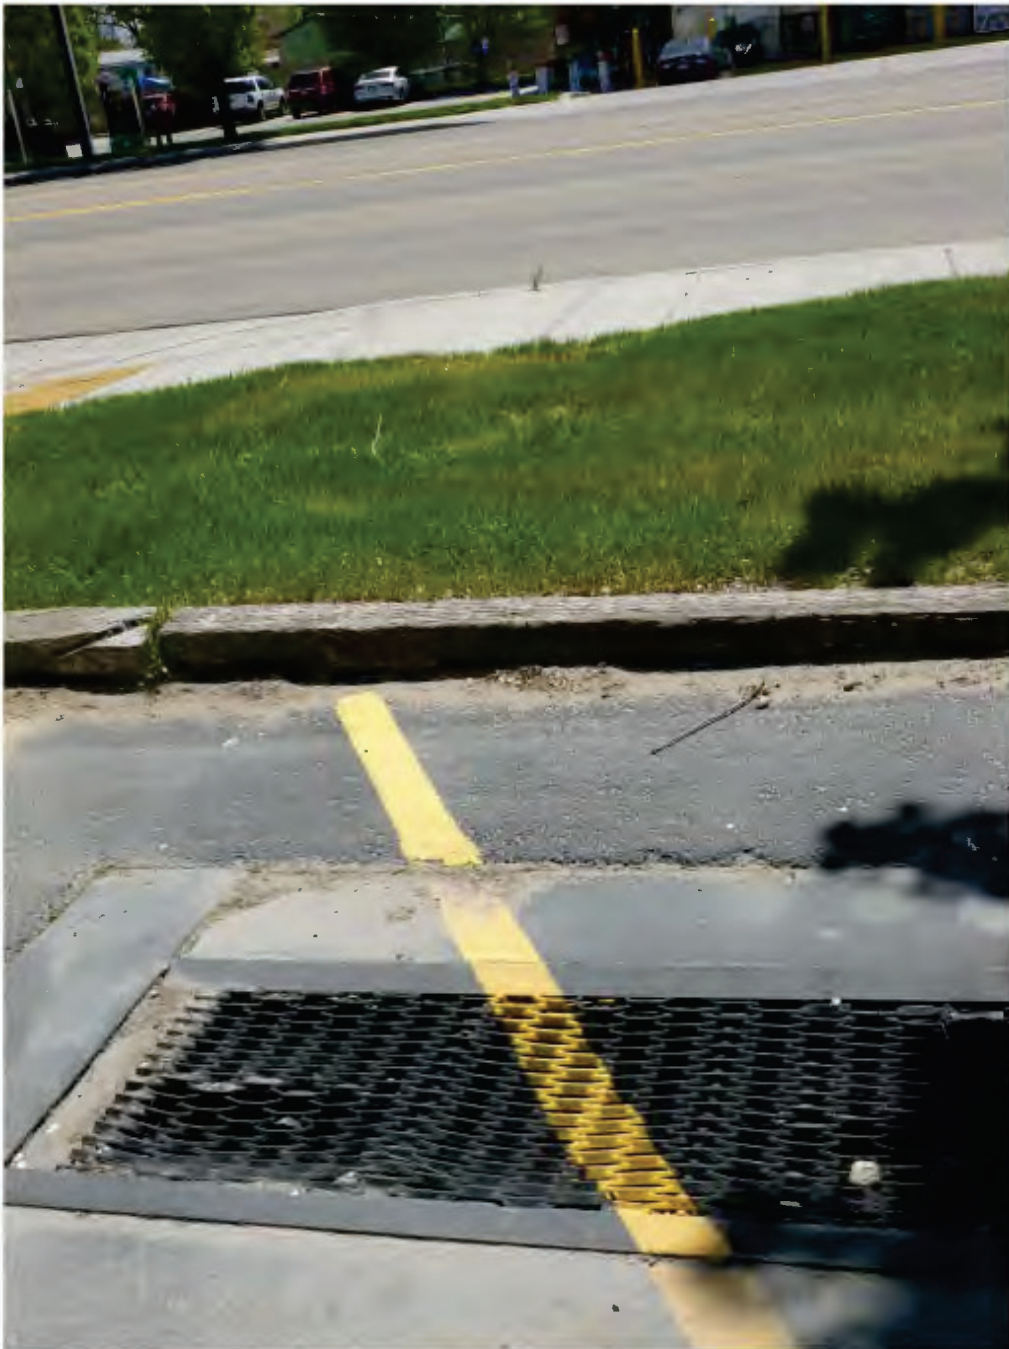
We proceeded to the east side of Barger Street. We started out walking north and circled the facility in a clock-wise direction. I observed that the junk car storage area was built up a little more than the rest of the area. The Representatives told me the area was built up to facilitate stormwater infiltration rather than run-off. On our tour around the site, I did not observe any vehicles parked outside. The tour of the site ended at the sampling point (**Photo 4**) located on the facility's property near Garrity Boulevard. The Representatives explained that the water sample was collected through sheet flow prior to the stormwater entering the MS4 grate.

**Photo 4 / P1000870 – Sampling Point**
