INSPECTION REPORT

**APALACHICOLA PUBLIC WATER SYSTEM  
DRINKING WATER TREATMENT PLANT  
APALACHICOLA, FLORIDA**

**U.S. ENVIRONMENTAL PROTECTION AGENCY  
REGION 4  
ENFORCEMENT AND COMPLIANCE ASSURANCE DIVISION  
WATER ENFORCEMENT BRANCH  
DRINKING WATER ENFORCEMENT SECTION**

February 2 - 3, 2022

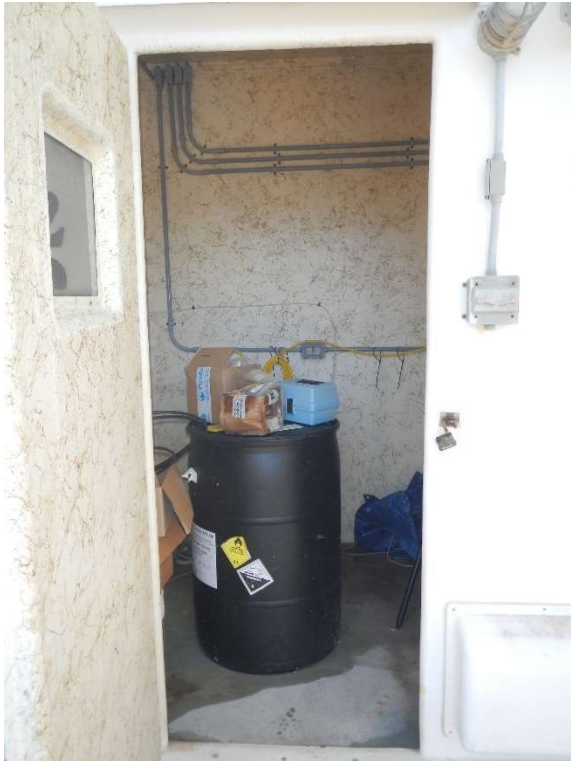
1. **Observation:** Housekeeping - The storage area and control room at the WTP were used to store boxes, chemical drum, unused chemicals and other items (refer to Appendix A, Photographs 1 and 2).  
**Comment:** Staff should keep the storage area and control room at the WTP clean and organized to prevent cross contamination of chemicals and tripping hazards.
2. **Observation:** Vegetative growth along the fence and/or in the vertical plane was noted at Well 6, WTP, and elevated storage tank (refer to Appendix A, Photographs 3-7).

**Photograph 1:** Water Treatment Plant Storage Area

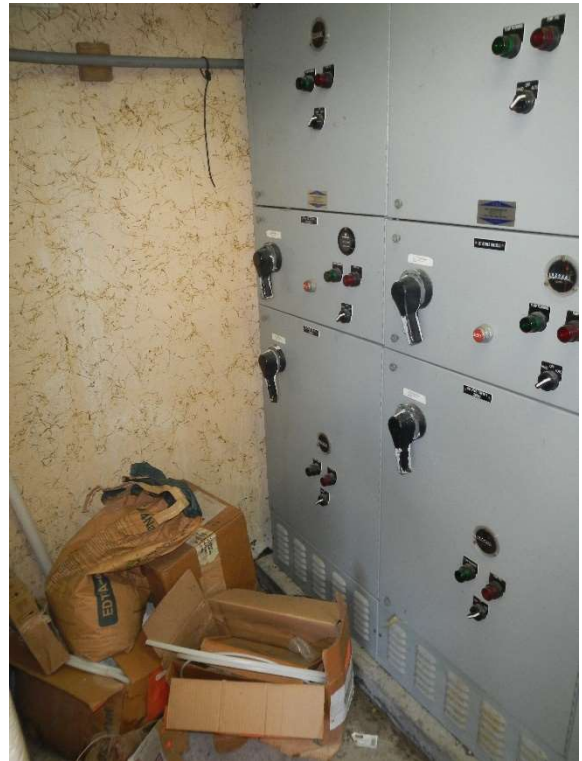
**Photograph 2:** Water Treatment Plant Control Room

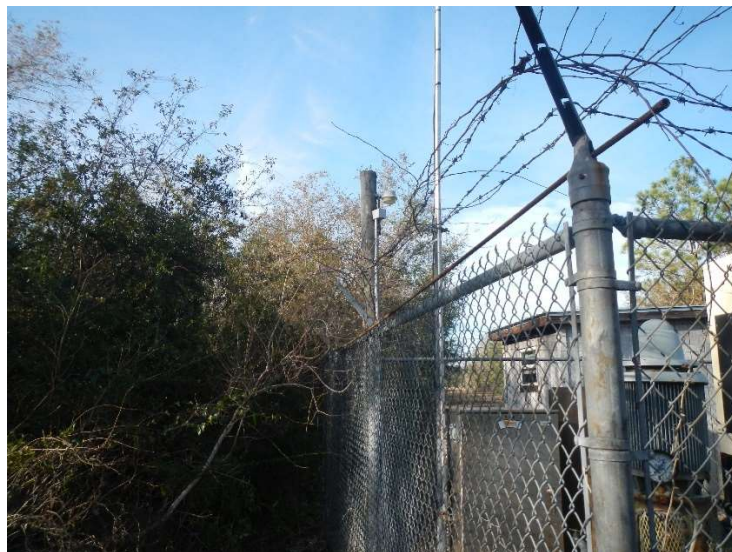
**Photograph 3:** Vegetation on Well 6 fence

**Comment:** The vertical plane should be kept free of vegetation to prevent damage to the tanks and entry of contaminants or animals to the finished water.

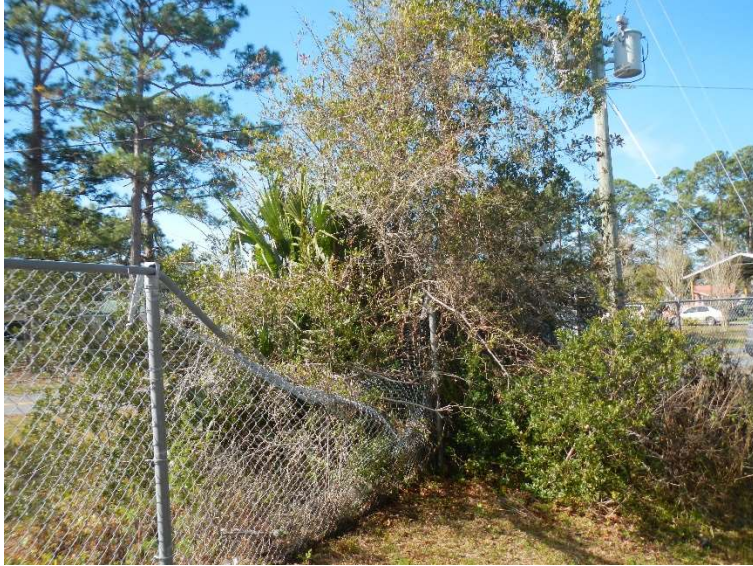
- a. WTP fence was bent down in one location (refer to Appendix A, Photo 4) .
- b. Ladders on the aerator towers adjacent to the ground water tank were not locked (refer to Appendix A, Photo 13).
- c. Ground water tank had a rope hanging from its roof.
- d. The elevated storage tank is located in a multi-use City property. Personnel not working for the System also have access to the location. State noticed the gate was left opened on February 3, 2022, which defeats its purpose.

**Photograph 4:** Vegetation on Water Treatment Plant fence

**Comment:** Fence at WTP needs to be repaired to prevent entry of unauthorized people. Access to aerator tower ladders must be restricted to authorized personnel. Rope hanging from ground storage tank needs to either be removed or secured to prevent potential access to tank. Access to the elevated storage tank must be limited to water treatment personnel.

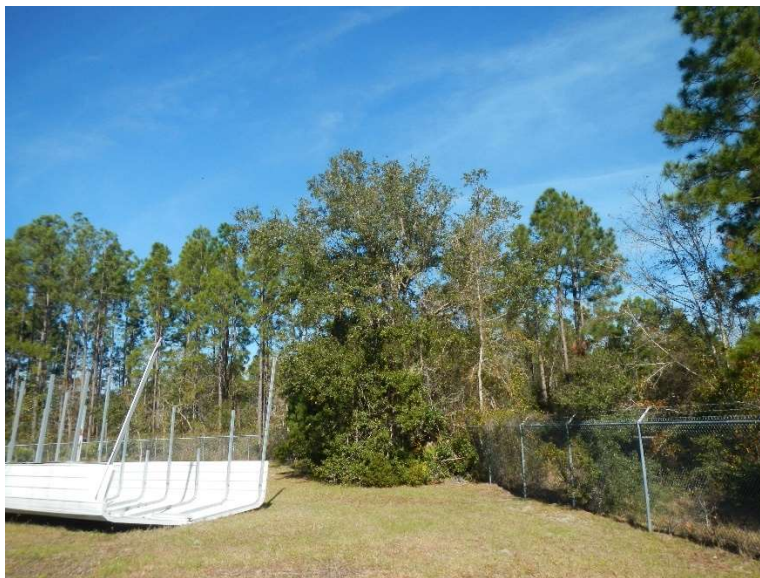
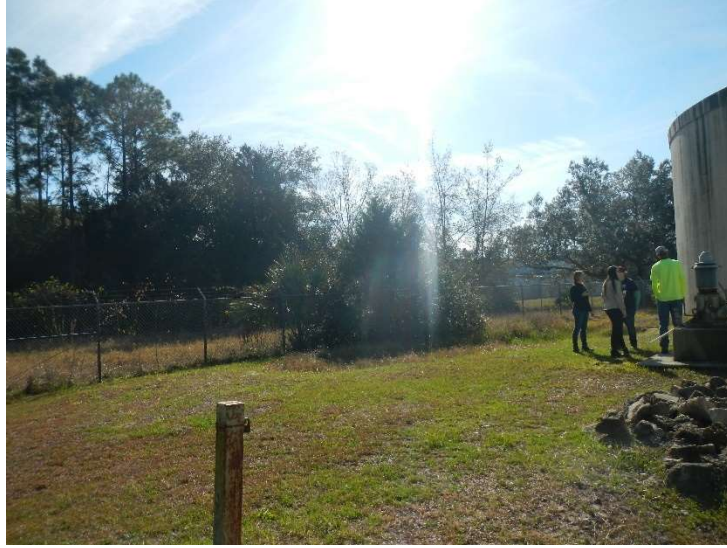
**Photograph 5:** Vegetation on Water Treatment Plant fence

**Photograph 6:** Vegetation on Water Treatment Plant fence

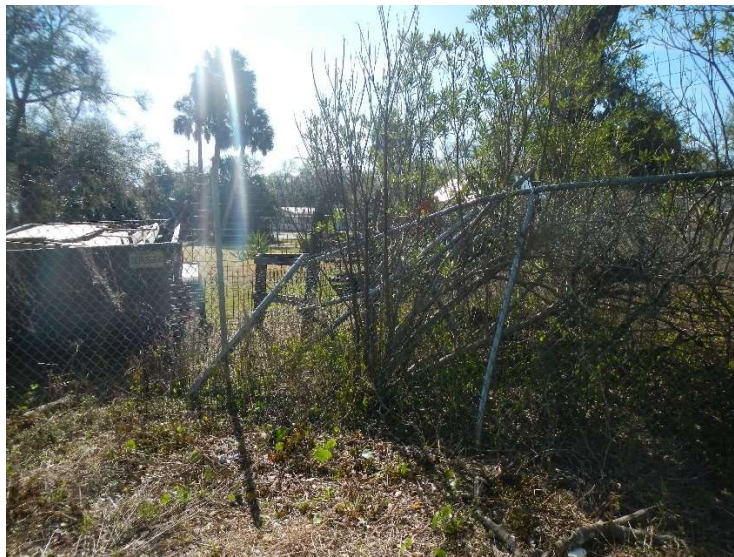
**Photograph 7:** Vegetation on Elevated Storage Tank fence

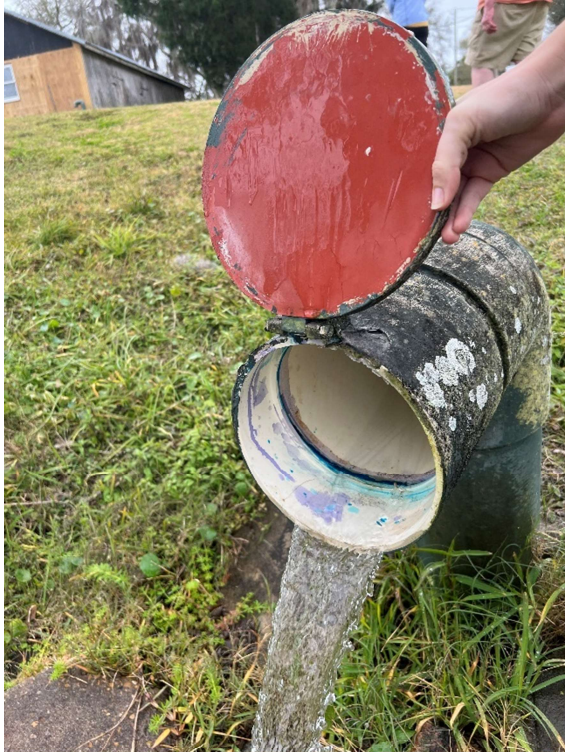
3. **Observation:** The elevated storage tank overflow pipe lacked size-24 mesh at the time of the inspection (refer to Appendix A, Photograph 8).

**Photograph 8:** Overflow pipe at Elevated Storage Tank  
Provided by FDEP staff – taken on February 3, 2022

**Comment:** Tank overflows must have appropriately attached screens to prevent contamination of the finished water.

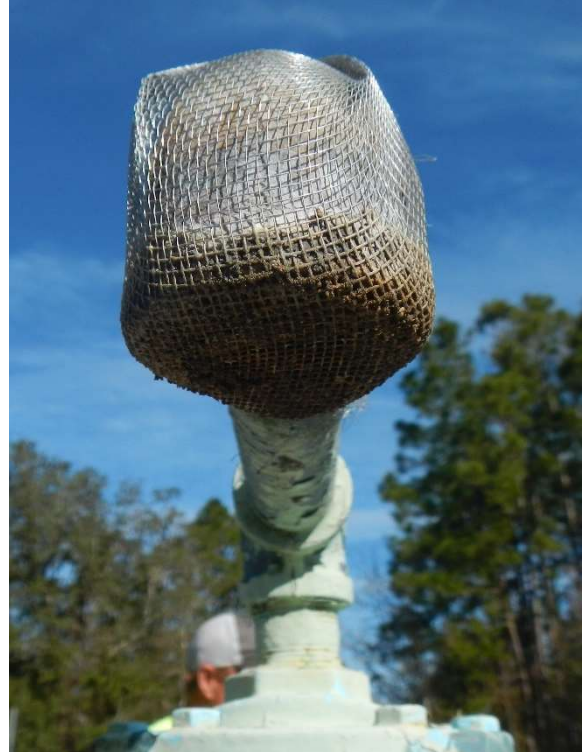
- i. The blowoff pipe is corroded and the corrosion is causing loose particles from the pipe to accumulate on the screen.
- ii. Sampling line at raw water tap is corroded.

*Florida Administrative Code (F.A.C.) 62-555.350 (2) Operation and Maintenance of Public Water Systems – “Suppliers of water shall keep all necessary public water system components in operation and shall maintain such components in good operating condition, so the components function as intended.... blistering, chipped, or cracked coatings and linings on treatment or storage facilities in contact with raw, partially treated, or finished drinking water shall be rehabilitated or repaired.”*

**Photograph 9:** Well 5 Blowoff pipe corrosion

**Comment:** Blowoff pipe at Well 5 and 6 needs to be replaced and 24-mesh screen installed. Sampling line at Well 5 needs to be replaced. Well 6 overflow pipe connecting plate needs to be replaced and 24-mesh screen installed. Leak and drainage line at Well 7 needs to be repaired. Leak and drainage line at Well 7 need to be repaired.

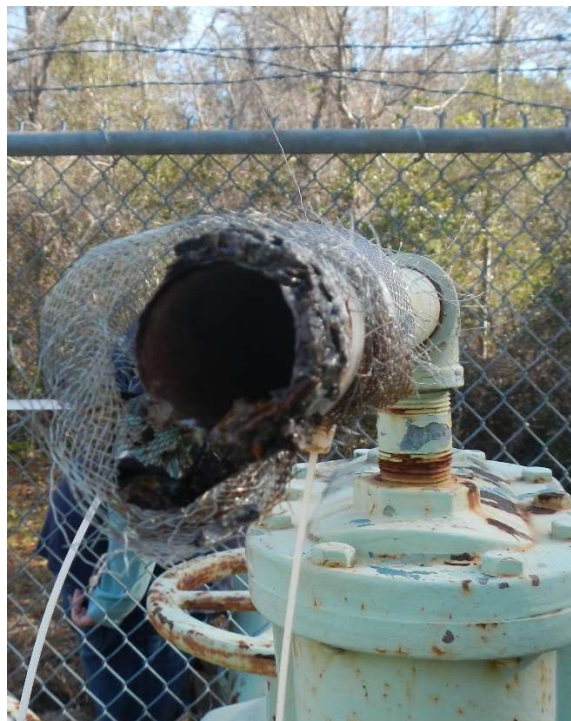
- i. The blowoff pipe is corroded and the corrosion is causing loose particles from the pipe to accumulate on the screen.
- ii. The threading on the overflow pipe connecting plate is corroded.

**Photograph 10:** Well 6 - Blowoff pipe corrosion

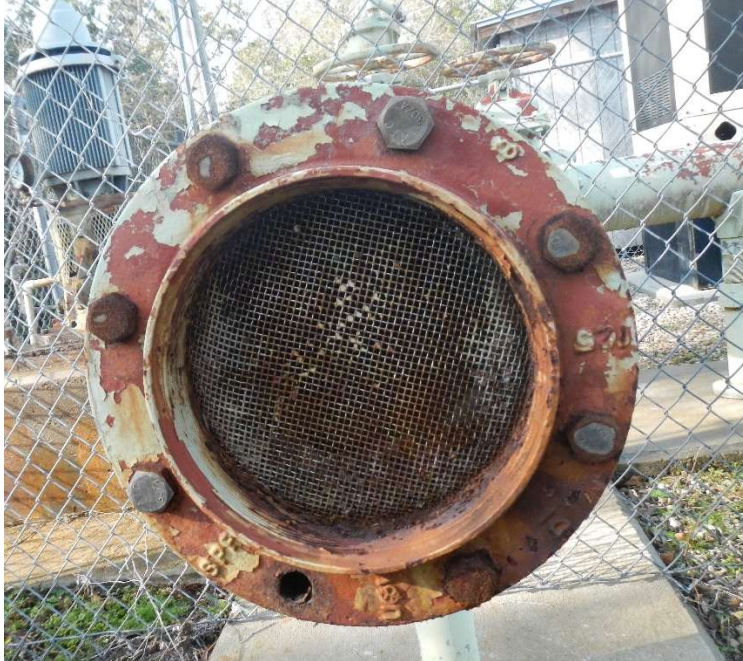
**Photograph 11:** Well 6 - Overflow pipe connecting plate

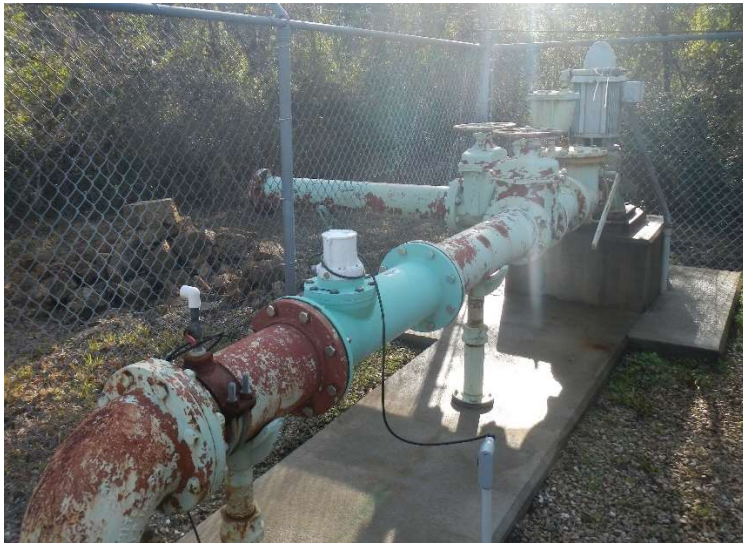
- i. The well is leaking. The drainage line is not working properly, and water is being accumulated on the pad.

**Photograph 12:** Well 7 – Water accumulation on pad

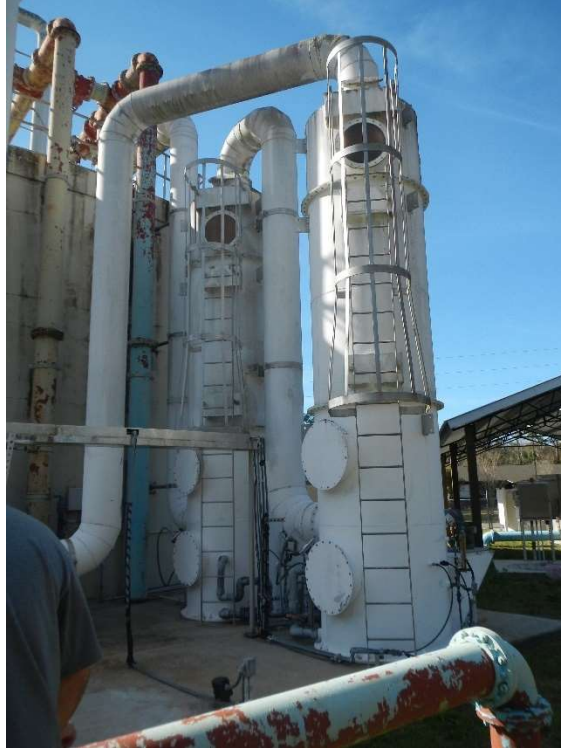
*F.A.C. 62-555.320 (5) Security - “Drinking water treatment or pumping facilities shall be enclosed by fences with lockable access gates, housed in lockable buildings or enclosures, or otherwise protected to prevent tampering, vandalism, and sabotage. Finished-drinking-water storage facilities shall be enclosed by fences with lockable access gates, shall have lockable access openings and lockable cages or enclosures*

**Photograph 13:** Aerator ladders

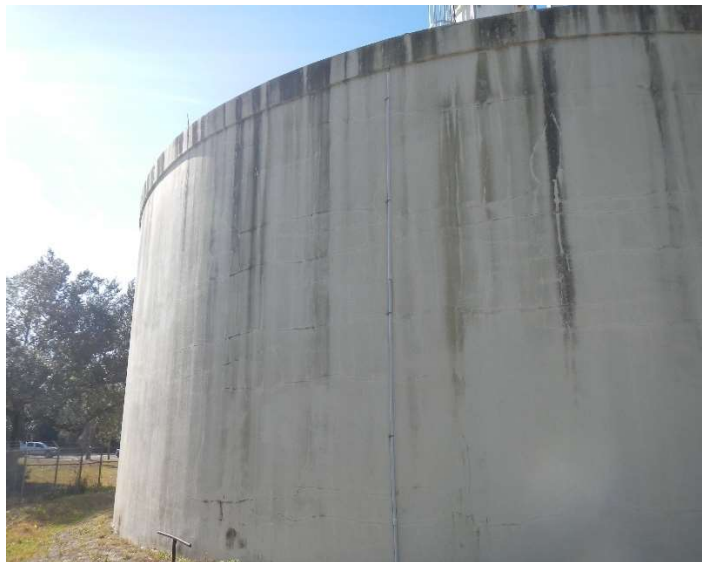
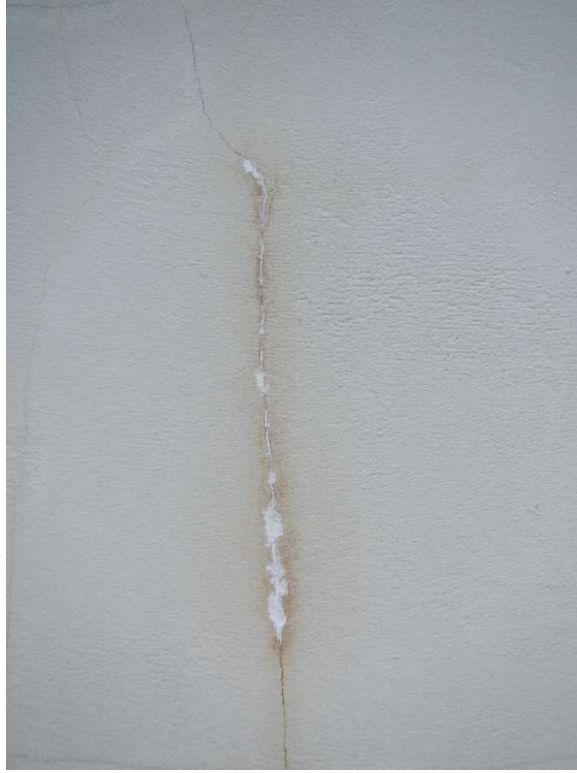
- a. Ground storage tank at WTP – (refer to Appendix A, Photo 14-17)
  - i. Significant cracking observed on the structure’s exterior.
  - ii. Concrete base of tank showed significant deterioration and is not sealed.
- b. Elevated storage tank – (refer to Appendix A, Photo 18-19)
  - i. Tree branches extending from the adjacent property are touching the support structure of the tank.
  - ii. Extensive biogrowth observed on tank exterior.

*F.A.C. 62-555.350 (2) Operation and Maintenance of Public Water Systems – “Suppliers of water shall keep all necessary public water system components in operation and shall maintain such components in good operating condition so the components function as intended.... blistering, chipped, or cracked coatings and linings on treatment or storage facilities in contact with raw, partially treated, or finished drinking water shall be rehabilitated or repaired.”*

**Photograph 14:** Ground storage tank with cracked exterior

**Photograph 15:** Ground storage tank with cracked exterior

**Comment:** Storage tanks must be maintained to ensure their integrity. Ground storage tank concrete base needs to be sealed. Cracks on the exterior of structure need to be evaluated and repaired. Vegetation obstructing the support structure of the elevated storage tank needs to be removed. Biogrowth on elevated storage tank needs to be removed.

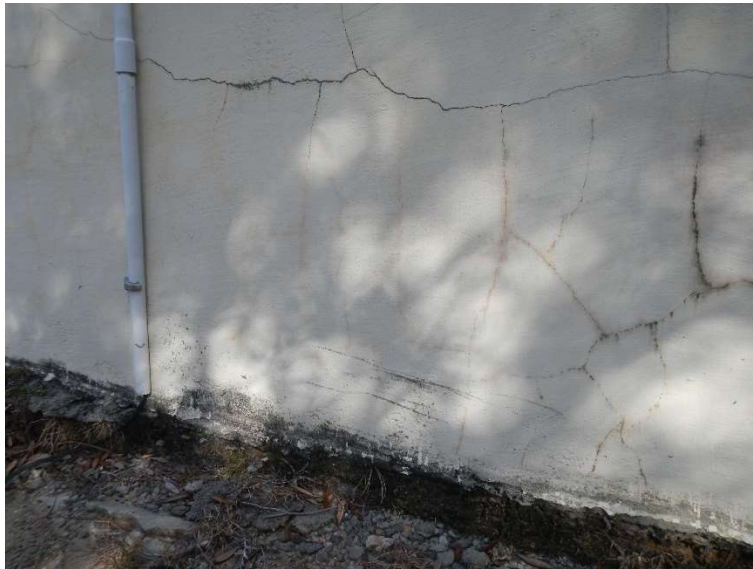
**Photograph 16:** Ground storage tank deteriorated concrete base

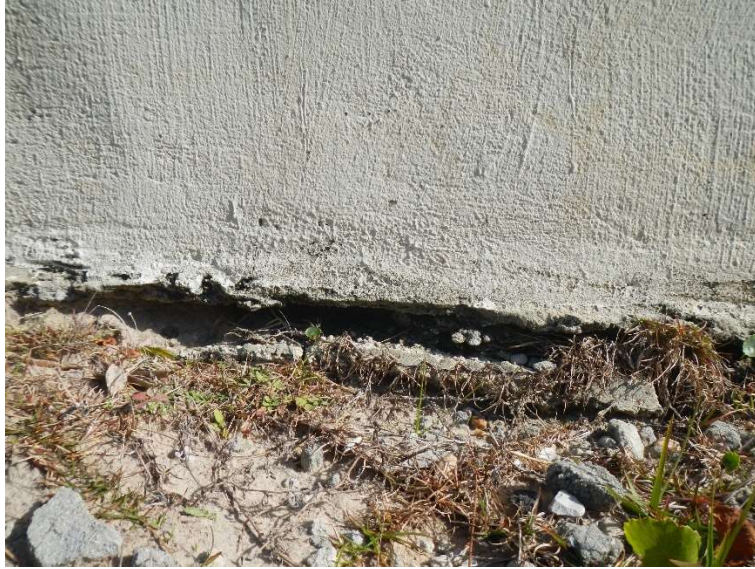
**Photograph 17:** Ground storage tank concrete base lacking seal

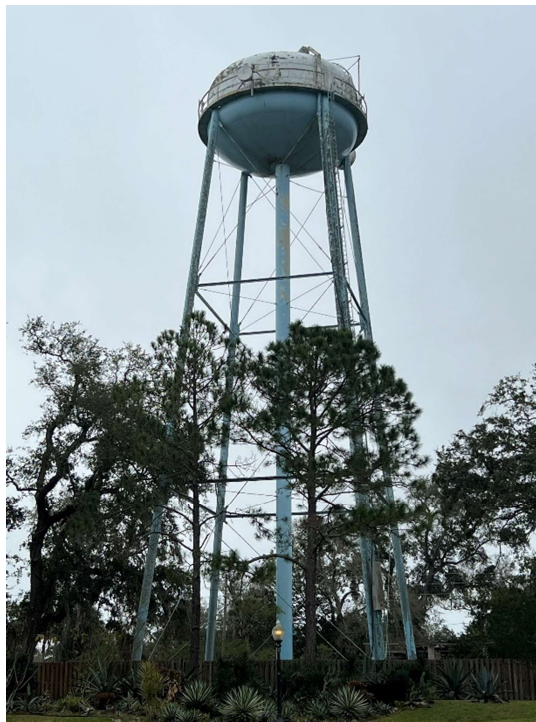
**Photograph 18:** Branches touching support structure  
Provided by FDEP staff – taken on February 3, 2022

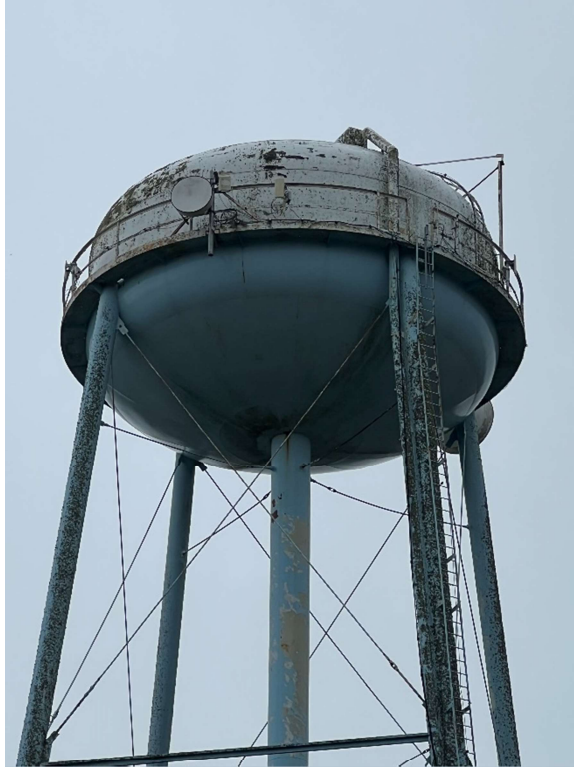
**Photograph 19:** Excessive biogrowth on tank  
Provided by FDEP staff – taken on February 3, 2022

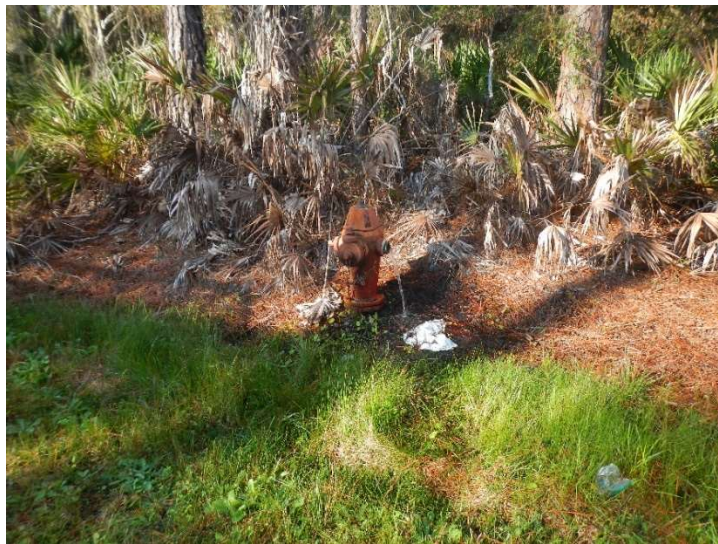
**Photograph 20:** Rivercrest Hydrant

- 9. **Finding:** The Rivercrest hydrant that is currently being used to collect compliance samples under the Disinfectants and Disinfection Byproducts Rule has not been approved as a sampling site by the State. Per 40 CFR 141.622 Subpart V, State needs to be consulted prior to revising sampling plans.
  - a. State approved sampling plan dated 1/2022 lists two sampling locations;
    - i. Robert's Fish Dock – Market Street
    - ii. Bay City Lodge
      - 1. Sampling site that has measured the highest level of total trihalomethanes (TTHM).
      - 2. Identified during the inspection as the old TTHM sampling site, which was moved to the Rivercrest fire hydrant during the 2021 summer.

3. Inspection tour included a visit to the Rivercrest fire hydrant (refer to Appendix A, Photograph 20), where the DBP samples are currently being collected from.
4. Upon review of the System records, there was no documentation stating that the State approved the sampling site location change. State personnel that joined the EPA inspection team confirmed that the change had not been approved by FDEP.
5. Chain of custodies for the October – December 2021 monitoring period list Robert's Fish Dock and Bay City Lodge as the sampling points used to collect the samples sent to the laboratory.

**Comment:** Compliance samples can only be collected from State approved sampling sites. If revisions to the sampling plan are needed, the System needs to submit them to the State for approval prior to implementing the changes.
