# EPA REGION 10 Enforcement Division

## INSPECTION REPORT

| <b>Type of Inspection</b> | Compliance Evaluation Inspection (CEI) | | |
| <b>Facility or Site Name</b> | Hilcorp North Slope Prudhoe Bay Unit | | |

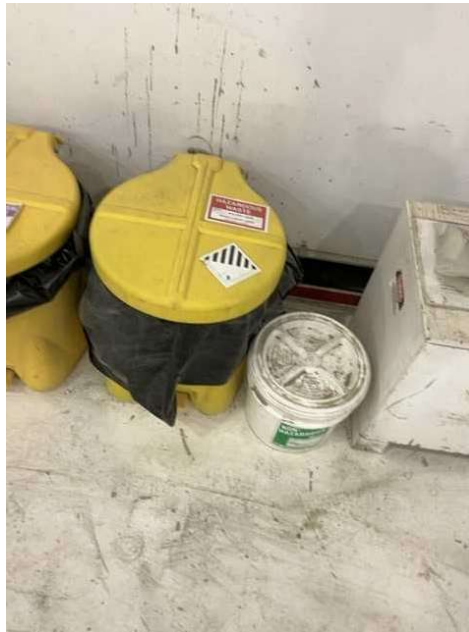
| [Title] | | | IMG-20230710111224122469308.jpg |

| <p>At the time of inspection, we saw a 15-gallon SAA container of waste solvent rags that was not marked with a hazard indicator that was specific to the hazard. The container was marked with a DOT Class 9 label. Hazard indicators are required to be specific to the hazard and a DOT Class 9 label does not meet this requirement.</p> <p>The word “TOXIC” was added to the label during the inspection.</p> | | | |

| At the time of inspection, there was a 15-gallon SAA container of waste solvent rags that was marked with a hazard indicator that was not specific to the hazard. The container was marked with a DOT Class 9 label. | <b>Citations:</b> | <b>Sections:</b> |

| View of a 15-gallon SAA container of solvent rags that is not marked with a hazard indicator that is specific to the hazard. The container seen here is marked with a DOT Class 9 label. | | | |

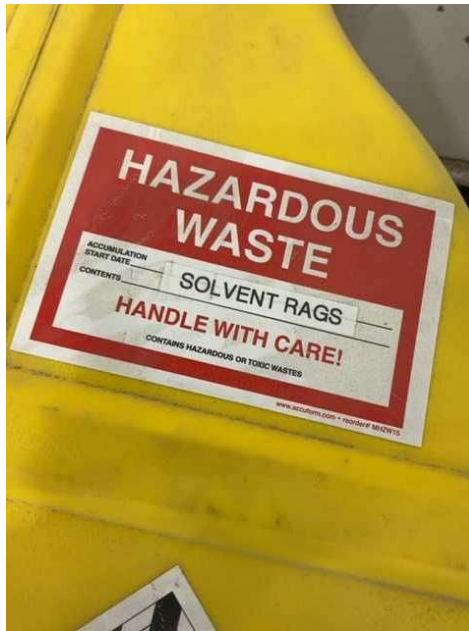
| [Title] | | | IMG-20230710111610161073126.jpg |

| Close-up view of the hazardous waste label. | | | |

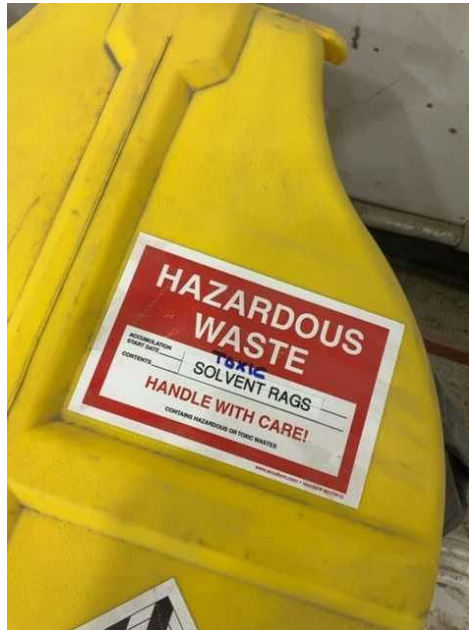
| [Title] | | | IMG-20230710111852185271812.jpg |

| Close-up view of the hazardous waste label, after the word "TOXIC" was added for a hazard indicator. | | | |

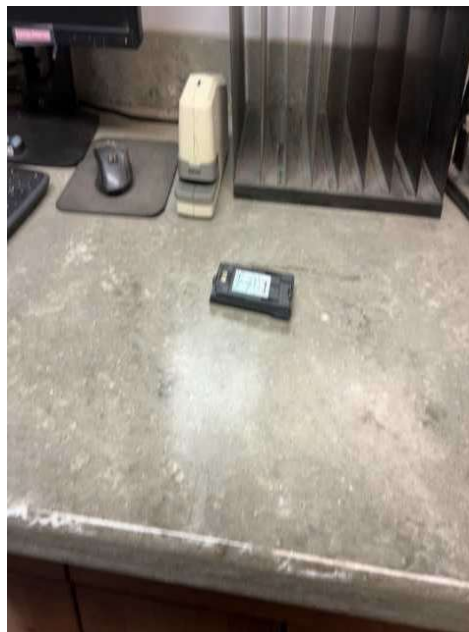
| [Title] | | | IMG-20230710144630463059575.jpg |

| <p>While checking-in with the Operator at Flow Station 2, we saw a battery on a counter that was marked with the word “BAD.” The battery was verified by facility personnel to be a waste battery. The facility manages their waste batteries as universal waste. At the time of the inspection, the battery was not labeled with either the phrase “Universal Waste – Battery,” “Waste Battery,” or “Used Battery.”</p> <p>Mr. Umatum took the waste battery to the Flow Station 2 SAA and placed it into the designated universal waste container for waste batteries.</p> | | | |

| A waste battery was observed on a countertop, just outside the control room, marked with the word "BAD.". At the time of the inspection, the battery was not labeled with either the phrase "Universal Waste – Battery," "Waste Battery," or "Used Battery." | <b>Citations:</b> | <b>Sections:</b> |

| View of a waste battery that is marked as "BAD" and not labeled with either the phrase "Universal Waste - Battery," "Waste - Battery," or "Used Battery." | | | |

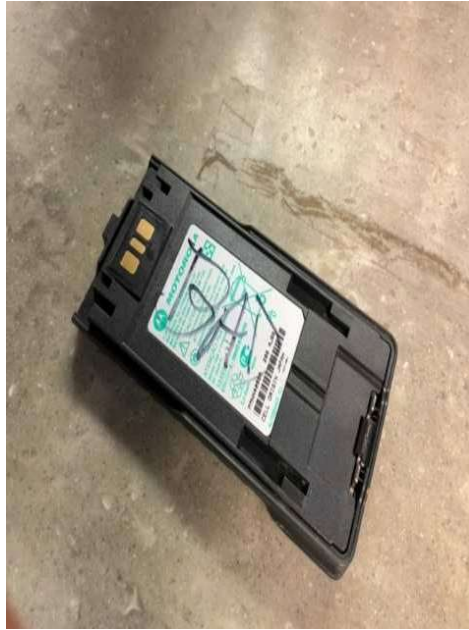
| [Title] | | | IMG-20230710144636463680218.jpg |

| Close-up view of the waste battery that is marked as "BAD" and not labeled with either the phrase "Universal Waste - Battery," "Waste - Battery," or "Used Battery." | | | |

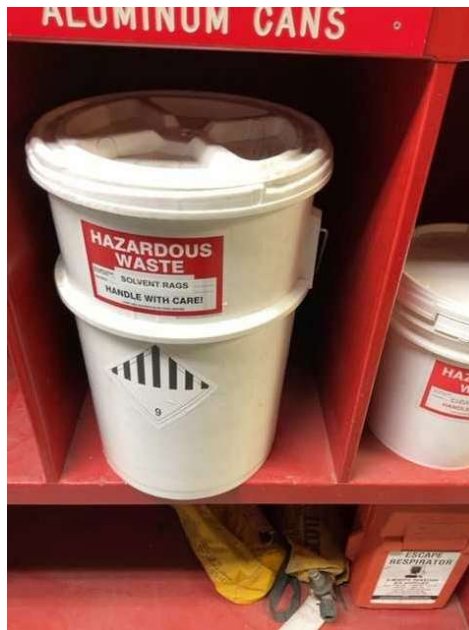
| [Title] | | | IMG-20230710144944494469634.jpg |

| <p>At the time of inspection, we saw a 15-gallon SAA container of waste solvent rags that was not marked with an appropriate hazard indicator. The container was marked with a DOT Class 9 label. Hazard indicators are required to be specific to the hazard and a DOT Class 9 label does not meet this requirement.</p> <p>The word “TOXIC” was added to the label during the inspection.</p> | | | |

| An SAA container was not marked with a hazard indicator that was specific to the hazard. The container was marked with a DOT Class 9 label. | <b>Citations:</b> | <b>Sections:</b> |

| View of a SAA container of waste solvent rags that is not marked with a hazard indicator that is specific to the hazard. The container seen here is marked with a DOT Class 9 label. | | | |

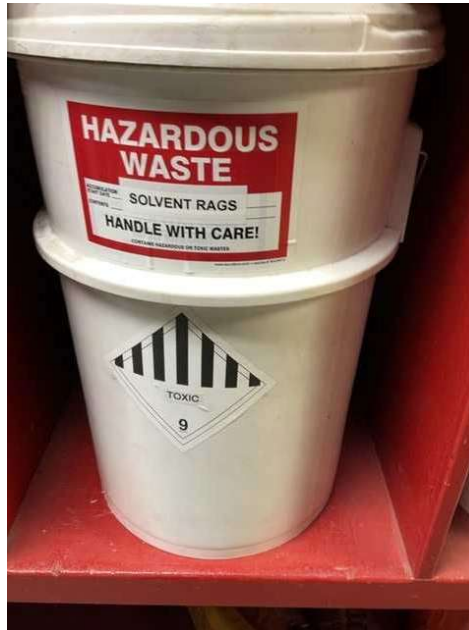
| [Title] | | | IMG-20230710145221522162477.jpg |

| View of the SAA container of waste solvent rags after being marked with the word "TOXIC" for the hazard indicator. | | | |

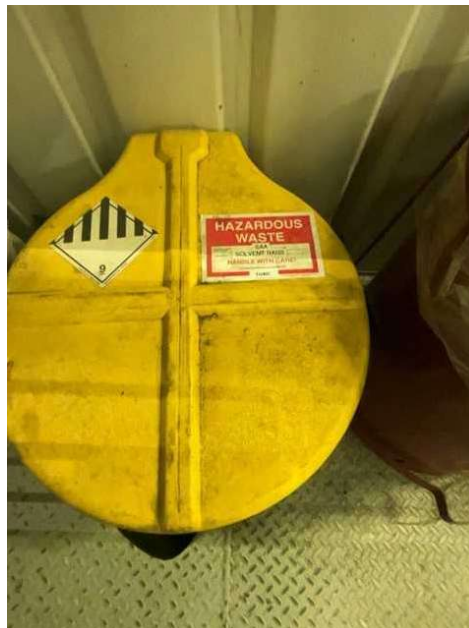
| [Title] | | | IMG-20230711091114111478049.jpg |

| View of a SAA container of waste solvent rags that is marked with the word "TOXIC." The container was marked at some point following the first day of the inspection (7/10/23) and the beginning of the inspection on the second day (7/11/23). | | | |

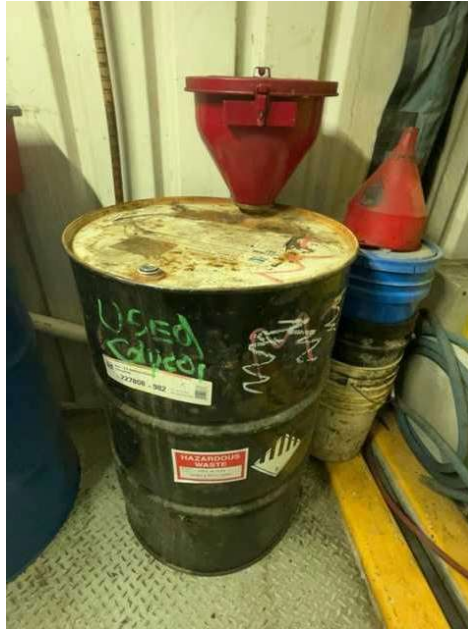
| [Title] | | | IMG-20230711091233123387851.jpg |

At the time of inspection, we saw a 55-gallon SAA container of waste glycol that was not marked with an appropriate hazard indicator. The container was marked with a DOT Class 9 label. Hazard indicators are required to be specific to the hazard and a DOT Class 9 label does not meet this requirement.

| A 55-gallon SAA container of waste glycol was not marked with a hazard indicator that was specific to the hazard. The container was marked with a DOT Class 9 label. | <b>Citations:</b> | <b>Sections:</b> |

| View of a 55-gallon SAA container of waste glycol that is not marked with a hazard indicator that is specific to the waste. | | | |

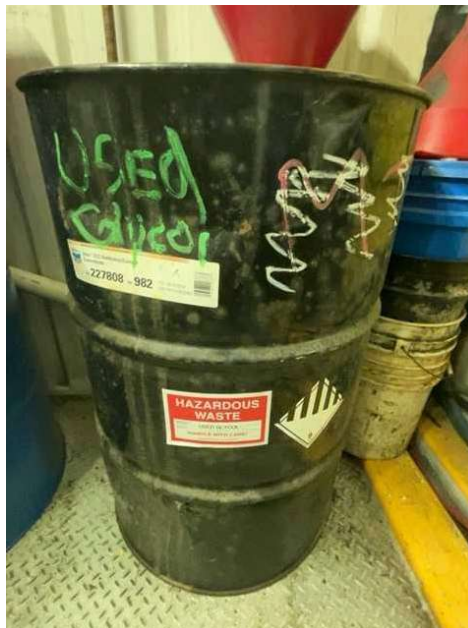
| [Title] | | | IMG-20230711091243124392769.jpg |

| Close-up view of the same 55-gallon SAA container of waste glycol that is not marked with a hazard indicator that is specific to the hazard. | | | |

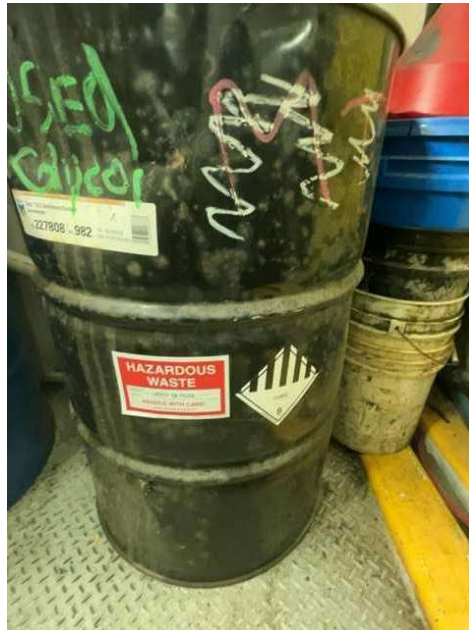
| [Title] | | | IMG-20230711091251125192111.jpg |

| Another close-up view of the same 55-gallon SAA container of waste glycol after being marked with the word "TOXIC" for the hazard indicator. | | | |

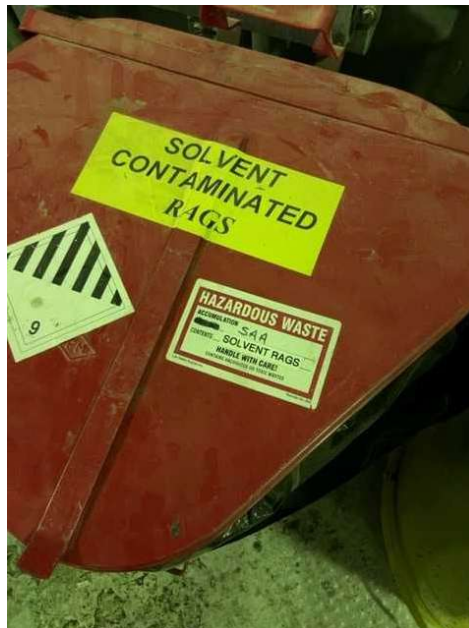
| [Title] | | | IMG-20230711132714271484626.jpg |

At the time of inspection, we saw a 15-gallon SAA container of waste solvent rags that was not marked with an appropriate hazard indicator. The container was marked with a DOT Class 9 label. Hazard indicators are required to be specific to the hazard and a DOT Class 9 label does not meet this requirement.

| At the time of inspection, there was a 15-gallon SAA container of waste solvent rags that was marked with a hazard indicator that was not specific to the hazard. The container | <b>Citations:</b> | <b>Sections:</b> |

| View of a SAA step-can of waste solvent rags that is not marked with a hazard indicator that is specific to the hazard. | | | |

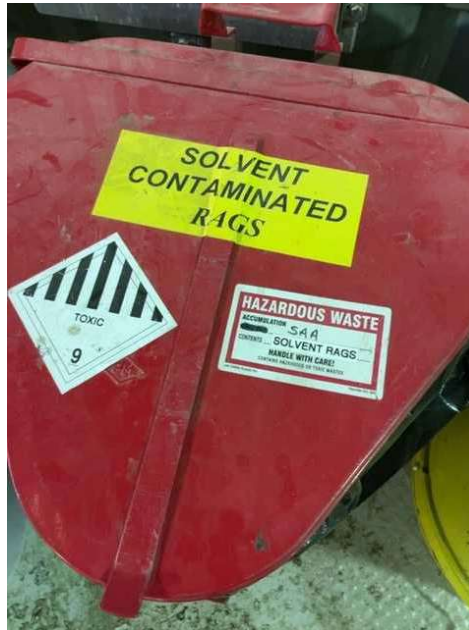
| [Title] | | | IMG-20230711132816281684552.jpg |

| View of the step-can after being marked with the word "TOXIC" for the hazard indicator. | | | |

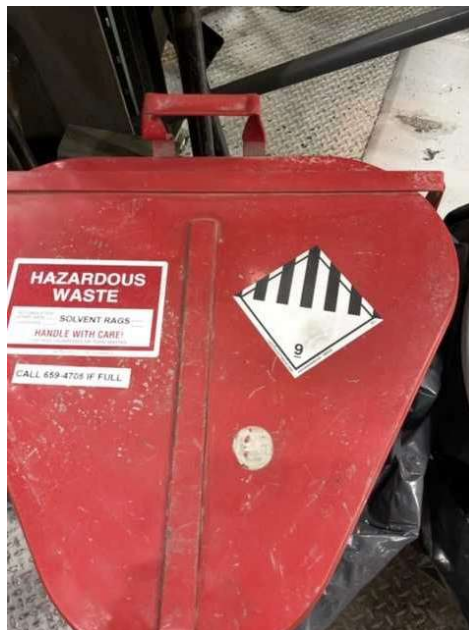
| [Title] | | | IMG-20230711134450445082200.jpg |

At the time of inspection, we saw a 15-gallon SAA container of waste solvent rags that was not marked with an appropriate hazard indicator. The container was marked with a DOT Class 9 label. Hazard indicators are required to be specific to the hazard and a DOT Class 9 label does not meet this requirement.

| At the time of inspection, there was a 15-gallon SAA container of waste solvent rags that was marked with a hazard indicator that was not specific to the hazard. The container was marked with a DOT Class 9 label. | <b>Citations:</b> | <b>Sections:</b> |

| View of a SAA step-can of waste solvent rags that is not marked with a hazard indicator that is specific to the hazard. | | | |

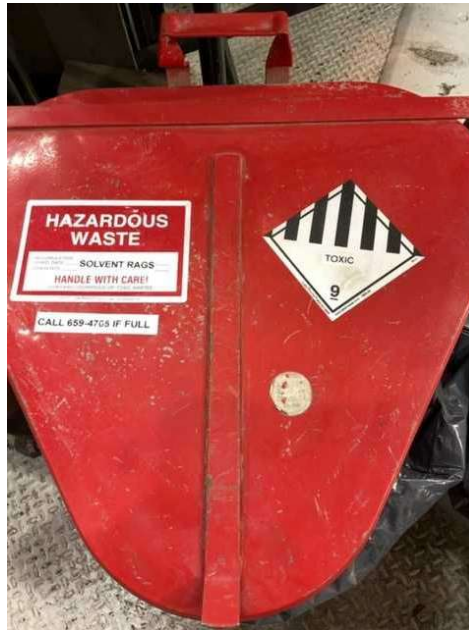
| [Title] | | | IMG-20230711134520452088409.jpg |

| View of the step-can after being marked with the word "TOXIC" for the hazard indicator. | | | |

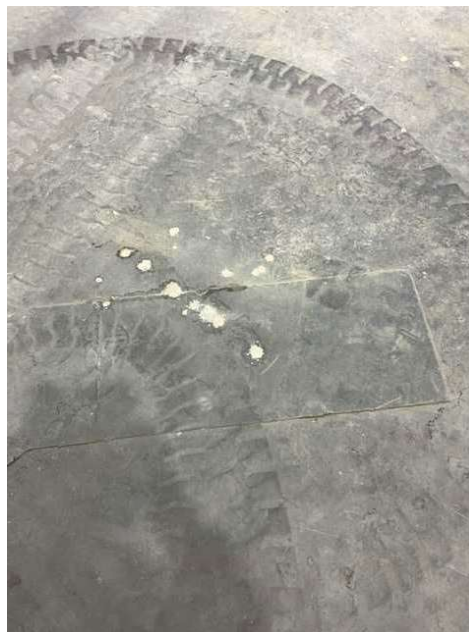
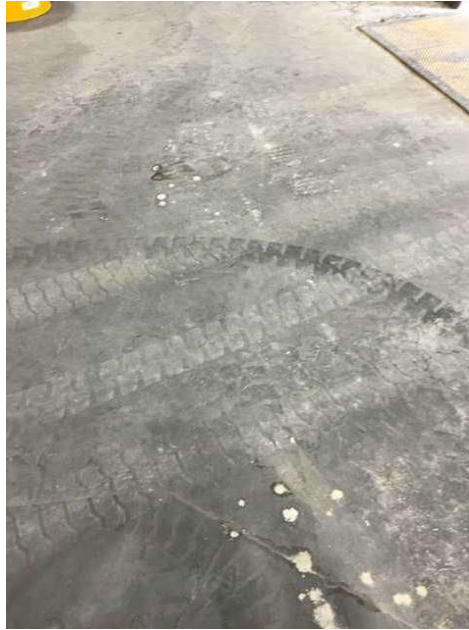
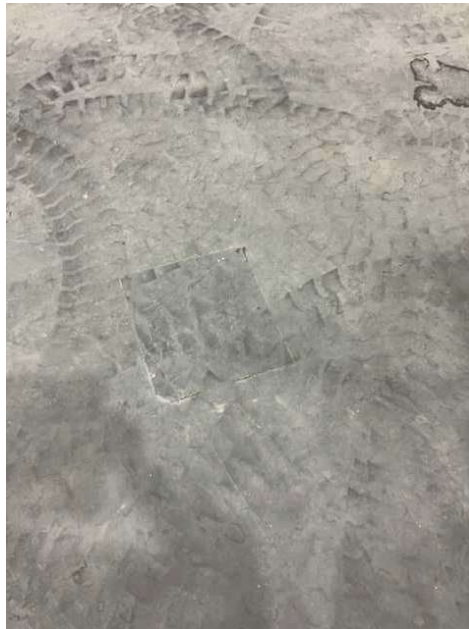
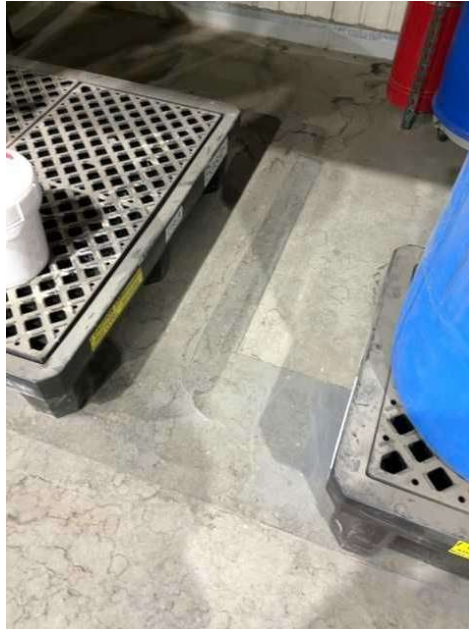
| The areas of the floor in the HWPf that were observed during the last inspection as areas where the floor sealant was damaged and identified as an area of concern had been repaired since the last inspection. | | | |

| View of the HWPf floor, showing the repairs that were made since the previous inspection. | | | |
