## EPA Region 10 Enforcement Division

### INSPECTION REPORT

| Type of Inspection | CEI - Compliance Evaluation Inspection | |
| Company Name | Western Washington University (WWU) | |

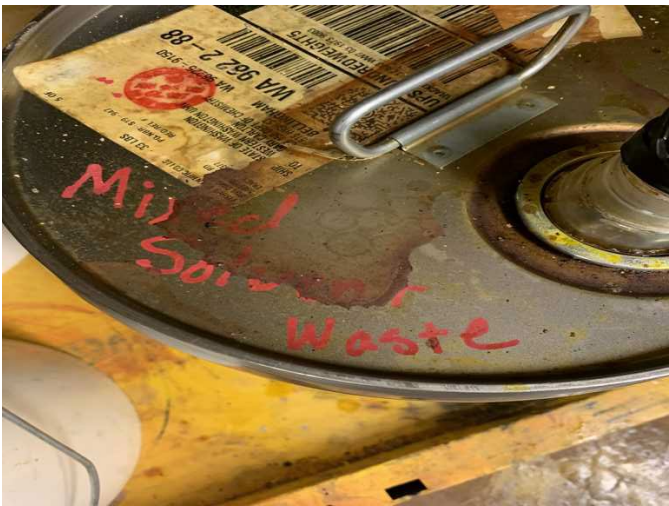
| [Title] | IMG_0264.jpg | |

| Close-up view of the same container seen in IMG_0262.jpg. The waste container is not labeled with the words "Hazardous Waste." The container lid is also seen here, not making a complete seal to close the container. | | |

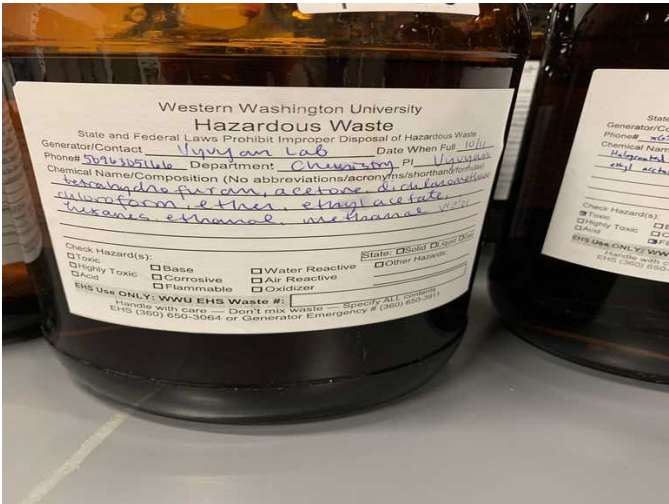
| [Title] | IMG_0236.jpg | |

| While inspecting the waste in the halogenated flammable neutral area, I saw a 1-gallon container of waste that was not marked with a hazard risk/indicator. | | | |

| View of the "Halogenated Flammable Neutral Area" in the CAA. A waste container seen here in the front, second from the left, is not marked with a hazard risk/indicator. | | |

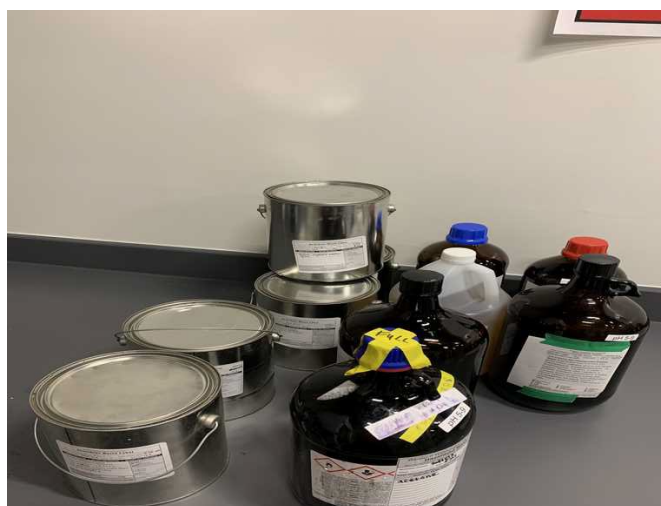
| [Title] | IMG_0238.jpg | |

| While inspecting the waste in the non-halogenated flammable neutral area, I saw a 1-gallon can of waste that was not marked with a hazard risk/indicator. | | | |

| View of the "Non-Halogenated Flammable Neutral Area" of the CAA. The 1-gallon, metal waste container seen here on the left, is not marked with a hazard risk/indicator. | | |

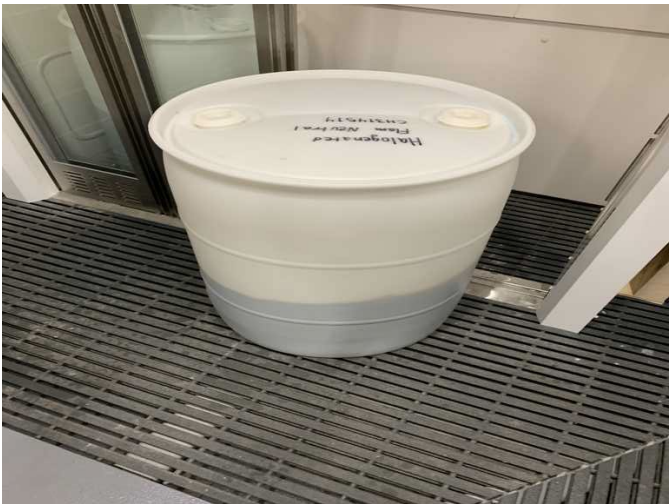
| [Title] | IMG_0241.jpg | |

| <p>At the time of the inspection, I saw two, 55-gallon hazardous waste containers. One of the containers was inside of the walk-in fume hood and the other was just outside of it.</p> <p>The 55-gallon container, just outside of the fume hood, was labeled as containing "Halogenated flammable neutral waste." At the time of the inspection, the container was not labeled with the words "Hazardous Waste" or marked with a hazard risk/indicator. Mr. Carlton applied a hazardous waste label to the container and marked the hazard risk/indicator during the inspection.</p> <p>The 55-gallon container, located inside the fume hood, was labeled as containing "Flammable acid waste." At the time of the inspection, the container was not labeled with the words "Hazardous Waste," marked with a hazard risk/indicator, or closed. Mr. Carlton applied a hazardous waste label to the container, marked the hazard risk/indicator, and closed the container during the inspection.</p> | | | |

| View of a 55-gallon hazardous waste container that is located just outside of a stand-up fume hood. The container is seen here labeled as "Halogenated Flammable Neutral Waste." The container is not labeled with the words "Hazardous Waste" or marked with a hazard risk/indicator. | | |

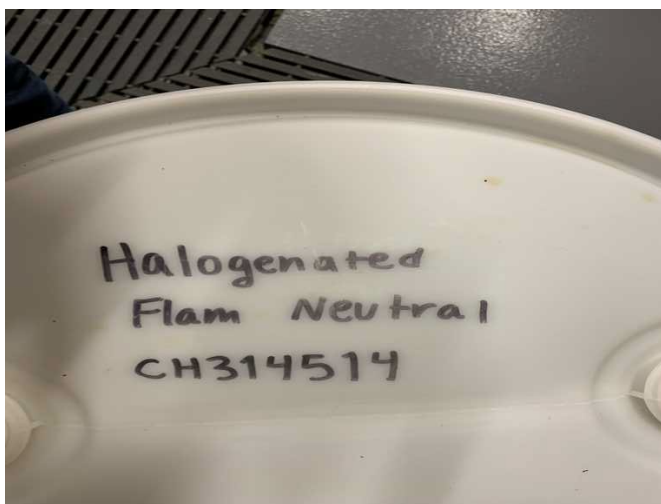
| [Title] | IMG_0243.jpg | |

| Another view of the same waste container, seen in IMG_0240.jpg and IMG_0241.jpg, show here with no hazardous waste label or hazard risk/indicator. | | |

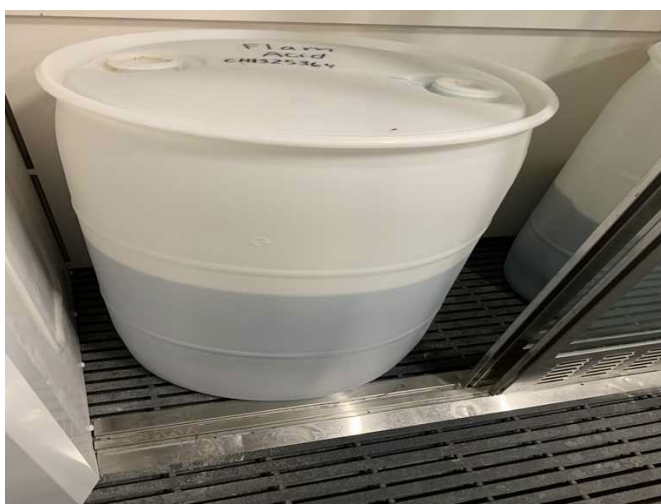
| [Title] | IMG_0245.jpg | |

| View of another 55-gallon hazardous waste container, seen here inside of the stand-up fume hood, that is labeled with the words, "Flam Acid Waste." The container is not marked with a hazardous waste label or a hazard risk/indicator. | | |

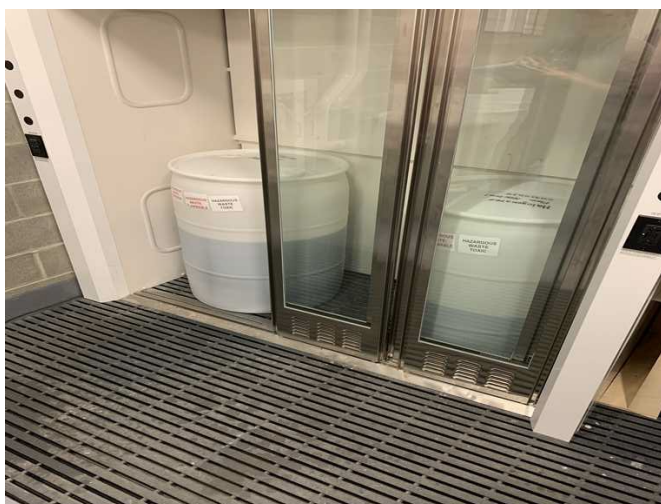
| [Title] | IMG_0247.jpg | |

| Another view of the same container, seen in IMG_0244.jpg and IMG_0245.jpg, showing that it is not marked with a hazardous waste label or a hazard risk/indicator. | | |

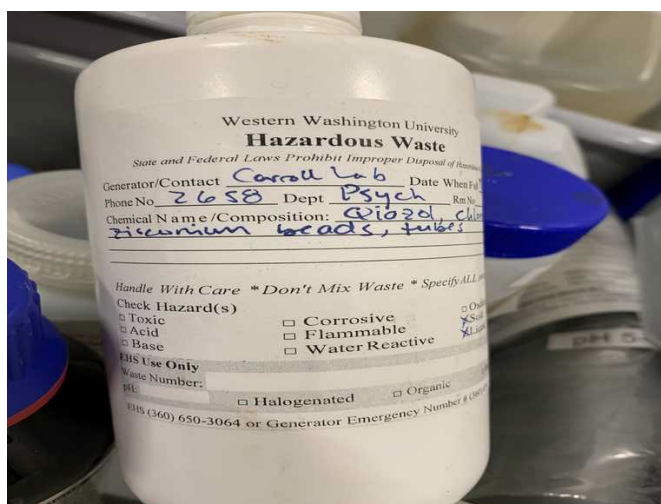
| [Title] | IMG_0230.jpg | |

| View of a white, pint sized container of hazardous waste, seen here sticking up in the center bin on the table. The container is not marked with a hazard risk/indicator. | | |

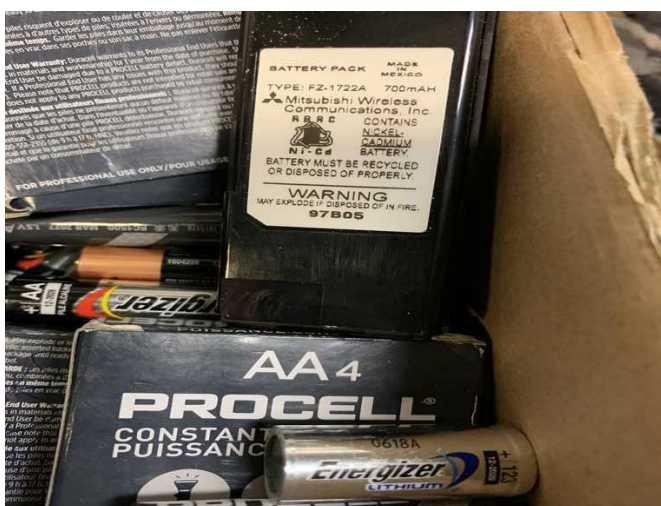
| [Title] | IMG_0115.jpg | |

According to Messrs. Carlton and Murphy, Room 141 was a waste battery accumulation area. After entering room 141, we saw three cardboard box containers of waste batteries on top of a desk. One of the boxes held waste "Button" type batteries. The box held both loose waste "Button" type batteries and a plastic bag that held additional waste "Button" type batteries. At the time of the inspection, the box was labeled with the words "Universal Waste - Batteries" and was dated 12/12/2020. According to Mr. Carlton, the date on the container was an old date that had been previously placed on the box and that the batteries were no older than eight months. The plastic bag inside the box was marked with the date, 3/16/22.

| View of the unlabeled and undated box of waste batteries. | | |

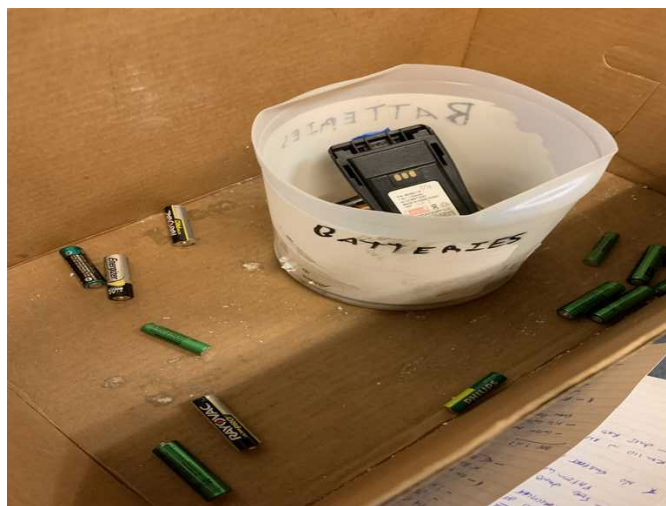
| [Title] | IMG_0117.jpg | |

| View of the third box of waste batteries, seen here unlabeled and undated. | | |

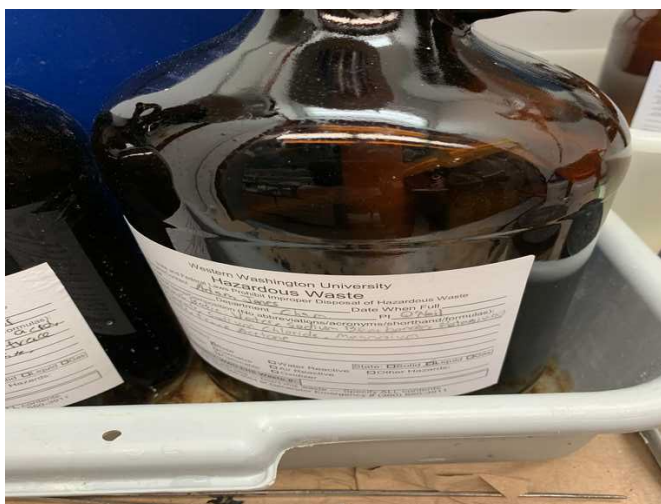
| [Title] | IMG_0138.jpg | |

| <p>While in the room 252 research lab, we looked inside of a fume hood SAA and saw a gray plastic tub that held two, 1-gallon glass containers of waste with attached funnels with lids and a 5-gallon blue poly container of waste. Both glass waste containers were labeled with the words "Hazardous Waste." One of the glass waste containers was labeled as containing waste acid and the other waste basic. Not only were the two incompatible waste containers being accumulated in the same gray plastic tub, but they were both not closed (funnel lids were not clasped down) and the waste acid container was not marked/labeled with a hazard risk/indicator. The 5-gallon blue poly container was only labeled as "O'Neil - 252" and was also not closed. The 5-gallon poly was not labeled with the words "Hazardous/Dangerous Waste" and was not marked/labeled with a hazard risk/indicator. Mr. Carlton stated that it might be a WT02, WA. State only toxic waste. I explained that a waste determination would need to be made. At the time of the inspection, no one was working in this area, actively adding or removing waste.</p> <p>Adjacent to the gray plastic tub, we saw a clear plastic tub that held two, 4-liter glass containers of waste. The two glass containers were labeled with the words "Hazardous Waste" and each was marked as containing flammable/toxic waste. The two, 4-liter waste containers had attached funnels with lids. At the time of the inspection, both of the, 4-liter, waste containers were not closed. The attached funnels had clasps to keep them closed and one was not clasped down and the other was broken and would not be able to close. At the</p> | | | |

| Close-up view of the two glass waste containers in the gray tub. The container on the left is seen here marked as containing waste acid and has no hazard risk/indicator label. | | |

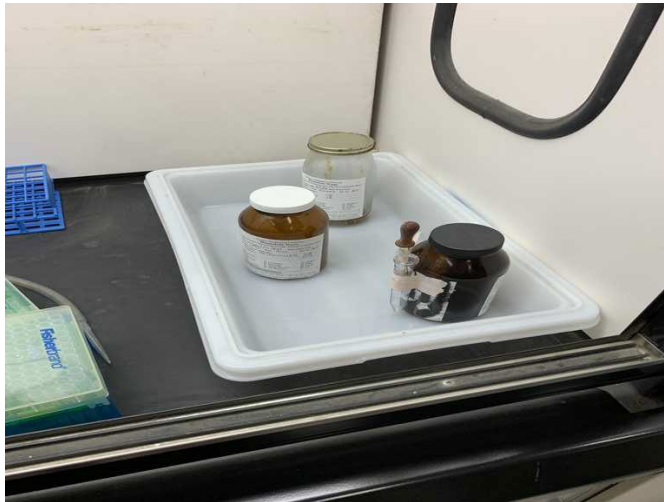
| [Title] | IMG_0202.jpg | |

| View of pint size waste container that is not marked with a hazard risk/indicator. | | |

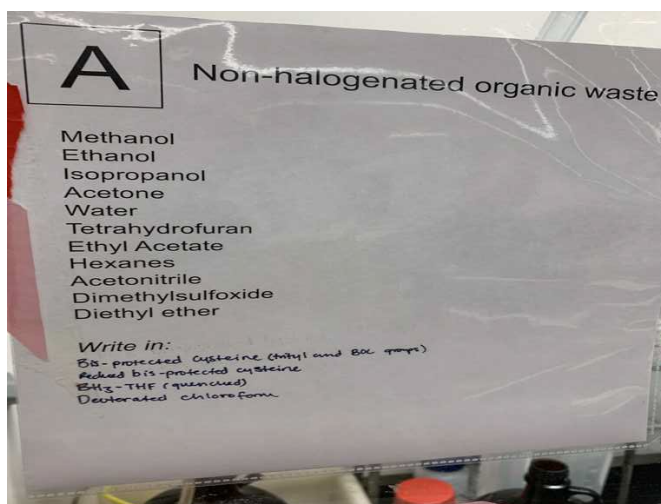
| [Title] | IMG_0183.jpg | |

| Another view of the same waste container, seen in IMG_181.jpg, shown here without a hazardous waste label and hazard risk/indicator. | | |

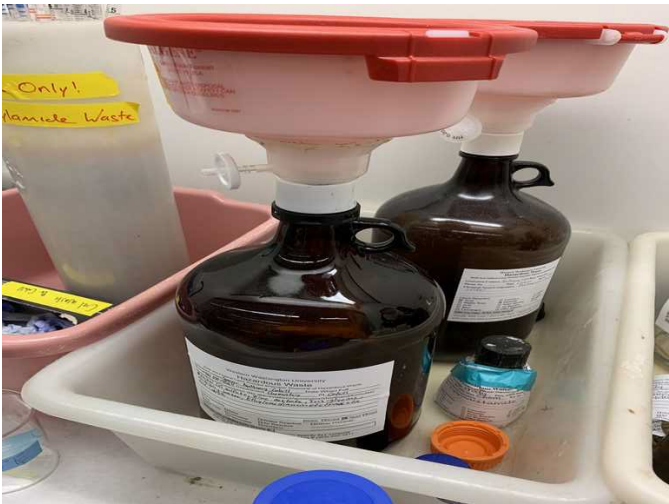
| [Title] | IMG_0185.jpg | |

| View of a pint size waste container, marked as an unknown, that is labeled as hazardous waste but not marked with a hazard risk/indicator. | | |

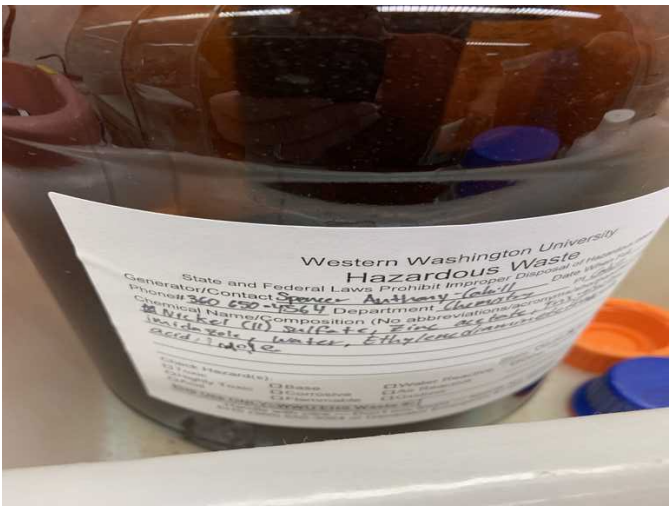
| [Title] | IMG_0186.jpg | |

| View of a 1-gallon brown, glass waste container, seen here in the front of the white bin, that is not marked with a hazard risk/indicator. | | |

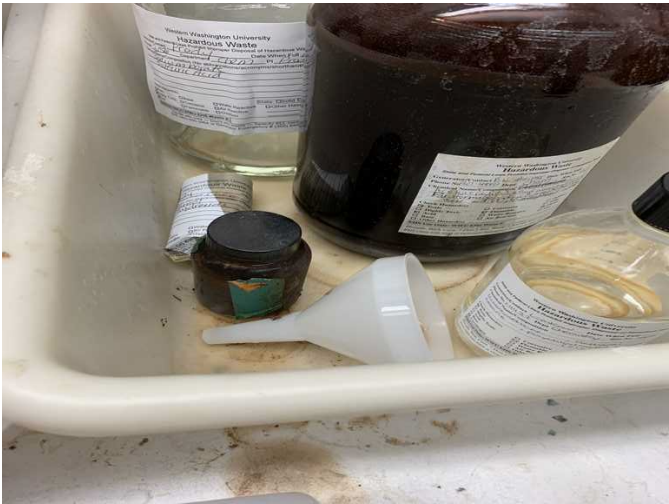
| [Title] | IMG_0187.jpg | |

| Close-up view of the label, showing that the hazard risk/indicator is not marked. | | |

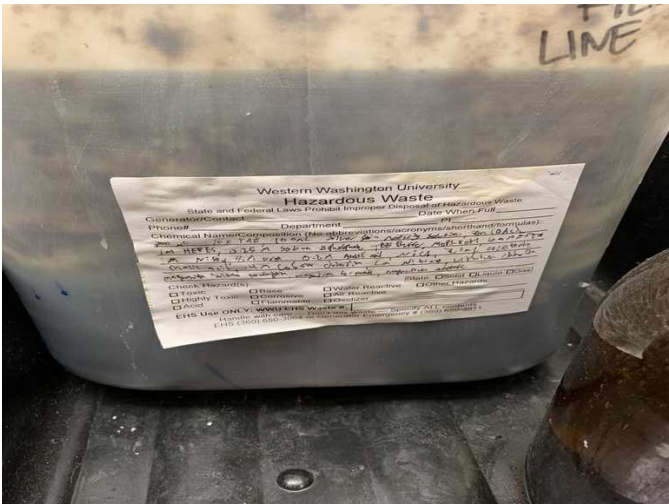
| [Title] | IMG_0171.jpg | |

| View of a waste container, seen here in the front of the blue tub, without a hazard risk/indicator. | | |

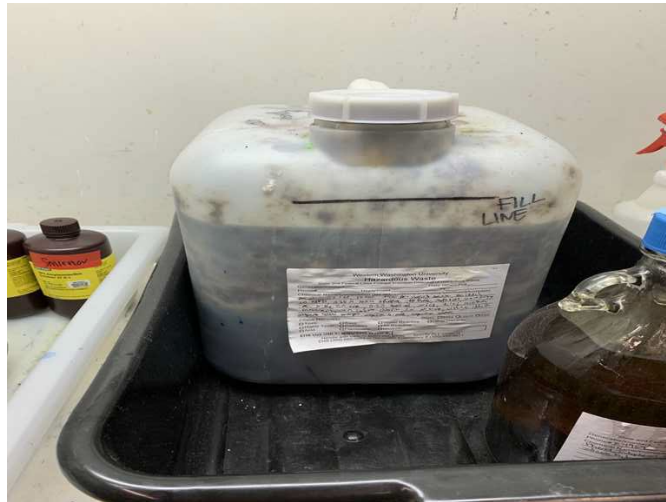
| [Title] | IMG_0172.jpg | |

| Close-up view of the label on the container seen in IMG_170.jpg, showing that it is not marked with a hazard risk/indicator. | | |

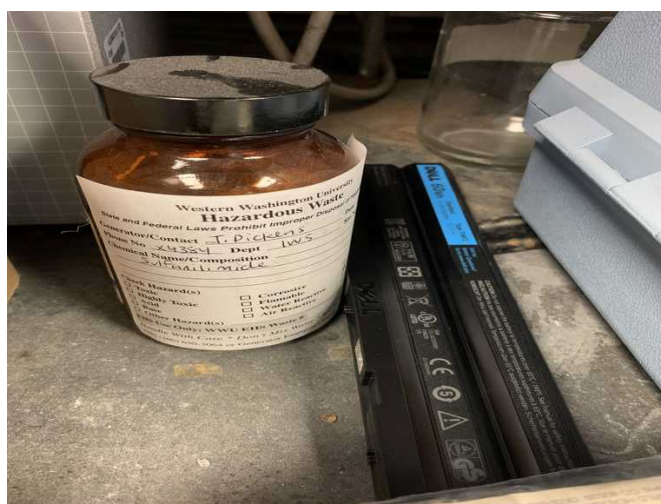
| [Title] | | IMG_0254.jpg | |

| View of a pint sized, brown glass waste container and a plastic bag, containing waste. Neither the plastic bag nor the glass container are marked with a hazard risk/indicator. | | | |

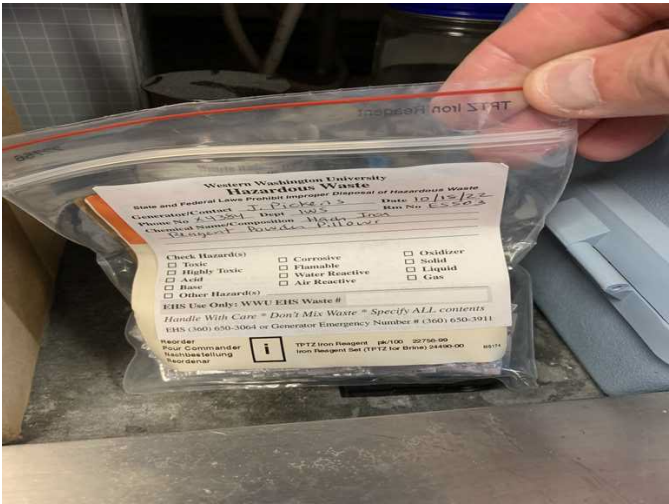
| [Title] | | IMG_0255.jpg | |

| Close-up view of the pint size waste container, showing that it is not marked with a hazard risk/indicator. | | | |

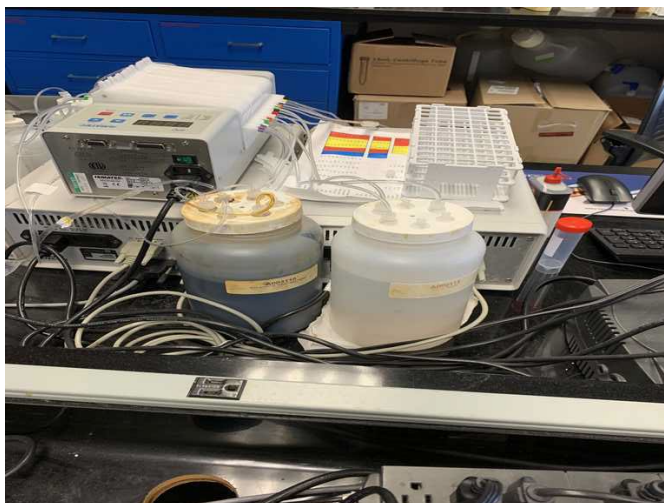
| [Title] | IMG_0258.jpg | |

We also saw several containers that were connected to lab analyzing equipment. I asked Mr. Carlton if the containers held waste and at the time of the inspection he did not know and he was unable to find anyone in the area that knew. Following the inspection, Mr. Carlton provided information and photos via SharePoint indicating that the containers in question held hazardous waste and had since been labeled as hazardous waste.

| View of suspected waste containers that are connected to lab analyzing equipment in the lab. The containers are not marked with hazardous waste labels or marked with hazard indicators. | | |

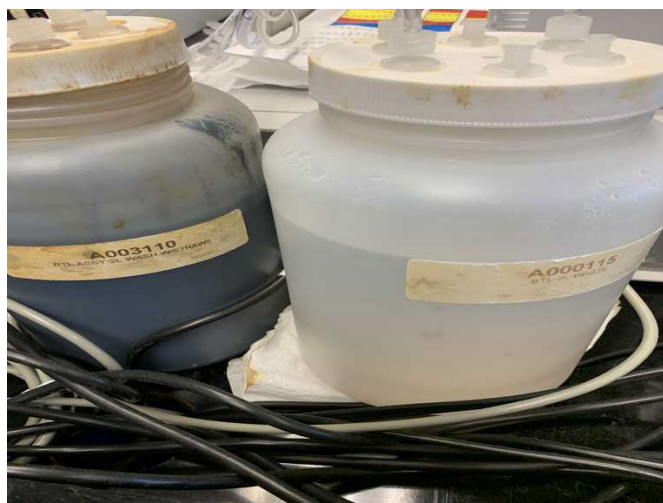
| [Title] | | IMG_0259.jpg | |

| View of suspected waste containers that are connected to lab analyzing equipment in the lab. The containers are not marked with hazardous waste labels or marked with hazard indicators. | | |

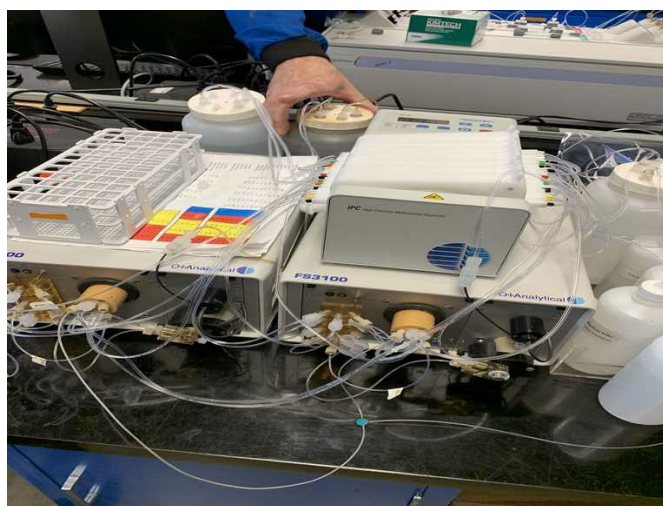
| [Title] | | IMG_0260.jpg | |

| View of suspected waste containers that are connected to lab analyzing equipment in the lab. The containers are not marked with hazardous waste labels or marked with hazard indicators. | | | |

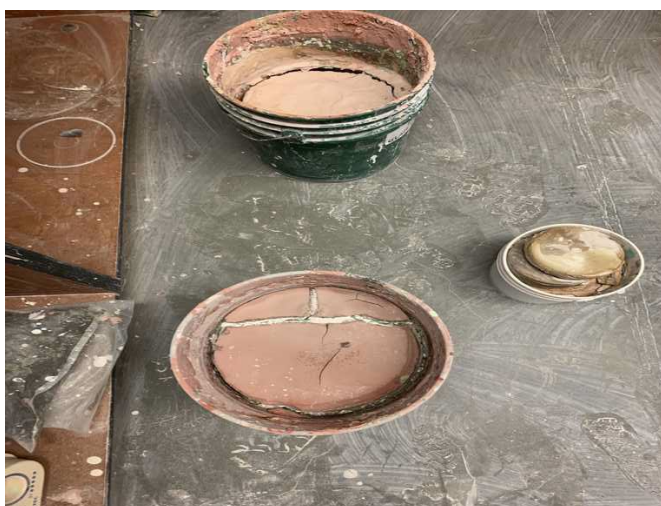
| [Title] | IMG_0313.jpg | |

| View of two, 5-gallon containers and a half-gallon container of waste glaze. The waste containers seen here are not closed, not labeled with the words "Hazardous Waste", or marked with hazard risks/indicators. | | |

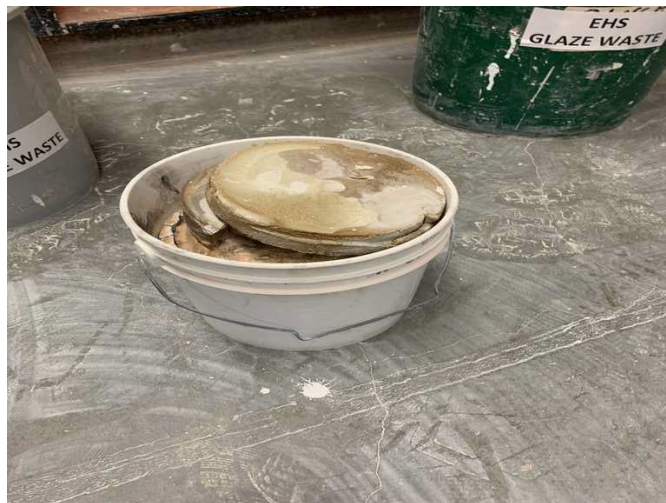
| [Title] | IMG_0315.jpg | |

| Close-up view of one of the 5-gallon waste containers, showing that it is not closed, not marked with a hazardous waste label or a hazard risk/indicator. | | |

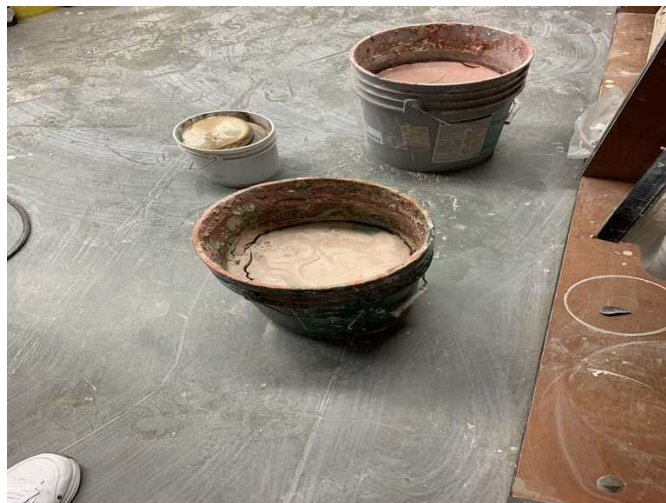
| [Title] | IMG_0317.jpg | |

| Close-up view of the other 5-gallon waste container, showing that it is not closed, not marked with a hazardous waste label or a hazard risk/indicator. | | |

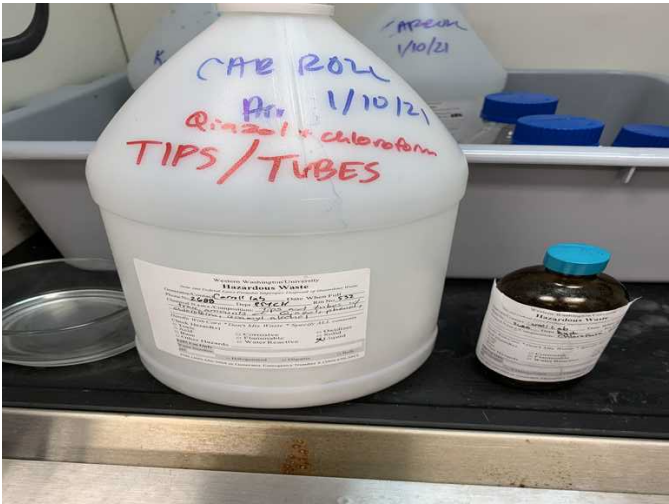
| [Title] | IMG_0307.jpg | |

| View of three waste containers that are all not marked with hazard risks/indicators. | | |

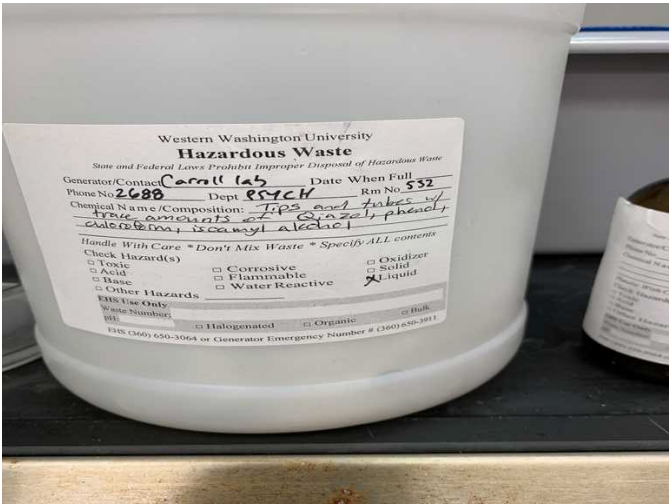
| [Title] | IMG_0308.jpg | |

| Close-up view of the labels showing that no hazard risk/indicator is marked. | | |

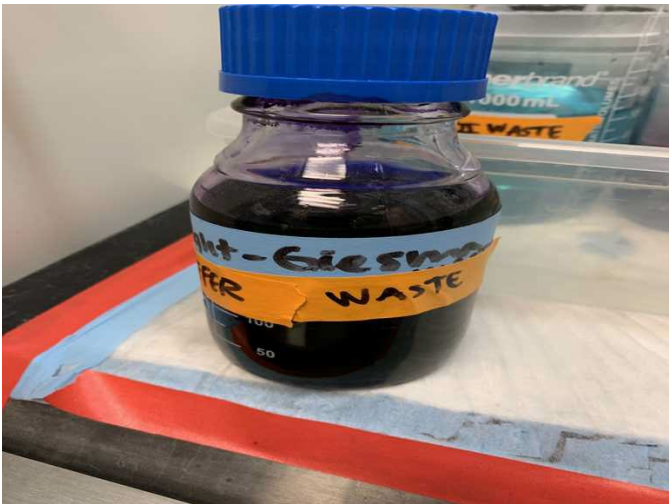
| [Title] | IMG_0297.jpg | |

| Close-up view of one of the containers seen in IMG_0295.jpg, not marked with a hazardous waste label or a hazard risk/indicator. | | |

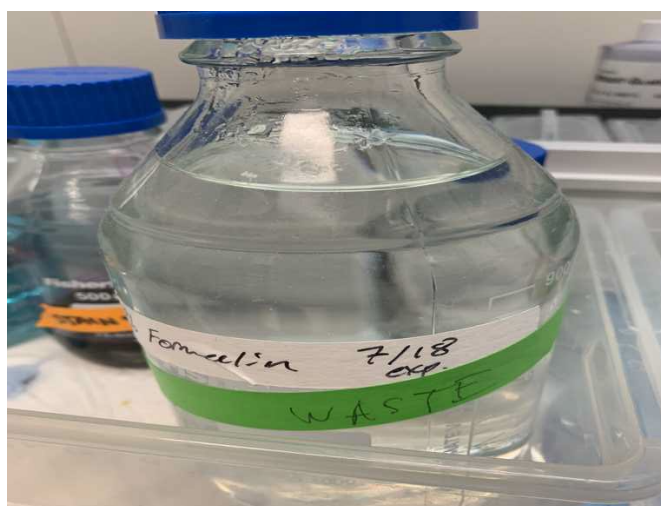
| [Title] | IMG_0301.jpg | |

| Close-up view of one of the containers seen in IMG_0295.jpg, not marked with a hazardous waste label or a hazard risk/indicator. | | |

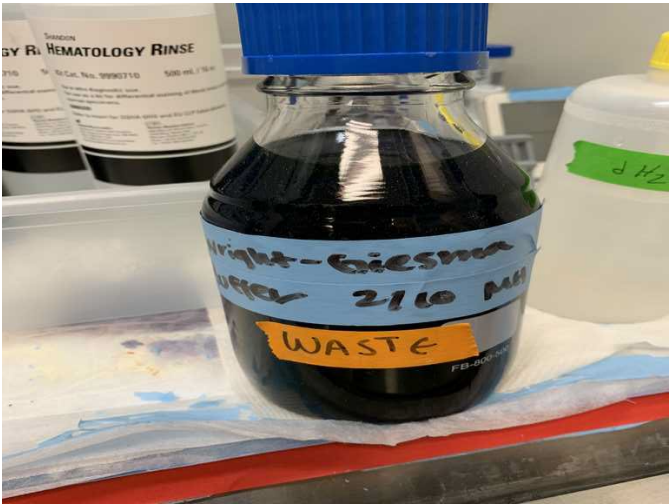
| [Title] | IMG_0305.jpg | |

| Close-up view of one of the containers seen in IMG_0295.jpg, not marked with a hazardous waste label or a hazard risk/indicator. | | |

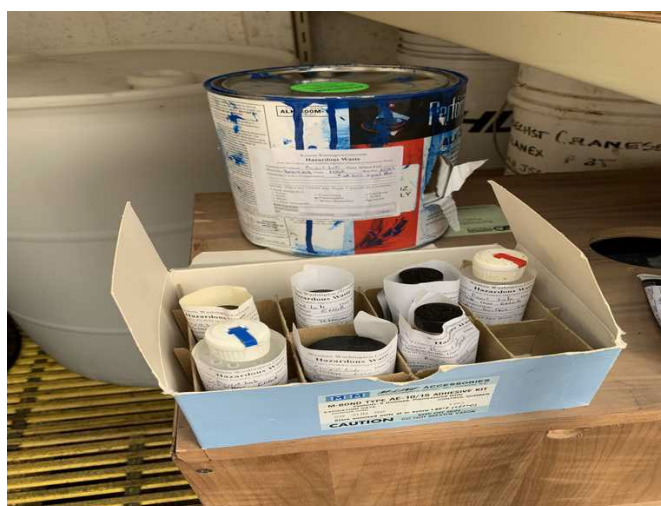
| [Title] | IMG_0279.jpg | |

| View of waste containers that are not marked with hazard risks/indicators. | | |
