**Region 6 - Enforcement & Compliance Assurance Division**  
**INSPECTION REPORT**

| Inspection Date(s): | 04/13/2022 | |
| Company Name: | <b>Phillips 66 Company</b> | |
| Facility Name: | <b><i>Lake Charles Refinery</i></b> | |

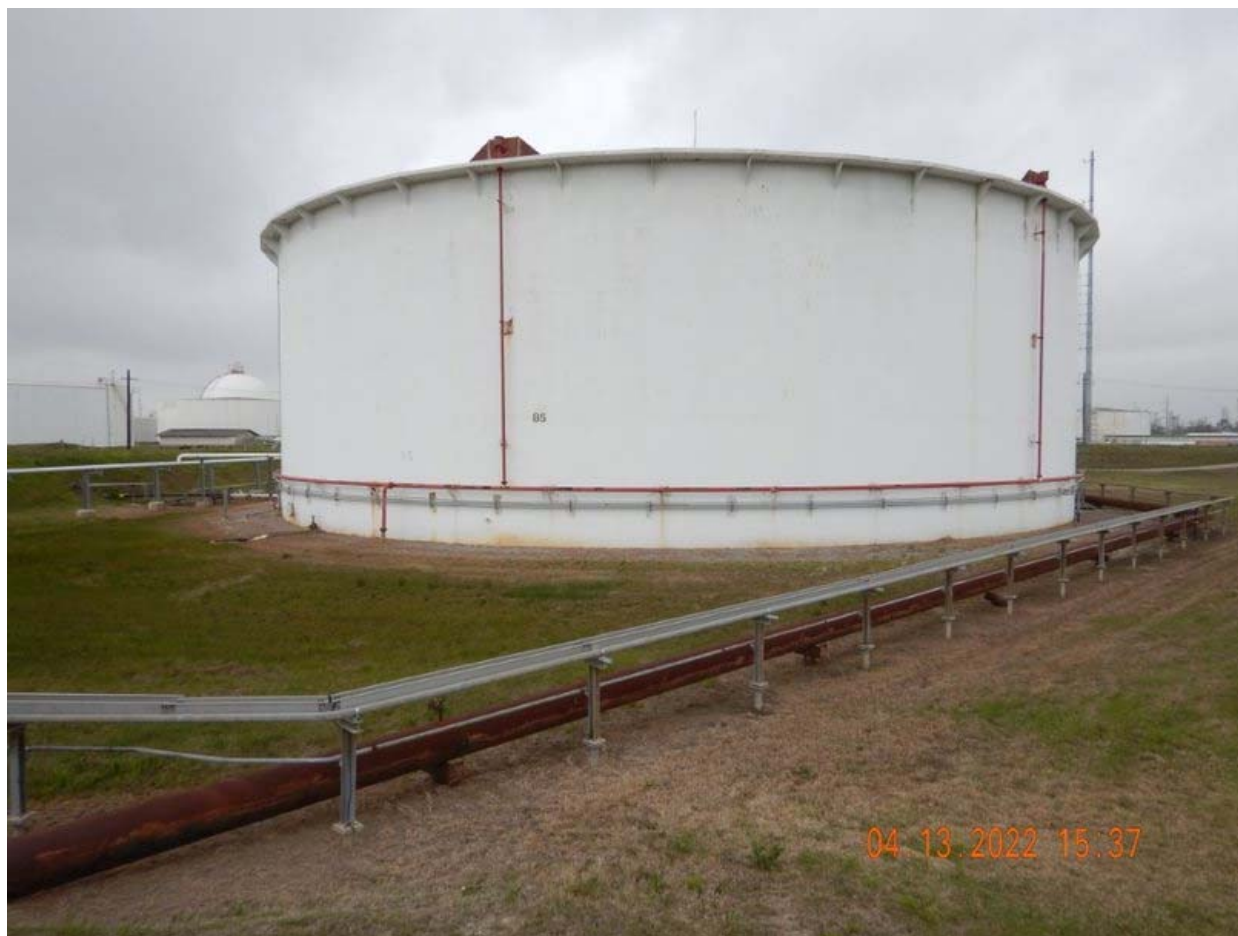
Photo No. 1

| <b>Tank Number</b> | <b>Tank Contents</b> | <b>Hydrocarbons Observed with the OGIC</b> | <b>Visualized Emissions Location</b> | <b>Viewing Location</b> |
|---|---|---|---|---|
| T-85 | Gasoline | Yes | Observed at seal gap. | Roof of Tank |

We observed hydrocarbon emissions using the OGIC at three tanks: T-82, T-85, and T-86. The OGIC video suggests that the tanks may not be effectively controlling emissions. Information provided by the facility indicates T-85 and T-86 failed respective seal gap measurement inspections. See Appendix 3 – Phillips 66 Lake Charles Refinery April 2022 EPA Inspection Response, for the T-85 and T-86 inspection report. T-86 was noted to have a 6-inch gap between the edge of the primary seal and the tank wall. T-85 was noted to have seal gap exceedances in and other deficiencies including an oily substance on the roof, a deficient gasket at the guide pole, and a deficient gasket at the vacuum breaker. T-85 and T-86 are classified as Group 1 storage vessels under 40 CFR Part 63 Subpart CC (MACT CC) – National Emission Standards for Hazardous Air Pollutants (“NESHAP”) From Petroleum Refineries which subjects them to the provisions of 40 CFR Part 63 Subpart WW – National Emission Standards for Storage Vessels (Tanks) - Control Level 2.

Description: Tank T-85. OGIC-visualized hydrocarbon emissions were observed on the roof of the tank.

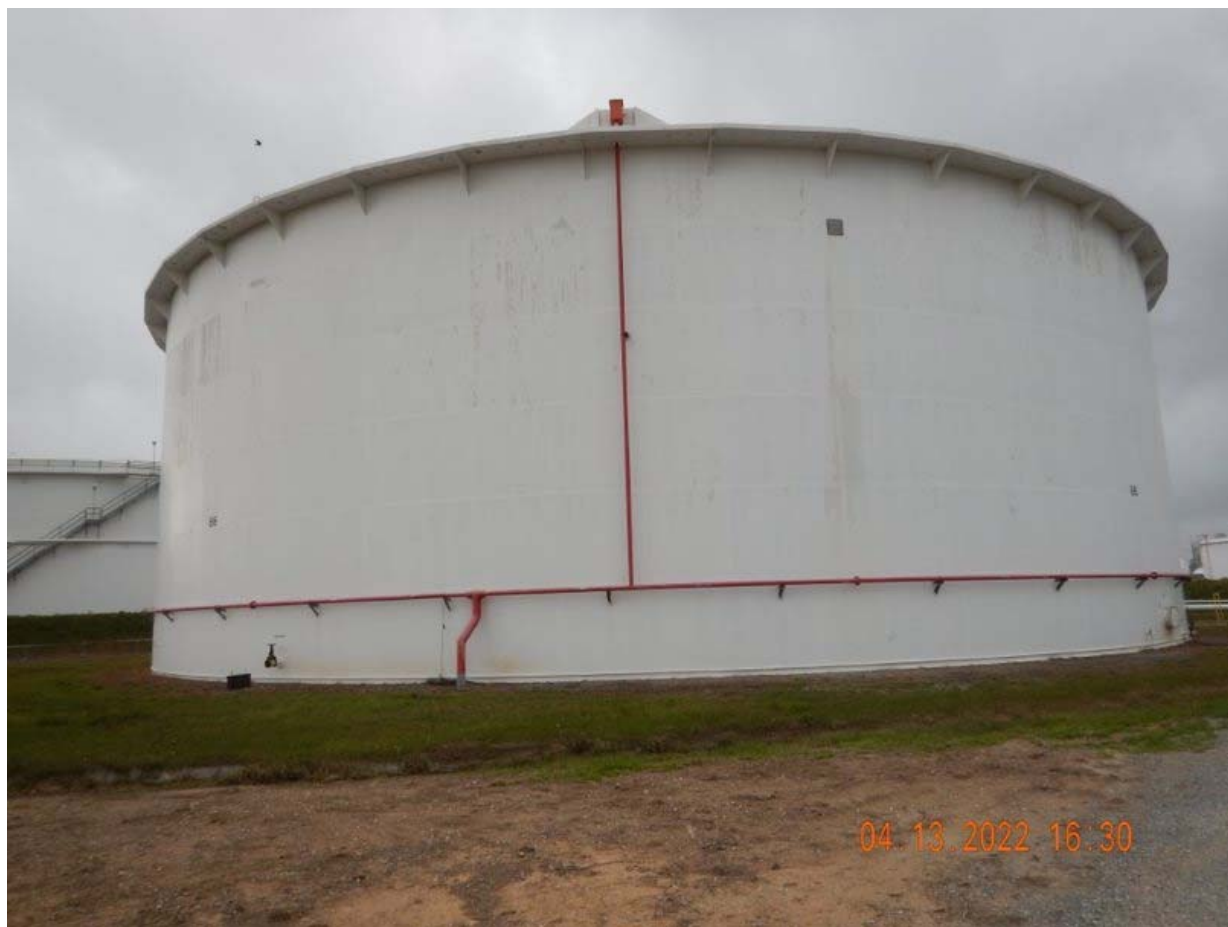
Photo No. 2

| <b>Tank Number</b> | <b>Tank Contents</b> | <b>Hydrocarbons Observed with the OGIC</b> | <b>Visualized Emissions Location</b> | <b>Viewing Location</b> |
|---|---|---|---|---|
| T-86 | Gasoline | Yes | Observed at open gooseneck vent on roof. | Roof of Tank |

Description: Tank T-86. OGIC-visualized hydrocarbon emissions were observed on the roof of the tank.

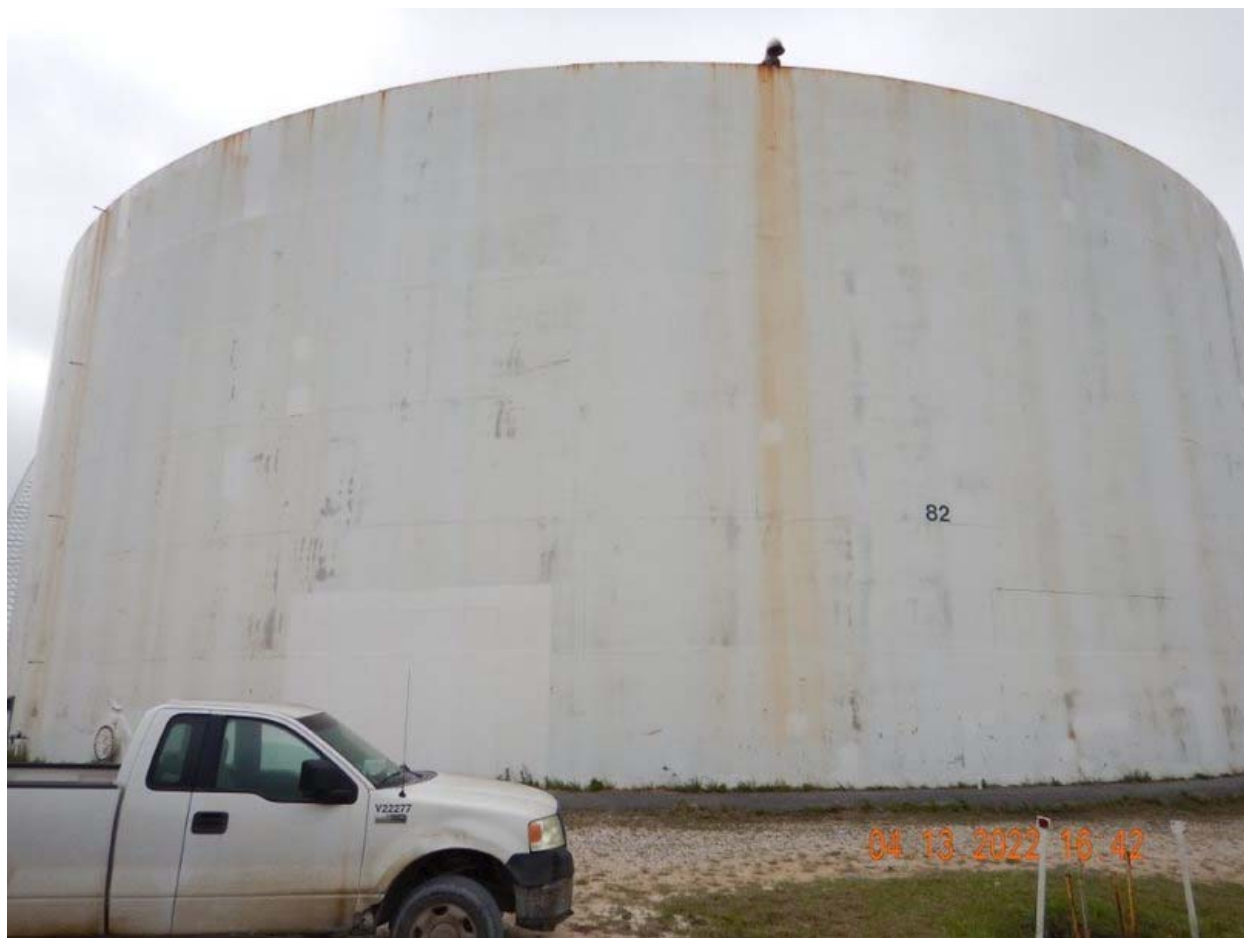
Photo No. 3

| <b>Tank Number</b> | <b>Tank Contents</b> | <b>Hydrocarbons Observed with the OGIC</b> | <b>Visualized Emissions Location</b> | <b>Viewing Location</b> |
|---|---|---|---|---|
| T-82 | Kerosene | Yes | Observed at seal gap and coming from pinhole leaks. | Base of Tank |

Tanks can be physically distorted when large openings are cut into a tank shell. Force displacements from this type of disruption can cause flattening above the door sheet itself, bulging at the corners of the door sheet, and could cause the tank shell to deform into a more oval shape (Lieb, John M. *Importance of Door Sheet Stiffening*). Without proper stabilization of the tank shell, these changes in design characteristics could lead to excess emissions.

Description: Tank T-82. OGIC-visualized hydrocarbon emissions were observed exiting the gooseneck valve at the top of the tank. Two door sheets are visible at the base of the tank.

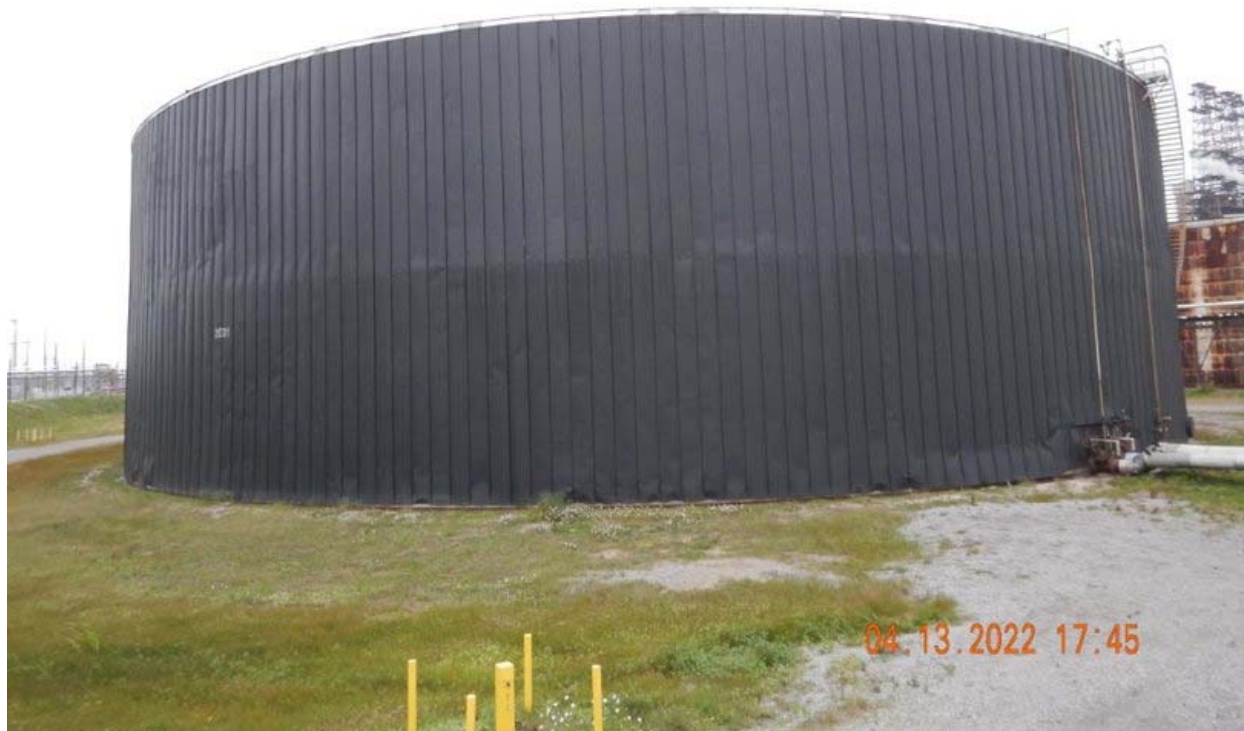
Photo No. 4

A facility LDAR technician observed readings over 30,000 ppm, or above 3% of the sampled air, at a hatch on the roof of T-2001. The tank is not currently classified or monitored as a MACT CC Group 1 storage vessel. The facility must record any data, assumptions and procedures used to make the determination that the weight percent total of the HAP of the stored liquid is less than or equal to 4 percent. Additionally, the Facility should maintain best practical housekeeping and maintenance practices to the highest possible standards to reduce the quantity of organic compound emissions pursuant to the practices listed in Title 33 of the Louisiana Administrative Code Section 2113.

Description: Tank T-2001.

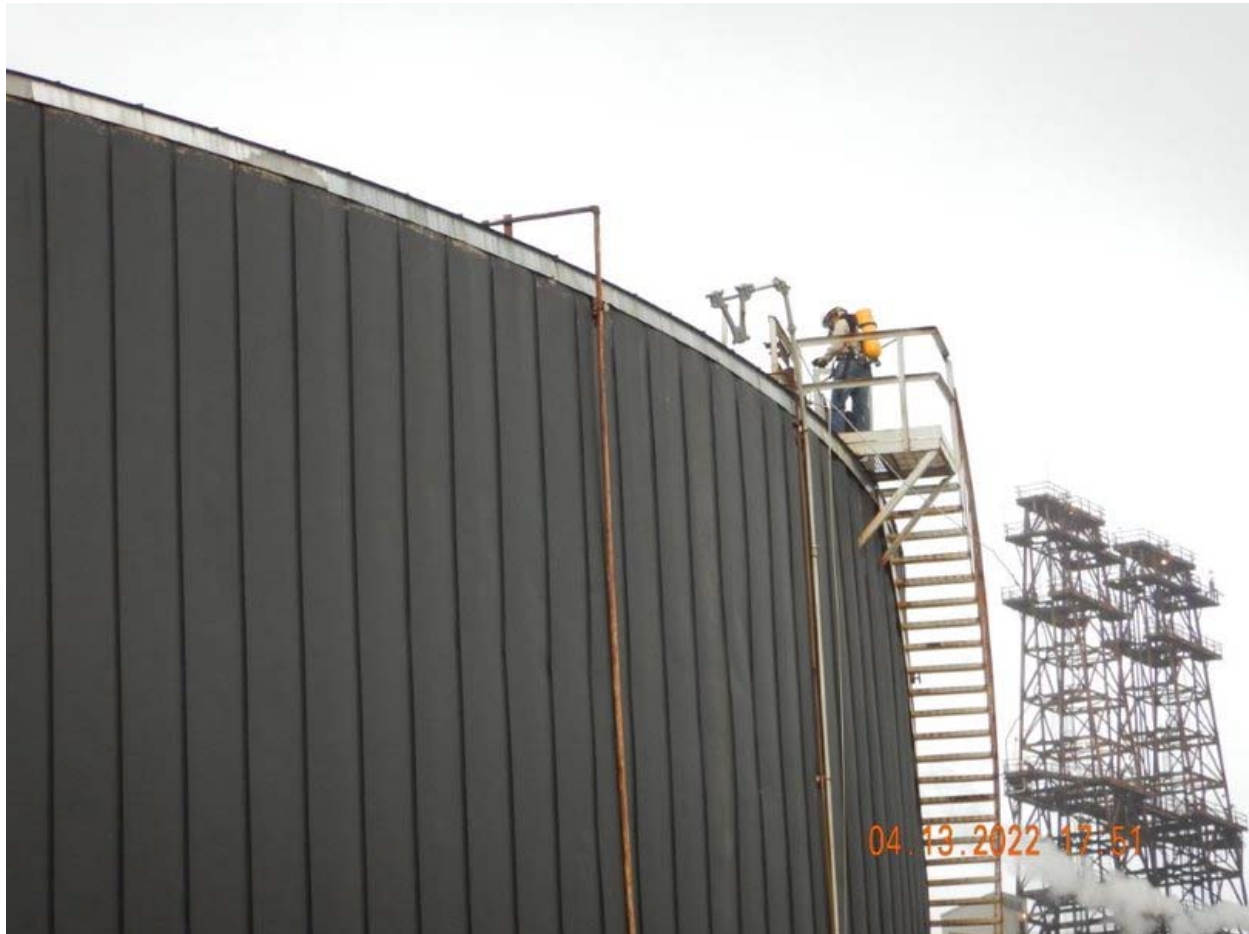
Photo No. 5

Description: Facility LDAR technician using handheld monitoring equipment at the top of T-2001.

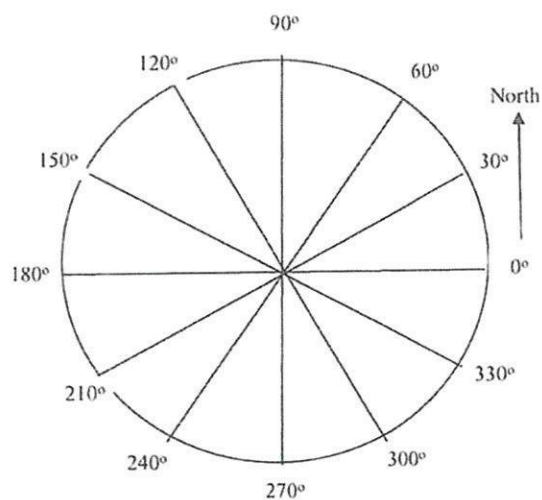
The measured primary gap width exceeded the maximum allowable gap width. Repairs have been initiated within 7 days by assessing the primary seal and scheduling work to complete the repair. Repairs will be completed within 45 days or the tank will be taken out of service.

| Gap Location<br>(clock position) | Gap length L<br>(inches) | Max. widths W<br>(inches) | Total Gap A<br>(sq. inches) |
|---|---|---|---|
| Max. Gap Width, inches = | | | 120 |
