**Region 6 - Enforcement & Compliance Assurance Division**  
**INSPECTION REPORT**

| Media Program: | RCRA Compliance Evaluation Inspection | |
| Company Name: | <b>Starpak LTD.</b> | |
| Facility Name: | <b>Starpak - Houston</b> | |

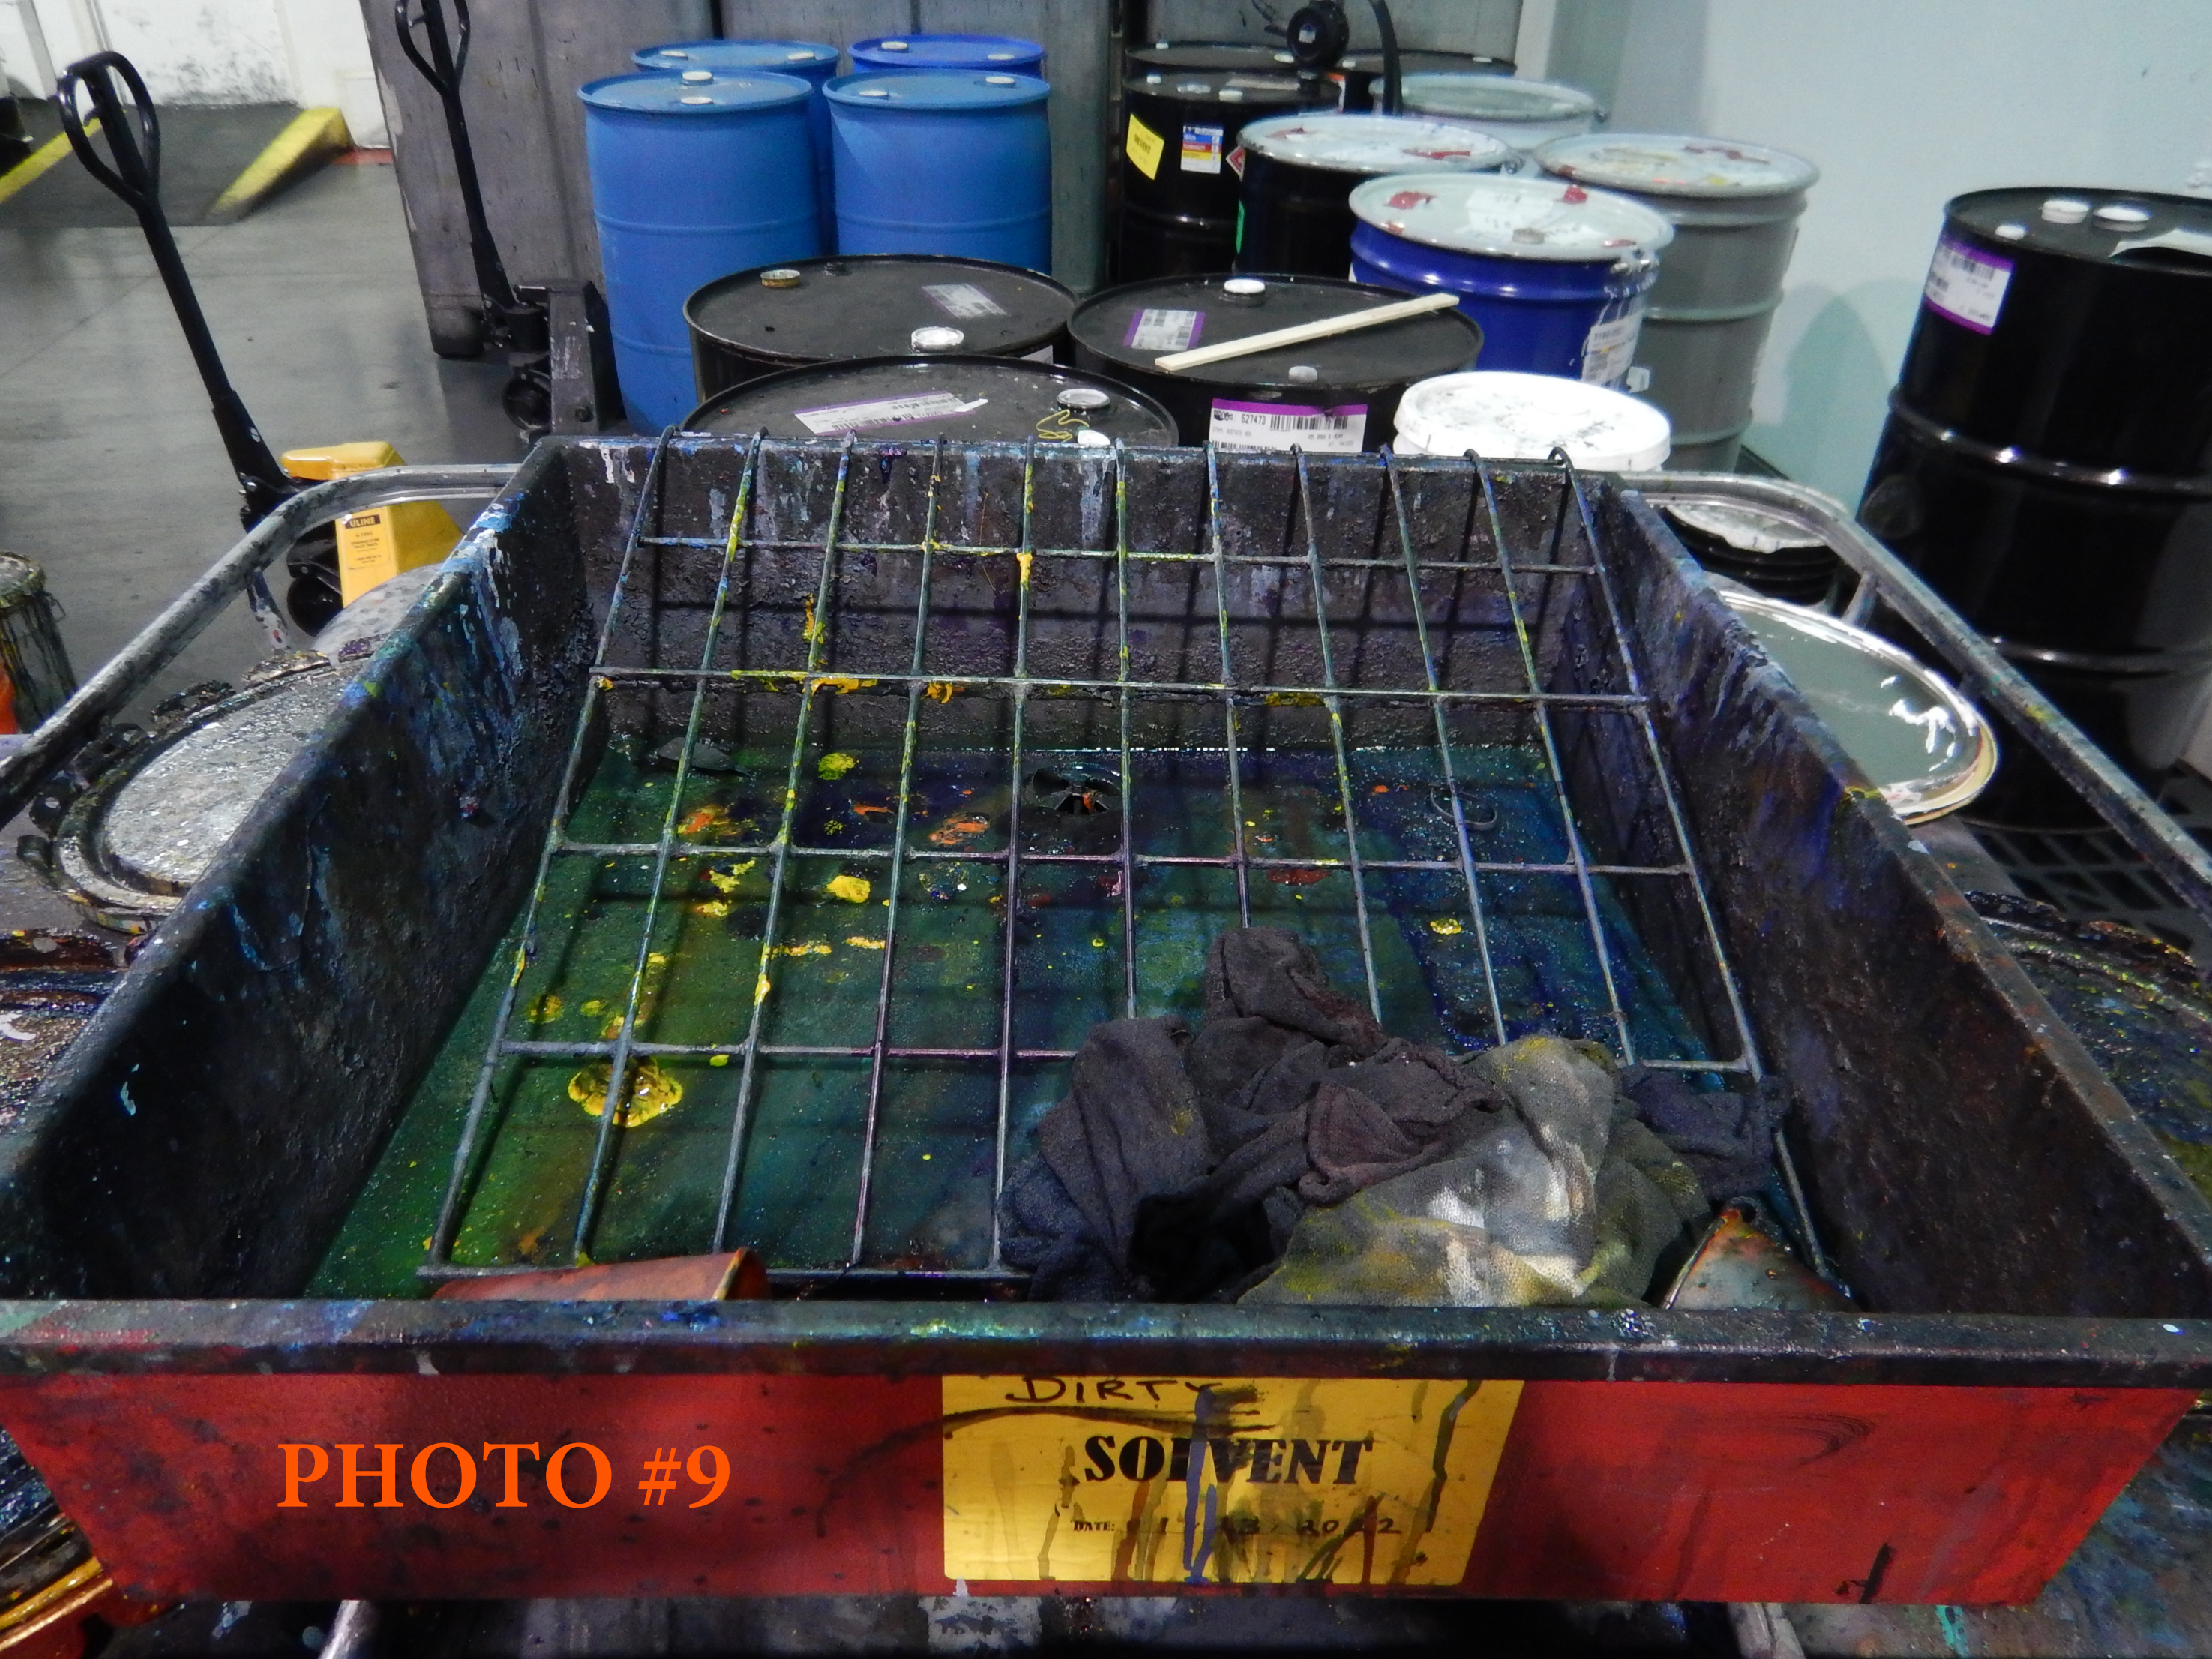
PHOTO #9

Areas of Concern - Hazardous Secondary Materials are required to be managed in a manner that meets the definition of contained (40 CFR 260.10). The tote Starpak uses to accumulate dirty solvent in the PRI Distillation Area was open when observed on Tuesday, February 22, 2022.

DIRTY  
SOLVENT  
DATE: 11/13/2012

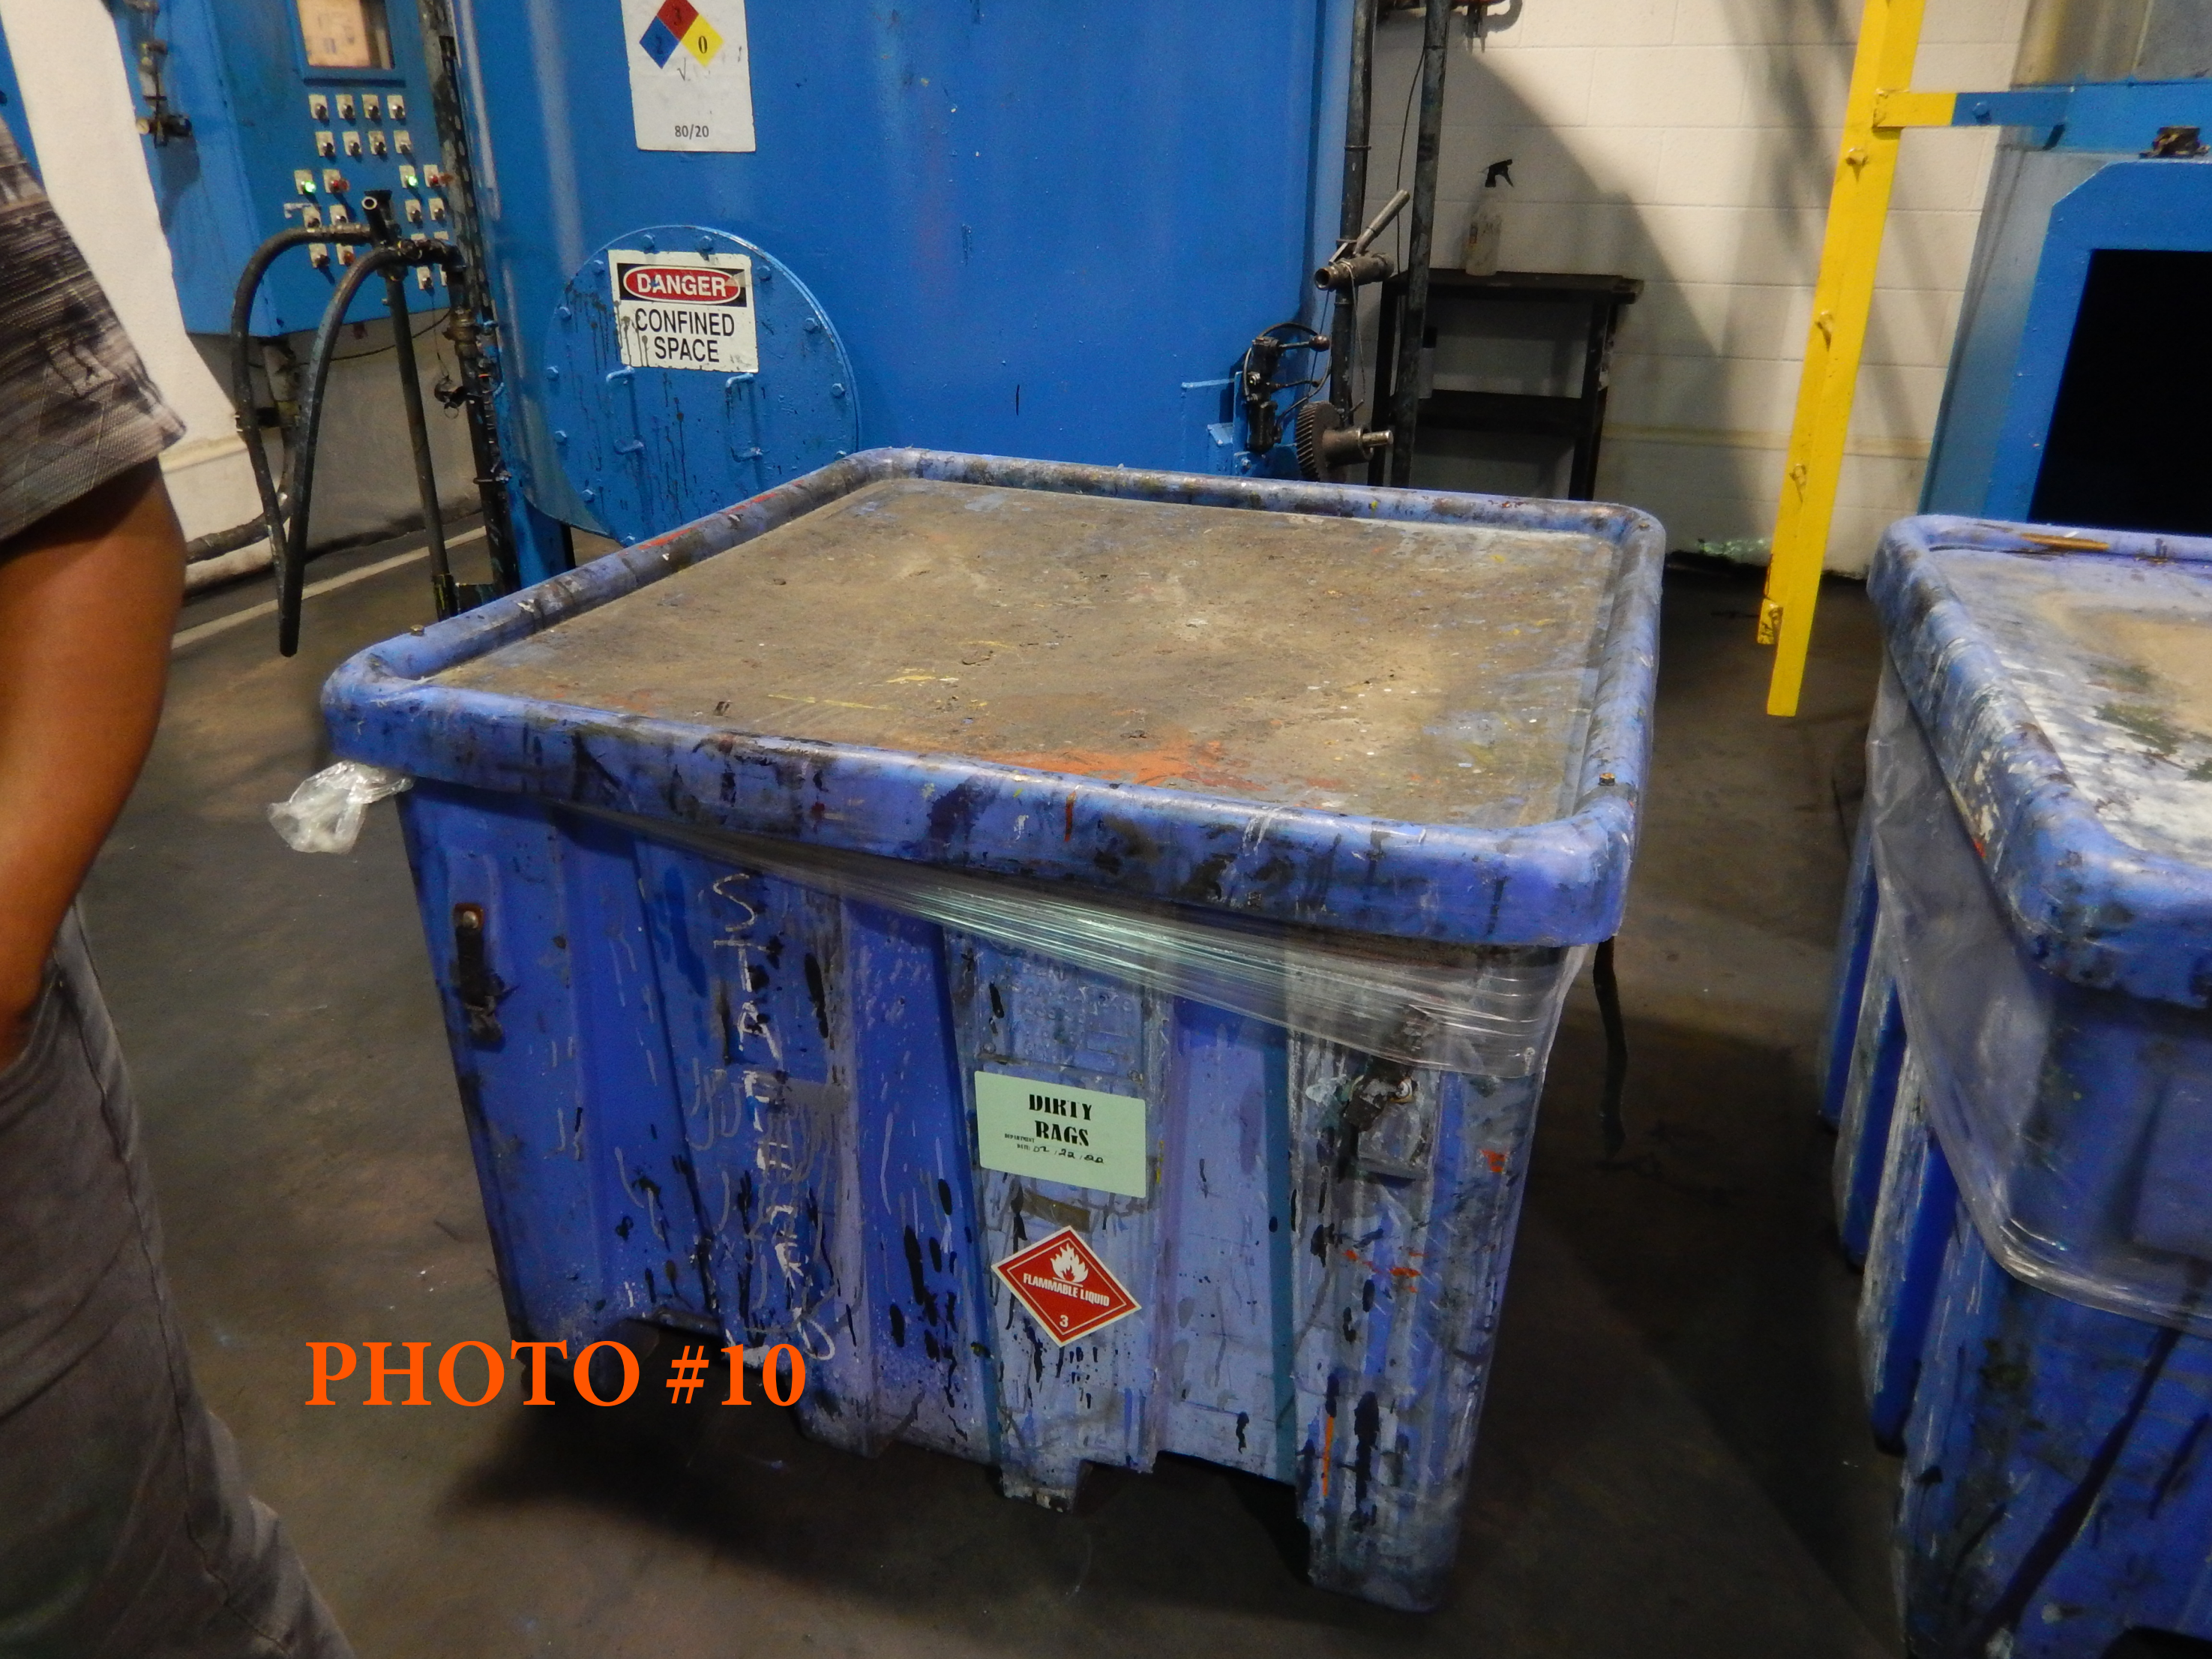
PHOTO #10

| Photo # | Image # | Date | Time | Subject |
|---|---|---|---|---|
| 10 | DSCN0534 | 2/22/2022 | 11:35 AM | View of 1 of 3 observed containers of rags that will go for laundering. |

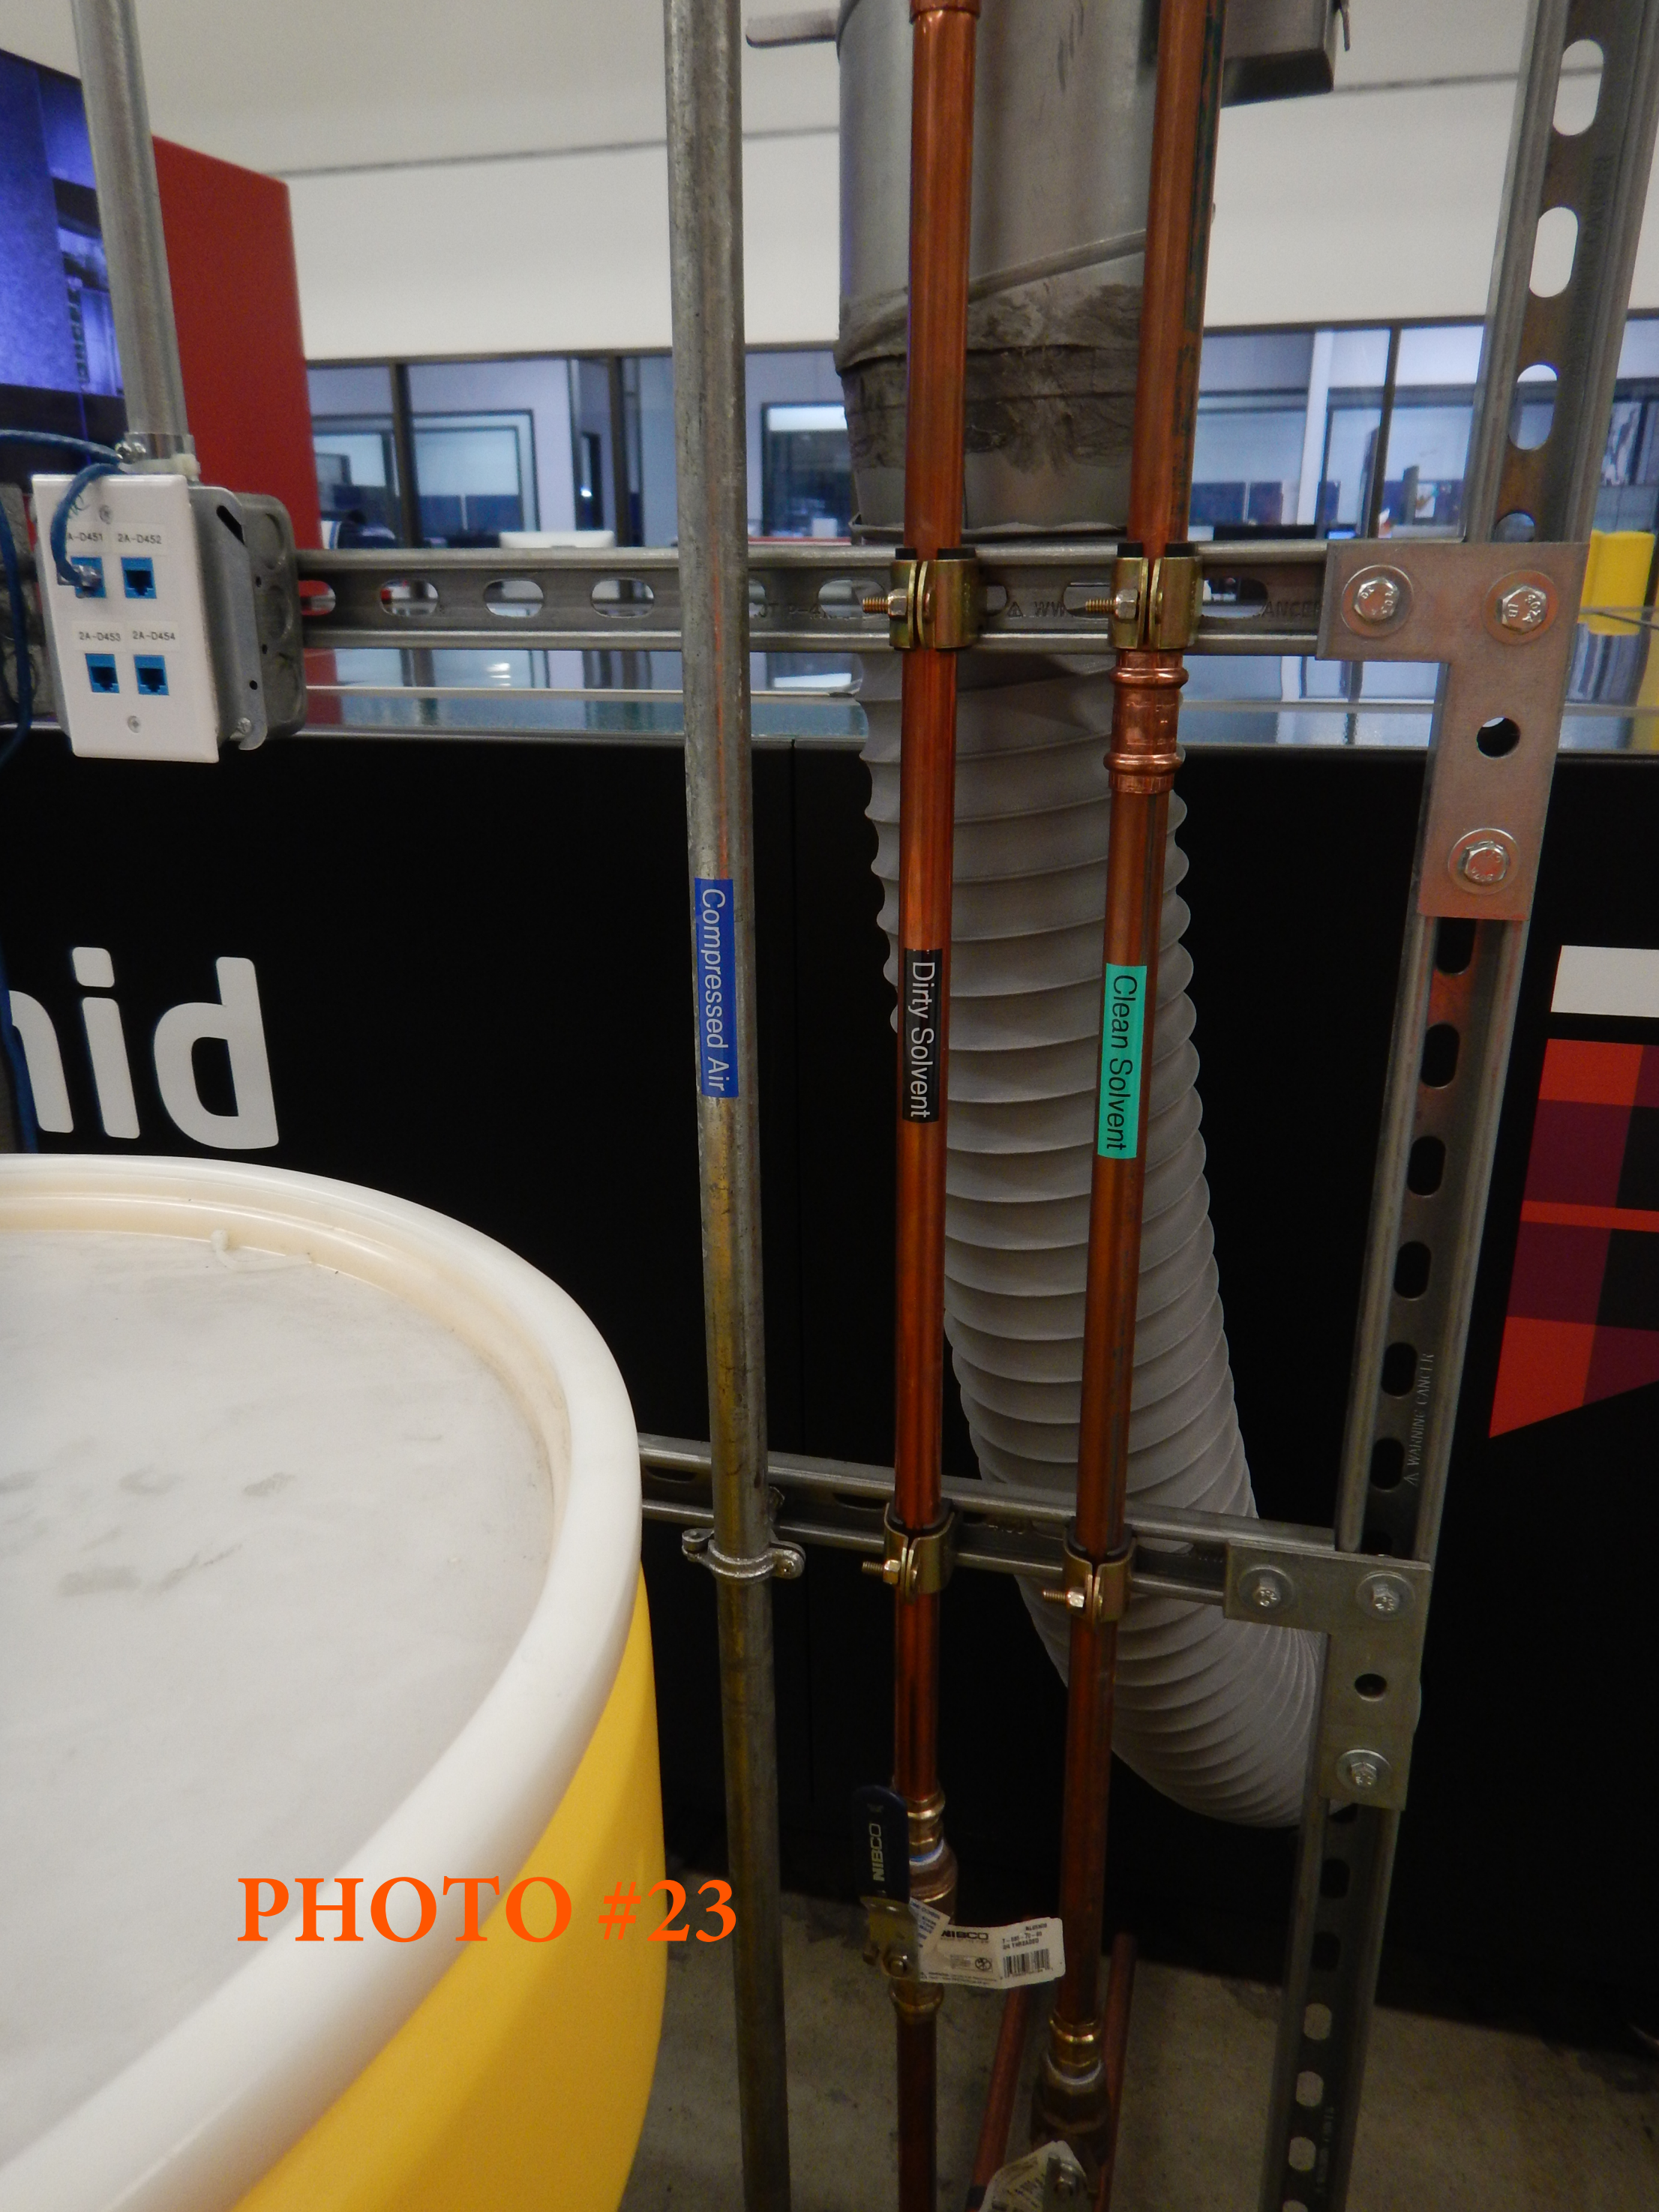
PHOTO #23

| Photo # | Image # | Date | Time | Subject |
|---|---|---|---|---|
| 23 | DSCN0547 | 2/22/2022 | 12:00 PM | Cyrel washout system - piping |

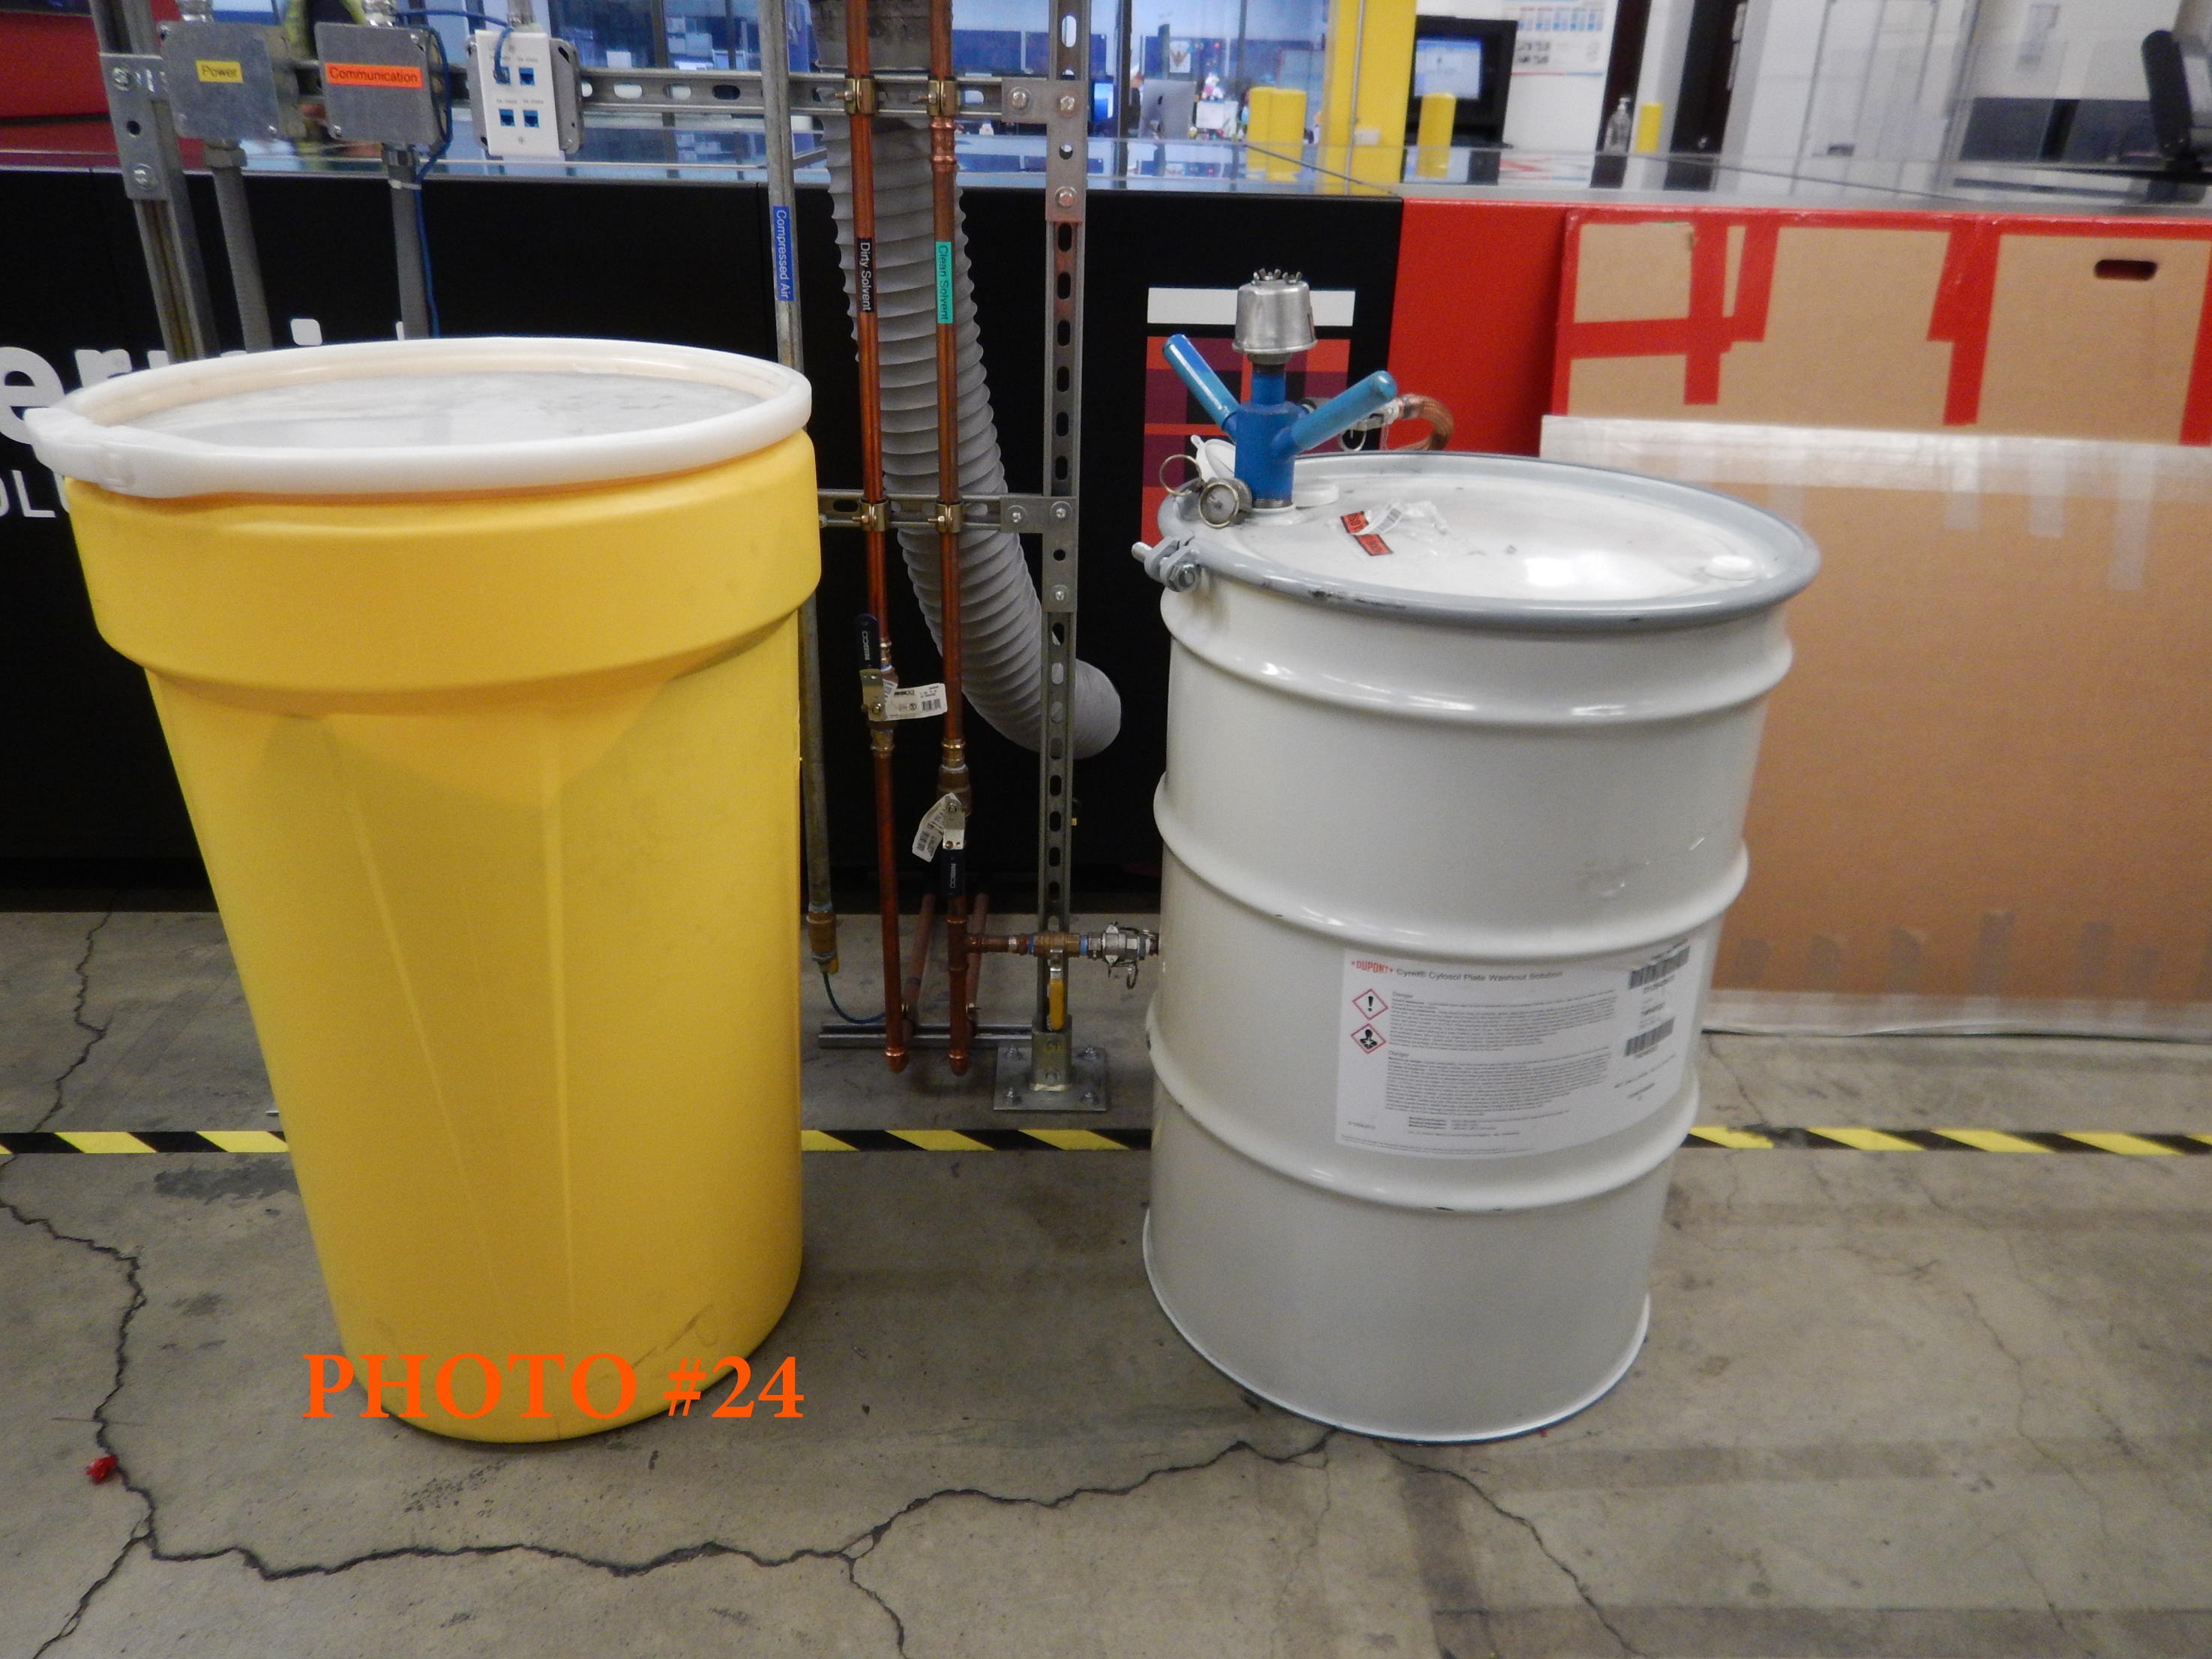
PHOTO #24

| Photo # | Image # | Date | Time | Subject |
|---|---|---|---|---|
| 24 | DSCN0548 | 2/22/2022 | 12:00 PM | Cyrel overview - clean washout solvent container. |
