INSPECTION REPORT

| <b>Type of Inspection</b> | CEI - Compliance Evaluation Inspection | | |
| <b>Permittee Name</b> | Eramet Marietta Metallurgical Plant | | |
| <b>Permit Number(s) (If Applicable)</b> | OH0004006 | | |

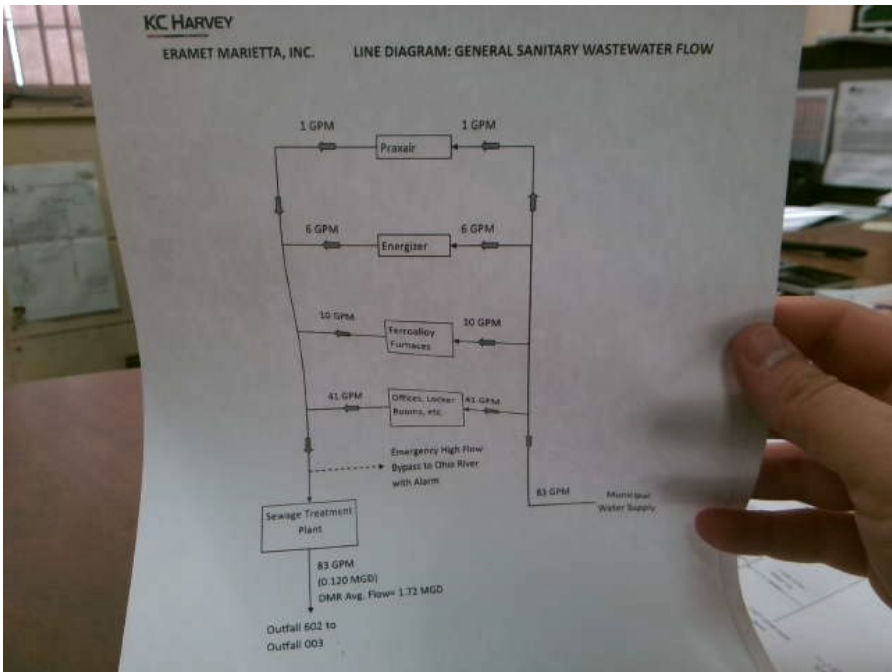
| Diagram of General Sanitary Wastewater Flow | IMG-20221213095800580103364.jpg | |

Line Diagram: General sanitary wastewater flow

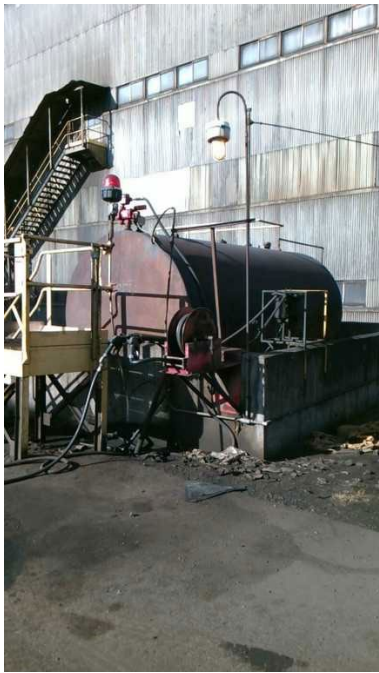
| Diesel refueling tank | IMG-202212131227292729591548.jpg | |

Diesel refueling tank with containment

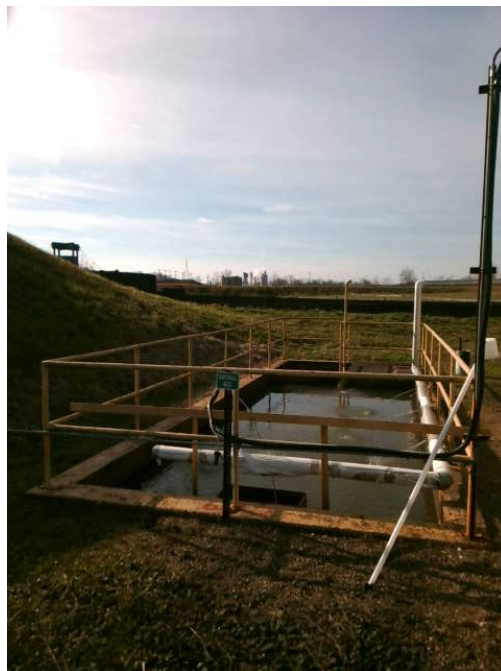
| Outfall 602 | No CBI | No PII |

| Sampling location for 605, acting as a clarifier, which then flows to 003. | | |

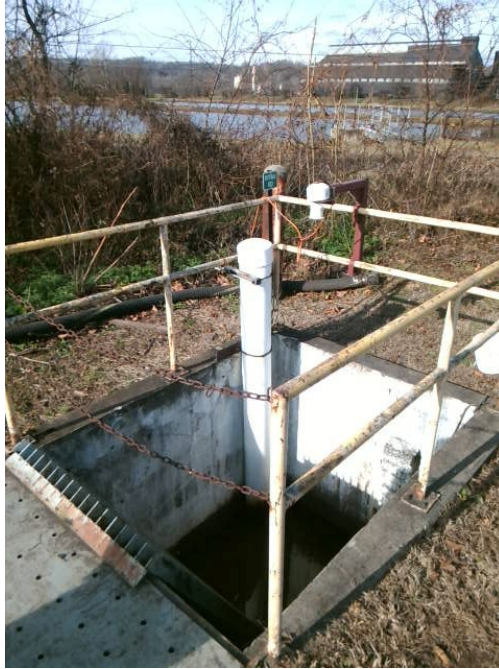
| Outfall 603 | No CBI | No PII |

| Outfall 603, containing scrubber recycle water. | | |

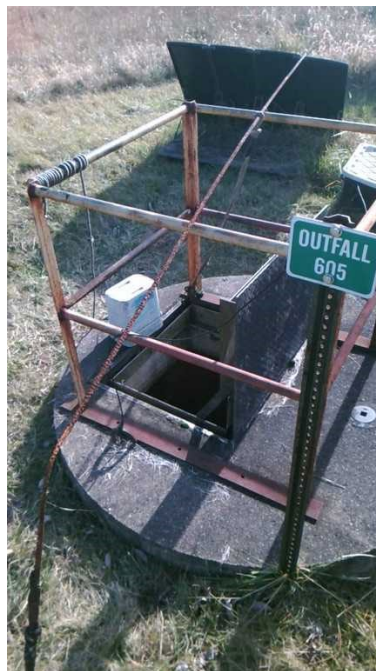
| Outfall 605 | No CBI | No PII |

| Outfall 605, flow monitoring and composite sampling | | |

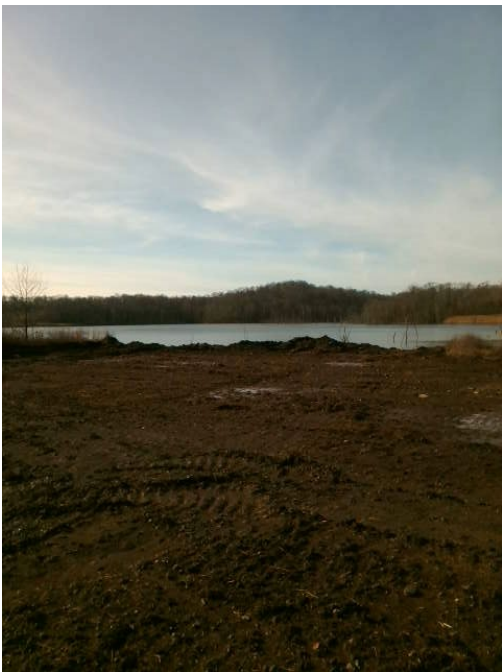
| Wastewater solids north impoundment | No CBI | No PII |

| Final resting place for manganese hydroxide. | | |
