**Region 6 Compliance Assurance and Enforcement Division  
INSPECTION REPORT**

| Inspection Date(s): | 05/14/2015 | | |
| Facility Name: | <b>Nambe Headstart Water System</b> | | |
| Identification/Permit Number: | NM3598726 | | |

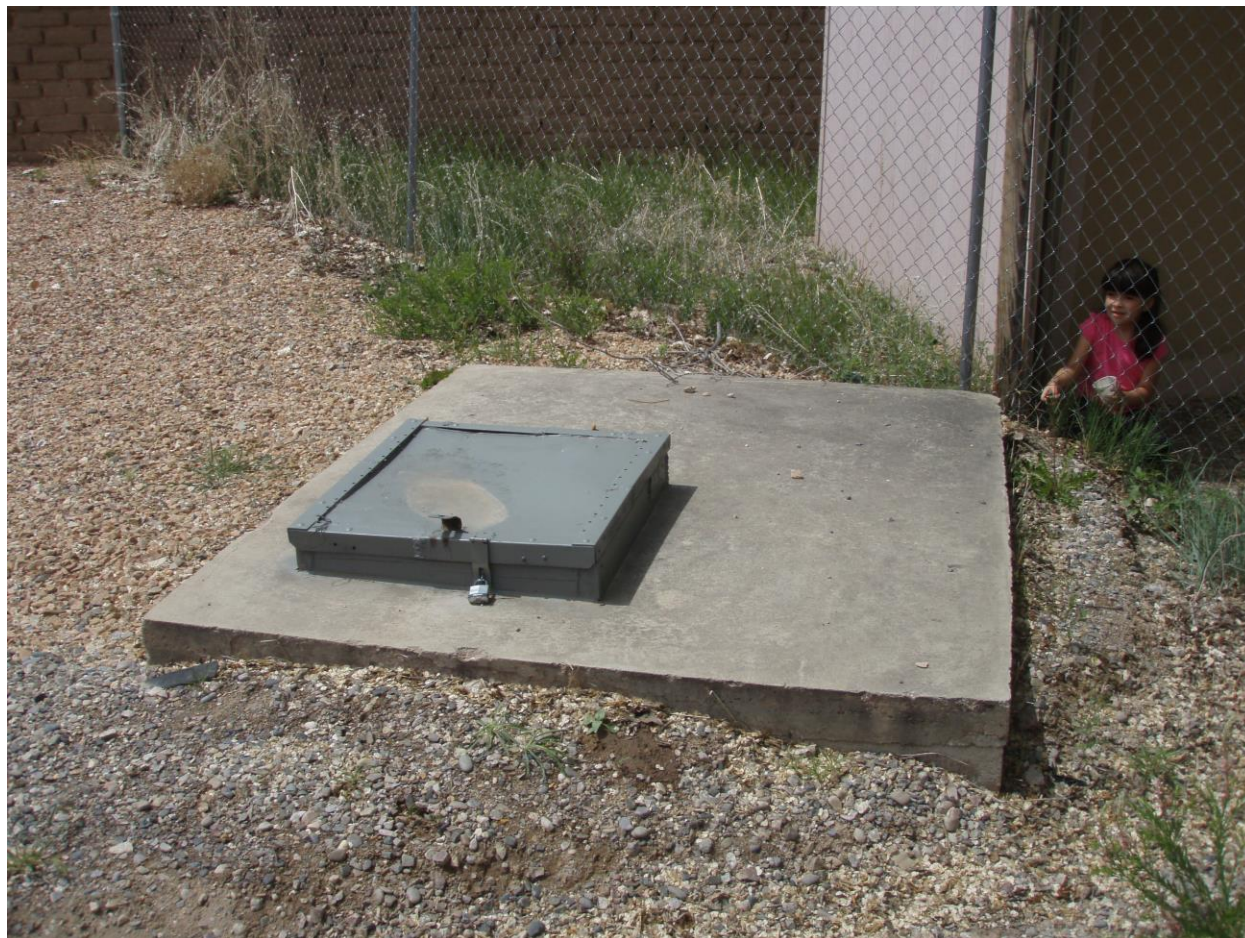
Photo No. 1

Photo File Name: Well #1 Pad & Hatch

Description: 30-year old well inside vault, with a depth between 50-100 feet.

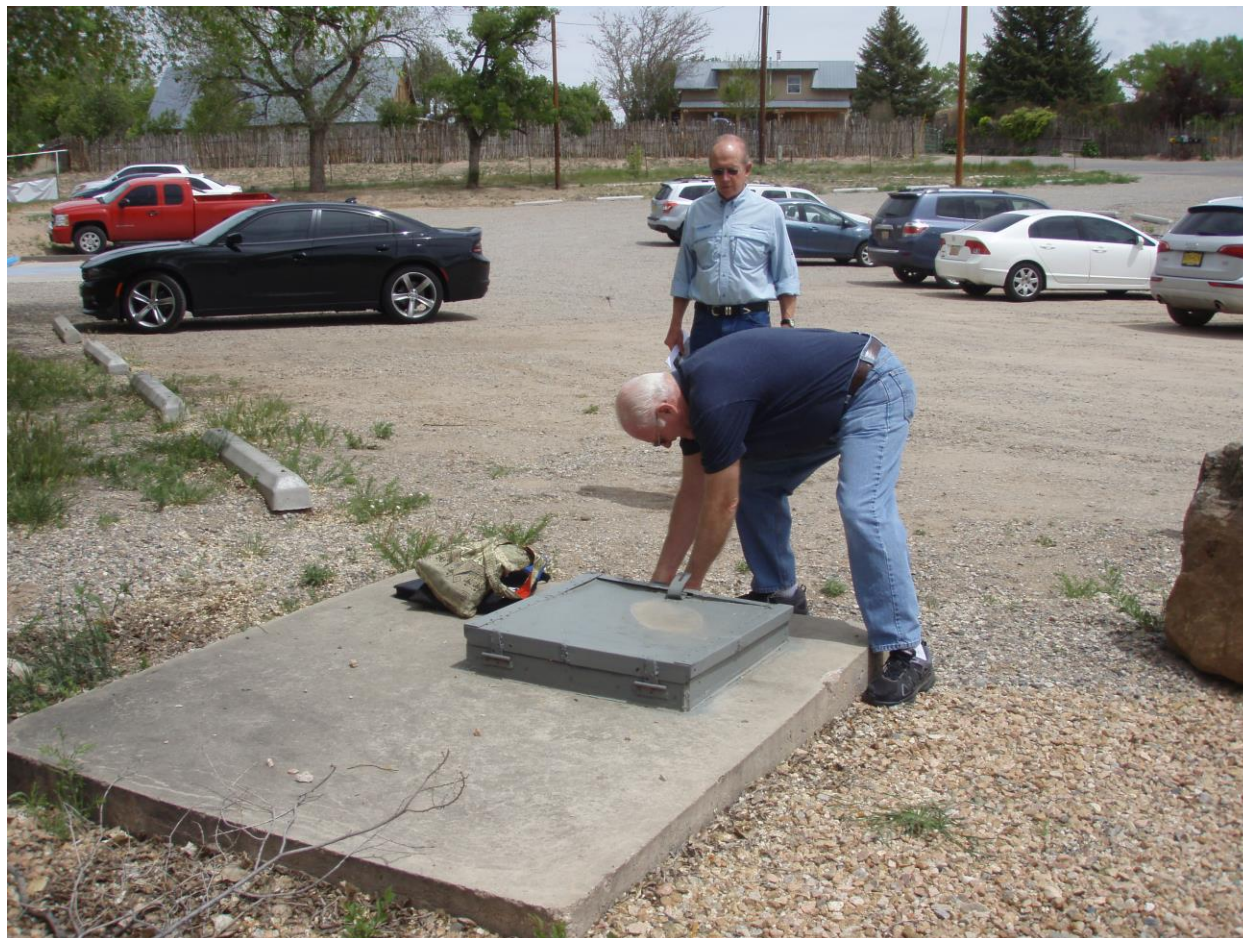
Photo No. 2

- Well #1 is located inside a vault adjacent to parking lot that slopes downward toward well (Appendix 1, Photo 2). The well pad is raised, but the well head itself is a few feet below grade (Appendix 1, Photo 3). Flooding from the parking lot is unlikely, but if the water level rose above well pad, it would present contamination to the source.

Photo File Name: Area Around Well #1

Description: Located adjacent to the parking lot, which slopes downward toward the well vault. The well pad is adequately raised, though well head is a few feet below grade.

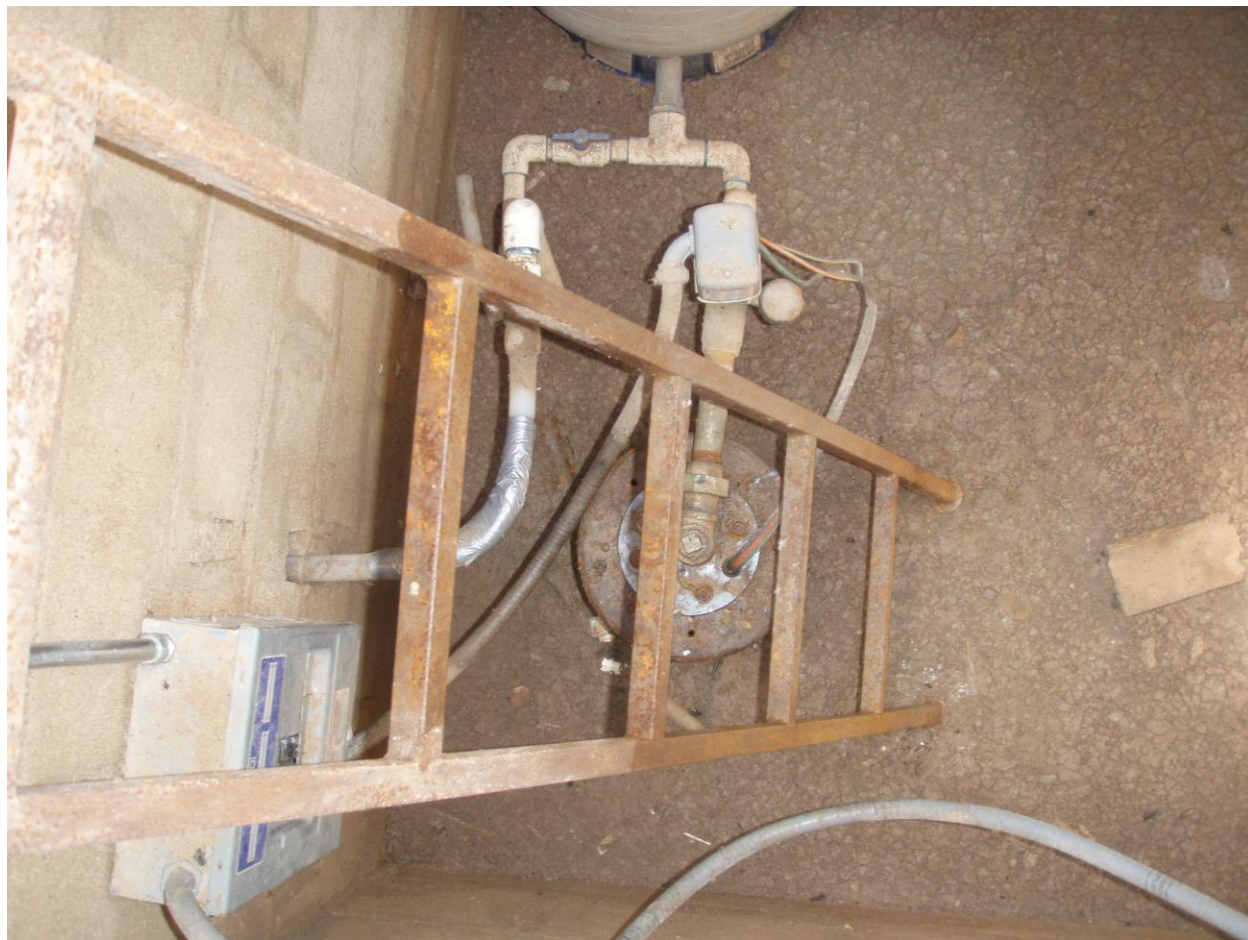
Photo No. 3

Photo File Name: Well #1 Vault

Description: Well #1 is located inside a vault, with top of well head a few feet below grade.

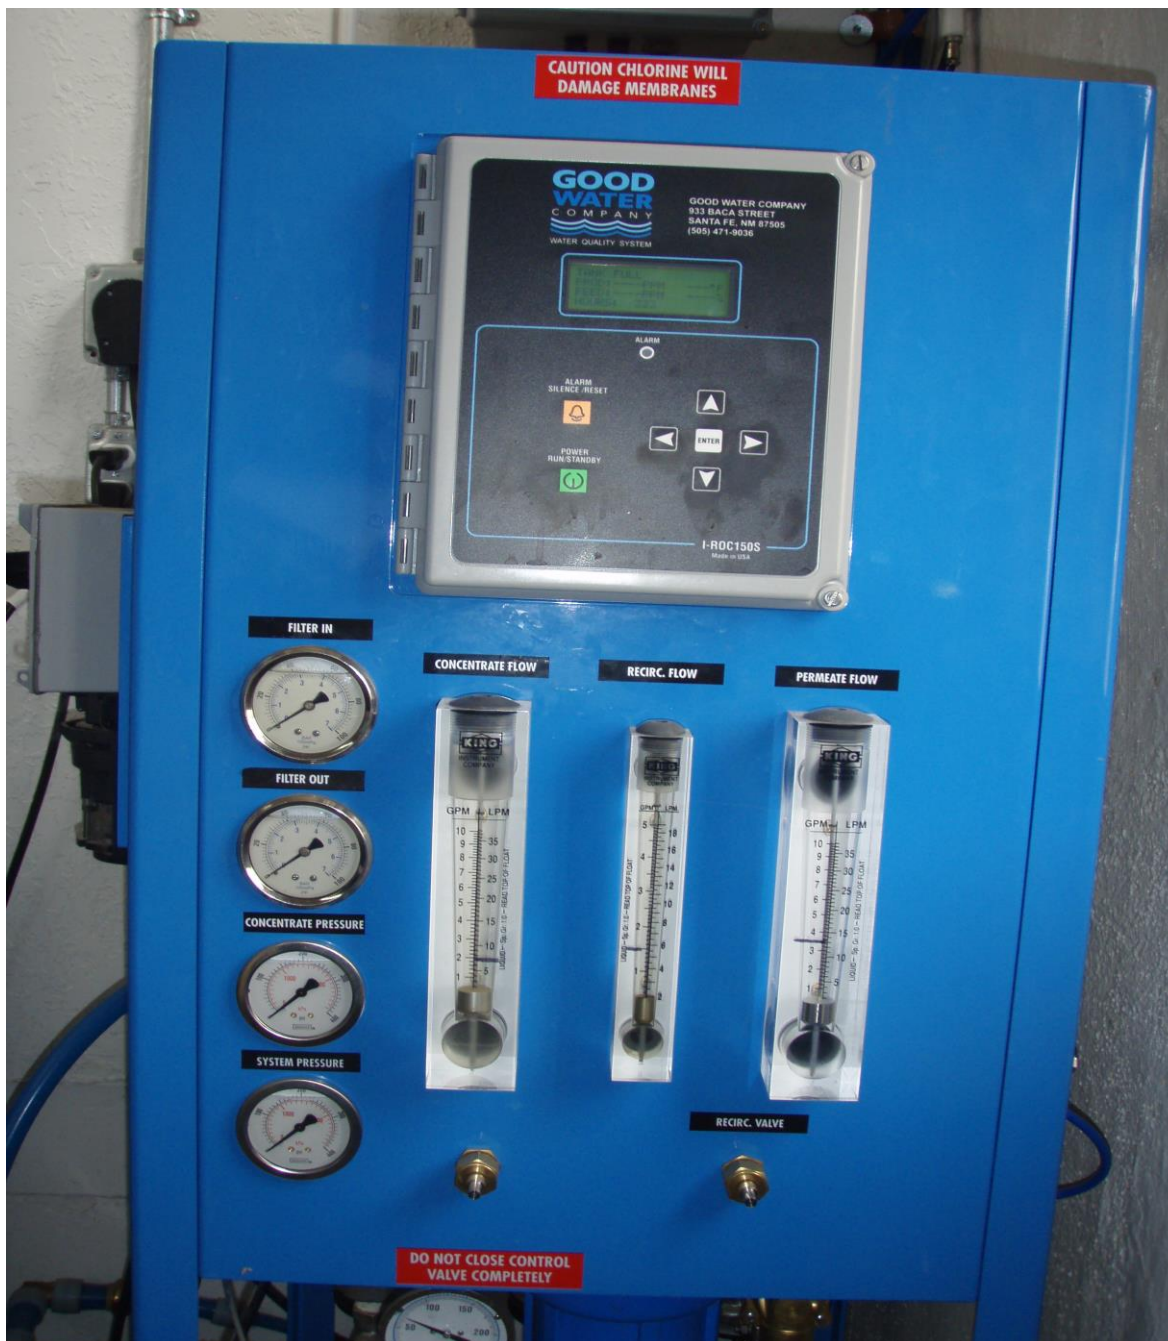
Photo No. 4

Photo File Name: Treatment System Controls

Description: Control panel and measurement gauges for nanofiltration system.

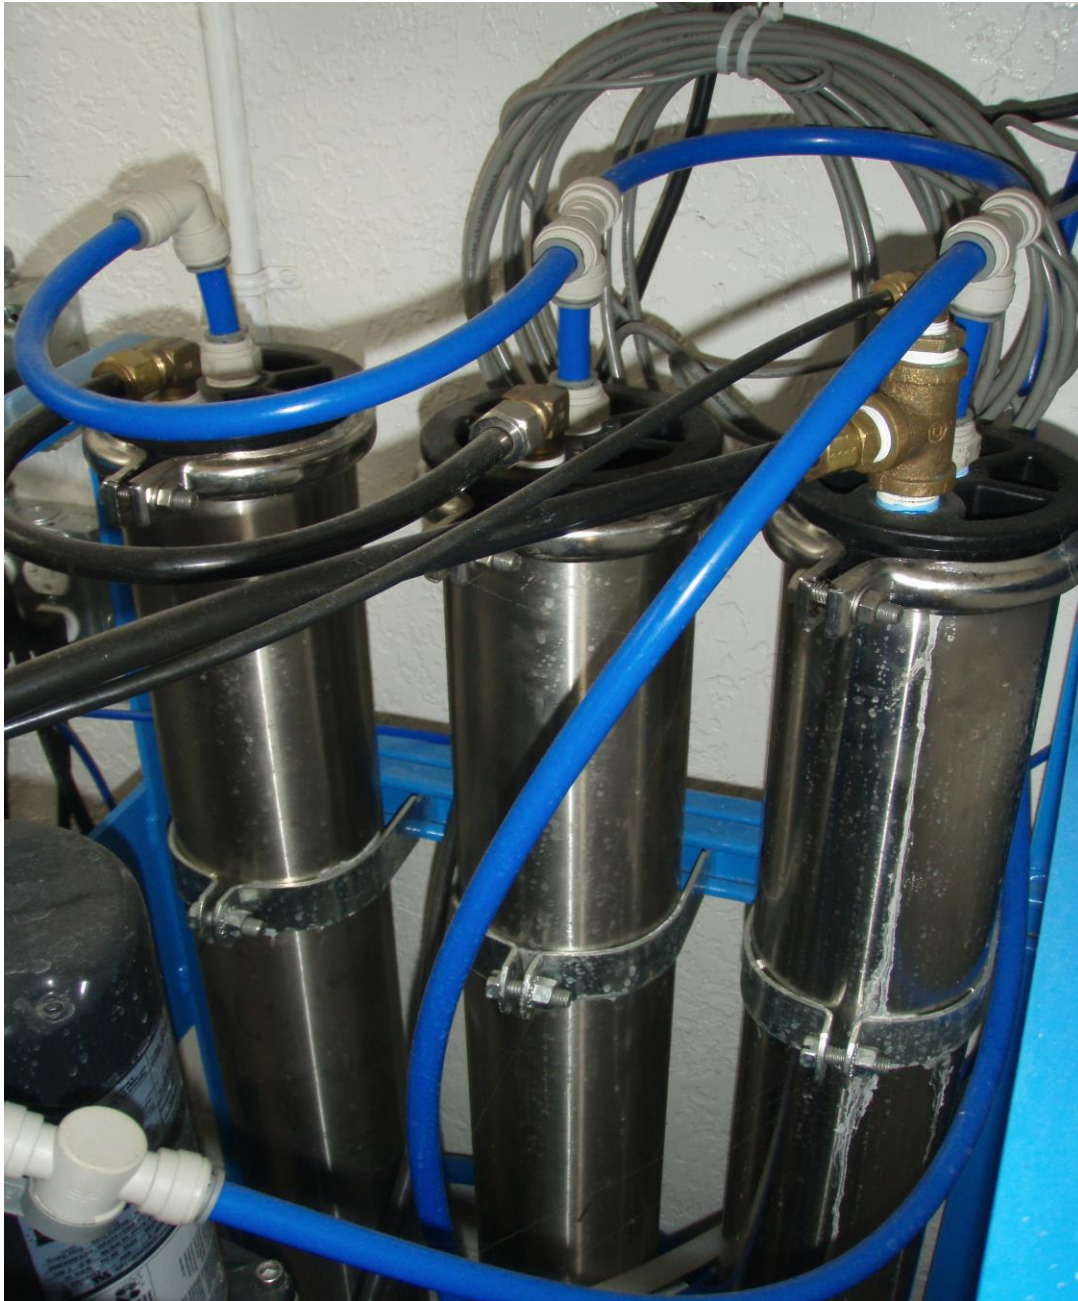
Photo No. 5

Photo File Name: Nanofiltration Units

Description: Canisters containing nanofiltration membranes.

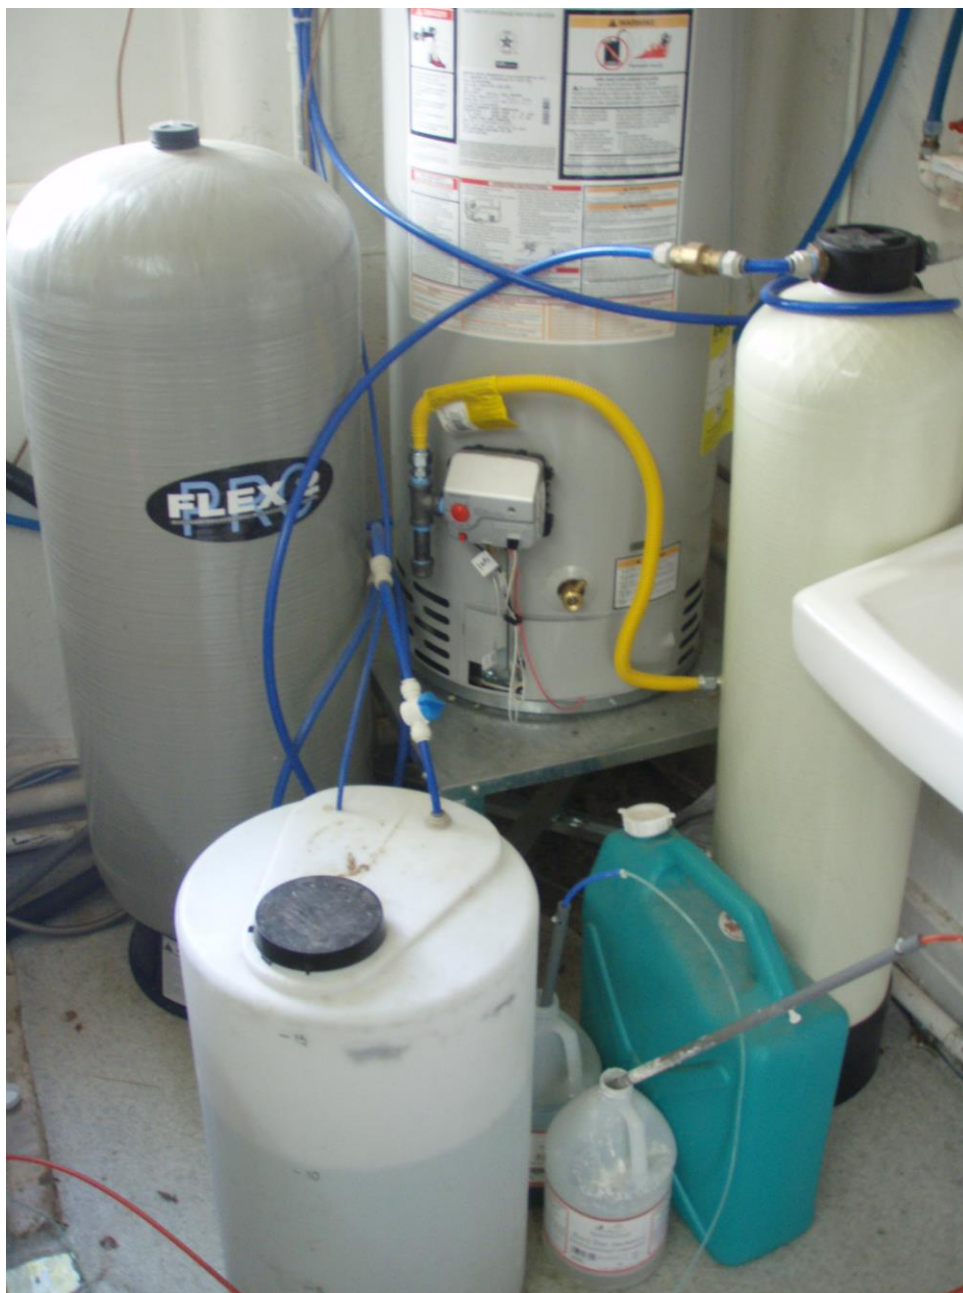
Photo No. 6

- The treatment system is housed inside a small kitchen, including antiscalent and calcite. These chemicals are not particularly hazardous, but it is important that they are properly contained and that employees are cautious when stepping around them.
- During the inspection, each party present confirmed that all water flowing from Well #1 into any given sample tap passes through nanofiltration. This was also observed by EPA and NMED inspectors, to the extent possible.
- There is a community center across the street from Nambe Headstart that utilizes the same well as the school. This facility hosts meetings 2-3 times each month by an unknown number of people. The community center is possibly registered under a separate PWS. There is a water softener installed, but no other treatment.

Photo File Name: Pressure Tank + Antiscalent Storage

Description: Tank to repressurize system post-membrane filtration, and antiscalent, which is added pre-membrane filtration to aide in the dispersion of insoluble particles, all located in school's kitchen.

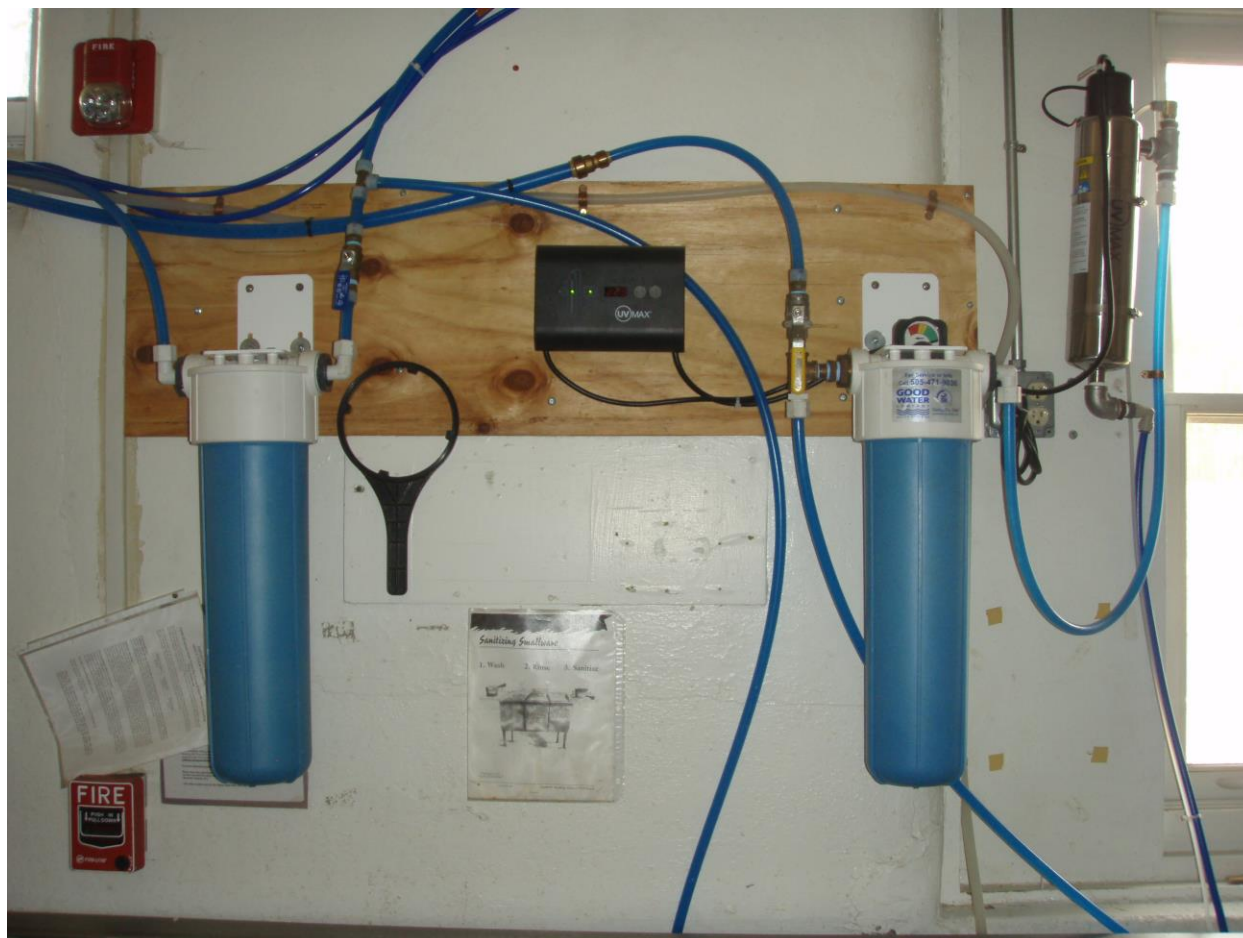
Photo No. 7

Photo File Name: UV + Carbon Filters

Description: After filtration, water passes through UV unit, and is then "polished" by carbon filters before entering distribution.

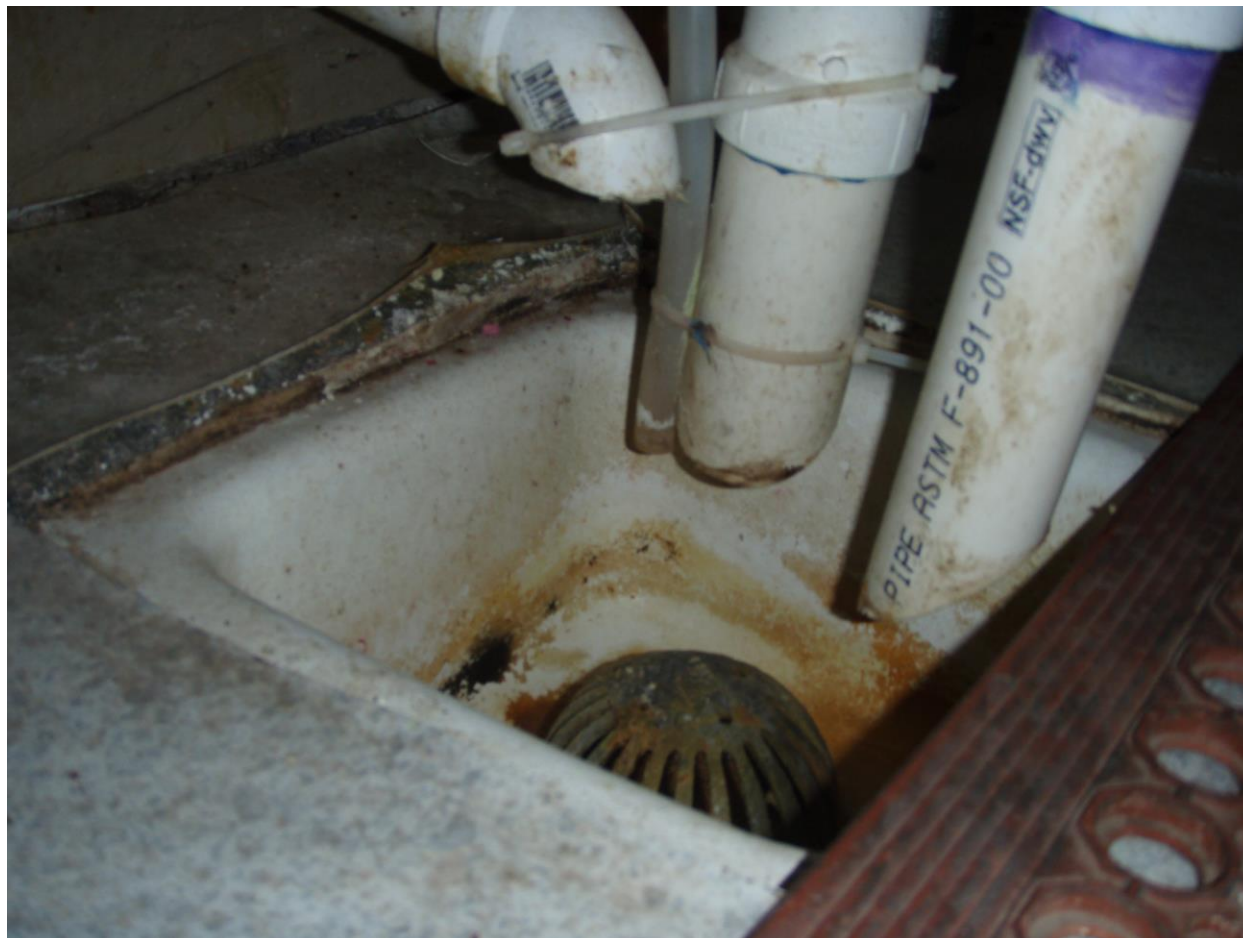
Photo No. 8

- Reject water from the filtration process is discarded into a drain (Appendix 1, Photo 8). Piping terminates below the upper rim of drain, which could back-siphon if the drain overflows.

Photo File Name: Waste Piping

Description: Effluent reject water pipes into kitchen drain.
