Clean Water Act (CWA) Inspection Report

| <b>Type of Inspection</b> | CEI - Compliance Evaluation Inspection | | | |
| <b>Permittee Name</b> | Emerald Forest Products – Plant 1 | | | |
| <b>Permit # / ODEQ File #</b> | ORR222065 / 10889 | | | |

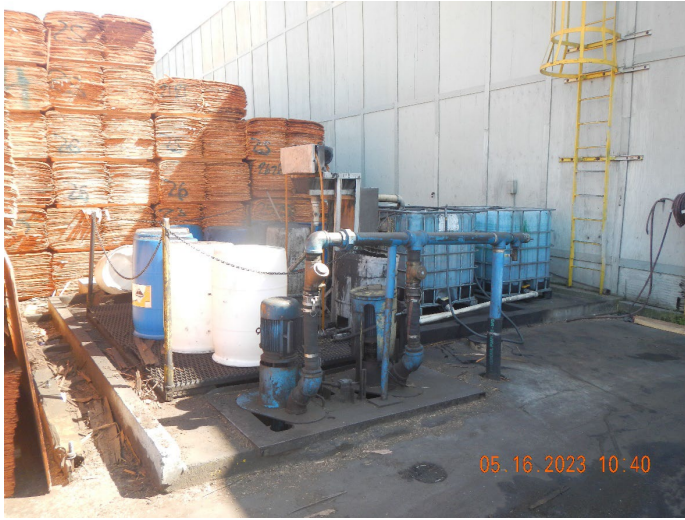
Photo #:01 (DSCN3256)

Description: Facing north, photo of the wastewater pit and skimmer located outside of the manufacturing building. Area is bermed, removed oil is recycled and wastewater is discharged to sanitary sewer.

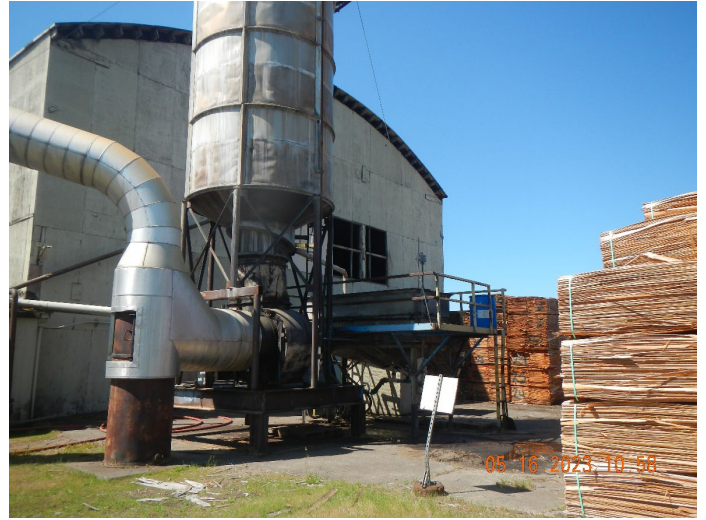
Photo #:02 (DSCN3258)

We travelled north and observed the scrubber wash tank (**Photo 2**), we observed a small amount of water dripping down from the scrubber and ponding on the concrete surface near a vegetated/gravel area just outside of Basin #2, within Drainage Basin #1. Mr. Maples discussed that he previously unaware of the observed dripping. While still at the location, Mr. Maples called and had two individuals from the maintenance staff come and investigate the issue. Upon their arrival, the dripping was determined to be caused from a small opening of the scrubber access hatch and was repaired while on-site. No discharge to the Basin #2 catch basin was observed.

Description: Facing southwest, photo of the facility's scrubber and scrubber wash tank. Observed some water coming off the scrubber and ponding on the ground. Determined to be a leak from the seal of the access hatch, was repaired at the time of inspection.

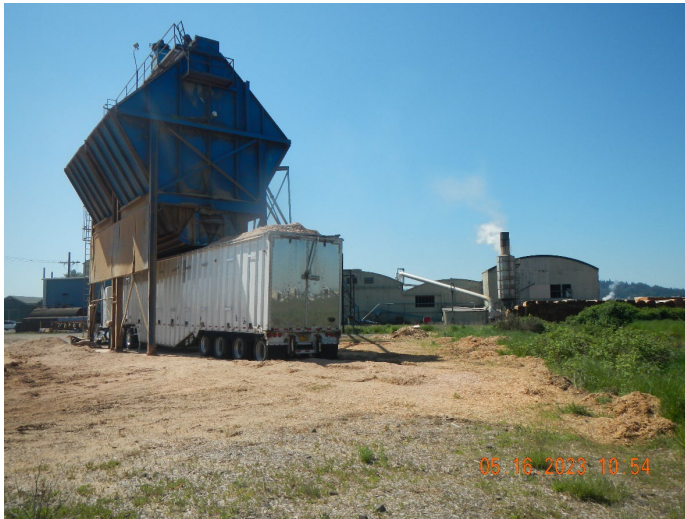
Photo #:03 (DSCN3257)

We first walked the north/northwest perimeter and viewed the chip bin area (**Photo 3**). North of the chip bin, we observed a municipal drainage ditch. According to Mr. Maples and the SWPCP, the ditch is located within a utility easement along the property boundary, flowing east to west and eventually discharging through a constructed concrete basin to the municipal stormwater system (subsurface) along W. 5<sup>th</sup> Avenue. We observed the chip bin area to have widespread overflow of woodchips within the area. According to Mr. Maples, the area is periodically scraped with a front loader to address the overflow of woodchips that occurs during loading. We observed the municipal drainage ditch and areas of vegetative berming between the chip bin area and the ditch.

Description: Facing south, photo of the chip bin in the northern section of the facility. Area is bermed to the west along the municipal drainage ditch.

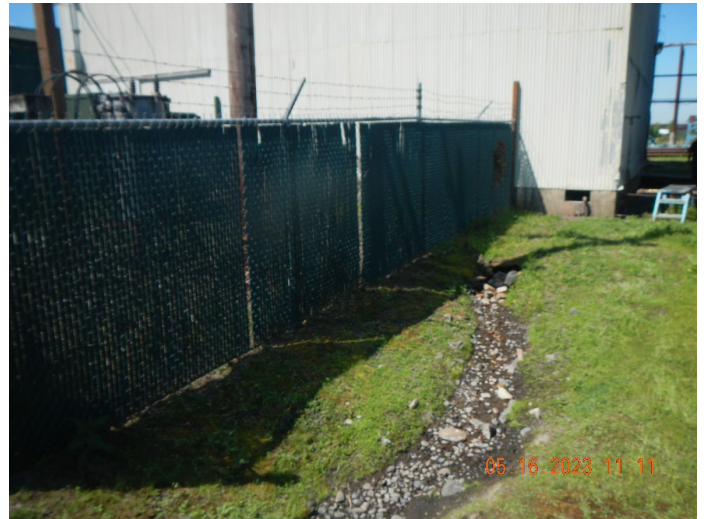
Photo #:04 (DSCN3259)

At the time of inspection, we observed a water conveyance/channel off of the older diesel boiler building (**Photo 4**). The water conveyance travelled west to east from an outdoor concrete sump and then went subsurface. When asked about the source of the water during dry weather conditions, Mr. Maples was unsure and called Mr. Scott Tucker, Maintenance Supervisor and Mr. Wes Cunningham, Boiler Operator/Millwright. Both Mr. Tucker and Mr. Cunningham arrived shortly after and we walked through the boiler process flow piping, it was discussed that the excess boiler make-up water and water from the deaerator tank is routed to sanitary sewer via an indoor sump and piping, as indicated on the Facility Map (**Attachment C**). The interior sump routes to sanitary sewer. We observed a small crack in the concrete that separates the interior sump from the outdoor structure. The outdoor structure contained standing water (**Photo 5 & Photo 6**). At the time of inspection, it was unclear where the water conveyance/channel from the outdoor structure is ultimately discharged.

As discussed earlier in this report, during the walk-through within Drainage Basin #1 we observed a water conveyance/channel off of the older diesel boiler building (**Photo 4**). The water conveyance travelled west to east from an outdoor concrete sump and then went subsurface via piping. It was discussed that inside the older boiler building, the excess boiler make-up water and water from the deaerator tank is routed to sanitary sewer via an indoor sump and piping, as indicated on the Facility Map (**Attachment C**). The interior sump routes to sanitary sewer. We observed a small crack in the concrete that separates the interior sump from the outdoor structure. The outdoor structure contained standing water (**Photo 5 & Photo 6**). At the time of inspection, it was unclear where the observed water conveyance/channel from the outdoor structure is ultimately discharged.

The concern was the crack observed within the interior sump containing excess boiler make-up water and water from the deaerator tank, possibly being discharged as stormwater via the observed water conveyance. In addition, the observed conveyance channel was not identified on the Facility Map.

Description: Facing west, photo of water conveyance off of the older hog fuel fired boiler building.

During the closing conference, Mr. Maples discussed that he would work with PBS Engineering and Environmental Inc. (Facility Consultant) to determine the discharge location/drainage of the observed conveyance channel and address the issue accordingly.

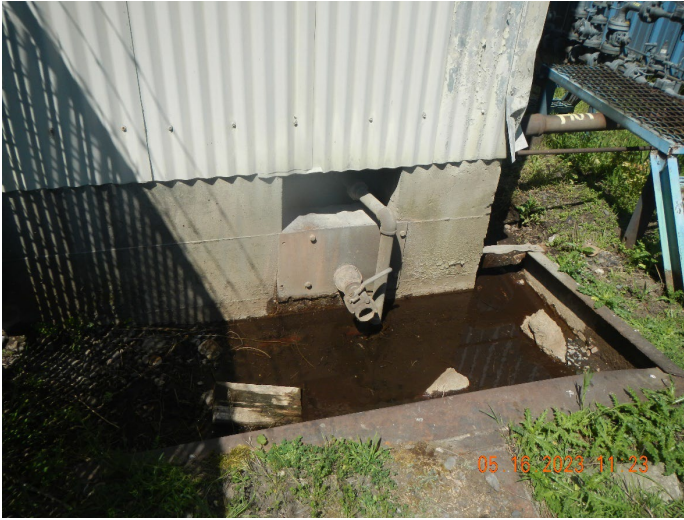
Photo #:05 (DSCN3260)

Description: Facing west, photo of basin off of the boiler building, discharging to the channel. Observed slight crack in the concrete structure holding the interior boiler make-up water being routed to sanitary.

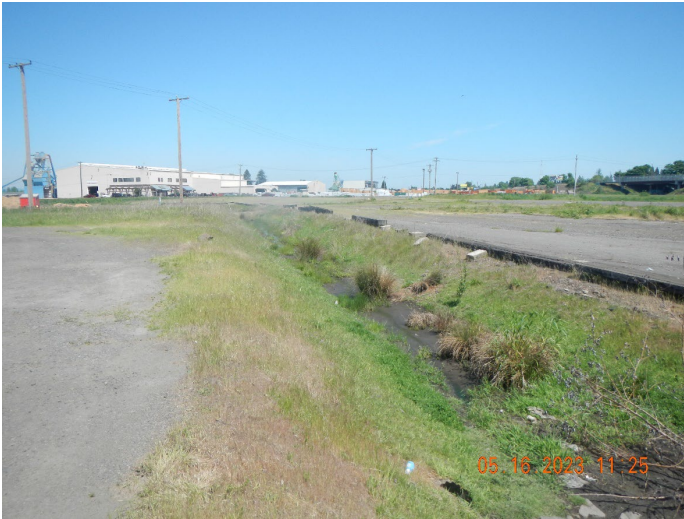
Photo #:07 (DSCN3262)

We then walked to the eastern portion of the municipal drainage ditch (**Photo 7**). We observed small amounts of standing water within the municipal drainage ditch and multiple inlet pipes (without flow) were observed on both sides of the ditch (**Photo 8**). A vacant lot/property is located on the eastern side of the eastern drainage ditch. Mr. Maples was not aware of any active connections to the municipal drainage ditch. We also observed a small

Description: Facing north, photo of the east end of the municipal drainage ditch. Observed some standing water.

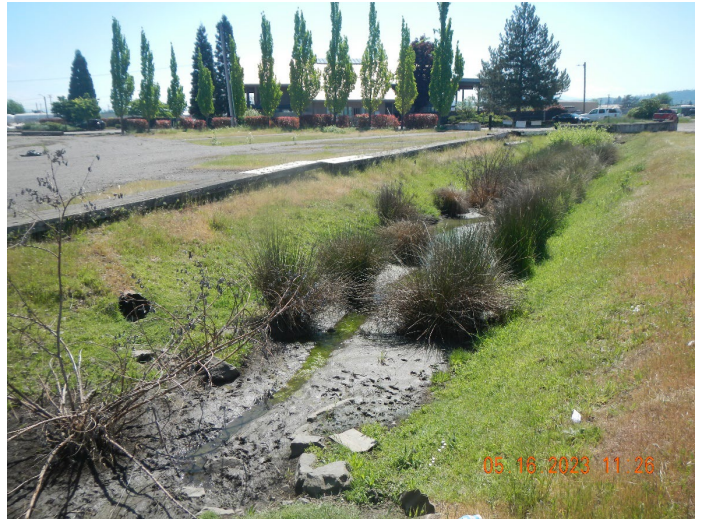
Photo #:08 (DSCN3263)

Description: Facing south, photo of the east end of the municipal drainage ditch. Multiple connection pipes observed on both sides (including neighboring property).

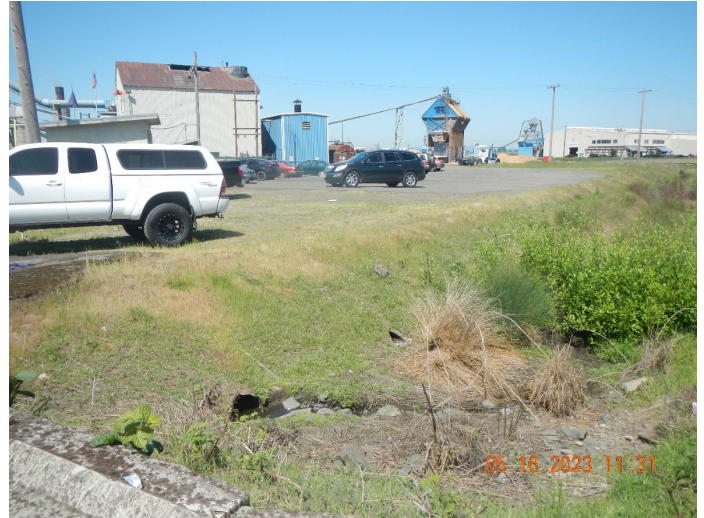
Photo #:10 (DSCN3265)  
Description: Facing west, observed flow within the eastern side of the municipal drainage basin.

We observed a northern catch basin within Basin #1 (**Photo 9**). We also observed a small amount of water flowing into the eastern portion of the municipal drainage basin from a subsurface pipe (**Photo 10**). Mr. Maples wasn't aware of source of the observed water. We continued south and observed the paved areas around the metal fabrication shop within Drainage Basin #5. (**Photo 12**).

As discussed earlier in the report, during the walk-through near the northern section of Drainage Basin #5, we also observed a small amount of water flowing into the eastern portion of the municipal drainage basin from a subsurface pipe (**Photo 10**). Mr. Maples wasn't aware of source of the observed water. As the inspection occurred during dry weather conditions, the concern was a possible non-stormwater source potentially entering the municipal drainage ditch.

During the closing conference, Mr. Maples discussed that he would work with PBS Engineering and Environmental Inc. (Facility Consultant) to determine the source of the observed piping/discharge and address the issue accordingly.

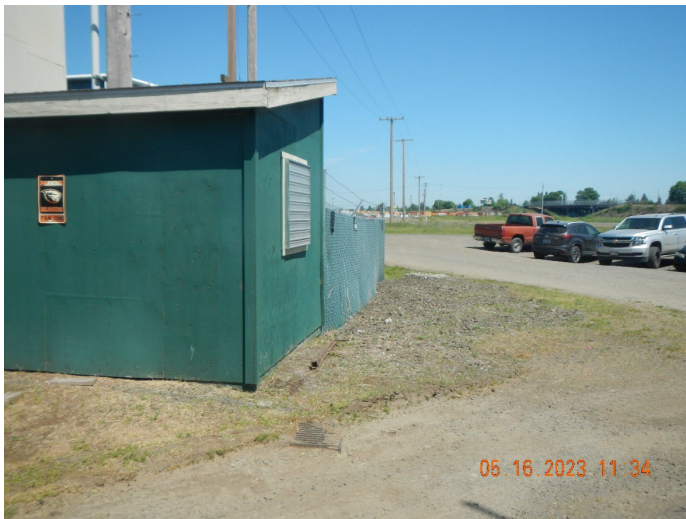
Photo #:11 (DSCN3266)  
Description: Facing north, photo of observed catch basin not on SWPCP Map.

grate/catch basin located near the southeast corner of the electrical shed (**Photo 11**). The grate/catch basin was not listed Facility Map (**Attachment C**).

As discussed earlier in the report, during the walk-through within Drainage Basin #1 we observed a small grate/catch basin located near the southeast corner of the electrical shed (**Photo 11**). The grate/catch basin was not listed within the Facility Map (**Attachment C**).

The concern was the observed catch basin not identified on the Facility Map and the unknown discharge location from the observed catch basin at the time of inspection.

During the closing conference, Mr. Maples discussed that he would work with PBS Engineering and Environmental Inc. (Facility Consultant) to determine the discharge location of the catch basin and have it added to the Facility Map.
