INVESTIGATION OF FLAME SPREAD CHARACTERISTICS  
OF TWO DECORATIVE WALLBOARDS

Westinghouse Electric Corporation  
Micarta Division

Project No. 717-2-35  
Final Report

March 26, 1959

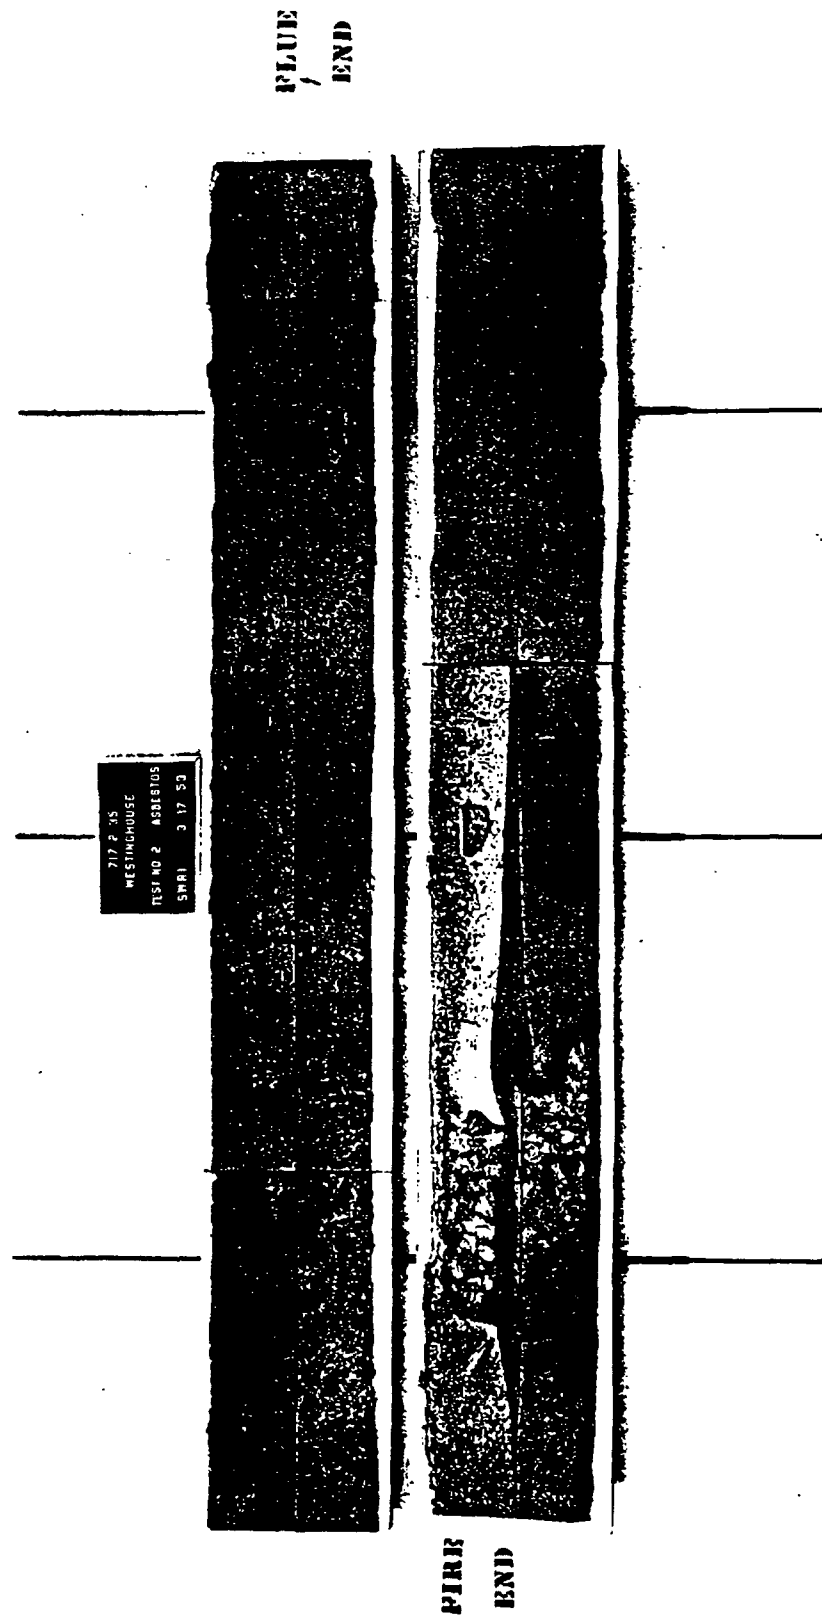
In each of the tests with "Asbestos Decorative Panel Wall" the center joint opened due to shrinkage, providing a gap of approximately 1/2" on the 8' section at the fire end of the specimen. This exposed the wood framing and released that side of the specimen that was not nailed. This side dropped at the center line 2-1/2" to 3-1/2" in the first 8' and 1/2" to 1" in the second 8' section. This opening also exposed the back of the specimen on one side to flame with resultant charring.

The exposed laminate lost bond for approximately 8'-11' on the unattached (unnailed) side and for 7'-8' on the attached side of the specimen

The core of these specimens appeared to be completely charred in the area of direct flame impingement with the depth of char decreasing to approximately 1/16" at the end of the specimens.

Fig. 1 Test No. 2. Asbestos Decorative Panel Wall after test.

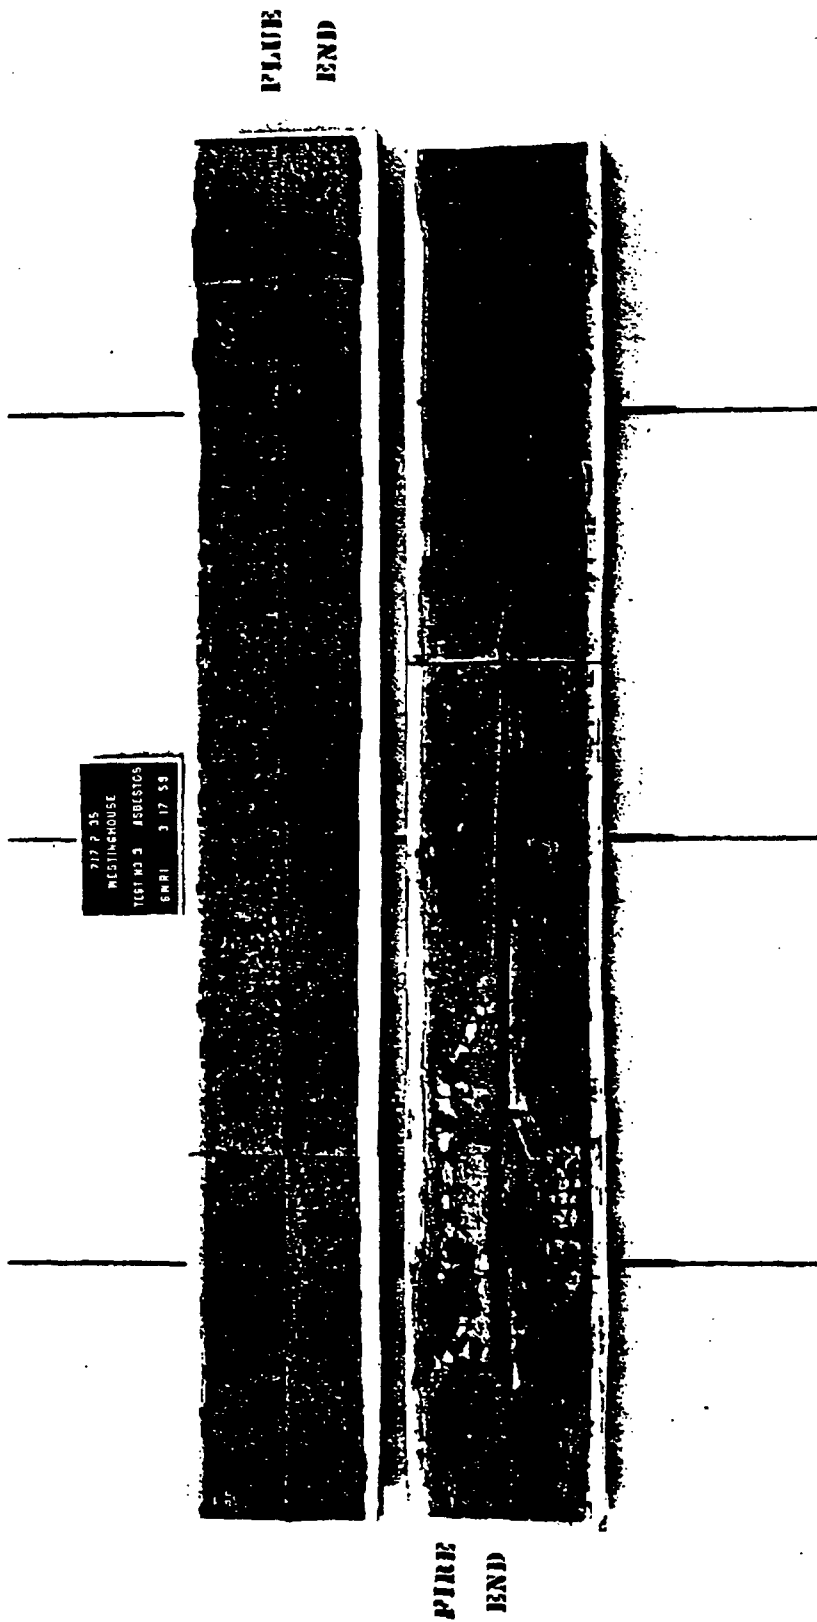
Fig. 2 Test No. 3 Asbestos Decorative Panel Wall after test.

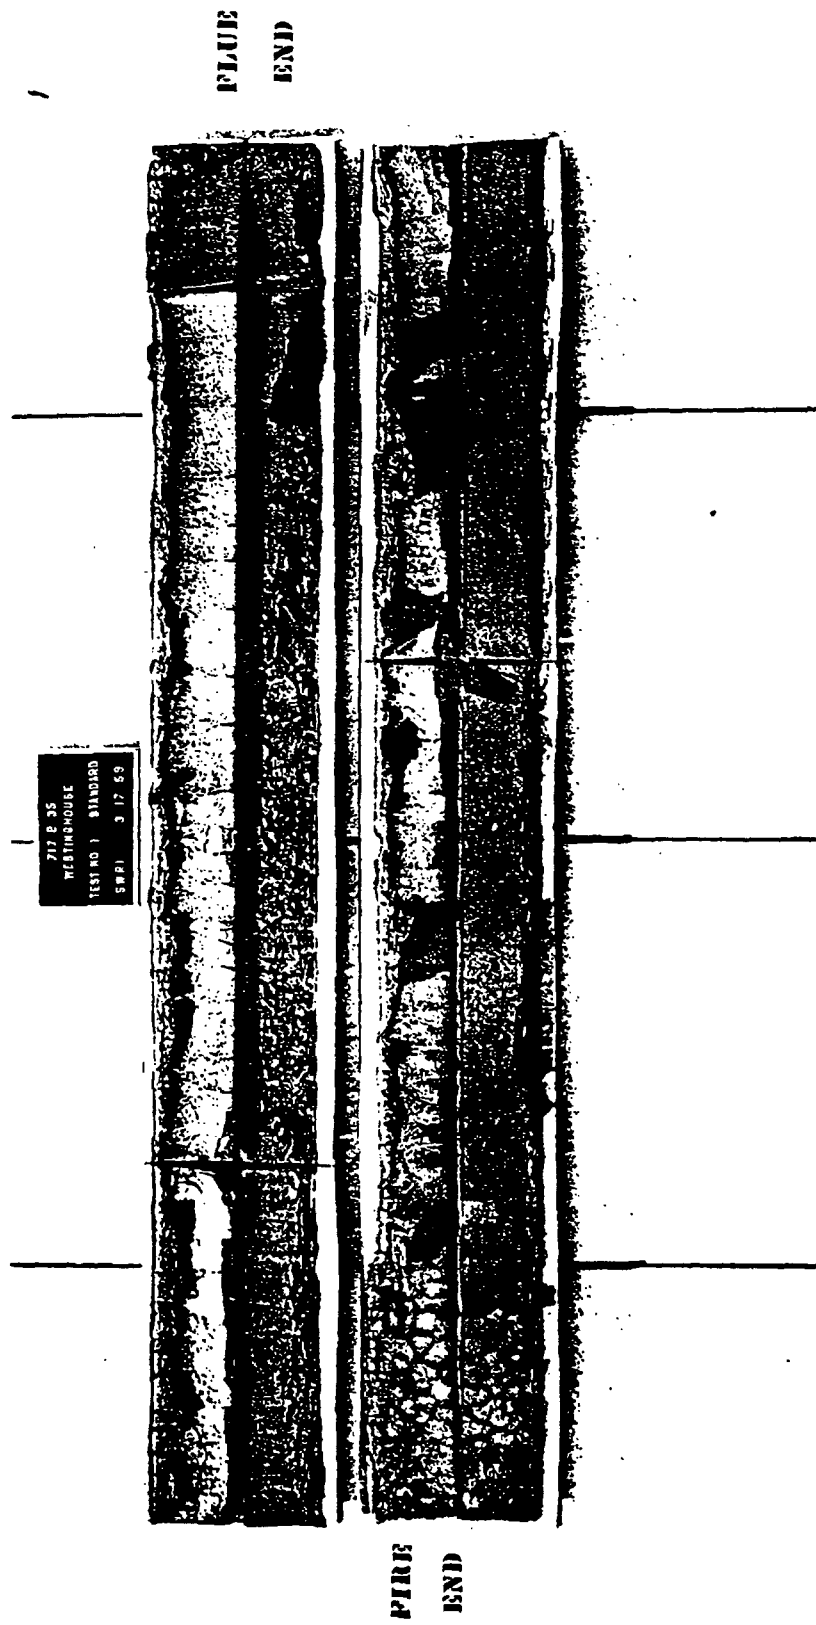
With the "Standard Decorative Panel Wall" specimens the center joint opened for approximately 20' from the burner end, exposing the center framing member for approximately 15'. This again released the unnailed side of the panel and exposed the back of one side to the flame with resultant charring on the back surface. The exposed laminate burned off the face of the specimens for their entire length.

The core of the "Standard" specimens apparently was completely charred along the entire length although the bond on the back surfacing material was not broken on the section furthest from the flame.

Fig. 4 Test No. 1 Standard Decorative Panel Wall after test.
