**UNITED STATES ENVIRONMENTAL PROTECTION AGENCY, REGION 2
CARIBBEAN ENVIRONMENTAL PROTECTION DIVISION
MULTIMEDIA PERMITS AND COMPLIANCE BRANCH**

NPDES COMPLIANCE EVALUATION INSPECTION

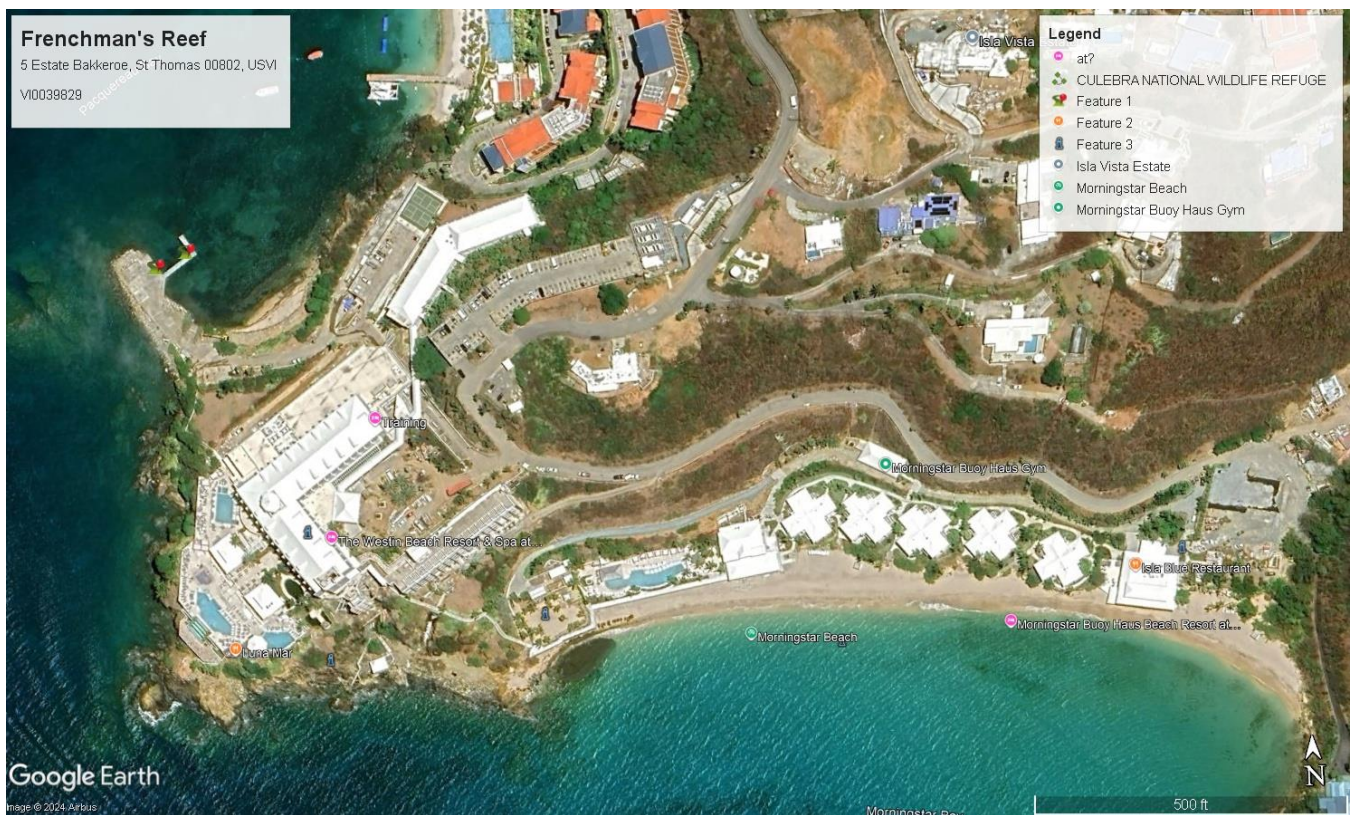
⁴ On The Level, Inc. (OTL) is a company providing support in management of the Physical Plan, general maintenance, and management of related records. The Solutions Group, LLC. (TSG) is a company who operates the ROP and the Wastewater Treatment Plant (“WWTP”) on behalf of Frenchman’s Reef.

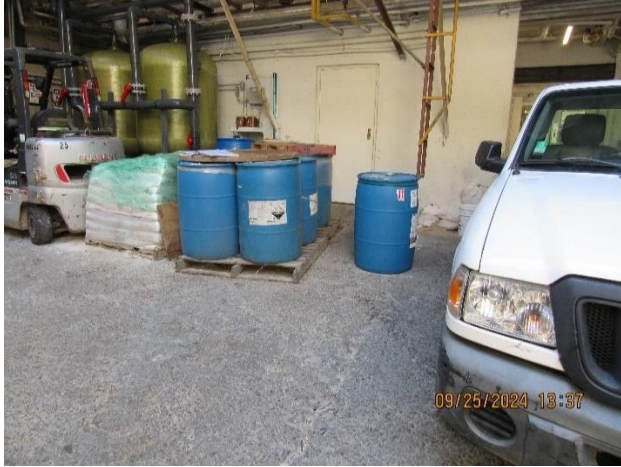
IMG 1379-Calcium carbonate and other chemicals improperly stored and unprotected from potential damage by operated vehicles in the LUB of Facility.

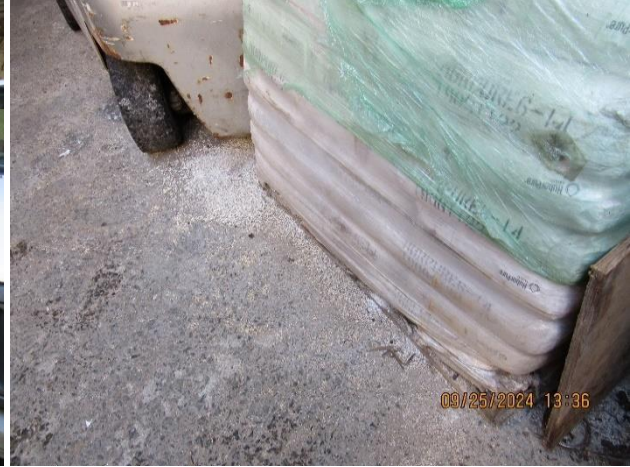
IMG 1376-Close-up of calcium carbonate spilled on pavement, exposed to rain and stormwater runoff and that will be readily washed-off.

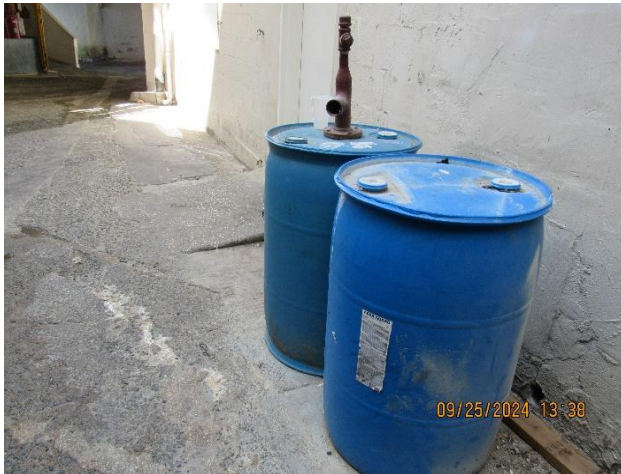
IMG 1381-55-gallons drums of aged chemicals in the LUB area unprotected from being damaged by operated vehicles.

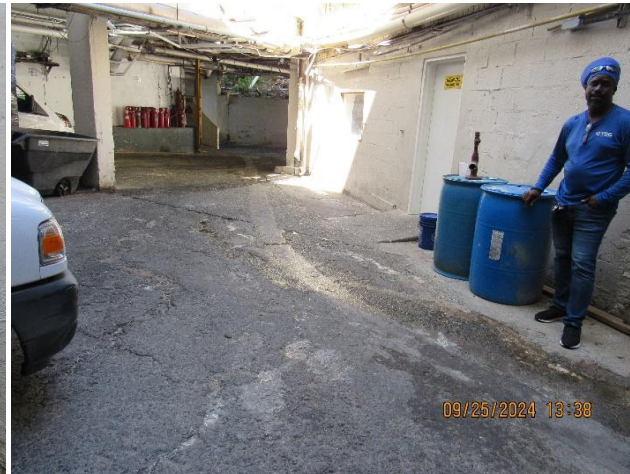
IMG 1380-Existing stormwater flow path in LUB area, that drains down gradient towards the Back-Of House (BOH)² area and into stormwater catch basins just downstream.

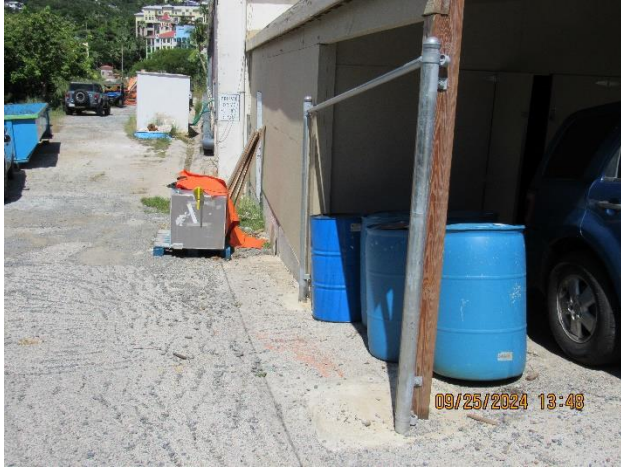
IMG 1388-Fuel tank exposed to weather conditions also owned by DWS, not within a containment.

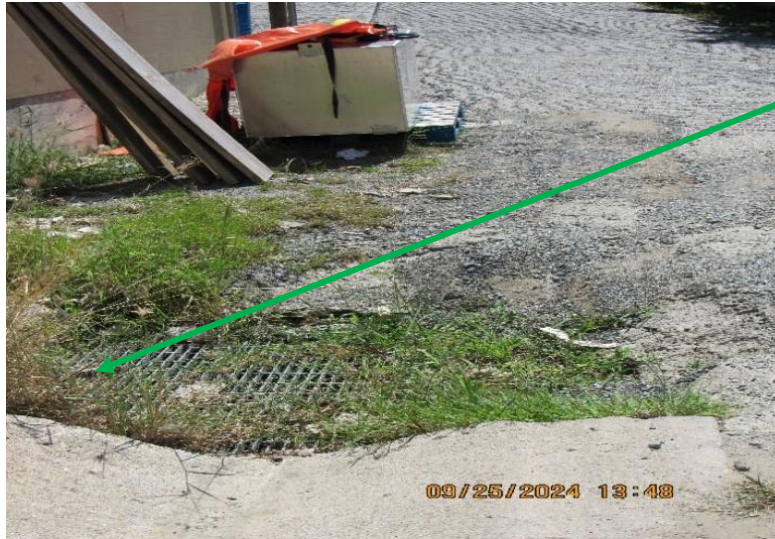
PART B. Permitted outfalls identified and observed during the 2024 Inspection, through which the Facility discharges pollutants into receiving water bodies identified in the Permit.
