### Lining Material Transfer

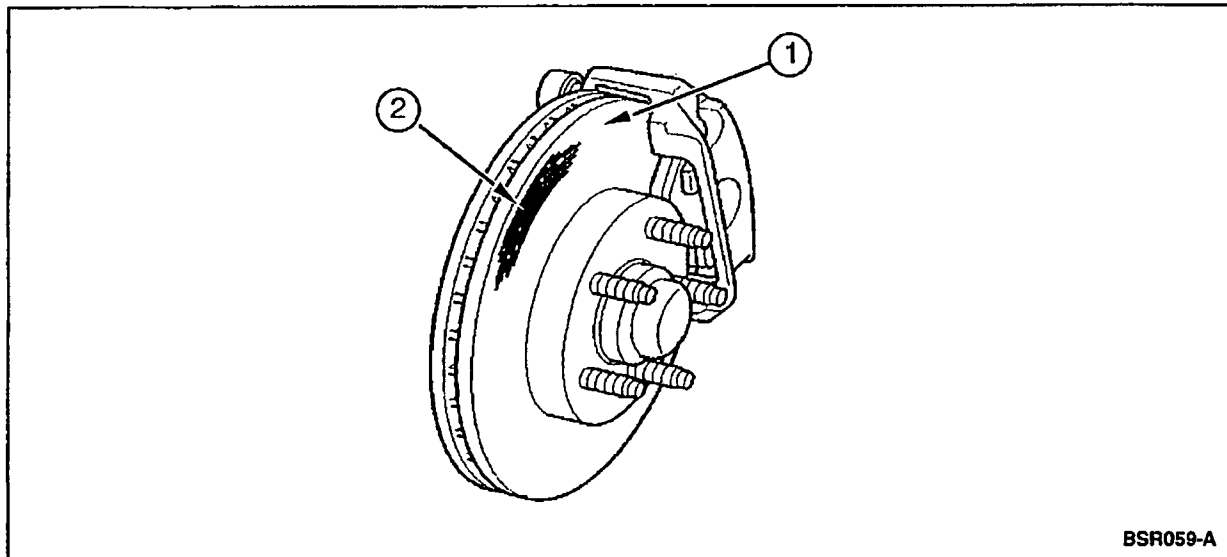
BSR059-A

### Lining Material Transfer

| Item | Description | Item | Description |
|---|---|---|---|
| 1 | Rotor | 2 | Lining Transferred To Rotor |

- As the vehicle is driven, lining material can become attached to the disc brake surface in very small amounts.
- Lining transfer is normal, but with some pad materials the transfer can be uneven or excessive in certain conditions.
- Lining material transfer creates an uneven friction surface on the rotor.
- The brake pads tend to grab where material has transferred to the rotor and this is felt in the steering wheel and the vehicle.
- If there is no runout or DTV, but the vehicle still has the roughness symptoms, lining material transfer may be the cause.
