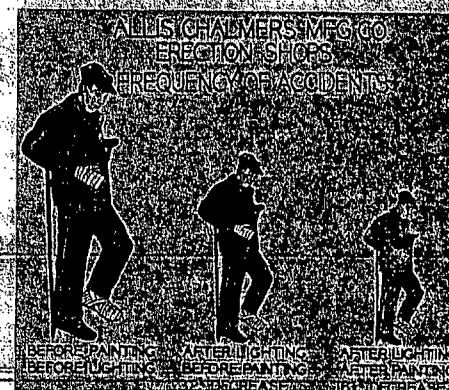
Figure 16. Benefits derived from relighting and painting the erection shop. Accident rate reduced 32 per cent after relighting and decreased 16 1/2 per cent further after painting.
