## How to analyze a clutch system by inspecting the clutch release bearing

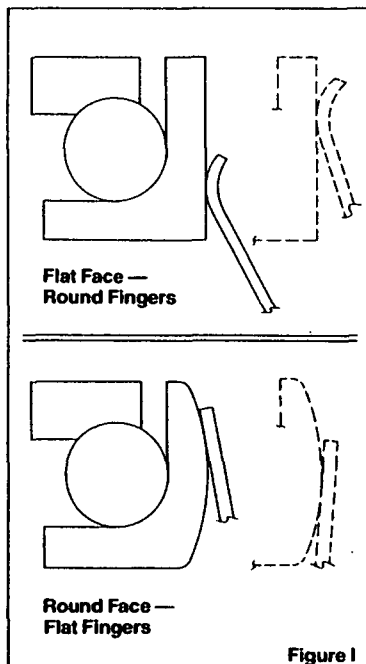
In an earlier Tech Tip, we discussed how the clutch system operates. As we described it, the clutch release bearing contacts the clutch fingers (or levers) and releases the clutch as the bearing moves into the clutch fingers. This movement along the inner face of the bearing is shown in the diagrams in Figure 1 below.

During this movement of the clutch bearing, the fingers slide radially on the face of the bearing. This sliding on the face results in a wear pattern on the face of the bearing. The resulting wear pattern can help diagnose a clutch system problem.
