**Bulletin for the Propane Insulation Systems**

PTB-48-7A  
February 15, 1979  
Replaces PTB-48-7

ASBESTOS IDENTIFICATION IN OLD CALSIL INSULATION\*

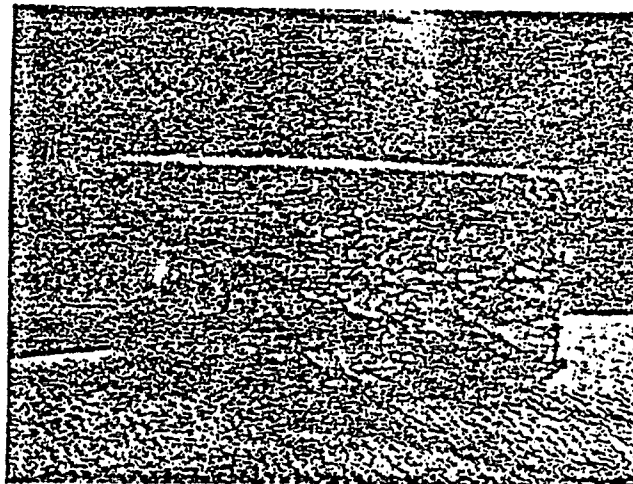
Figure No. 1

Appearance of asbestos-  
containing insulation  
in propane flame.  
Asbestos fiber does not  
melt and shows up as  
little glowing rods in  
the flame.

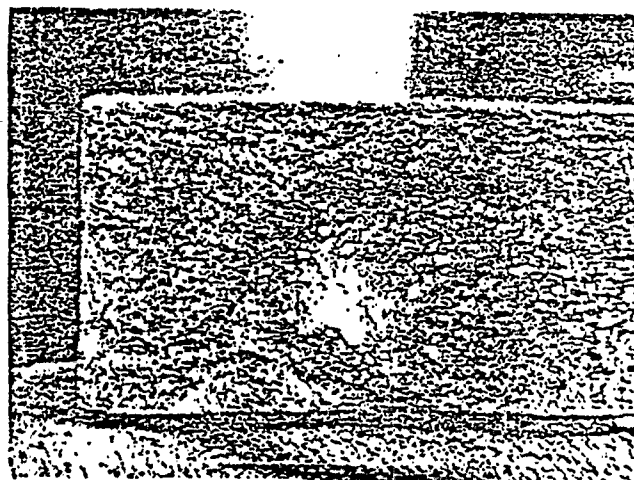
Figure No. 2

Appearance of non-  
asbestos insulation in  
propane flame. No rods.
