Examination and Test

CORRULUX

Laboratory Report  
No. 11864  
July 1, 1951  
Revised March 23, 1953

REPORT NO. 11864  
Class No. 4420  
EXAMINATION AND TEST OF  
Corrulux

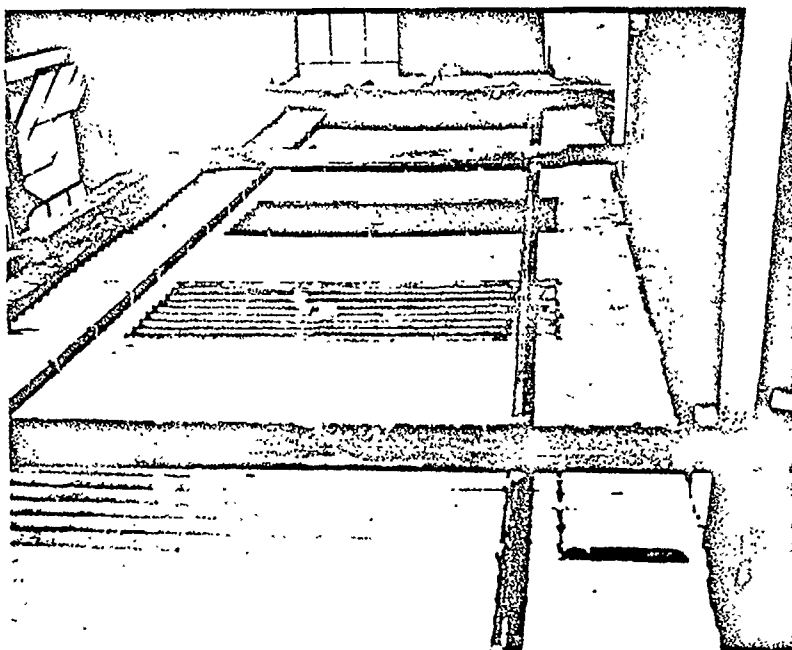
The discoloration on the outside of the Corrulux sheets was somewhat slower than on the exposed surface. No visual damage was noted at 6 minutes. However, at 8 minutes, the first sheet was black in color and the discoloration became less pronounced toward the flue end of the furnace, extending to the 4th sheet when the test ended.

First Sheet: Plastic resins were almost completely consumed with fiberglass mat left intact. Fiberglass mat still retains the corrugated shape but was being supported in place at the sides and ends by the corrugated iron. Fiberglass is black in color with white streaks in the low corrugations.

Second Sheet: Practically all of the plastic resins have been burned or distilled out of Fiberglass mat. Individual fibers in mat are easily distinguished. Corrugations in the material can be easily crushed with finger pressure. Top of corrugations are dark brown in color while the low portion is black.

Third Sheet: Low corrugation is blackish brown in color while the top is the original green color. Plastic resins have been distilled from low corrugation as individual glass fibers are apparent.

Fourth Sheet: Low corrugation brown in color but top is original color. Strength of sheet has been impaired as sheet is easily deflected.

Unexposed Surface of Corrugulux  
After Furnace Test
